# **SCHEDULE OF WORKS TO IDENTIFIED HERITAGE ASSETS**

## **ST MARY'S CHURCH HULME**

**SEPTEMBER 2025  
REV A**

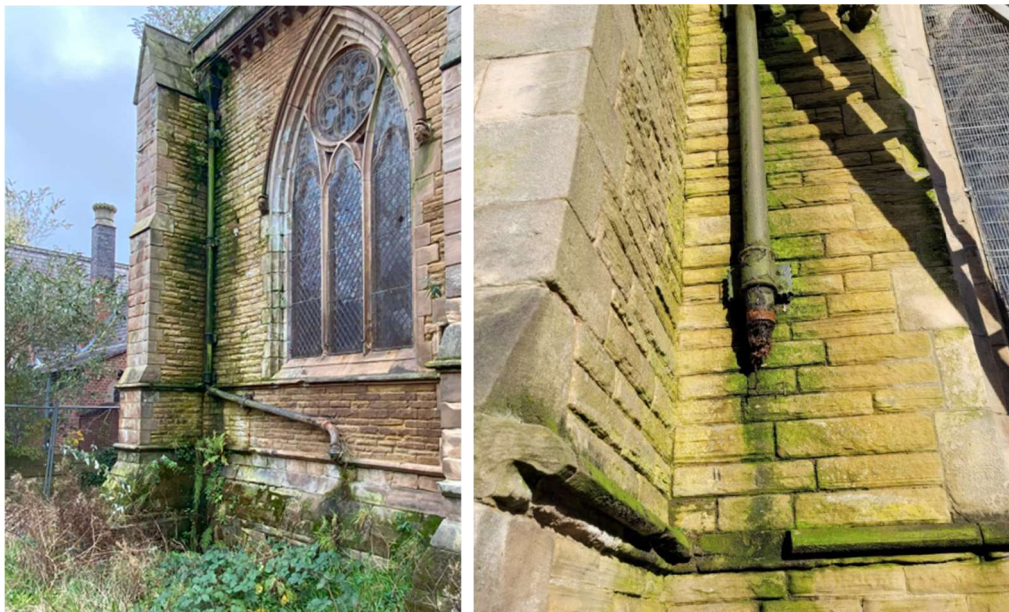
- 5.1.4 The high-level cast-iron rainwater goods to the main nave appear to be in good condition with no evidence of leaks or excessive rusting
- 5.1.5 Of the four external cast iron pipes on the low-level aisles three were in poor condition with evidence of rusting and failed junctions

- 5.1.6 Leaking junctions had caused excessive damp and vegetation growth to the adjacent stonework
- 5.1.7 The ongoing damp was a possible source of internal damp affecting the plaster finish

*Fig 2 & 3 Damp and vegetation growth associated with corroding cast iron pipes in 2024*

- 5.1.8 In 2024 the three cast iron pipes were removed and replaced, as a temporary solution, with upvc downpipes
- 5.1.9 All hoppers, collars and brackets have been retained and can be reused in the final repairs

| 5.2.2 | The proposed works involve the permanent replacement of these three rainwater pipes with new cast iron downpipes and the reuse of existing brackets and hoppers |

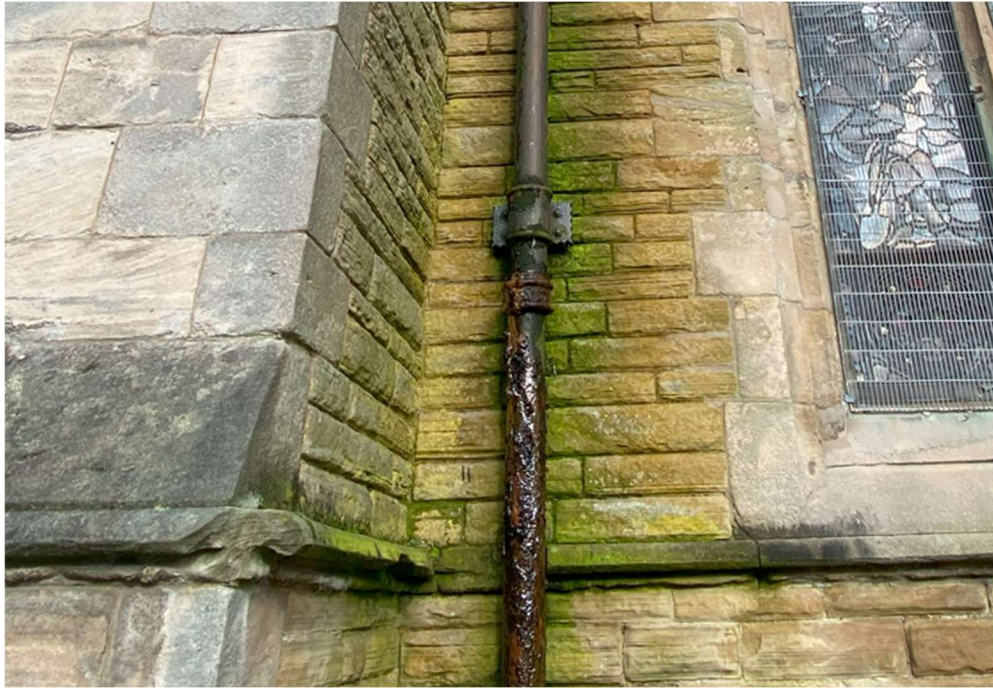
*Fig 4 Example of excessive rust and of existing cast iron brackets*

| 5.3.3 | For all existing cast iron fitting gently remove any loose or flaking paint using a wire brush. Use suitable PPE equipment as pipes may have been painted with lead paint. |

- 5.3.4 Sand all rust spots back to bare metal and until smooth and apply a rust converter to any persistent rust spots
- 5.3.5 Ensure clean and dry and apply a rust inhibitor zinc-based primer to any exposed rust. Primer to be compatible with any linseed oil paints

- 5.3.6 Apply a high-quality rust resistant paint in several thin layers allowing coats to completely dry before applying the next. Colour to match that of any new cast iron fittings in black

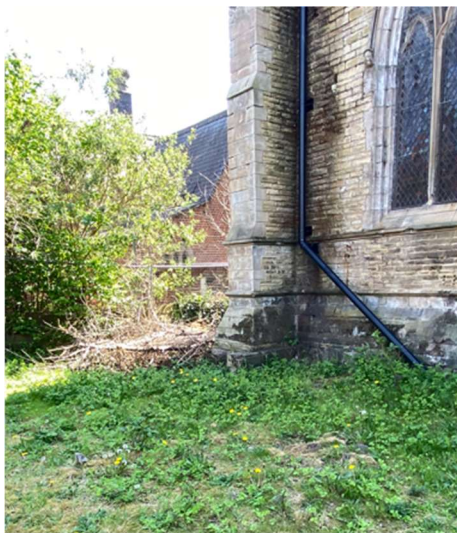
- 5.1.10 The replacement has already made a visual improvement as the damp and vegetation is receding to the adjacent stonework

*Fig 5 Temporary repair in upvc in 2024*

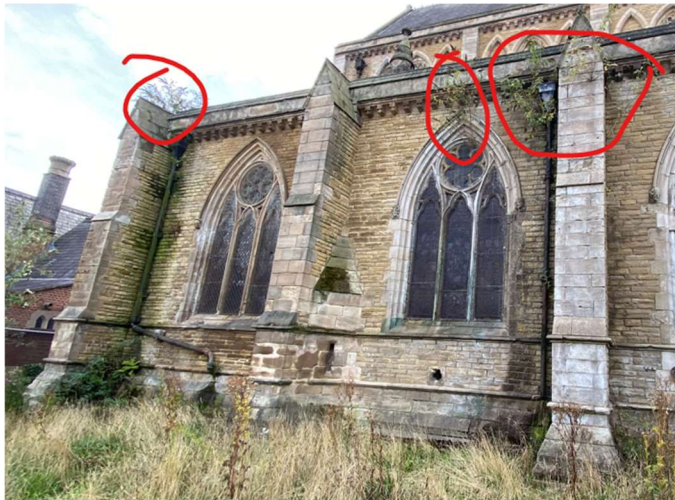
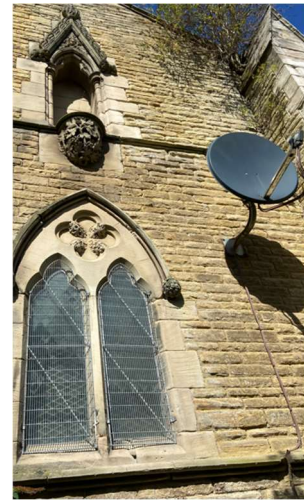
- 6.1.6 Some pointing within these former damp walls has eroded and should be repaired
- 6.1.7 There are some areas where shrubbery has rooted into the mortar joints that need to be attended to

*Fig 6&7 High level shrubbery within mortar joints*

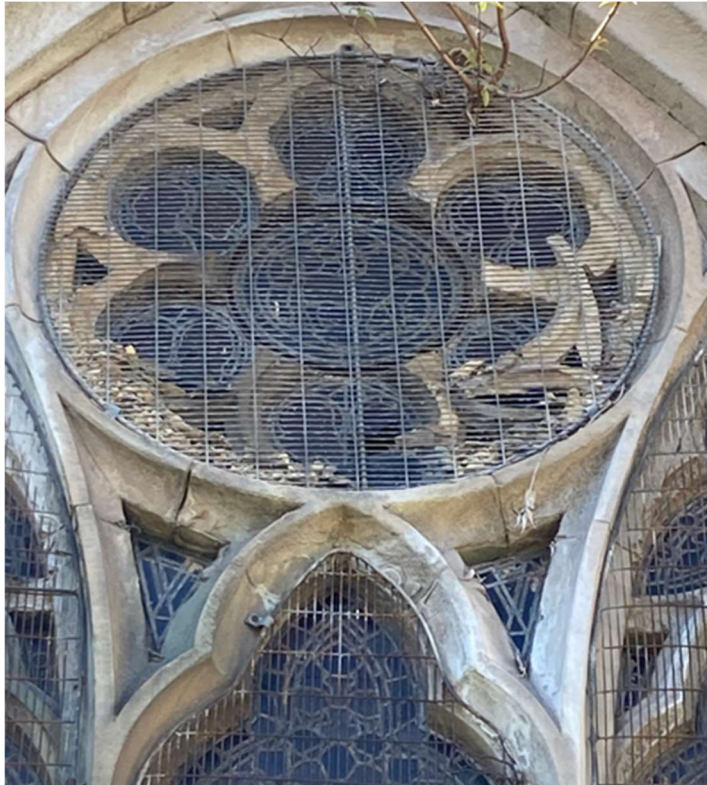
- 6.1.8 Stone tracery to one of the stained-glass windows appears to have delaminated leaving the glazed panel unstable. This could be a cause of future ingress and will need to be repaired

*Fig 8 Crumbled stone to external side of tracery window*

| 6.2.6 | A tracery rose within one of the feature stained-glass windows appears to have delaminated and will be made good |

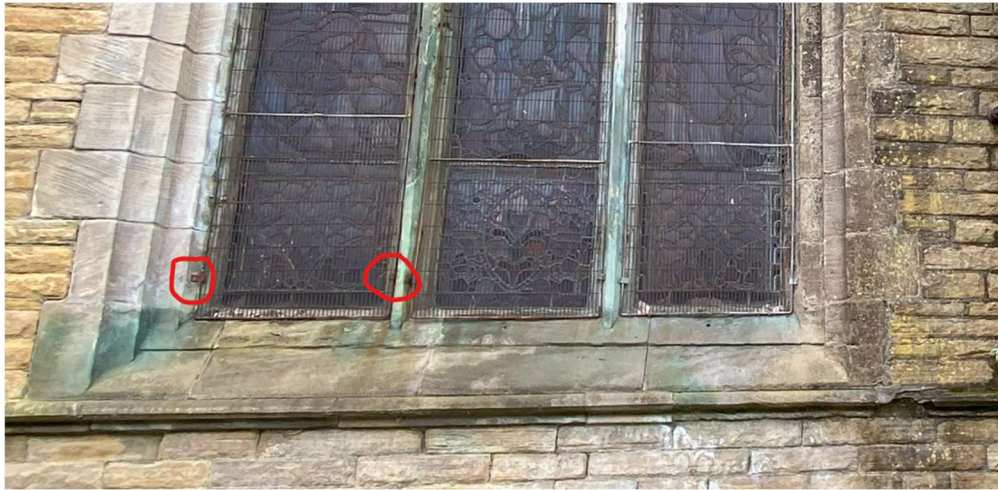
- 6.1.10 There are some isolated instances where the fixings used to secure the mesh appear to have iron content and have corroded causing some localised damage to the stone mullions

*Fig 11 Ferrous fixing clamps used to secure metal security grilles*

| 6.2.8 | Where ferrous fixings have been used to secure security mesh they will be replaced with a stainless steel or brass fixings. |

| 6.3.6 | Each fixing position is to be examined once removed to check on the deterioration of any stonework due to corroding fixings. |
| 6.3.7 | Wholesale surgery to each fixings is not recommended as the preservation of the existing stone is preferred. Cathodic protection is also unsuitable within the centre of stone mullions |
| 6.3.8 | New stainless steel or brass fixings should be utilised when refixing the screens to ensure no corrosion will damage the stone further |

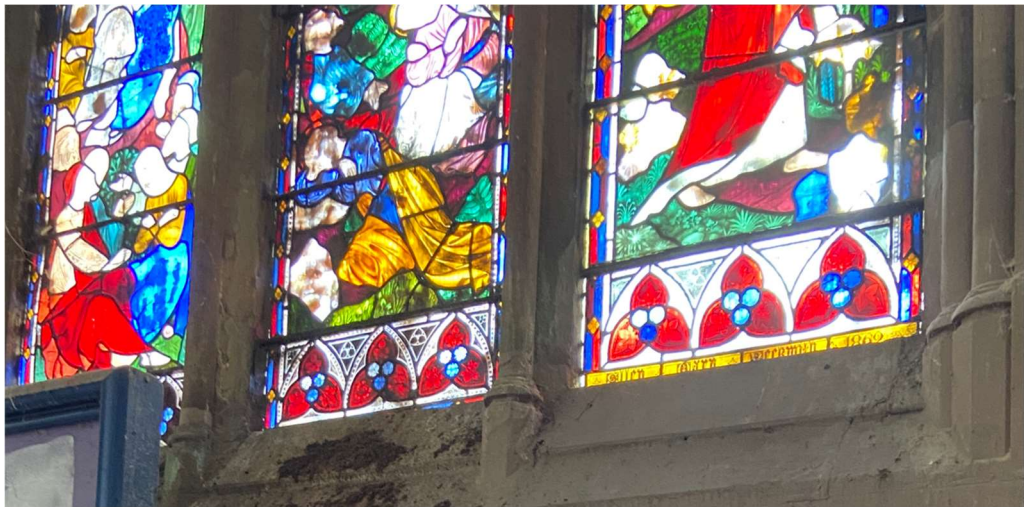
- 8.1.6 There are instances where the panels are bowed and a few instances where the coloured glass is either missing or appears to have been replaced with a clear glass infill.

*Fig 16 missing pieces within stained-glass panels*

- 8.3.5 A test area would be prepared first to assess the state of any paintwork
- 8.3.6 New glass will be inserted into any missing section of the work by lifting the inside leaf of lead and inserting a slightly smaller piece of glass

- 8.3.7 Glass will be coloured if it is obvious what colour the missing section should be but will otherwise be clear as per any previous repairs
- 8.3.8 The glass will be secured with new lead cement

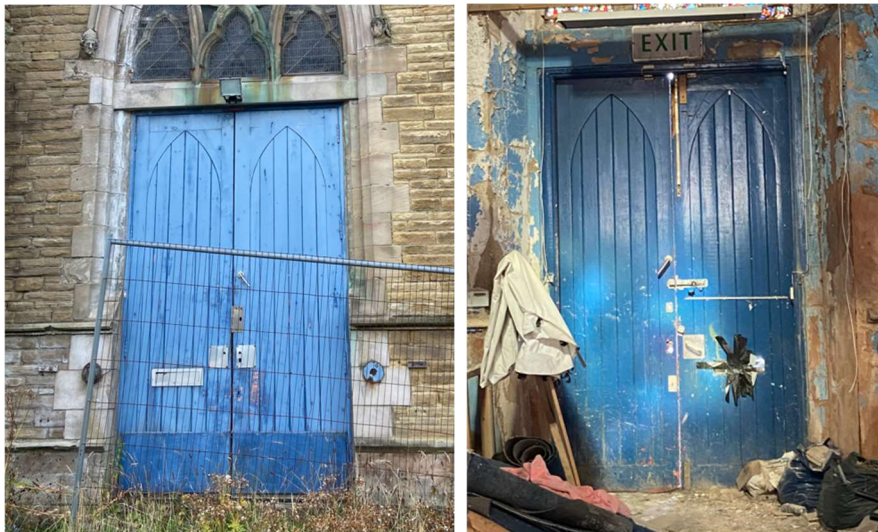
*Fig 17 & 18 existing entrance door off St Marys Street*

Given that this door is not an original feature this is considered an acceptable approach that does not cause any greater harm to the heritage asset. The existing front door has been altered many times in terms of the locks and handles and is also warped so needs to be replaced in any case

| 9.2.1 | The existing double entrance door on to St Mary's Street is to be removed and replaced with a new modern solid timber door as detailed within the submission. |

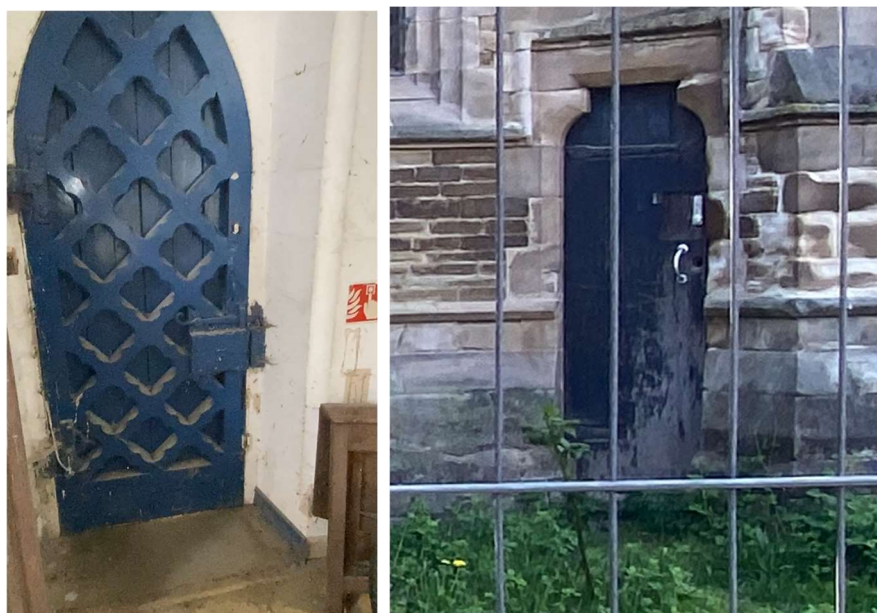
9.1.6 The small external door leading to the basement has been overclad with a plywood panel but includes what appear to be original ornate hinges.

9.1.7 However, newer secure ironmongery and handles have been added to the door which are not of a heritage style

*Fig 19 & 20 external side door and basement door*

| 9.2.5 | The plywood over panel will be removed from the basement door and the level of any damage will be fully assessed and repaired where this is feasible. |
| 9.2.6 | Newer heritage style ironmongery will be added and the existing hinges will be fully cleaned, inspected for any rust, treated and repainted |

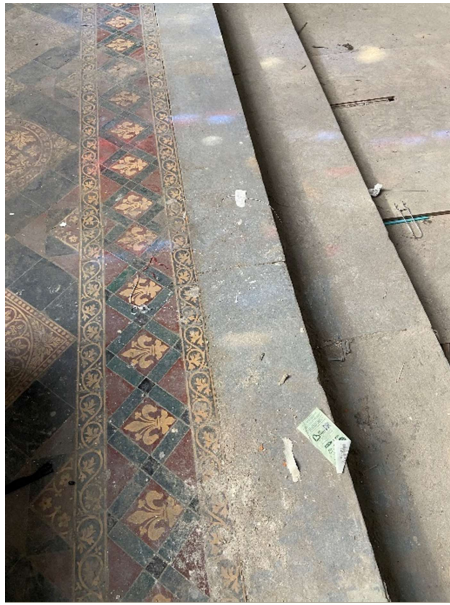
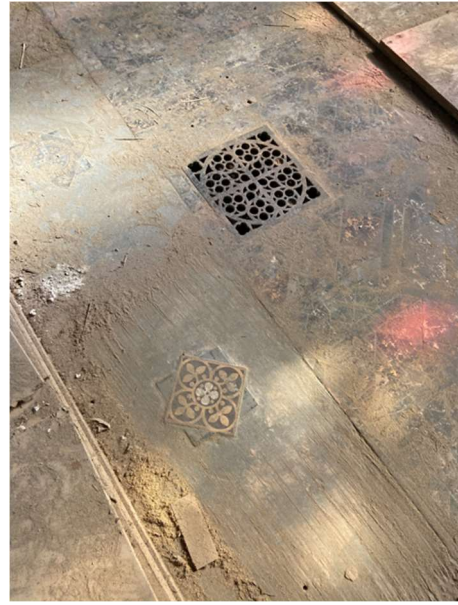
| 10.0 | FLOORS |
|---|---|
| 10.1.4 | The highest part of the floor at the former altar is tiled with encaustic patterned tiles. There is some damage to these tiles. |

*Fig 21 & 22 Encaustic tiles to former altar and inlaid to some steps and also showing metal grillage*

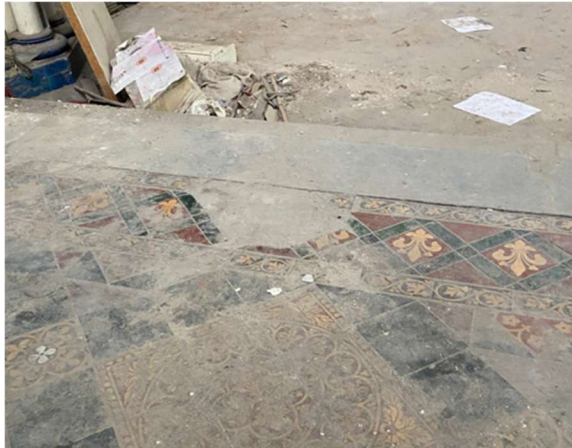
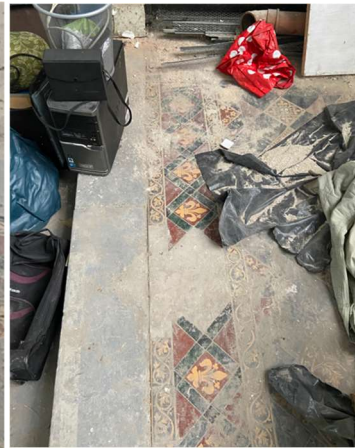
| 10.0 | FLOORS |
|---|---|
| 10.1.5 | There is some evidence of cement infills where previous tiles have been damaged and a previous raised timber floor that has since been removed has left some visible fixing holes. Around the perimeter where some former demolition has occurred at the change in level the tiles are broken |

*Fig 23 & 24 Infills to broken and missing tiles*

- 10.2.8 The client is actively seeking a local craftsperson who may be able to make similar through coloured tiles to replace some of the cement infills so that the full splendour of the original floor can be reinstated in due course

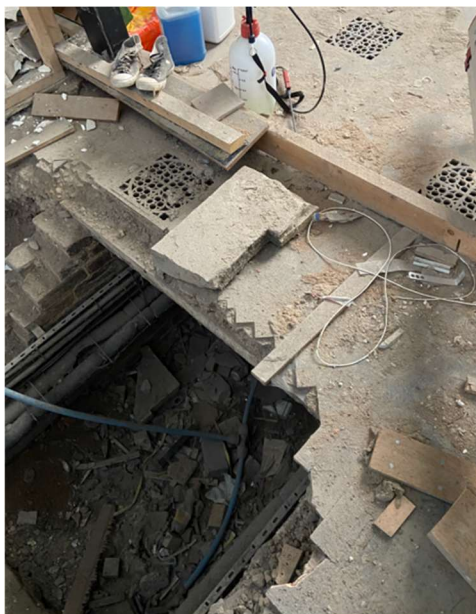
| 10.0 | FLOORS |
|---|---|
| 10.1.7 | The remaining of the tiled floor is of a plainer small format thin clay tile. Much of this has been damaged by the former demolitions to expose the services trenches and presumably for foundations in relation to one of the previous approved schemes for the building |

*Fig 25 Smaller format plain tiles damaged by former demolition*

- 10.3.5 A similar action should be used on the plainer clay tiles throughout the rest of the nave. And loose tiles from the edges of excavations should be carefully removed and retained for use in any patching of areas on completion of the proposed works to the kitchen areas

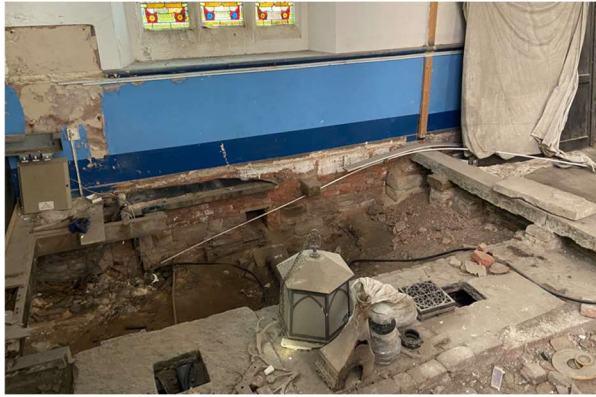
| 10.0 | FLOORS |
|---|---|
| 10.1.13 | In the south-west corner the floors are missing entirely |

*Fig 26 Areas where floors have entirely been removed, cast iron grilles retained*

- 10.2.12 Where floors are missing these will be replaced. Where spanning over the sub-floor trenches this will be done in similar stone slabs. Elsewhere there is an opportunity to include some insulation beneath floors and use stone slab paving above

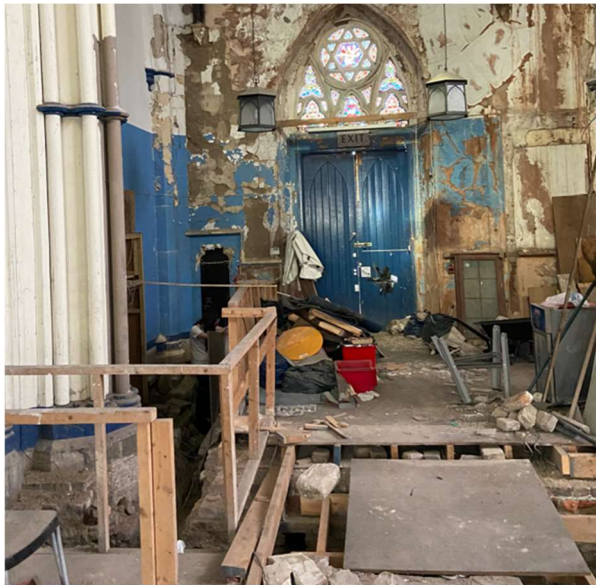
| 10.0 | FLOORS |
|---|---|
| 10.1.11 | At the entrance doors on St Marys Street there has been some attempt to provide a level access and a new raised timber floor has been constructed. It is difficult to ascertain, without further demolitions, what the existing floor is beneath this and what condition it is likely to be in. It is anticipated that some stone slabs will be encountered similar to the aisle on the opposite side. |

*Fig 27 Raised timber floor added to main entrance doors*

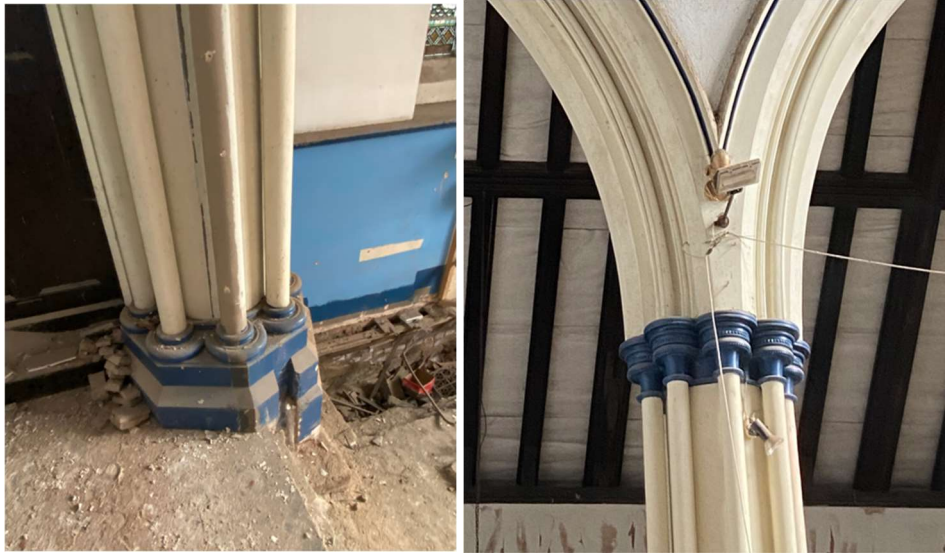
*Fig 30 & 31 Former partition where plinth is incomplete and services fixed to columns*

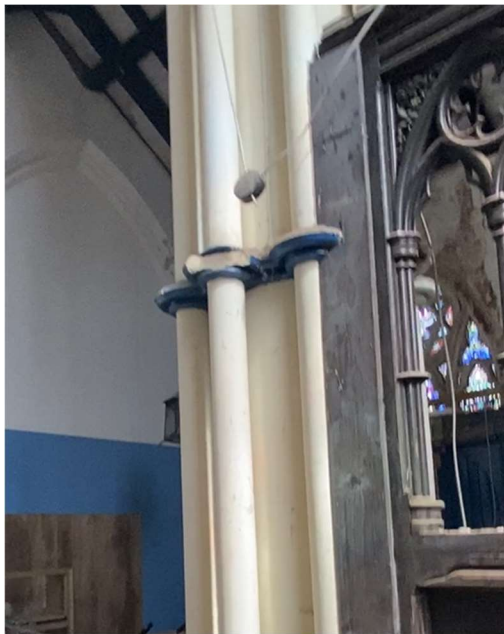
*Fig 32 Broken collar feature to the fluted column*

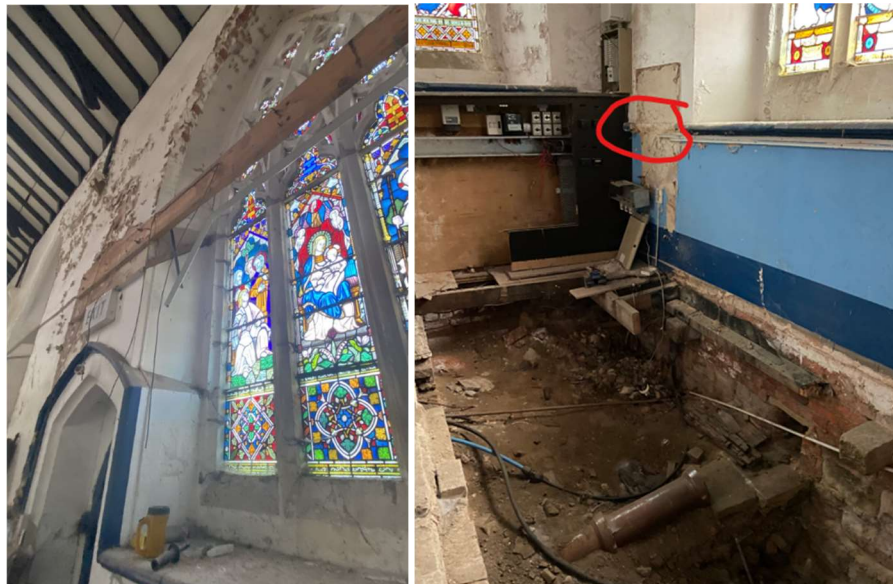
*Fig 33 & 34 Blue painted plaster moulding to window cills and door surrounds including some missing sections*

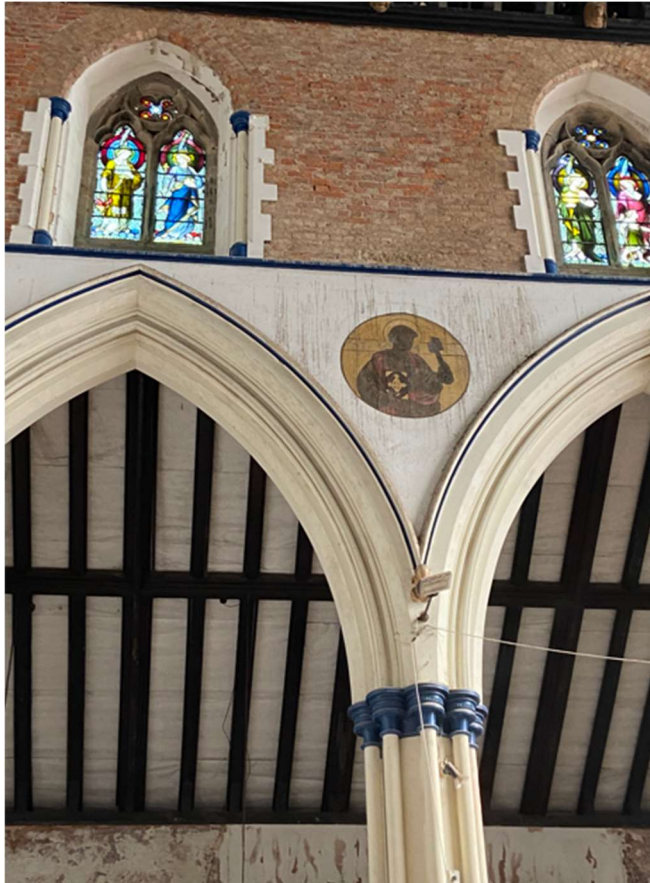
*Fig 35 Plaster previously removed from clerestorey, damaged plaster to the external wall in background, plastered partition with decorative roundel*

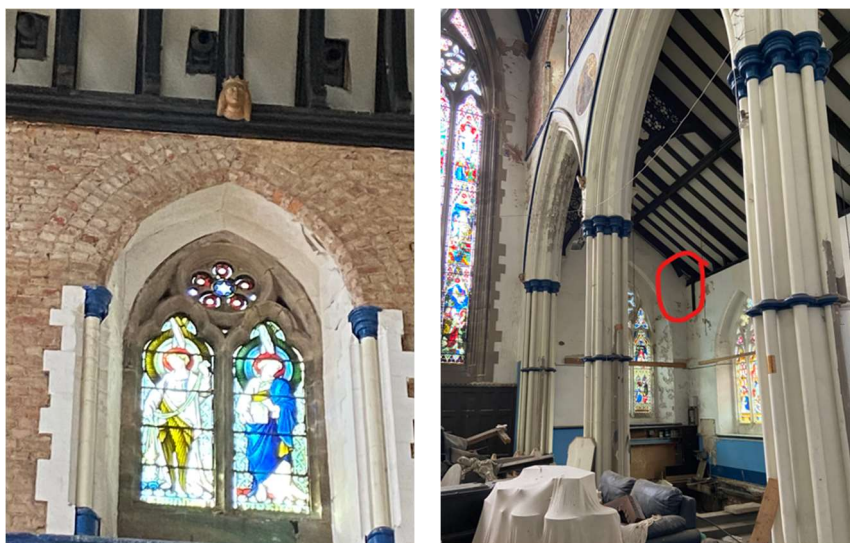
*Fig 41 and 42 cut felt to upper roof and missing ends to trusses*
