**GAS MEMBRANE VALIDATION**

| Site Name: Belle Vue Stadium | Project Number: 12-123 |
| Company Name: Countryside | Date: 11-07-2022 |

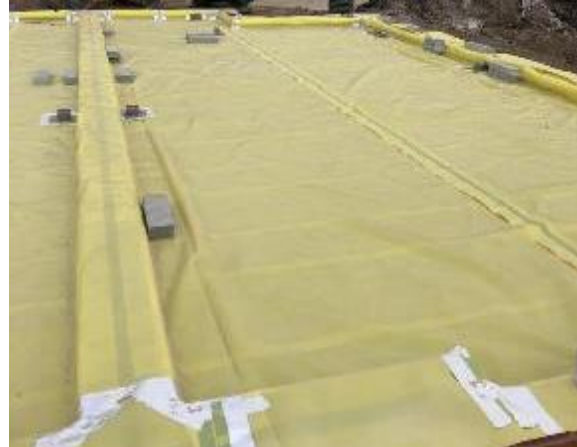
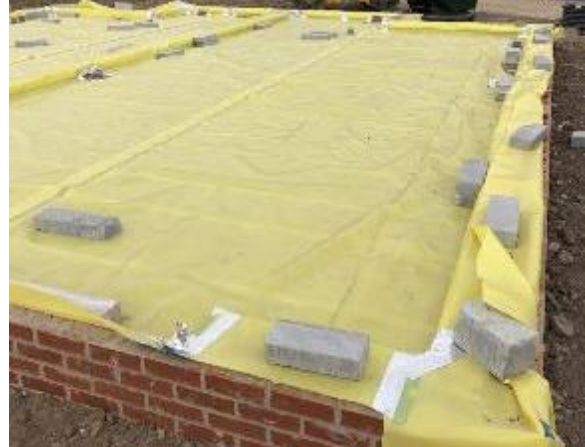
**Plot – 143**

**General Condition of Membrane-Good Condition**

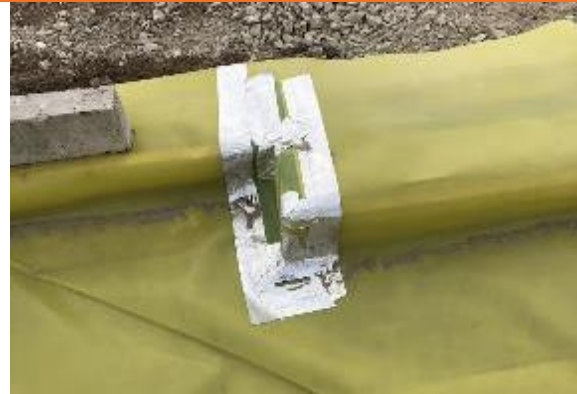
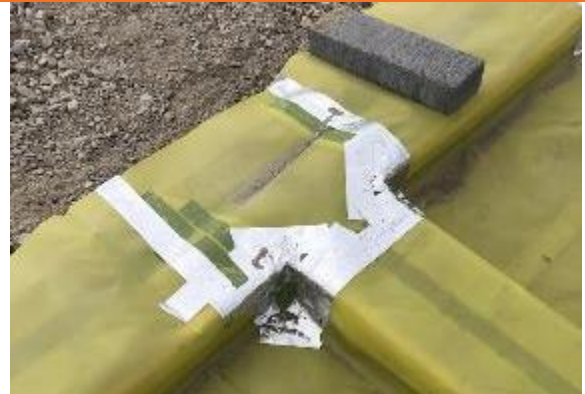
**Verification of Joints and Seals-Overlapped and sealed correctly**

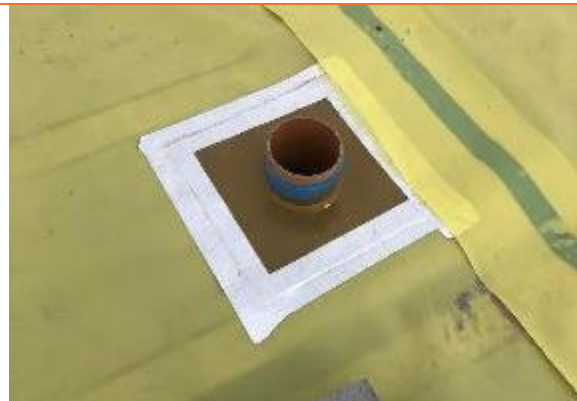
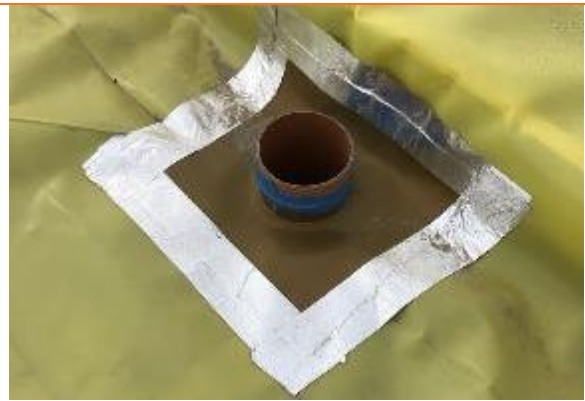
**Verification of Service Penetrations-Good Condition**

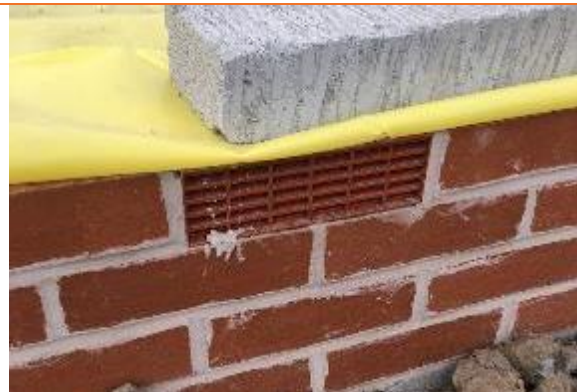
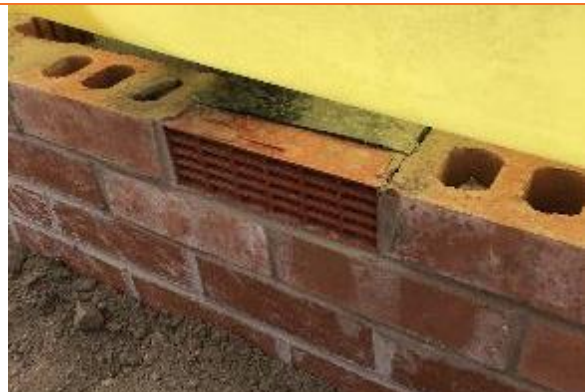
**Verification of Ventilation-Good Condition**

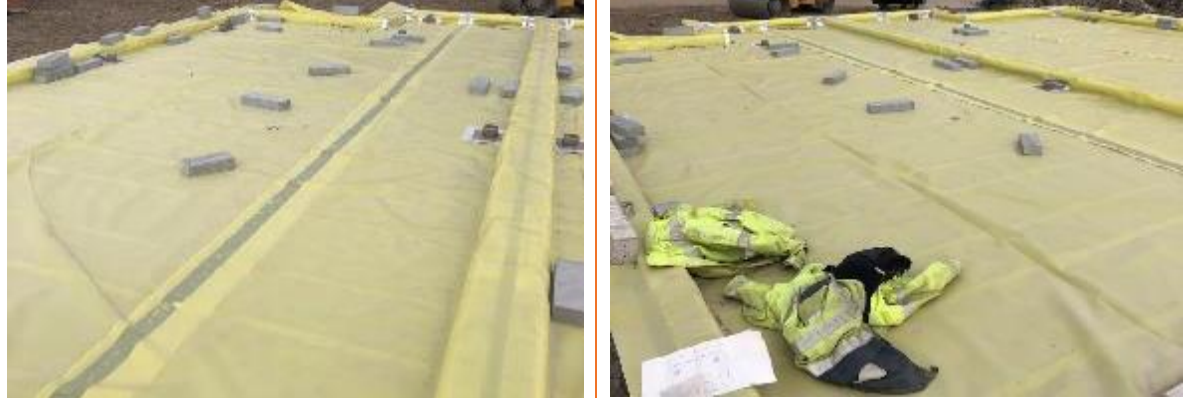
**Plot – 144**

**General Condition of Membrane-Good Condition**

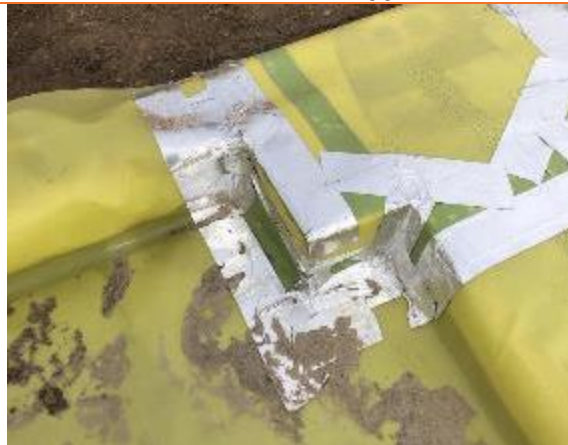
**Verification of Joints and Seals-Overlapped and sealed correctly**

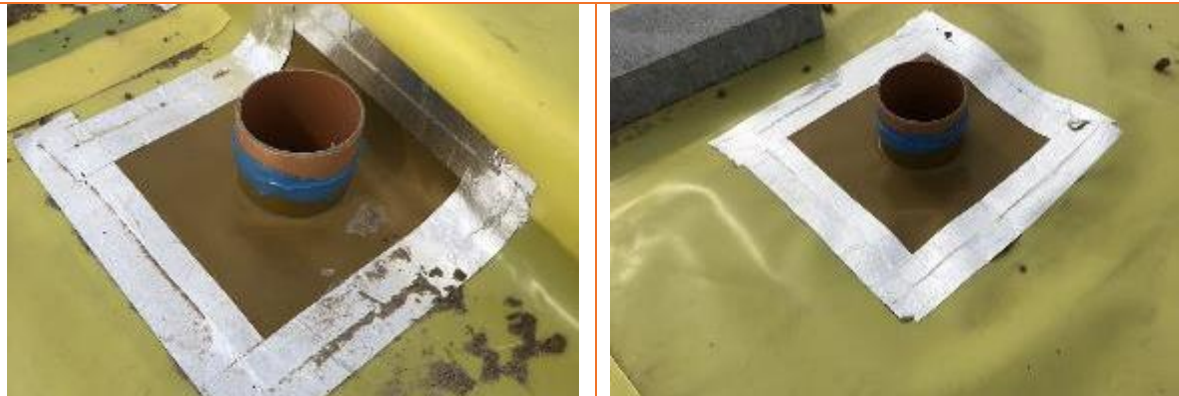
**Verification of Service Penetrations-Good Condition**

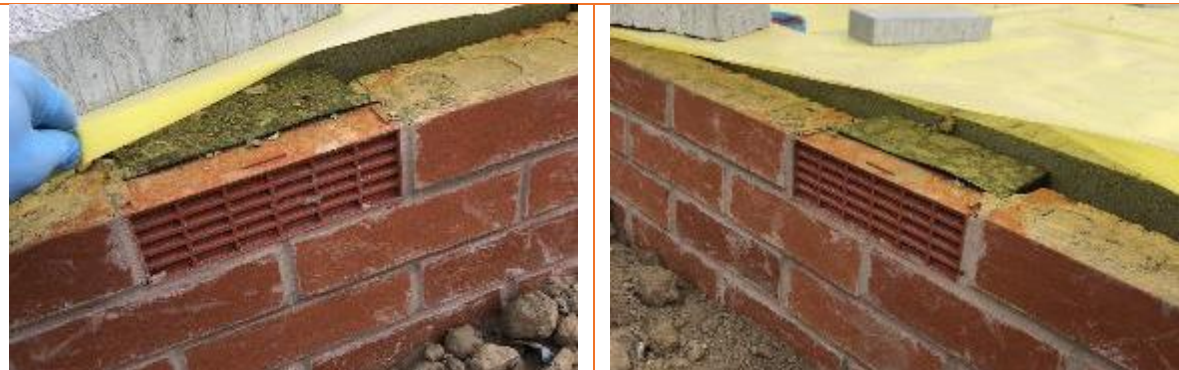
**Verification of Ventilation-Good Condition**

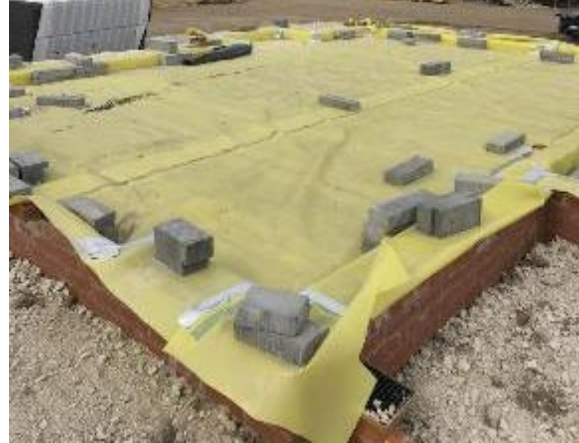
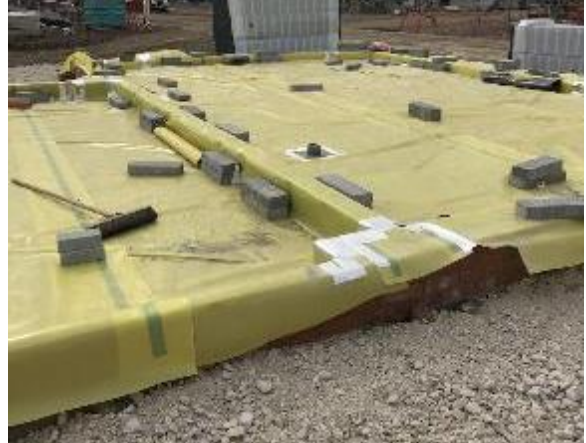
**Plot – 145**

**General Condition of Membrane-Good Condition**

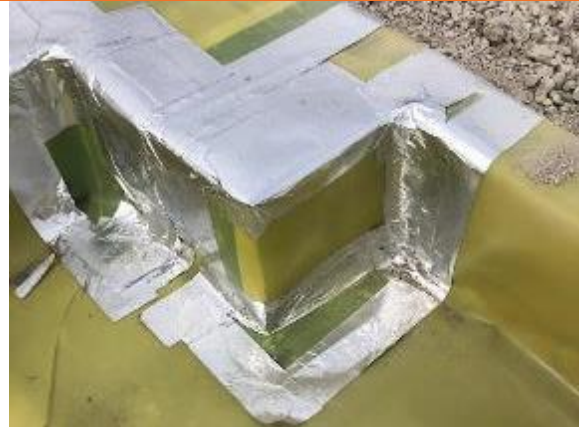
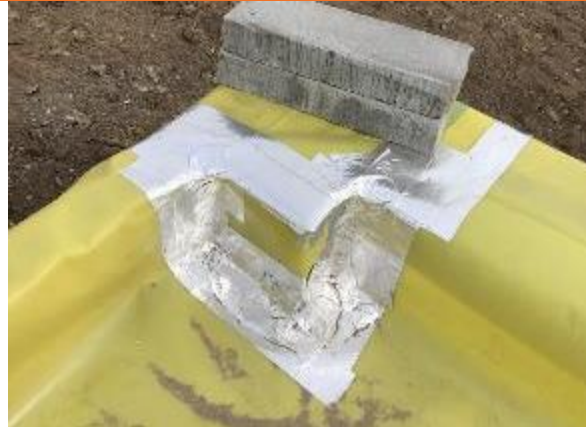
**Verification of Joints and Seals-Overlapped and sealed correctly**

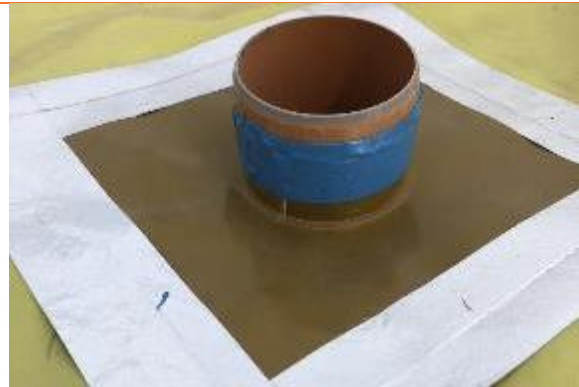
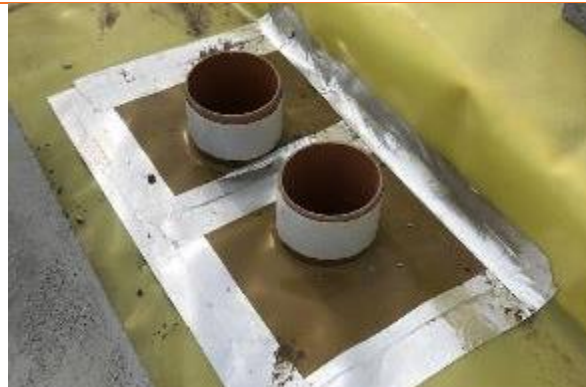
**Verification of Service Penetrations-Good Condition**

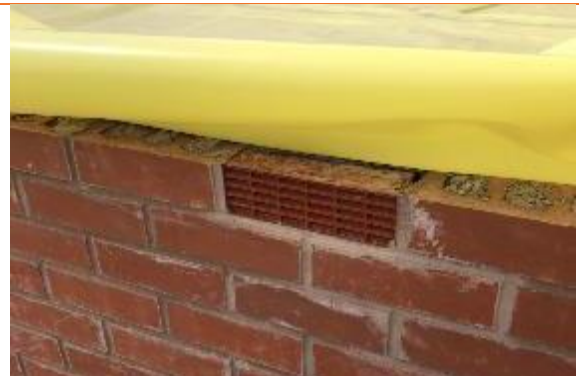
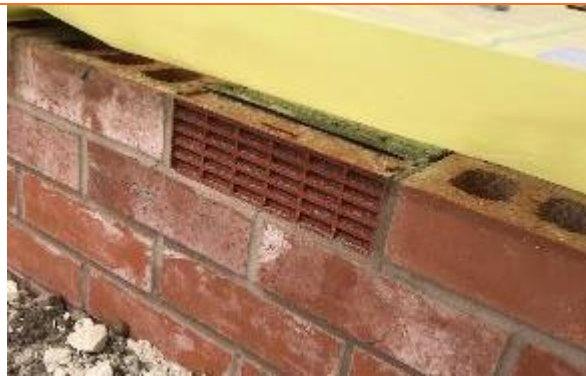
**Verification of Ventilation-Good Condition**
