## GAS MEMBRANE VALIDATION

| <b>Site Name:</b> Belle Vue | <b>Project Number:</b> 12-123 |
| <b>Company Name:</b> Countryside Properties | <b>Date:</b> 15-12-2022 |

Plot Number 177

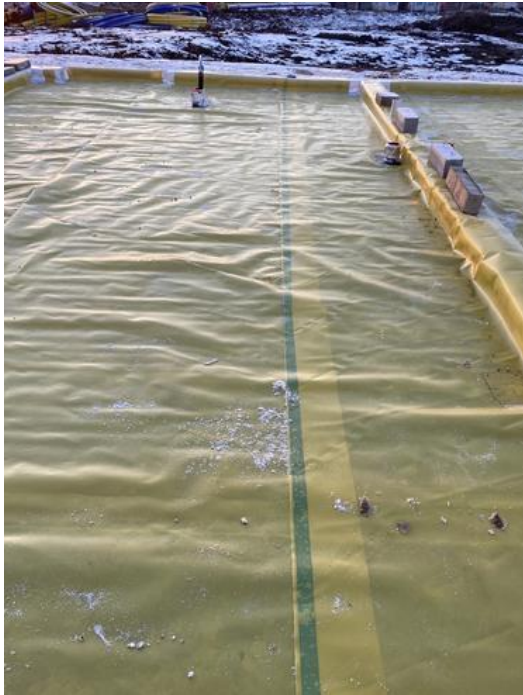
Photo 1

Laps, welds, and joints seals: Joints lapped and sealed in accordance with manufacturer's requirements/ specification? Minimum overlap insured? Sections taped twice? Are welds complete? Appropriate joining/double-sided tape used, Folds running in line with joints? (no joints cutting across folds)

Pass

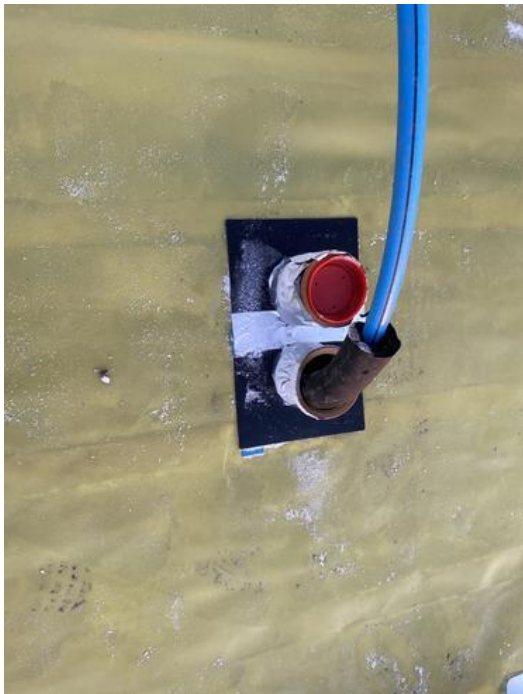
Photo 3

Service entries seals: Top hats seal arrangements fixed around service entries? Use of Jubilee clips?

Yes

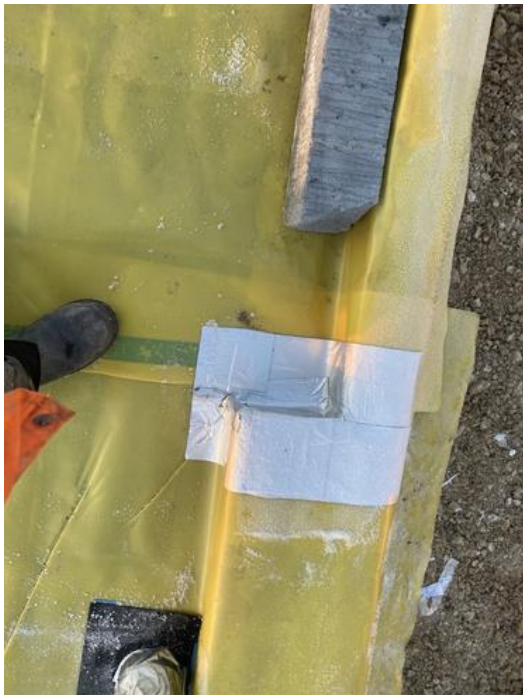
Photo 7

Corners / Internal joints: Check all corners are correctly formed or contractor has used performed corners.

Pass

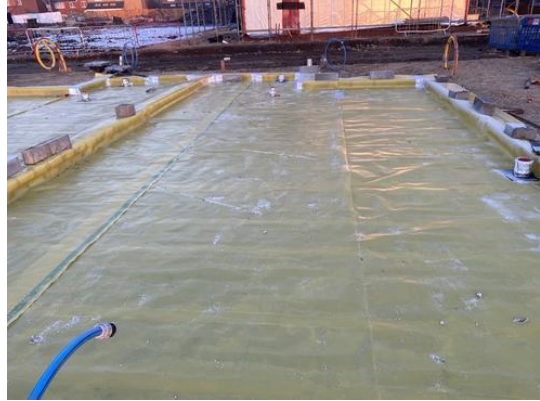
Photo 14

**Extent of Coverage: Is the membrane covering the entire plot? Does membrane span over outside walls?**

Yes

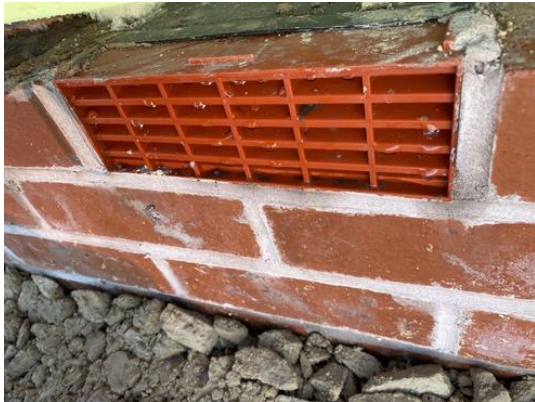
Photo 15

**External Wall Air bricks: Numbers, size. positions as design drawing? (Minimum of 3 walls)**

Pass

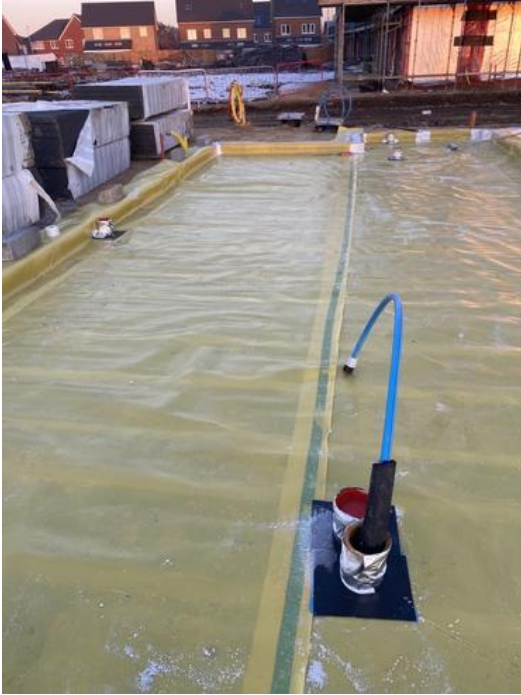
Photo 17

**Laps, welds, and joints seals: Joints lapped and sealed in accordance with manufacturer's requirements/ specification? Minimum overlap insured? Sections taped twice? Are welds complete? Appropriate joining/double-sided tape used, Folds running in line with joints? (no joints cutting across folds)**

Pass

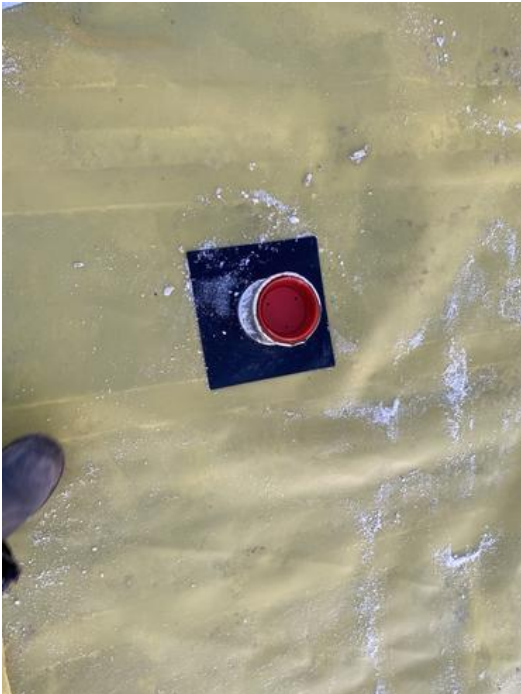
Photo 19

**Service entries seals: Top hats seal arrangements fixed around service entries? Use of Jubilee clips?**

Yes

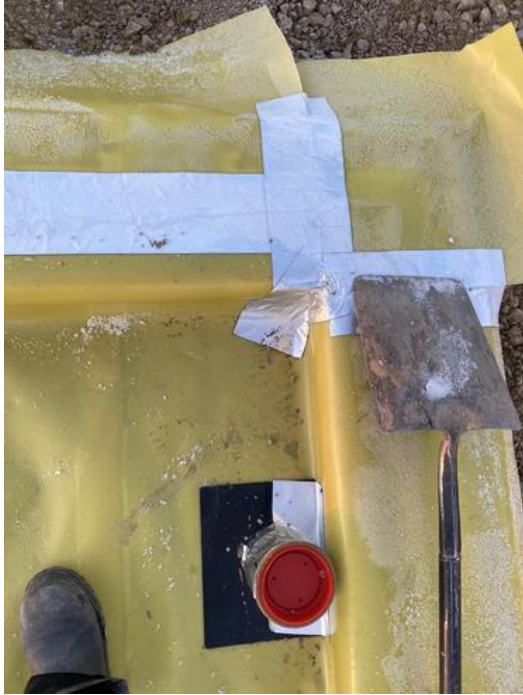
Photo 21

**Corners / Internal joints: Check all corners are correctly formed or contractor has used performed corners.**

Pass

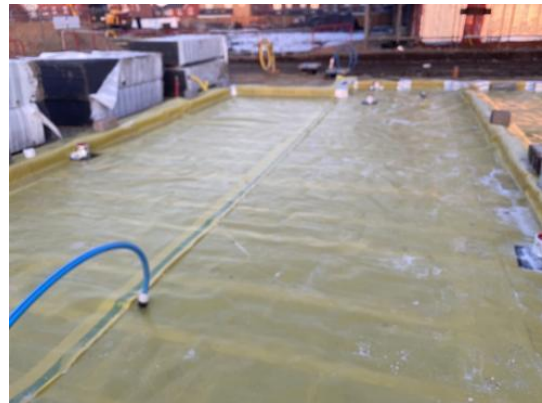
Photo 28

**Extent of Coverage: Is the membrane covering the entire plot? Does membrane span over outside walls?**

Yes

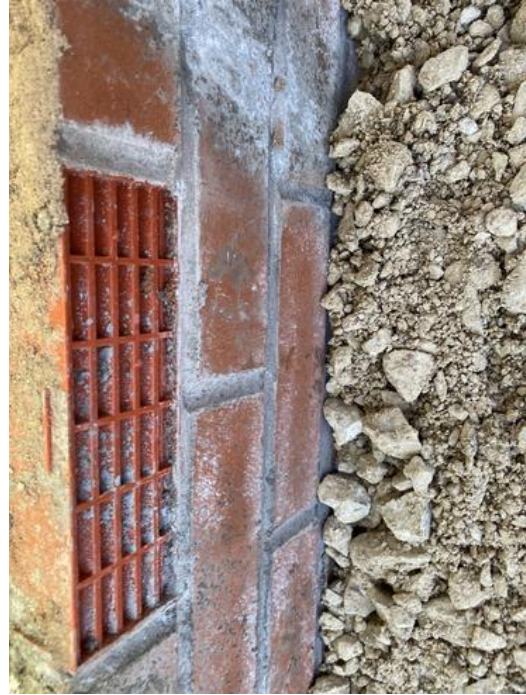
Photo 30

**External Wall Air bricks: Numbers, size. positions as design drawing? (Minimum of 3 walls)**

Pass
