# Flood Risk Assessment

## Waterside Hotel

**Project Name**      Waterside Hotel

**Project Number**    EVY1238

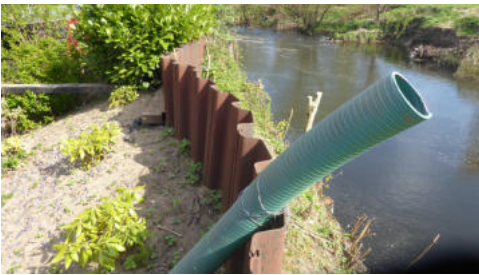
Figure 2.1: Sheet pile 2025

- Deflection of the wall outwards associated with lateral earth pressures acting towards the river (see Figure 2.1)
- Distortion of the pile clutches along the length of the wall (see Figure 2.2).
- Failure of the waling.

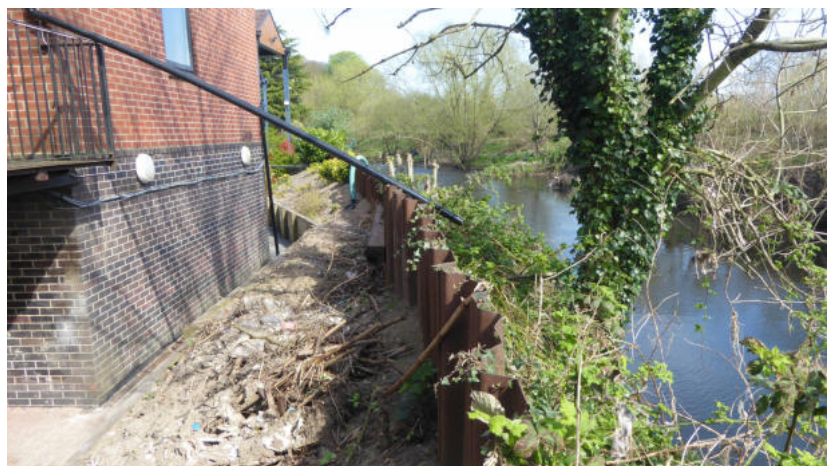
Figure 2.3: Sheet pile 2025

Accordingly, there are concerns relating to the structural integrity of the piles.

A structural / geotechnical assessment of the options for improving the standard of protection indicated that a less substantial solution (i.e welding a plate to the top of the wall to increase its height) would result in structural failure of the sheet piled wall under hydrostatic loading in flood conditions. Indeed, it is highly likely that the piled wall only survived the 2024 / 2025 event because water levels and therefore pressures equalised on both sides of the wall. Due to the uncertainty associated with the length of embedment and deformation of the piles, it is considered that the piles cannot be relied on to provide geotechnical or structural stability and a separate stand alone solution should be required.

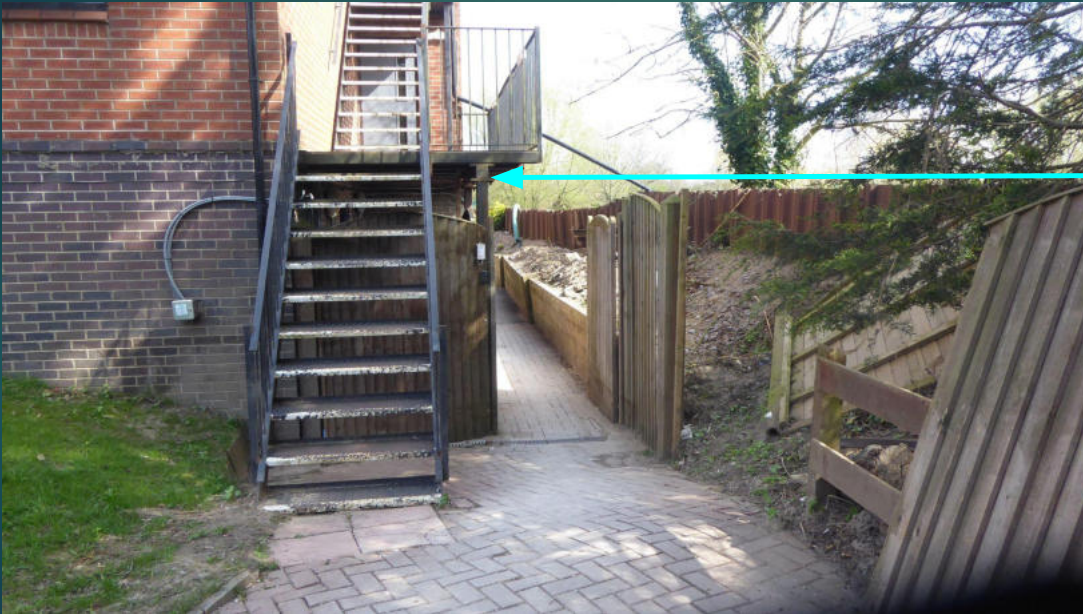
Anecdotal  
reported level of  
flooding in  
December 2024.

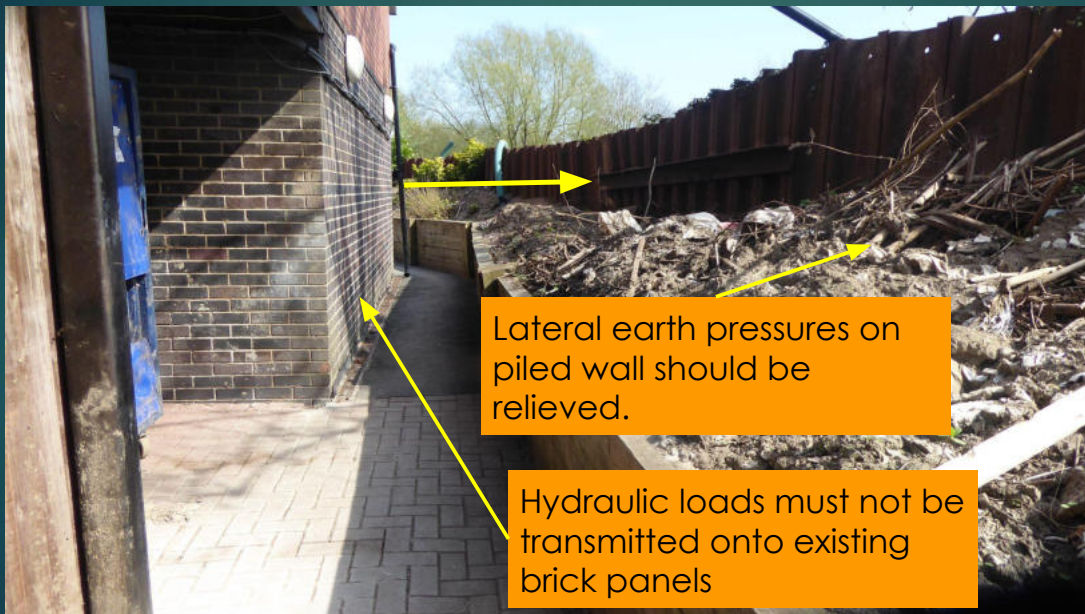
Constraint on Construction

Narrow width for access for construction plant

Narrow width to accommodate an independent retaining wall setback from the existing piled wall

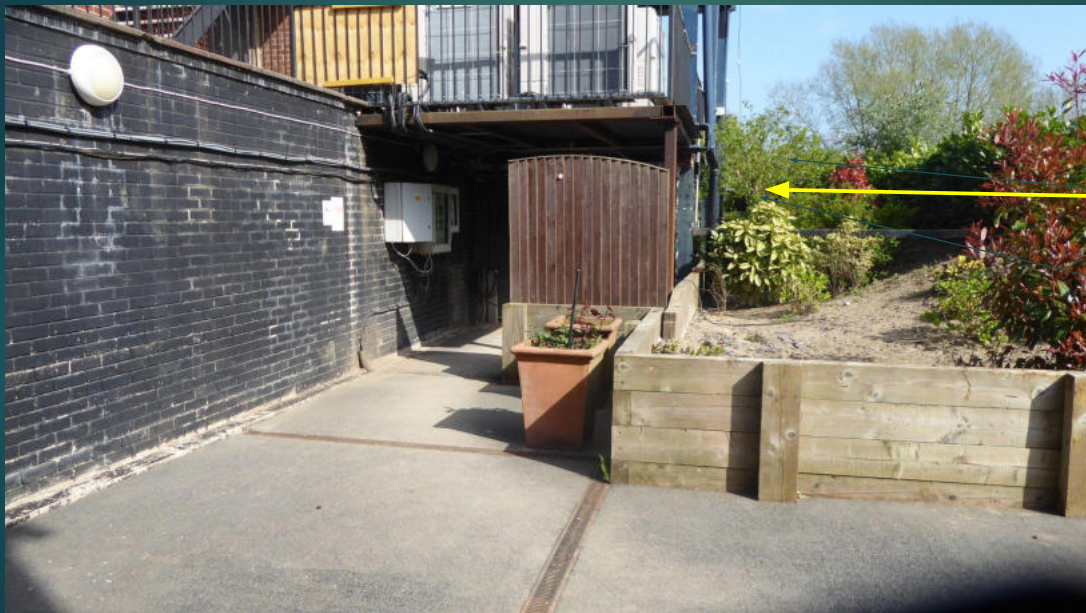
Constraint on  
Construction

Narrow width for  
access for  
construction plant

Narrow width to  
accommodate  
an independent  
retaining wall  
setback from the  
existing piled wall

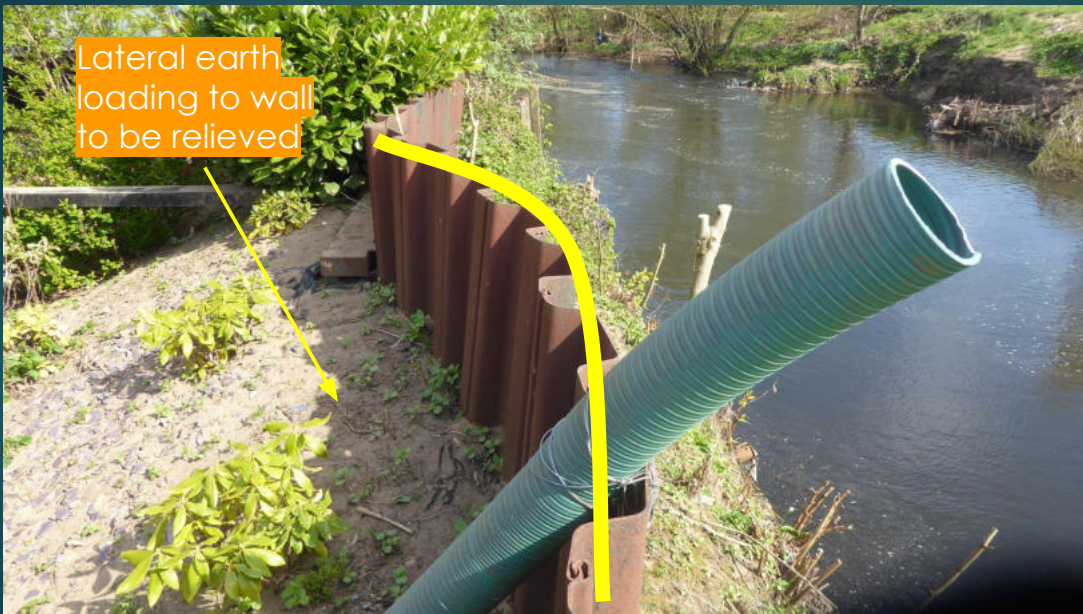
Wall has deflected outwards which is a sign of progressive failure.

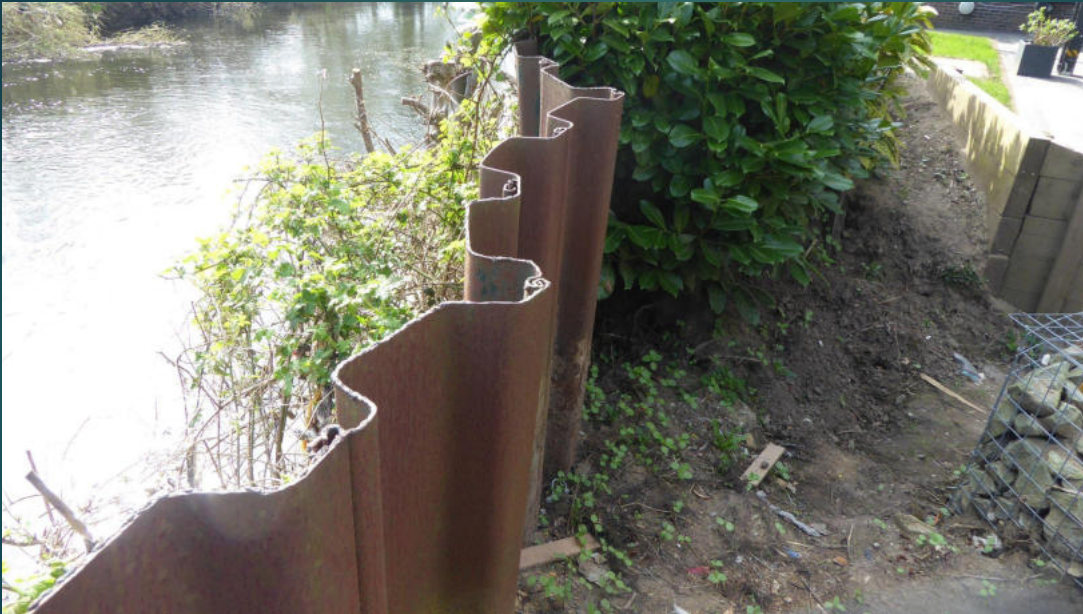
Pile clutches in the wall have deflected outwards which is a sign of progressive failure.
