# Parrs Wood High School

**Flood Risk Assessment**

**FINAL DRAFT REPORT**

**May 2018**

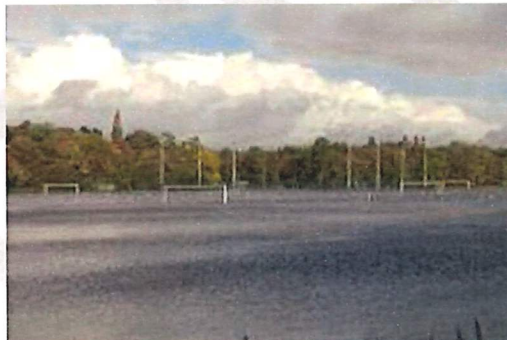
In 2010 floods hit the playing fields at Parrs Wood High School, as a result of the high volume of water in the River Mersey following a period of heavy rain, which forced the Environment Agency workers to open the sluice gates at Millgate Lane, just behind Fletcher Moss Park.

**Figure 4 – Sports Ground 2010 flood picture (source: manchestereveningnews.com)**

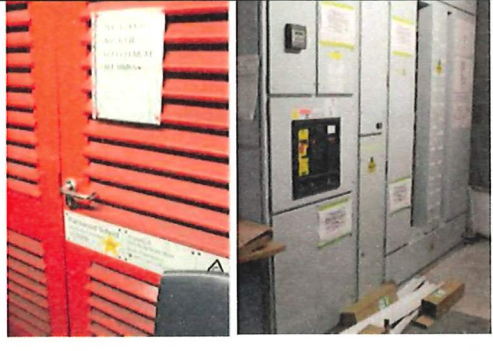
| | <ul style="list-style-type: none"> <li>• Parrs Wood Main School Substation No: 178495: this substation contains a 1MVA dry transformer, built in 1999 (Winder refurb) with SF6 vacuum switch (switchgear HV), which feeds the main school, the music block and the sports centre.</li> <li>• 1 x solar panel main electrical cabin and inverters (not elevated).</li> </ul> <p style="text-align: right;">LIFT NO (ADJES TEL<br/>REF. SOL. 2 BORR</p> |

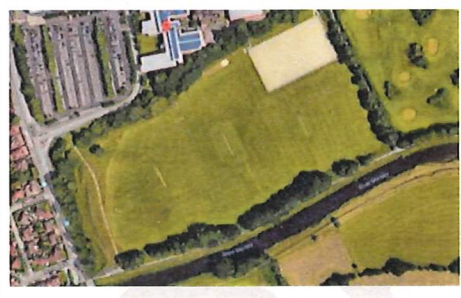
| | <p>This area of the school is the most relevant in terms of flood loss history.</p> <p>Another parcel of land south of River Mersey is also owned by the school, and it is protected by the southern embankment which acts as a local flood defence. This area was not inspected during the survey.</p> |

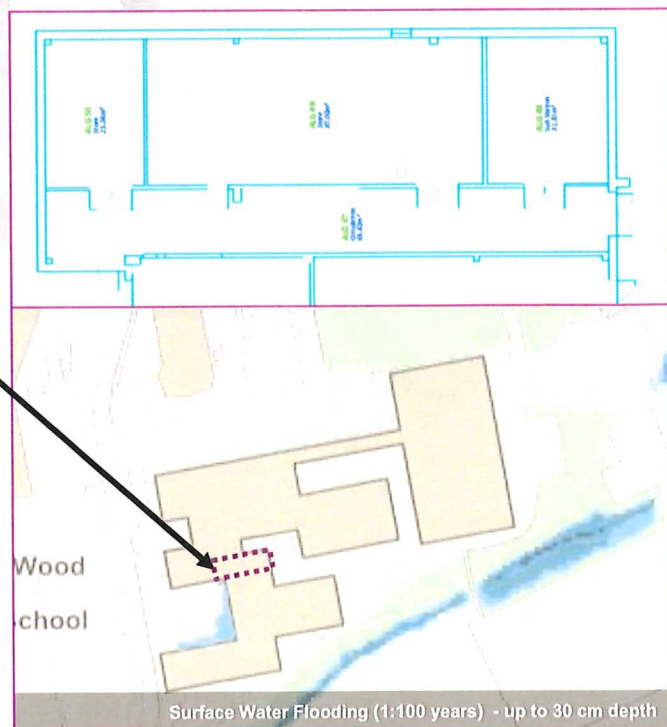
Main Electrical Room Entrance

- B. Surface Water Flood:** a medium to low level of flooding risk exists at the school and flash flood waters could impact the Main Building Electrical Rooms: transformer rooms and PV system inverter room. Here, it should be noted that in a more remote scenario (1:100 to 1:1,000 year return period), also the Music Block – Main Boiler Room and the Potting Shed – Boiler Room could be considered at risk (ref: Local Hazard Assessment Section).

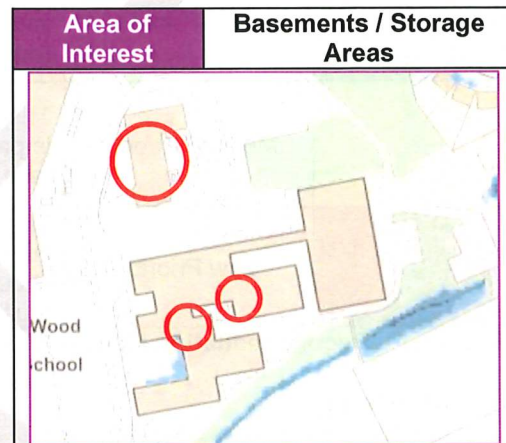
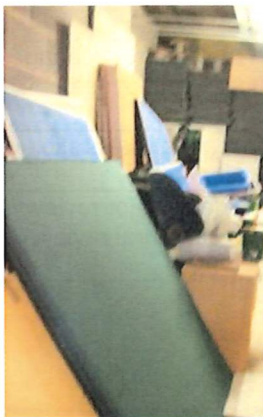
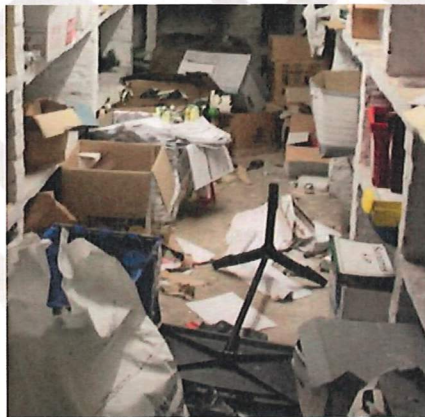
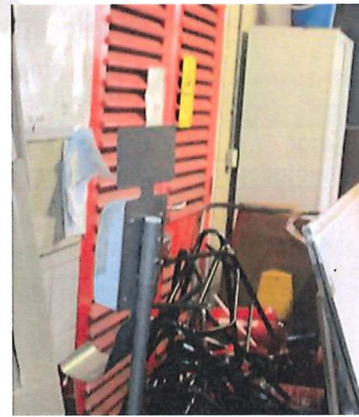
During the survey, it was observed that most of the escape routes were blocked and /or not easily accessible due to a general low housekeeping standard. This was observed particularly in basements / utility areas.

It is important to keep key areas as tidy as possible in order to facilitate any eventual emergency operations and avoid loss amplification factors.

We recommend that Parrs Wood considers including a self-inspection walk around of the key basements, storage areas and utility rooms in the routine maintenance procedure. This would allow an early identification of corrective actions and the site management to address any potential issue in a timely manner.

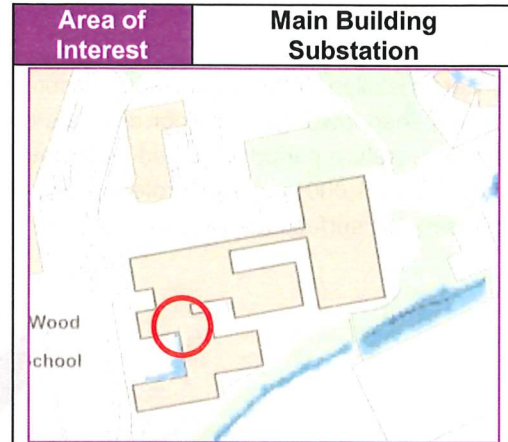
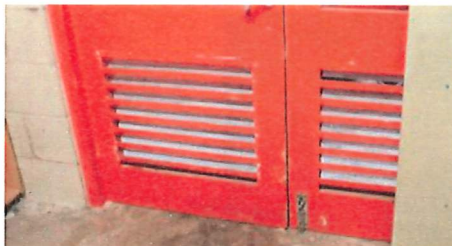
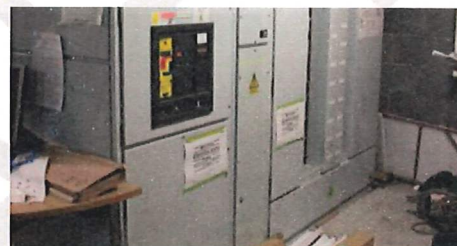
Transformers installed in the electrical areas could be elevated on plinths above the lower return period expected water level (30 – 90 cm at the 1 in 1,000 year) to protect the assets from a catastrophic surface flooding event.

We recommend that Parrs Wood High School considers elevating the key electrical equipment on plinths in order to keep the assets at approximately 90 cm from the ground (above the estimated surface flood dept. at the 1 in 1,000 year return period).
