## GAS MEMBRANE VALIDATION

| <b>Site Name:</b> Belle Vue | <b>Project Number:</b> 12-123 |
| <b>Company Name:</b> Countryside Properties | <b>Date:</b> 24-10-2022 |

Inspection Gas Membrane - 100% 100%

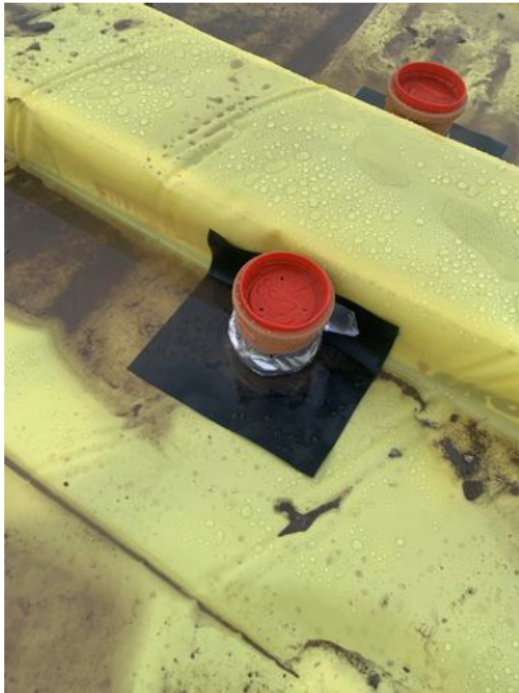
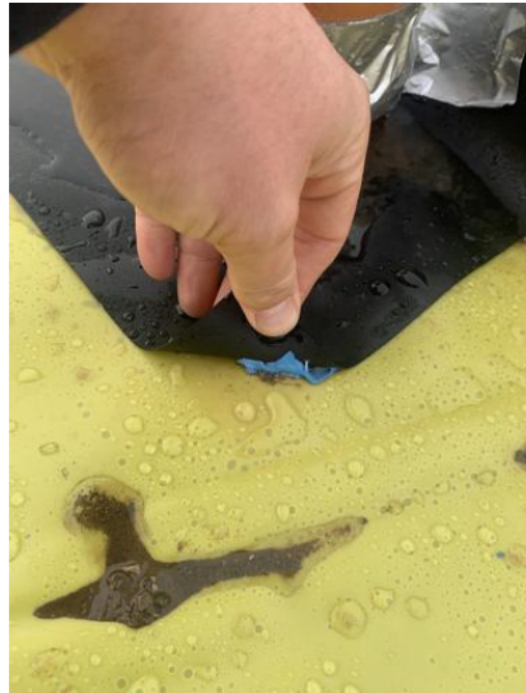
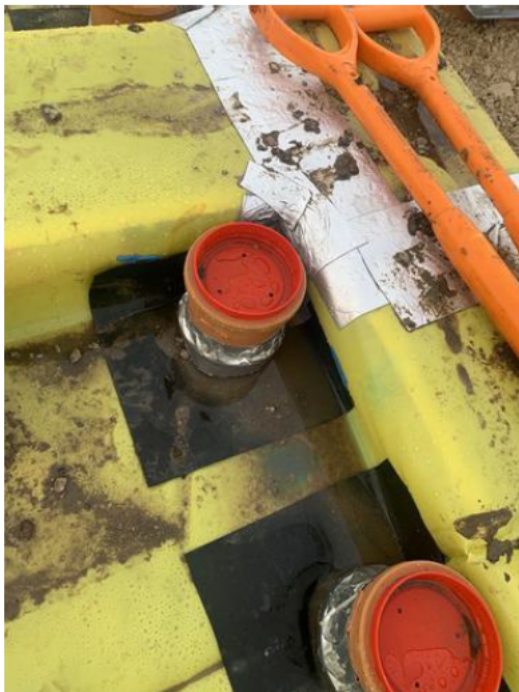
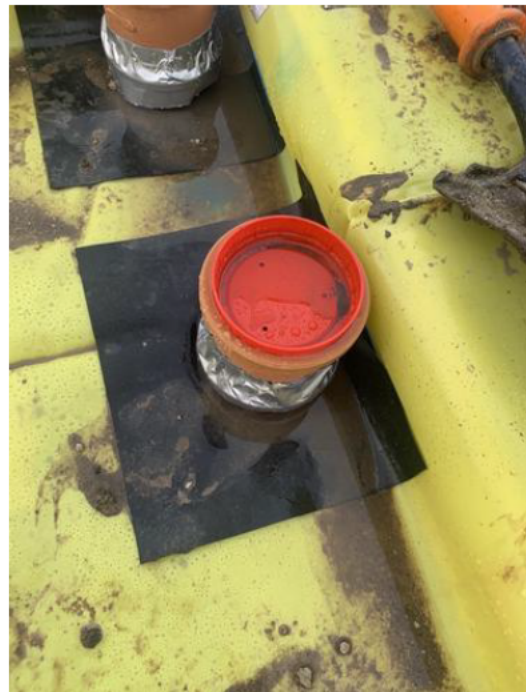
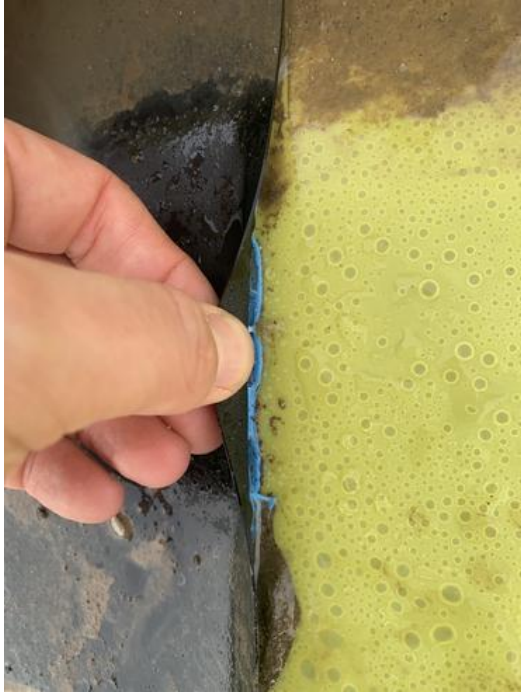
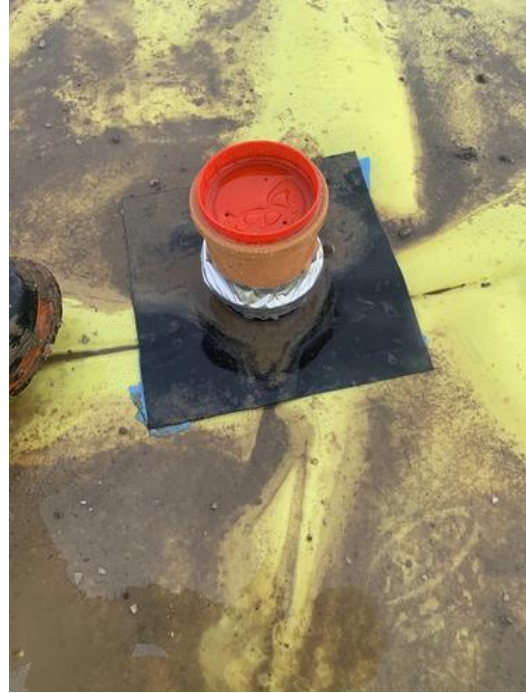
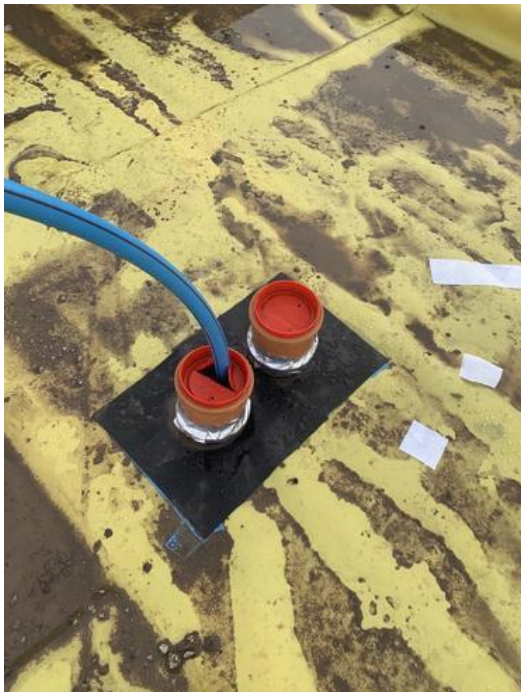
Service entries seals: Top hats seal arrangements fixed around service entries? Use of Jubilee clips? Yes

Detailing strip instead of jubilee clips

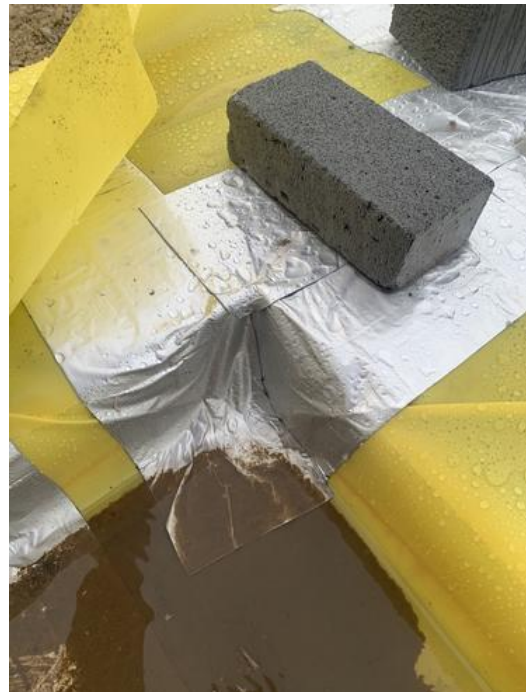
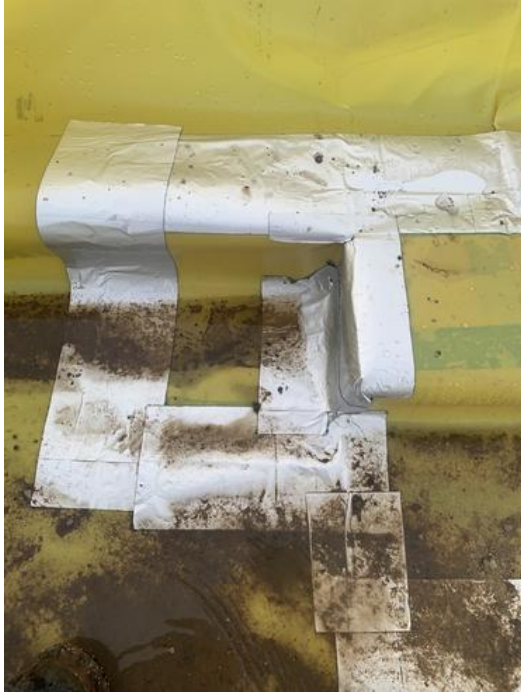
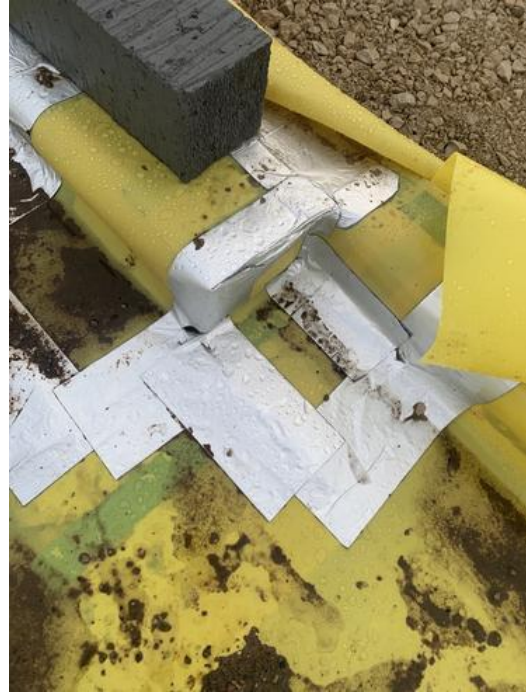
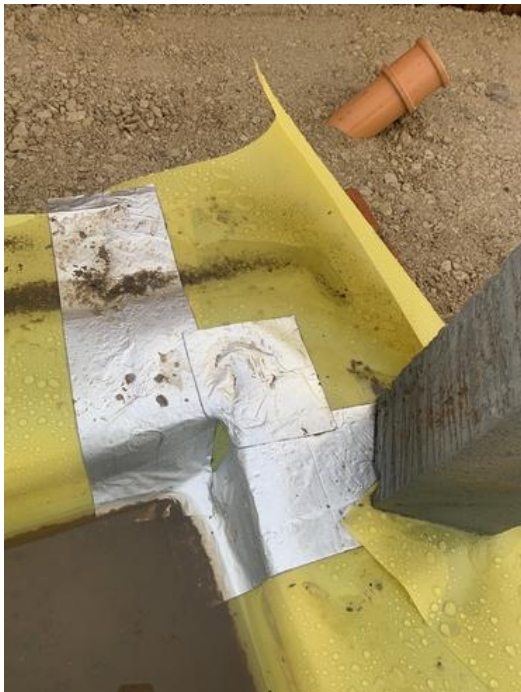
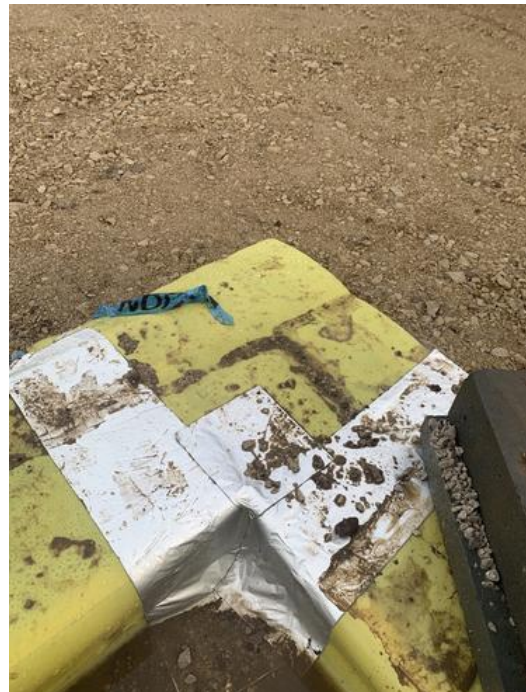
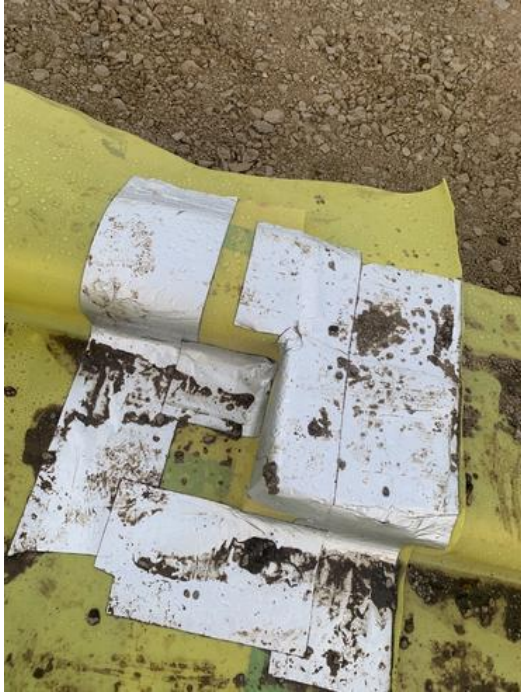
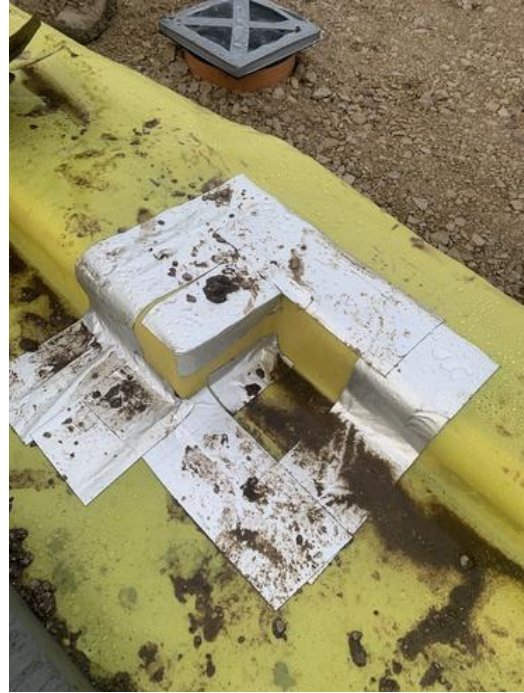
Corners / Internal joints: Check all corners are correctly formed or contractor has used performed corners.

Pass

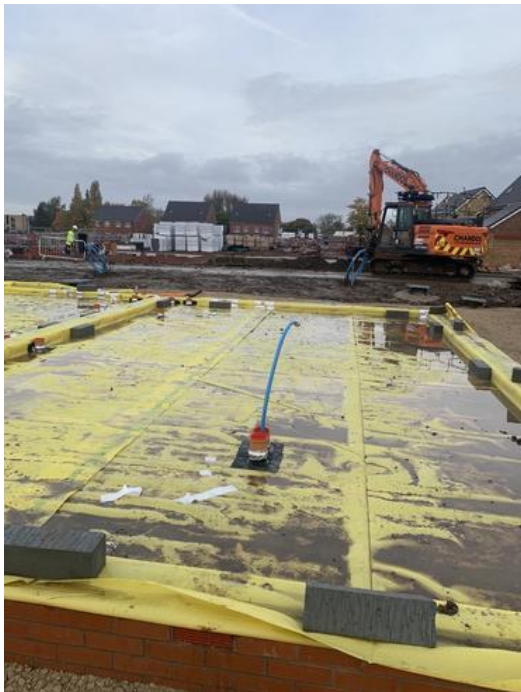
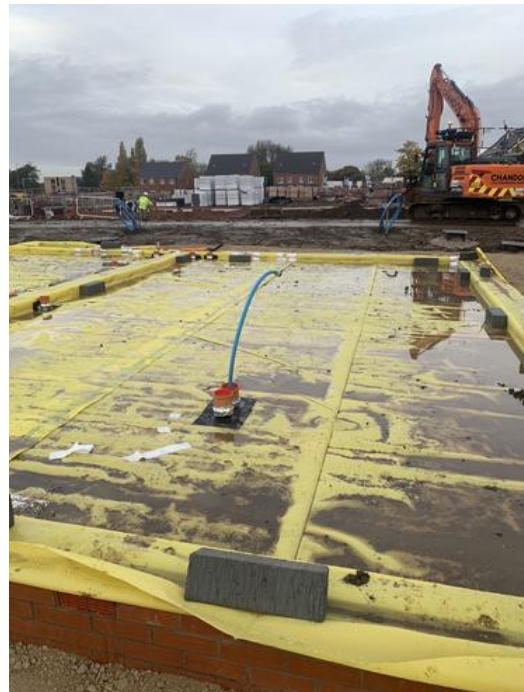
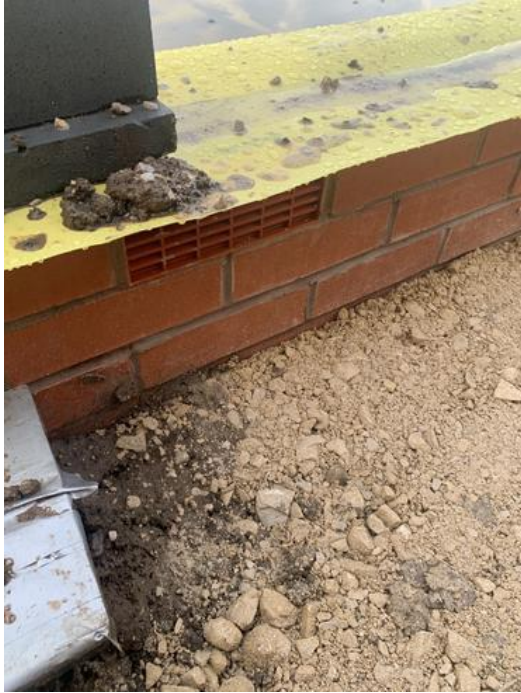
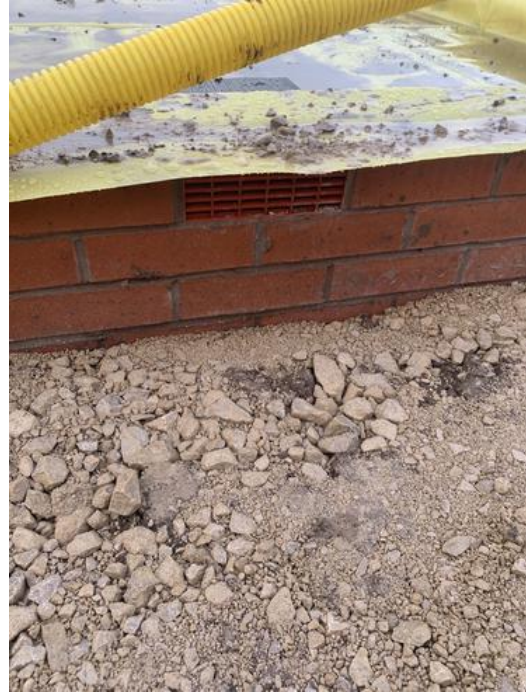
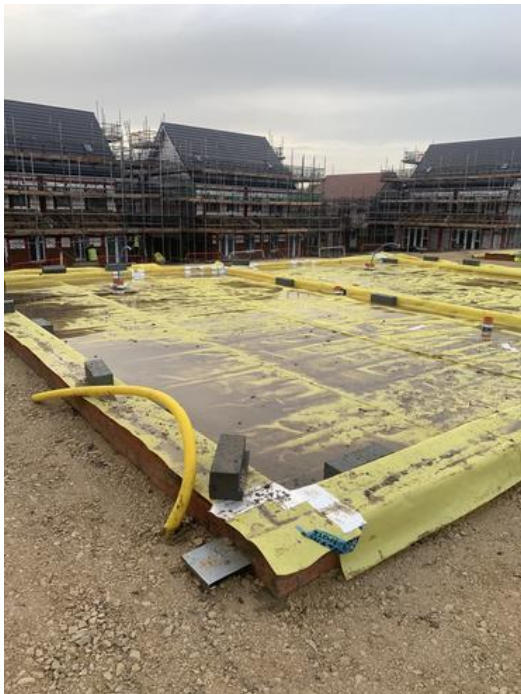
Extent of Coverage: Is the membrane covering the entire plot? Does membrane span over outside walls?

Yes

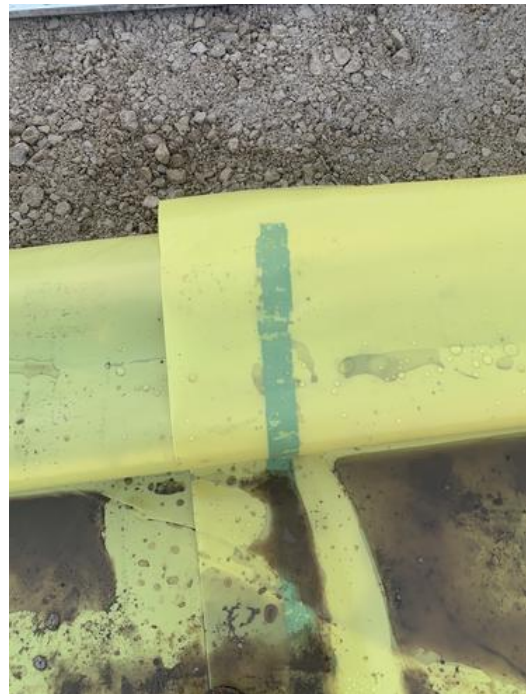
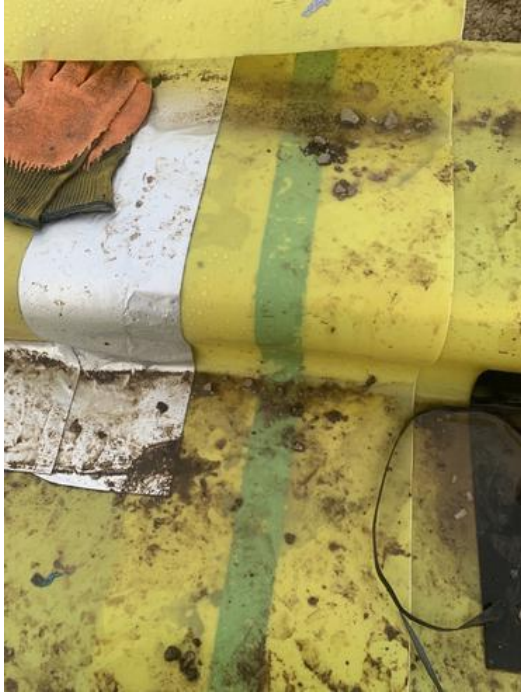
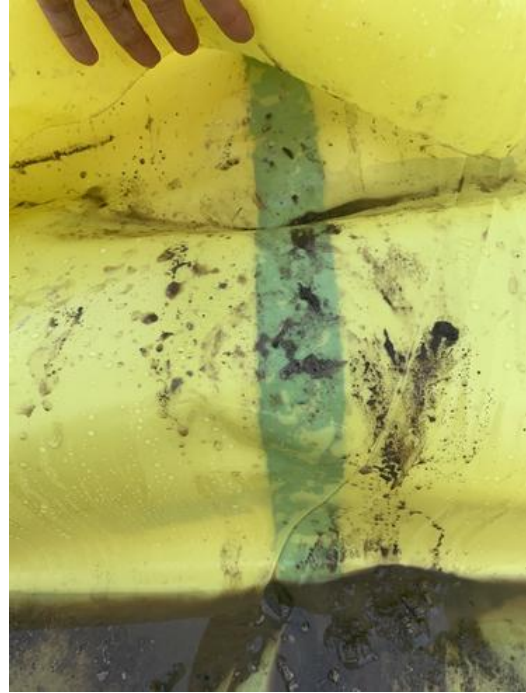
Laps, welds, and joints seals: Joints lapped and sealed in accordance with manufacturer's requirements/ specification? Minimum overlap insured? Sections taped twice? Are welds complete? Appropriate joining/double-sided tape used, Folds running in line with joints? (no joints cutting across folds)

Pass

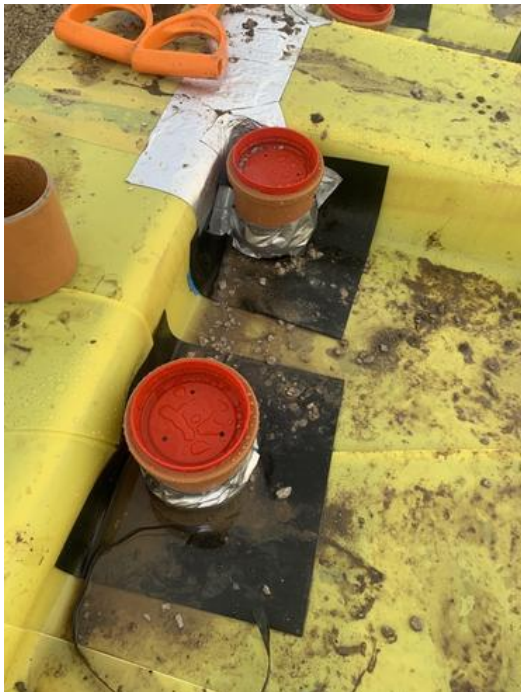
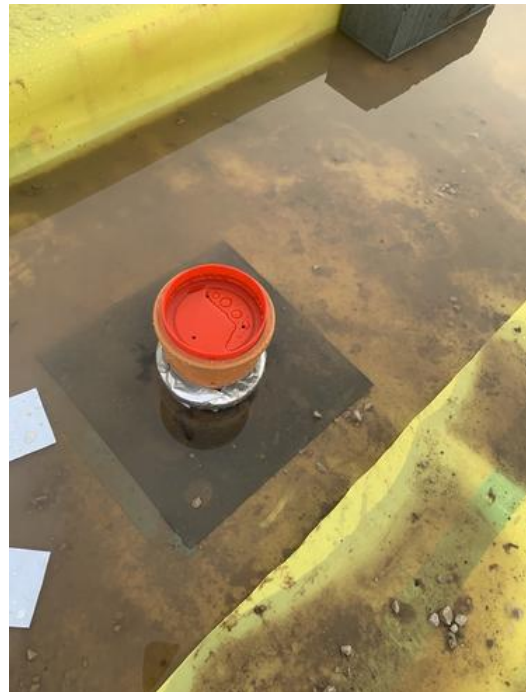
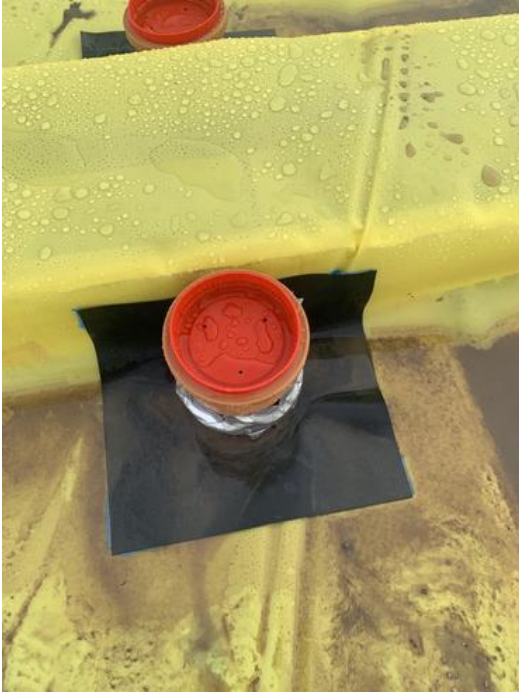
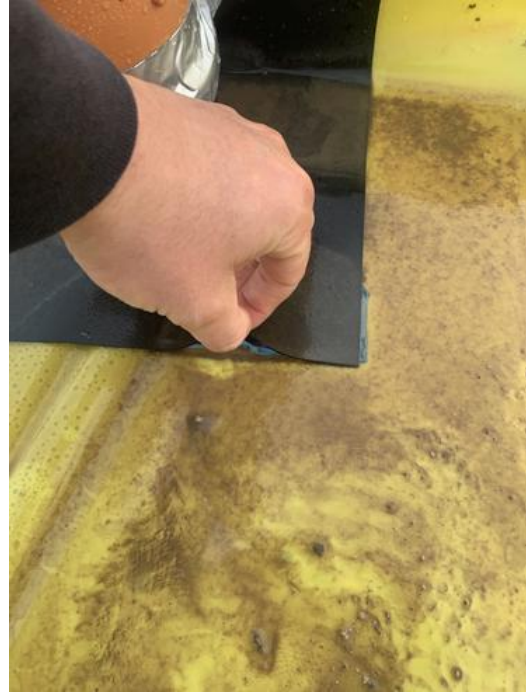
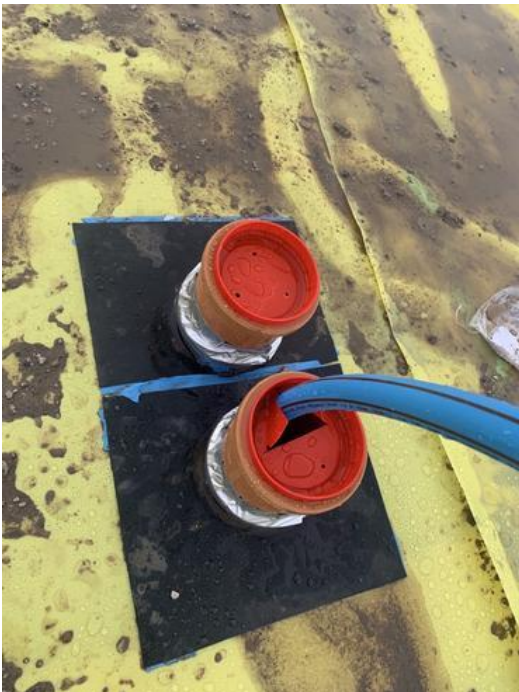
Service entries seals: Top hats seal arrangements fixed around service entries? Use of Jubilee clips?

Yes

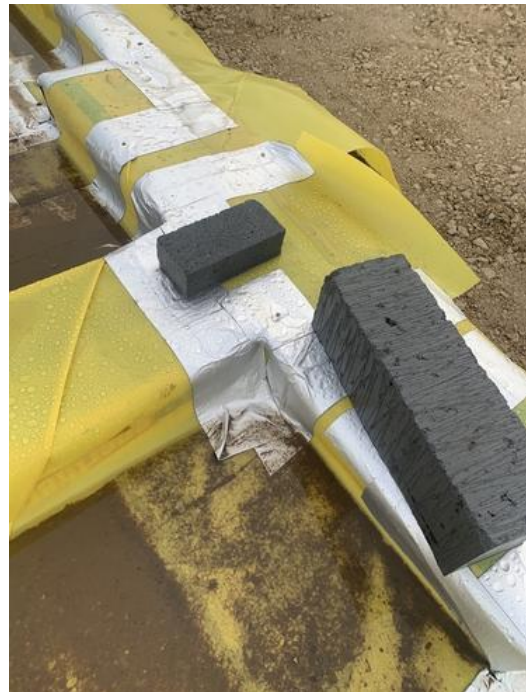
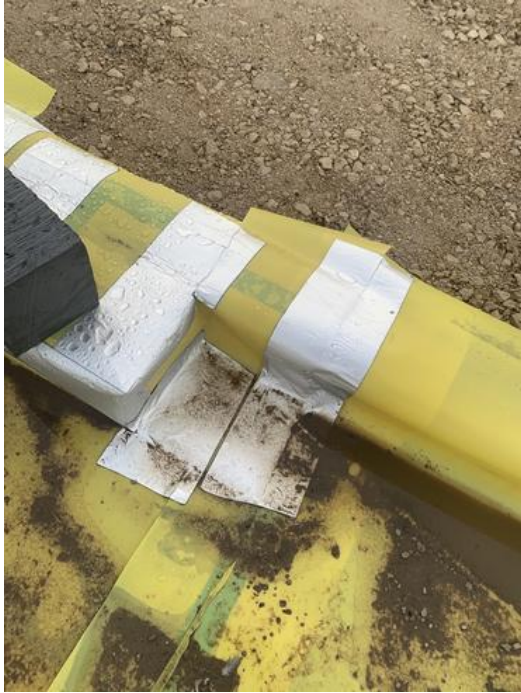
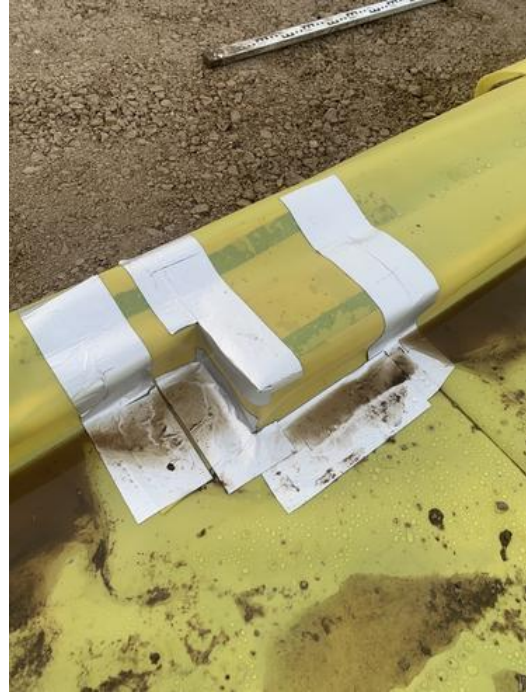
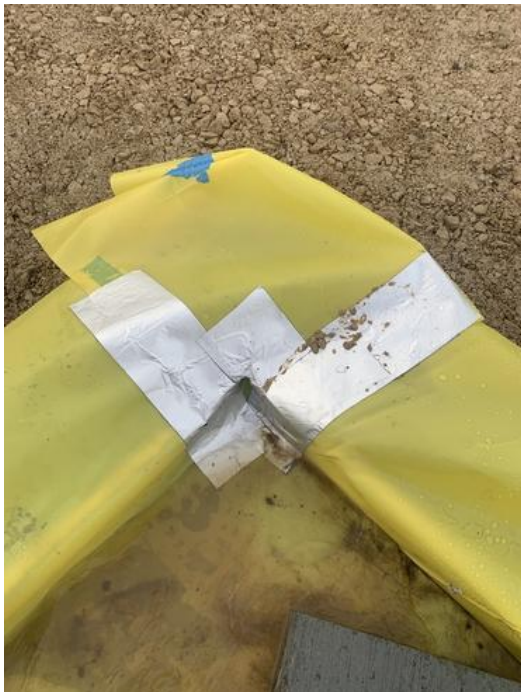
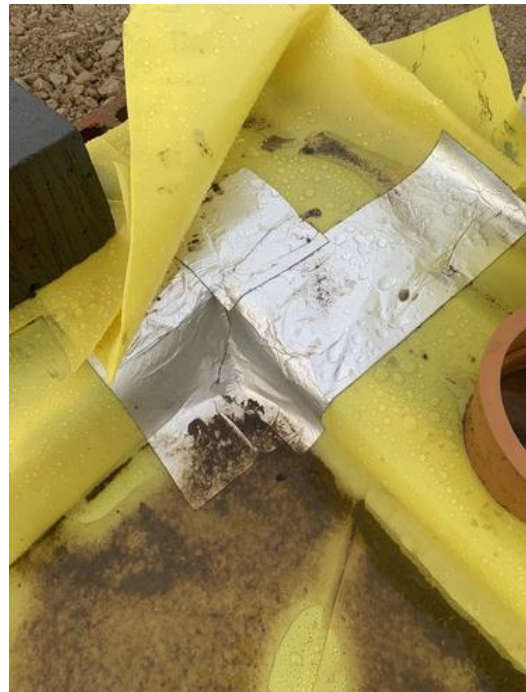
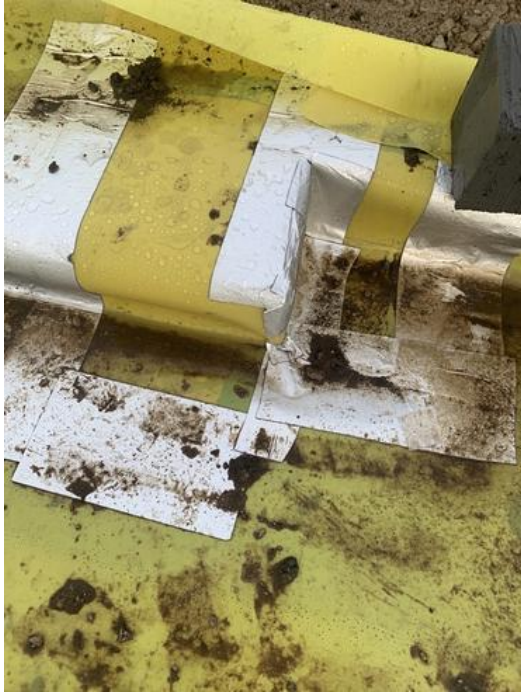
Corners / Internal joints: Check all corners are correctly formed or contractor has used performed corners.

Pass

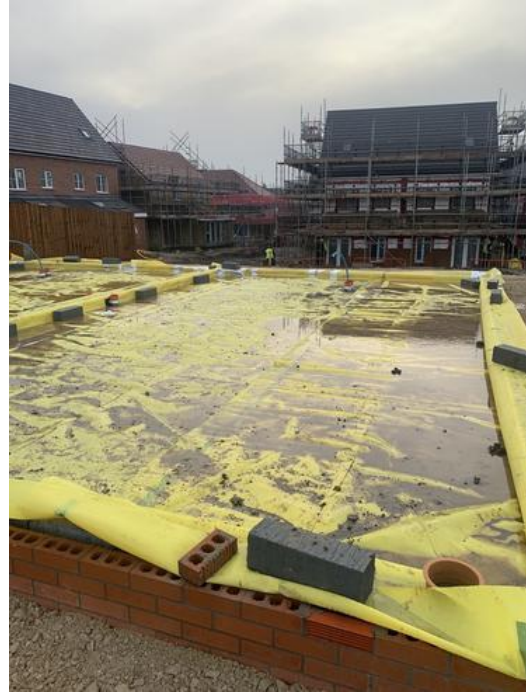
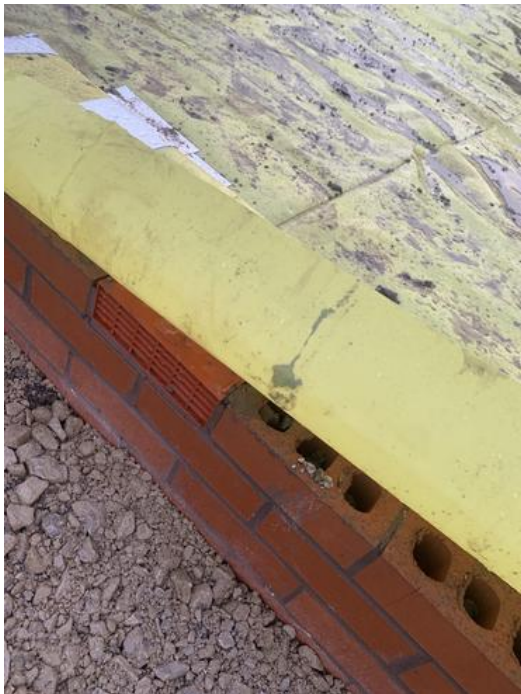
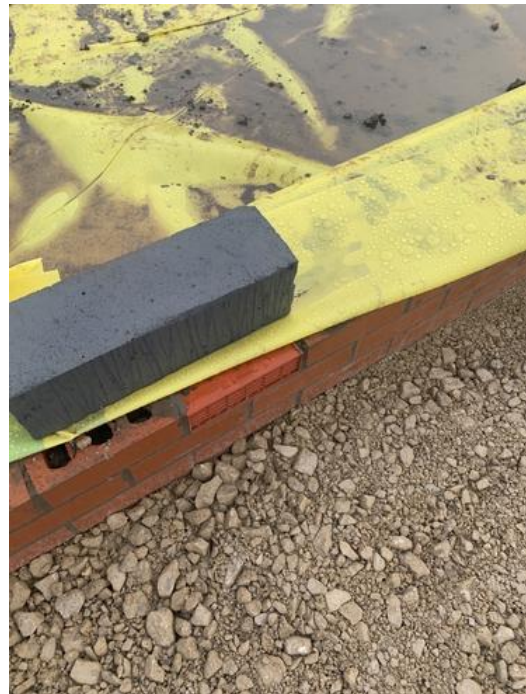
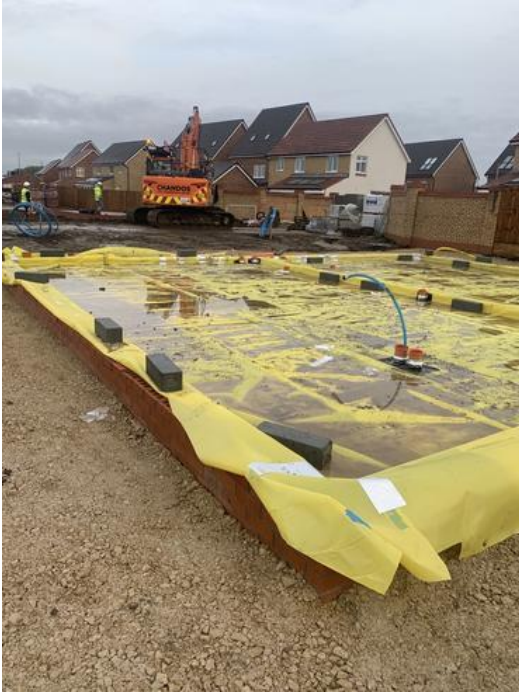
Extent of Coverage: Is the membrane covering the entire plot? Does membrane span over outside walls?

Yes

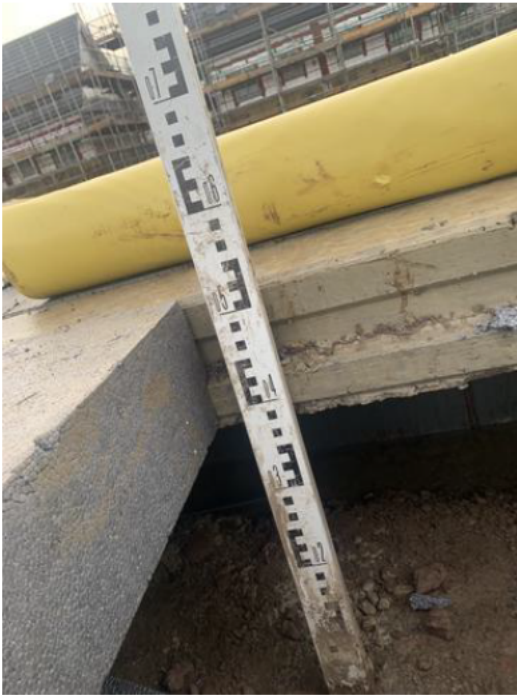
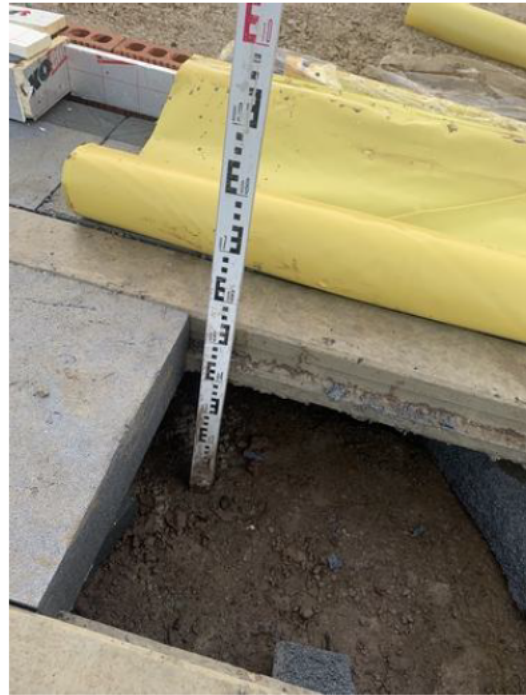
Is the void clear? Yes

Depth of Void 500mm

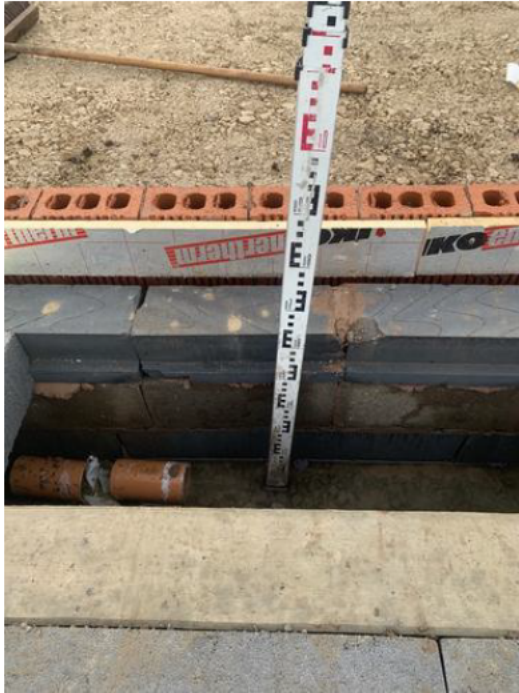
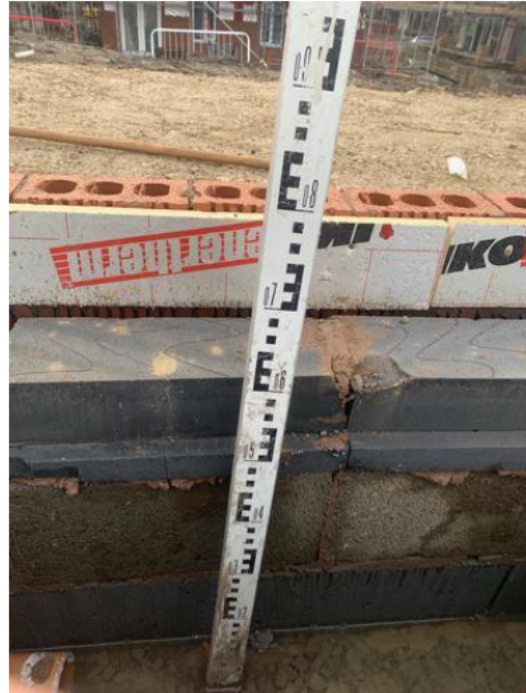
Is the void clear? Yes

Depth of Void 500mm
