## GAS MEMBRANE VALIDATION

| Site Name: Belle Vue Stadium | Project Number: 12-123 |

**Plot – 134**

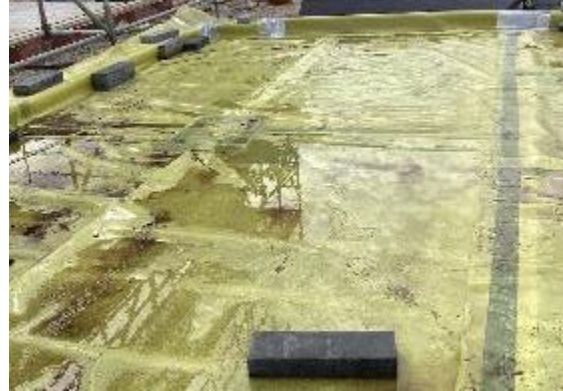
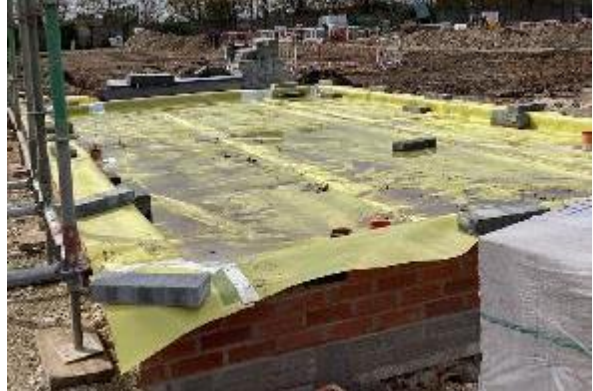
The membrane comprised a Visqueen gas membrane (yellow) resistant to radon, carbon dioxide and low levels of methane. E3P can confirm there were no holes or rips at the time of inspection. Upon being laid the membrane is to be covered with a Celotex (closed Cell) floor insulation material which is considered to provide a high degree of protection.

**General Condition of Membrane-Good Condition**

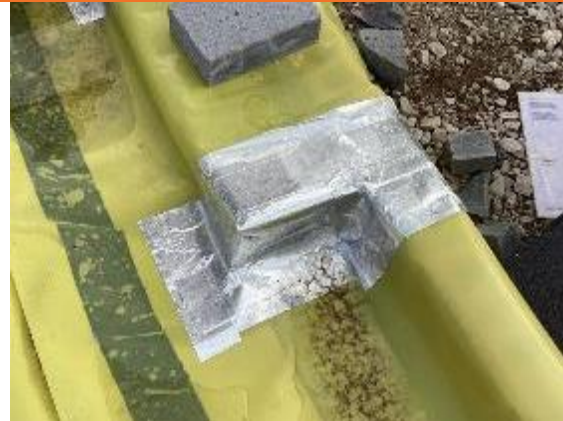
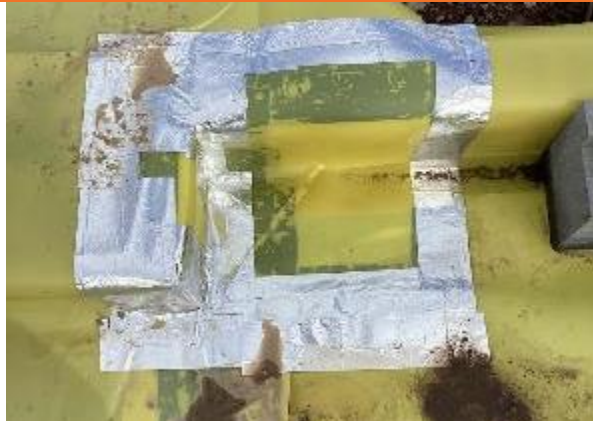
All external joints were inspected and E3P can confirm that the membrane was overlapped and double taped to external and internal gas resistant DPM. The membrane was taped to the gas resistant DPM using a double-sided jointing tape.

**Verification of Joints and Seals-Overlapped and sealed correctly**

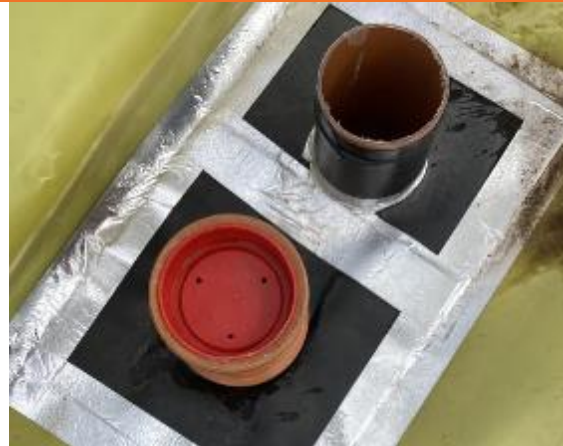
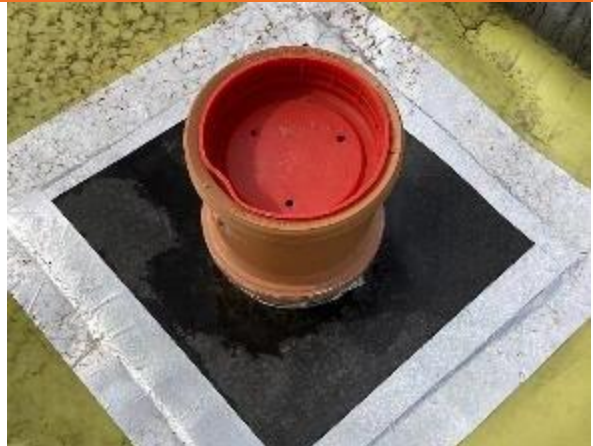
Each unit has a service duct located to the front and outer edge of the property. E3P inspected each one and can confirm that the top-hats have been adequately sealed against the membrane.

**Verification of Service Penetrations-Good Condition**

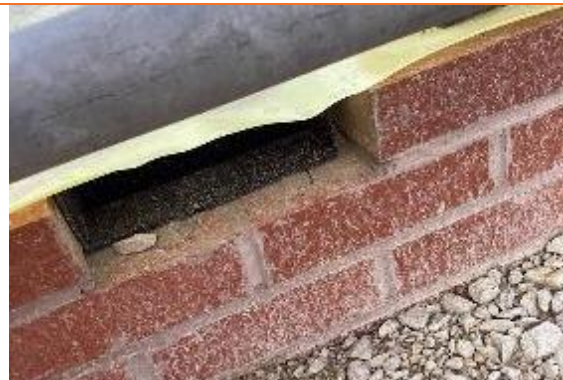
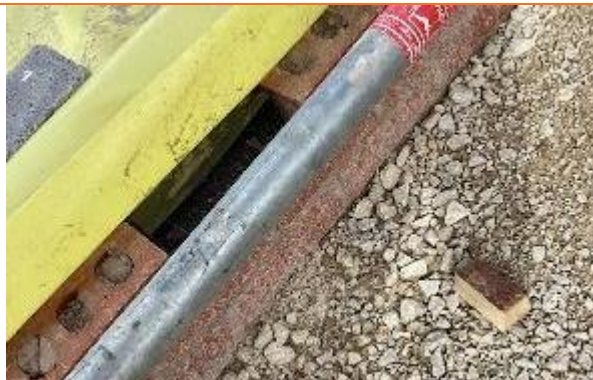
**Verification of Ventilation-Good Condition**
