**SHELDON BAKERY,  
OPENSHAW,  
MANCHESTER,  
M11 2FB**

## **CULVERT DIVERSION STRATEGY**

**8885-HBL-XX-XX-RP-C-0010**

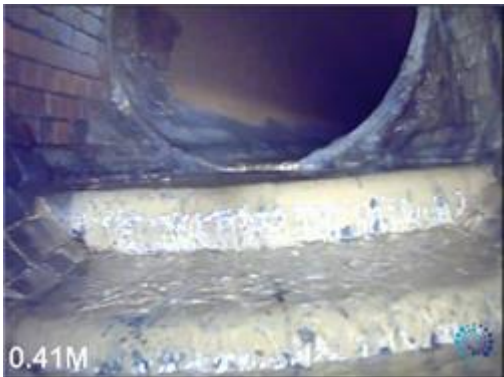
| Pos | Video Ref | Code | Description | Image |
|---|---|---|---|---|
| 00.00m | 0:00:00 | REM | General remark<br>STEPS LEADING INTO MH | Image Provided - Ref: 0_2<br> 0.41M |

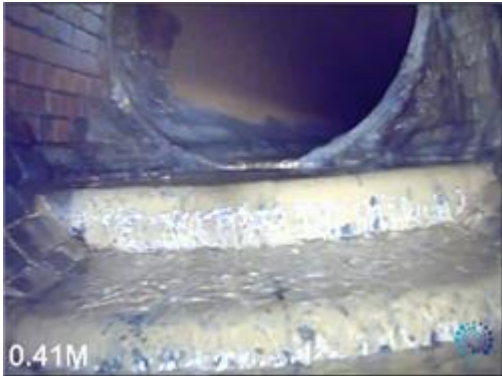
| Pos | Video Ref | Code | Description | Image |
|---|---|---|---|---|
| 00.00m | 0:00:00 | REM | General remark<br>EVIDENCE OF FOUL WATER<br>PRESENT | Image Provided - Ref: 0_3<br> 0.41M |

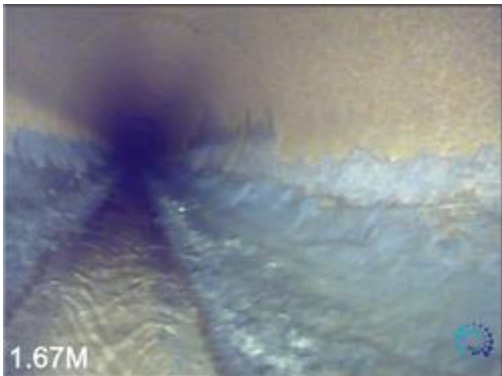
| Pos | Video Ref | Code | Description | Image |
|---|---|---|---|---|
| 01.67m | 0:00:50 | MCCI | Material of pipe changes to<br>Cast Iron | Image Provided - Ref: 0_4<br> 1.67M |

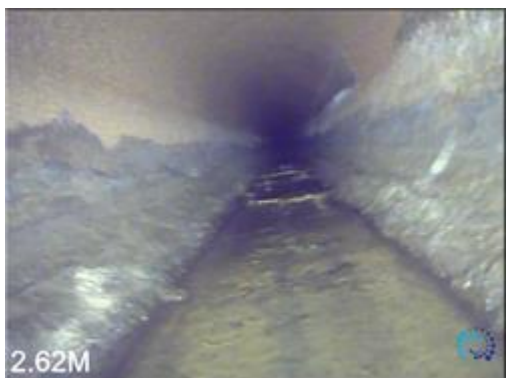
| Pos | Video Ref | Code | Description | Image |
|---|---|---|---|---|
| 02.60m | 0:00:11 | S1 DEG | Attached deposits, grease<br>2.6m - 21.98m from 05 o'clock<br>to 07 o'clock: 10% Cross<br>sectional area loss - Severity 3 | Image Provided - Ref: 1_2<br> |
| 21.98m | 0:00:11 | F1 DEG | Attached deposits, grease<br>Defect End from 05 o'clock to<br>07 o'clock: 10% Cross<br>sectional area loss - Severity 3 | |

| <b>Section: 2</b><br><br>From: MH SW2<br>To: UP STREAM | RECOMMEND FURTHER VISIT WITH TANKER AND CCTV UNITS IN ORDER TO CAT AND GENIE THE CAST IRON PIPE TO LOACTE AND EXPOSE MH SW2, TANKER TO CARRY OUT HIGH PRESSURE WATER JETTING TO ENABLE FURTEHR CCTV UPTO AREA OF KELBROOK ROAD<br><br>VERY POOR ACCESS ISSUES<br>FULL MAN ENTRY EQUIPMENT REQUIRED<br>INVERT LEVEL - 4.25mtr | DRB Grade: <b>B</b><br>Pipe Size: 1200<br>Material: Cast Iron<br>Use: Surface Water |

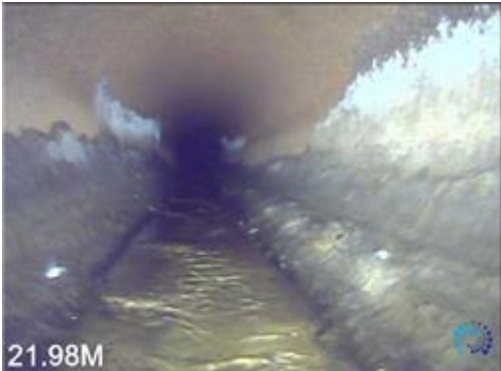
| Pos | Video Ref | Code | Description | Image |
|---|---|---|---|---|
| 21.98m | | SA | Survey abandoned<br>CRWALER UNITS WHEELS<br>SLIPPING ON GREASE<br>RESIDUE, CAMERA UNABLE<br>TO PROCEED | <p>Image Provided - Ref: 1_9999</p> |

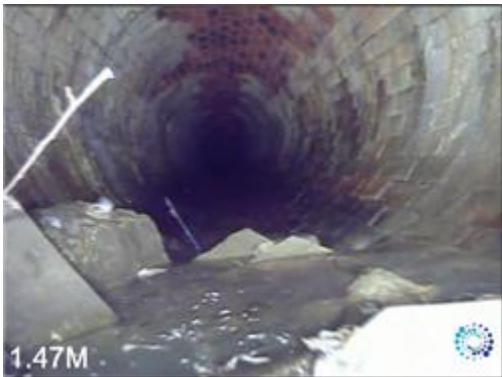
| Pos | Video Ref | Code | Description | Image |
|---|---|---|---|---|
| 01.47m | 0:00:00 | DEE | Attached deposits,<br>encrustation from 04 o'clock to<br>07 o'clock: 20% Cross<br>sectional area loss - Severity 3 | Image Provided - Ref: 2_2<br> |

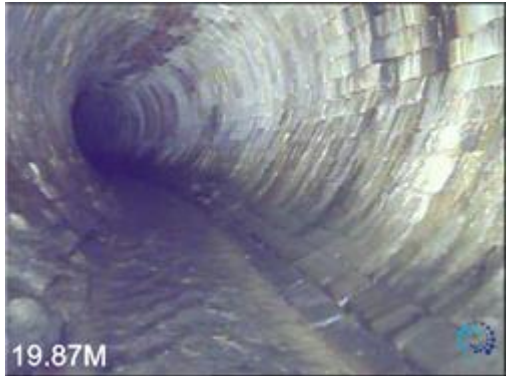
| Pos | Video Ref | Code | Description | Image |
|---|---|---|---|---|
| 19.90m | 0:01:56 | S1 LLQ | Line of drain/sewer deviates left [quarter] 19.9m - 29.05m | <p>Image Provided - Ref: 2_4</p> <p>19.87M</p> |
| 29.05m | 0:01:56 | F1 LLQ | Line of drain/sewer deviates left [quarter] Defect End | |

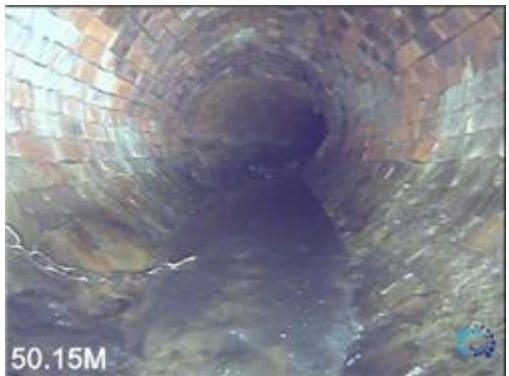
| Pos | Video Ref | Code | Description | Image |
|---|---|---|---|---|
| 50.15m | 0:04:44 | REM | General remark<br>MH SONAR PROBED,<br>MARKED AND EXPOUSED | <p>Image Provided - Ref: 2_5</p> <p>50.15M</p> |

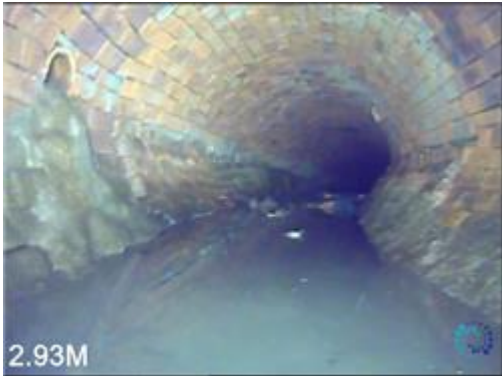
| Pos | Video Ref | Code | Description | Image |
|---|---|---|---|---|
| 02.93m | 0:00:21 | CN | Connection other than junction at 09 o'clock: 100mm Diameter | Image Provided - Ref: 3_3<br> |

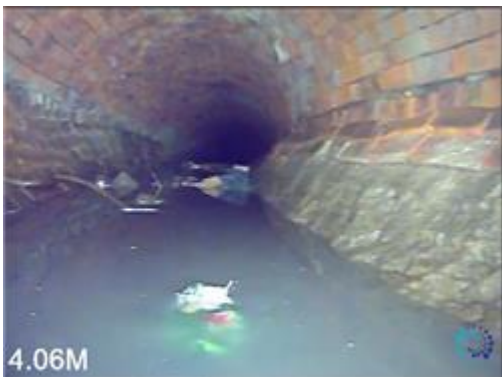
| Pos | Video Ref | Code | Description | Image |
|---|---|---|---|---|
| 04.10m | 0:00:29 | S1 DER | Settled deposits coarse 4.1m - 5.38m: 25% Cross sectional area loss - Severity 3 | Image Provided - Ref: 3_5<br> |
| 05.38m | 0:00:29 | F1 DER | Settled deposits coarse Defect End: 25% Cross sectional area loss - Severity 3 | |

| <b>Section: 4</b><br><br>From: MH SW3<br>To: DOWN STREAM | RECOMMEND TANKER ATTEND WITH REMOTE HIGH PRESSURE JETTING REEL IN ORDER TO BACK JET THE 1200mm BRICK SEWER TO ENABLE FURTHER CCTV. SURVEY TO INCLUDE THE SONAR PROBING AND MARKING OF THE LINE OF THE SEWER<br><br>VERY POOR ACCESS TO WORKING AREA<br>FULL MAN ENTRY EQUIPMENT REQUIRED | DRB Grade: <b>B</b><br>Pipe Size: 1200<br>Material: Brick<br>Use: Surface Water |

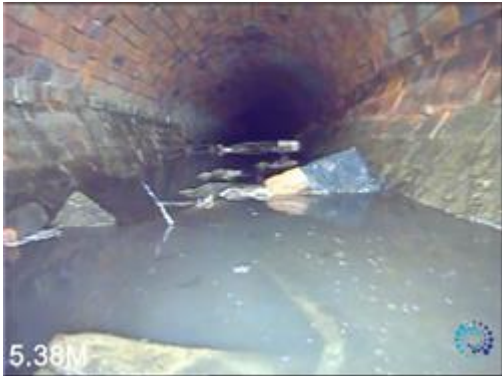
| Pos | Video Ref | Code | Description | Image |
|---|---|---|---|---|
| 05.38m | 0:00:48 | VR | Vermin Rat - Severity 2<br>VISIBLE FURTHER<br>DOWNSTREAM IN THE<br>DEBRIS | Image Provided - Ref: 3_6<br> |

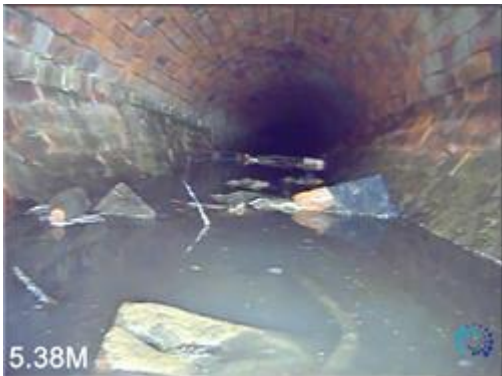
| Pos | Video Ref | Code | Description | Image |
|---|---|---|---|---|
| 05.38m | | SA | Survey abandoned<br>CRAWLER UNIT UNABLE TO<br>PROCEED PAST HEAVY<br>DEBRIS | Image Provided - Ref: 3_9999<br> |
