### GAS MEMBRANE VALIDATION – BELLE VUE

| <b>Project Name: Belle Bue Stadium</b> |
| <b>Plots: 162 &amp; 225</b> |

**Belle Vue**  
Gas Validation  
August 2023

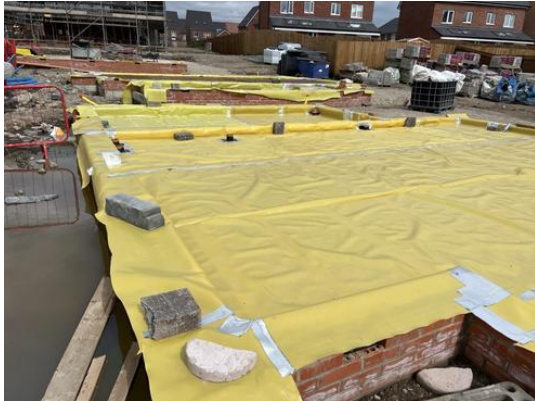
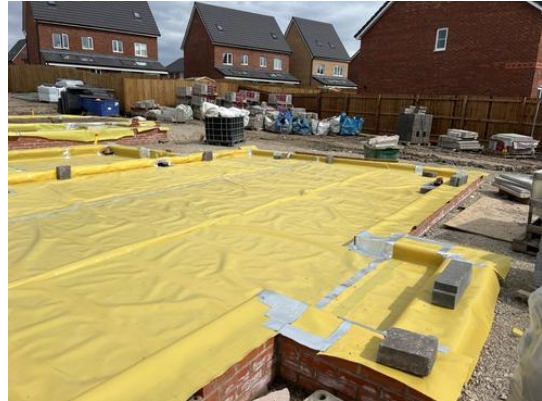
Gas Membrane Condition: Open punctures, tears, rips, stretching, Presence of debris, Repairs, Signs of weakness such as raised or sunken indentations, Protection plan in place to restrict access to lain gas membrane? IF FAIL DESCRIPTION IN ACTIONS AND PHOTOS REQUIRED

Pass

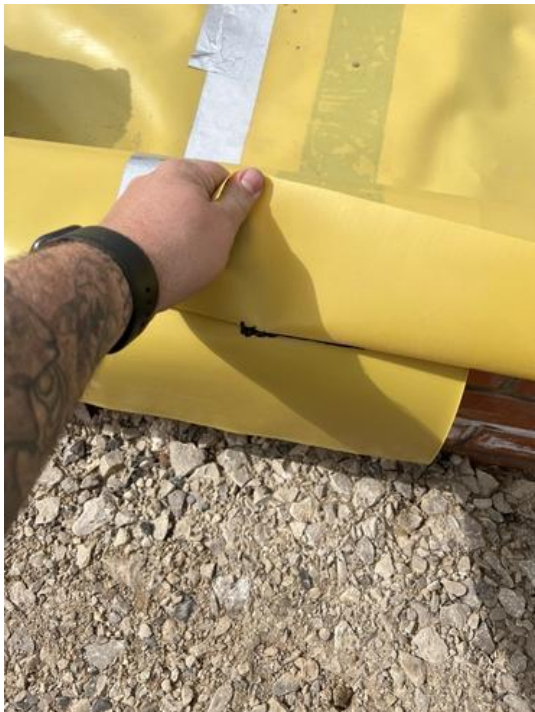
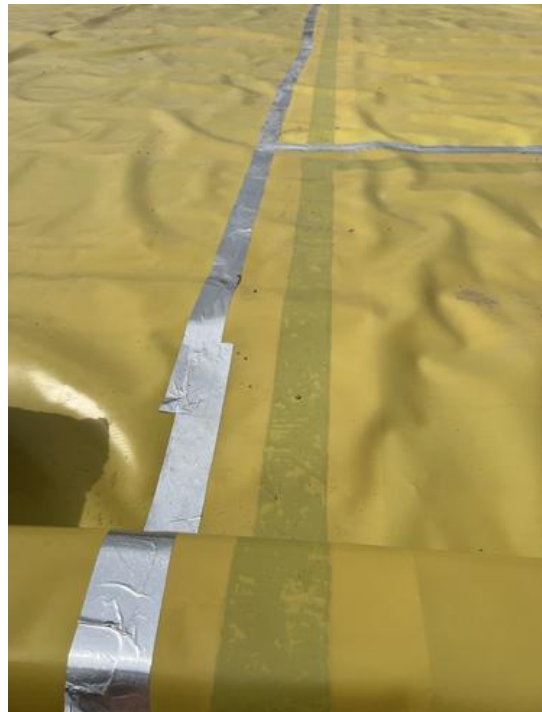
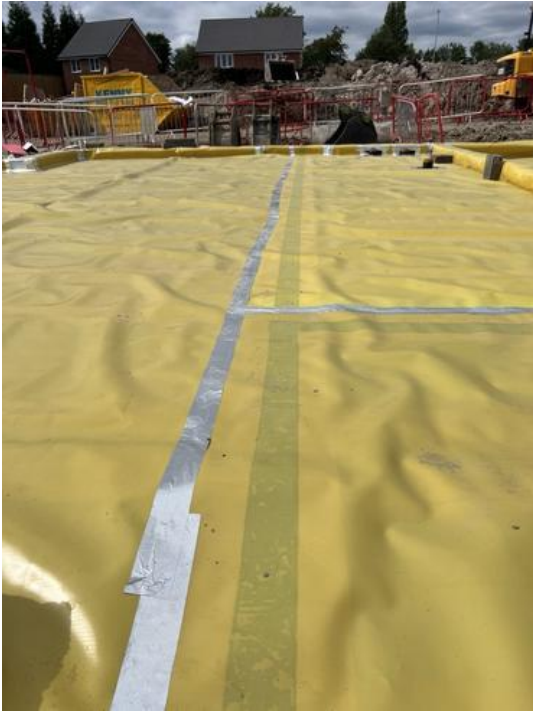
Laps, welds, and joints seals: Joints lapped and sealed in accordance with manufacturer's requirements/ specification? Minimum overlap insured? Sections taped twice? Are welds complete? Appropriate joining/double-sided tape used, Folds running in line with joints? (no joints cutting across folds)

Pass

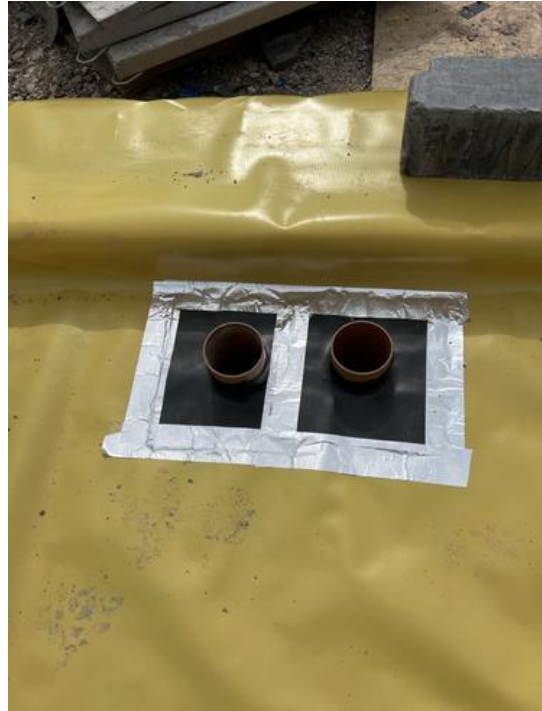
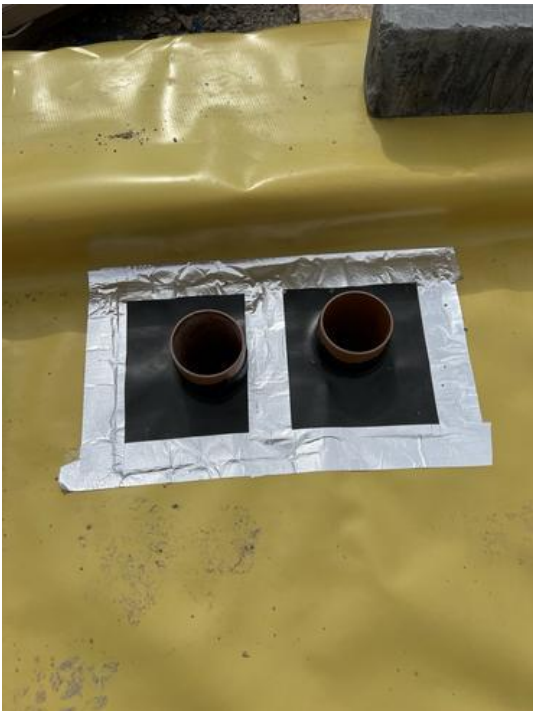
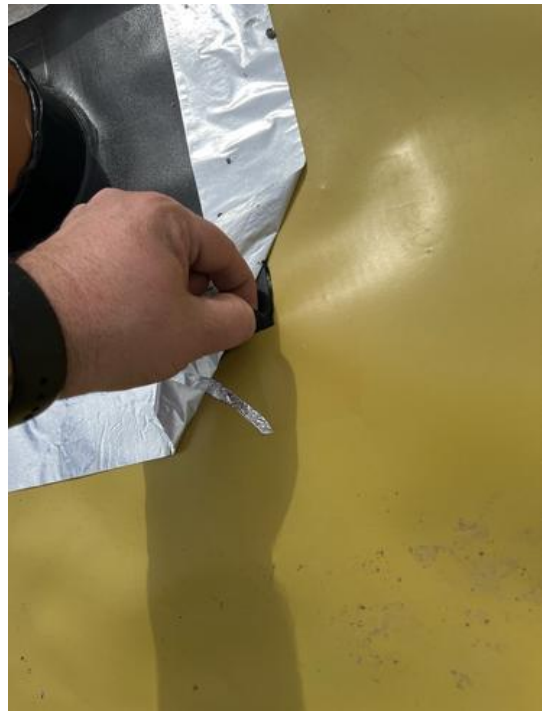
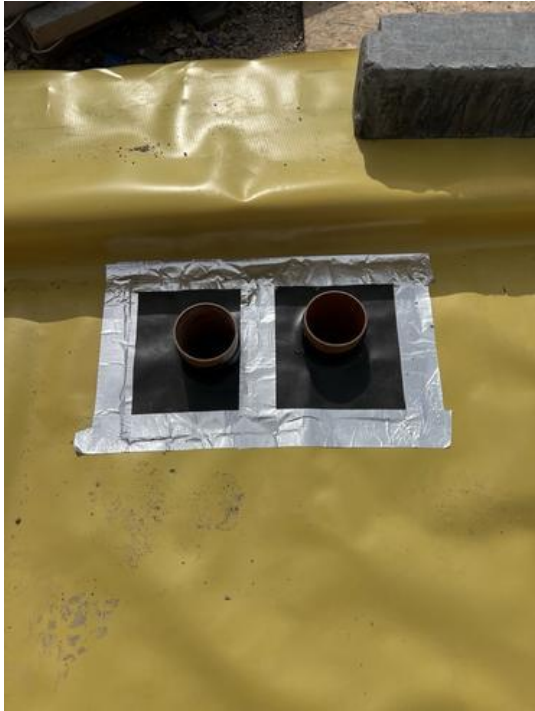
Service entries seals: Top hats seal arrangements fixed around service entries? Use of Jubilee clips?

Yes

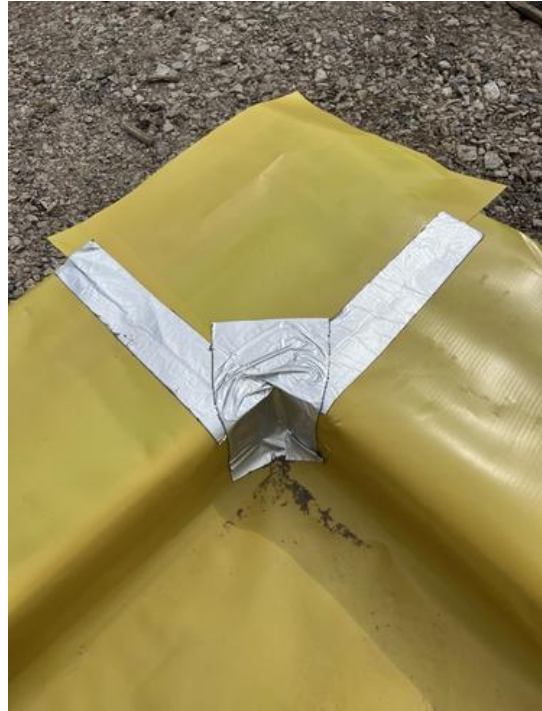
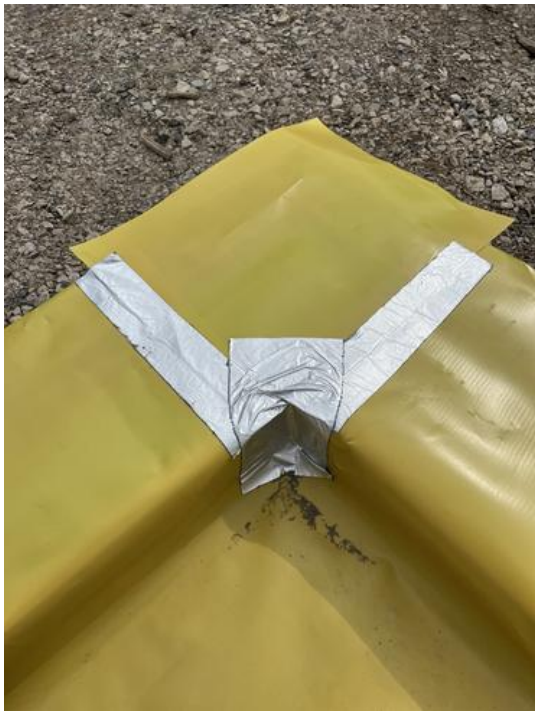
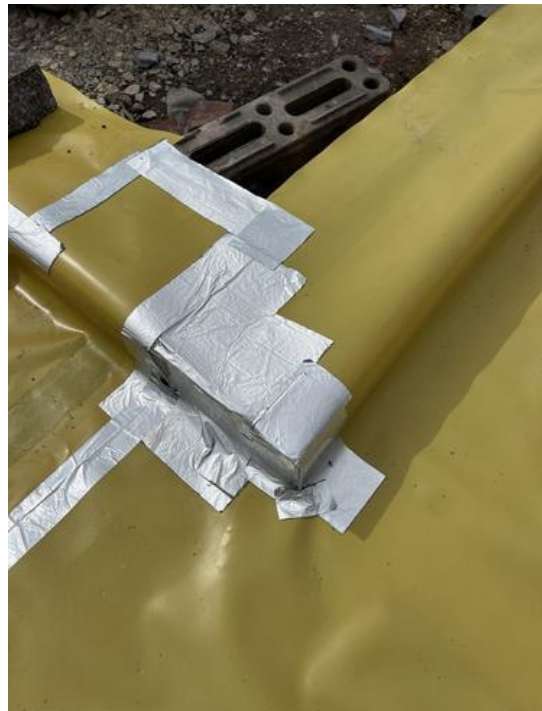
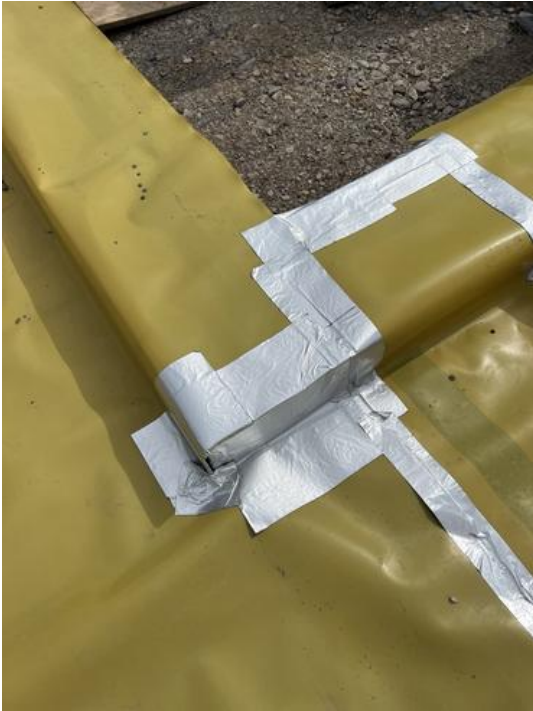
**Corners / Internal joints:** Check all corners are correctly formed or contractor has used preformed corners.

Pass

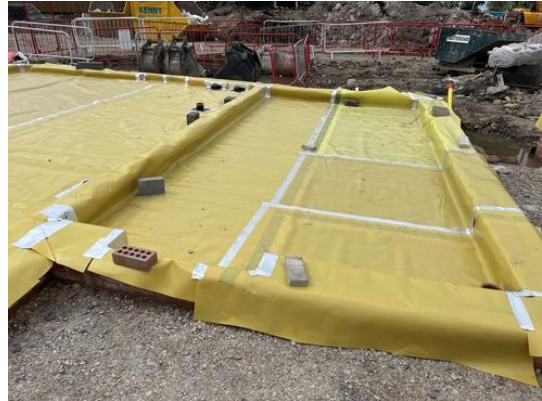
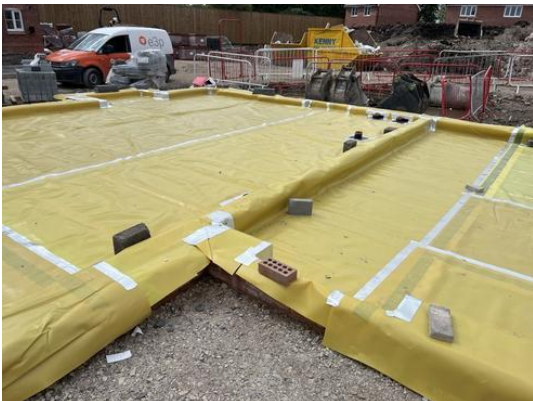
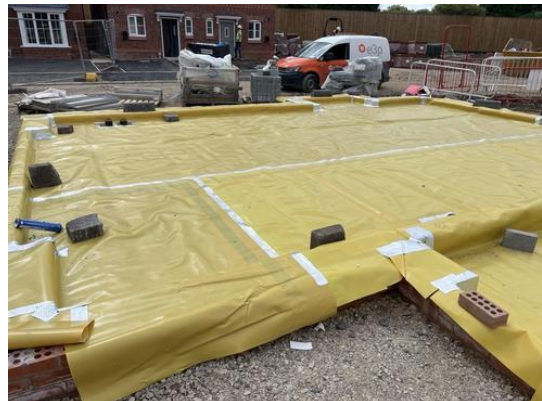
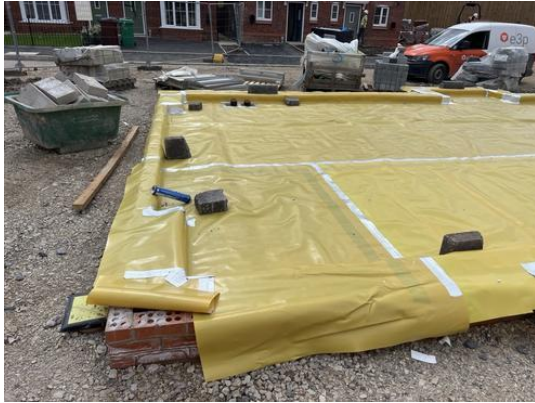
**Extent of Coverage:** Is the membrane covering the entire plot?  
Does membrane span over outside walls?

Yes

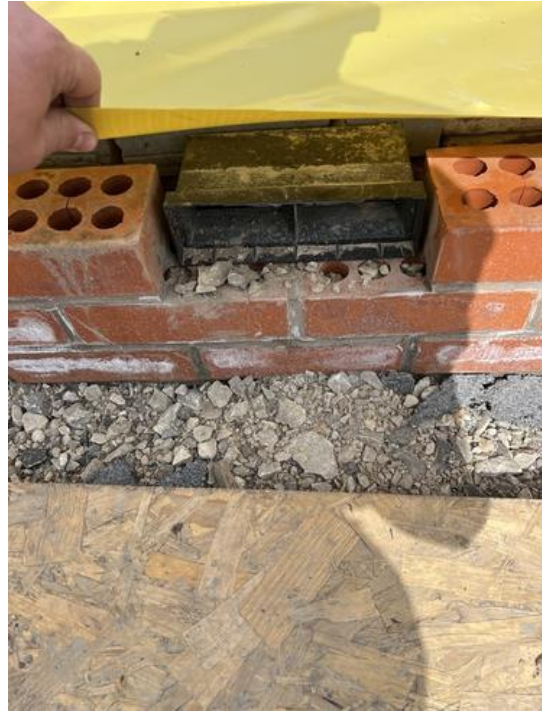
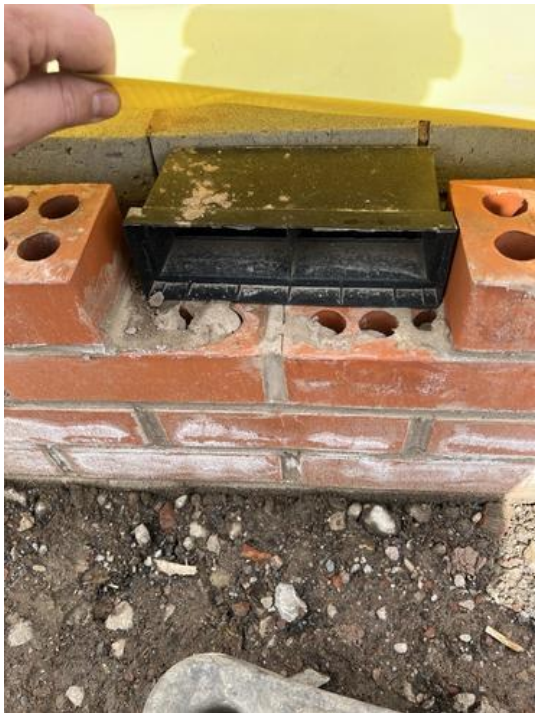
**External Wall Air bricks:** Numbers, size. positions as design drawing? (Minimum of 3 walls)

Pass

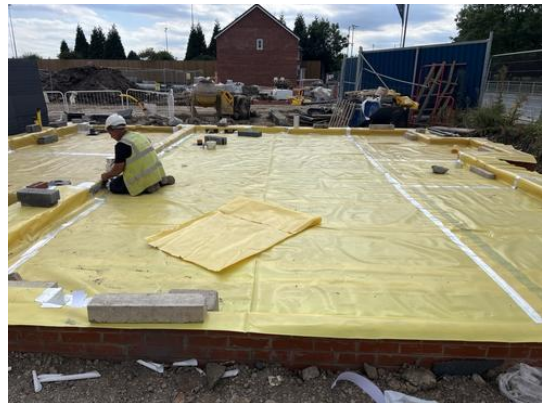
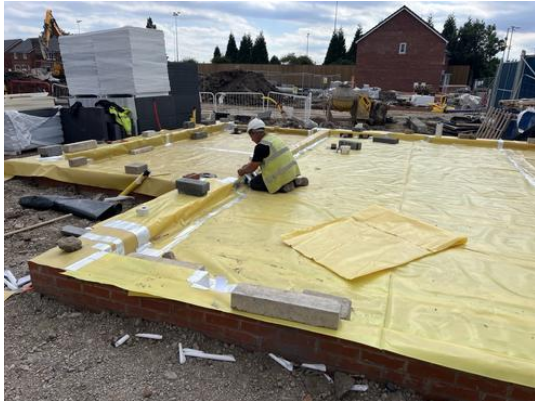
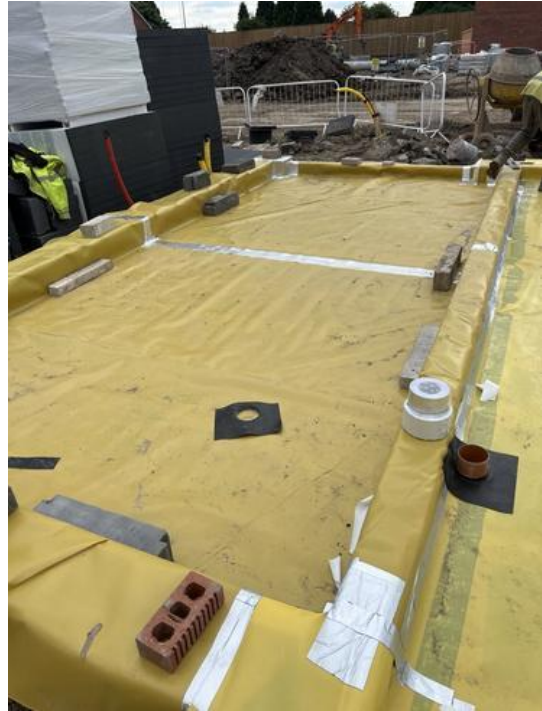
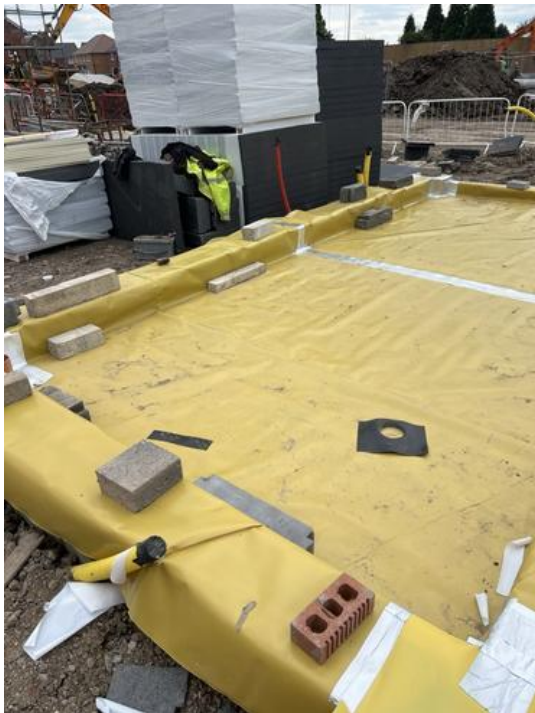
Gas Membrane Condition: Open punctures, tears, rips, stretching, Presence of debris, Repairs, Signs of weakness such as raised or sunken indentations, Protection plan in place to restrict access to lain gas membrane? IF FAIL DESCRIPTION IN ACTIONS AND PHOTOS REQUIRED

Pass

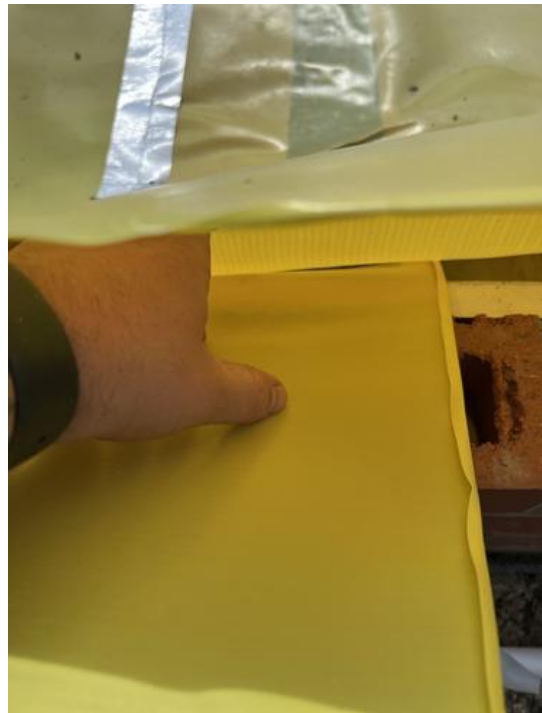
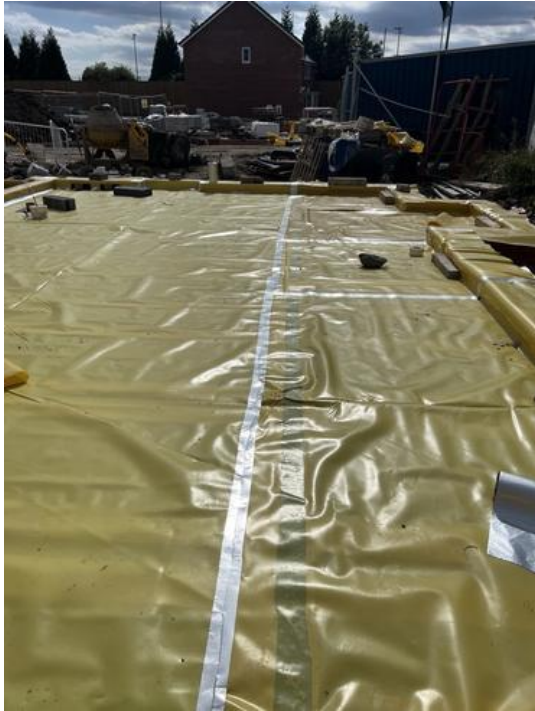
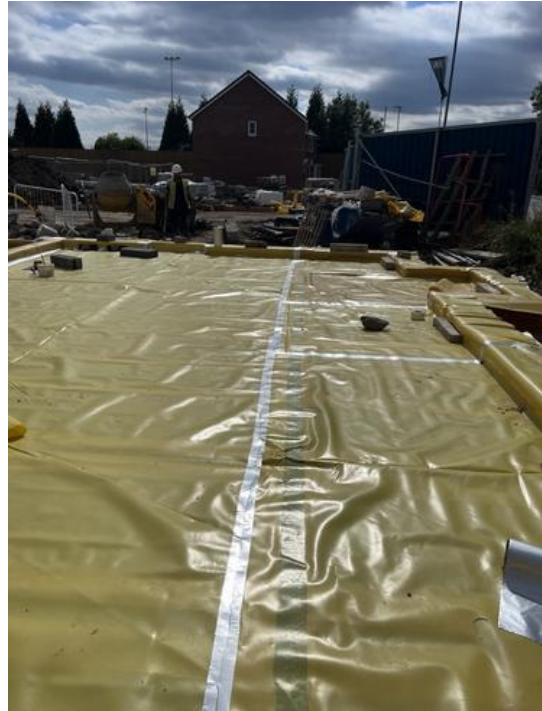
Laps, welds, and joints seals: Joints lapped and sealed in accordance with manufacturer's requirements/ specification? Minimum overlap insured? Sections taped twice? Are welds complete? Appropriate joining/double-sided tape used, Folds running in line with joints? (no joints cutting across folds)

Pass

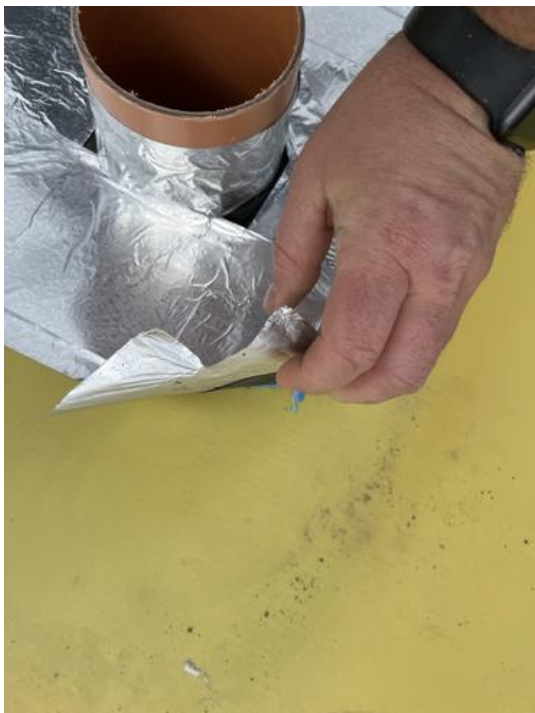
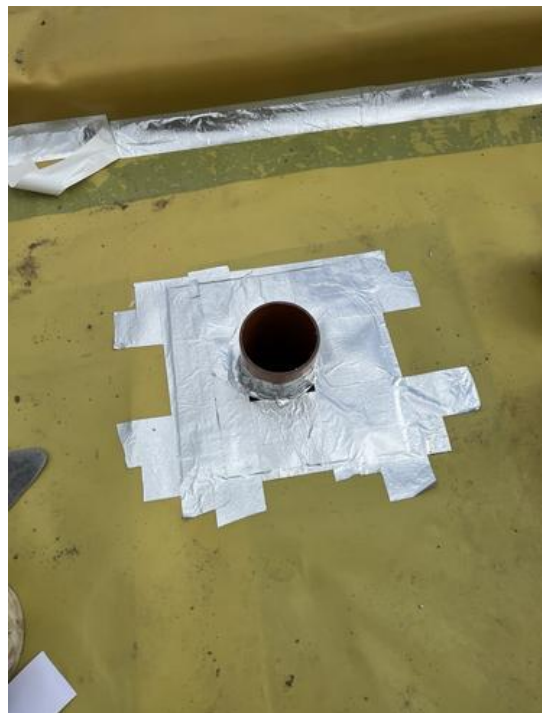
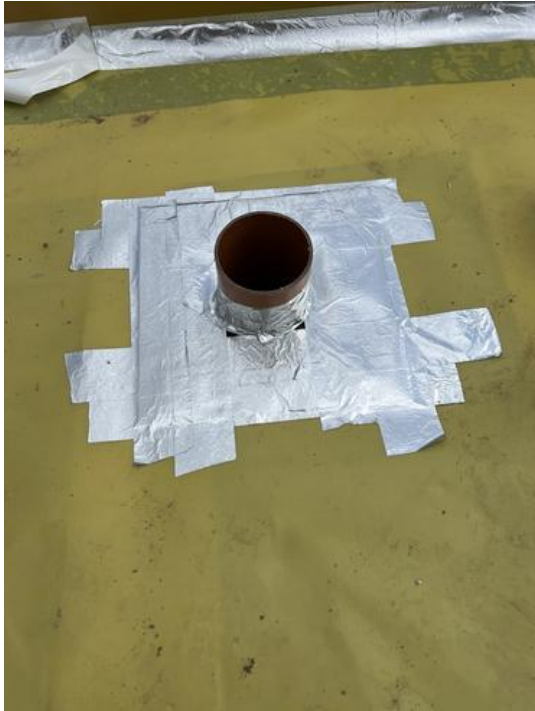
Service entries seals: Top hats seal arrangements fixed around service entries? Use of Jubilee clips?

Yes

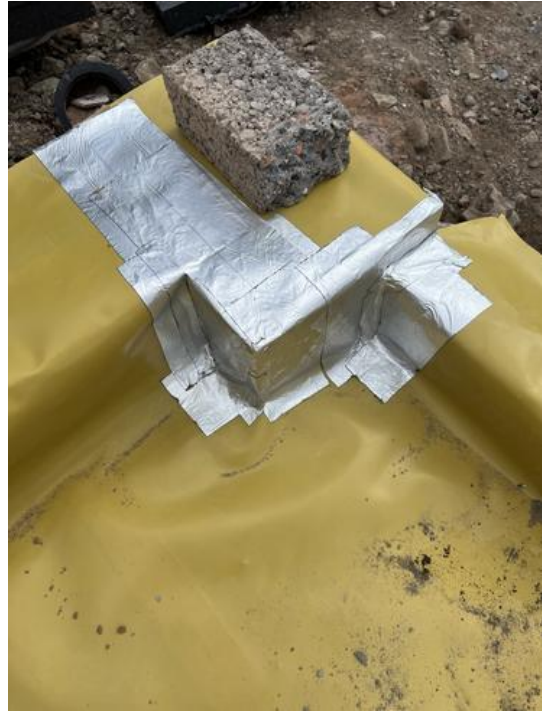
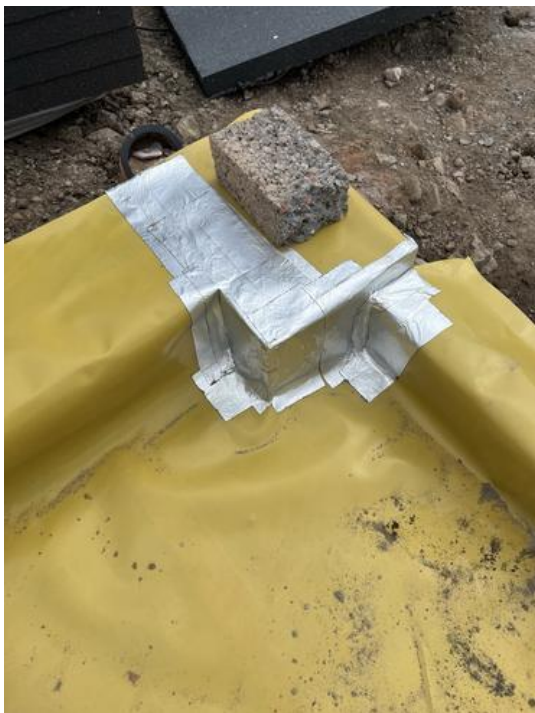
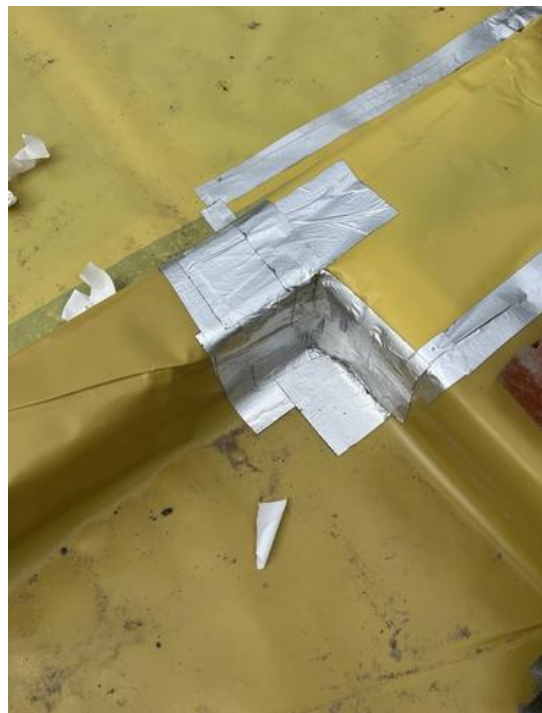
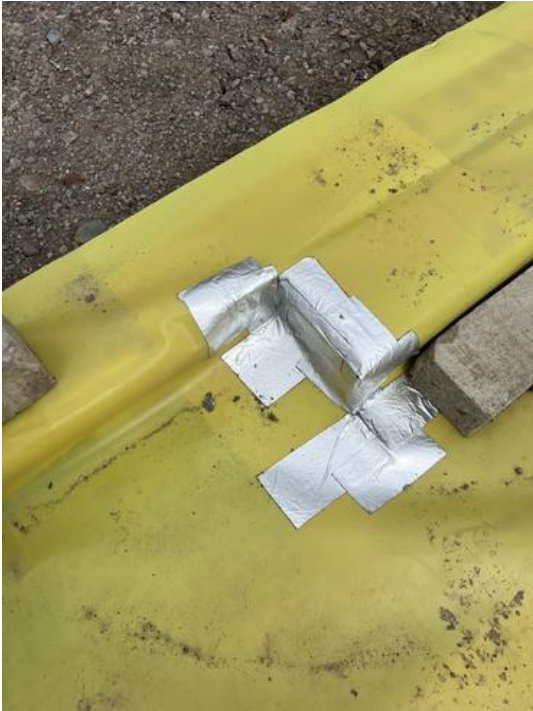
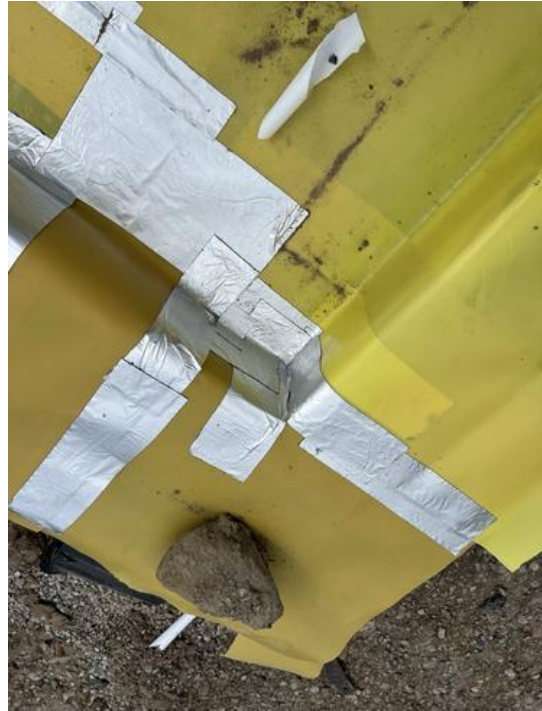
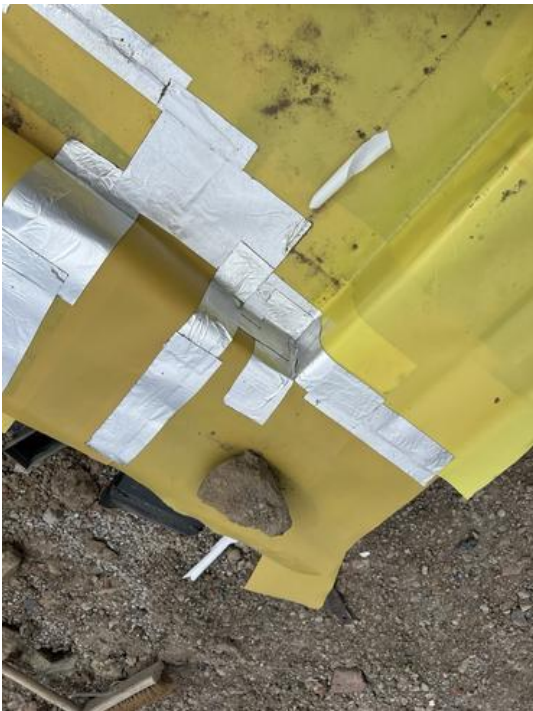
**Corners / Internal joints: Check all corners are correctly formed or contractor has used preformed corners.**

Pass

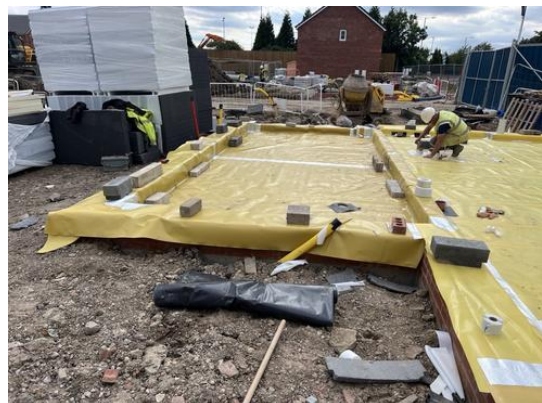
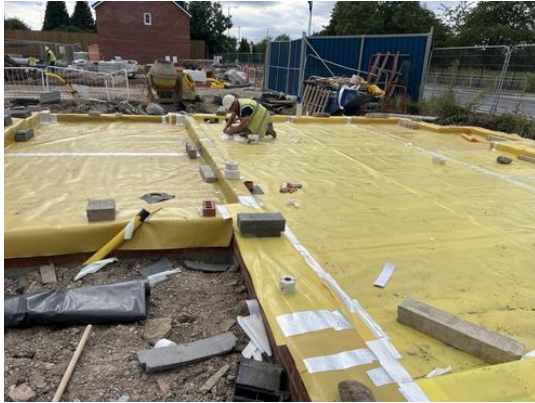
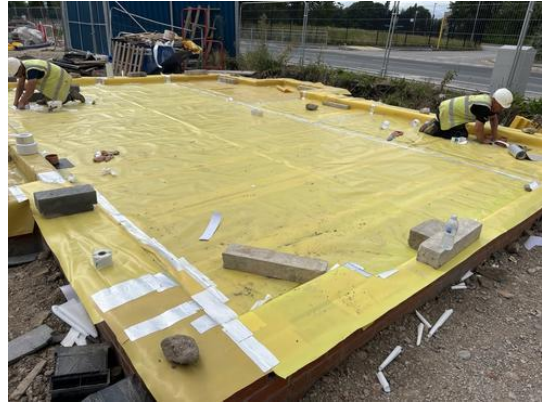
**Extent of Coverage: Is the membrane covering the entire plot? Does membrane span over outside walls?**

Yes

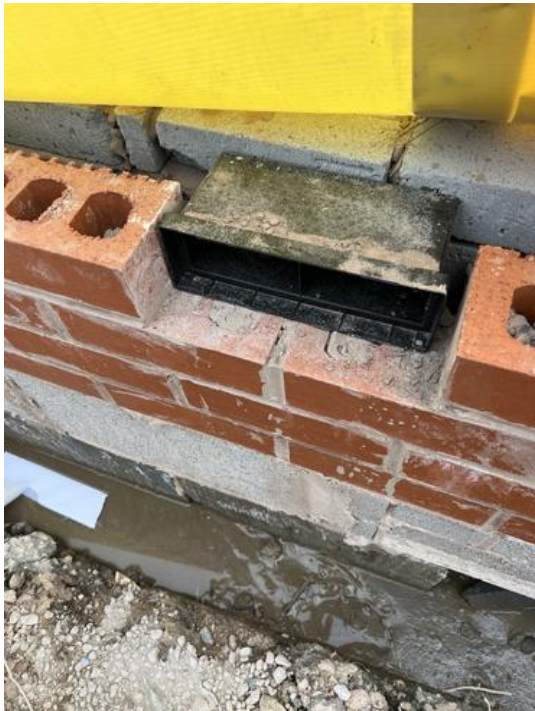
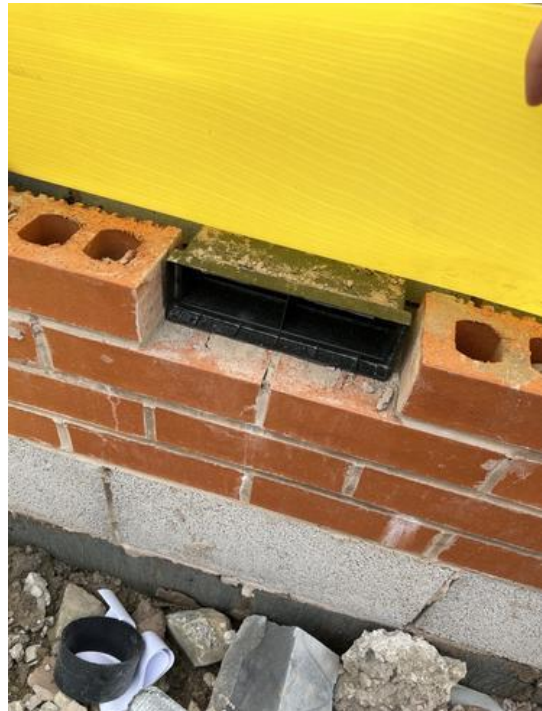
**External Wall Air bricks: Numbers, size. positions as design drawing? (Minimum of 3 walls)**

Pass
