| KELIOS AMEY METROLINK INSPECTIONS |
| A53 - WILLIAM STREET ARCHES |

## Appendix B: Photographs

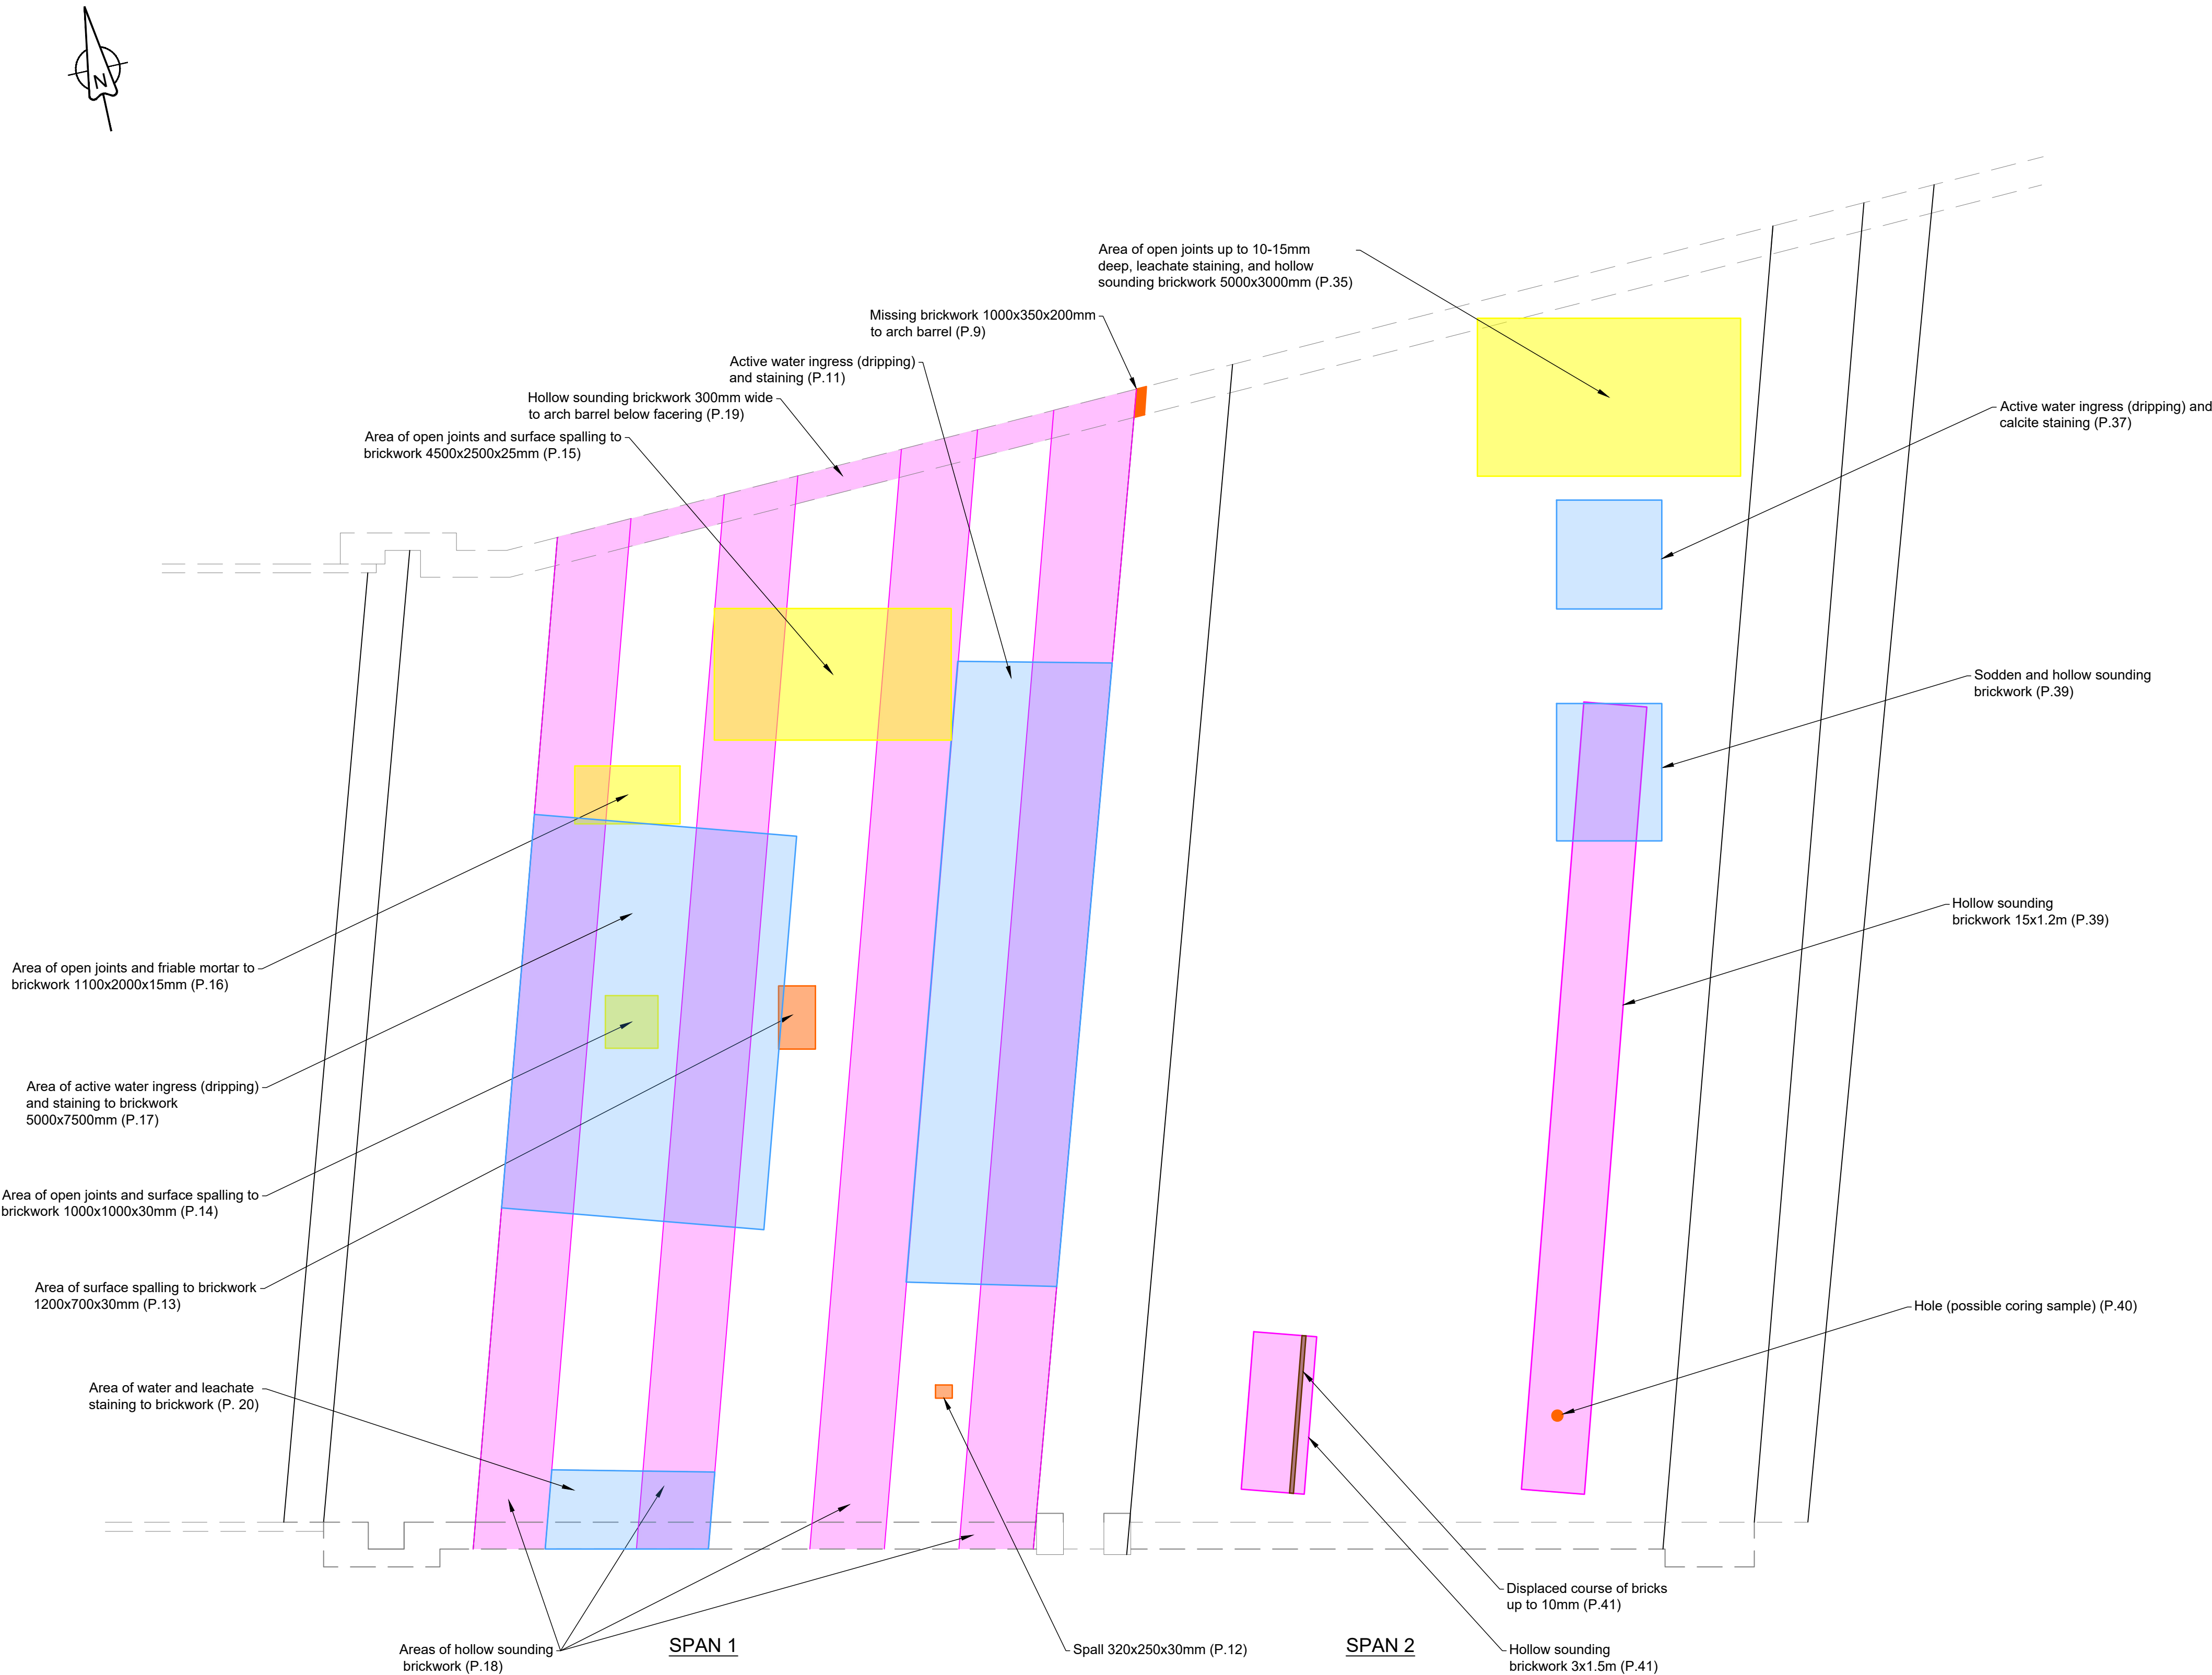
PLAN

**PLAN DEFECTS**

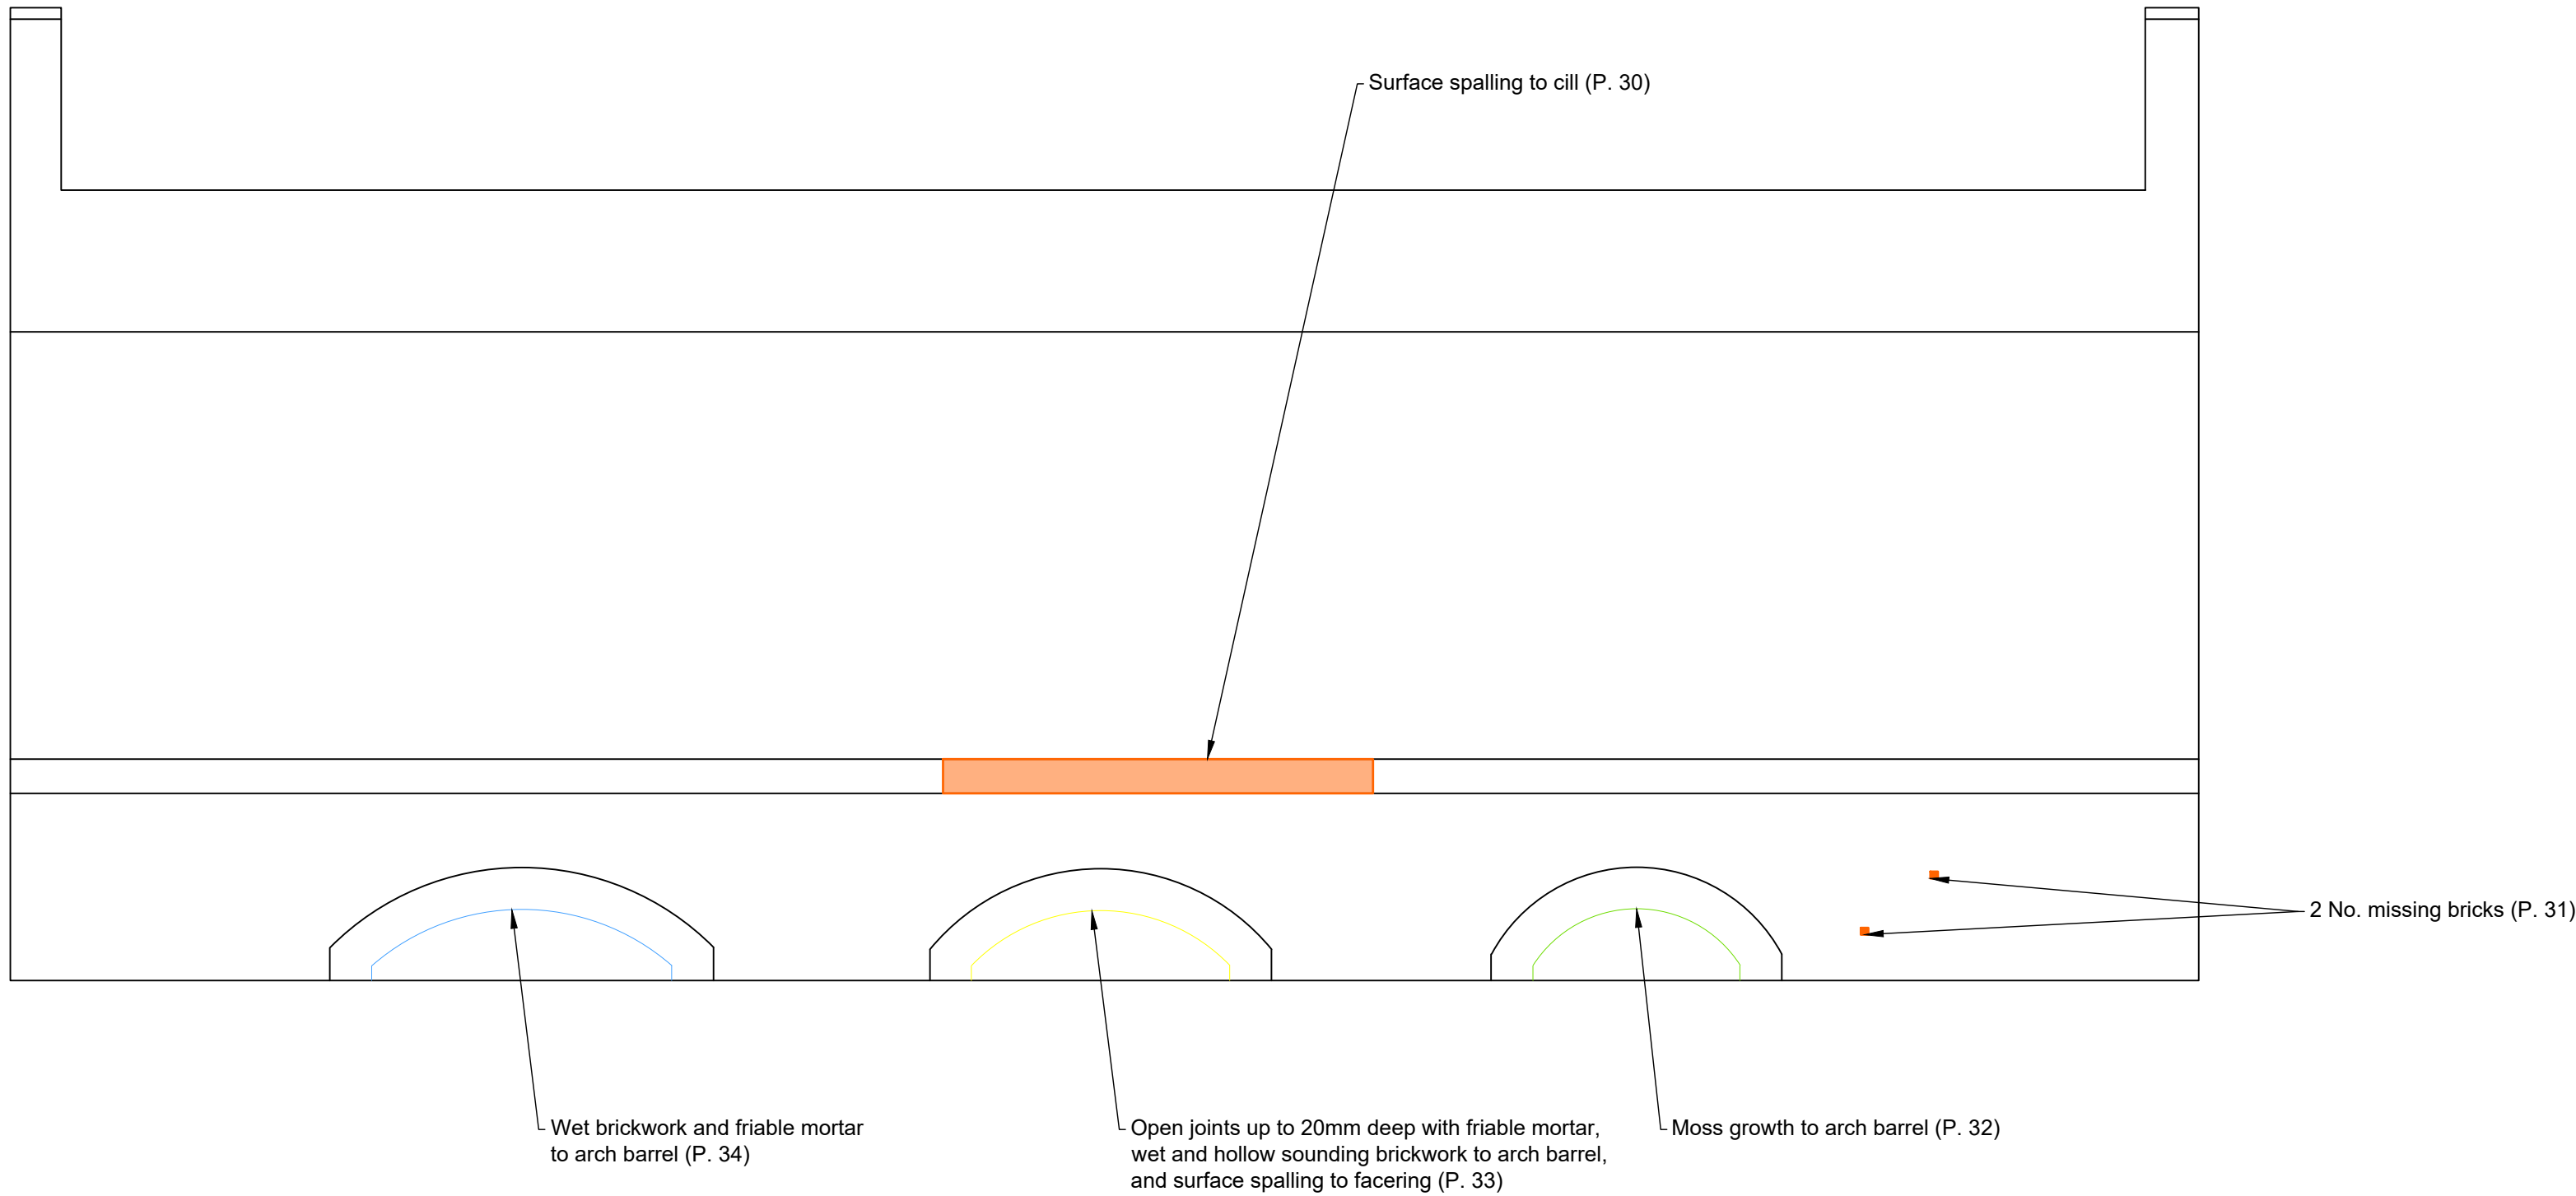
CENTRAL PIER - WEST ELEVATION DEFECTS

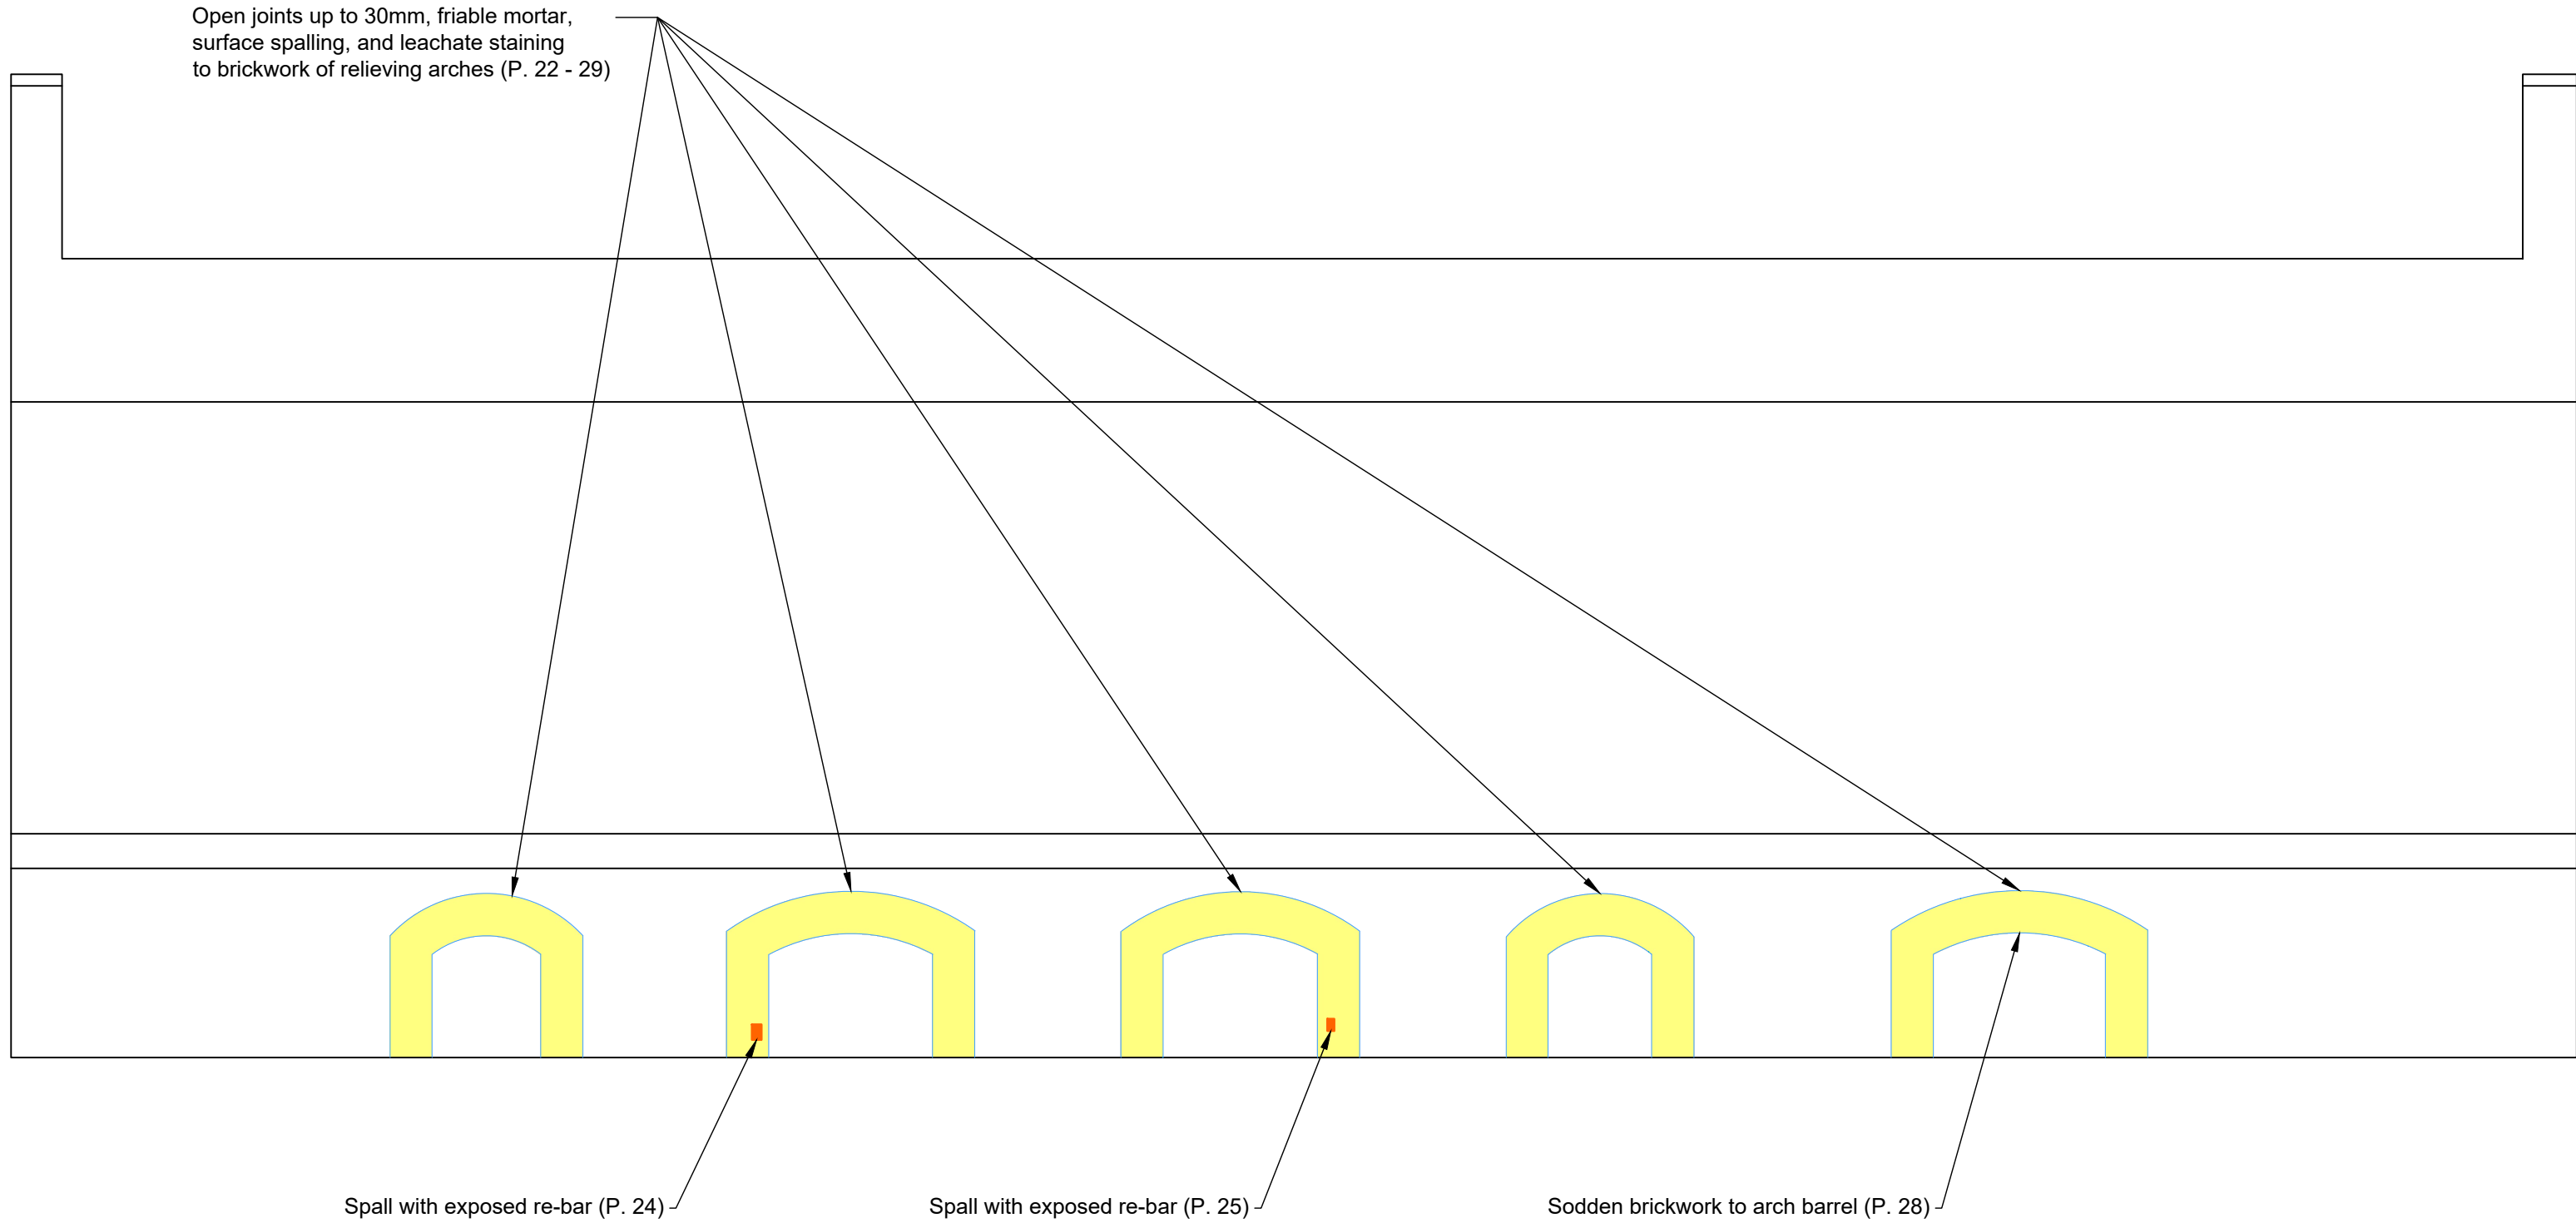
EAST ABUTMENT DEFECTS

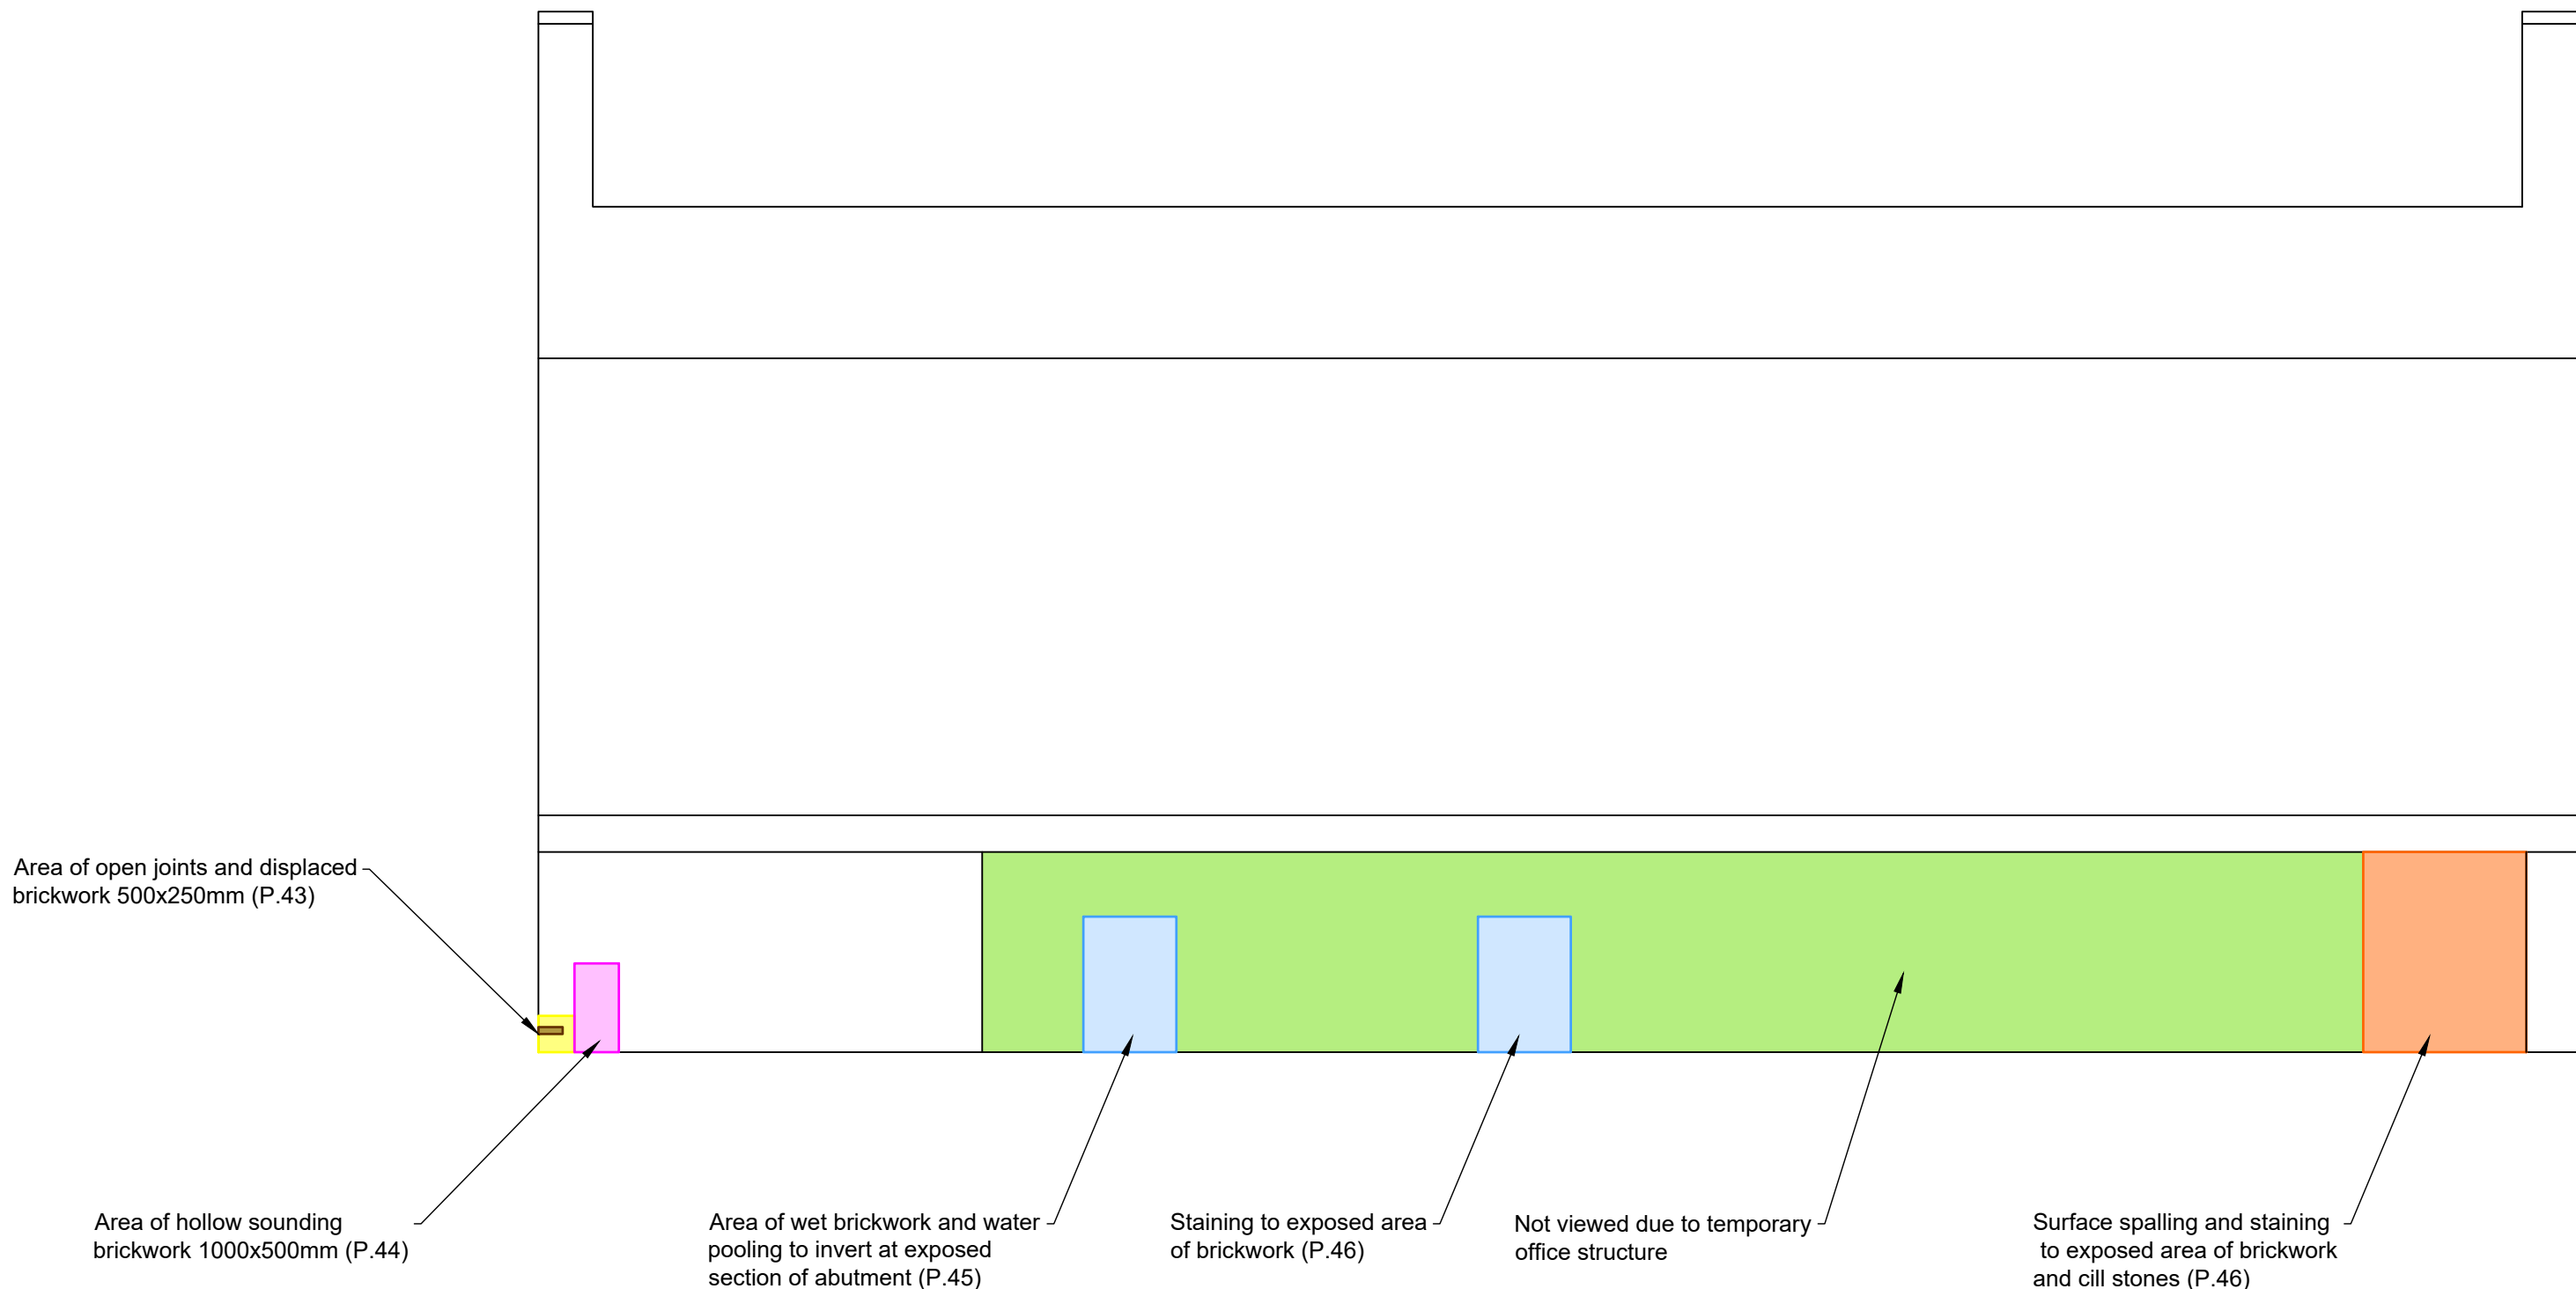
EAST ABUTMENT DEFECTS

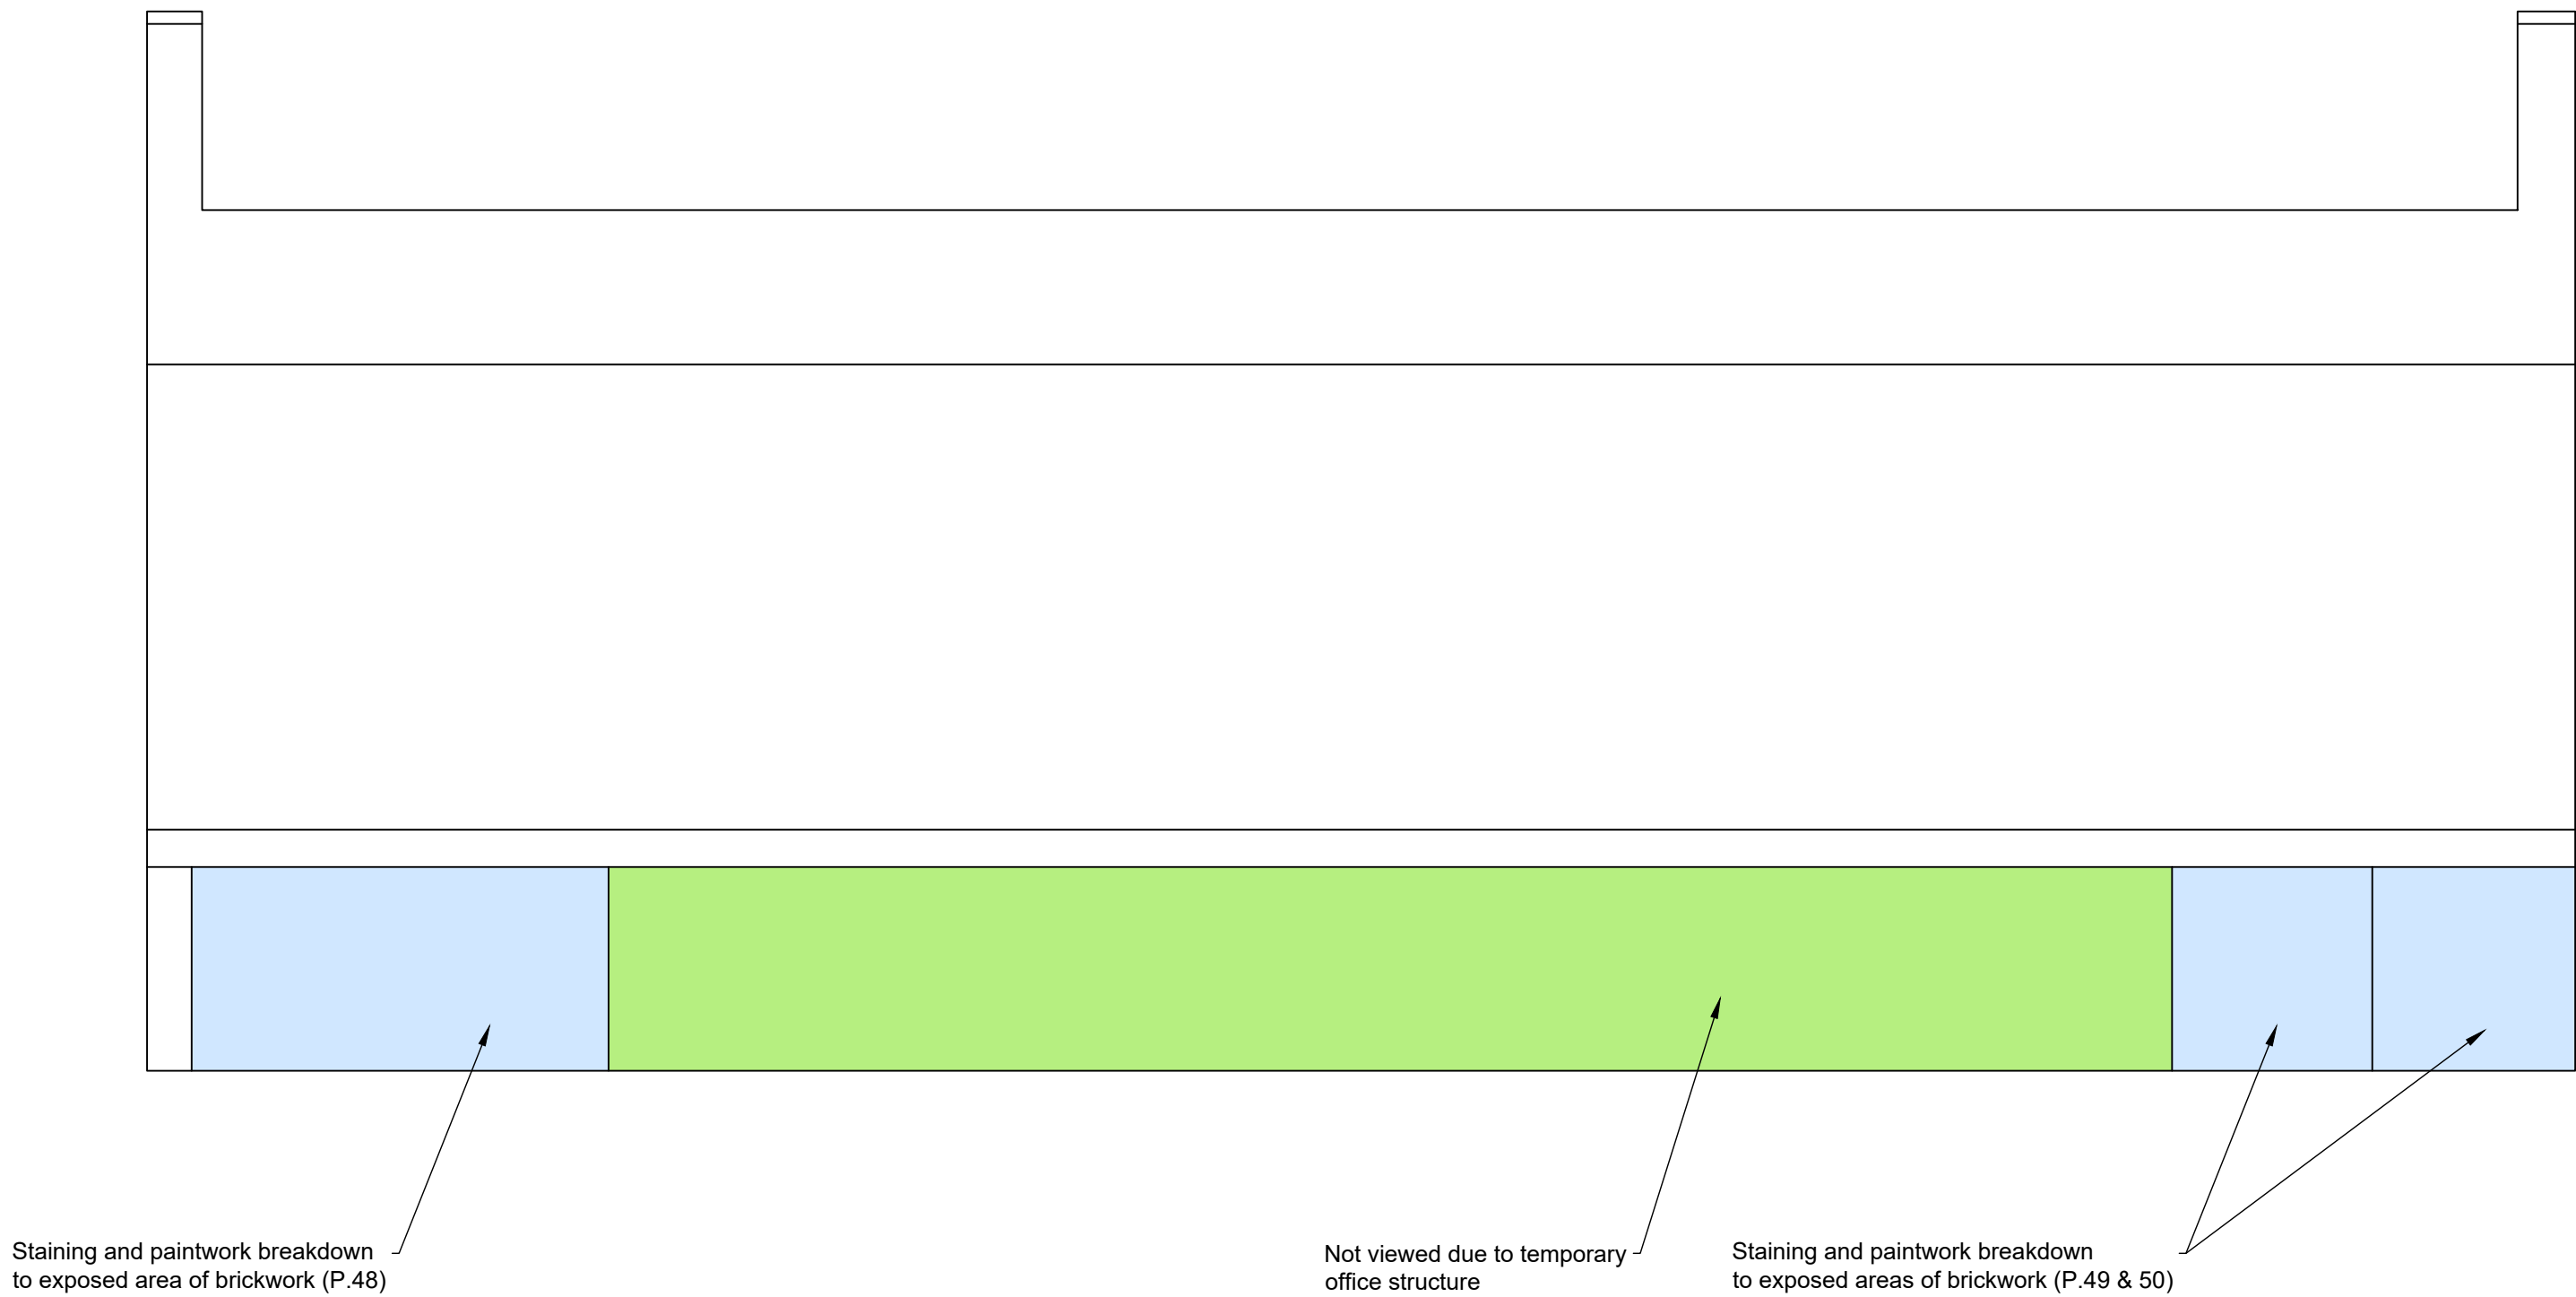
CENTRAL PIER - EAST ELEVATION DEFECTS

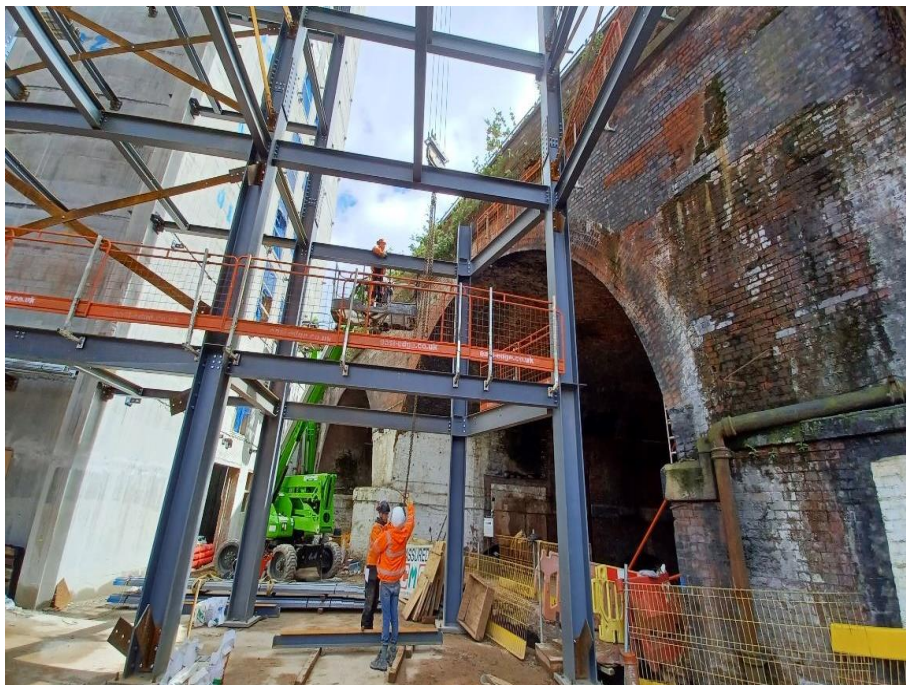
Photo 4: General view north elevation showing construction works affecting access.

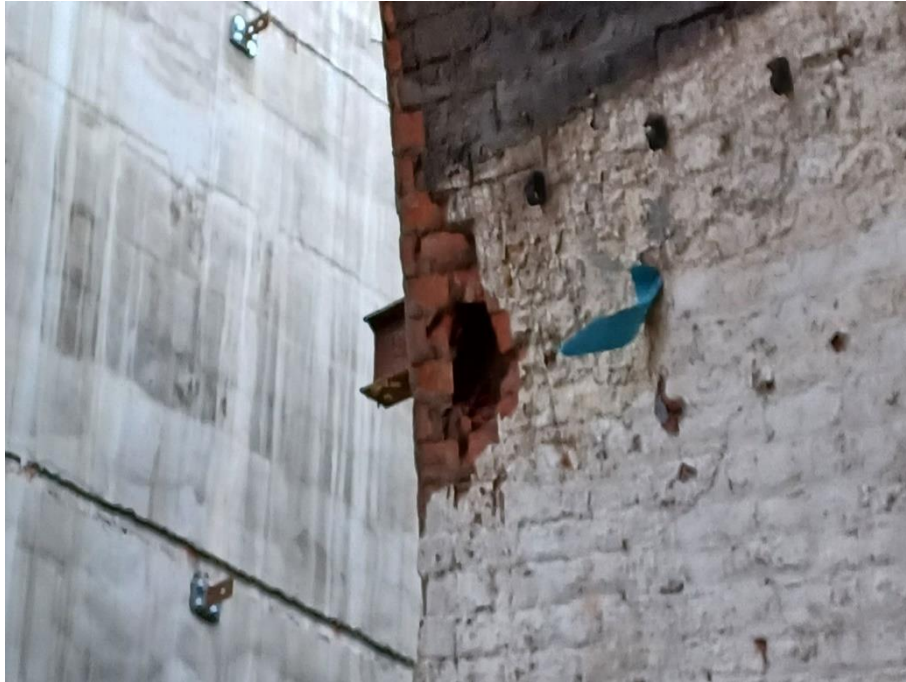
Photo 9: Spall to brickwork 1000x350x200mm to northeast quarter point of span 1 arch barrel.

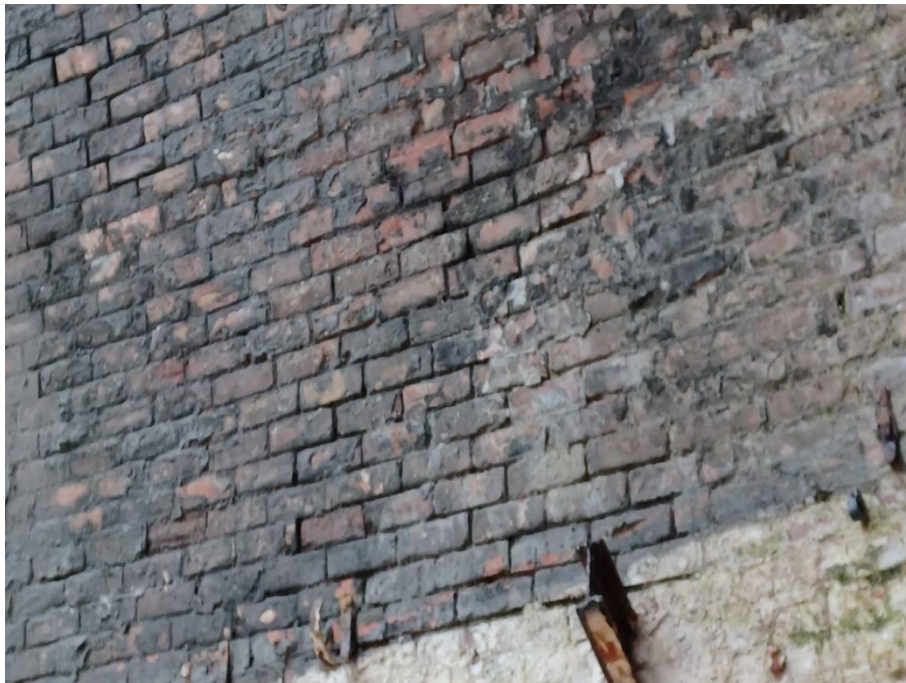
Photo 10: Area of open joints 1m²x15mm deep to northeast end of span 1 arch barrel.

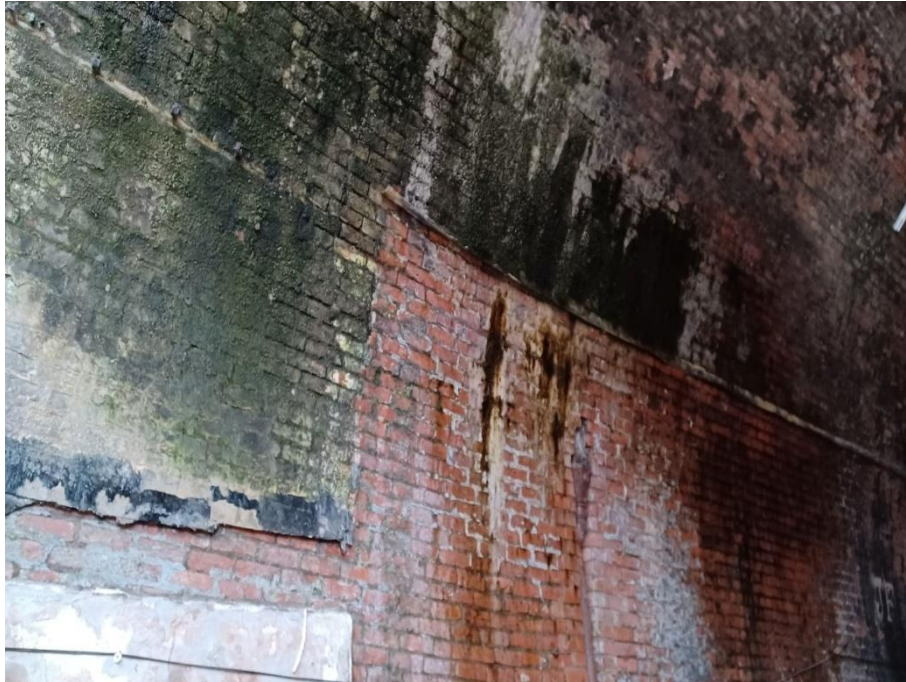
Photo 11: Moss growth, isolated open joints, and water staining / active ingress (dripping) to east face of span 1 arch barrel.

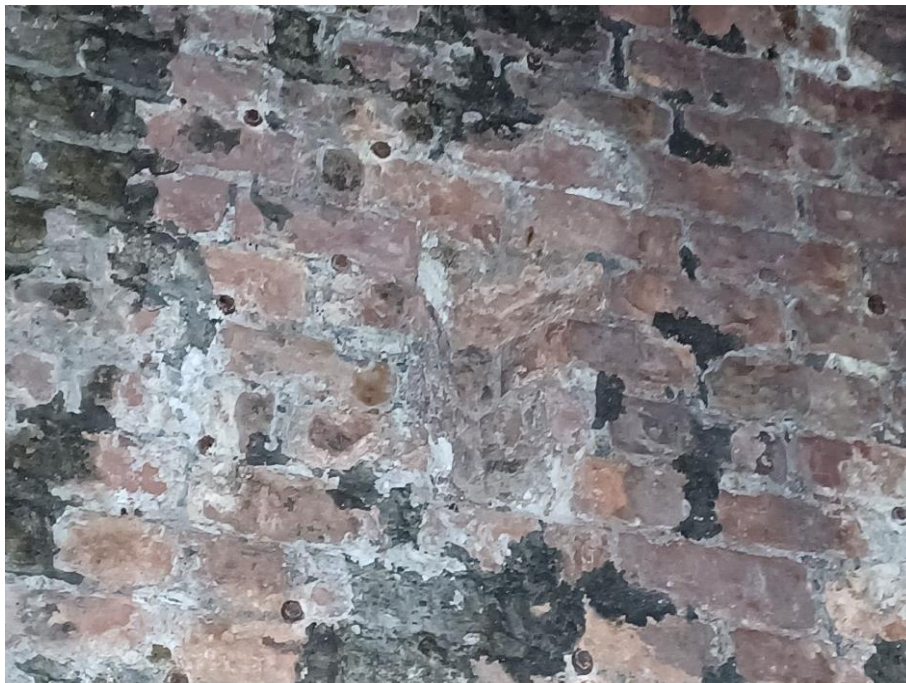
Photo 12: Spall 320x250x30mm to southeast end of span 1 arch barrel.

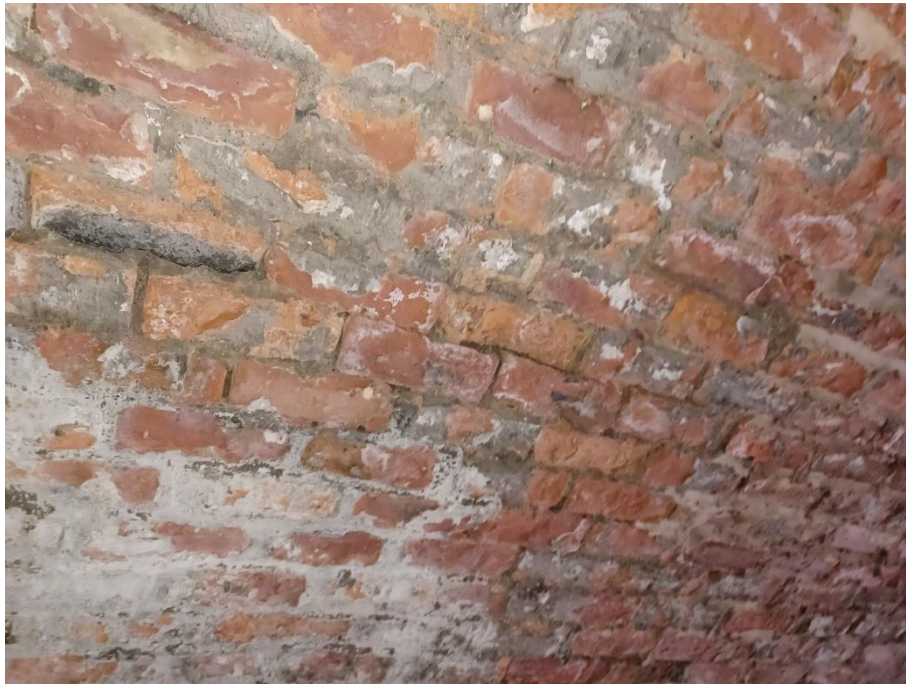
Photo 13: Area of spalling 1200x700x30mm and open joints at mid-span crown of span 1 arch barrel.

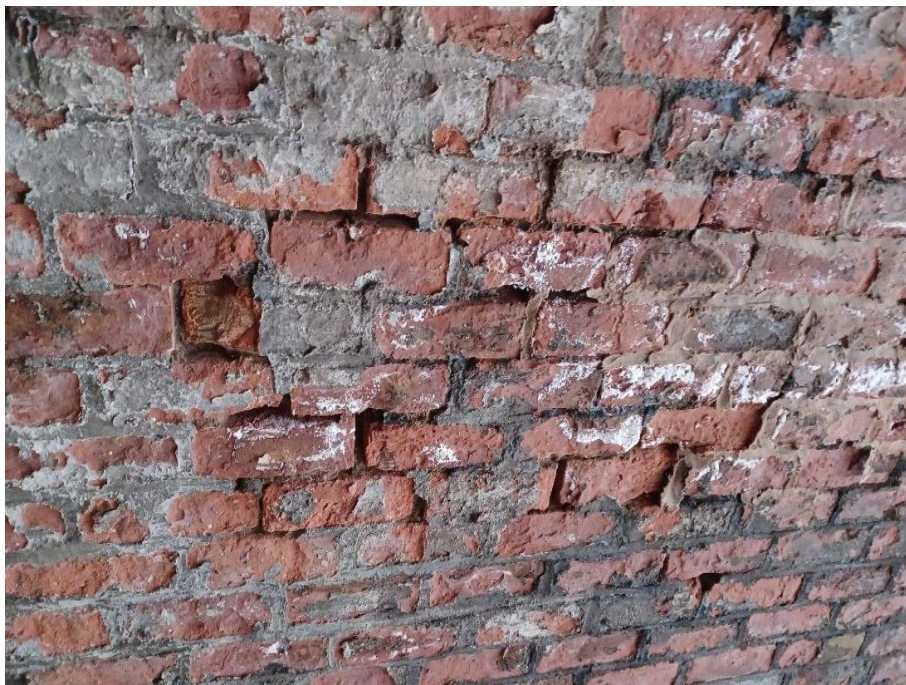
Photo 14: Area of spalling and open joints 1m<sup>2</sup>x30mm at mid-span of west face of span 1 arch barrel.

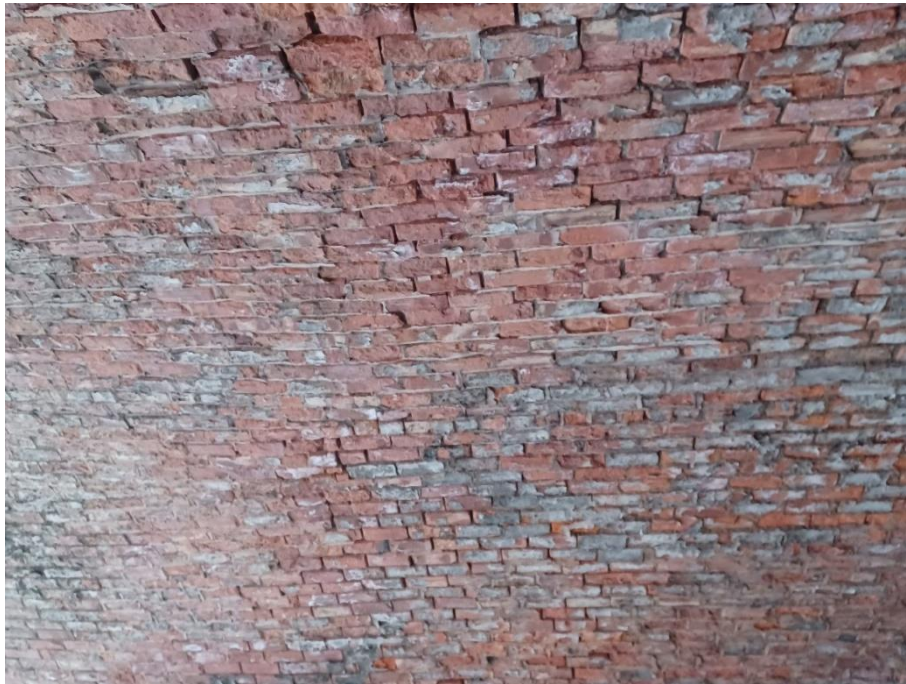
Photo 15: Area of surface spalling and open joints 4500x2500x25mm from east quarter point to west quarter point at north end of span 1 arch barrel.

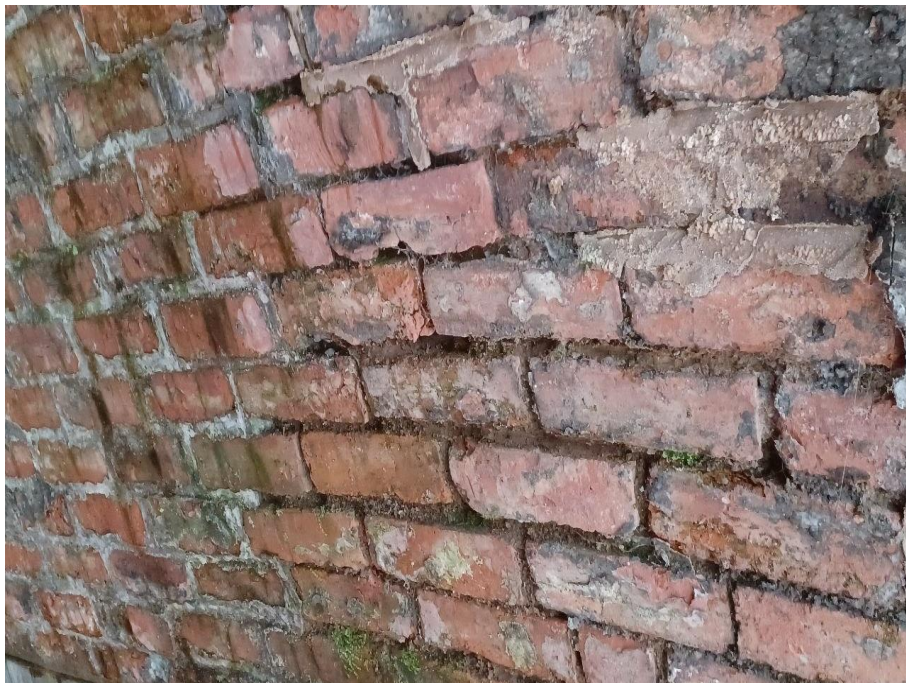
Photo 16: Area of wet friable mortar and open joints 1100x2000x15mm to quarter point at northwest end of span 1 arch barrel.

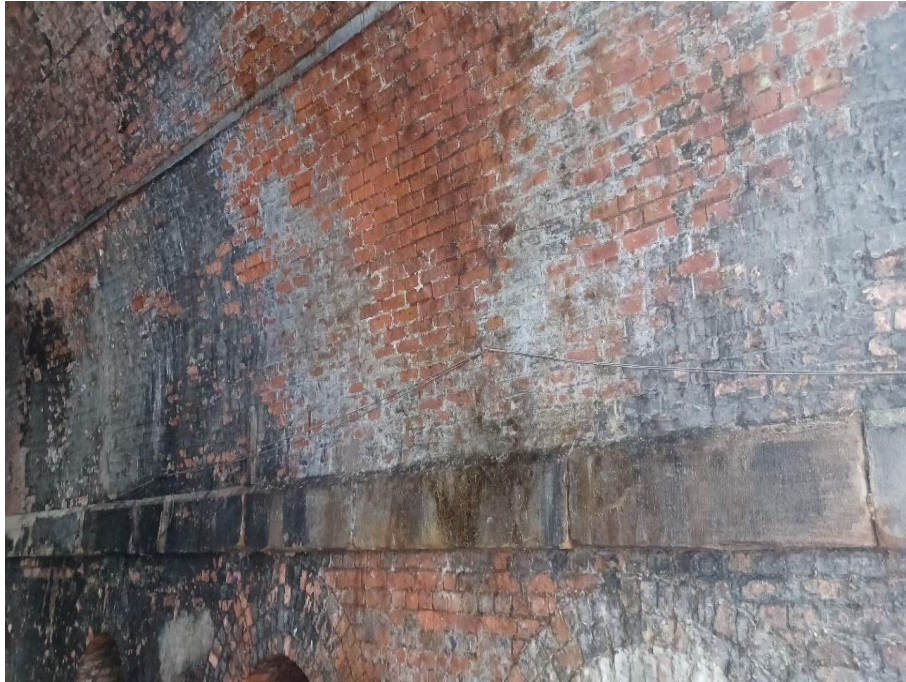
Photo 17: Area of wet friable mortar and active water ingress (dripping) 5000x7500mm to mid-span of west face of span 1 arch barrel.
