| KELIOS AMEY METROLINK INSPECTIONS |
| A53 - WILLIAM STREET ARCHES |

## Appendix B: Photographs

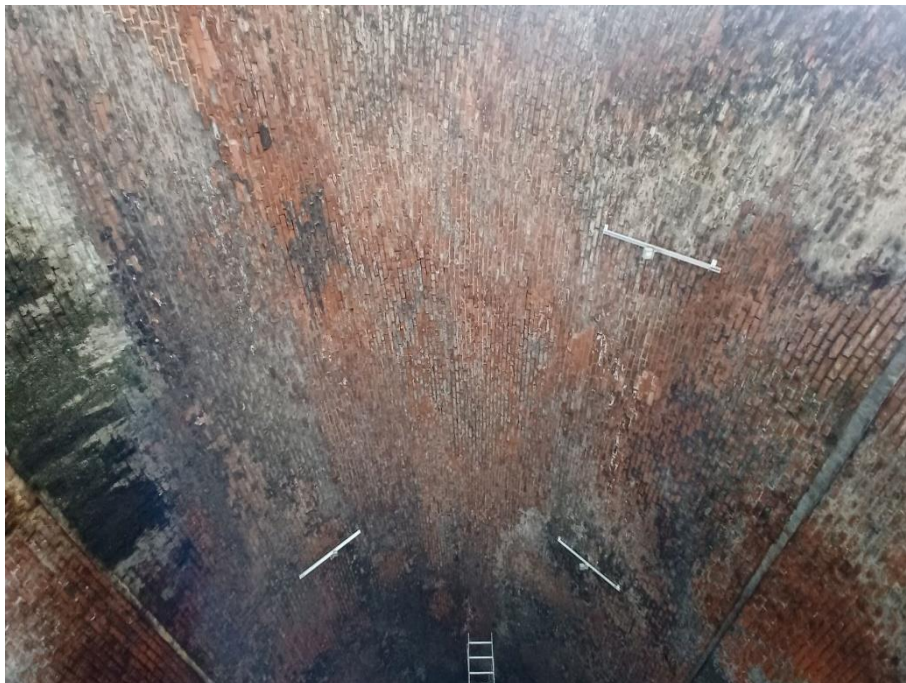
Photo 18: Areas of hollow sounding brickwork between east and west springing's and quarter points, and quarter points and crown (approx. 65% total area) throughout span 1 arch barrel.

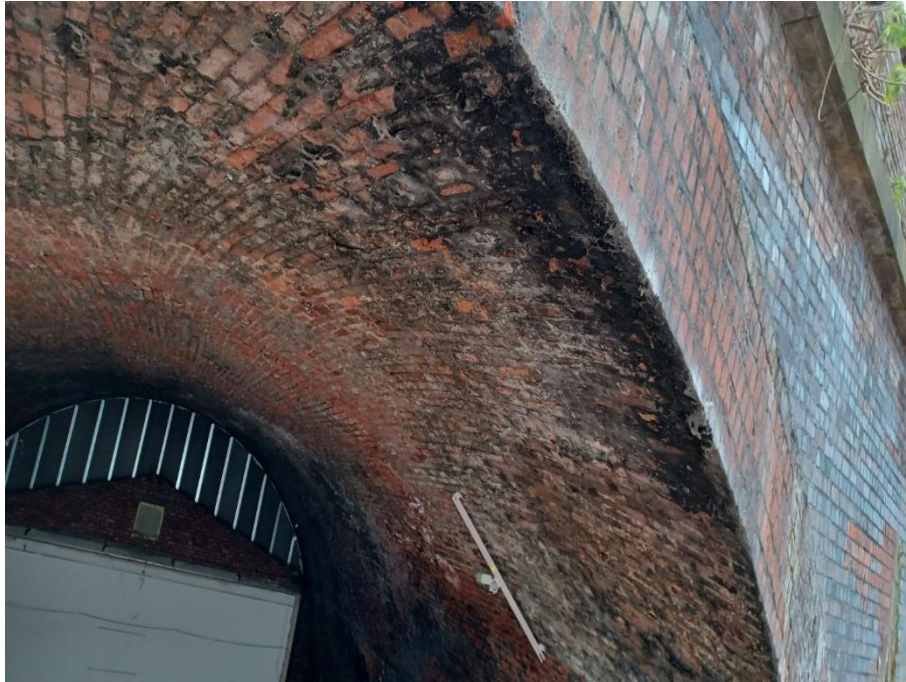
Photo 19: Area of hollow sounding brickwork 300mm wide from east to west springing's at north end of span 1 arch barrel.

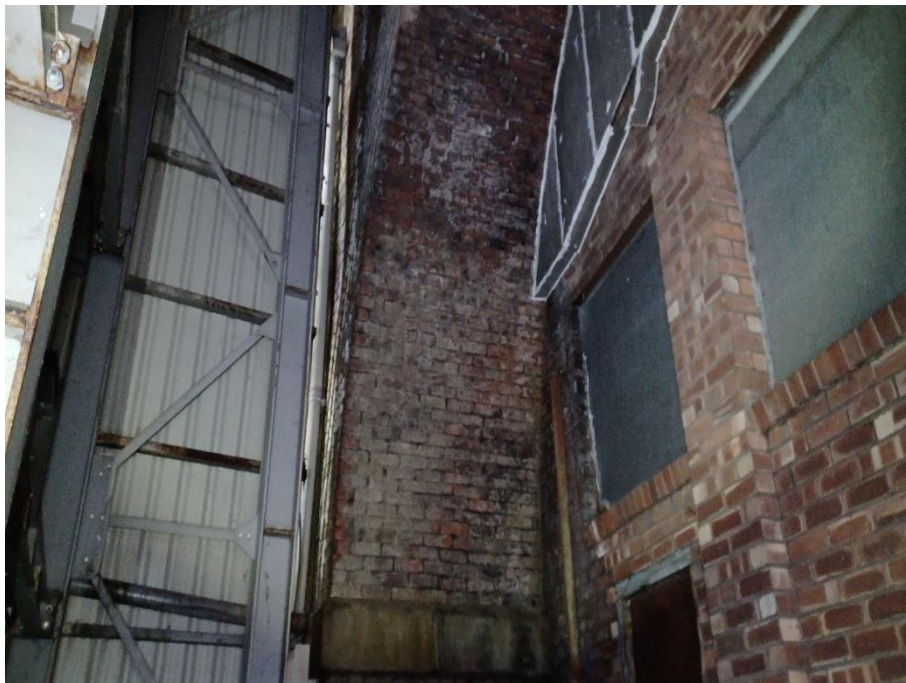
Photo 20: Water/leachate staining to southwest end of span 1 arch barrel.

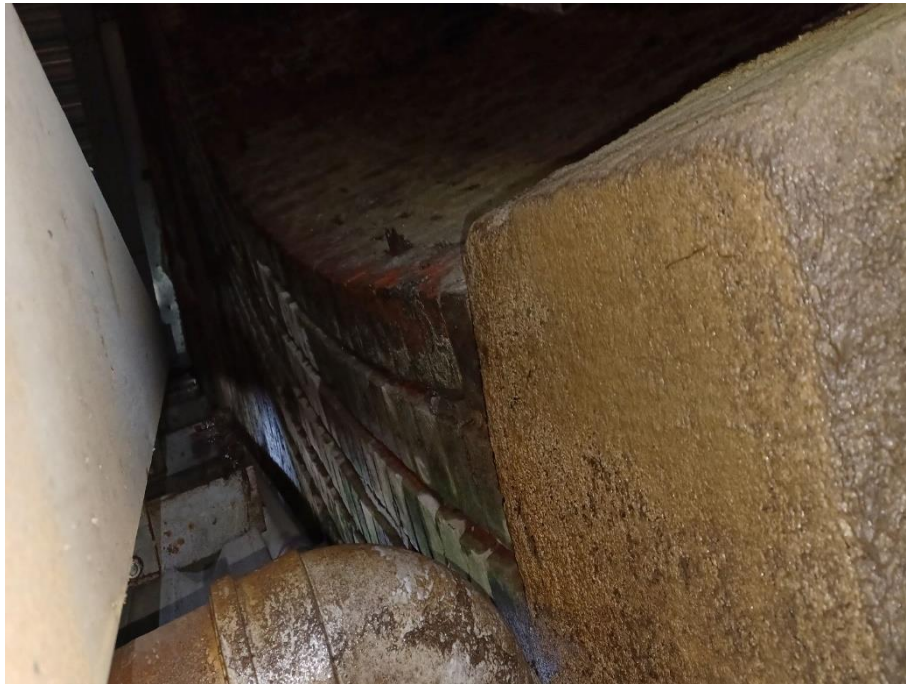
Photo 21: Area of open joints to southwest of face ring from springing up 2.2m by width of face ring and up to 20mm deep of span 1.

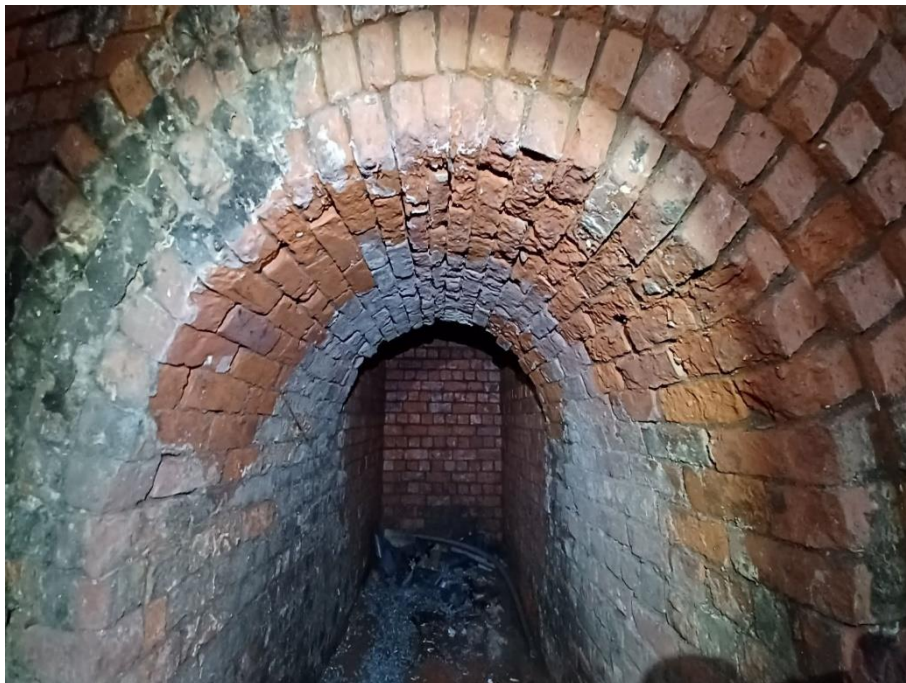
Photo 22: Open joints up to 30mm deep, wet friable mortar, surface spalling, and leachate staining to arch barrel of 1<sup>st</sup> relieving arch from south end of west abutment span 1.

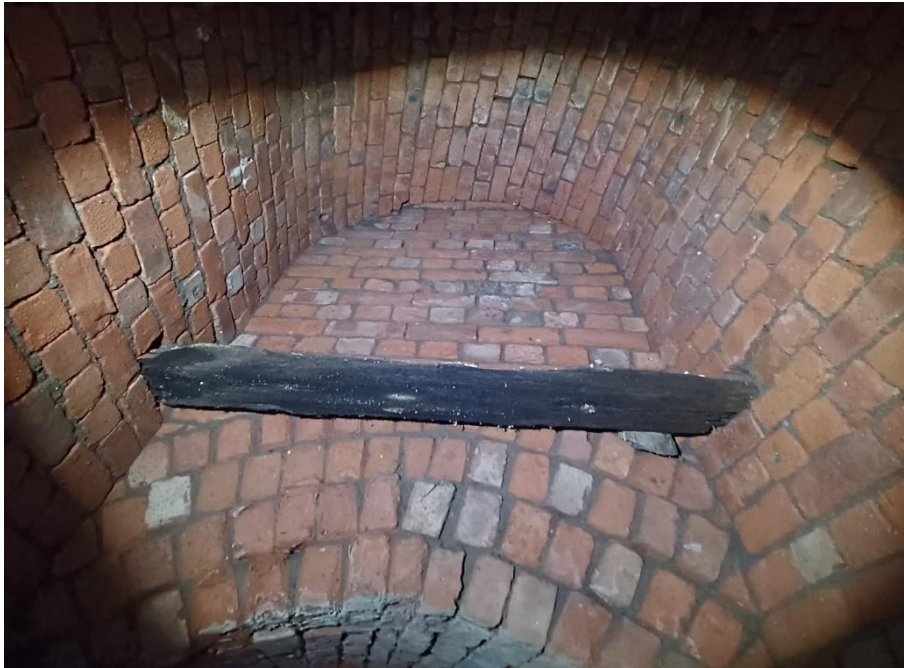
Photo 23: Wet friable mortar and damp brickwork to west face of 1<sup>st</sup> relieving arch from south end of west abutment span 1.

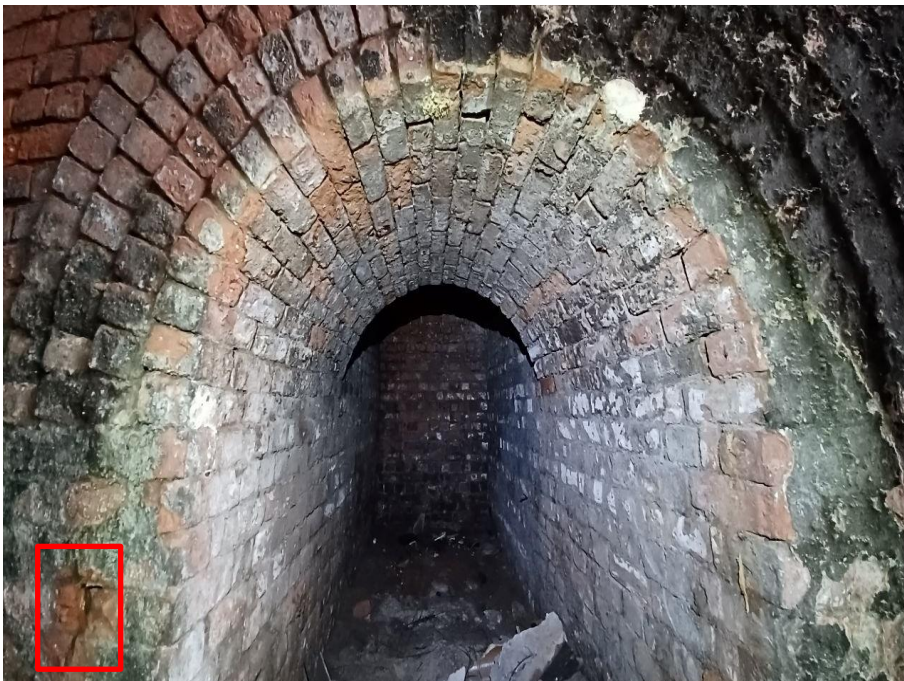
Photo 24: Open joints up to 30mm deep, wet friable mortar, surface spalling, and leachate staining to arch barrel and exposed re-bar to face ring of 2<sup>nd</sup> relieving arch from south end of west abutment span 1.

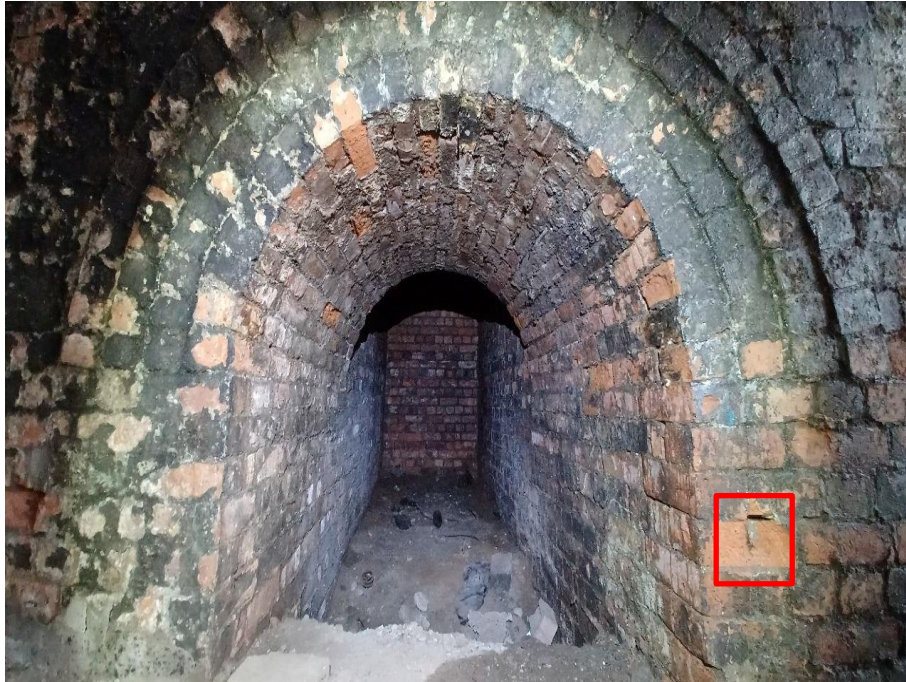
Photo 25: Open joints up to 30mm deep, wet friable mortar, surface spalling, and leachate staining to arch barrel and exposed re-bar to face ring of 3<sup>rd</sup> relieving arch from south end of west abutment span 1.

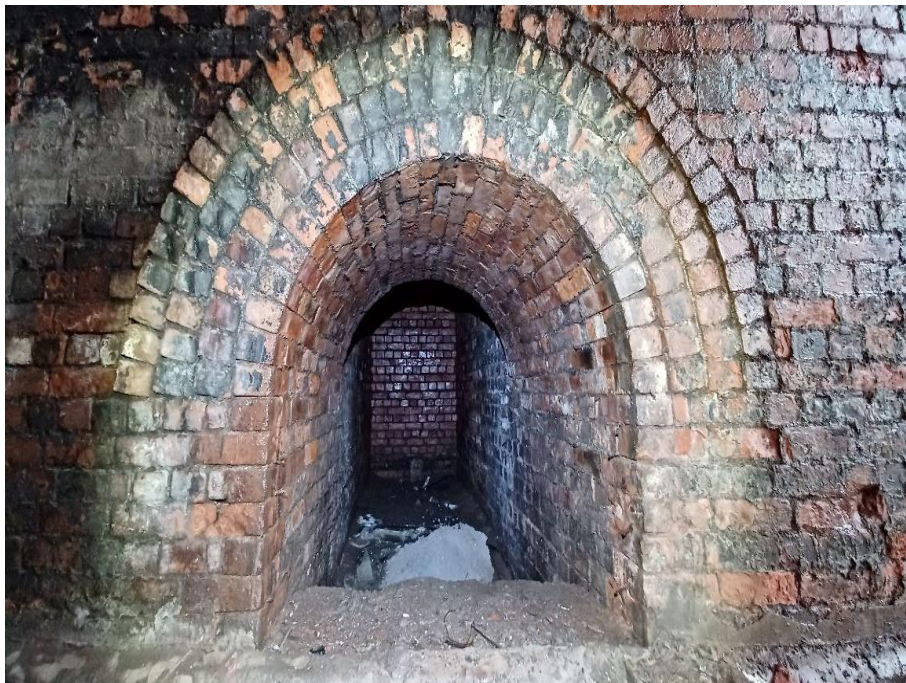
Photo 26: Open joints up to 30mm deep, wet friable mortar, surface spalling, and leachate staining to arch barrel of 4<sup>th</sup> relieving arch from south end of west abutment span 1.

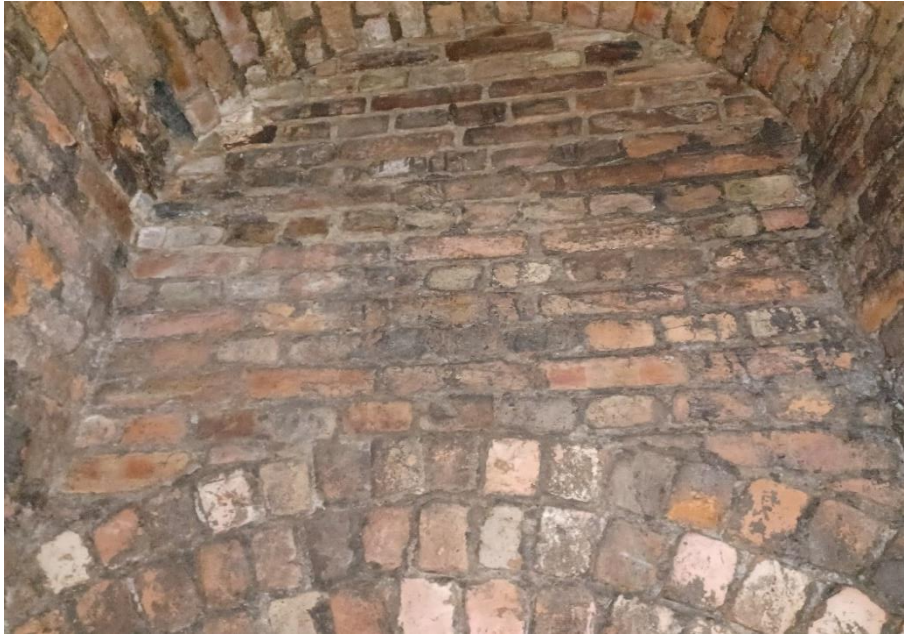
Photo 27: Wet friable water to west face of 4<sup>th</sup> relieving arch from south end of west abutment span 1.

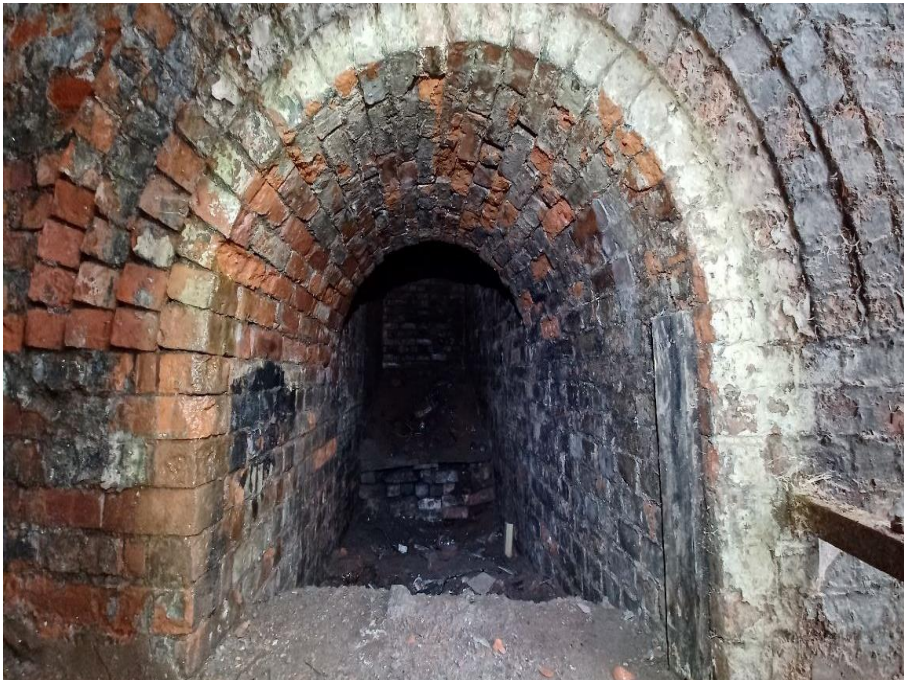
Photo 28: Open joints up to 30mm deep, wet friable mortar, surface spalling, leachate staining, and sodden brickwork to arch barrel of 5<sup>th</sup> relieving arch from south end of west abutment span 1.

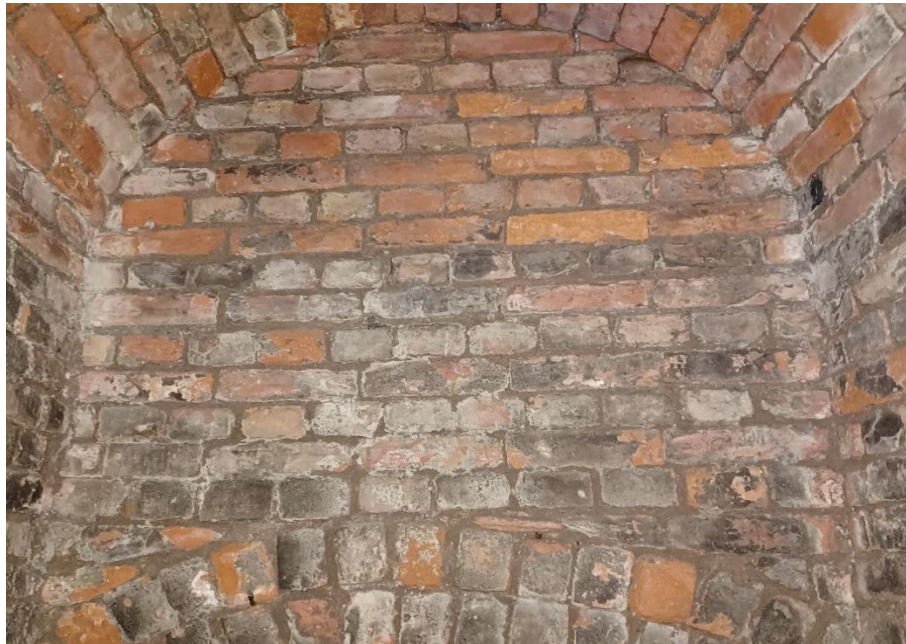
Photo 29: Wet friable water and drummy brickwork to west face of 5<sup>th</sup> relieving arch from south end of west abutment span 1.

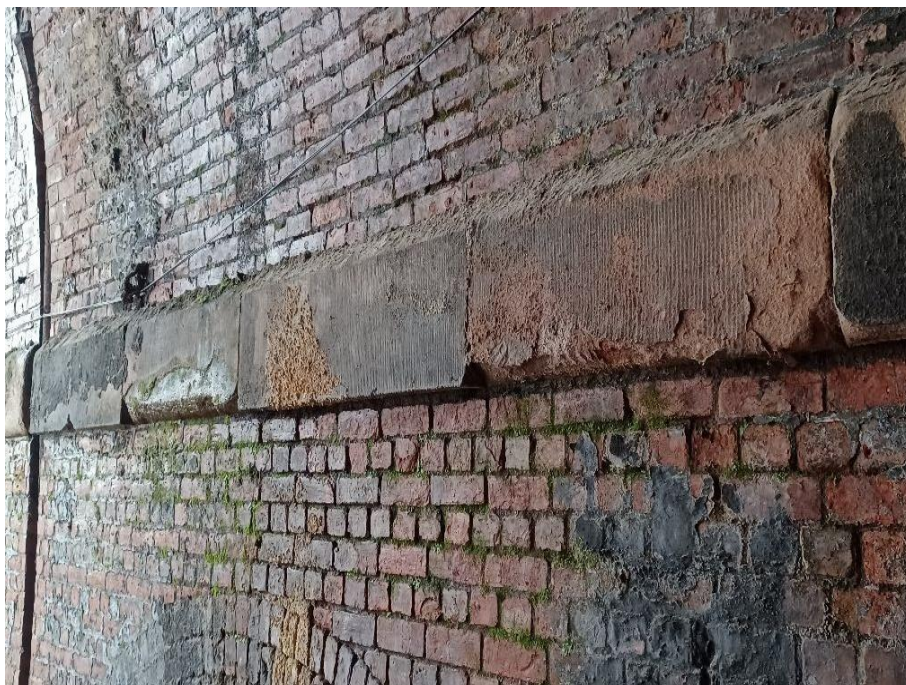
Photo 30: Isolated areas of surface spalling to mid-span of cill at west face of central pier.

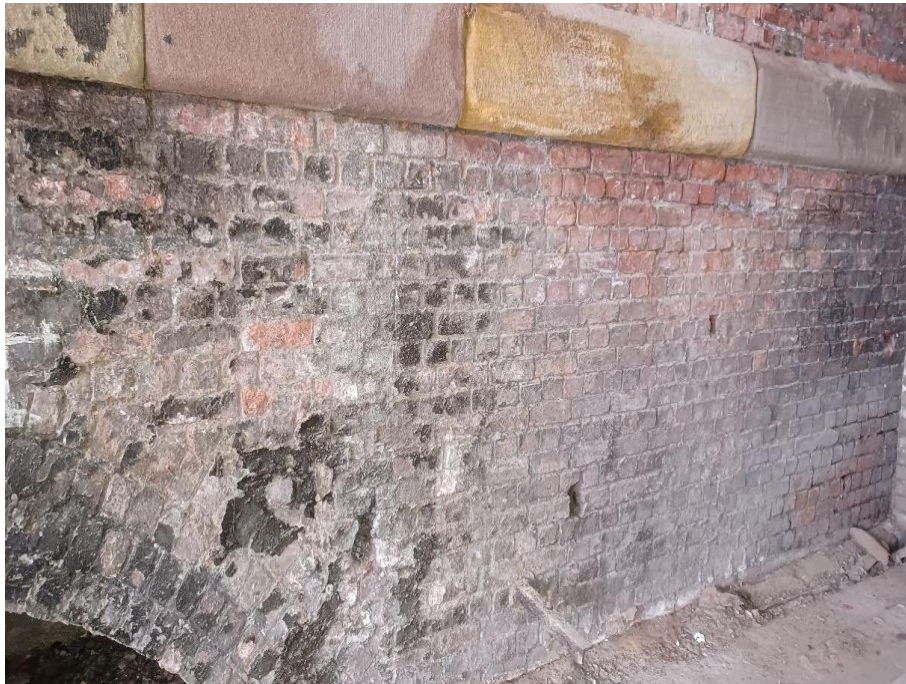
Photo 31: 2 No. missing bricks and leachate staining to south end of central pier west face.

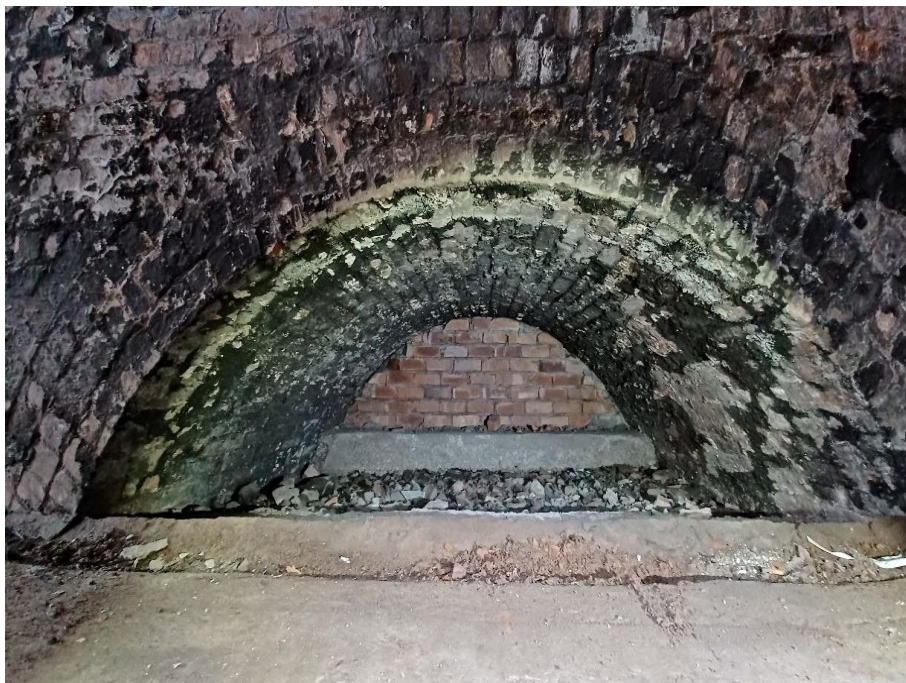
Photo 32: Moss growth and leachate deposits to arch barrel and face ring of 1<sup>st</sup> relieving arch from south end of central pier west face.

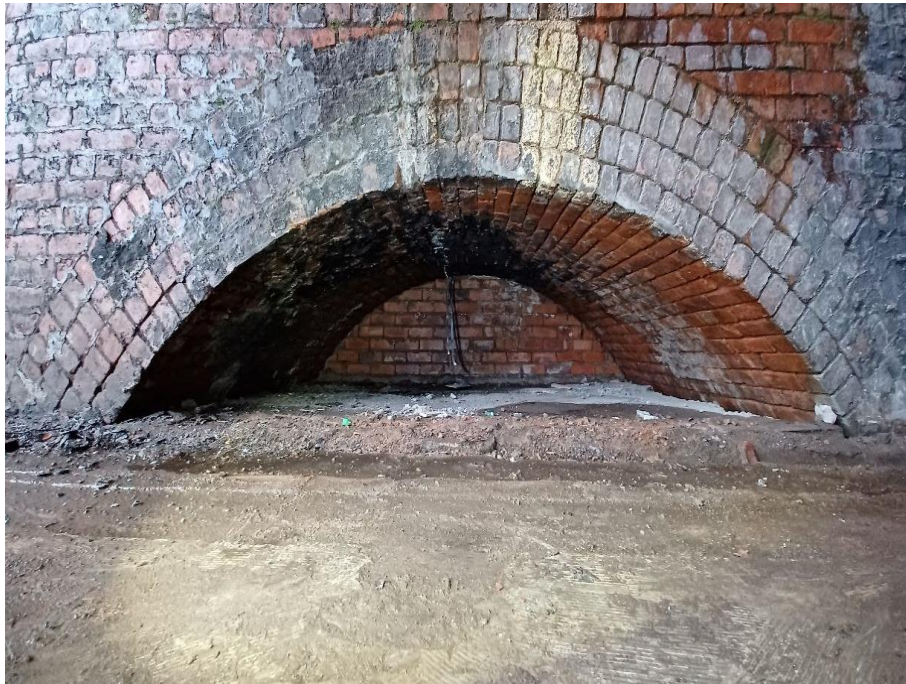
Photo 33: Open joints up to 20mm deep with friable mortar, wet brickwork, hollow sounding brickwork to crown of arch barrel and surface spalling to face ring of 2<sup>nd</sup> relieving arch from south end of central pier west face.

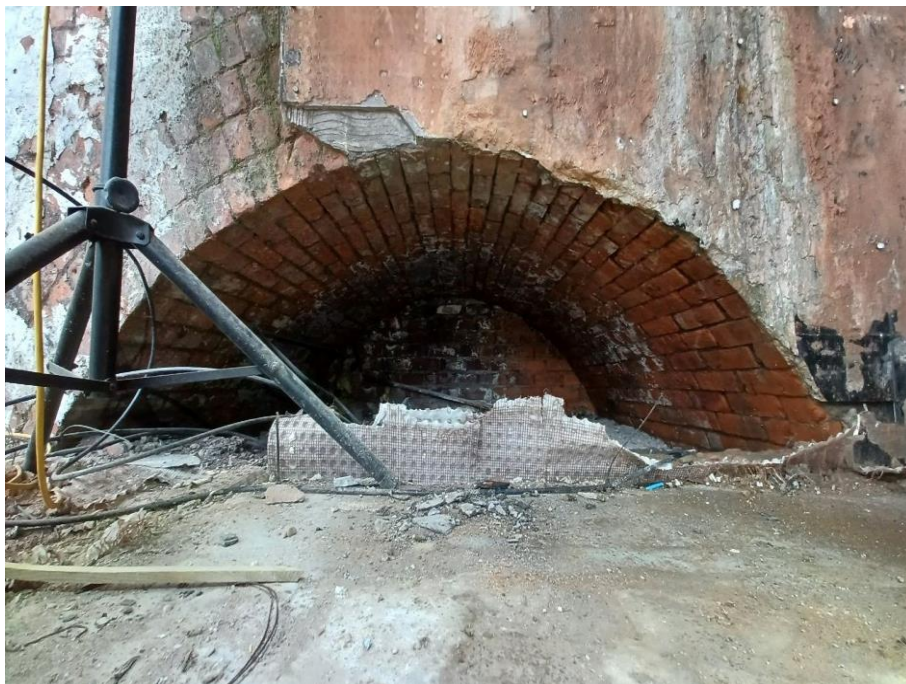
Photo 34: Wet brickwork and friable mortar to 3<sup>rd</sup> relieving arch from south end of central pier west face.

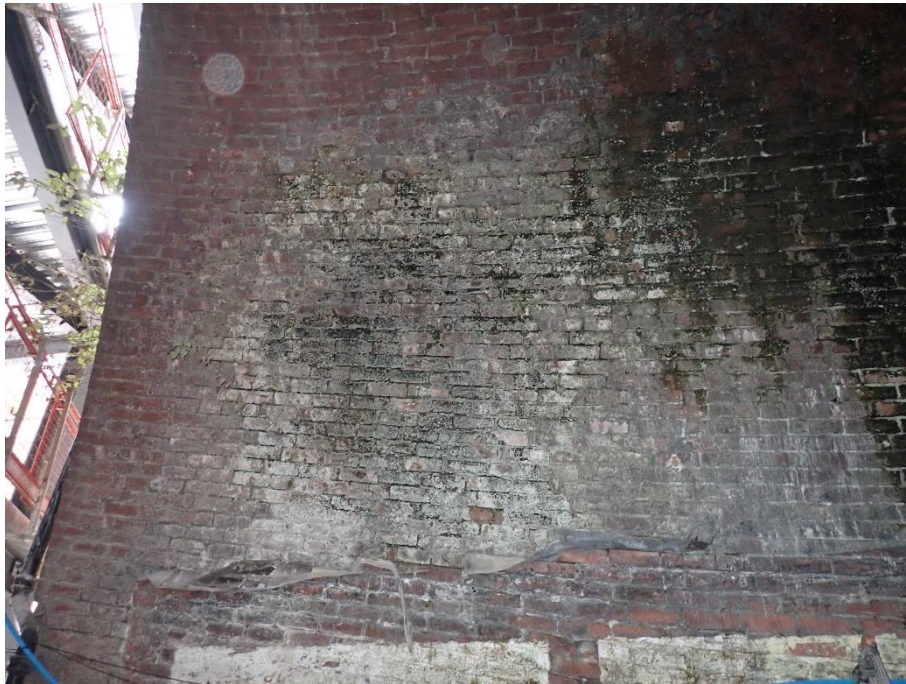
Photo 35: Leachate staining, open joints 10-15mm deep, and hollow sounding area of brickwork 3000x5000mm to northeast of span 2 arch barrel.

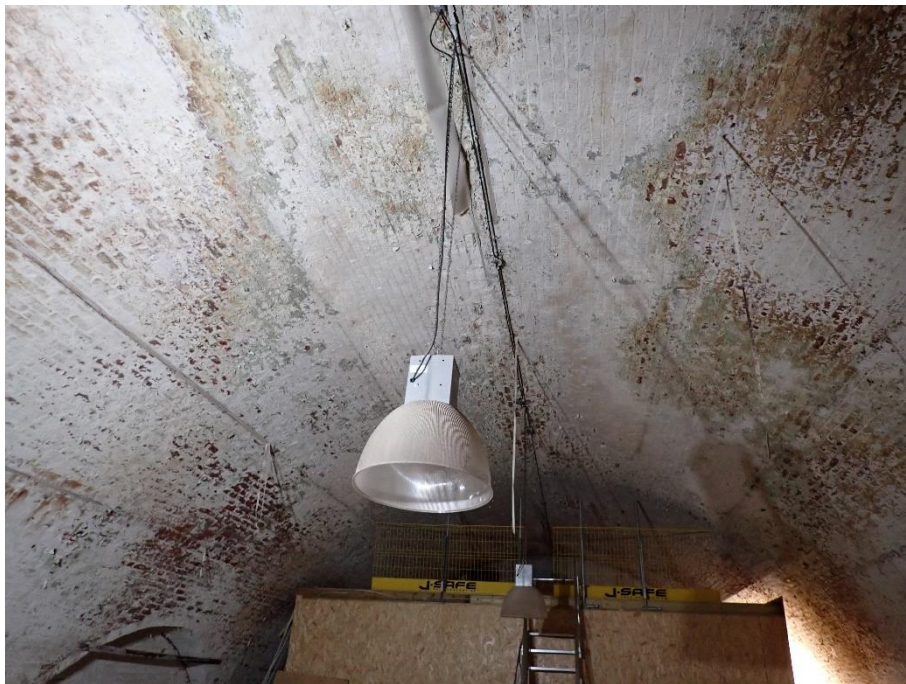
Photo 36: Typical paintwork breakdown throughout to internal section of span 2 soffit.

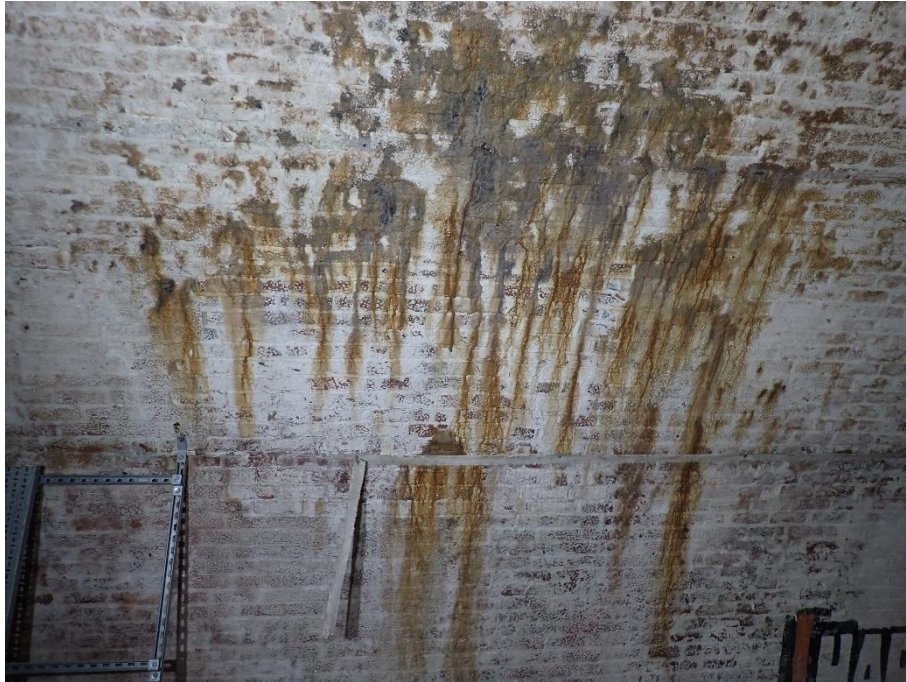
Photo 37: Calcite staining and active water ingress (dripping) to northeast end to internal section of span 2 soffit.

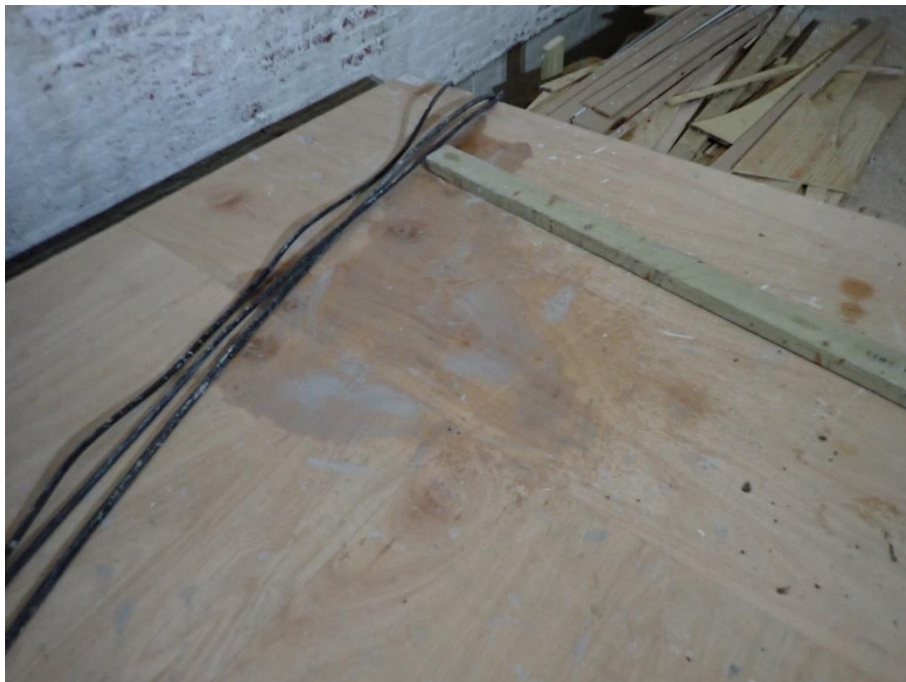
Photo 38: Water pooling to temporary ceiling below water ingress in previous photograph.

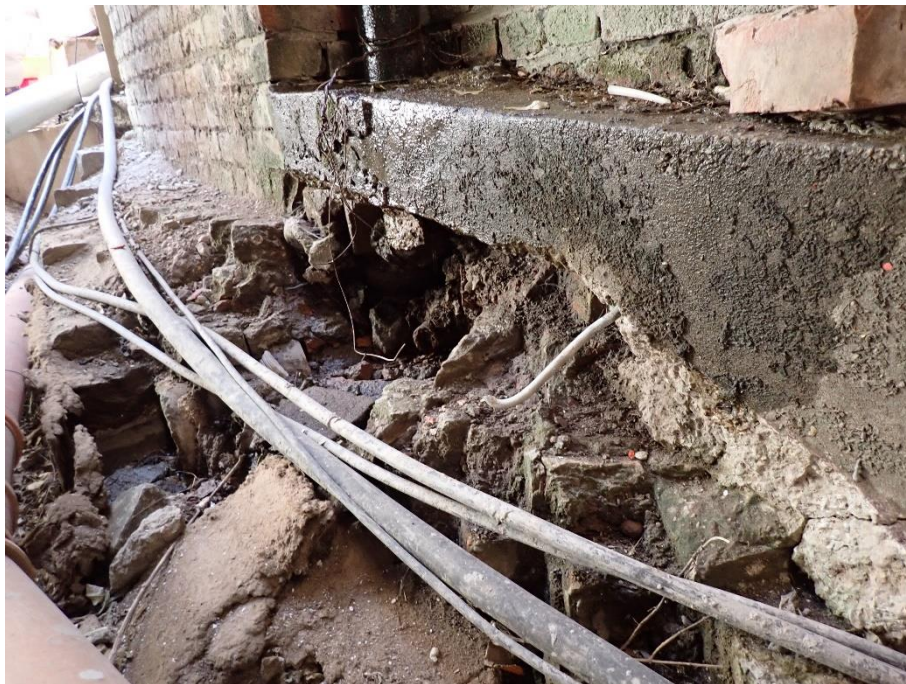
Photo 42: Area of section loss 1100x200x110mm to concrete section at base of east abutment north end.

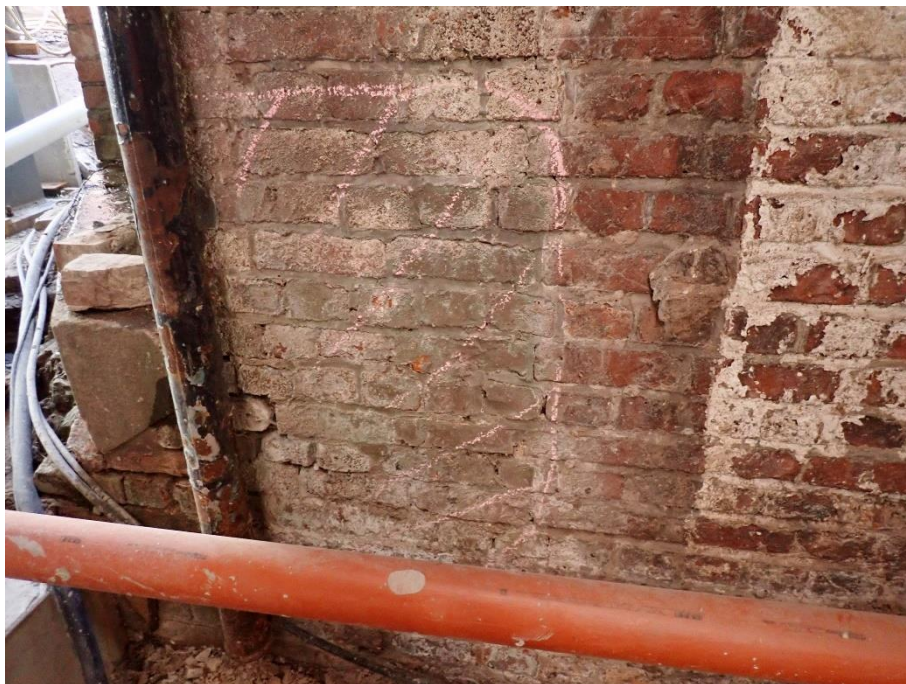
Photo 44: Area of hollow sounding brickwork 1000x500mm to north end of east abutment.

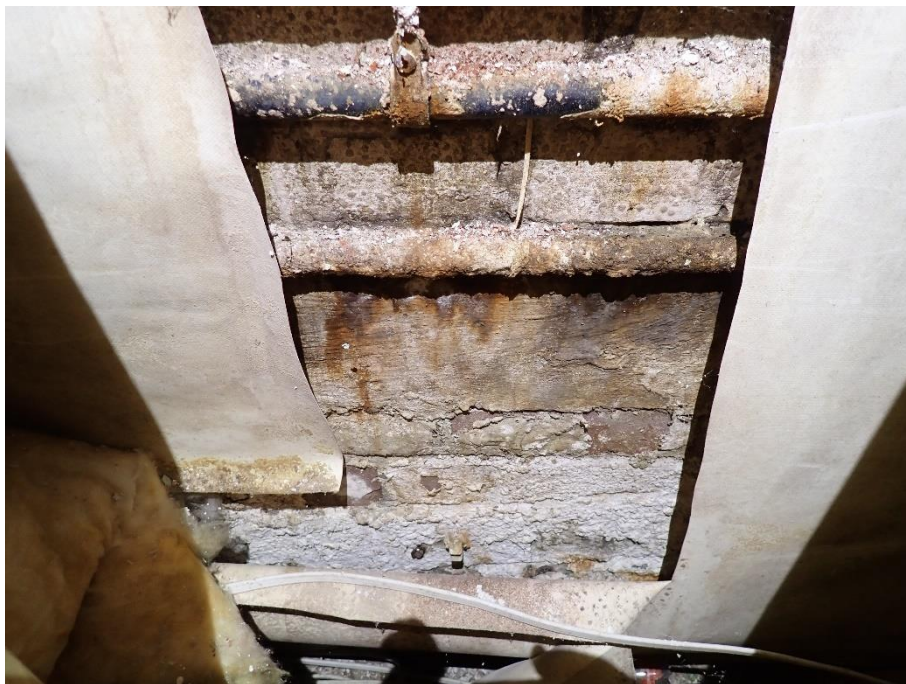
Photo 46: Staining to exposed section of east abutment at approx. mid-span.

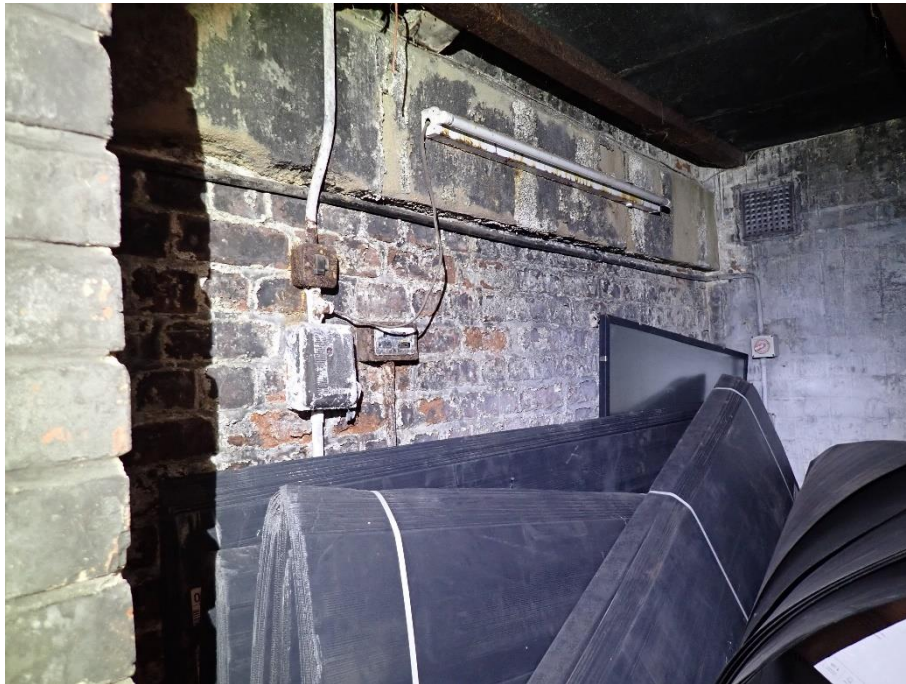
Photo 47: Isolated surface spalling and staining to brickwork at south end of east abutment.

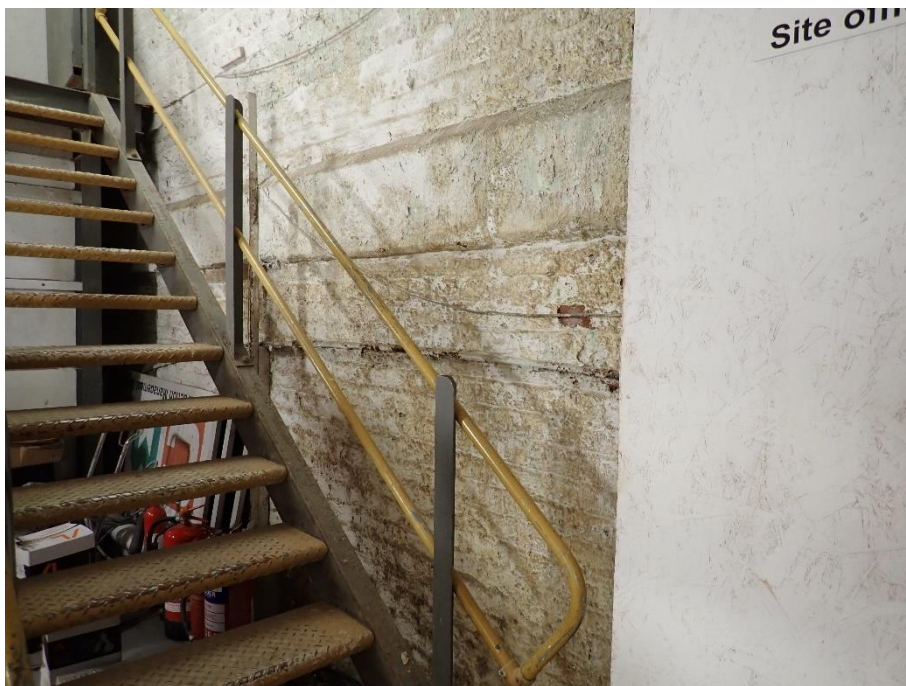
Photo 48: Paintwork breakdown to south end of central pier east face.

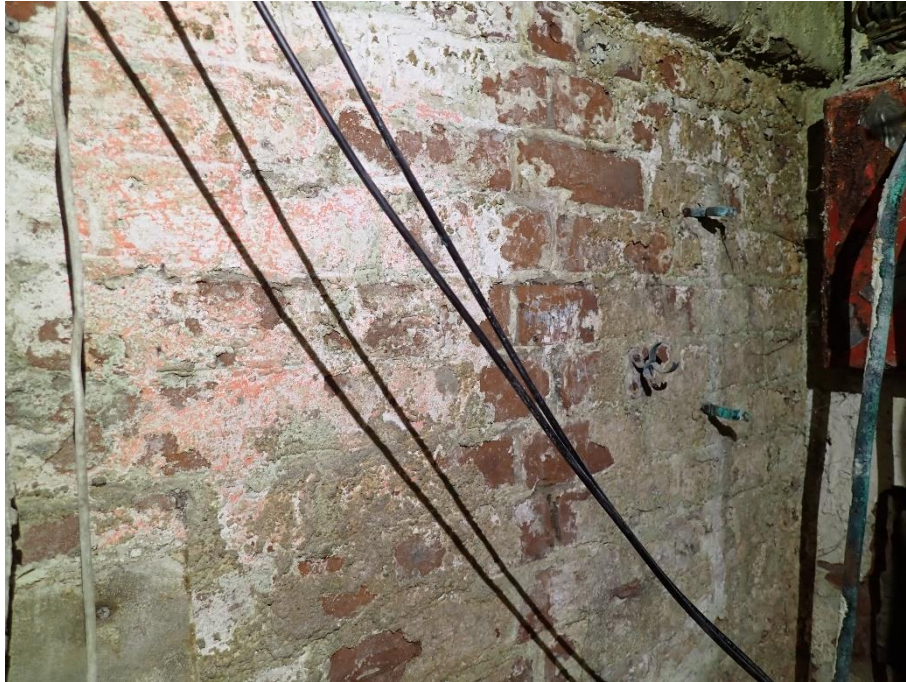
Photo 49: Staining and paintwork breakdown to north end of central pier east face.

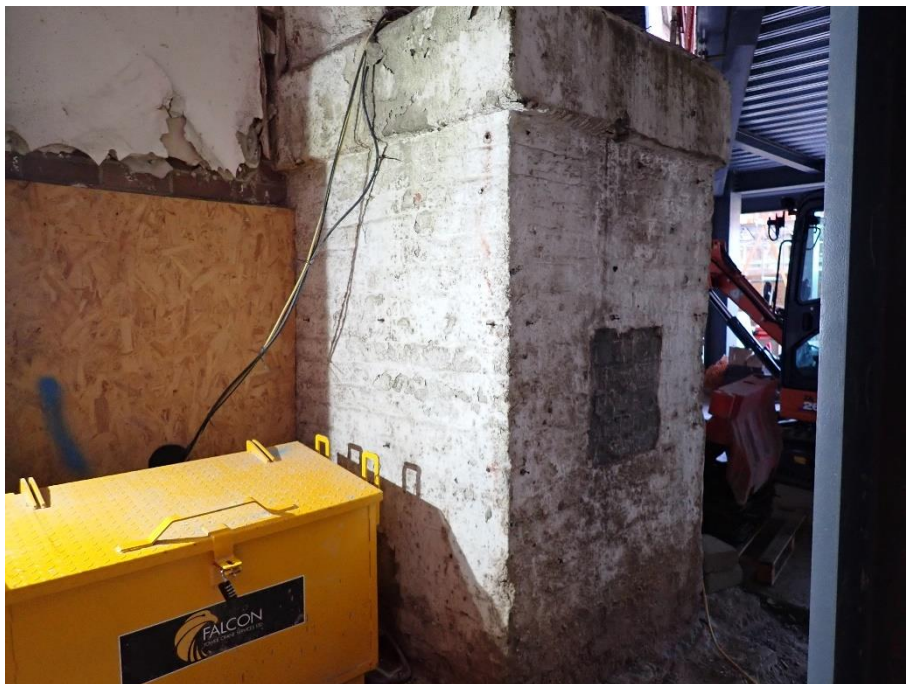
Photo 50: Paintwork breakdown and staining to north end of central pier.

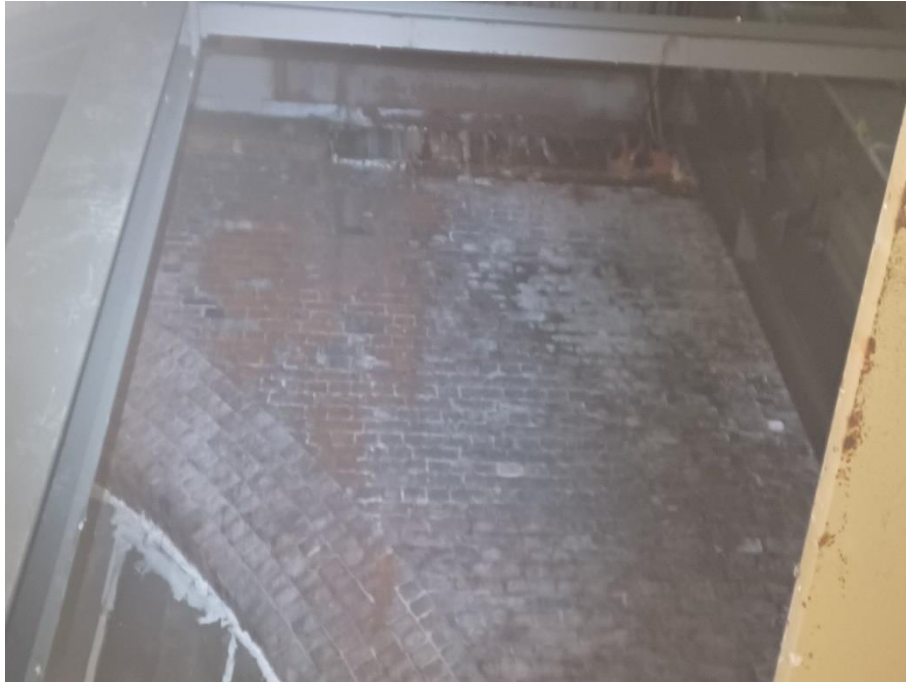
Photo 51: Leachate staining to east spandrel of span 1 south elevation.

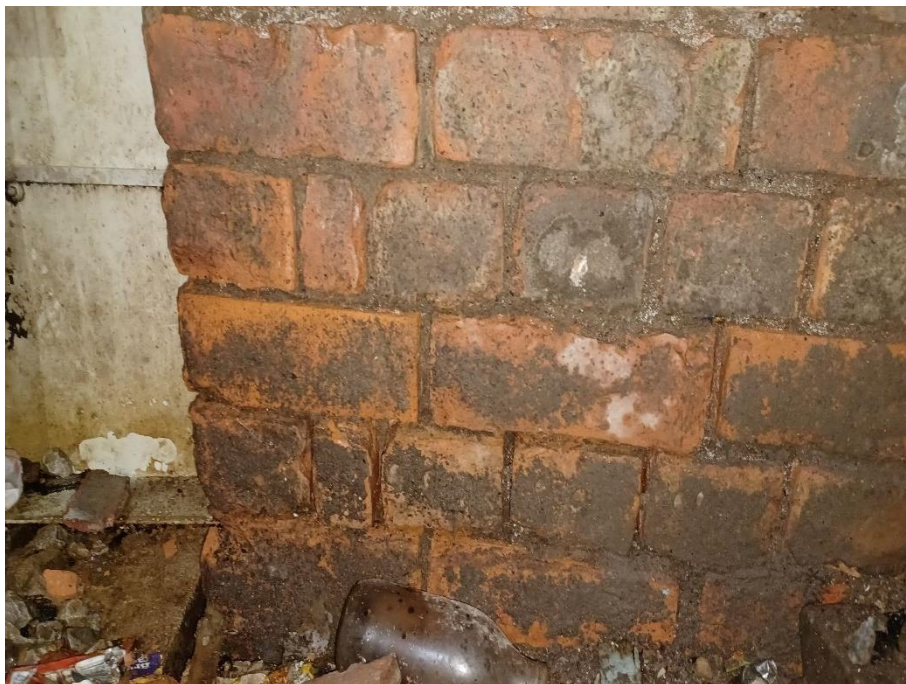
Photo 52: Area of open joints 500x300x10mm to south end of central pier.

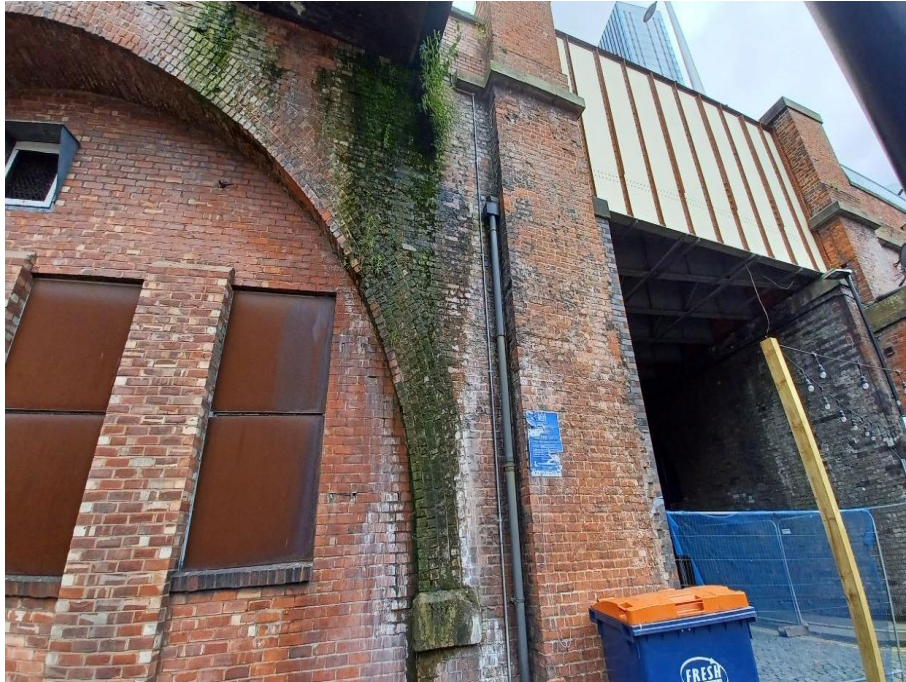
Photo 53: Moss/vegetation growth, isolated surface spalling, isolated open joints, and water ingress (wet) to east spandrel of span 2 south elevation below footbridge.

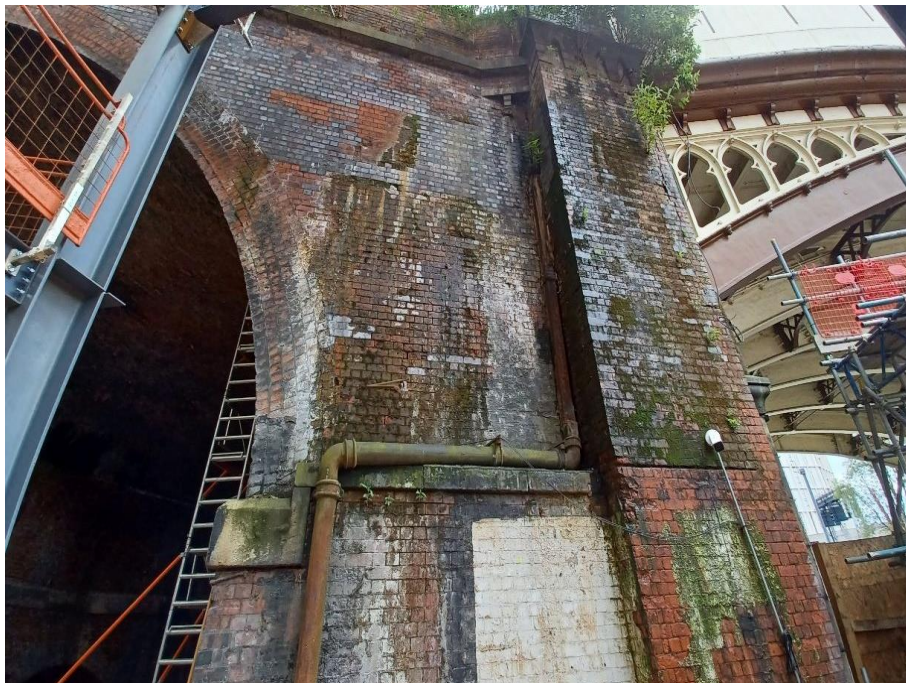
Photo 54: Water ingress (wet), isolated areas of surface spalling, and vegetation growth to west abutment and spandrel north elevation of span 1.

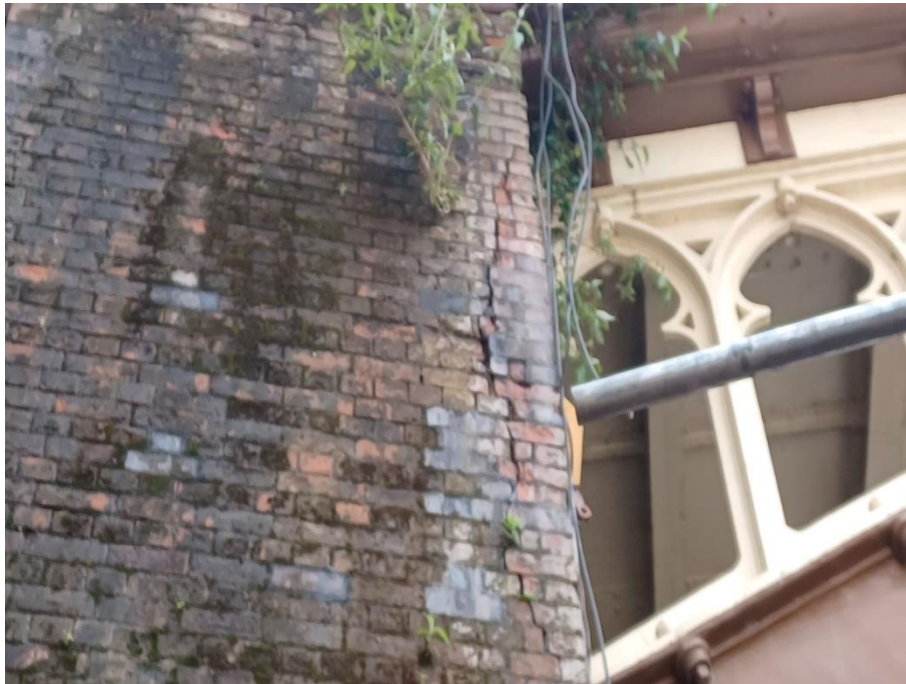
Photo 55: Vertical fracture up to 20mm with hollow sounding brickwork 2800x550mm surrounding fracture to west edge of west abutment north end.

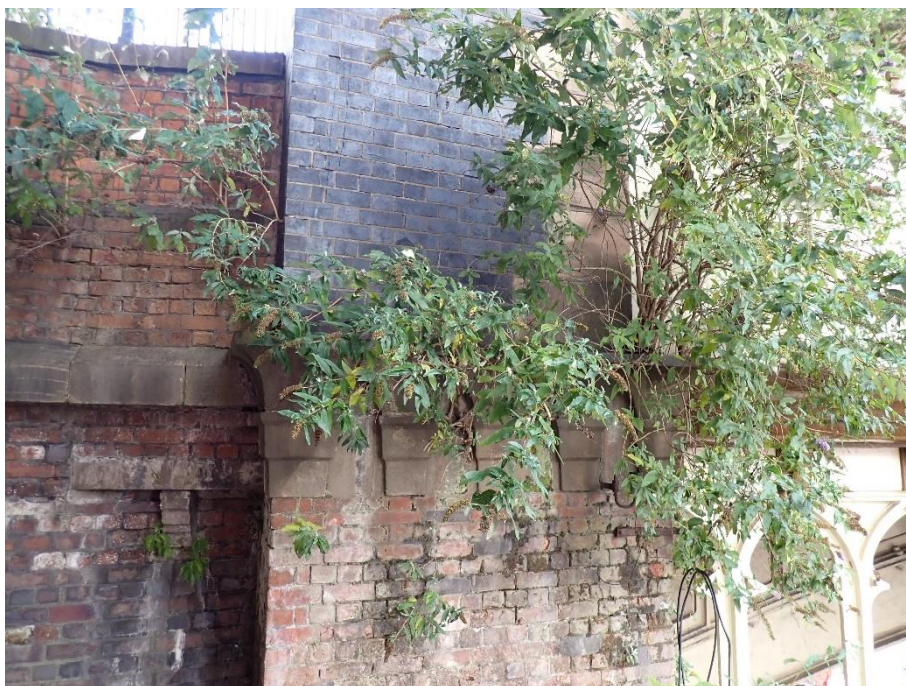
Photo 56: Vegetation growth to top section of west abutment north end.

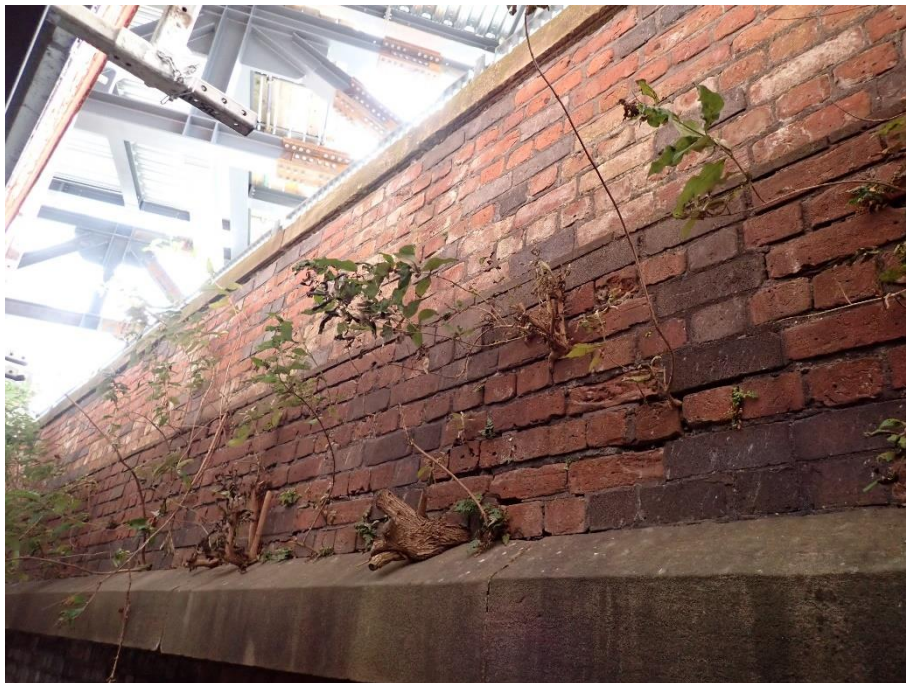
Photo 58: Typical vegetation growth and isolated surface spalling to brickwork of north elevation parapet.
