| KELIOS AMEY METROLINK INSPECTIONS |
| A53 - WILLIAM STREET ARCHES |

## Appendix B: Photographs

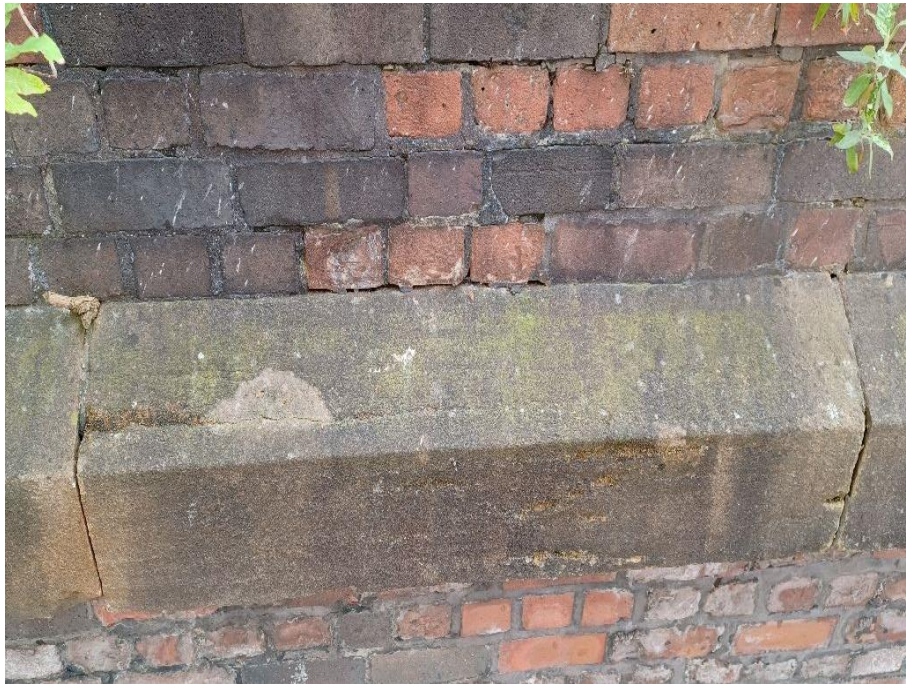
Photo 59: Horizontal hairline fracture to string course stone between span 1 & 2 of north elevation.

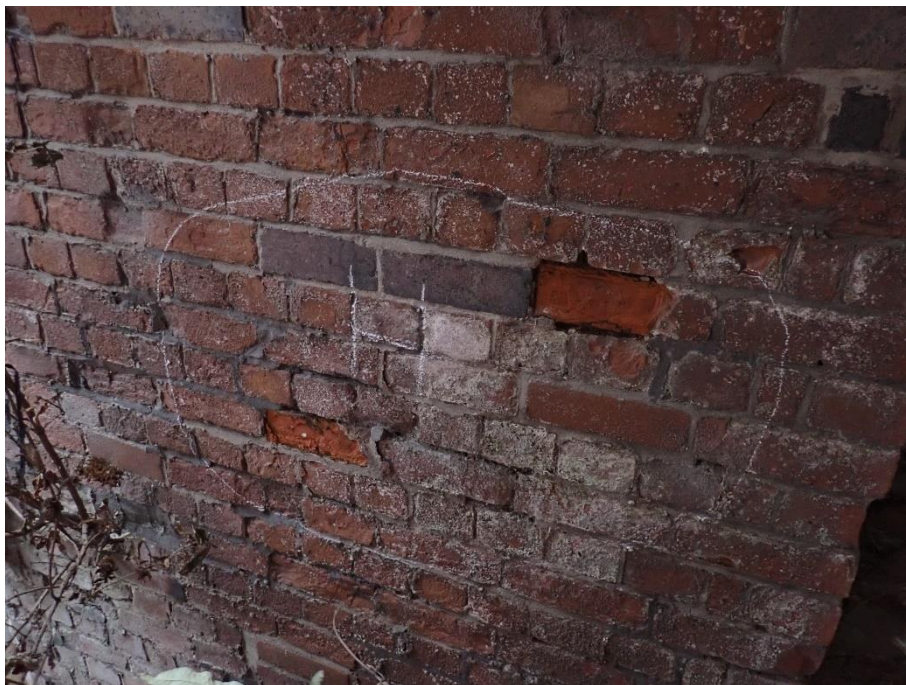
Photo 60: Area of hollow sounding brickwork 1000x650mm to north elevation of east abutment.

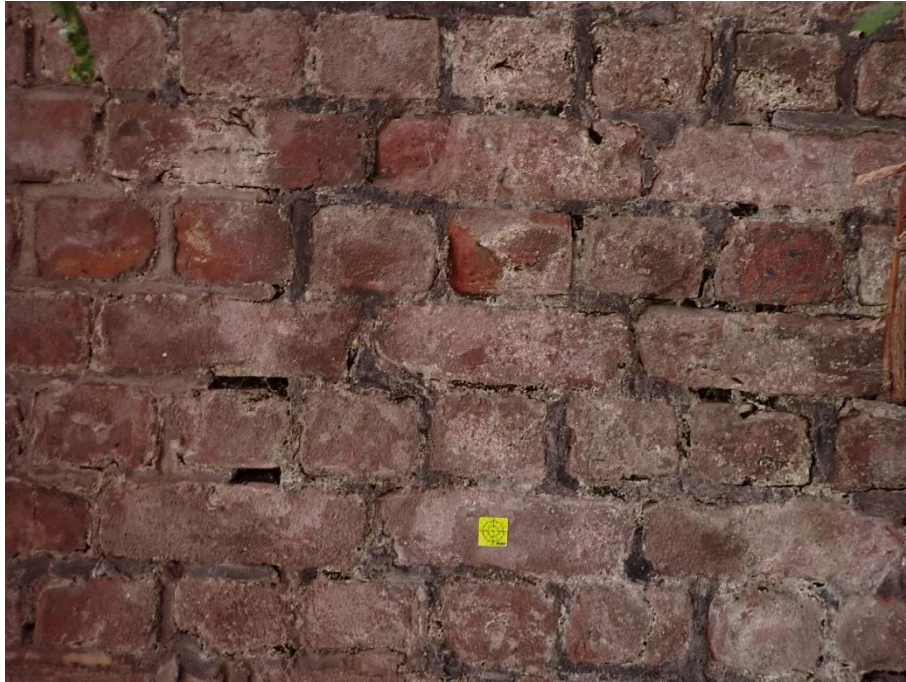
Photo 61: Typical isolated open joints and surface spalling to north elevation of east abutment.

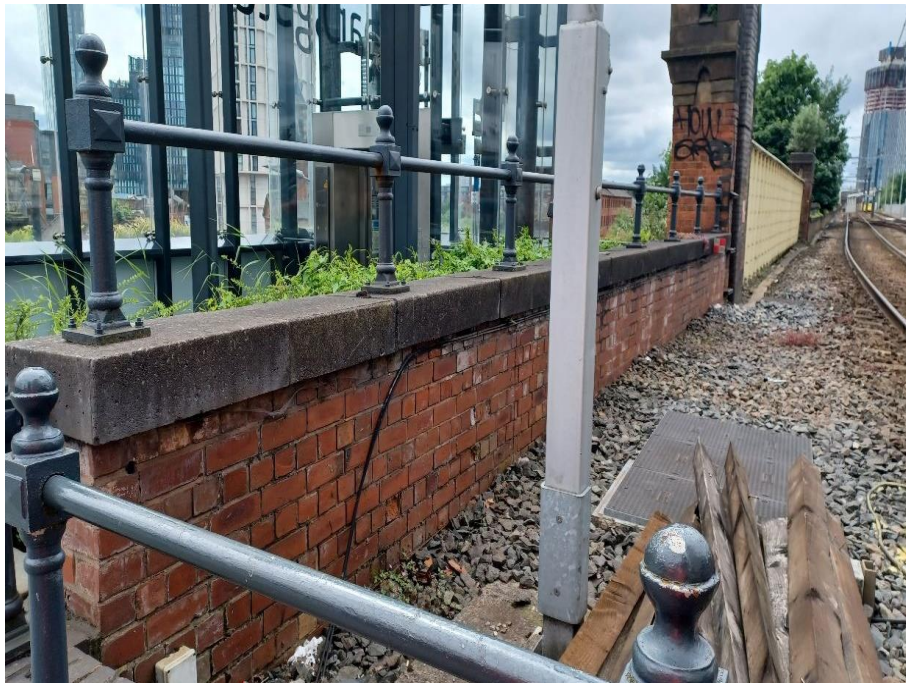
Photo 62: Isolated open joints, joint fractures, leachate staining, surface spalling, and minor vegetation growth to north face of south parapet.

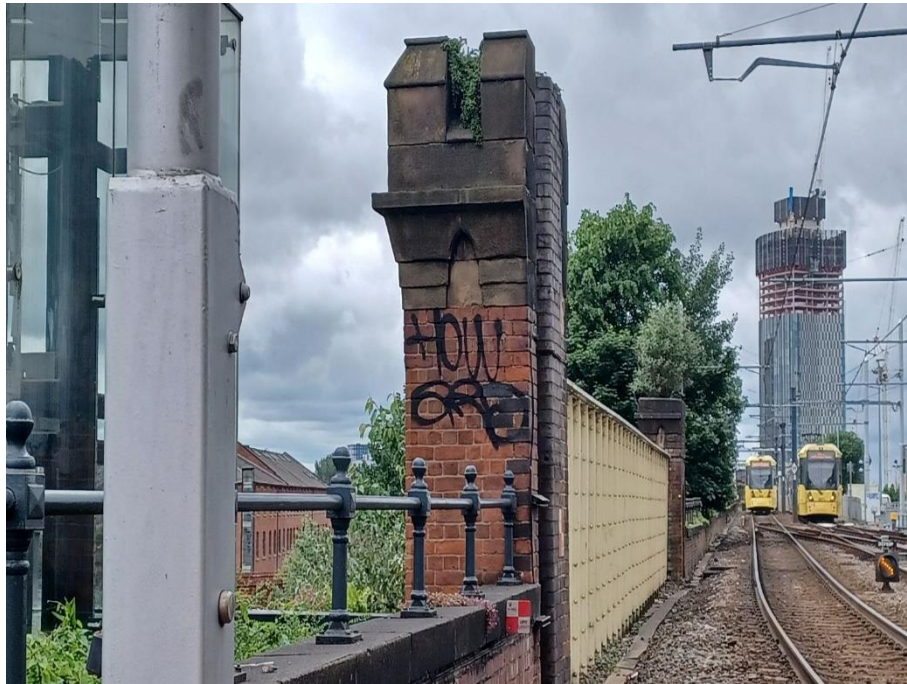
Photo 63: Vegetation and graffiti to southwest pilaster.

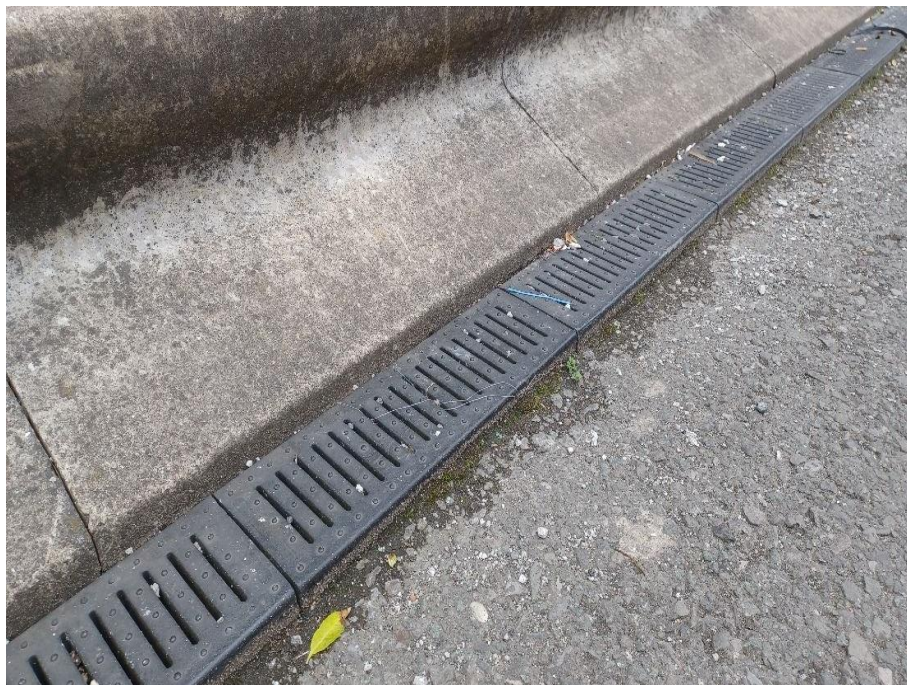
Photo 64: Gutter raised above carriageway surfacing by 30mm affecting drainage.

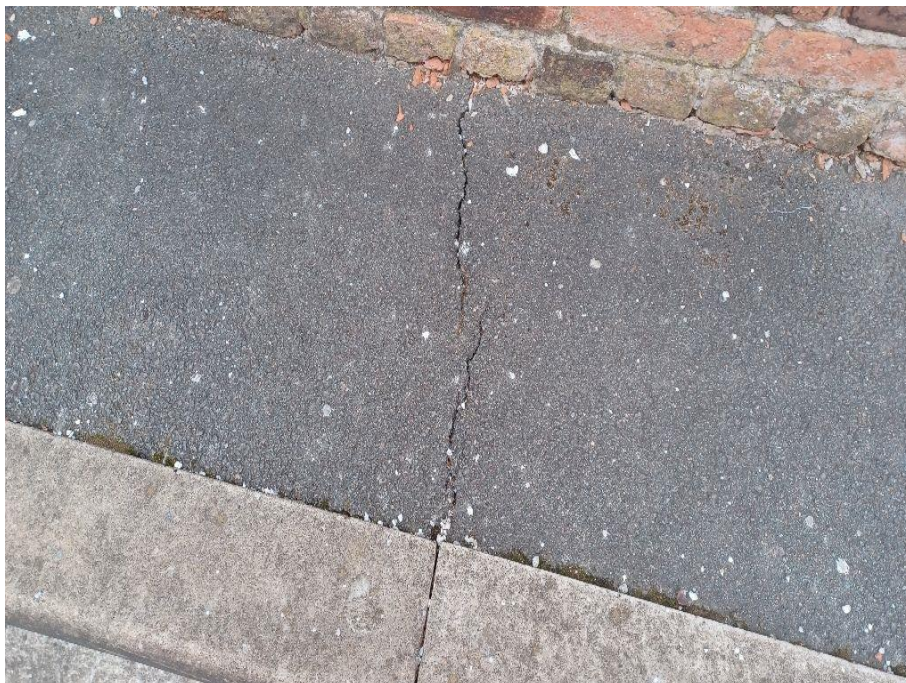
Photo 66: Cracks in footway surfacing adjacent to north parapet.

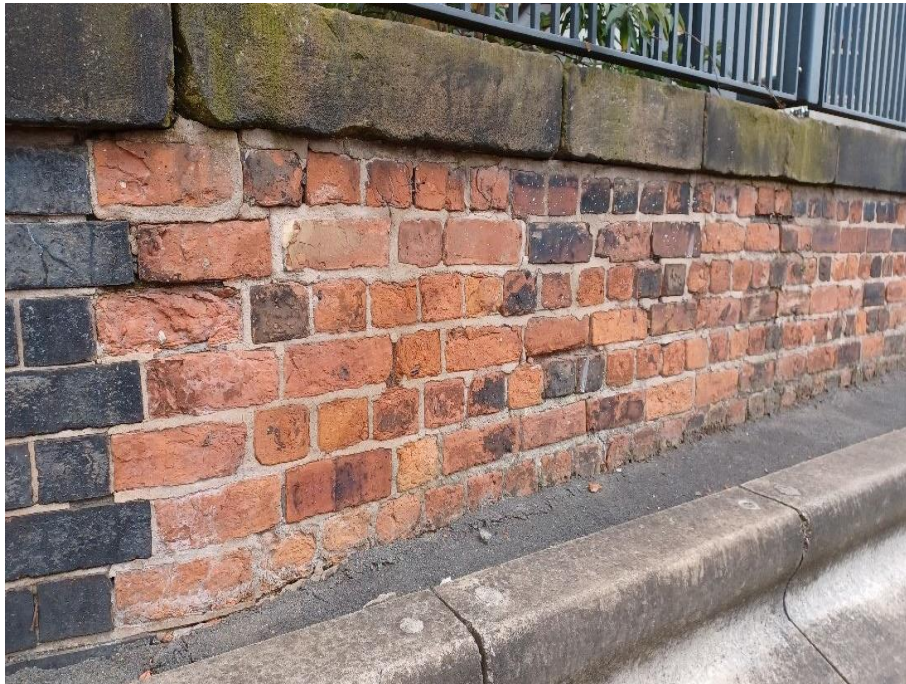
Photo 67: Isolated open joints and surface spalling to brickwork of north parapet south face.

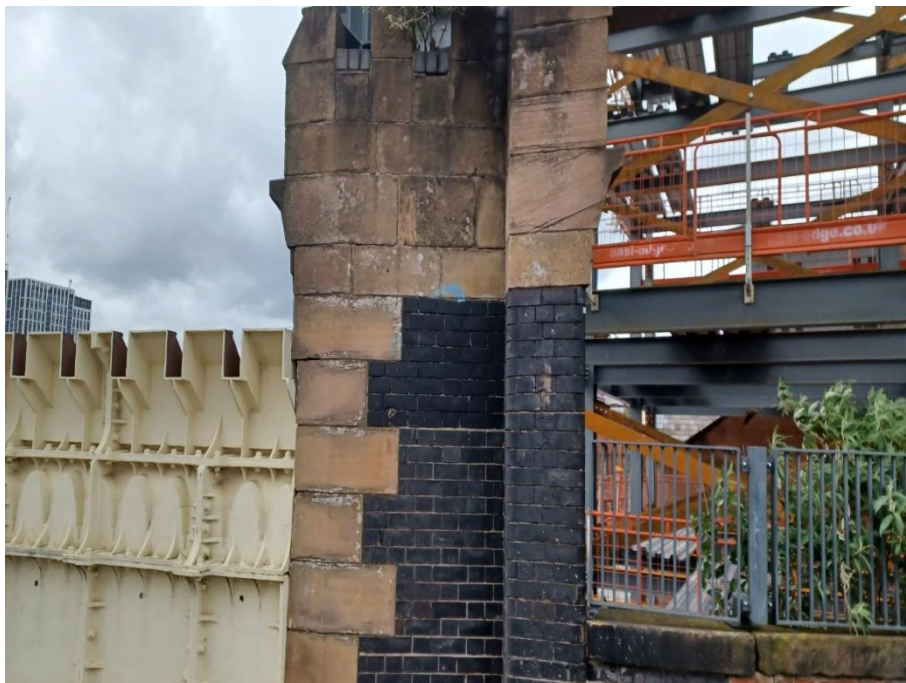
Photo 68: Isolated open joints and vegetation growth to northwest pilaster.

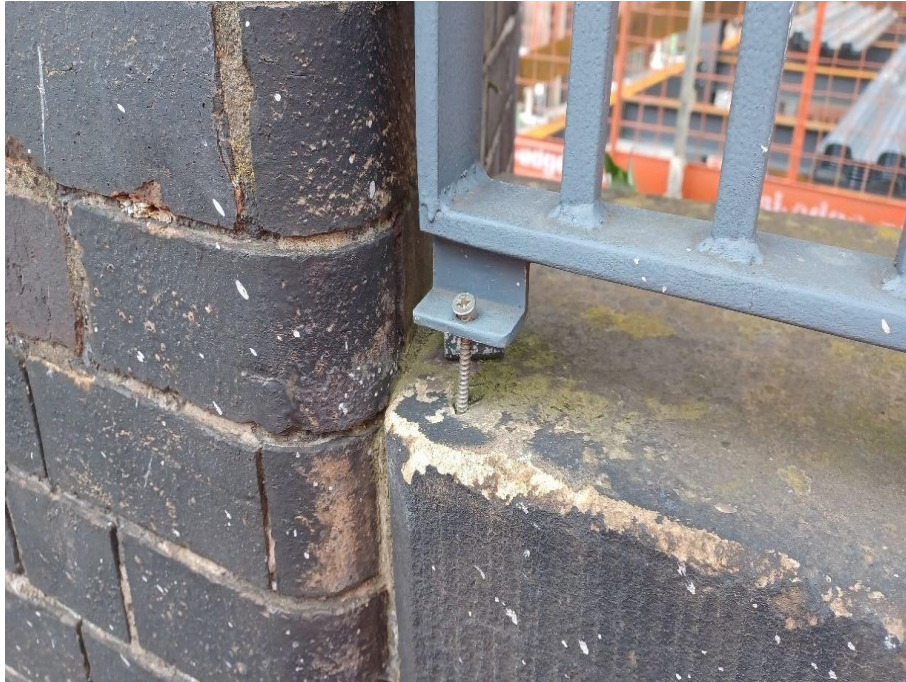
Photo 69: Loose fixing and railing at north end of north metallic parapet.

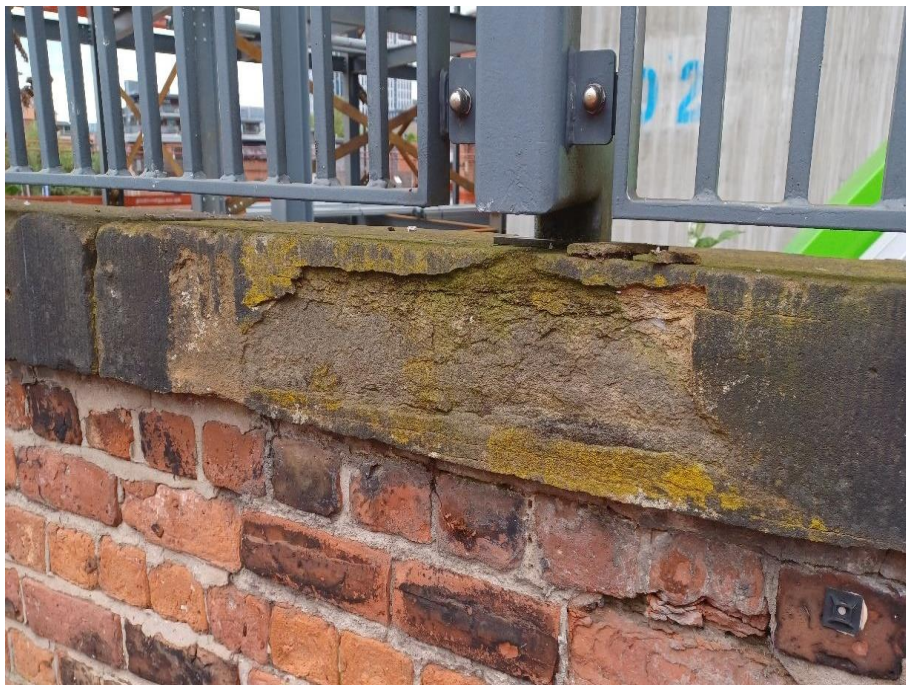
Photo 70: Surface spall to coping stone at mid-span of north parapet south face.
