**GAS MEMBRANE VALIDATION**

| <b>Site Name: Belle Vue Stadium</b> | <b>Project Number: 12-123</b> |
| <b>Company Name: Countryside</b> | <b>Date: 27-05-2022</b> |

**Plot - 86**

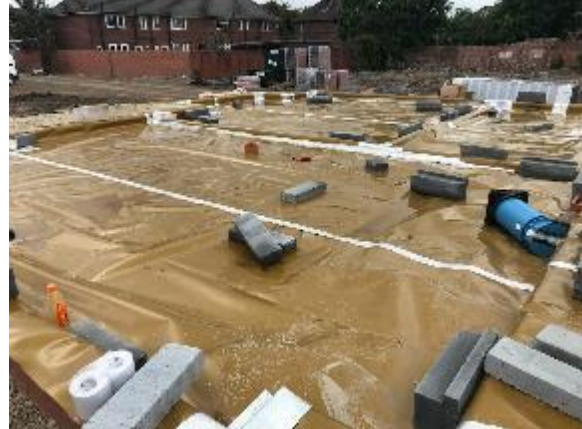
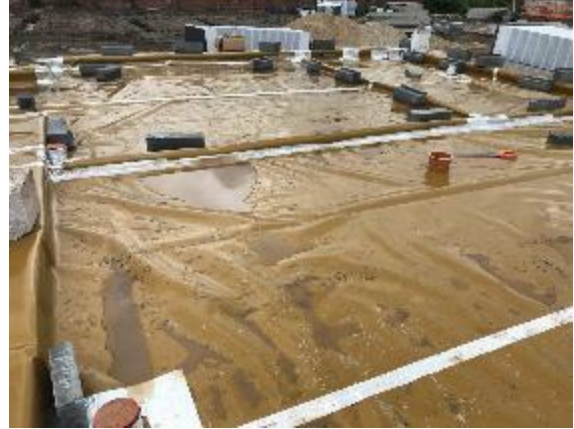
**General Condition of Membrane-Good Condition**

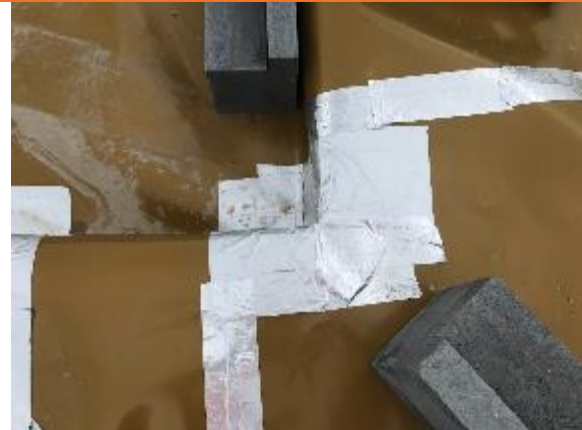
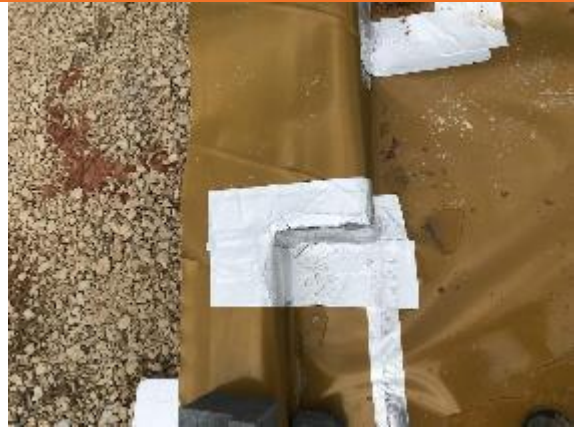
**Verification of Joints and Seals-Overlapped and sealed correctly**

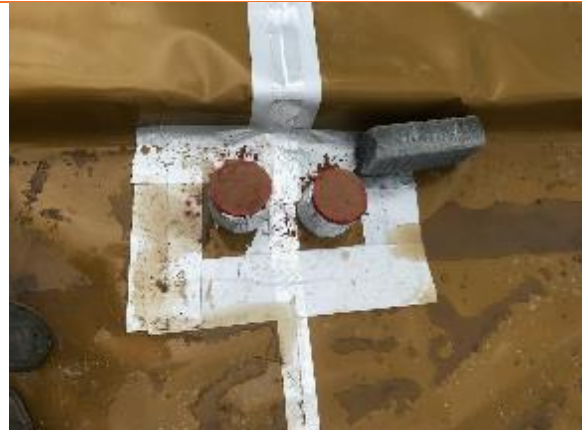
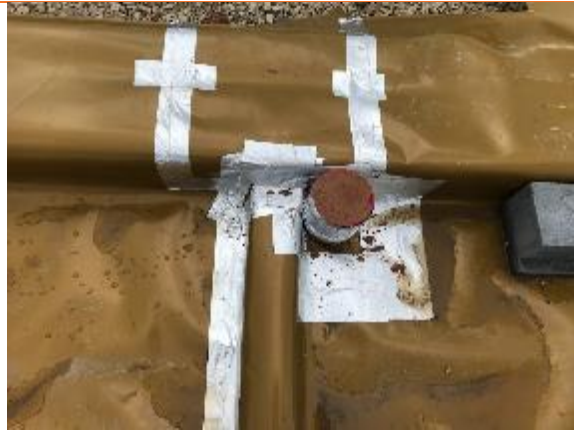
**Verification of Service Penetrations-Good Condition**

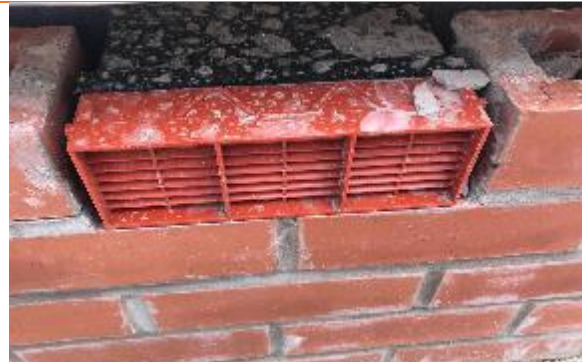
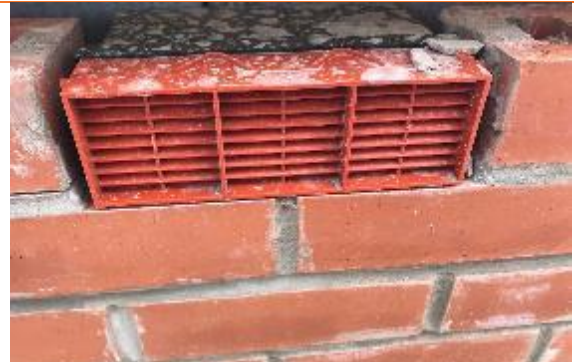
**Verification of Ventilation-Good Condition**

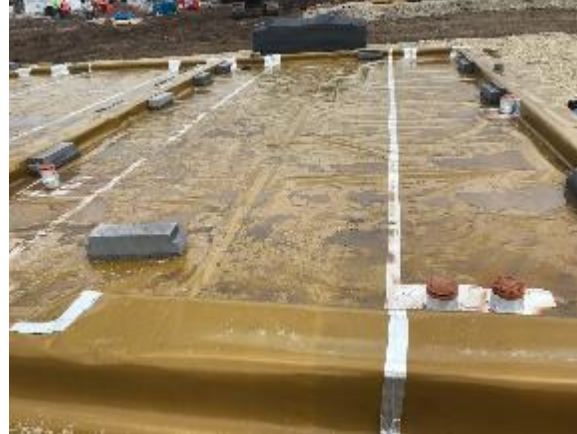
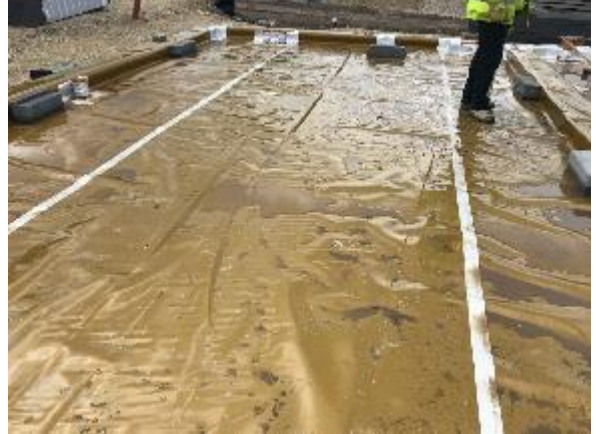
**Plot - 87**

**General Condition of Membrane-Good Condition**

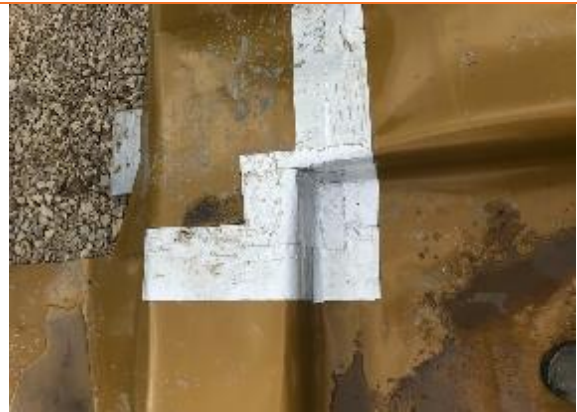
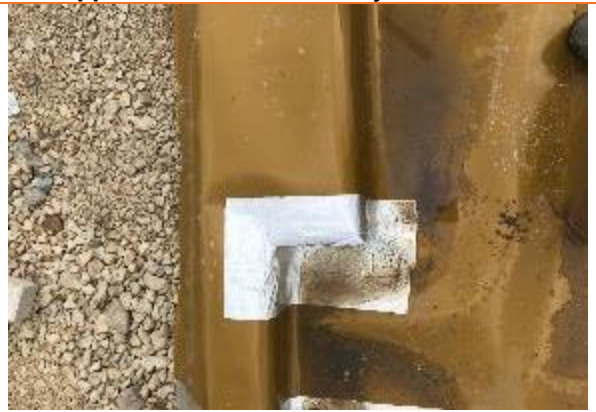
**Verification of Joints and Seals-Overlapped and sealed correctly**

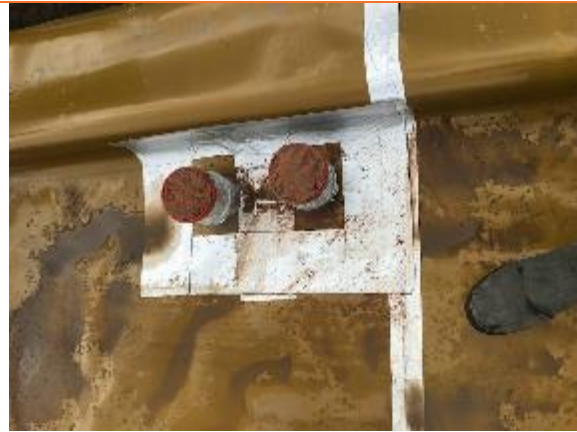
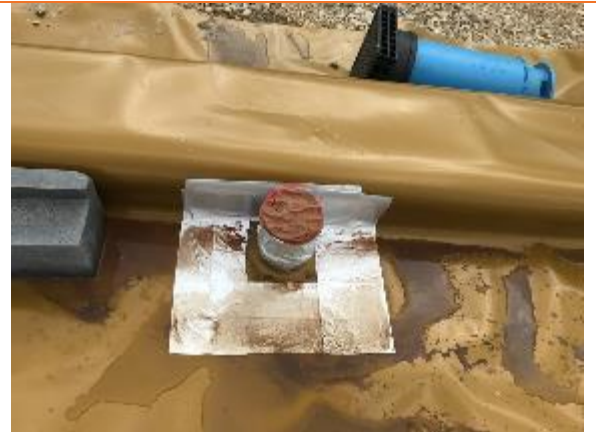
**Verification of Service Penetrations-Good Condition**

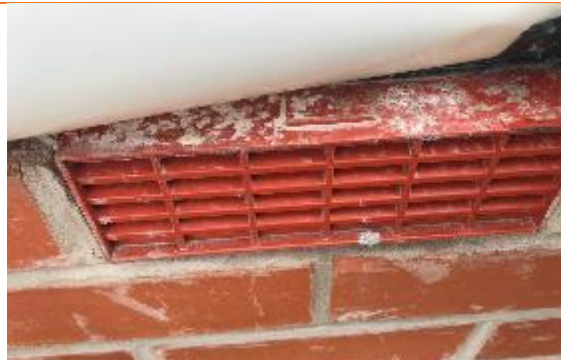
**Verification of Ventilation-Good Condition**

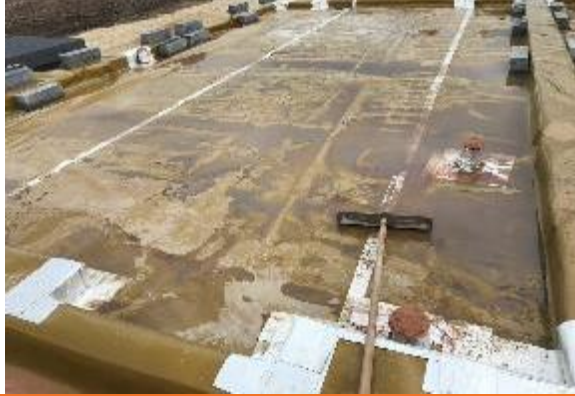
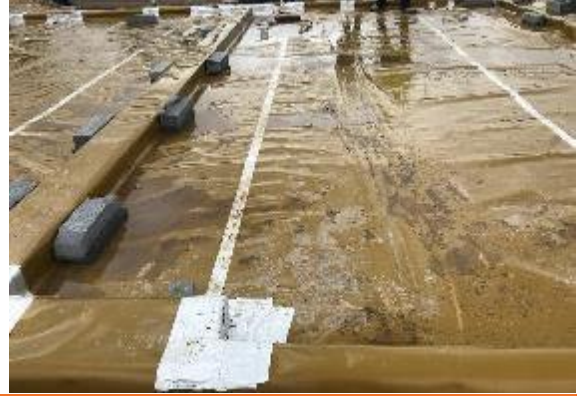
**Plot - 88**

**General Condition of Membrane-Good Condition**

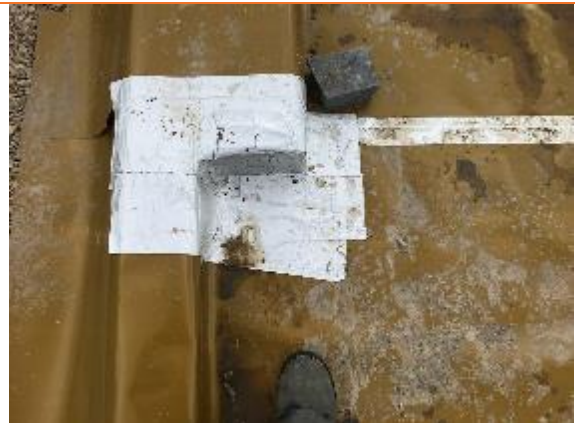
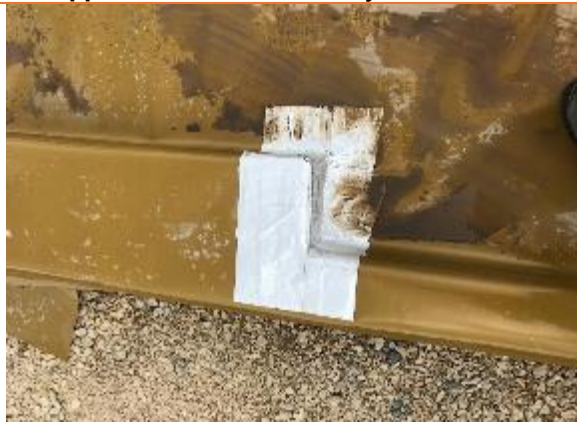
**Verification of Joints and Seals-Overlapped and sealed correctly**

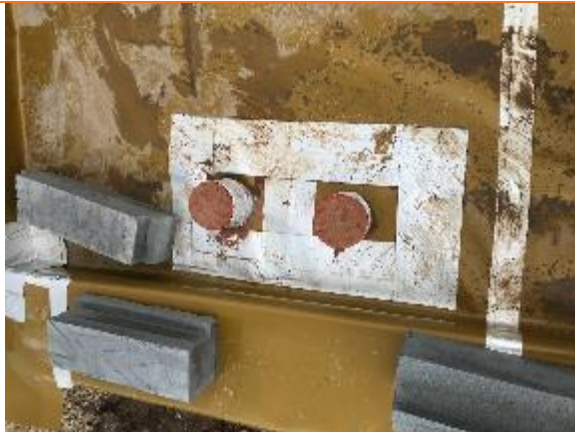
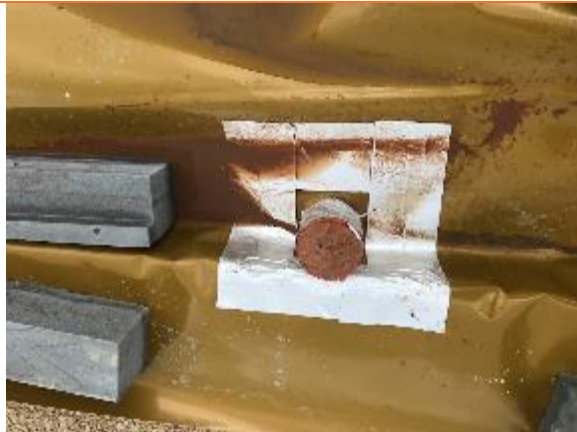
**Verification of Service Penetrations-Good Condition**

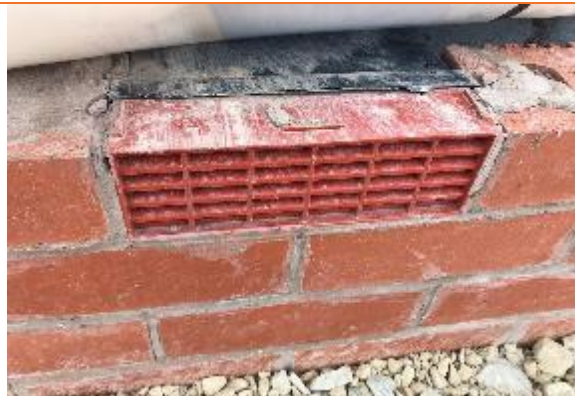
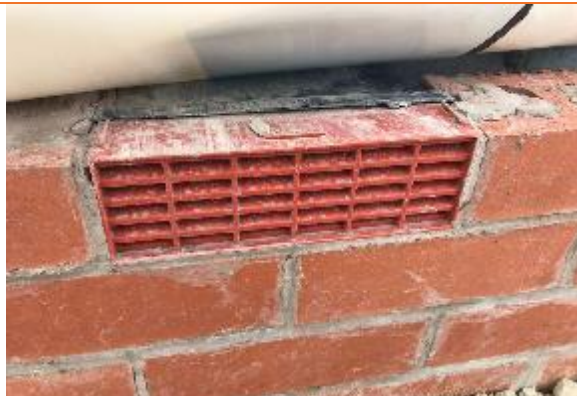
**Verification of Ventilation-Good Condition**
