### GAS MEMBRANE VALIDATION – BELLE VUE

| <b>Project Name: Belle Bue Stadium</b> |
| <b>Plots: 220-222</b> |

## GAS MEMBRANE VALIDATION

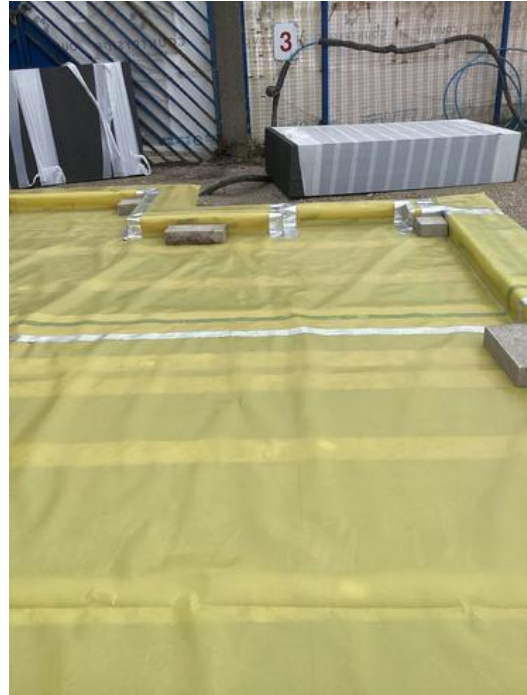
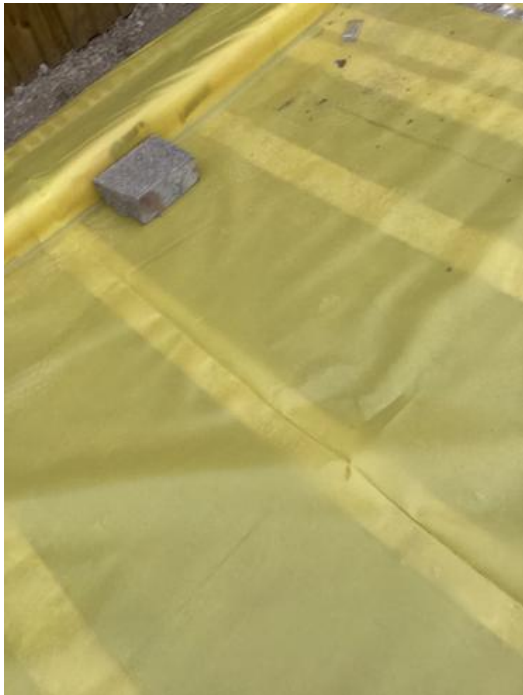
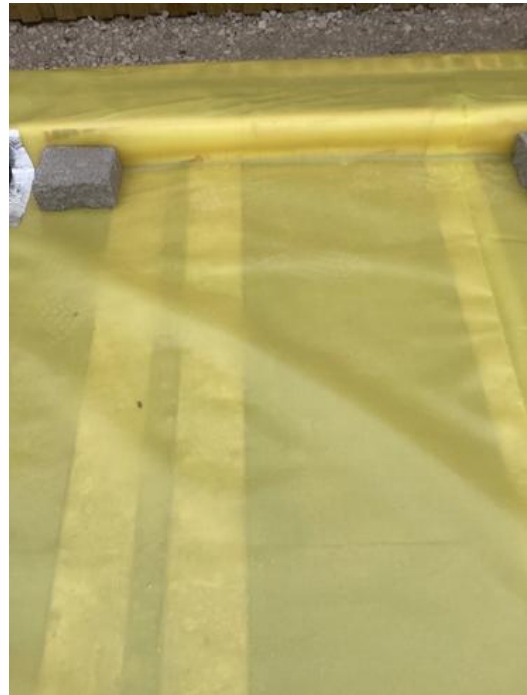
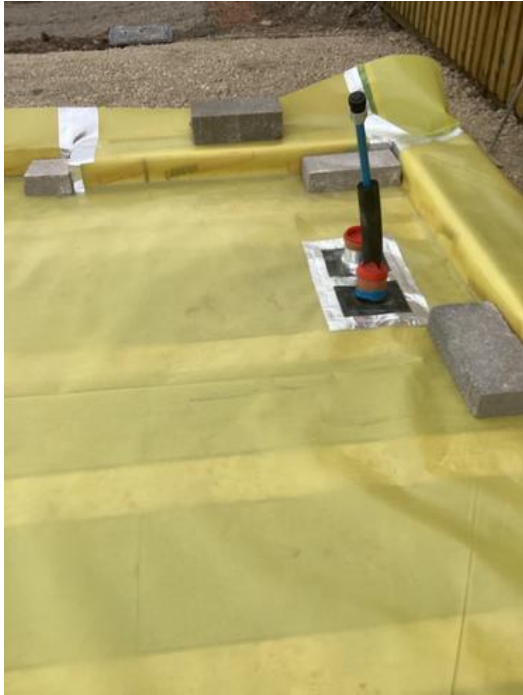
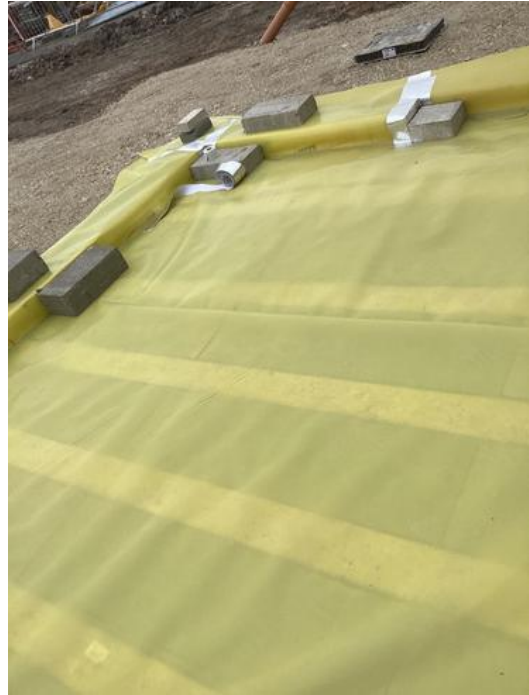
Gas Membrane Condition: Open punctures, tears, rips, stretching, Presence of debris, Repairs, Signs of weakness such as raised or sunken indentations, Protection plan in place to restrict access to lain gas membrane? IF FAIL DESCRIPTION IN ACTIONS AND PHOTOS REQUIRED

Pass

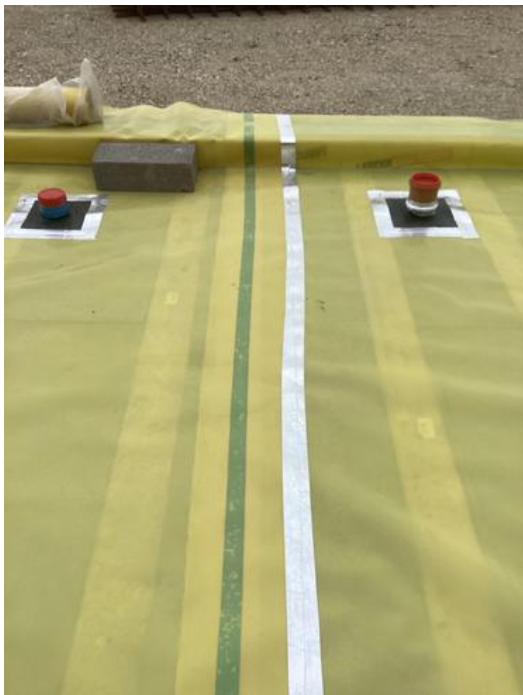
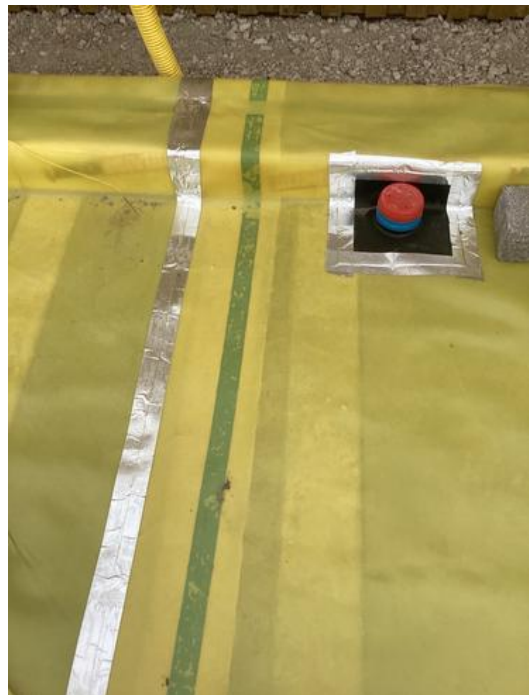
Laps, welds, and joints seals: Joints lapped and sealed in accordance with manufacturer's requirements/ specification? Minimum overlap insured? Sections taped twice? Are welds complete? Appropriate joining/double-sided tape used, Folds running in line with joints? (no joints cutting across folds)

Pass

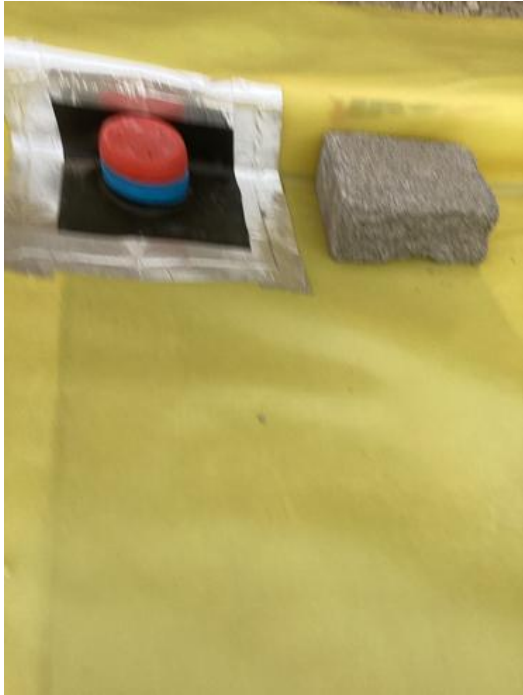
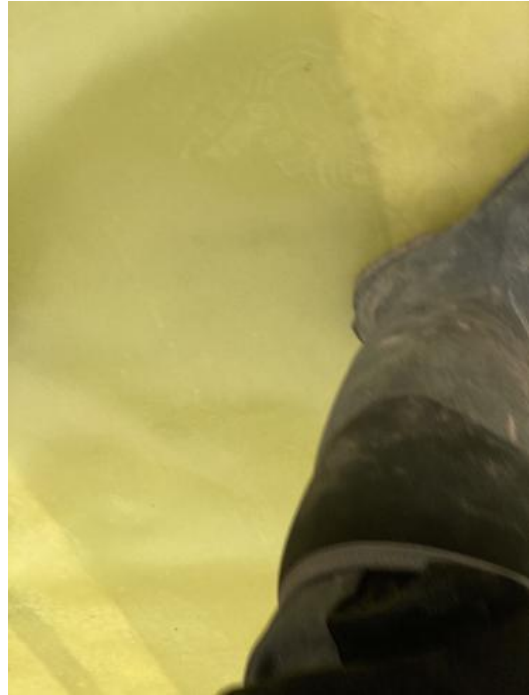
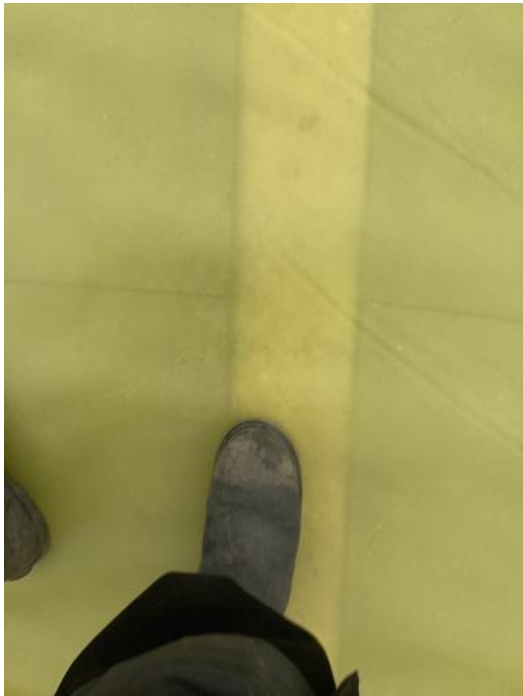
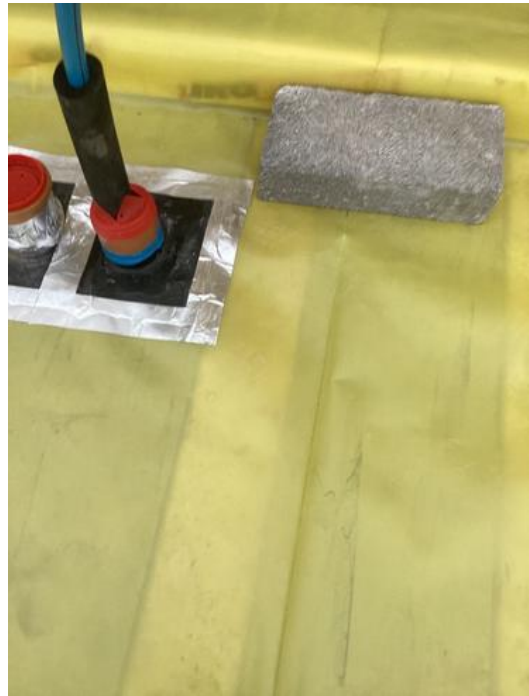
**Service entries seals: Top hats seal arrangements fixed around service entries? Use of Jubilee clips?**

Yes

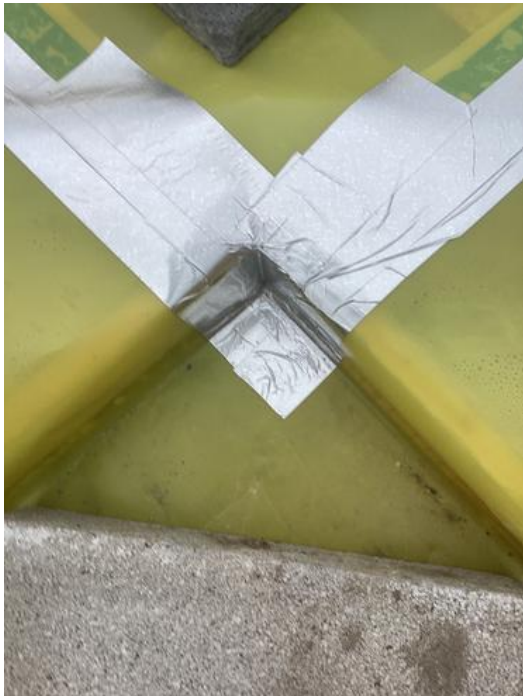
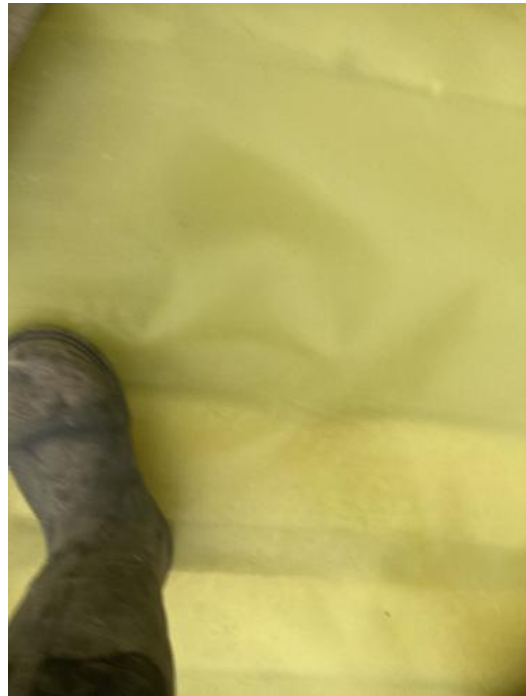
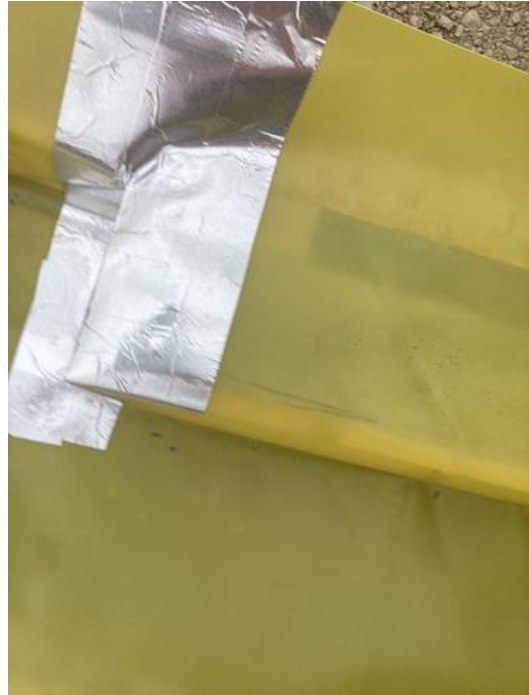
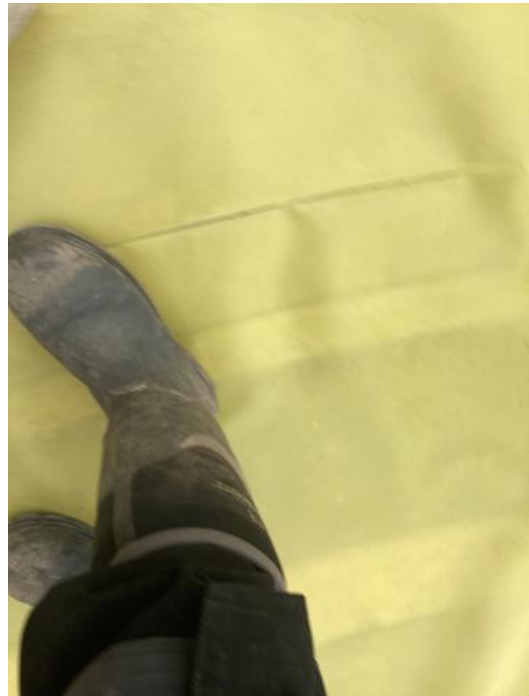
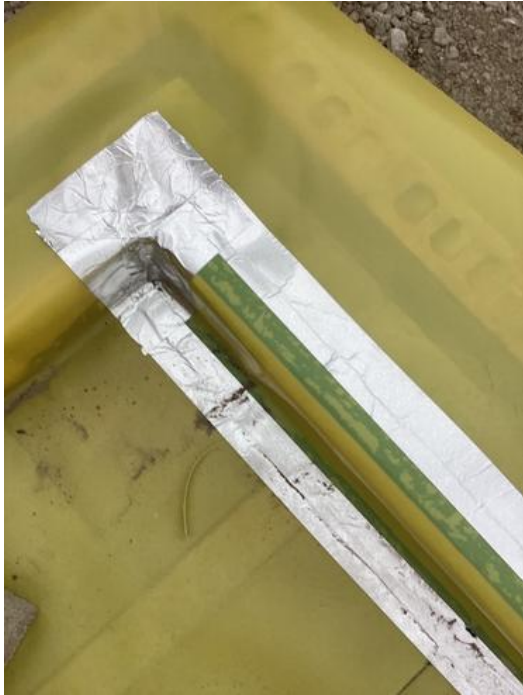
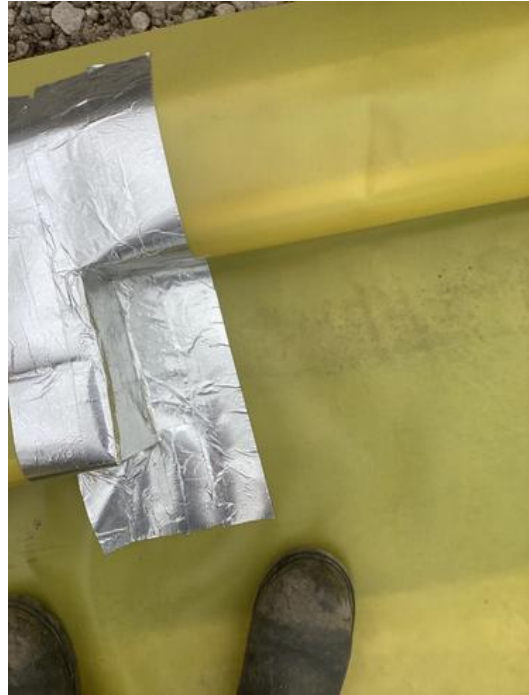
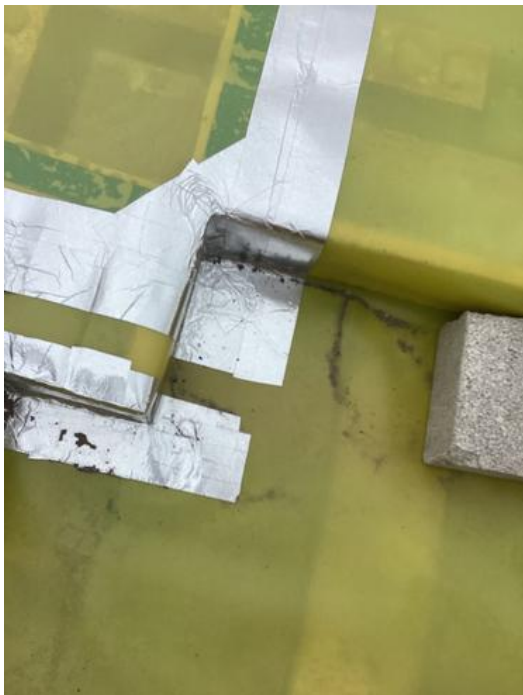
**Corners / Internal joints: Check all corners are correctly formed or contractor has used preformed corners.**

Pass

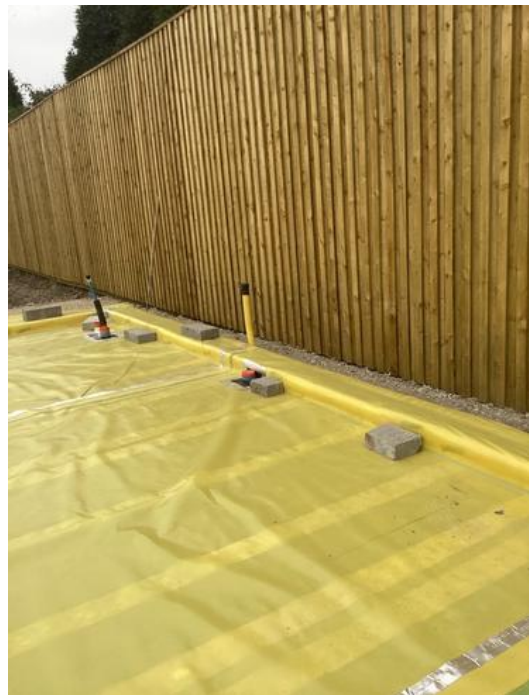
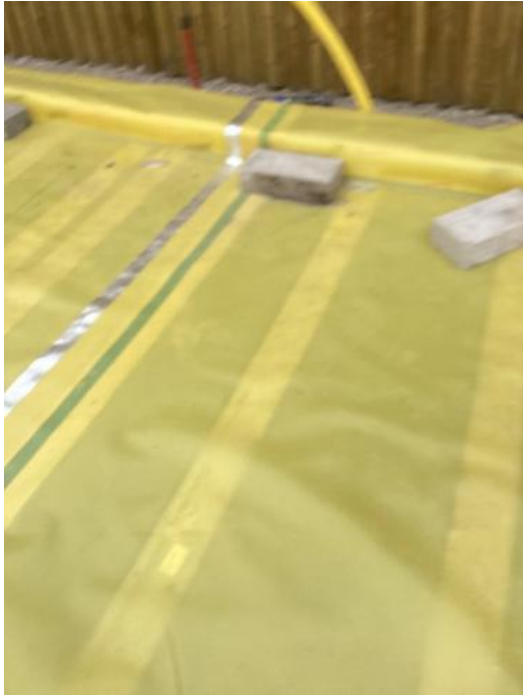
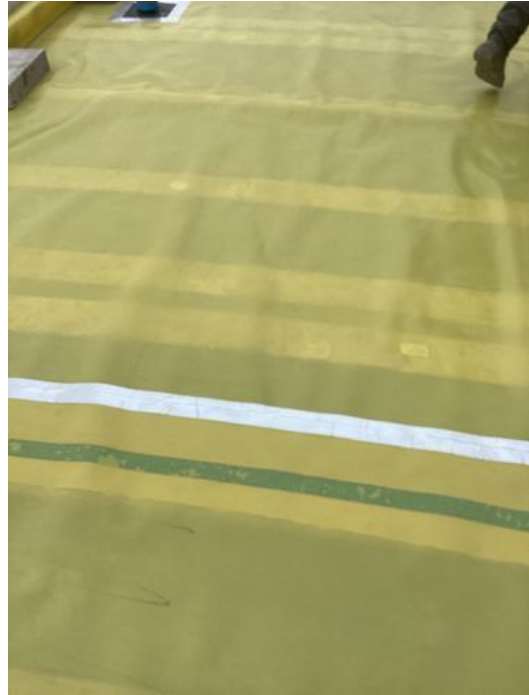
**Extent of Coverage: Is the membrane covering the entire plot? Does membrane span over outside walls?**

Yes

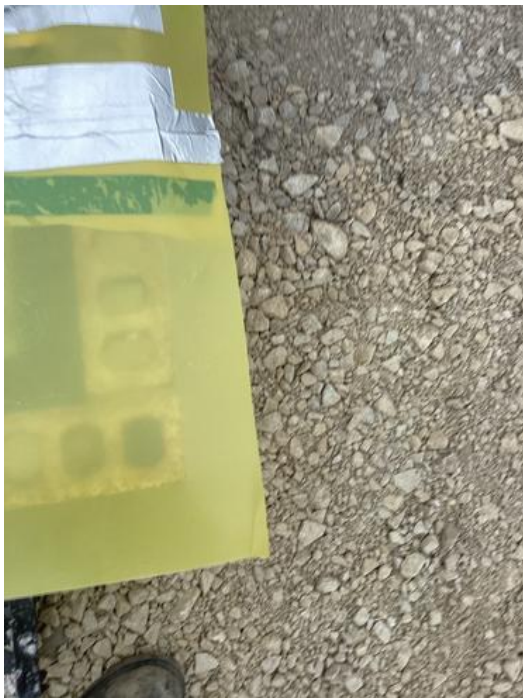
Photo 27

**Condition of sub-grade and underside of gas membrane:** Check that the subgrade does not contain rough/uneven surfaces, is appropriately clean and that there are no hard/sharp objects. That protective sand blinding or geotextile (if specified) is present and meets the design criteria.

Pass

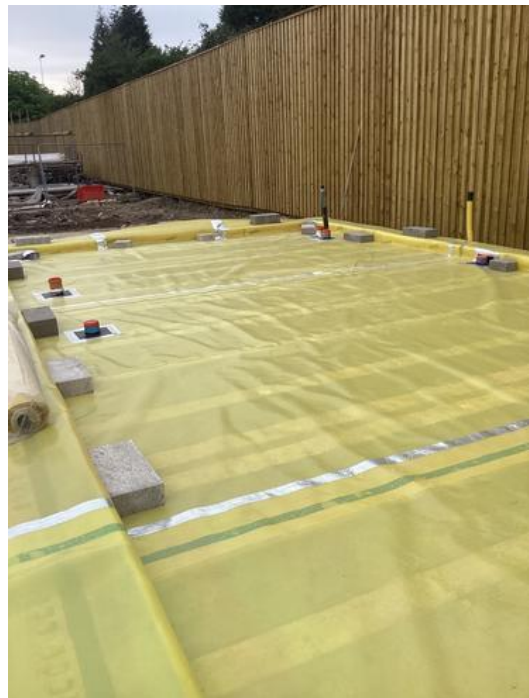
Photo 28

**Slab / membrane condition** (is membrane clear of debris or insulation): Can membrane be fully seen and photographed – ask contractor to remove an debris so membrane can be fully seen and inspected – this is a requirement of NHBC and local authorities.

Pass

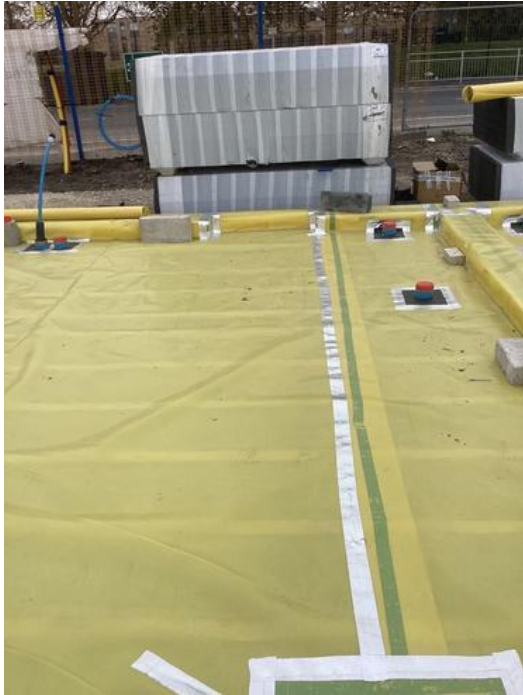
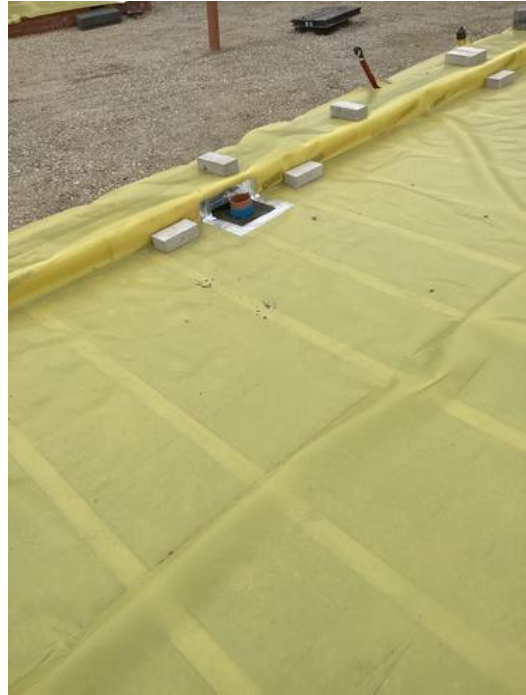
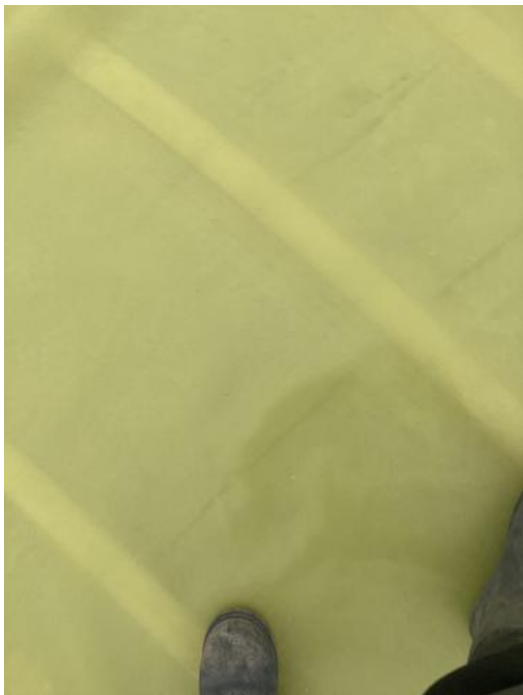
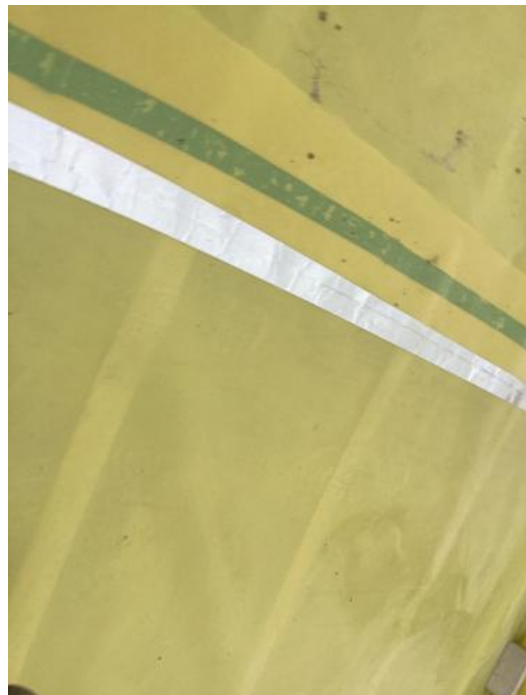
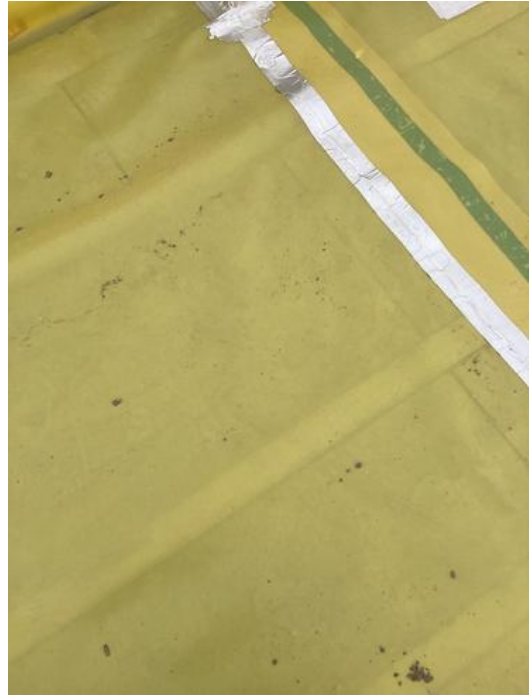
Gas Membrane Condition: Open punctures, tears, rips, stretching, Presence of debris, Repairs, Signs of weakness such as raised or sunken indentations, Protection plan in place to restrict access to lain gas membrane? IF FAIL DESCRIPTION IN ACTIONS AND PHOTOS REQUIRED

Pass

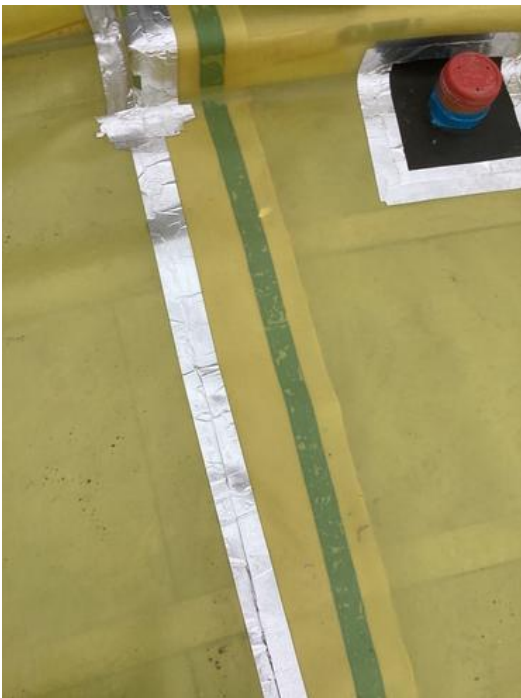
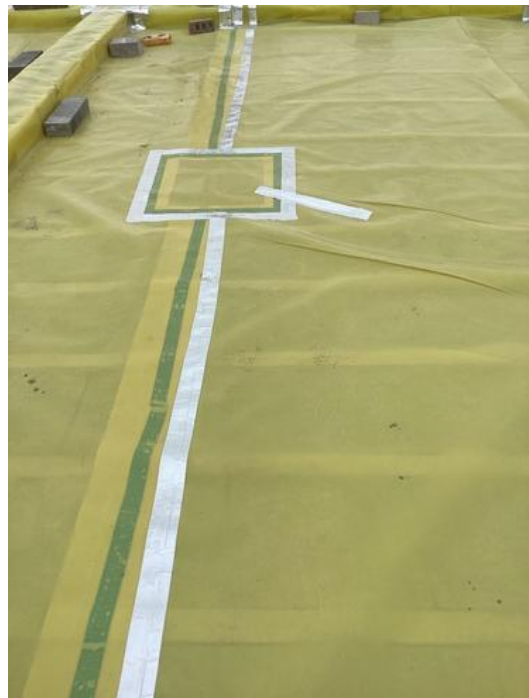
Laps, welds, and joints seals: Joints lapped and sealed in accordance with manufacturer's requirements/ specification? Minimum overlap insured? Sections taped twice? Are welds complete? Appropriate joining/double-sided tape used, Folds running in line with joints? (no joints cutting across folds)

Pass

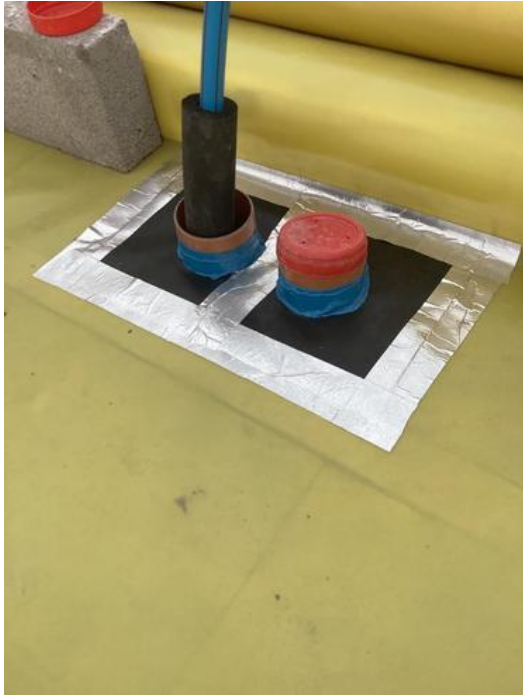
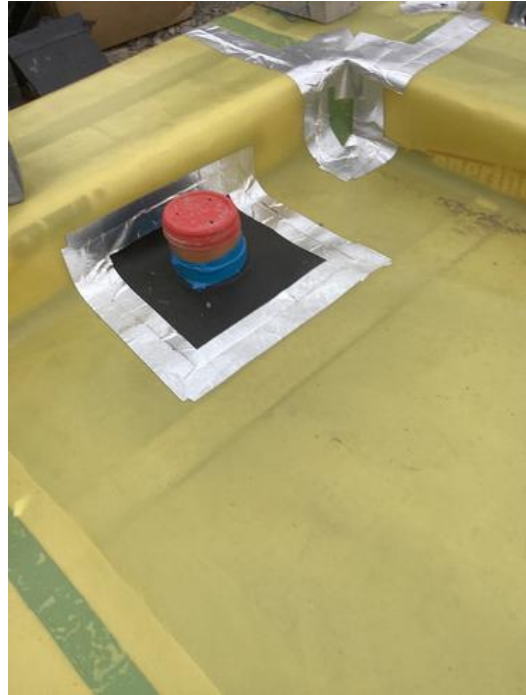
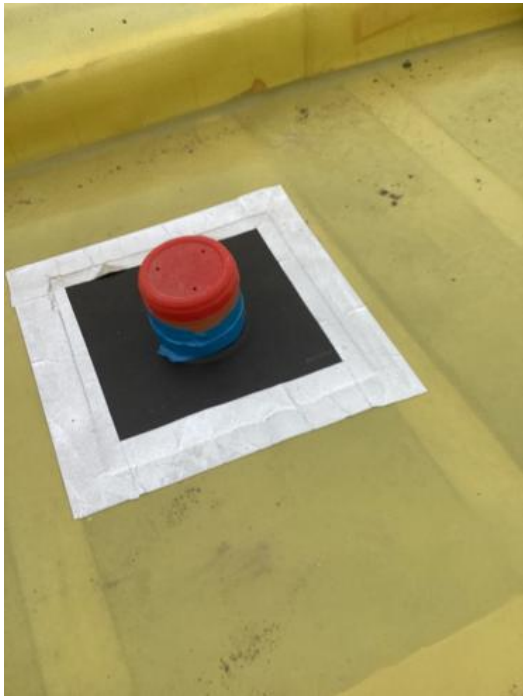
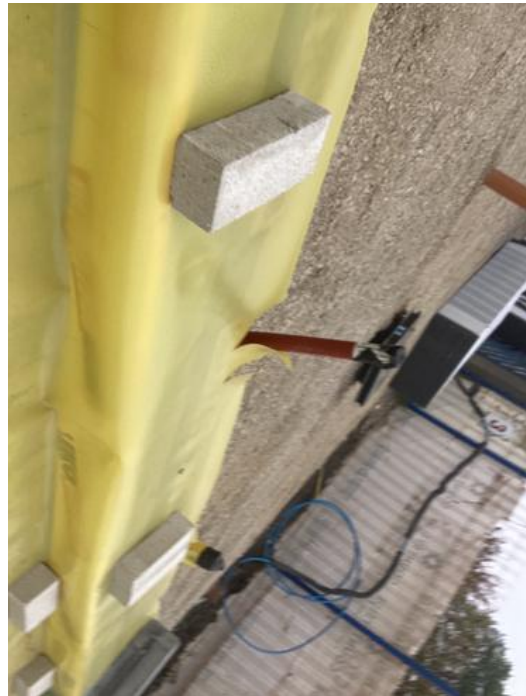
Service entries seals: Top hats seal arrangements fixed around service entries? Use of Jubilee clips?

Yes

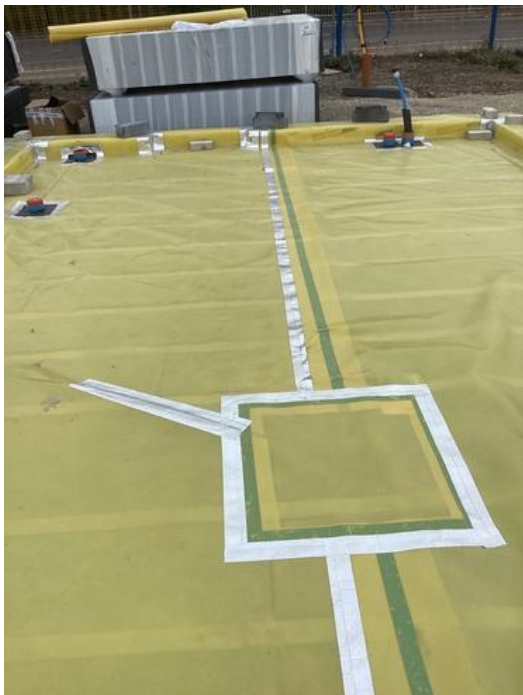
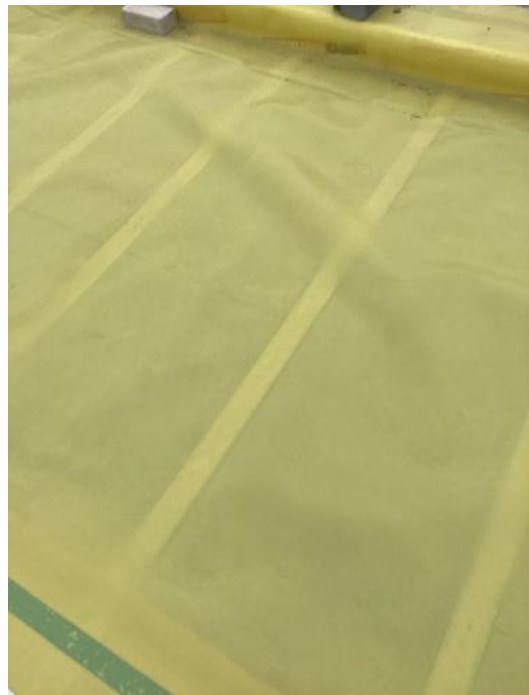
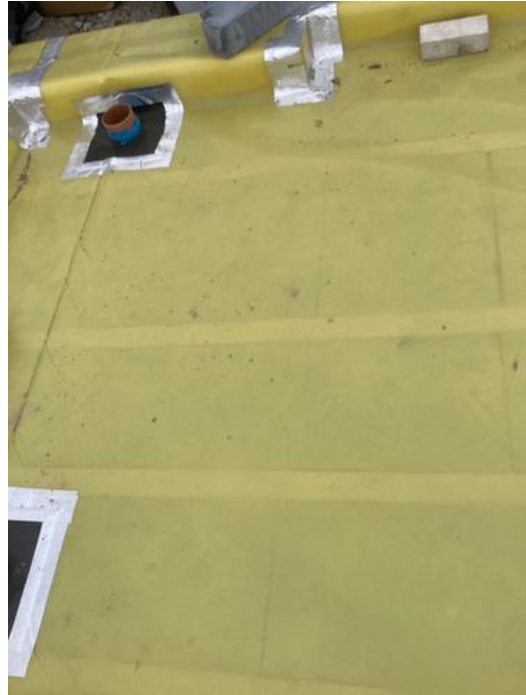
**Gas Membrane Condition: Open punctures, tears, rips, stretching, Presence of debris, Repairs, Signs of weakness such as raised or sunken indentations, Protection plan in place to restrict access to lain gas membrane? IF FAIL DESCRIPTION IN ACTIONS AND PHOTOS REQUIRED**

Pass

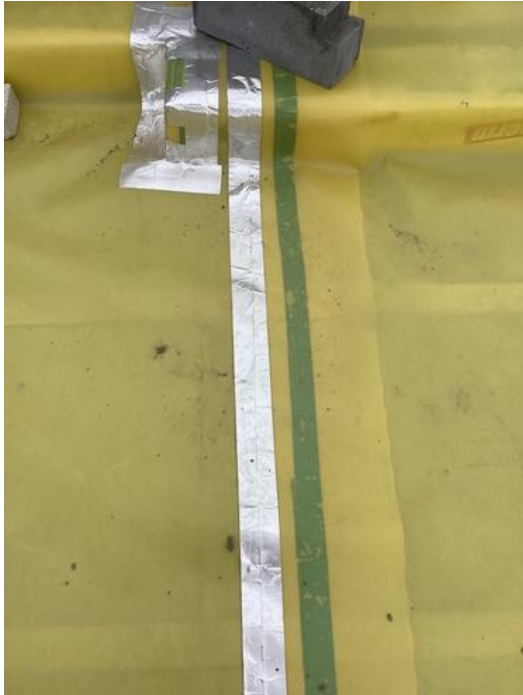
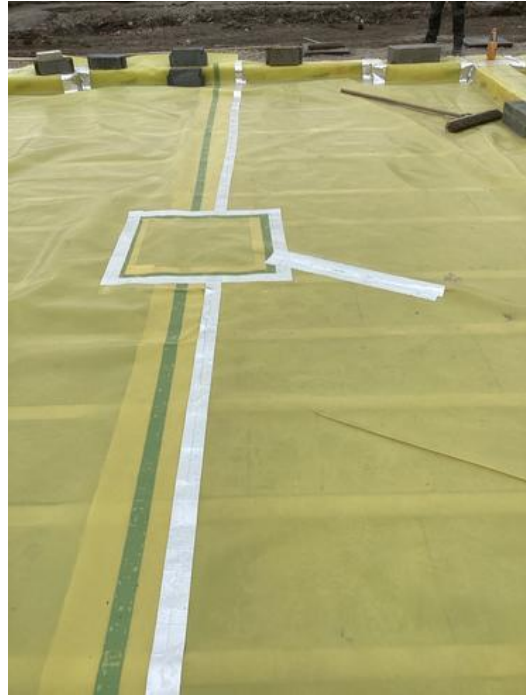
**Laps, welds, and joints seals: Joints lapped and sealed in accordance with manufacturer's requirements/ specification? Minimum overlap insured? Sections taped twice? Are welds complete? Appropriate joining/double-sided tape used, Folds running in line with joints? (no joints cutting across folds)**

Pass

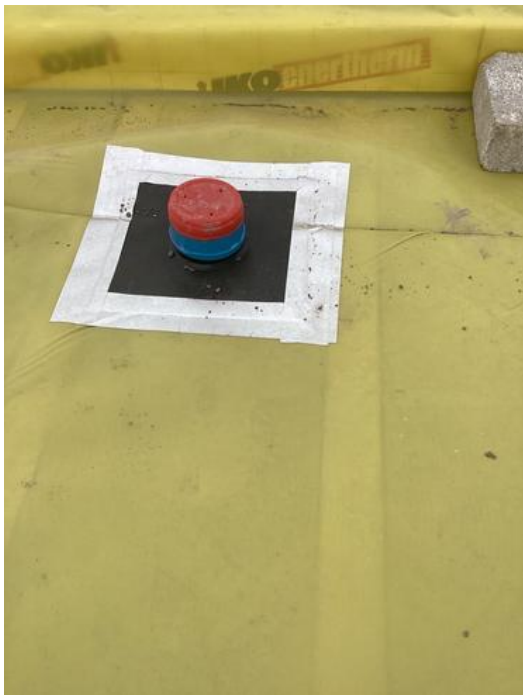
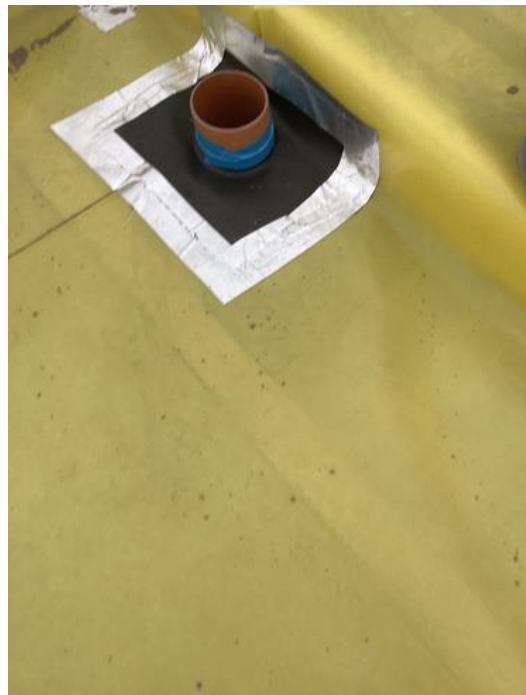
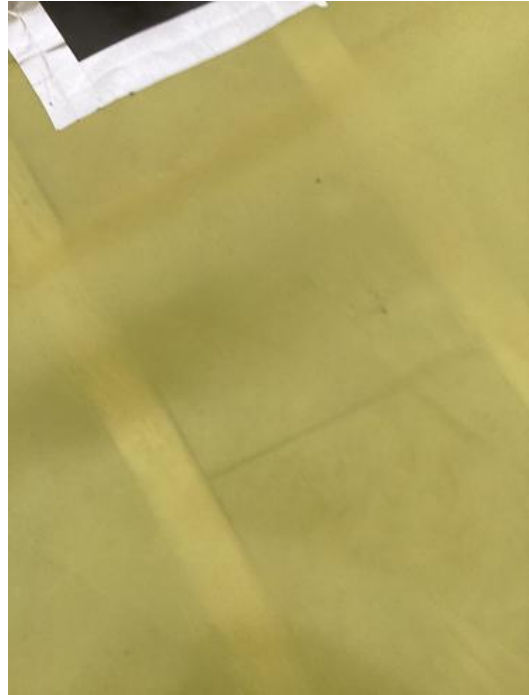
**Service entries seals: Top hats seal arrangements fixed around service entries? Use of Jubilee clips?**

Yes
