## GAS MEMBRANE VALIDATION

| Site Name: Belle Vue Stadium | Project Number: 12-123 |
| Company Name: Countryside | Date: 15-09-2022 |

**Plot – 135**

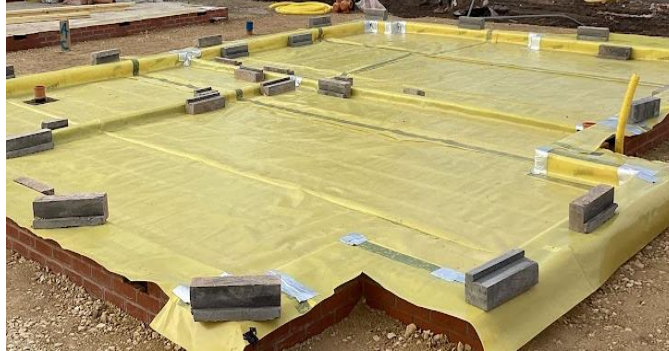
**General Condition of Membrane-Good Condition**

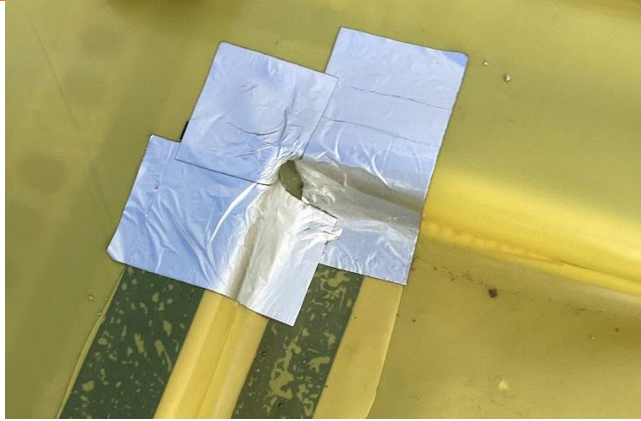
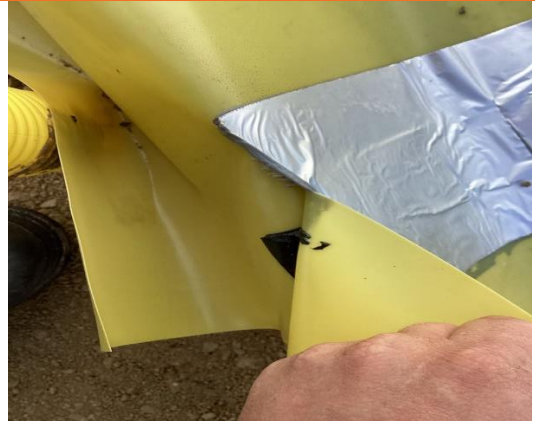
**Verification of Joints and Seals-Overlapped and sealed correctly**

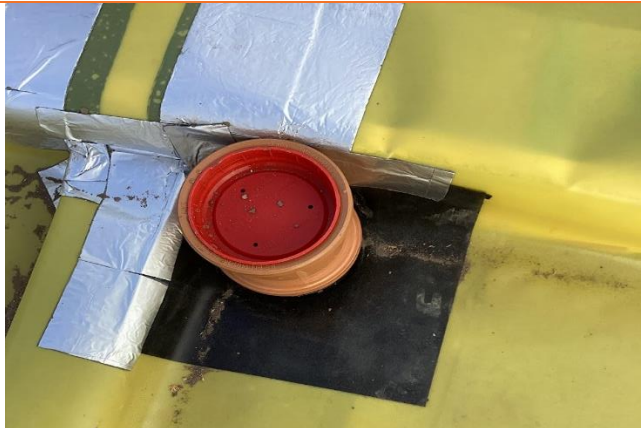
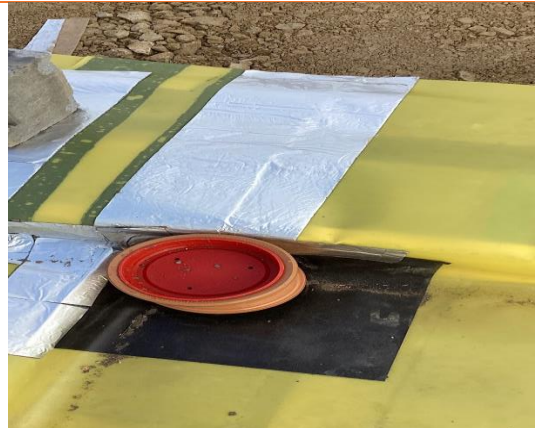
**Verification of Service Penetrations-Good Condition**

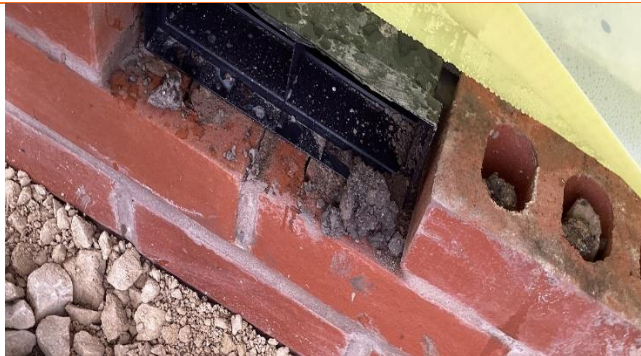
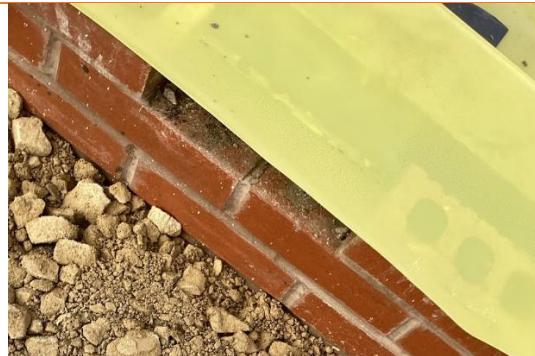
**Verification of Ventilation-Good Condition**

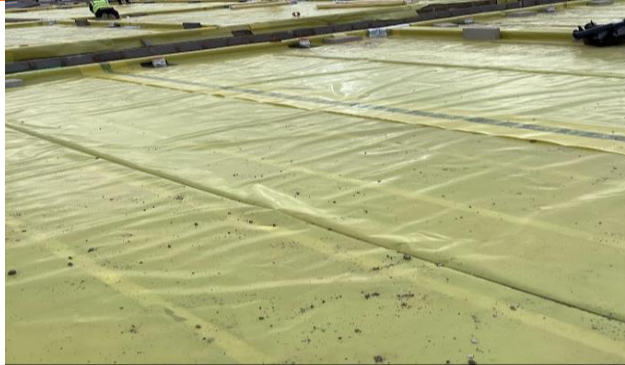
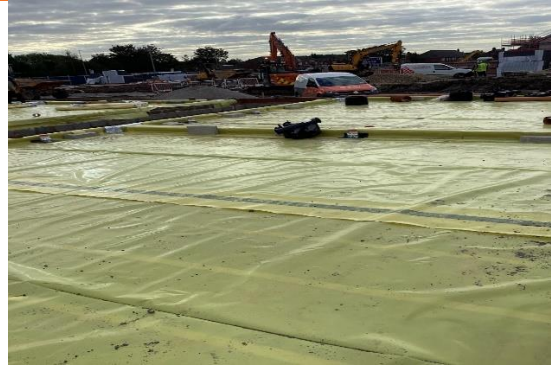
**Half App Block 1**

**General Condition of Membrane-Good Condition**

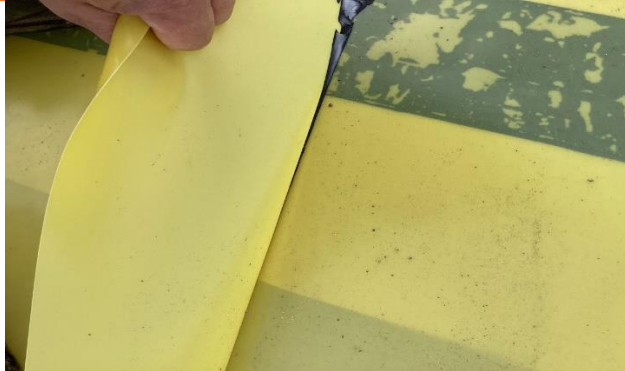
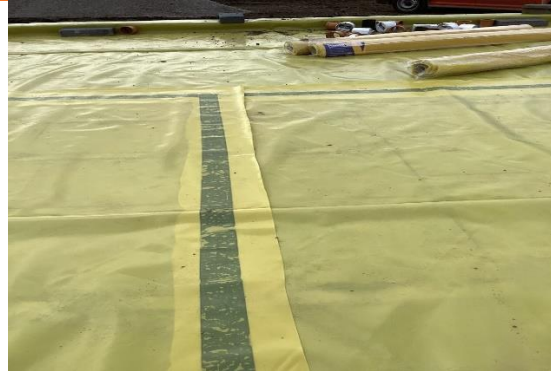
**Verification of Joints and Seals-Overlapped and sealed correctly**

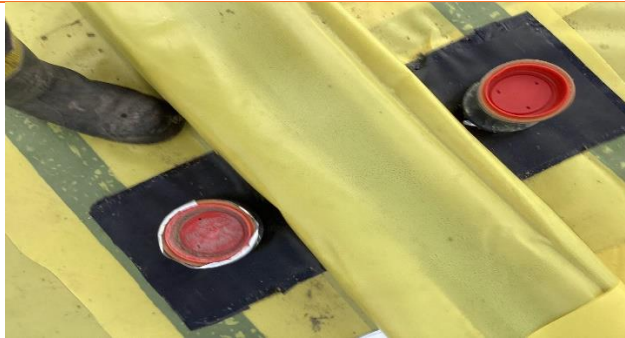
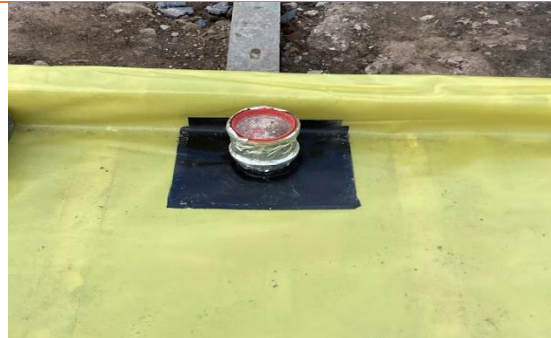
**Verification of Service Penetrations-Good Condition**

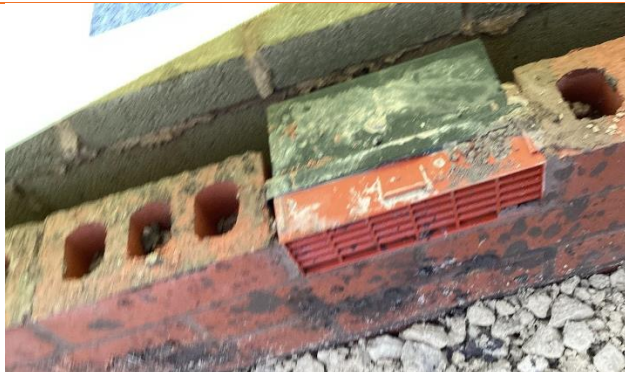
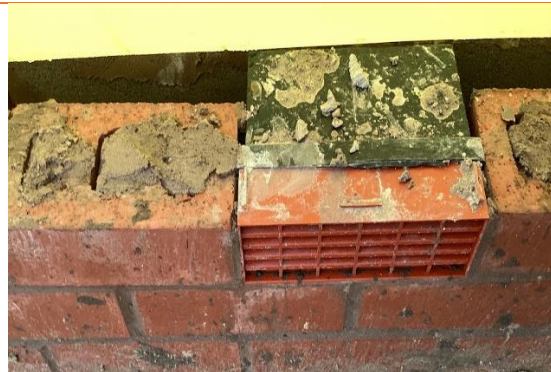
**Verification of Ventilation-Good Condition**
