### GAS MEMBRANE VALIDATION – BELLE VUE

**Project Name: Belle Bue Stadium****Project Number: 12-123****Client: Countryside Properties****Date: 13-09-2023****Project Manager: S. Ellis – FGS, CEnv****E3P Engineer: R. Webster****Gas Membrane Installers Chandos Civils****Ground Gas Risk Assessment: Amber 1****Plots: 217-219**

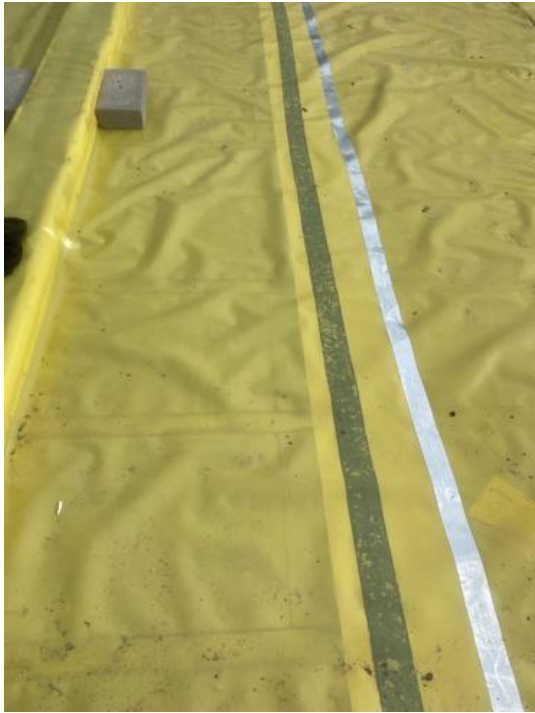
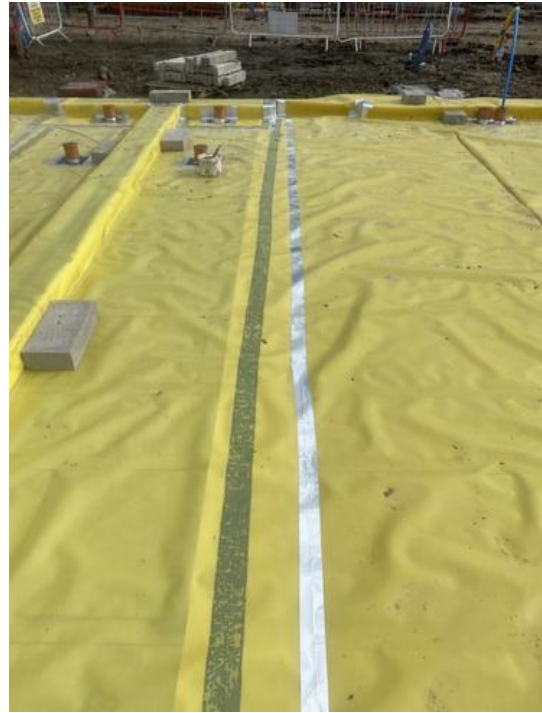
Laps, welds, and joints seals: Joints lapped and sealed in accordance with manufacturer's requirements/ specification? Minimum overlap insured? Sections taped twice? Are welds complete? Appropriate joining/double-sided tape used, Folds running in line with joints? (no joints cutting across folds)

Pass

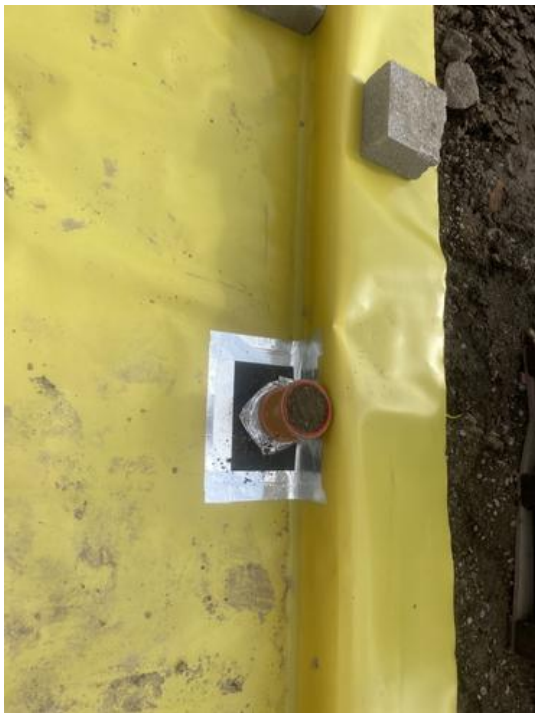
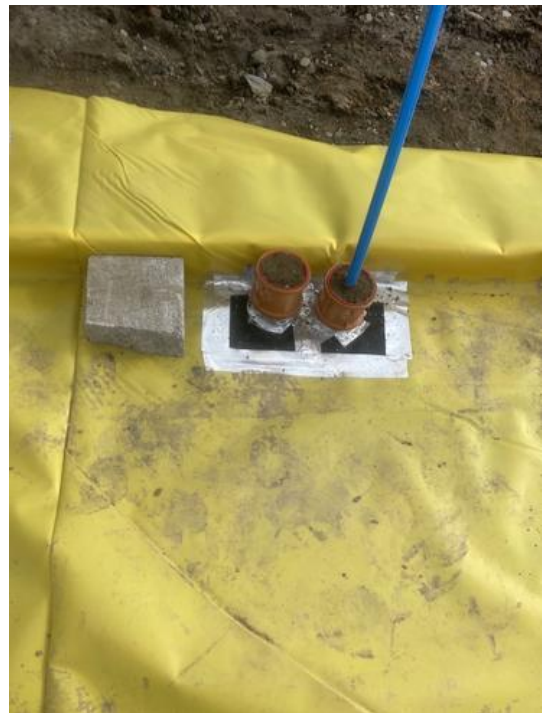
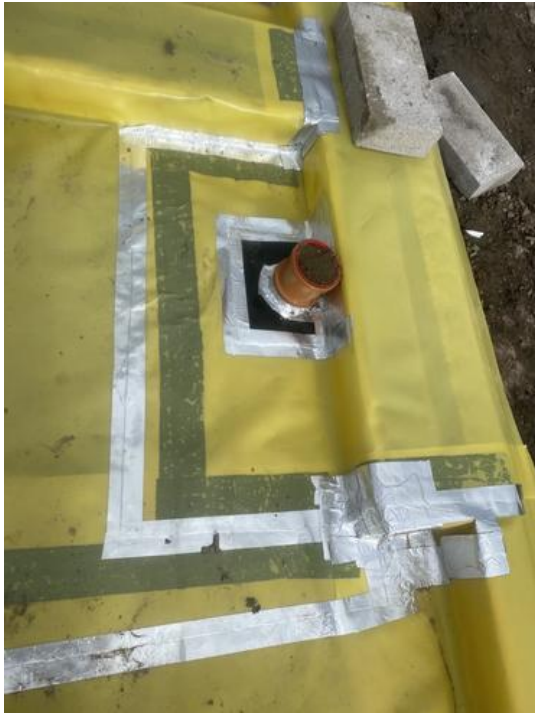
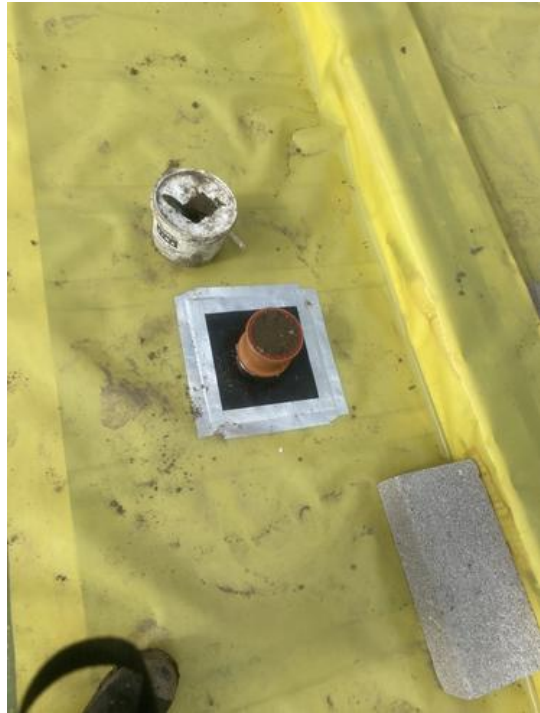
Service entries seals: Top hats seal arrangements fixed around service entries? Use of Jubilee clips?

Yes

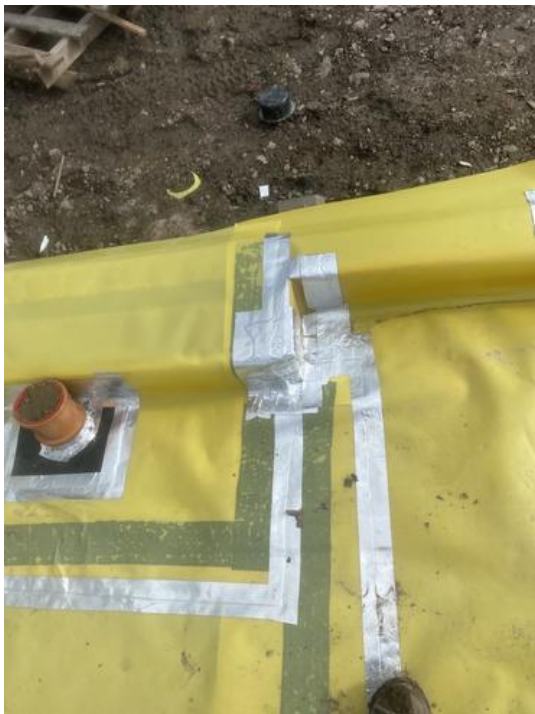
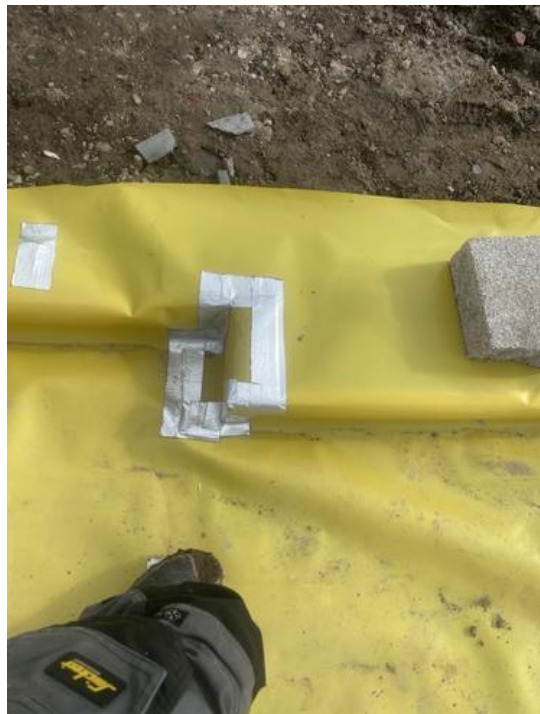
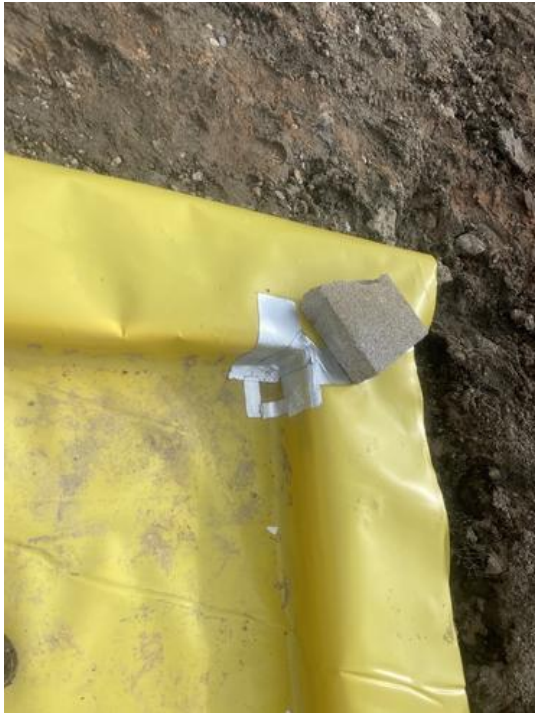
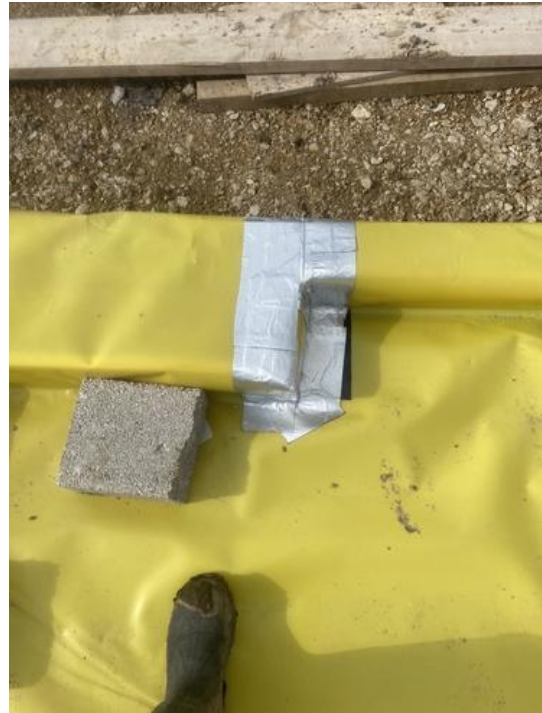
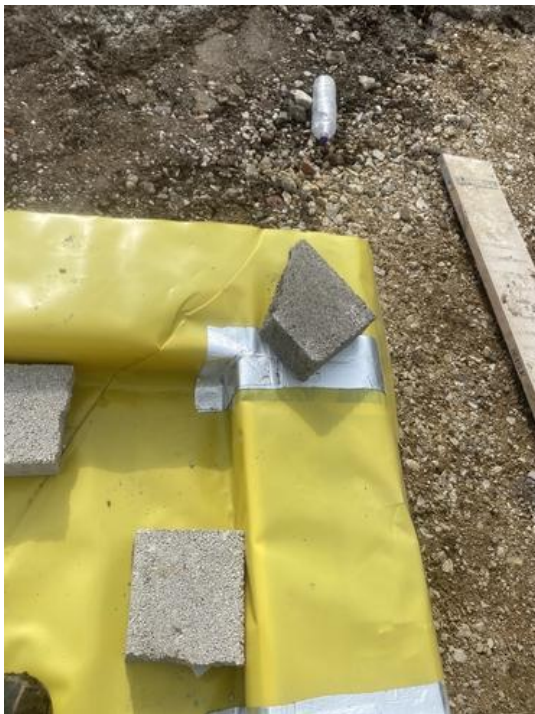
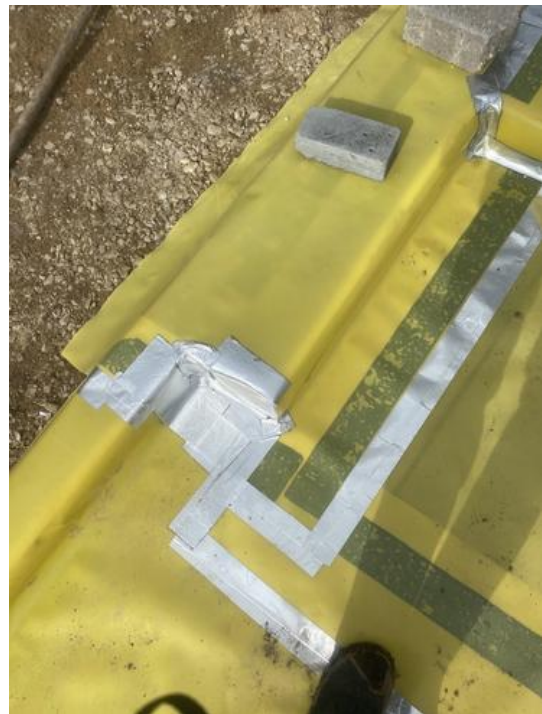
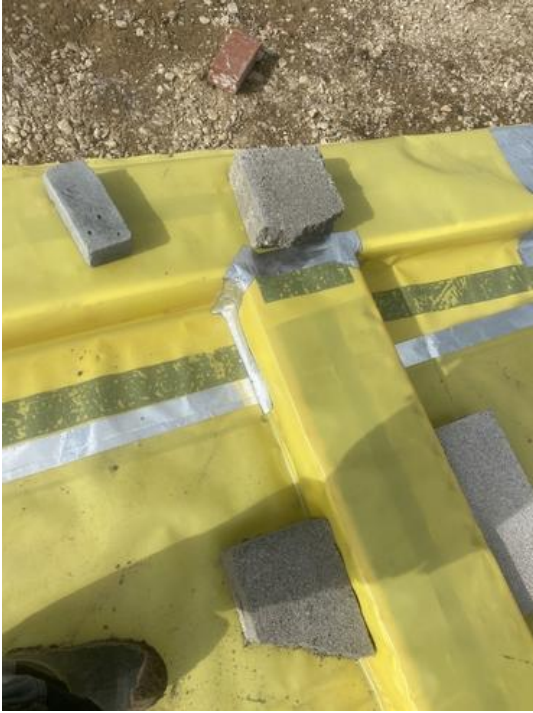
Corners / Internal joints: Check all corners are correctly formed or contractor has used preformed corners.

Pass

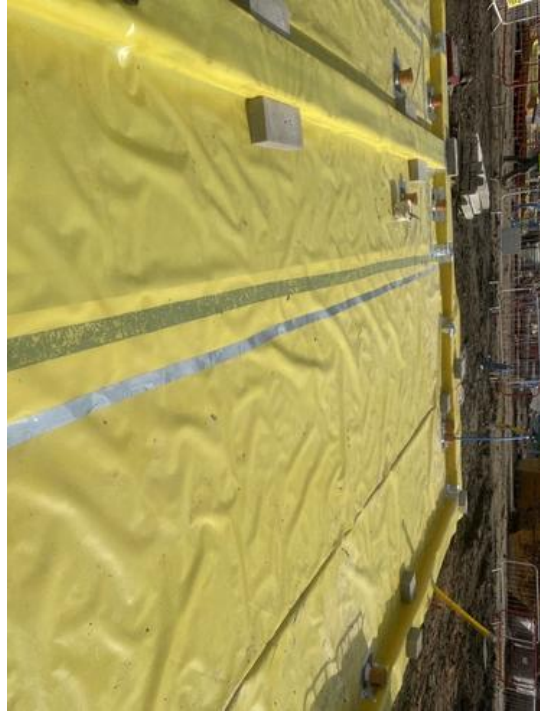
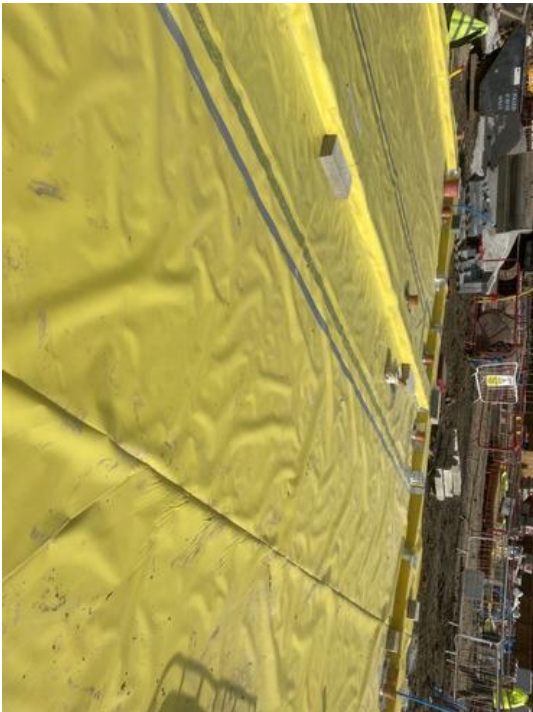
**Extent of Coverage: Is the membrane covering the entire plot? Does membrane span over outside walls?**

Yes

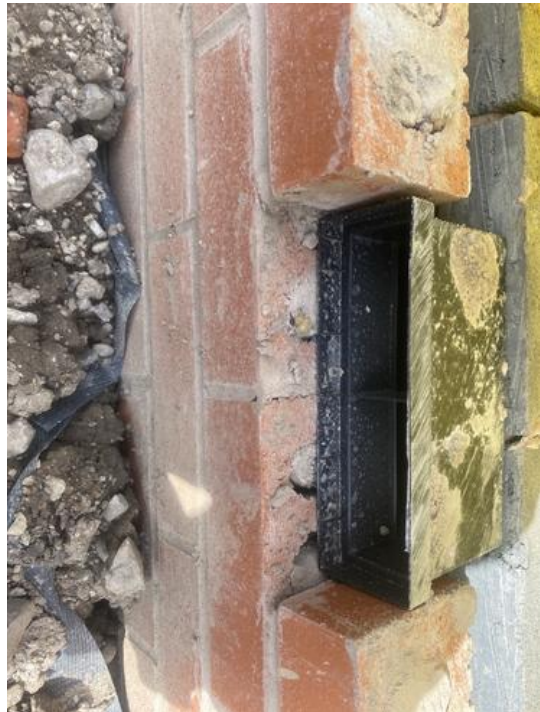
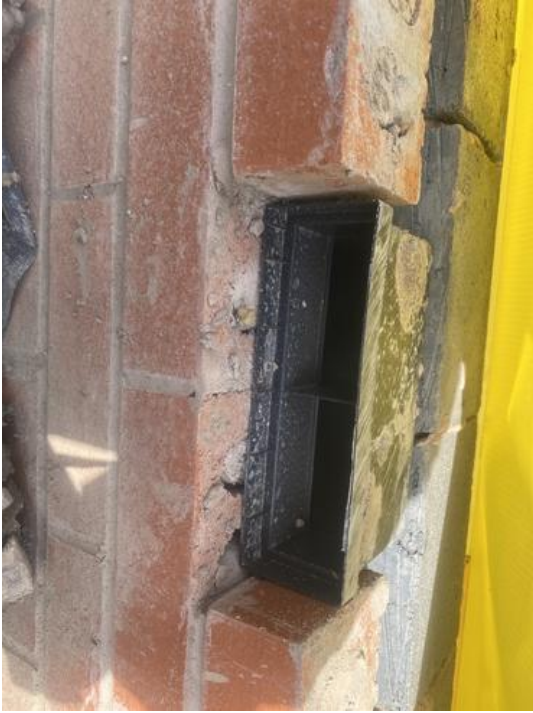
**External Wall Air bricks: Numbers, size. positions as design drawing? (Minimum of 3 walls)**

Pass

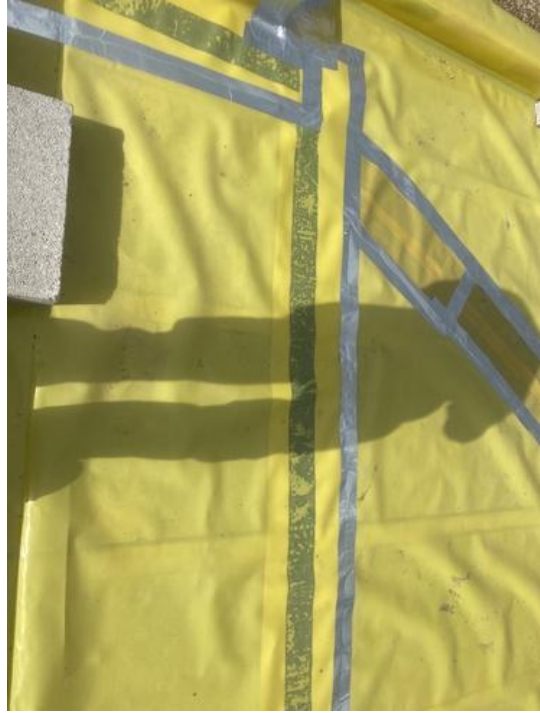
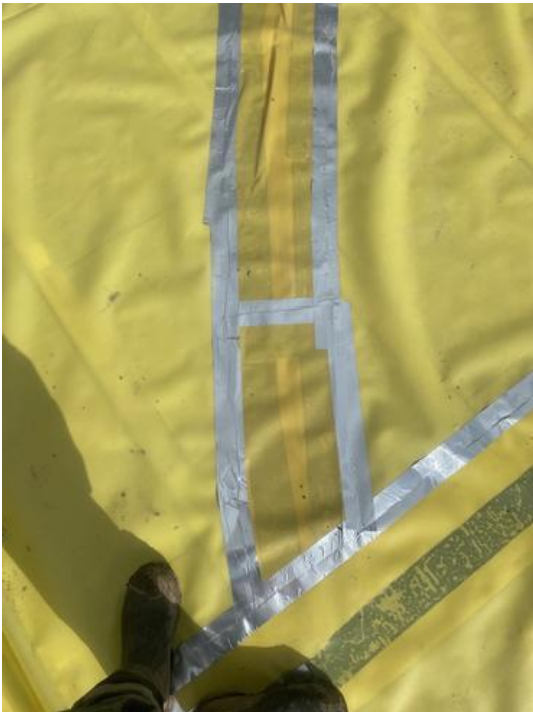
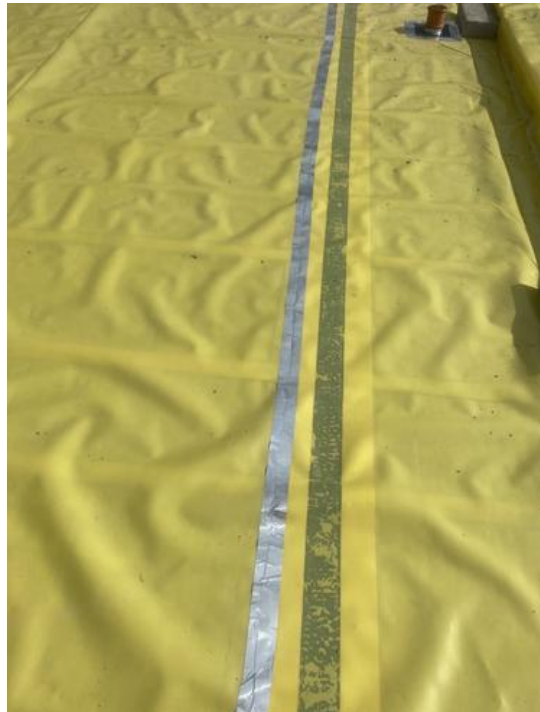
Laps, welds, and joints seals: Joints lapped and sealed in accordance with manufacturer's requirements/ specification? Minimum overlap insured? Sections taped twice? Are welds complete? Appropriate joining/double-sided tape used, Folds running in line with joints? (no joints cutting across folds)

Pass

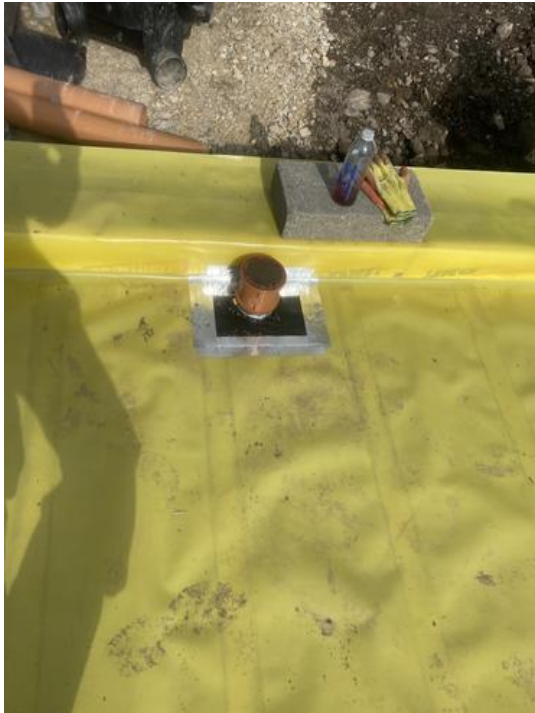
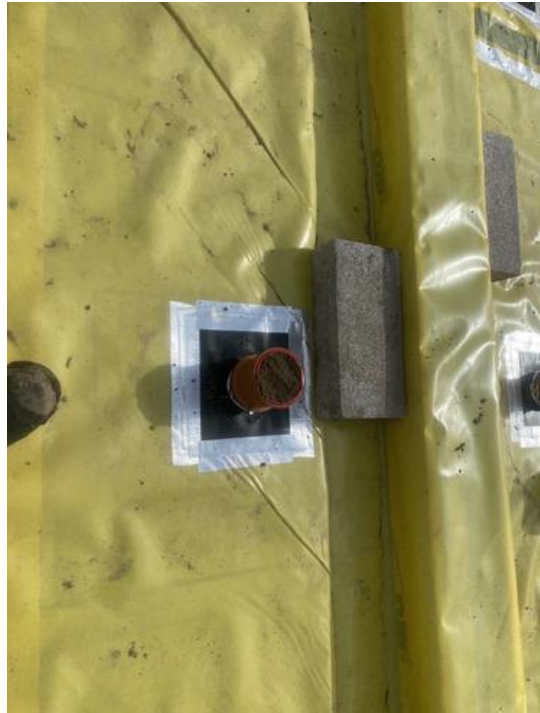
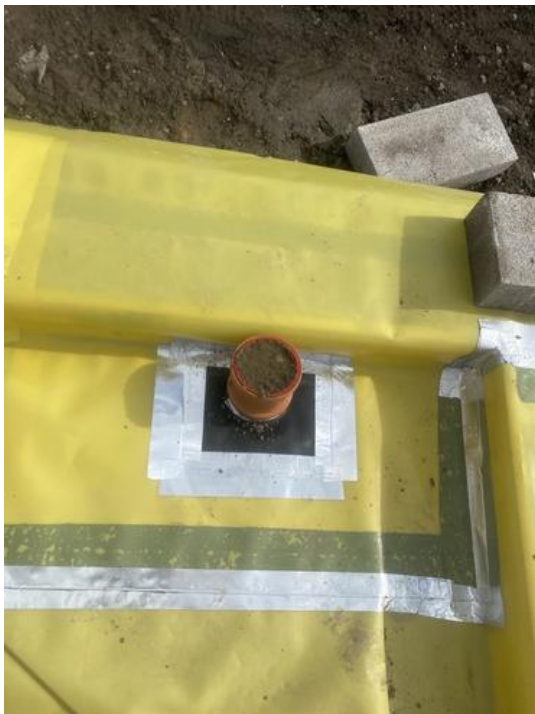
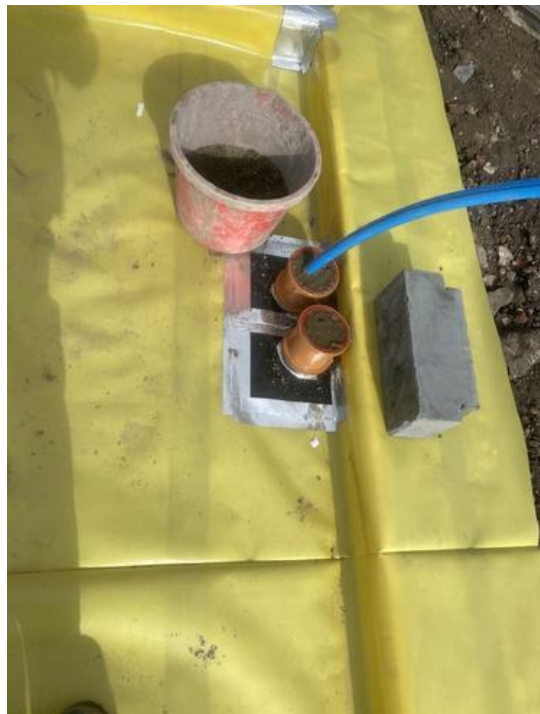
Service entries seals: Top hats seal arrangements fixed around service entries? Use of Jubilee clips?

Yes

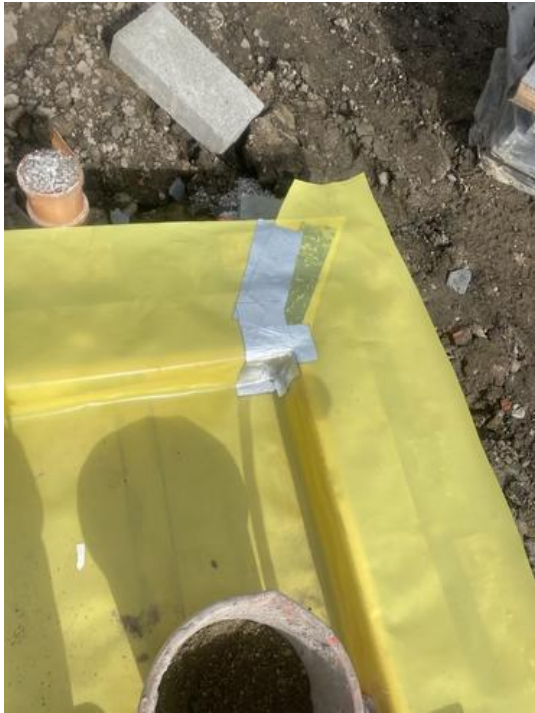
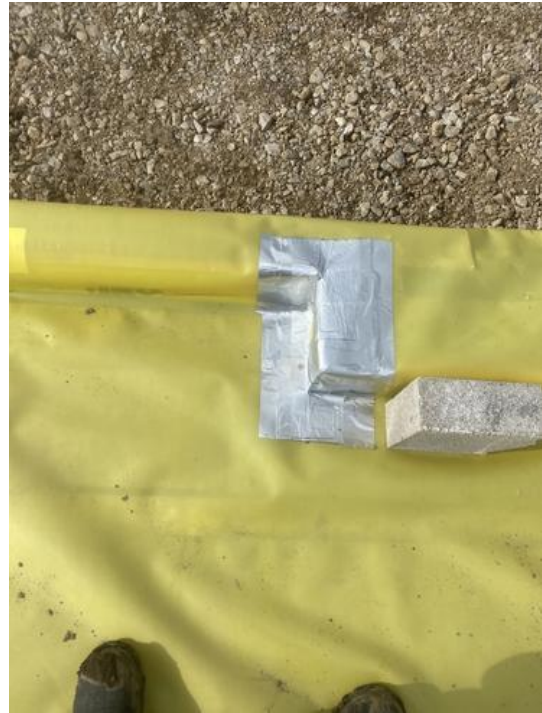
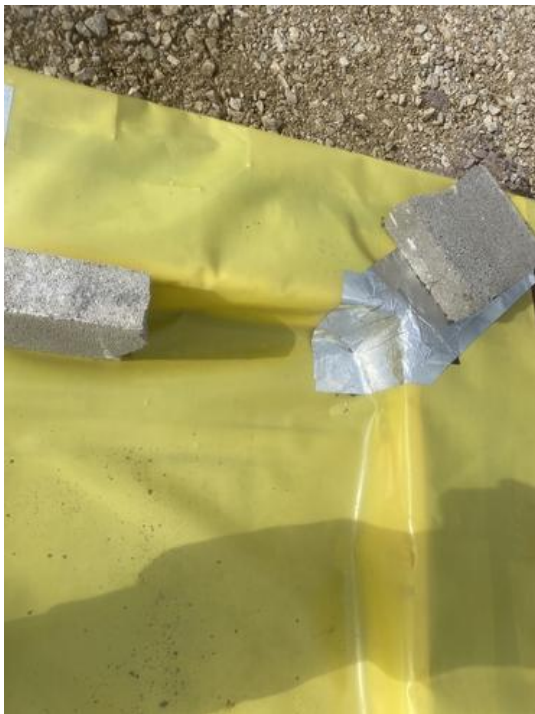
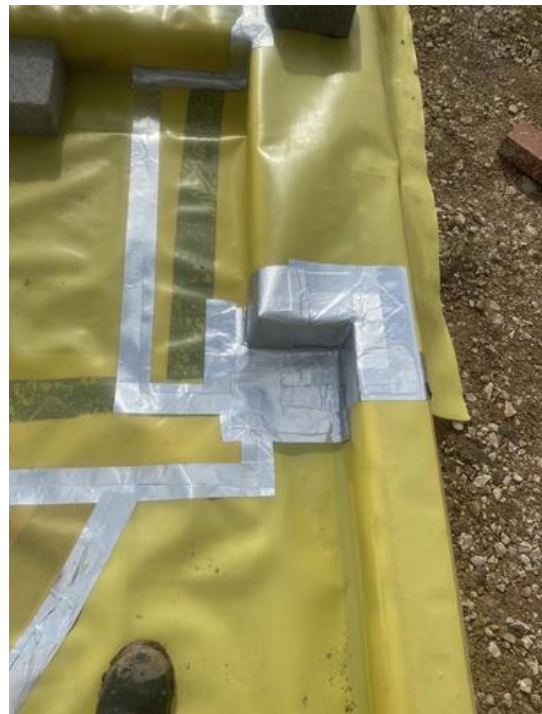
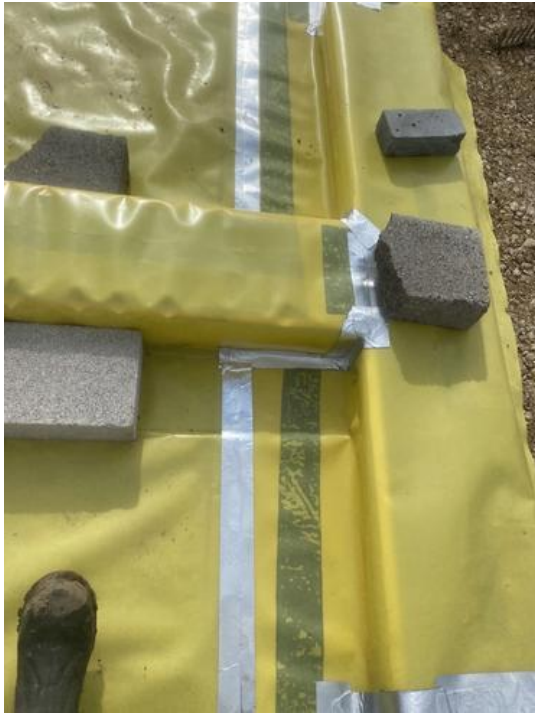
Corners / Internal joints: Check all corners are correctly formed or contractor has used preformed corners.

Pass

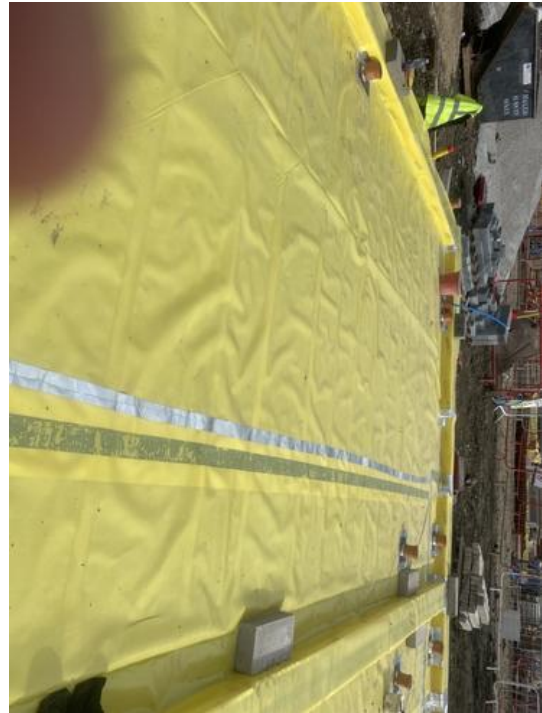
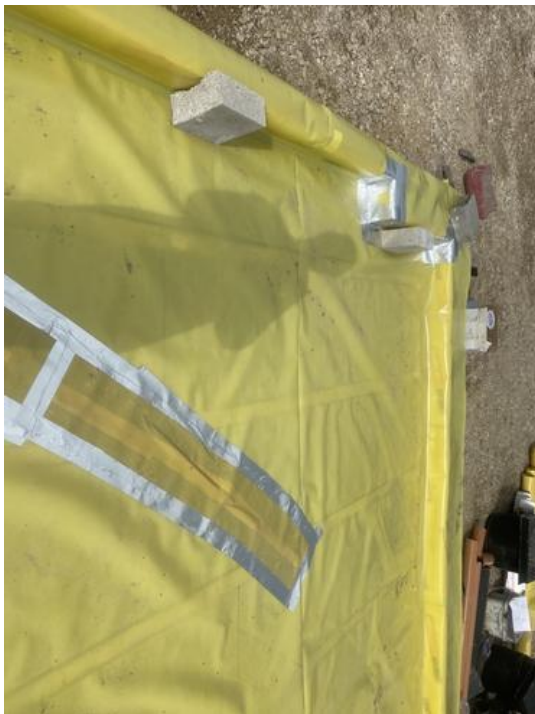
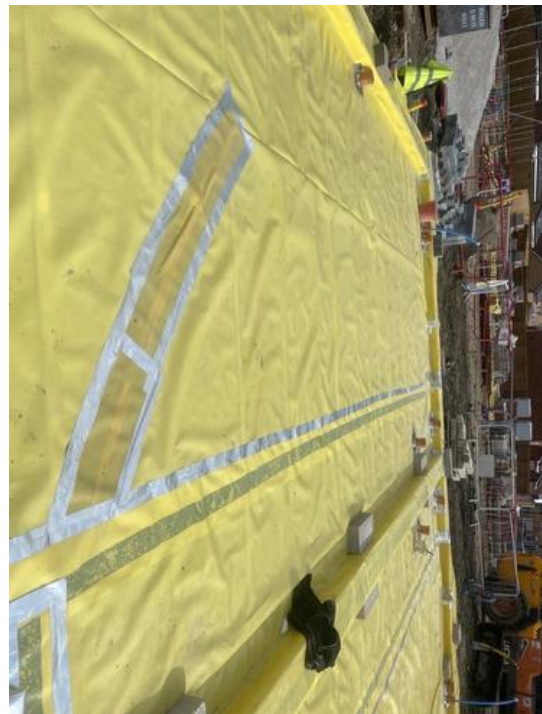
**Extent of Coverage: Is the membrane covering the entire plot?  
Does membrane span over outside walls?**

Yes

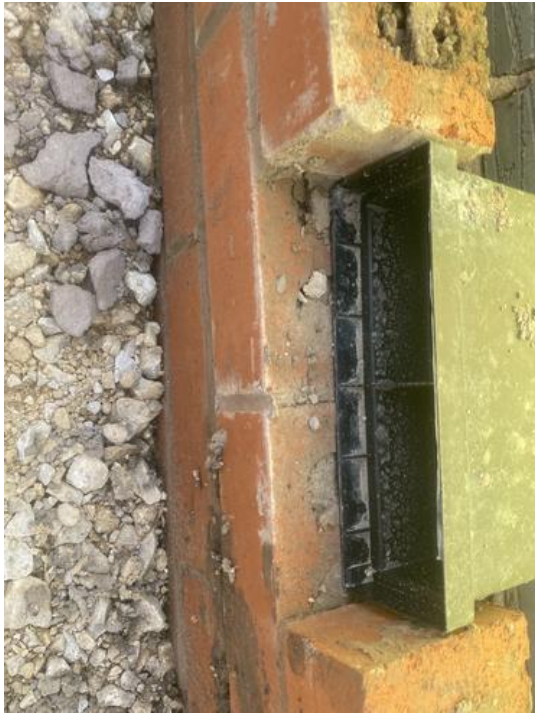
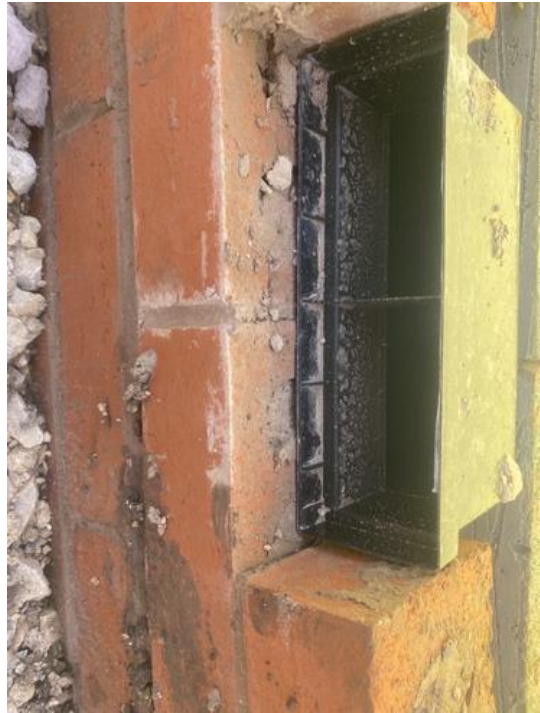
**External Wall Air bricks: Numbers, size. positions as design drawing? (Minimum of 3 walls)**

Pass

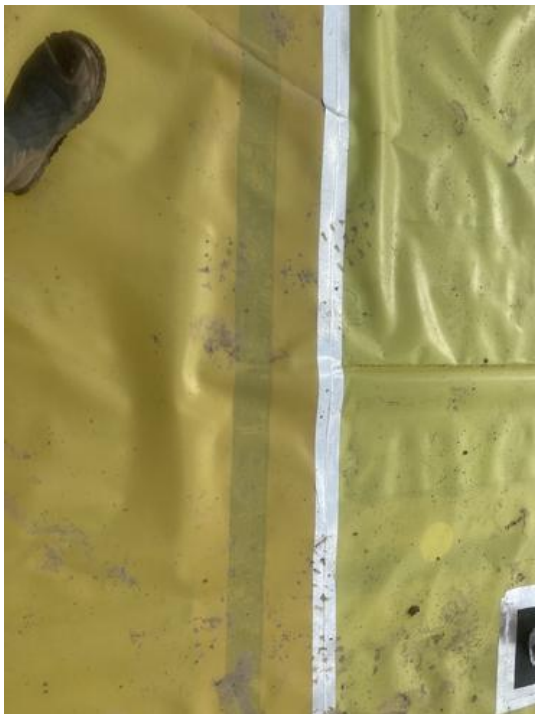
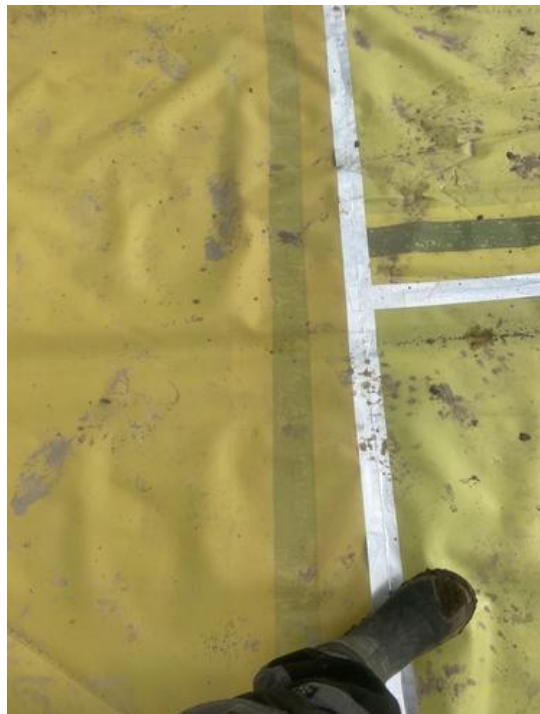
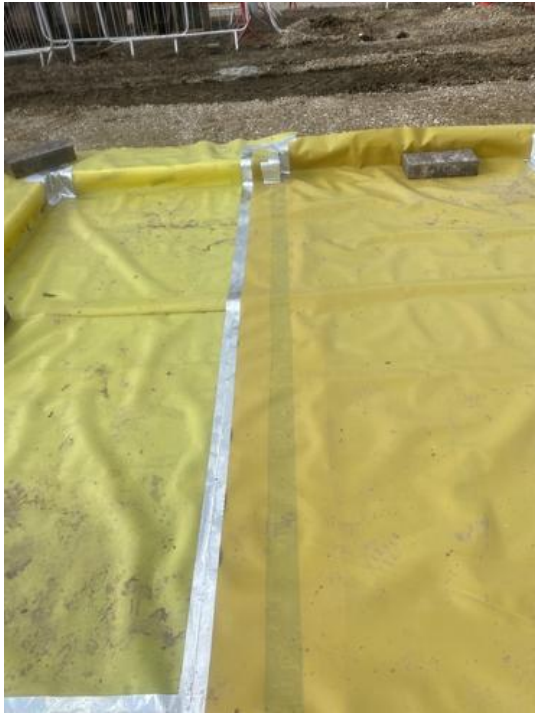
Laps, welds, and joints seals: Joints lapped and sealed in accordance with manufacturer's requirements/ specification? Minimum overlap insured? Sections taped twice? Are welds complete? Appropriate joining/double-sided tape used, Folds running in line with joints? (no joints cutting across folds) Pass

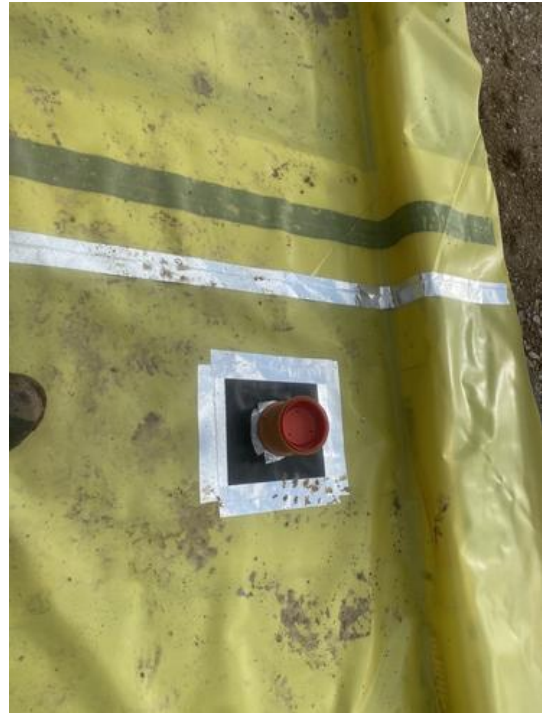
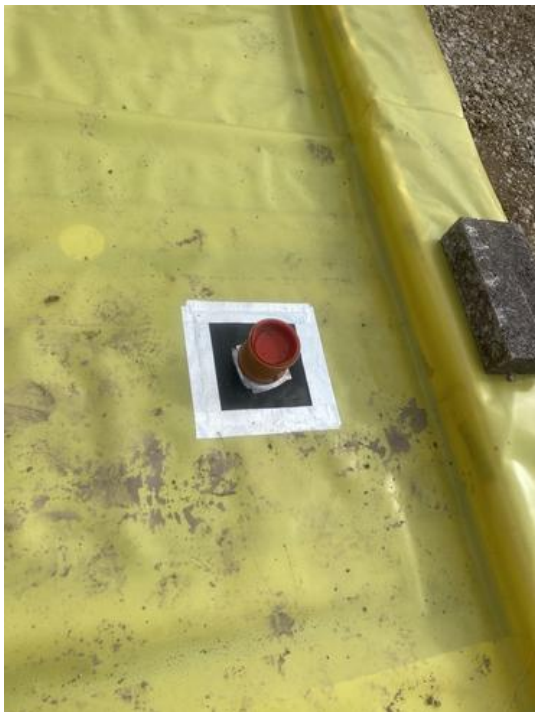
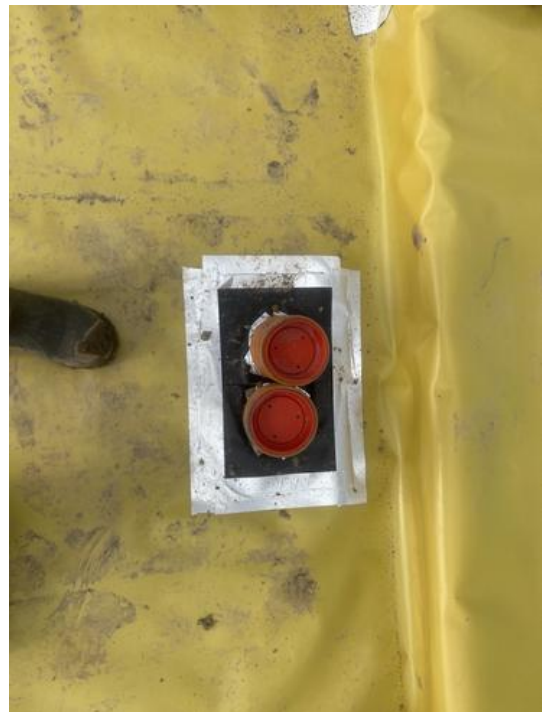
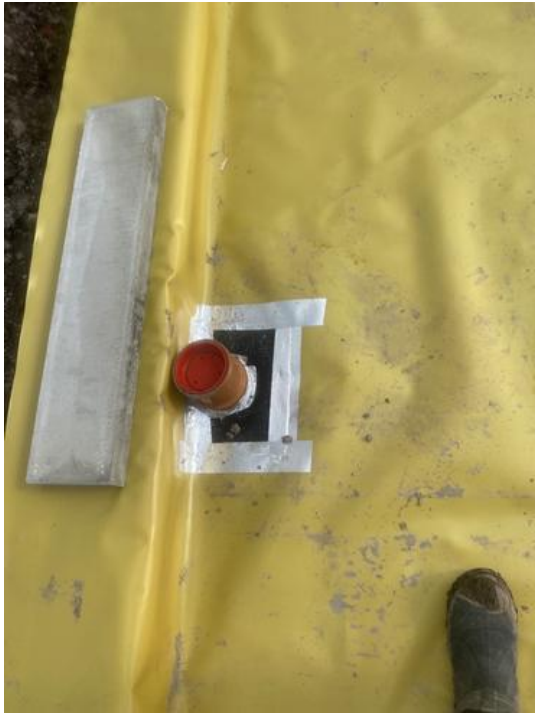
Service entries seals: Top hats seal arrangements fixed around service entries? Use of Jubilee clips? Yes

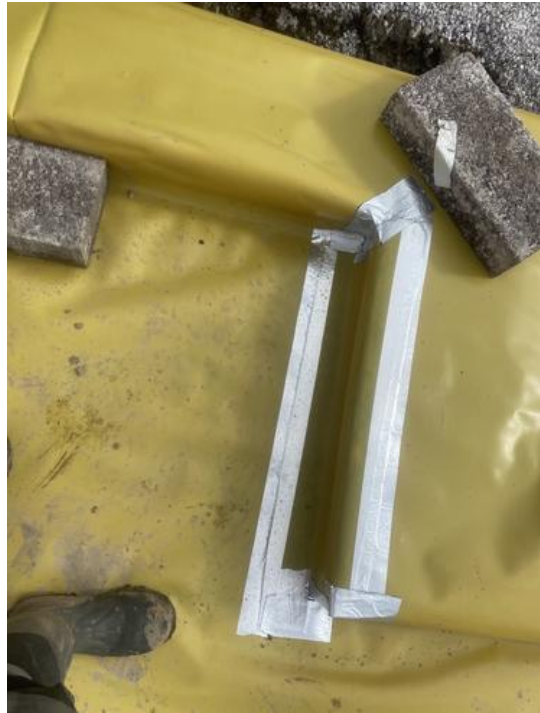
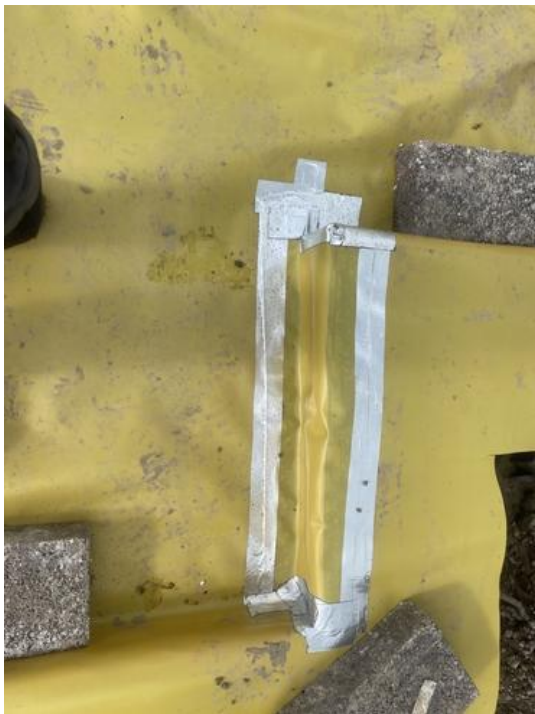
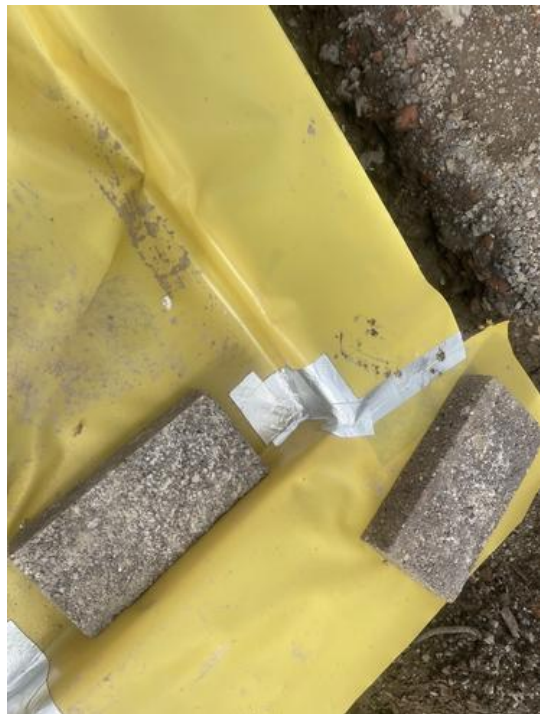
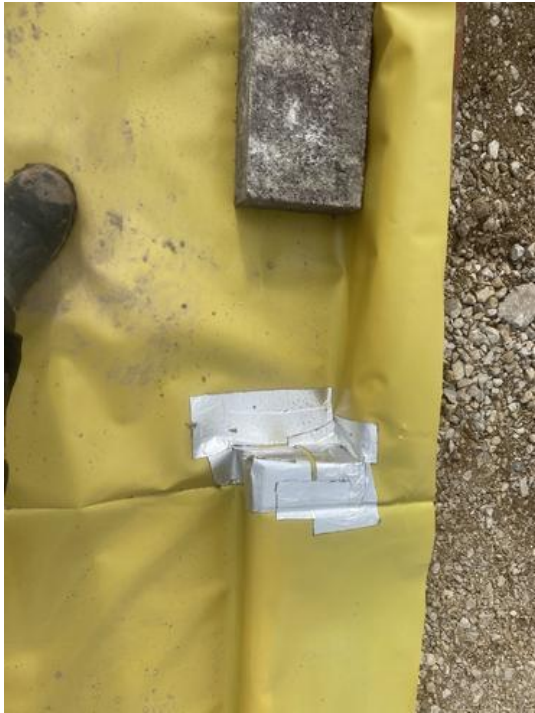
Corners / Internal joints: Check all corners are correctly formed or contractor has used preformed corners. Pass

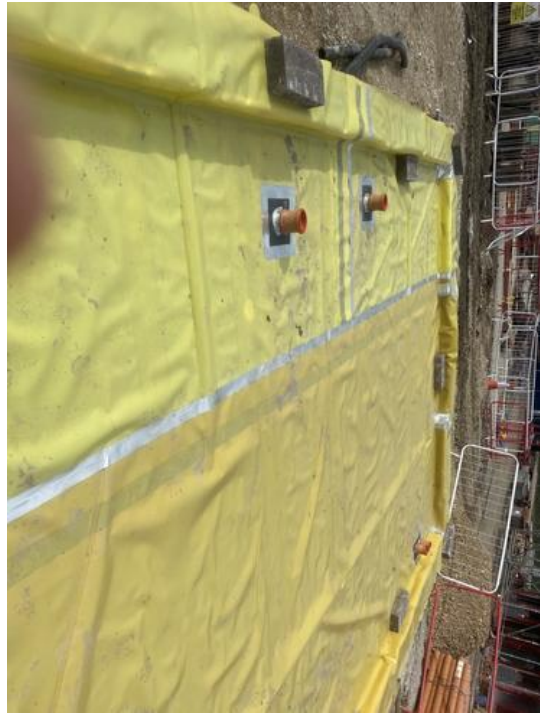
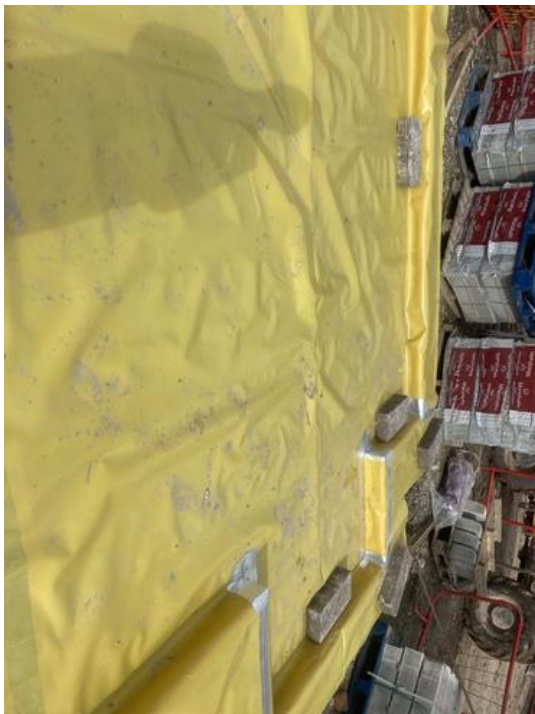
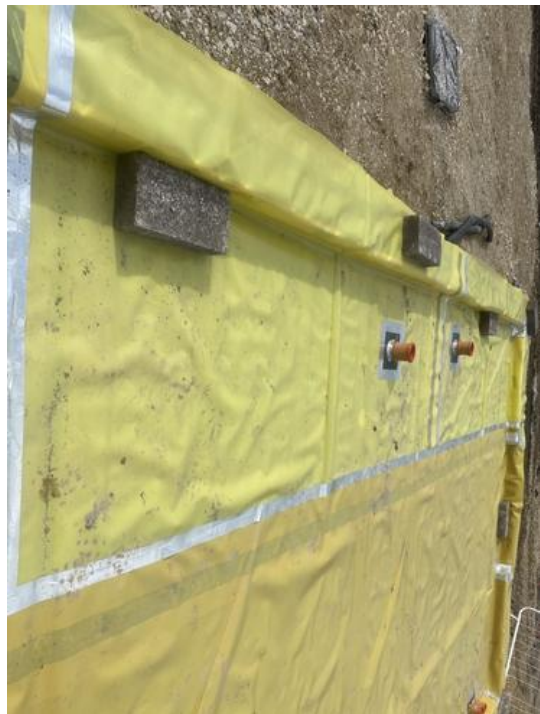
**Extent of Coverage: Is the membrane covering the entire plot?  
Does membrane span over outside walls?**

Yes

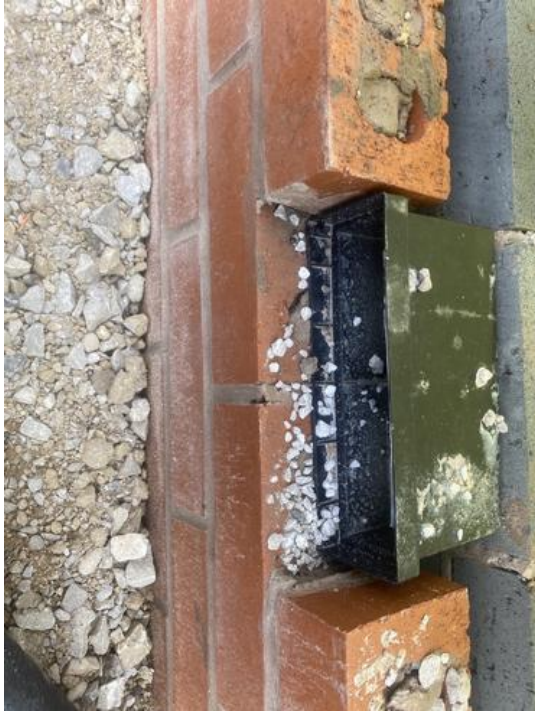
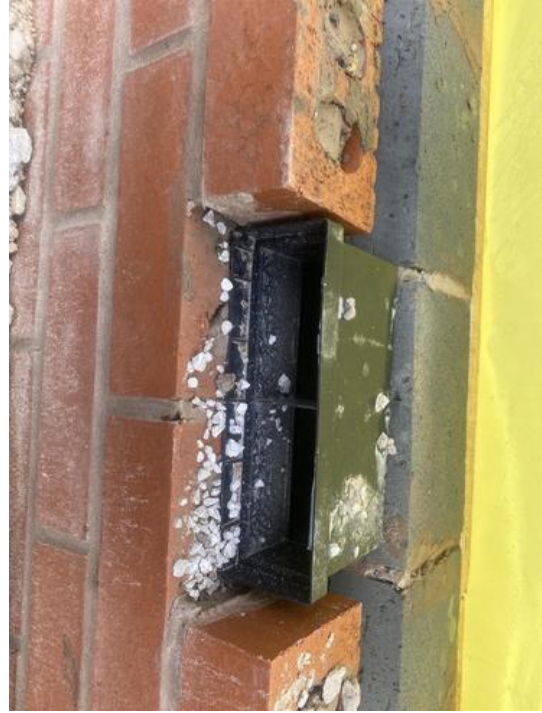
**External Wall Air bricks: Numbers, size. positions as design drawing? (Minimum of 3 walls)**

Pass
