## GAS MEMBRANE VALIDATION

| <b>Site Name: Belle Vue Stadium</b> | <b>Project Number: 12-123</b> |
| <b>Company Name: Countryside</b> | <b>Date: 15-02-2022</b> |

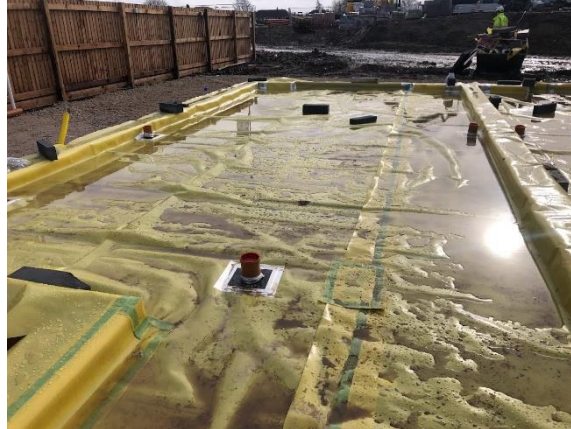
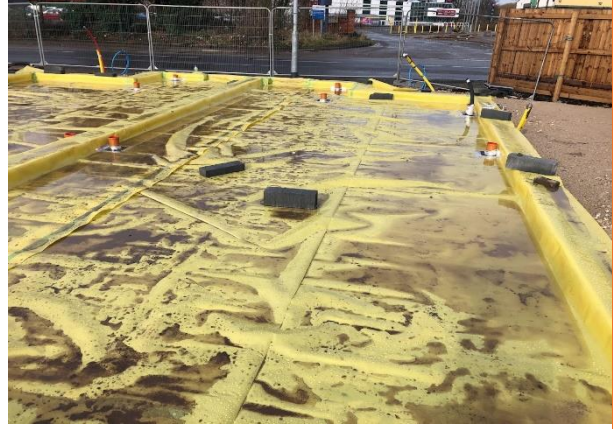
**Plot - 242**

**General Condition of Membrane-Good Condition**

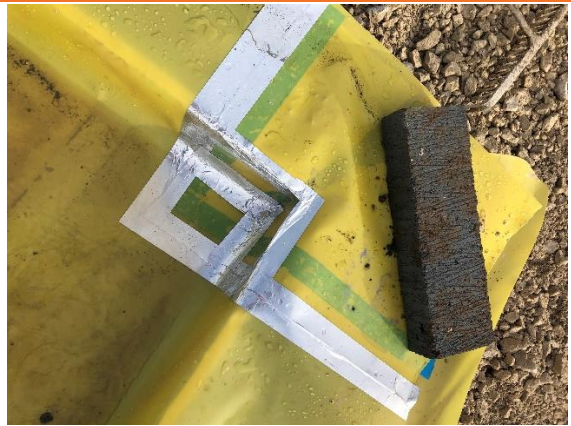
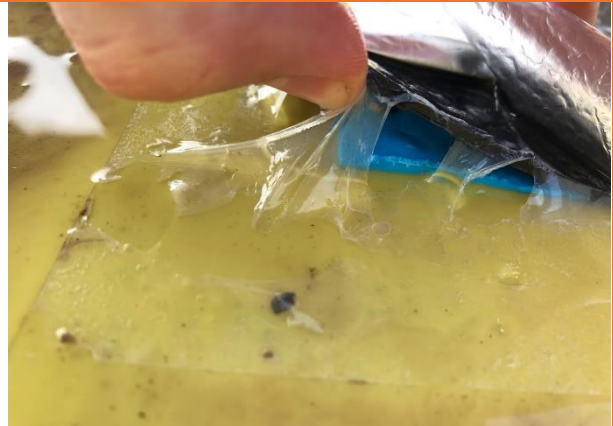
**Verification of Joints and Seals-Overlapped and sealed correctly**

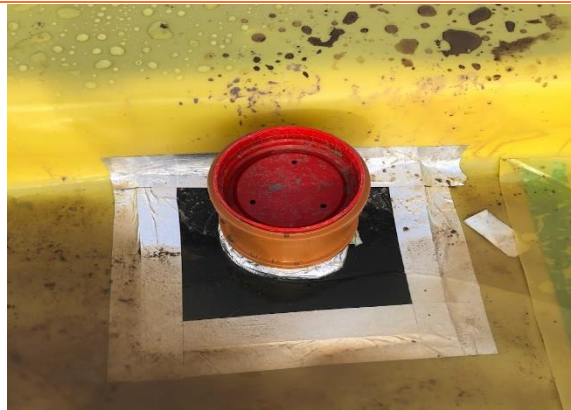
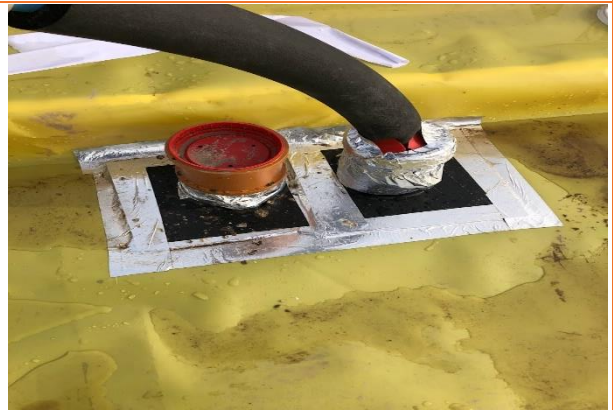
**Verification of Service Penetrations-Good Condition**

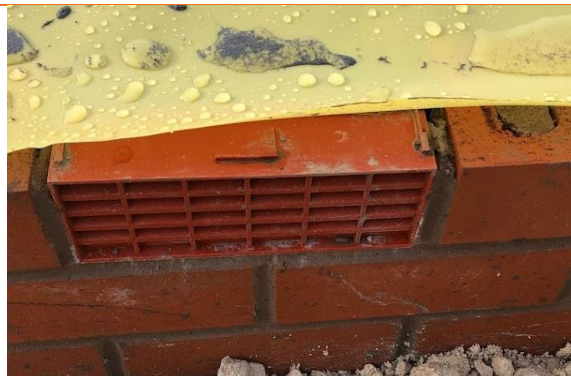
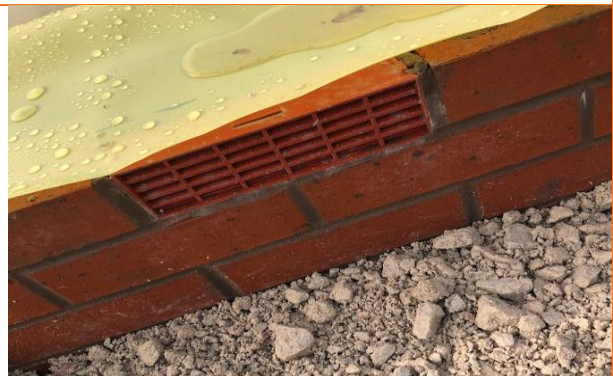
**Verification of Ventilation-Good Condition**

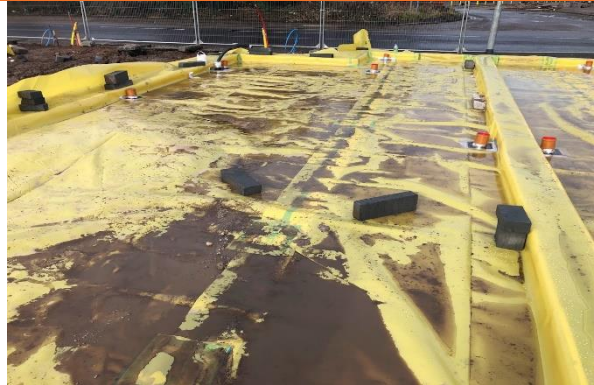
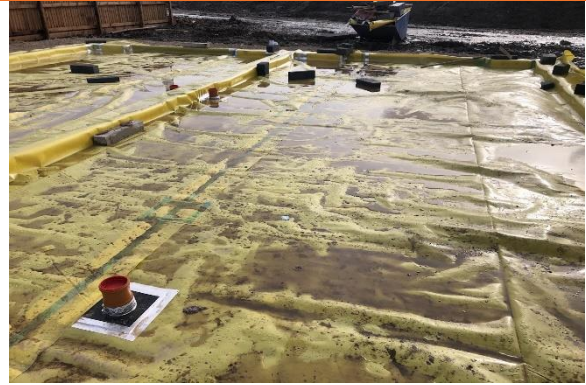
**Plot - 243**

**General Condition of Membrane-Good Condition**

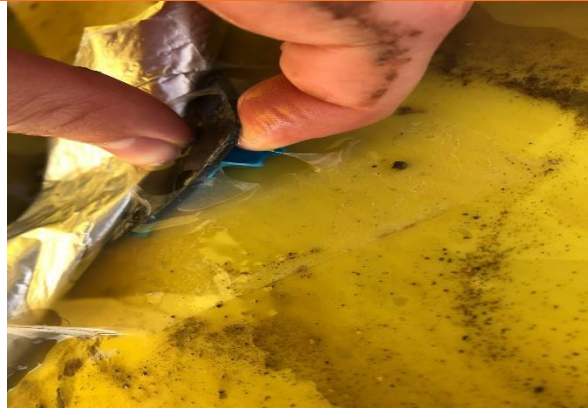
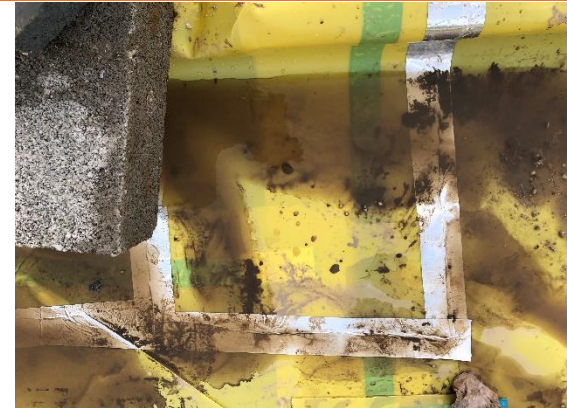
**Verification of Joints and Seals- Overlapped and sealed incorrectly**

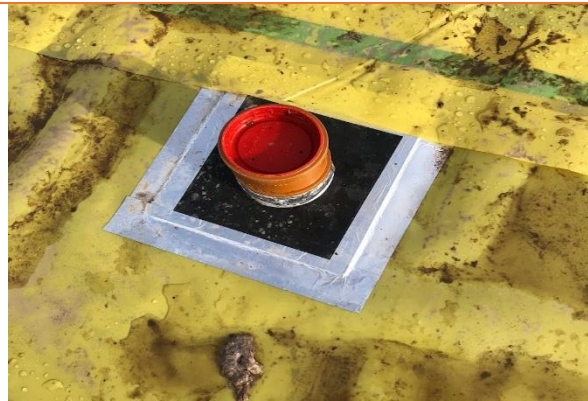
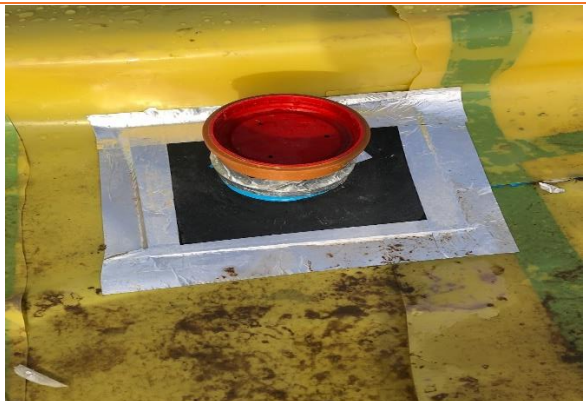
**Verification of Service Penetrations-Good Condition**

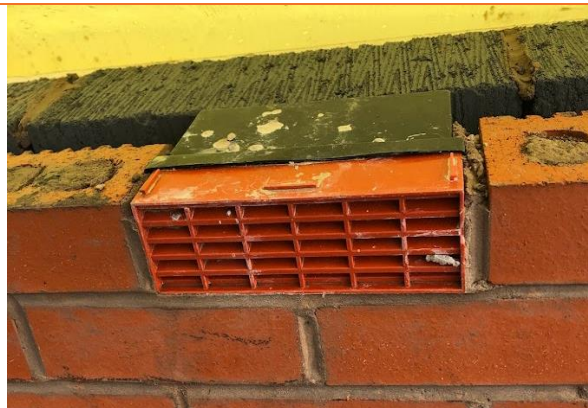
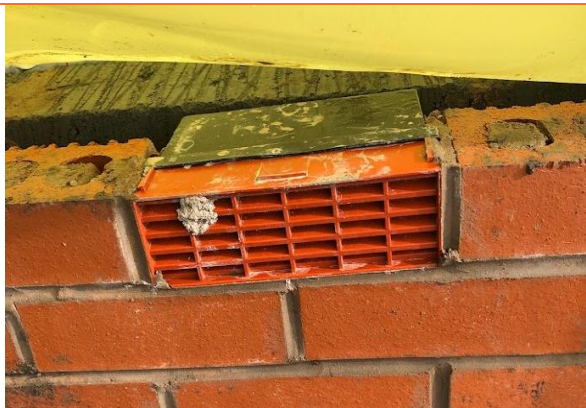
**Verification of Ventilation-Good Condition**
