## GAS MEMBRANE VALIDATION

| Site Name: Belle Vue Stadium | Project Number: 12-123 |
| Company Name: Countryside | Date: 22-06-2022 |

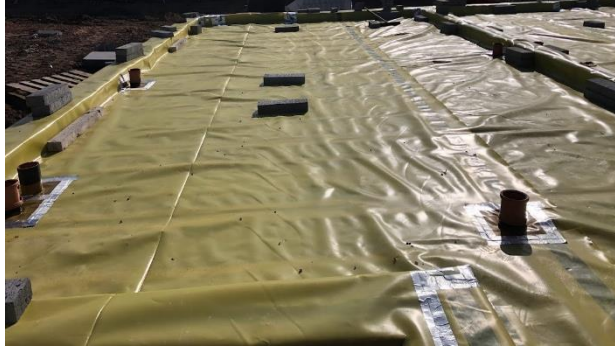
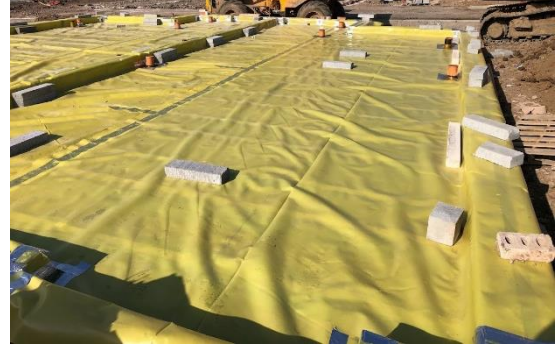
**General Condition of Membrane-Good Condition**

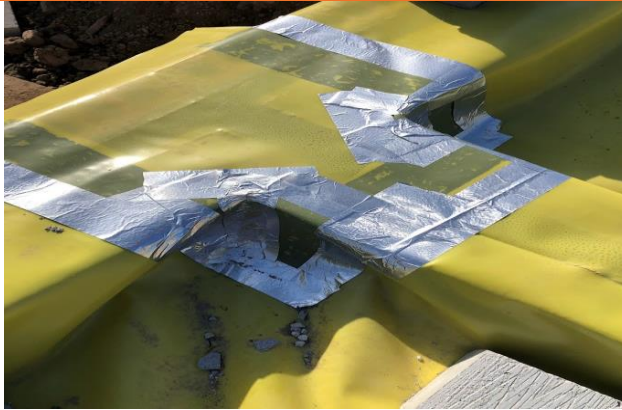
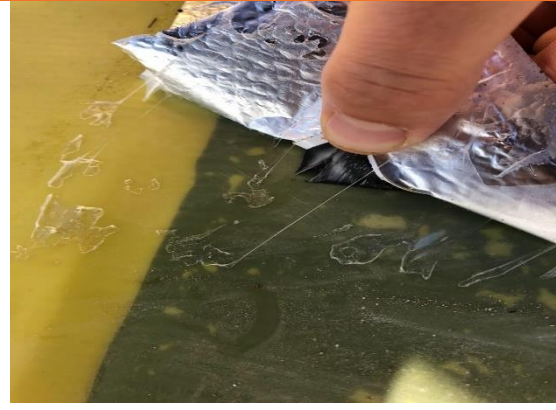
**Verification of Joints and Seals-Overlapped and sealed correctly**

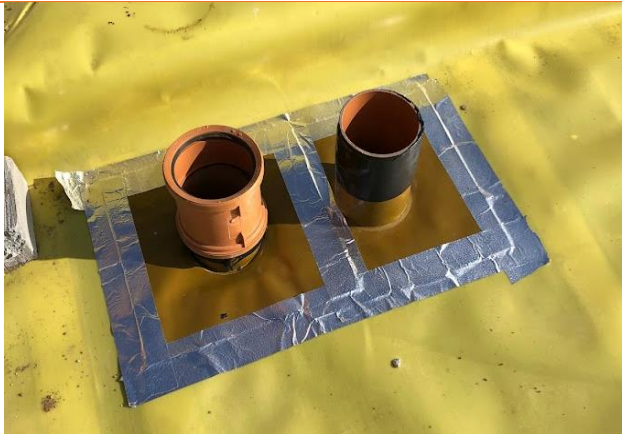
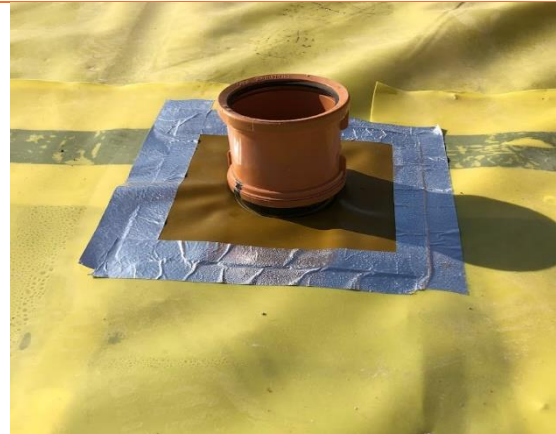
**Verification of Service Penetrations-Good Condition**

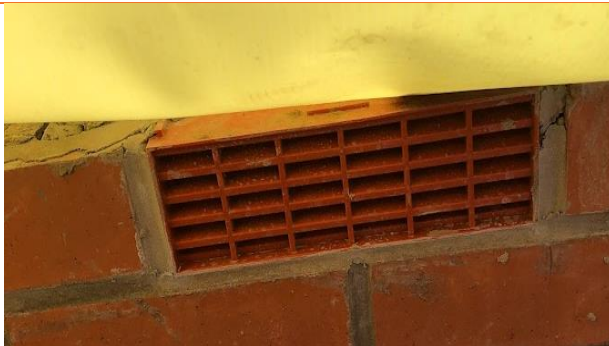
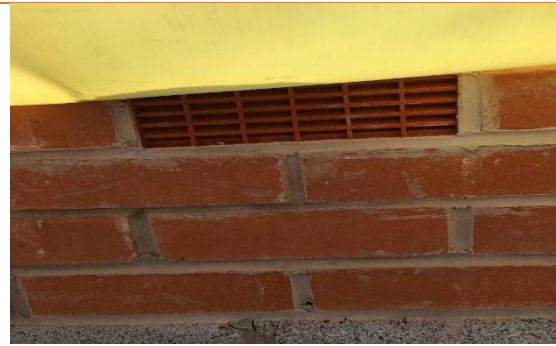
**Verification of Ventilation-Good Condition**

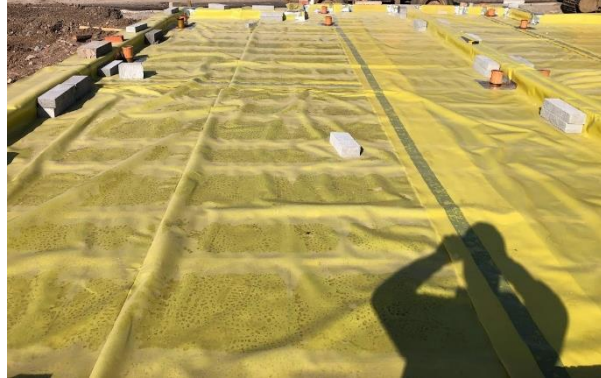
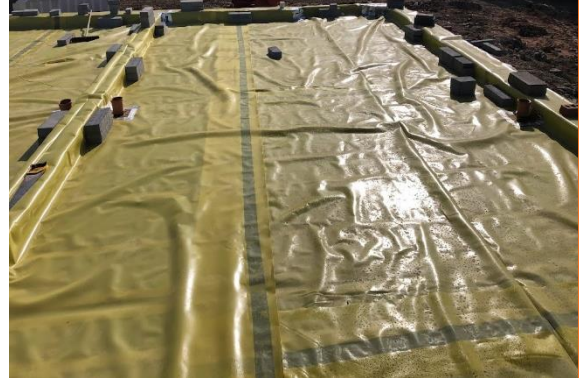
**General Condition of Membrane-Good Condition**

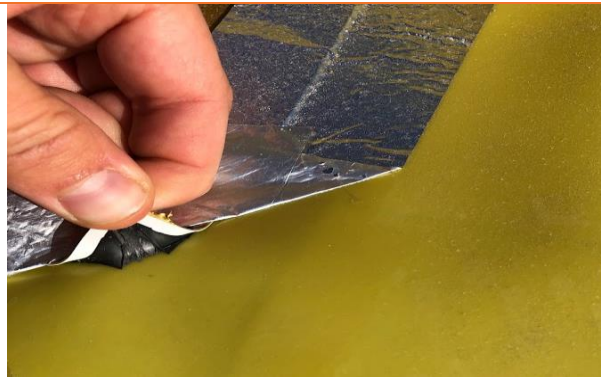
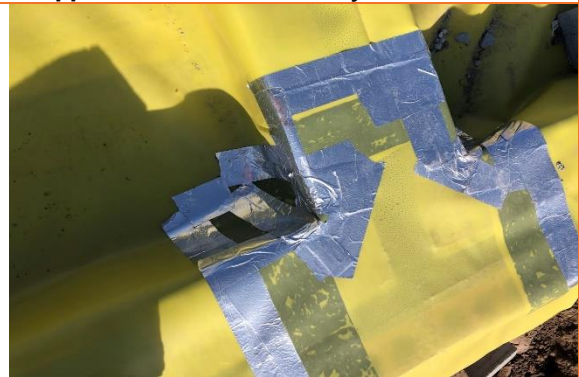
**Verification of Joints and Seals-Overlapped and sealed correctly**

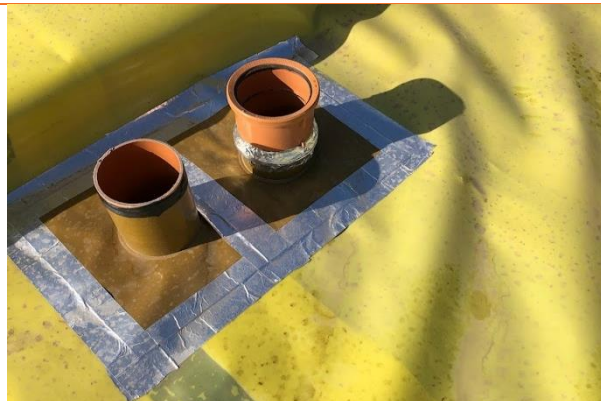
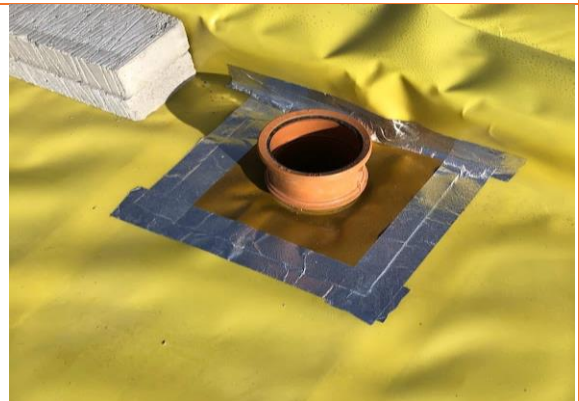
**Verification of Service Penetrations-Good Condition**

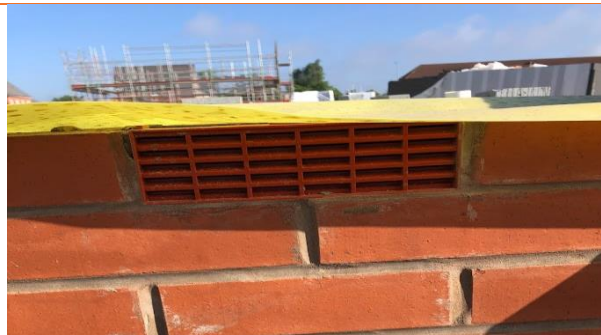
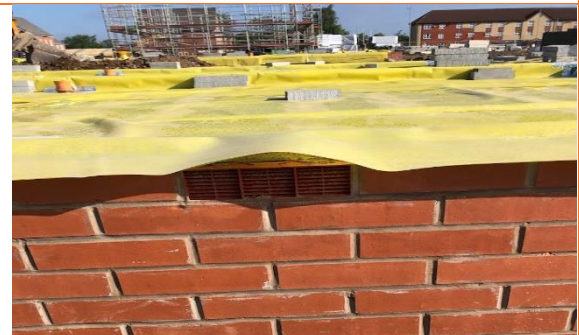
**Verification of Ventilation-Good Condition**
