## Structural Note

119 Palatine Road

16/10/2025

**2B Design Ltd**

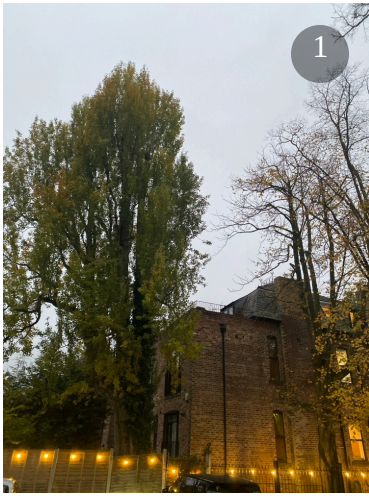
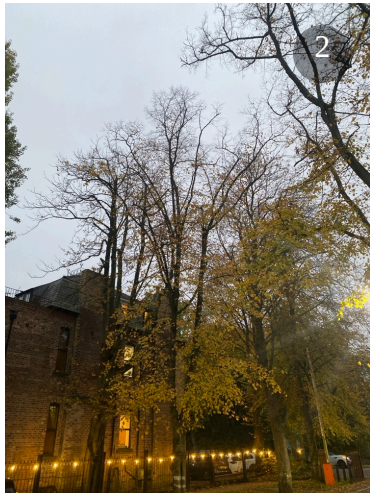
### Note 1

Several large trees along the party wall with two close to building.

It is recommended these two trees are removed and subsequent planting and vegetation growth is managed to prevent future damage to adjacent structures.

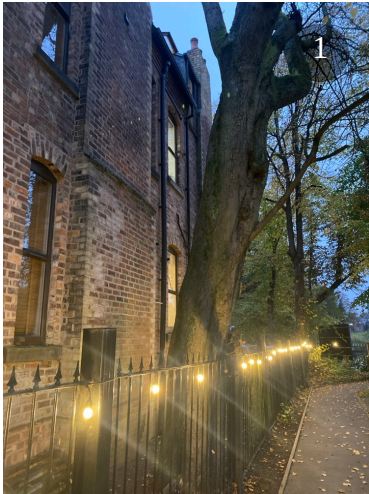
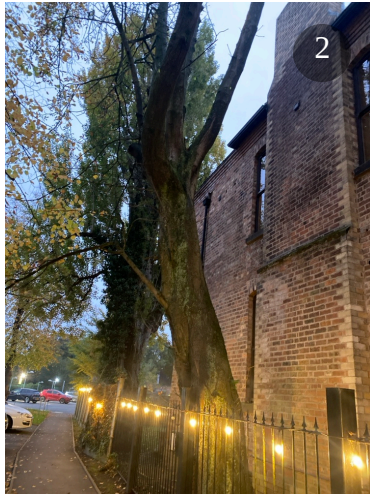
### Note 2

- The existing masonry has been repointed and patch repaired historically, however it appears in good overall condition.
- There are two large, mature trees close to the building. One is approximately 1m from the chimney stack on the façade facing the

adjacent car park; the other is approximately 2m from the rear corner of the building.

Large diameter tree approx 1m from chimney stack.

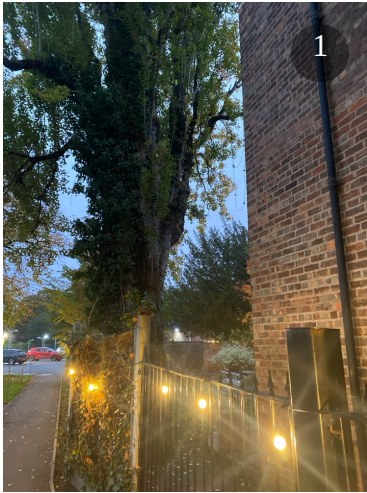
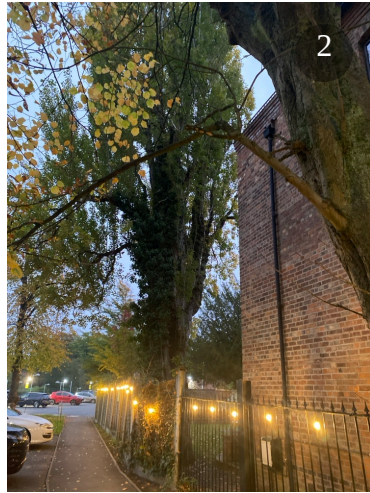
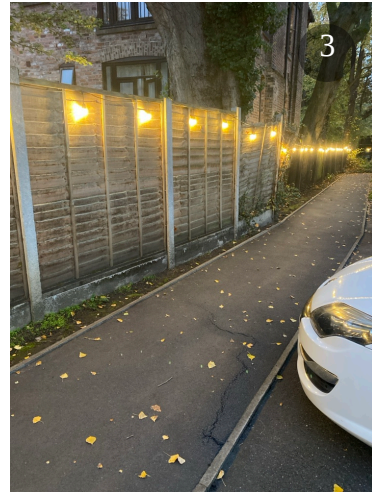
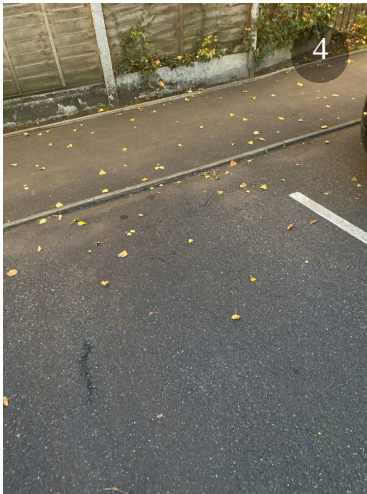
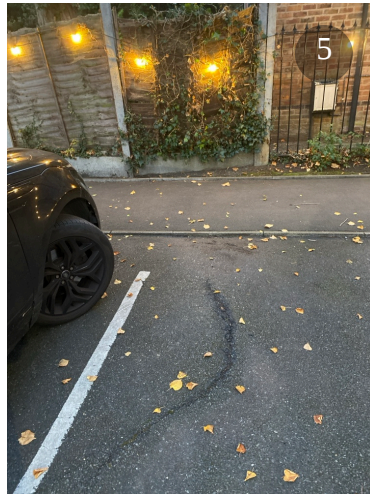
### Note 3

- There is a basement present which has likely provided resilience to damage from the adjacent trees.
- Root damage from these two trees can be seen in the car park where the surfacing has raised and fractured.

The property appears in fair condition and has been maintained and repaired externally. Damage to external surfacing has been caused by the two trees close to the building and it is likely that damage will be caused to the building itself if the trees are not appropriately managed.

Large diameter tree approximately 2m from building rear corner.  
Potential root damage in adjacent footway and parking area.

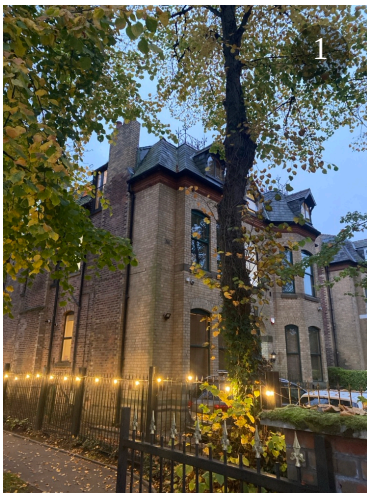
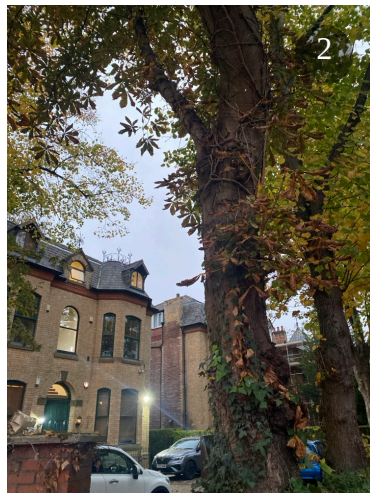
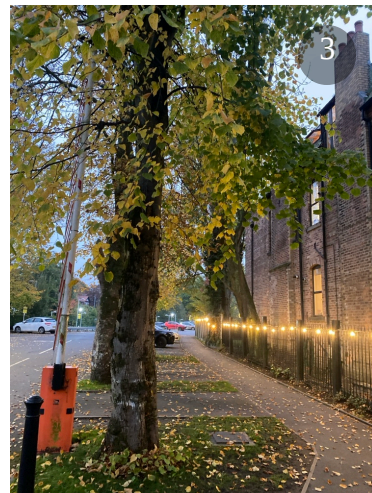
#### Note 4

Remaining trees at greater distance from building.

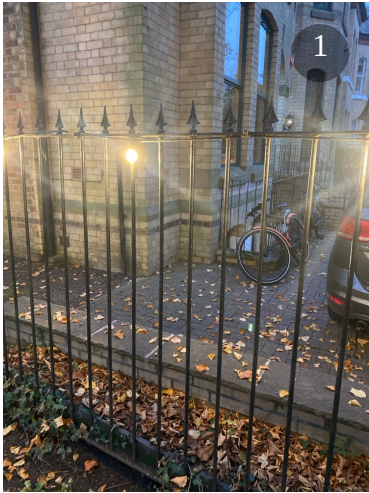
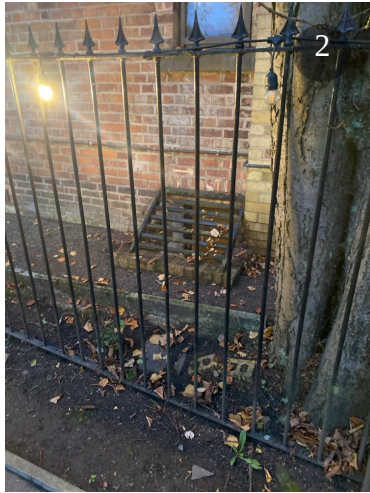
#### Note 5

Building has a basement level so existing foundations are deep.

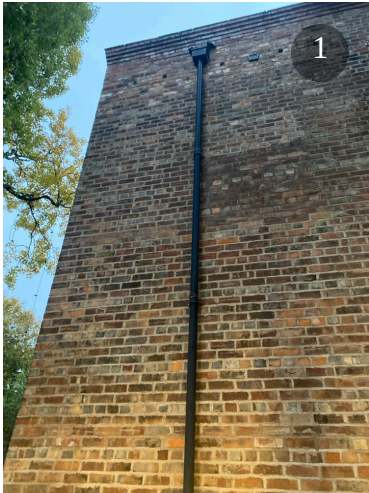
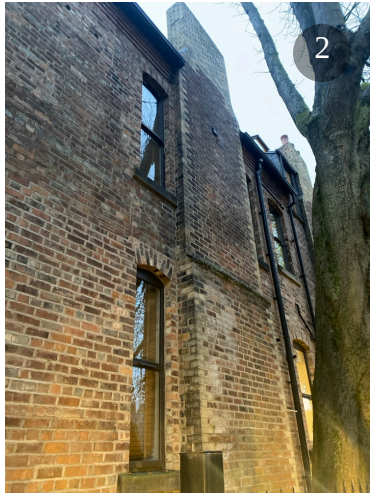
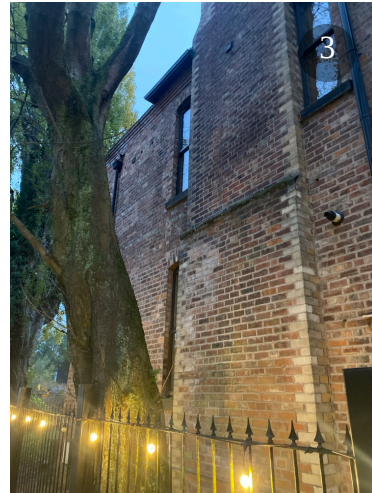
### Note 6

Brickwork has been repointed and patch repaired historically though looks in good general condition.
