10<sup>th</sup> November 2025

## **Brunswick Mill, Manchester - Heritage Methodology: Condition 7 – Repair works to interior and exterior masonry and stonework**

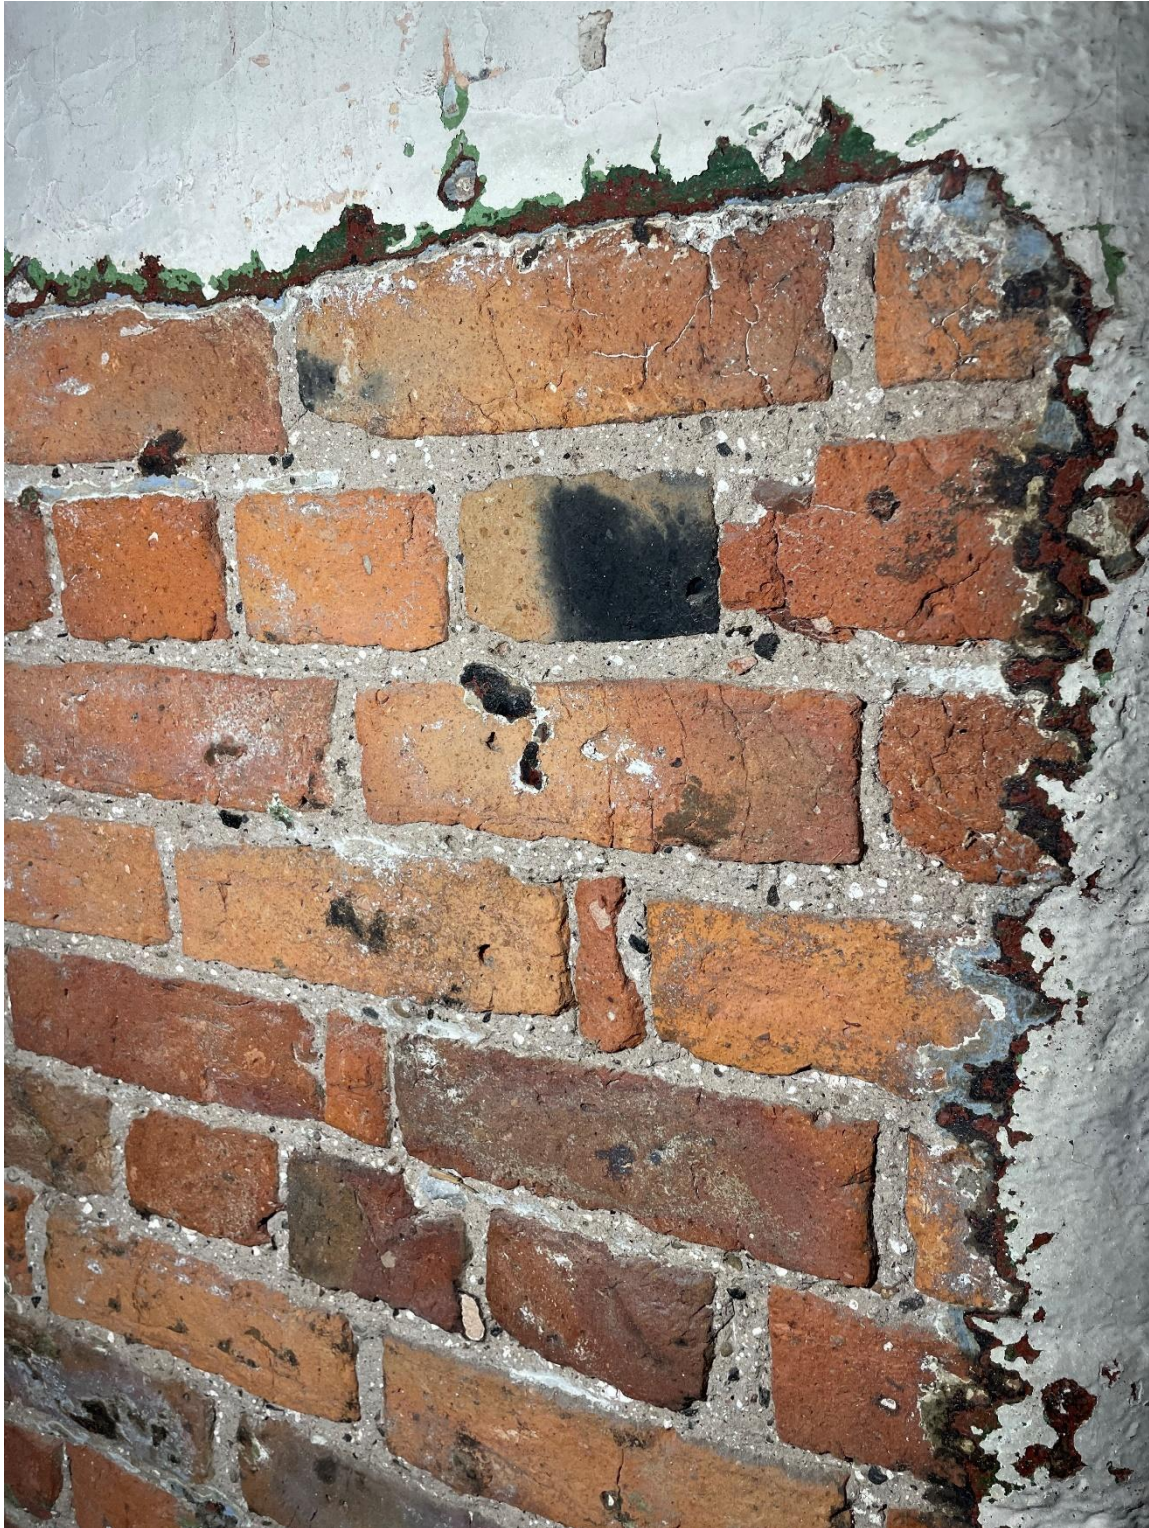
These trials successfully removed almost all paint layers from the internal brickwork and did not damage the face of the brick nor eat into the historic lime mortar, whilst allowing small particles of paint to remain within a number of gaps within the face of the brickwork.

*The resulting finish following the successful low-pressure shotblasting machine fitted with fine glass media process, which removed paint layers but retained small pockets of paint in undulations within the brick. This process did not damage the face of the brick nor the original lime mortar.*

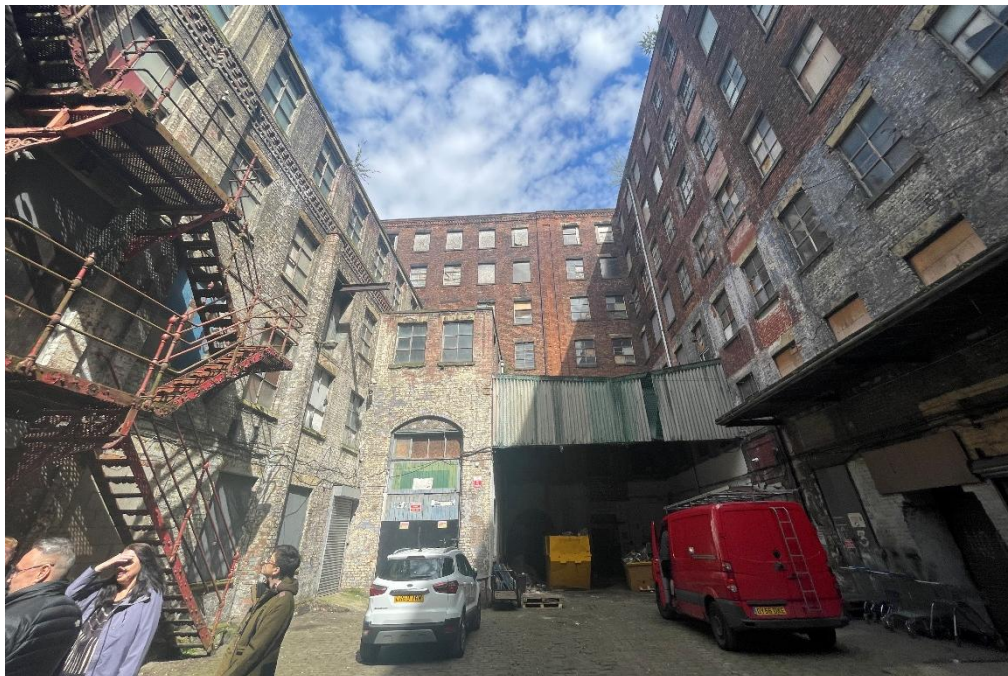
*Looking north across the central courtyard, illustrating the lower levels of the exterior masonry that requires paint removal.*

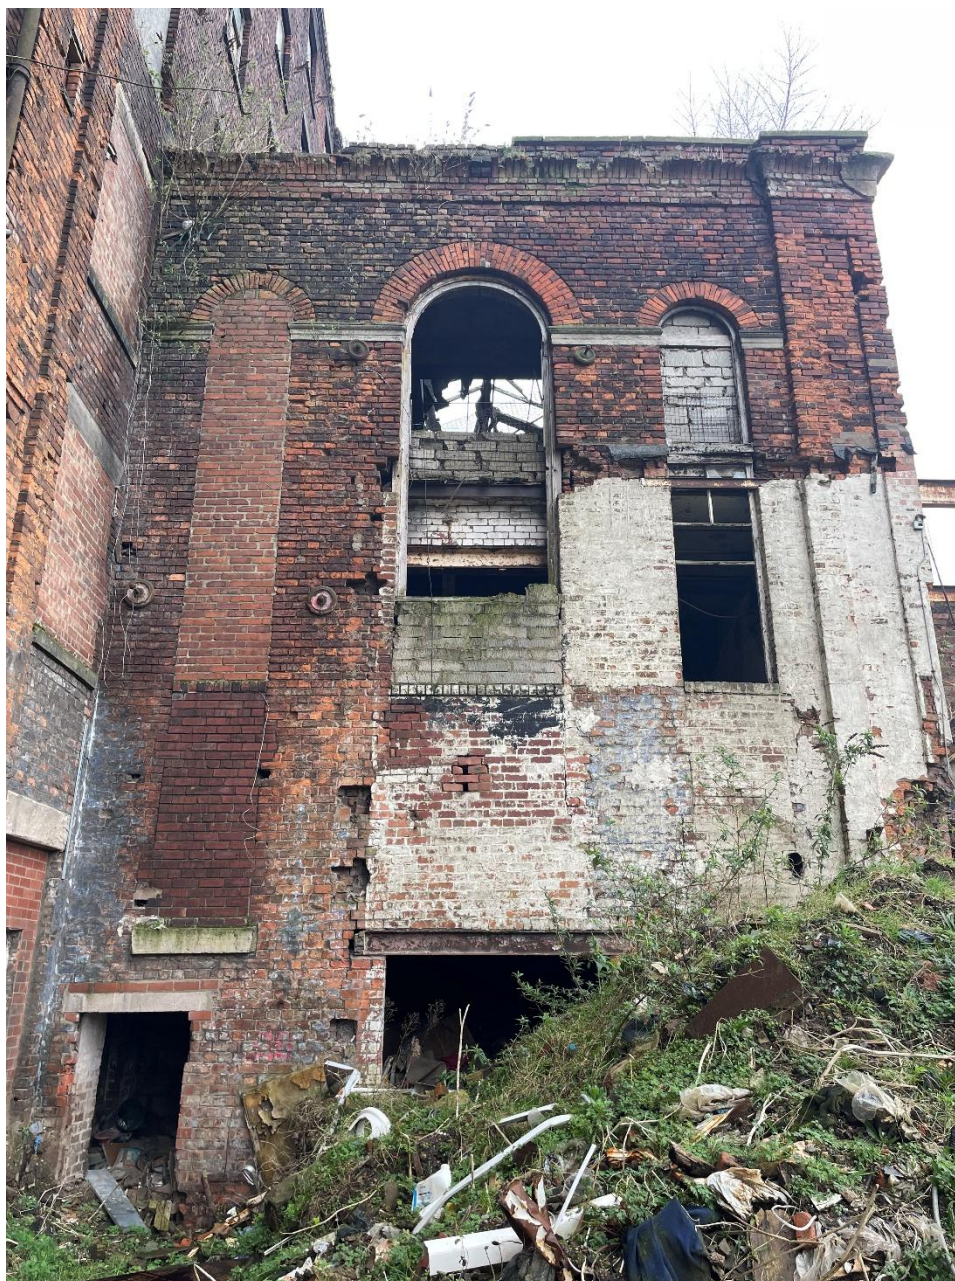
*The north elevation of the engine house, illustrating the lower levels of the exterior masonry that requires paint removal to the north-west corner.*

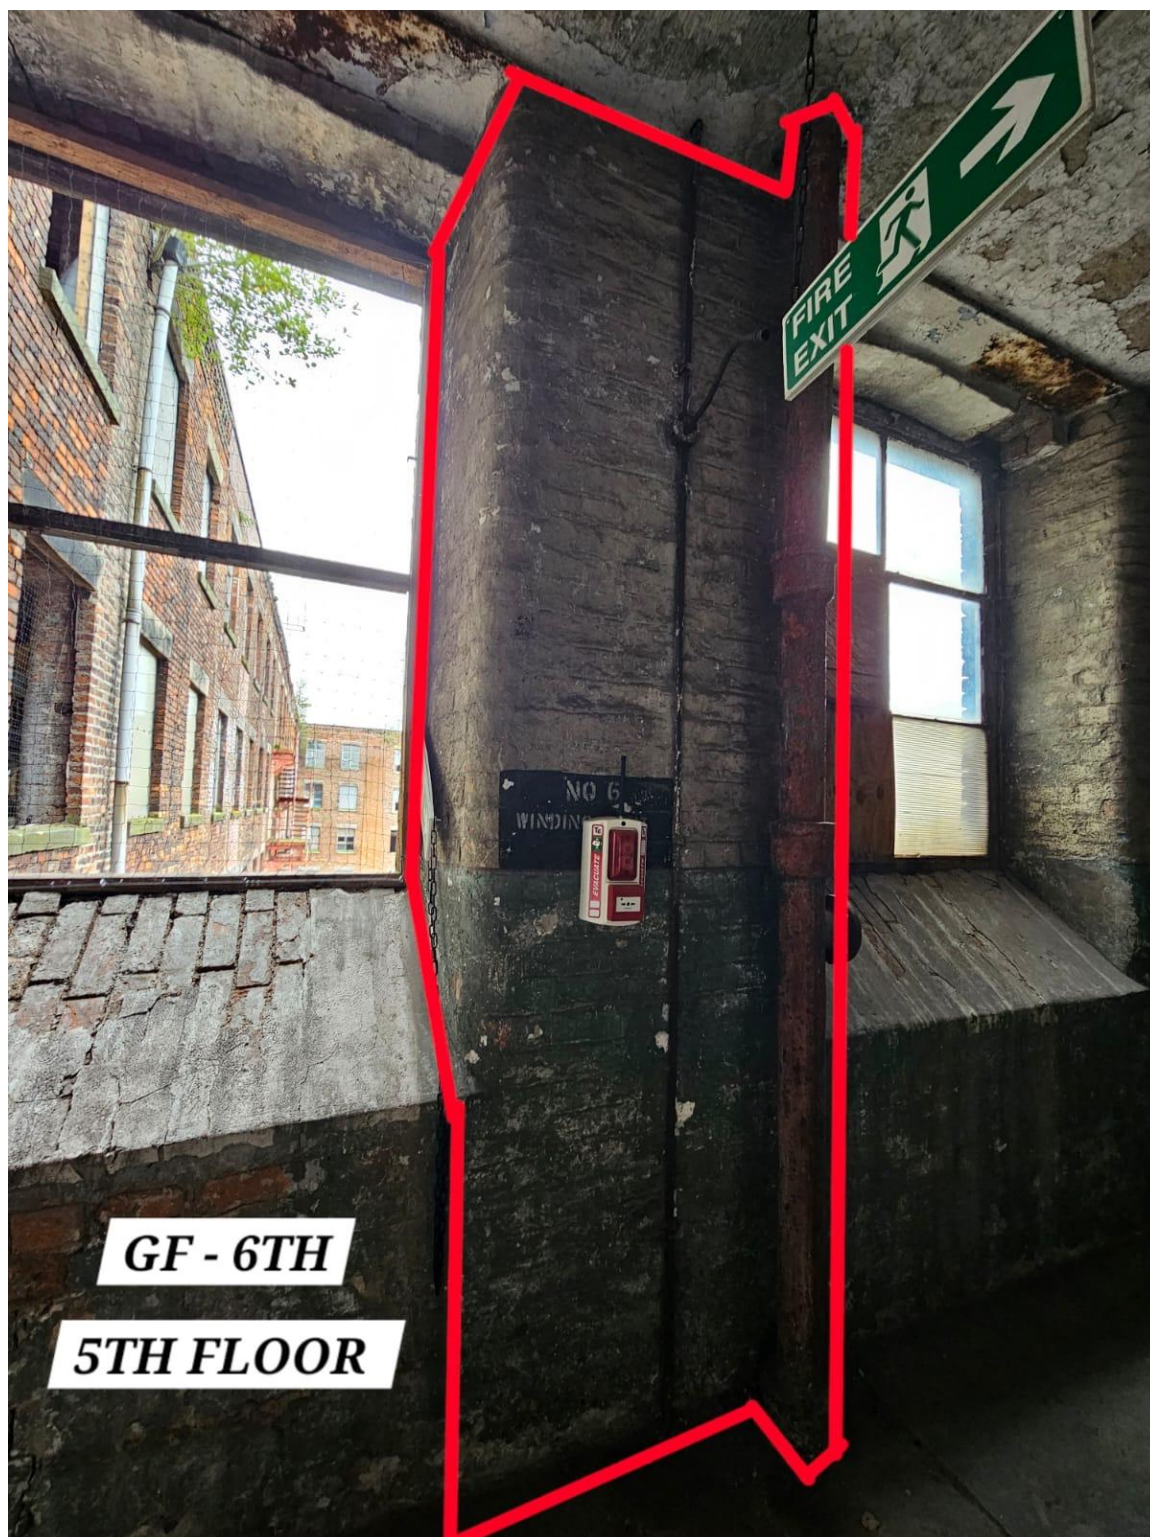
*East staircase - 5th floor. Early 20th century painted floor level sign for “No 7 Spinning Dept”. The red outline denotes the extent of paint retention, which includes the pier from floor to ceiling, both returning reveals to either side, and the late-Victorian/Edwardian vertical red fire sprinkler pipe.*

In order to create a crisp line between the retained paintwork and the grit-blasted brickwork, timber boards should be secured to the walls/sills to create a straight and crisp line that will protect the paintwork from the grit-blasting procedure. It is likely this will largely concentrate on the junction between window reveal and window sill, so boarding can be wedged in place within the width of the reveal to avoid the need for fixings into the brickwork.

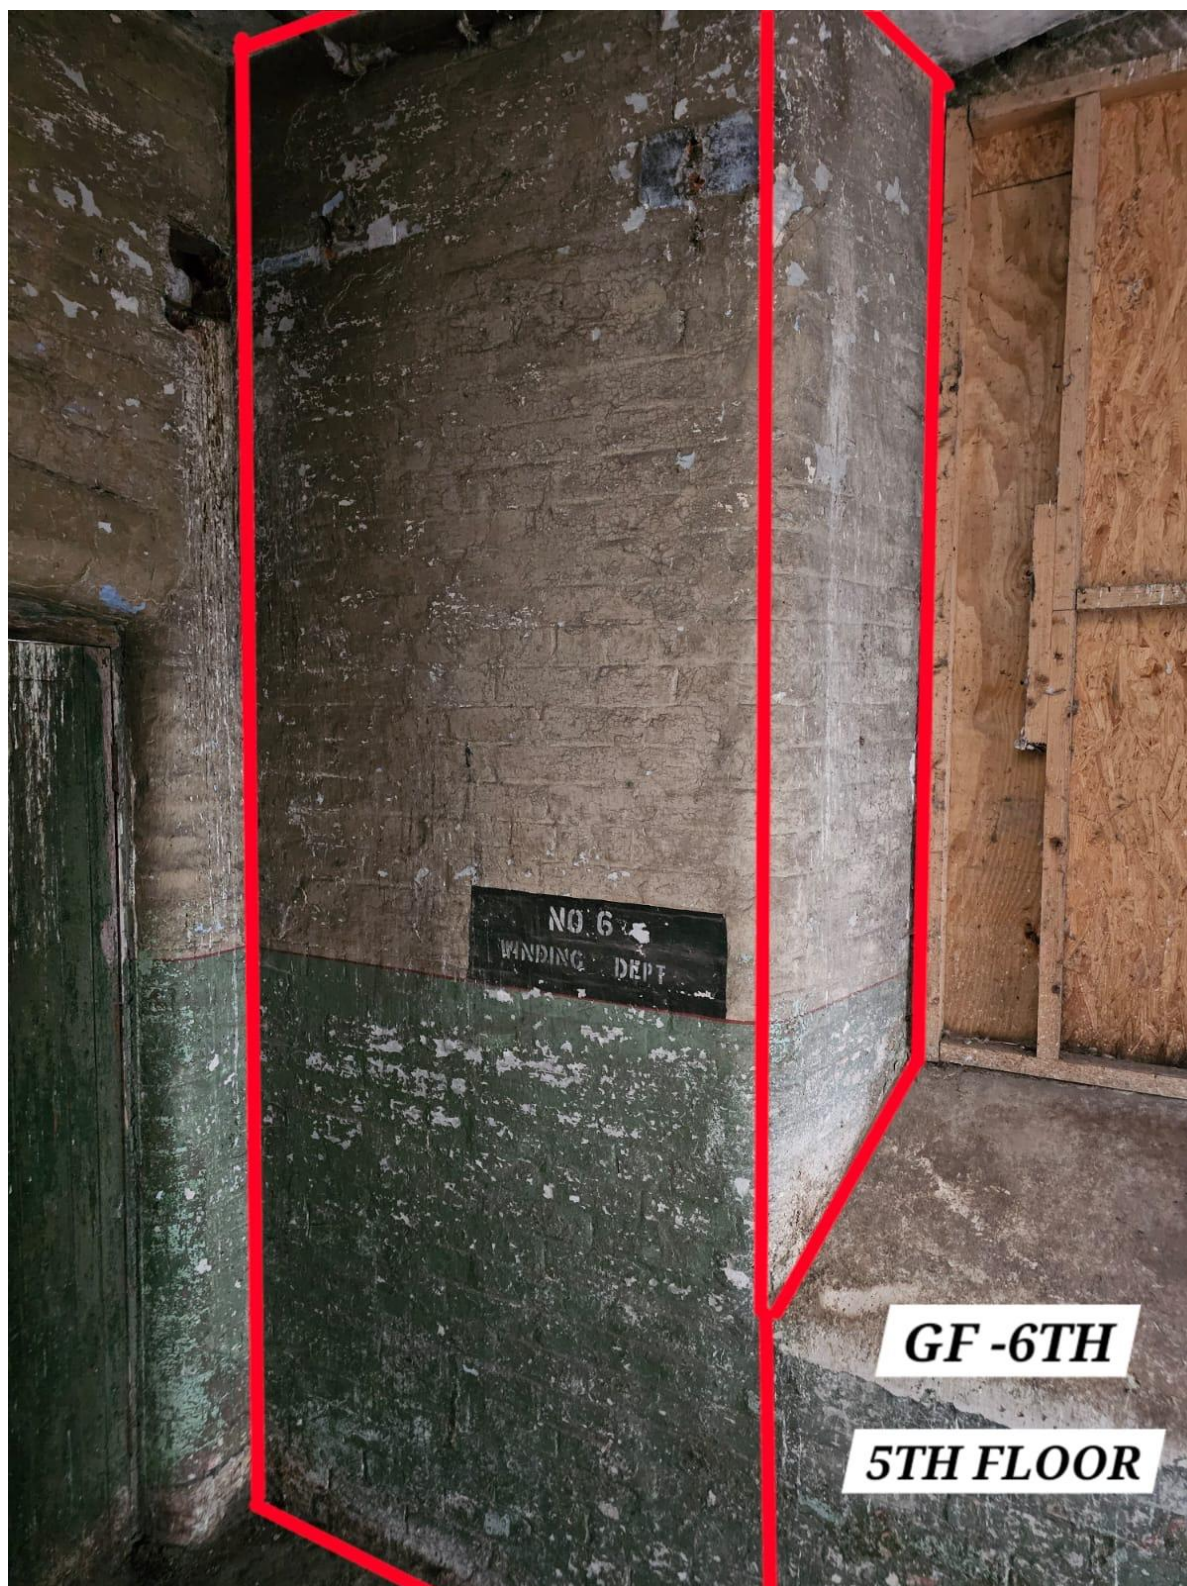
*West staircase - 5th floor. Early 20th century painted floor level sign for “No 6 Winding Dept”. The red outline denotes the extent of paint retention, which includes the pier from floor to ceiling and returning reveal to the window side.*

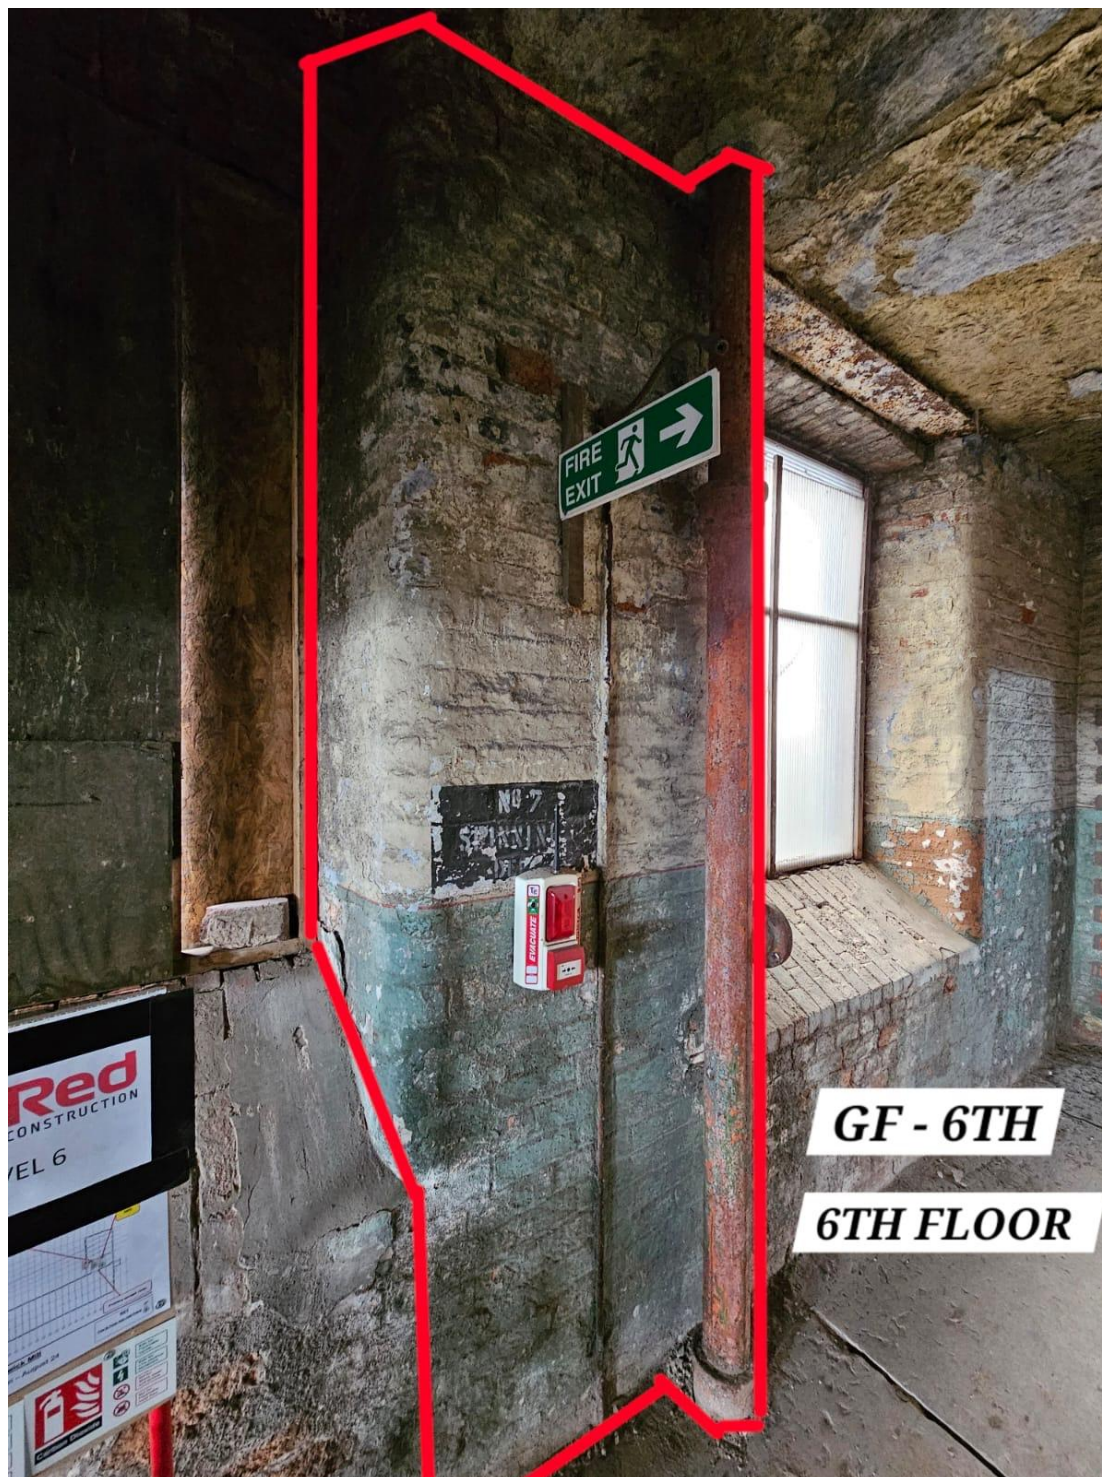
*East staircase - 6th floor. Early 20th century painted floor level sign for "No 7 Spinning Dept". The red outline denotes the extent of paint retention, which includes the pier from floor to ceiling, both returning reveals to either side, and the late-Victorian/Edwardian vertical red fire sprinkler pipe.*

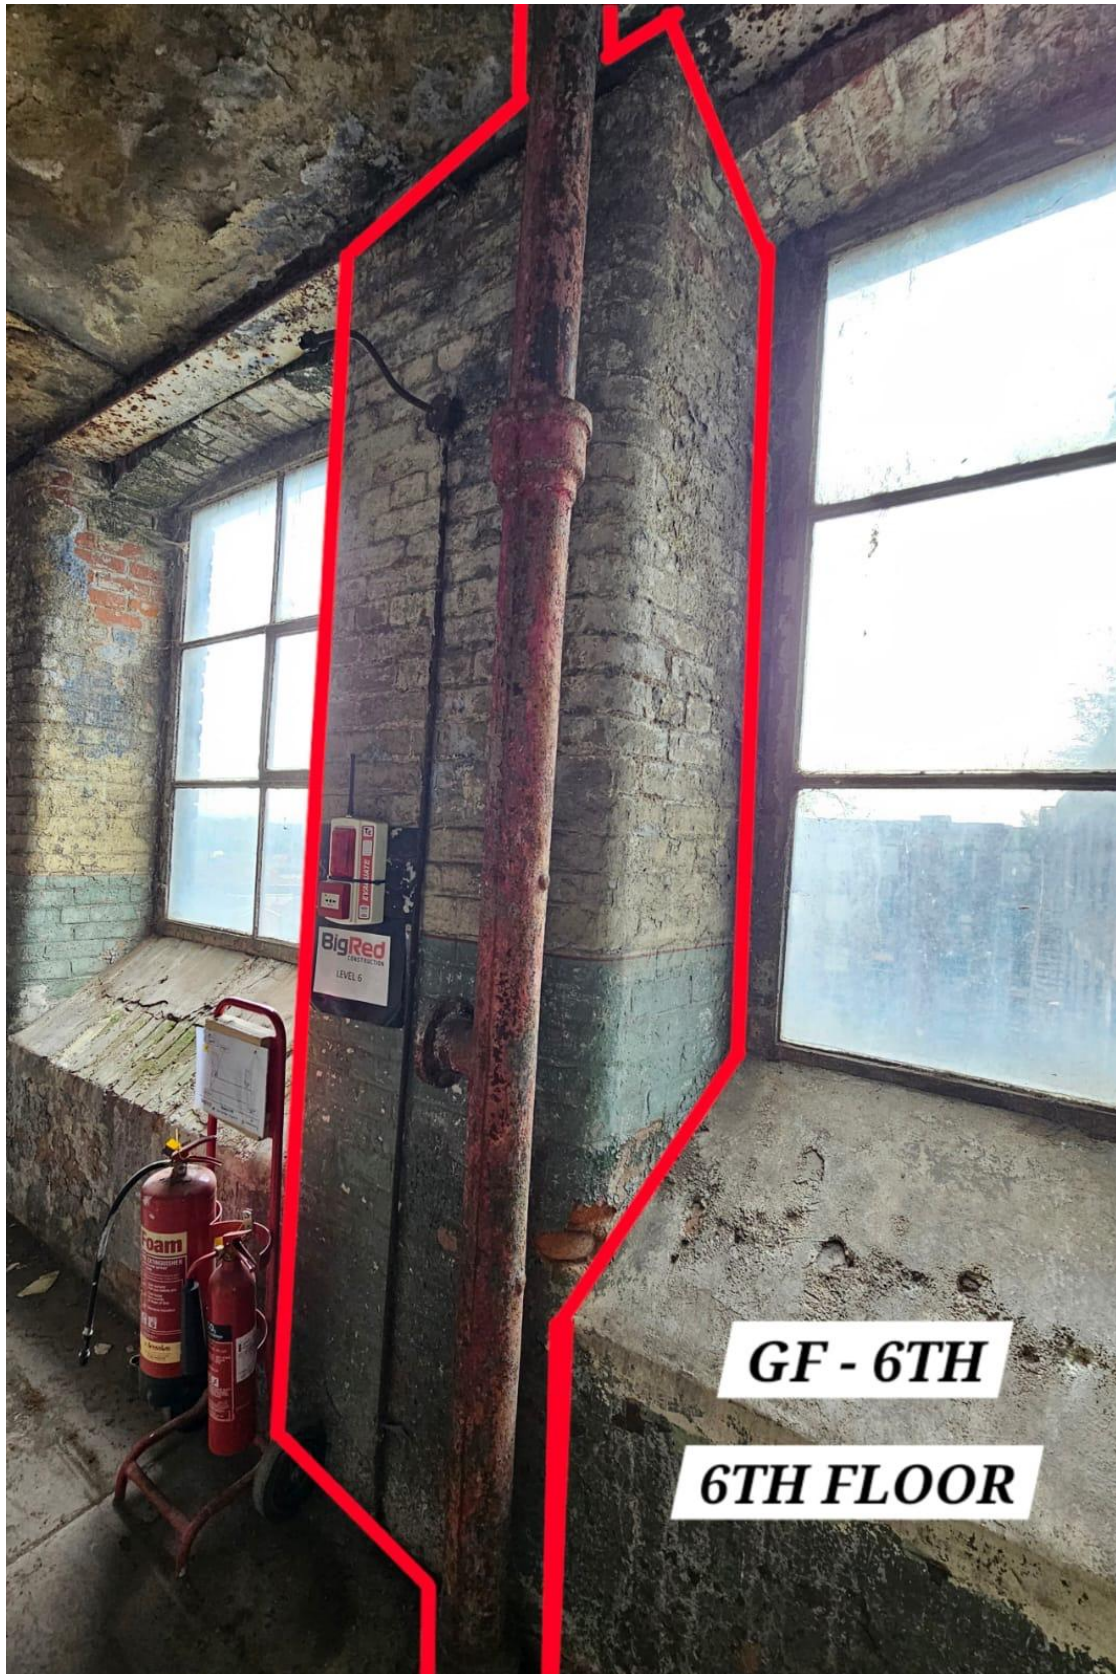
*West staircase - 6th floor. Early 20th century painted floor level sign for “No 7 Spinning Dept”. The red outline denotes the extent of paint retention, which includes the pier from floor to ceiling, both returning reveals to either side, and the late-Victorian/Edwardian vertical red fire sprinkler pipe.*

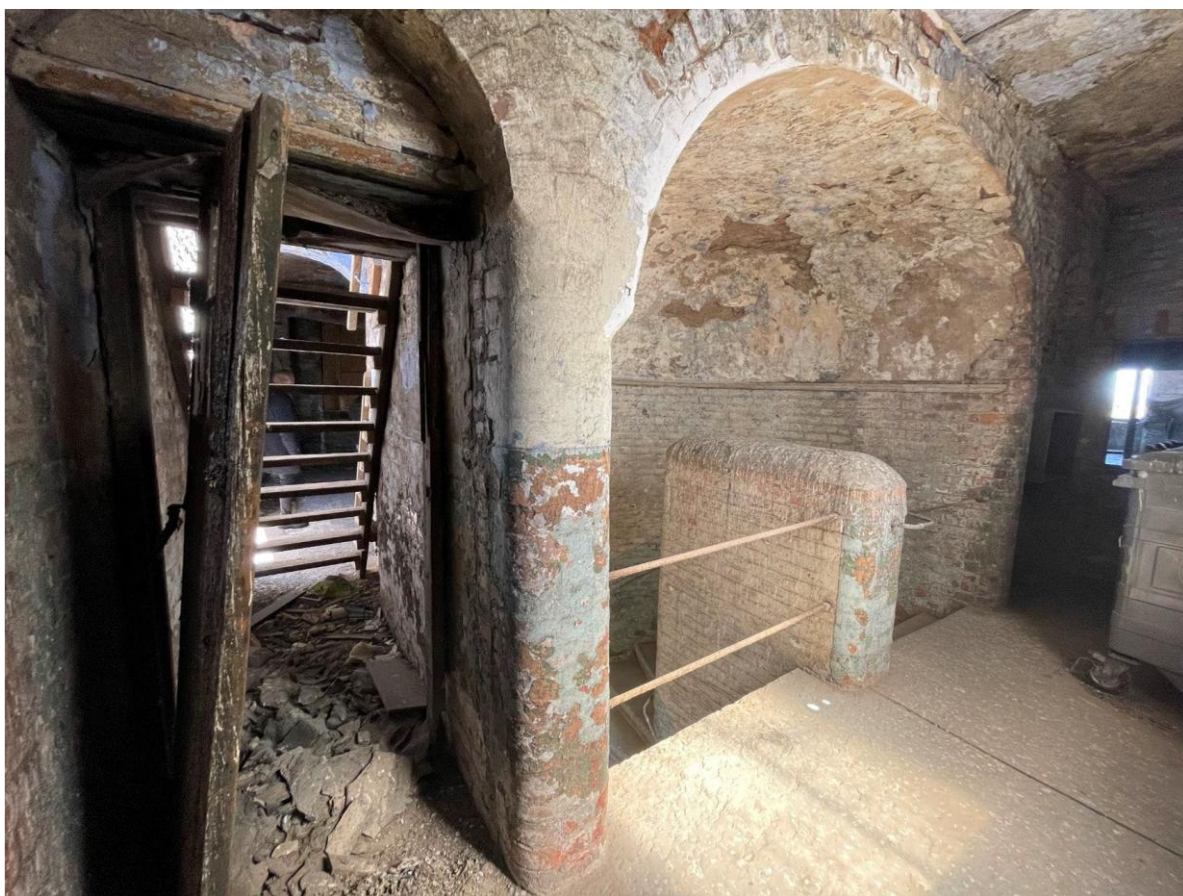
*The landing of the east staircase at 6<sup>th</sup> floor level, showing the original plastered domed ceiling of the staircase, which will be retained as part of the paint removal process.*

The two final areas of retention concentrate on areas of original lime plaster to the domed ceilings of the east and west staircases (at 6<sup>th</sup> floor level), which will be repaired/replastered as part of the consented scheme.

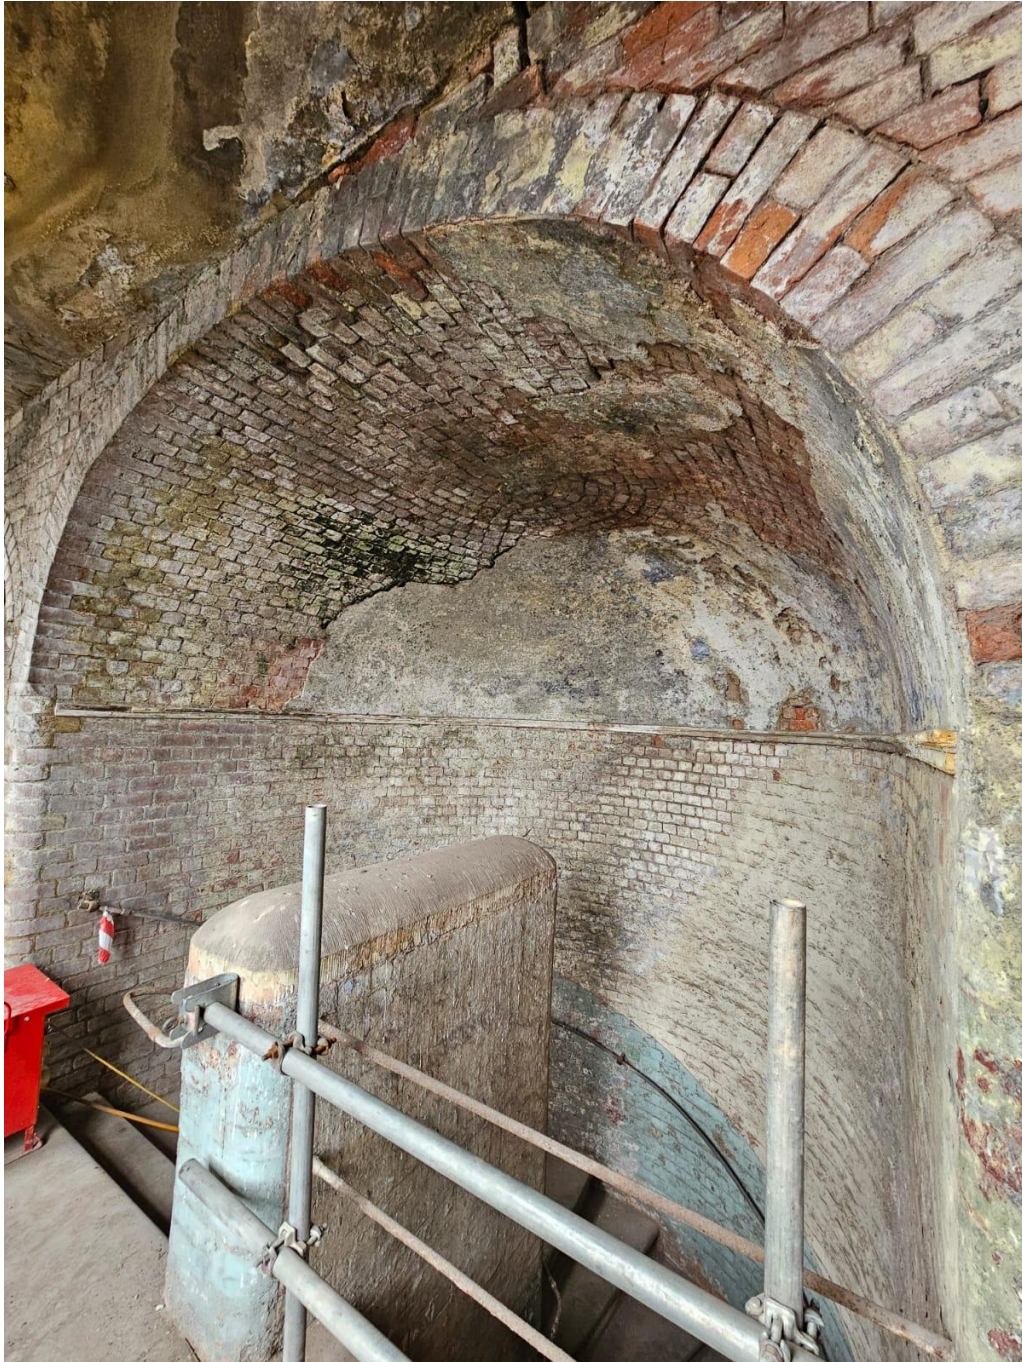
*The landing of the west staircase at 6<sup>th</sup> floor level, showing the remains of the original plastered domed ceiling of the staircase, which will be retained as part of the paint removal process.*
