# CIS Tower- Manchester

## Condition Survey of the William Mitchell Mural

September 2019

## Condition Survey of the Barry Daniels Mural

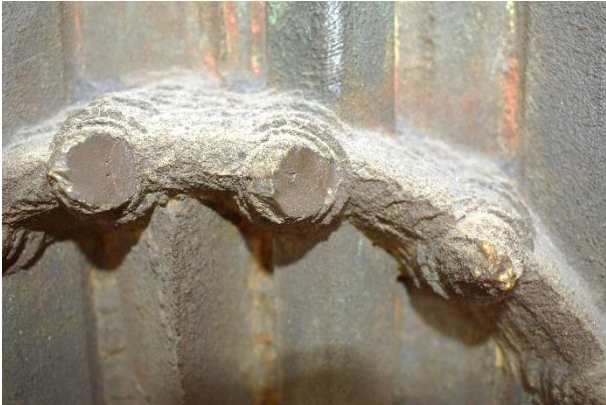
| Description | Photograph |
|---|---|
| <p><b>Physical Damage</b> – protruding elements of the mural panel especially at low level have been broken away as a result of physical impacts. Photo shown 2No pointed elements which have been broken away from the main panel.</p> | |

**Recommendation 2** - The damaged resin areas of the panels should be repaired to reinstate the original surface profile of the panels. Repairs should be carried out in a matching polyester repair material. Repairs should be colour matched with acrylic paint to blend in with existing finishes.

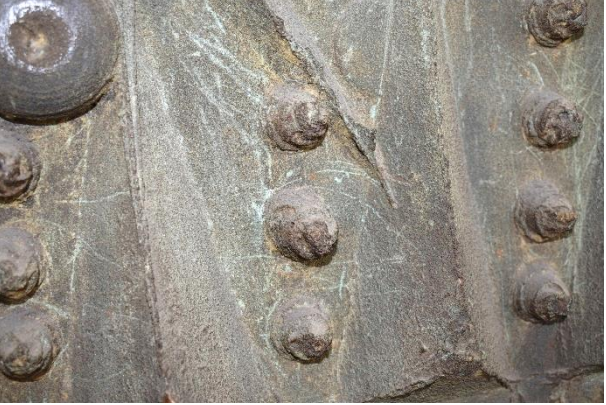
| Description | Photograph |
|---|---|
| <p><b>Surface Scratches</b> – in areas of the panels there are scratches within the surface finishes of the mural panels. These may be the result of resting materials regularly or during refurbishment activities on the surface of the mural.</p> | |

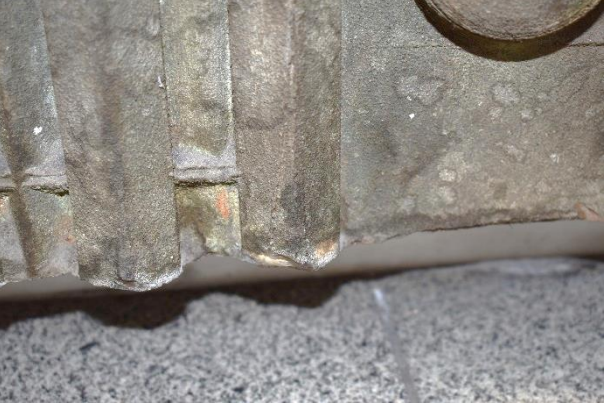
| Description | Photograph |
|---|---|
| <p><b>Water Staining</b> – at floor level there is considerable dirt build-up and evidence of water marking of the mural from floor cleaning operations.</p> | |

**Recommendation 1** - The panels should be cleaned to remove dirt and debris that has built-up on the surface of the panels. Cleaning should initially be undertaken by vacuum cleaner and soft brushes to agitate loose material. Water stained areas will require additional cleaning and trials should be undertaken with lint free cloths with 5% non-ionic detergent on these more stubborn areas.

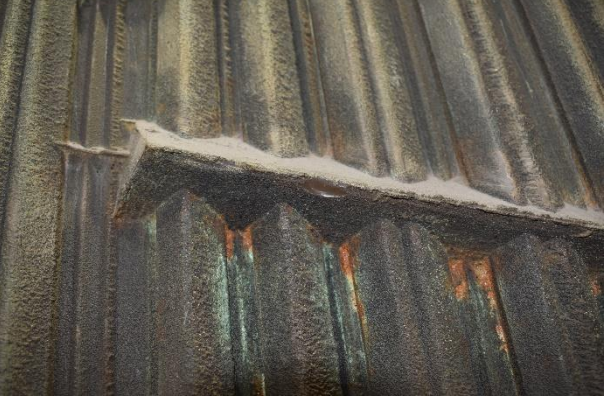
| Description | Photograph |
|---|---|
| <p><b>Dust / Dirt Build-up</b> – over the whole mural there is considerable dust and dirt build-up especially on projecting surfaces.</p> | |

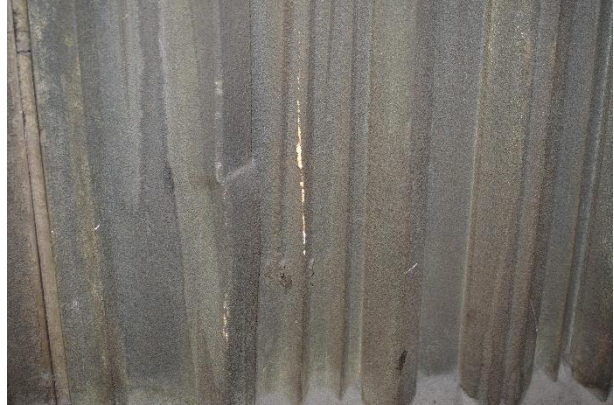
**Paint splashes** – in areas there is evidence of paint splashes and spotting from adjacent decoration works.

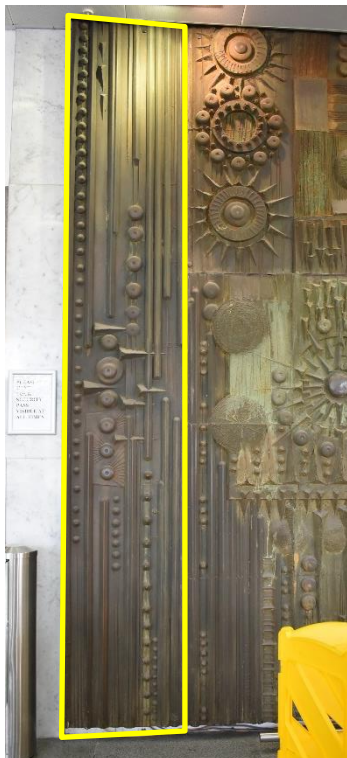
### 5.1 Panel Ref A (Size 3,870mm high x 590mm wide)

Panel A is secured to the main wall with 2 No coach screws – although additional hidden fixings may be present if this was the first panel section to be fitted to the wall.

The panel is in a sound condition however has a considerable build-up of dust and dirt especially on the projecting surfaces. At the base the GRP corner has become chipped possibly whilst cleaning the floor and water staining is present. There are two minor defects present in the GRP and some blue paint is present from adjacent decoration works.

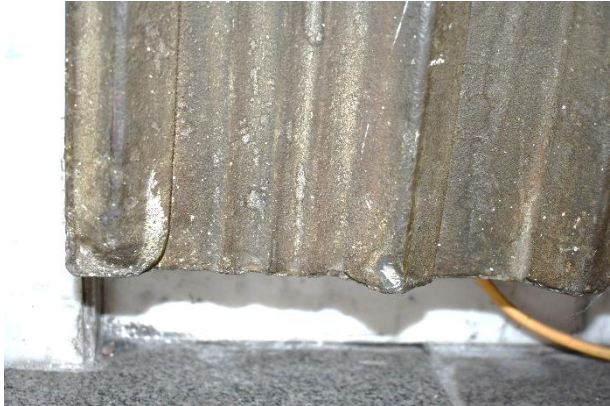
| Description | Photograph |
|---|---|
| <p>Minor damage to the bottom of the GRP panel at the corner together with dirt / marking from cleaning operations.</p> | |

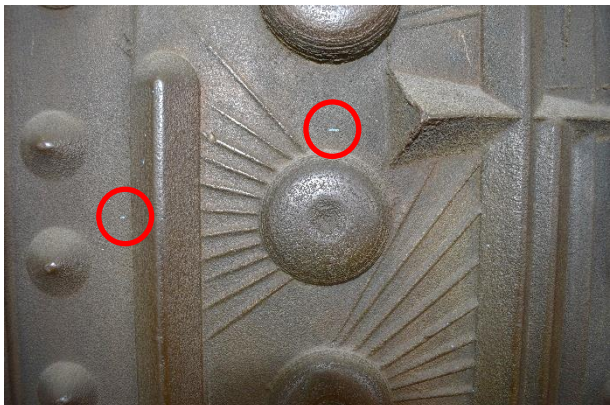
| Description | Photograph |
|---|---|
| <p>Minor spots of blue paint on the surface of the panel.</p> | |

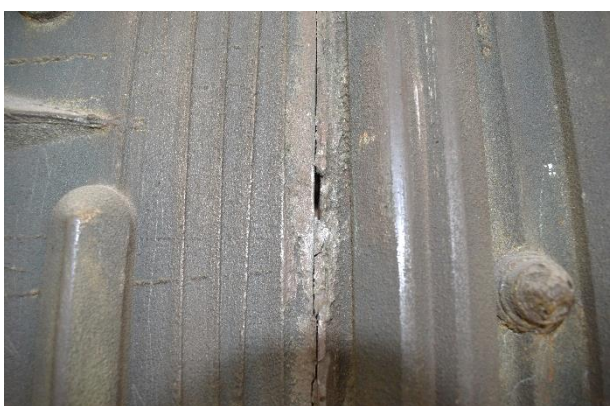
| Description | Photograph |
|---|---|
| <p>Minor loss of filler material between adjacent panels.</p> | |

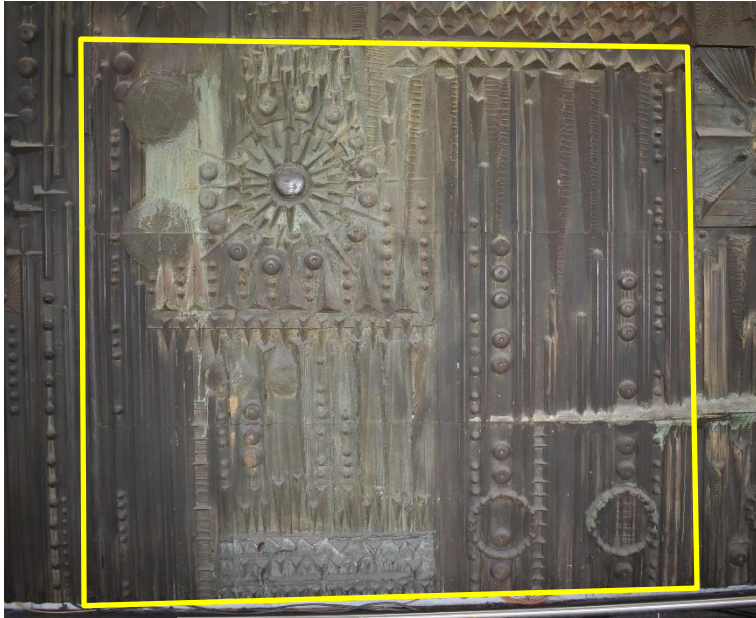
### 5.1 Panel Ref B (Size 2,220mm high x 2,440mm wide)

Panel B is secured to the main wall with 5No coach screws.

The panel is in a sound condition however has a considerable build-up of dust and dirt on the surface finishes. At its base the GRP is very dirty and water staining is present. There are a number of areas of minor damage to the GRP as noted below.

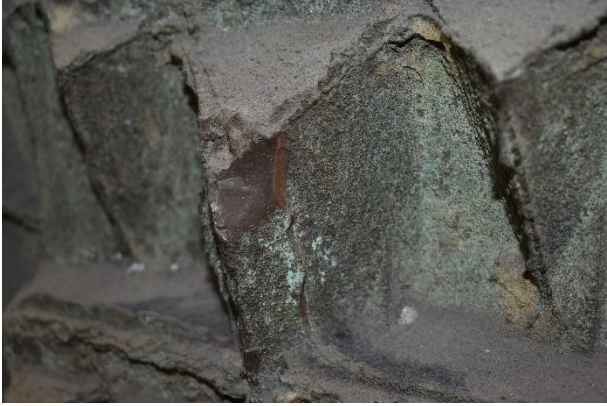
| Ditto. | |

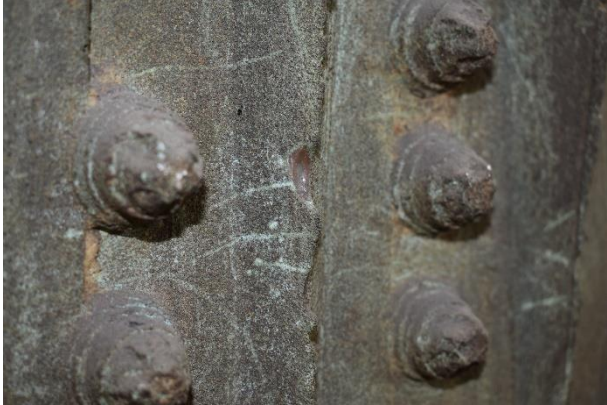
| Surface scratches to GRP. | |

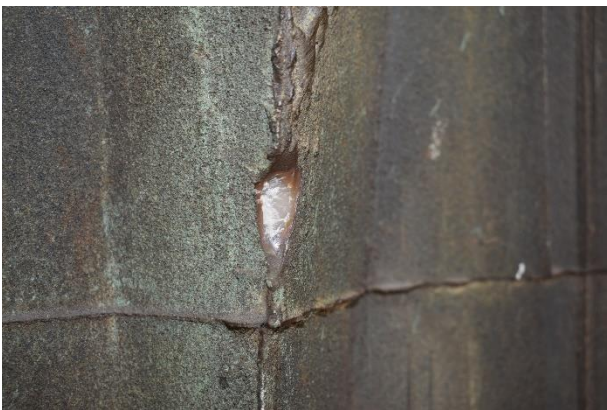
| Impact damage to GRP – removing resin and surface finishes | |

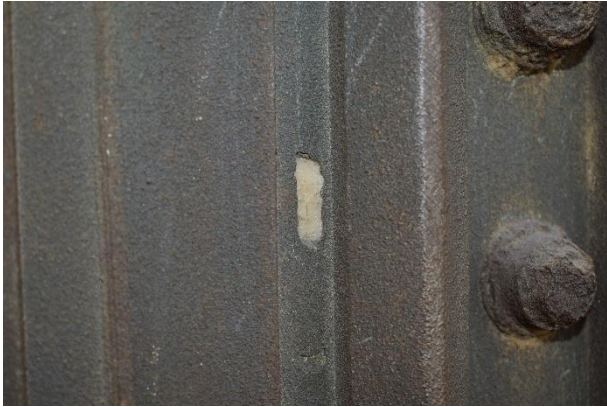
| Loss of surface finishes. | |

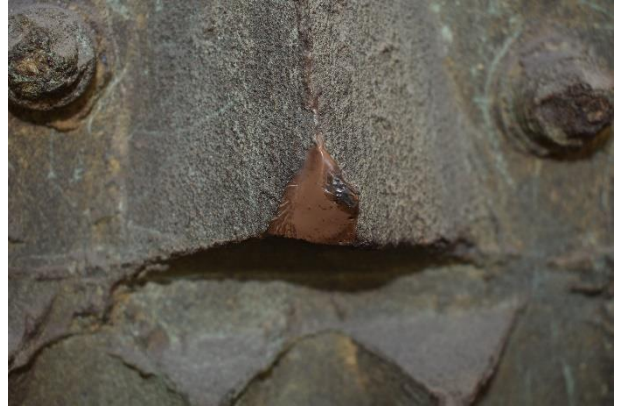
Impact damage to GRP – removing resin and surface finishes

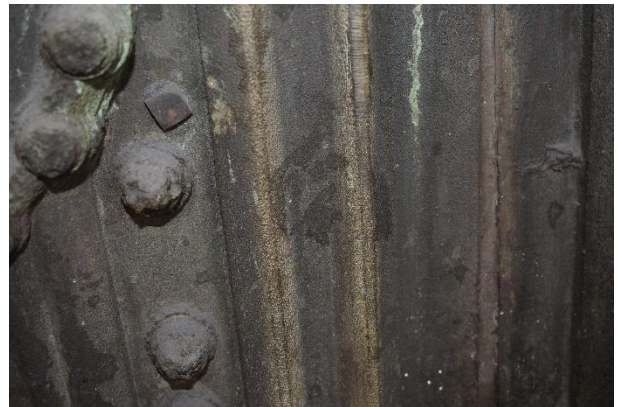
Dirt, water staining and marking to the bottom of the panel.

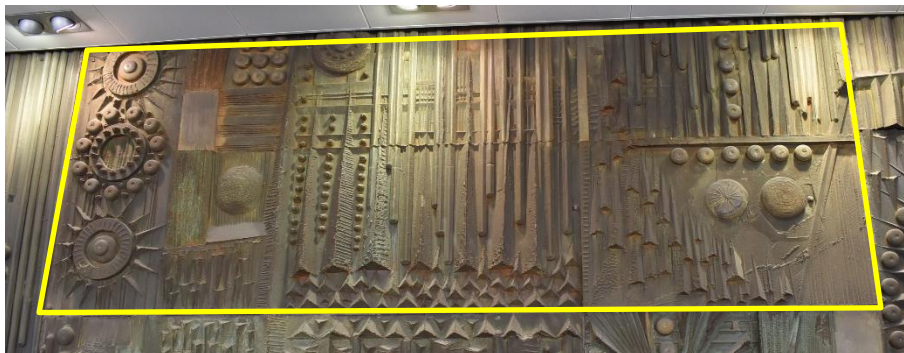
### 5.1 Panel Ref C (Size 1,530mm high x 3,670mm wide)

Panel C is secured to the main wall with 5No coach screws.

The panel is in a good condition however has a considerable build-up of dust and dirt on the surface finishes. Being at high level the panel has not suffered from significant damage through impact and cleaning operations.

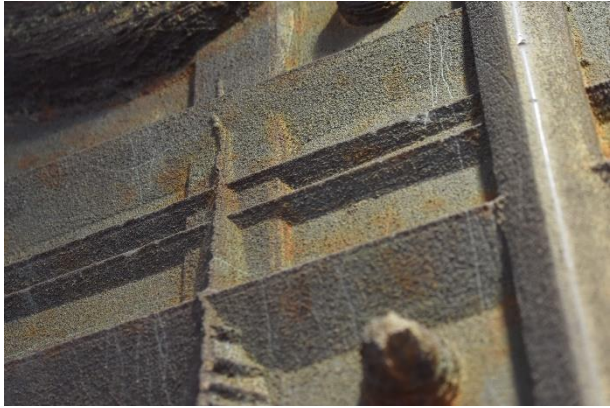
| Description | Photograph |
|---|---|
| Surface scratches to the panel. | |

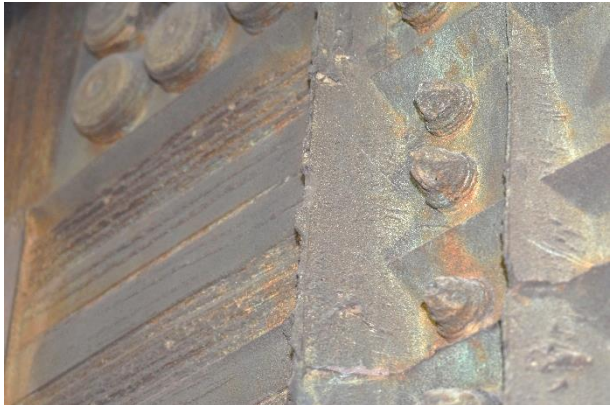
| Description | Photograph |
|---|---|
| Very minor damage to edges of GRP. | |

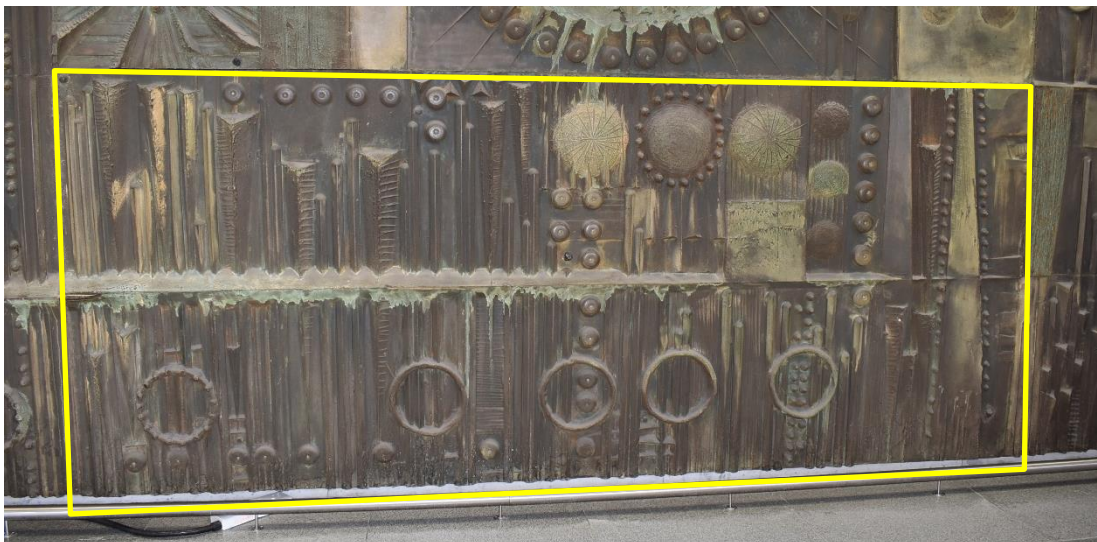
### 5.1 Panel Ref D (Size 1,530mm high x 3,670mm wide)

Panel D is secured to the main wall with 6No coach screws.

The panel is in a sound condition however has a build-up of dust and dirt on the surface finishes. At its base the GRP is very dirty and water staining is present. There are a number of areas of minor damage to the GRP as noted below.

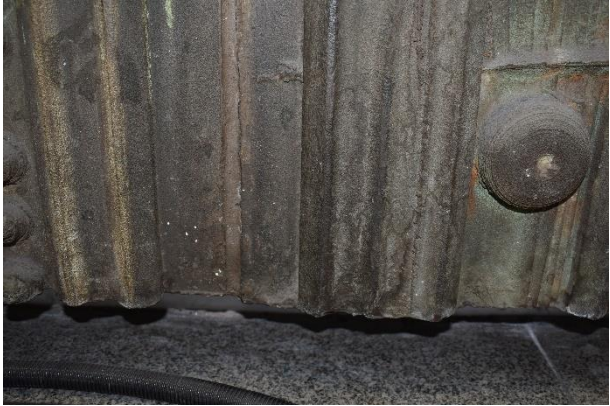
| Description | Photograph |
|---|---|
| Dirt and water staining to the base of the panel. | |

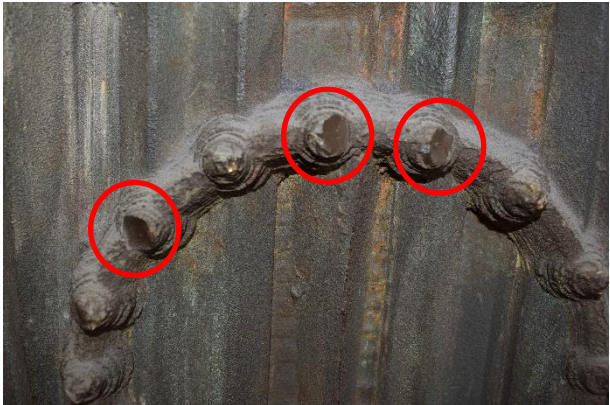
| Description | Photograph |
|---|---|
| Impact damage to 3No areas of ring detail – resin material broken away. | |

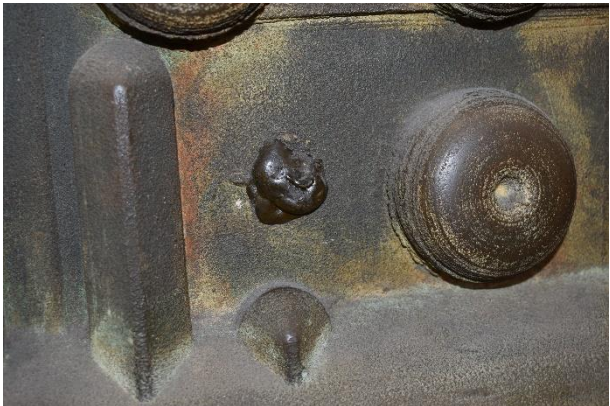
| Description | Photograph |
|---|---|
| Soft resinous material applied to panel – differs from main panel construction. (Not at fixing position but possible later repair). | |

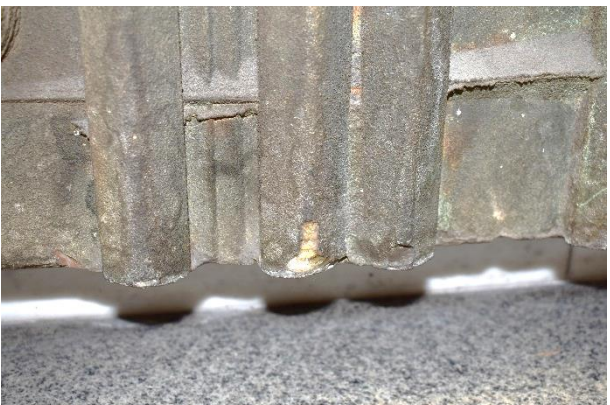
| Description | Photograph |
|---|---|
| Minor impact damage to base of panel – exposing fibreglass material. | |

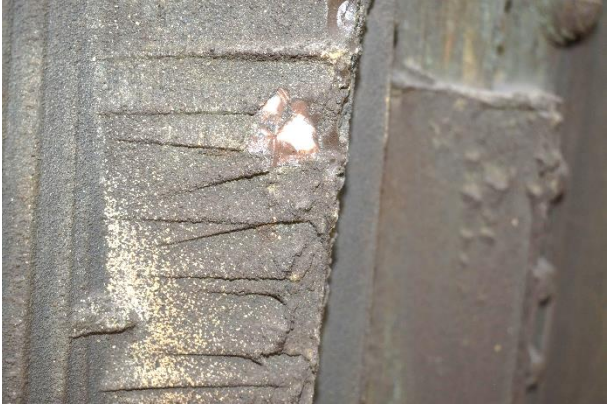
| Impact damage / chipping of the GRP. | |

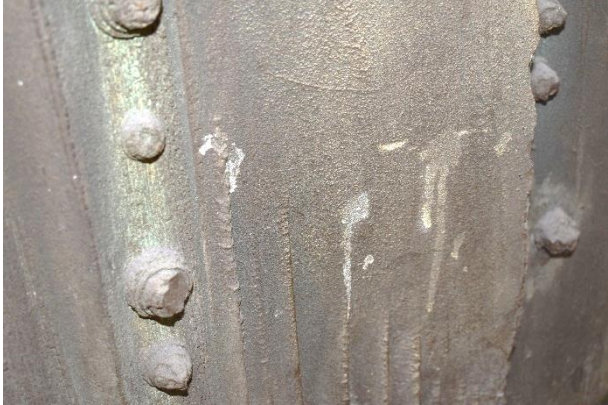
| Staining to lower panel – possible diluted paint material. | |

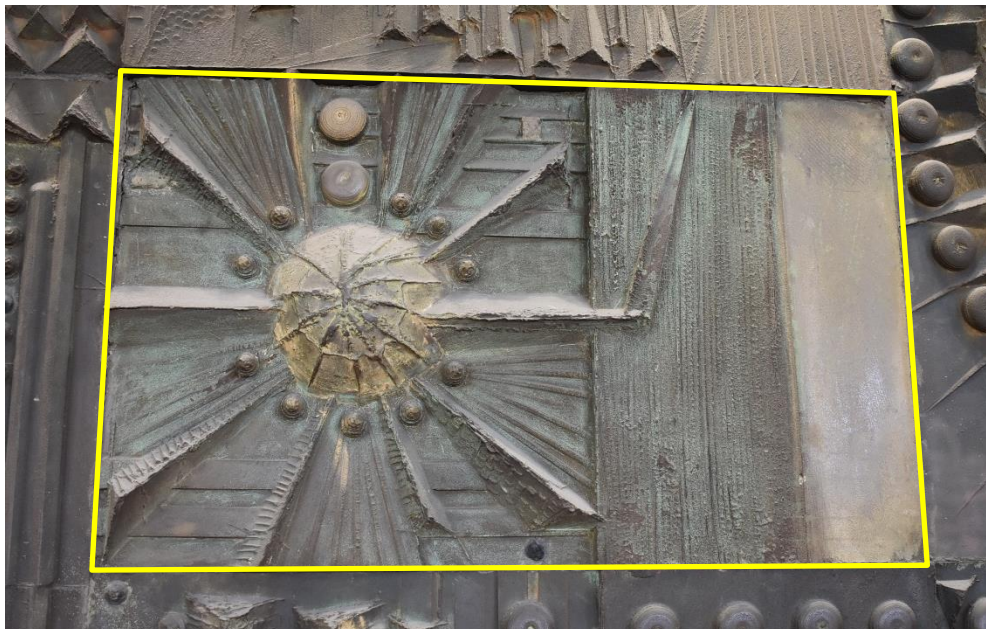
### 5.1 Panel Ref E (Size 745mm high x 1,220mm wide)

Panel E is secured to the main wall with 3No coach screws.

The panel is in good condition however like all the panels it has a considerable build-up of dust and dirt on the surface finishes. Only one minor defect was noted.

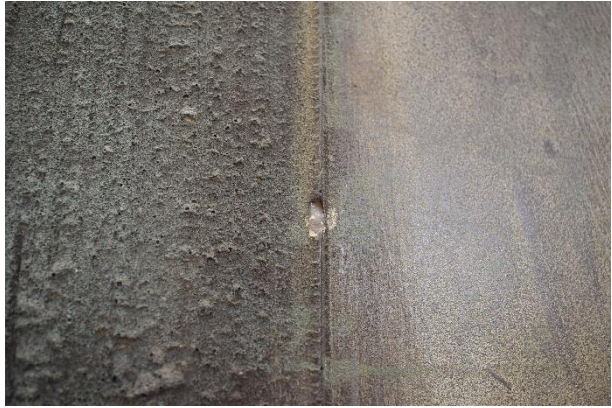
| Description | Photograph |
|---|---|
| Minor impact damage to GRP. | |

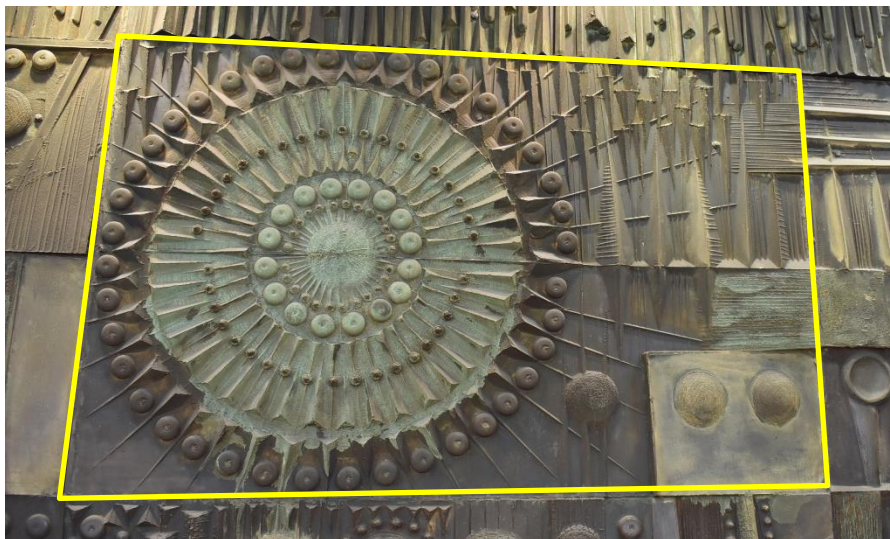
### 5.1 Panel Ref F (Size 2,440mm high x 1,540mm wide)

Panel F is secured to the main wall with 3No coach screws.

The panel is in a good condition however has a considerable build-up of dust and dirt on the surface finishes.

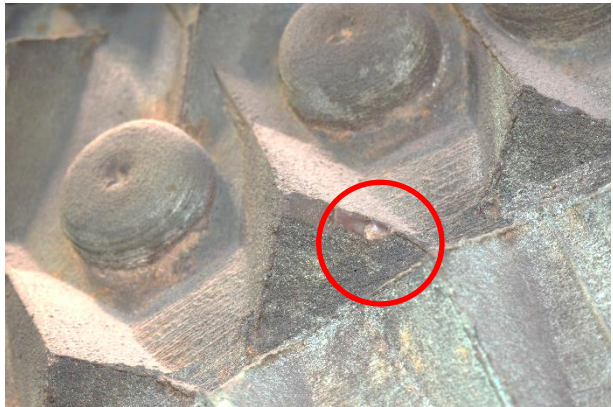
| Description | Photograph |
|---|---|
| Minor impact to exposed edges of GRP. | |

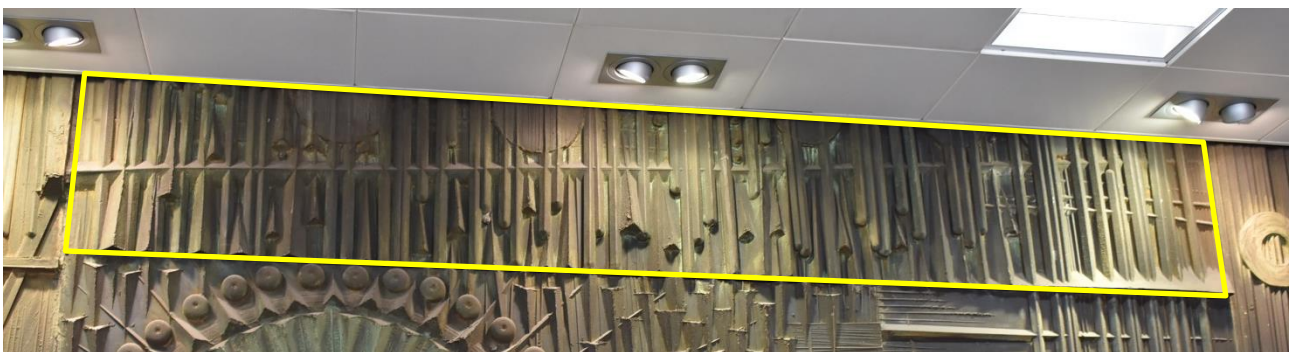
### 5.1 Panel Ref G (Size 650mm high x 3,670mm wide)

Panel G is secured to the main wall with 3No coach screws.

The panel is in a good condition however like all the panels it has a considerable build-up of dust and dirt on the surface finishes. Few defects were noted for the panel – noted below.

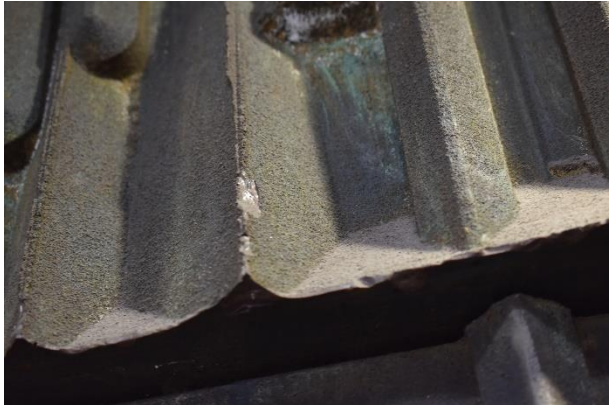
| Description | Photograph |
|---|---|
| Minor chipping of GRP on exposed edges. | |

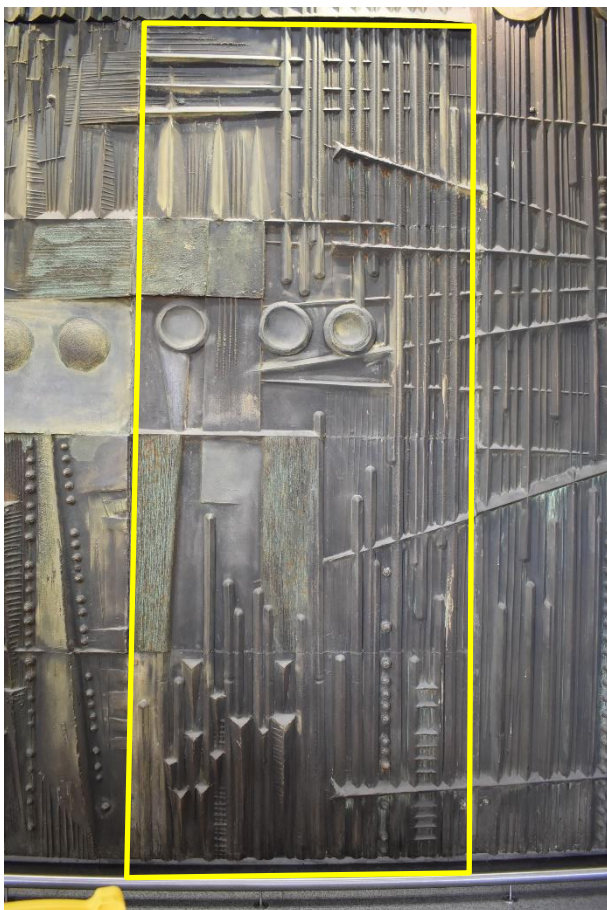
### 5.1 Panel Ref H (Size 3,070mm high x 1,230mm wide)

Panel H is secured to the main wall with 4No coach screws.

The panel is in a sound condition with significant dust and dirt on the surface finishes. At its base the GRP is very dirty and water staining is present. There are a number of areas of minor damage to the GRP as noted below.

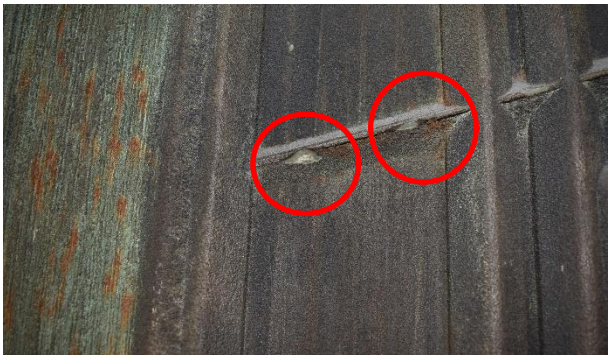
| Description | Photograph |
|---|---|
| Impact damage to exposed GRP edges. | |

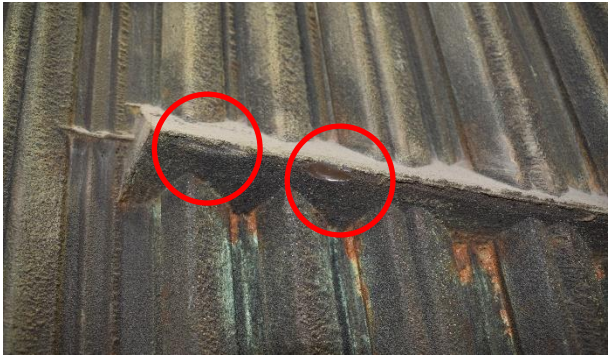
| Description | Photograph |
|---|---|
| Ditto. | |

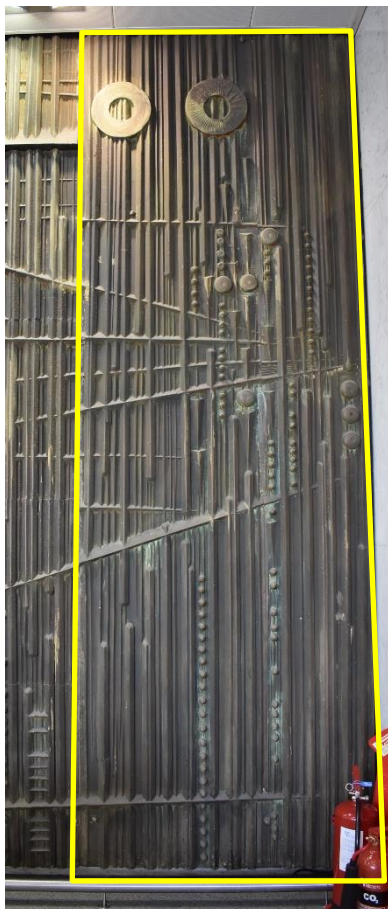
### 5.1 Panel Ref I (Size 3,870mm high x 1,220mm wide)

Panel I is secured to the main wall with 6No coach screws.

The panel is overall in a good condition however like all the panels it has a considerable build-up of dust and dirt on the surface finishes. At its base the GRP is very dirty and water staining is present. There are a number of areas of minor damage to the GRP as noted below.

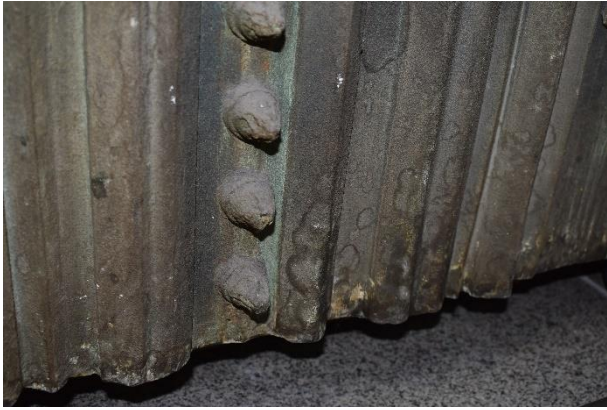
| Description | Photograph |
|---|---|
| Dirt and water staining to lower panel. | |

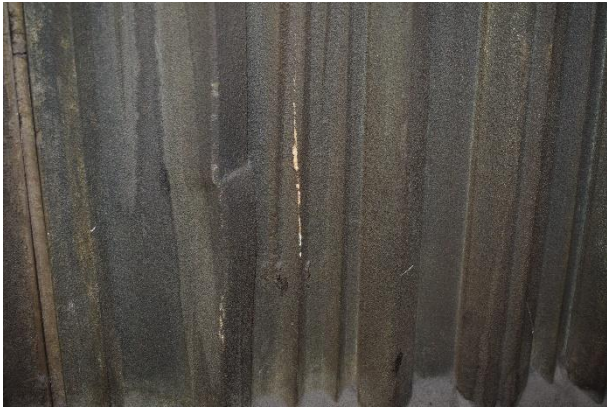
| Description | Photograph |
|---|---|
| Paint splashes to panel | |

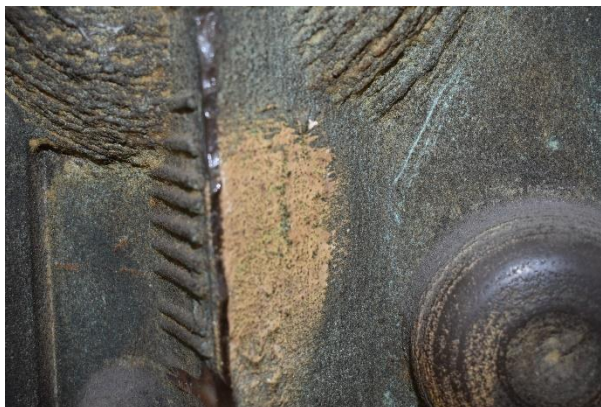
Applied paint finish - possibly covering area of previous damage.

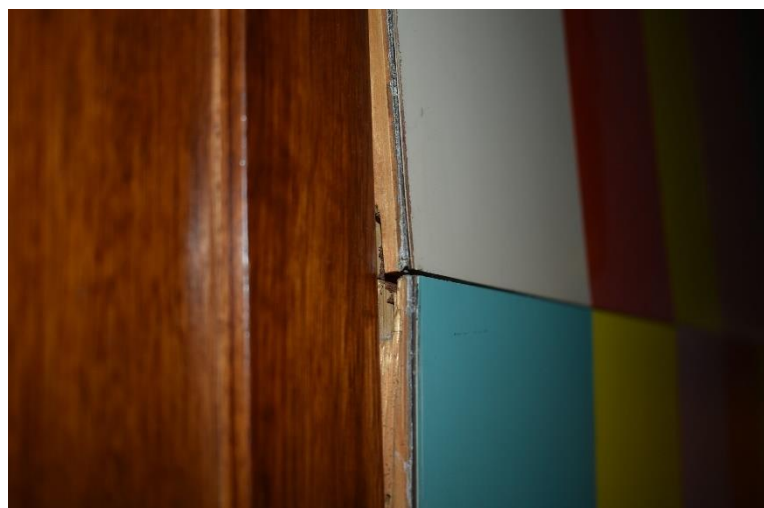
Joint line between the upper and lower panels showing the blockboard constriction of the panels together with the distortion of the panels. A tongue is fitted between the panels to joint the two panels.

**Recommendation 2** – The mural panels should be removed from their framing to further investigate the deformation of the panels. The upper panels should be carefully lifted and separated from the lower panels taking care not to damage the delicate and deformed tongue and groove joint at the base of the upper panels.

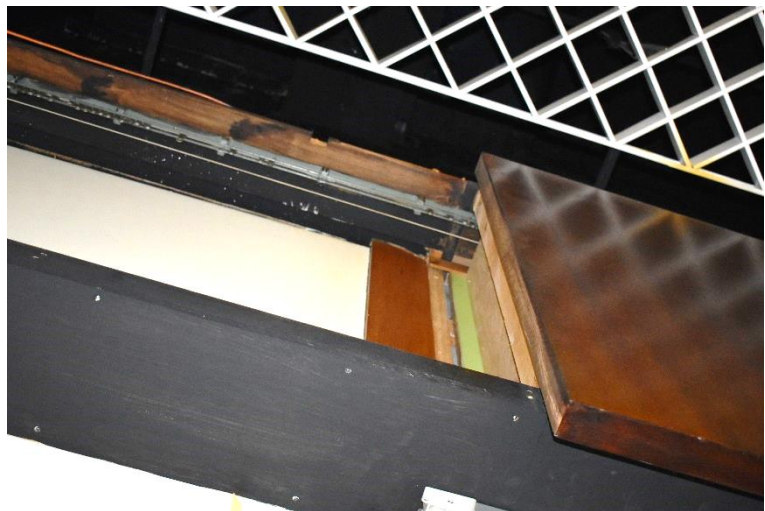
Modern upper panels covering the mural panels – green laminate of the mural is visible behind the timberwork.

Fabricated timber cover appears to be fixed to the mural panel.

**Recommendation 1** – The 6 timber panels fitted to the top of the mural panel should be removed to allow the laminate panels to be fully inspected. It appears that this new panel construction is screw fixed directly to the laminate panels with resultant damage which should be fully assessed.

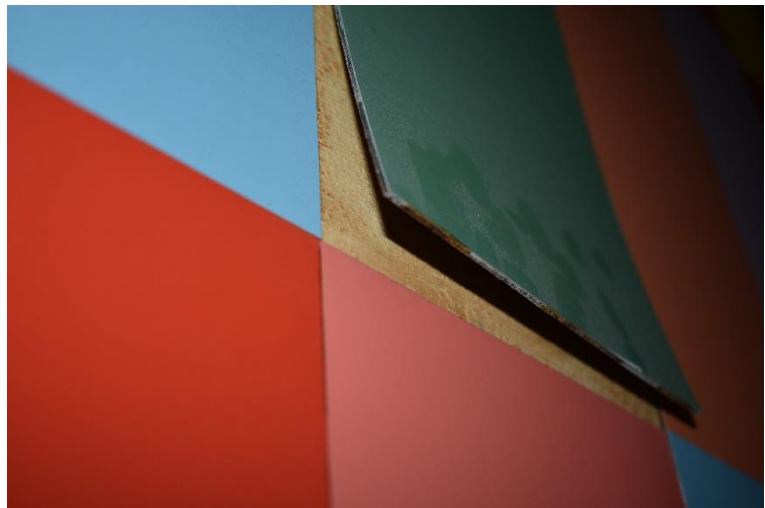
Peeling laminate sheets on panel B. Laminate remains intact however glue adhesion has failed.

Laminate sheets are 2.0mm thick.

**Recommendation 3** – The partly detached laminate should be carefully removed from the backing board material and glue removed from both the board material and the laminate. Trials will be required to determine the most effective means to soften and remove the glue that will not damage the laminate. Following removal the laminate should be re-applied with contact adhesive to the manufacturers recommendations.

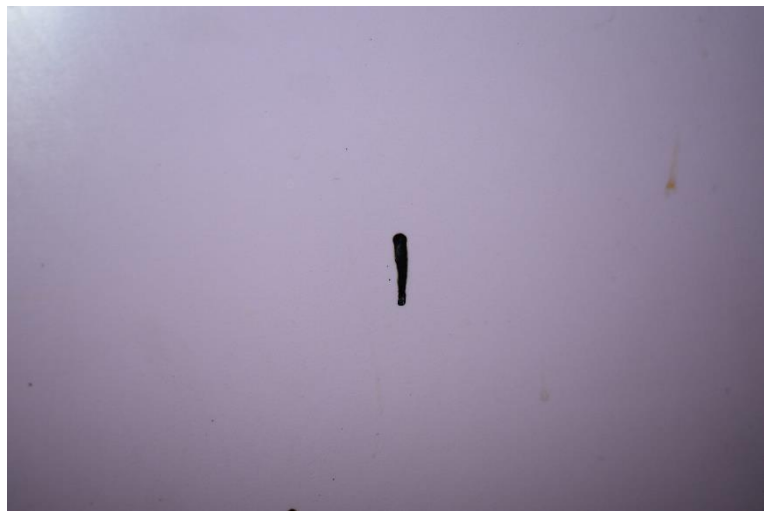
Paint splashes on mural panels – mainly on panel I at low level however other small spots are present on other panels.

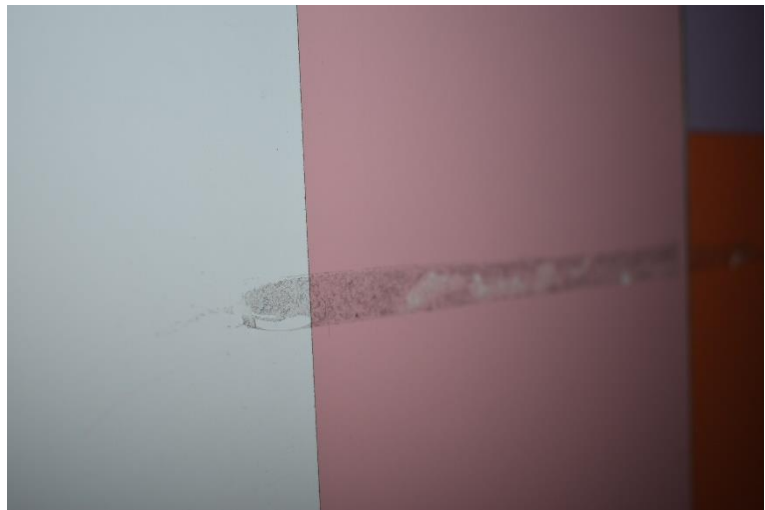
Adhesive tape residue is present on lower panels together with some minor marking.

**Recommendation 4** - The panels should be cleaned to remove dirt and debris that has built-up on the surface of the panels. Cleaning should initially be undertaken by vacuum cleaner and soft brushes to agitate loose material followed by lint free cloth with 5% non-ionic detergent on more stubborn areas. Trials areas should always be undertaken to test effectiveness and techniques adapted accordingly.
