**AN ARBORICULTURAL IMPACT ASSESMENT AND  
METHOD STATEMENT  
AT PARRSWOOD LEISURE COMPLEX ,  
WILMSLOW ROAD, DIDSBURY.**

**Prepared for Charlie Coghlan of Raw Charging Ltd.**

**Paul Hanson – LANTRA Professional Tree Inspector**

**1<sup>st</sup> December 2025**

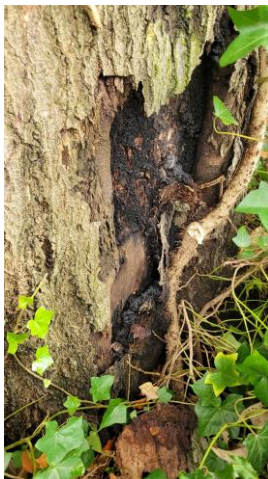
*Kretzschmaria deusta* T58

- 2.2.2 The tree of most concern is a large Beech (T58), which has significant bark death at base and the presence of the decay fungus *Kretzschmaria deusta* at base. This is a particularly aggressive fungus often leading to complete tree failure at base (see photo below).
