## Asbestos Refurbishment Survey

**Block 06 (Fire Panel 4)  
North Manchester General Hospital  
Delaunays Road  
Crumpsall  
Manchester  
M8 5RB**

**Manchester Foundation Trust**

| Project Number: | Survey Date: | Issue Date: |
|---|---|---|
| B-39207 | 03 November 2022 | 16 November 2022 |

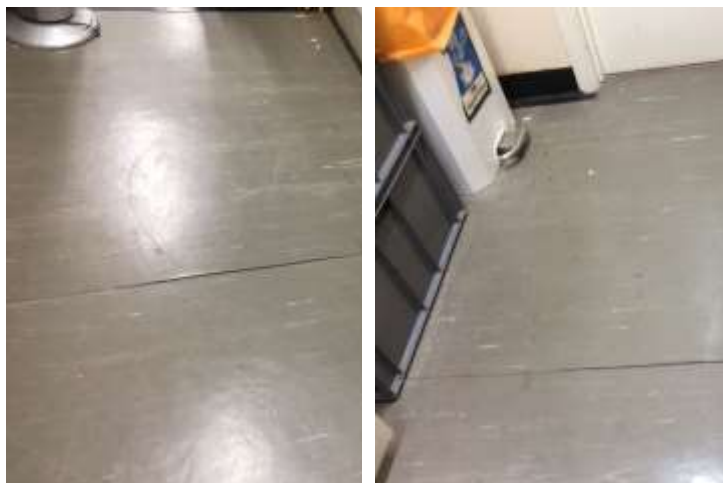
| Sample Reference | PS |

| Condition | |
|---|---|
| Good Condition | 0 |

Whilst the asbestos containing material continues to remain undisturbed, no immediate action is required. However a system of ongoing management should be implemented which includes routine condition inspections.

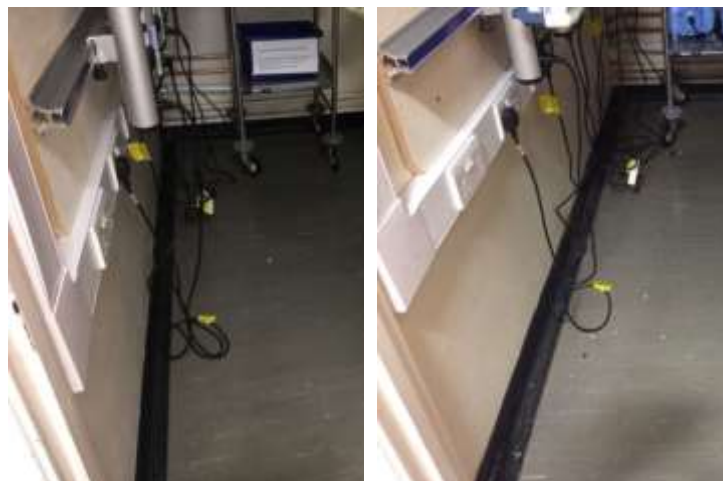
| Sample Reference | PS |

| Condition | |
|---|---|
| Good Condition | 0 |

Whilst the asbestos containing material continues to remain undisturbed, no immediate action is required. However a system of ongoing management should be implemented which includes routine condition inspections.

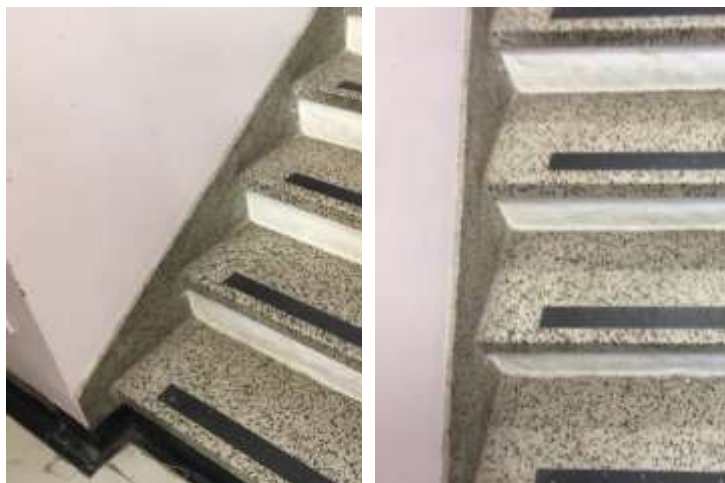
| Sample Reference | PS |

| Condition | |
|---|---|
| Good Condition | 0 |

Whilst the asbestos containing material continues to remain undisturbed, no immediate action is required. However a system of ongoing management should be implemented which includes routine condition inspections.

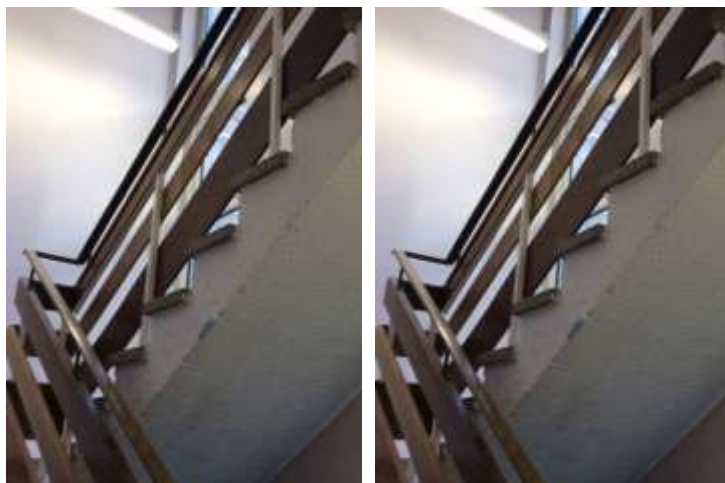
| Sample Reference | PS |

| Condition | |
|---|---|
| Good Condition | 0 |

Whilst the asbestos containing material continues to remain undisturbed, no immediate action is required. However a system of ongoing management should be implemented which includes routine condition inspections.

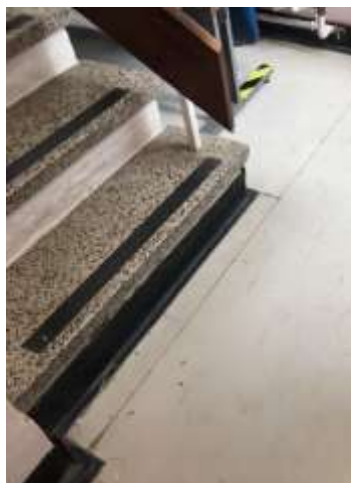
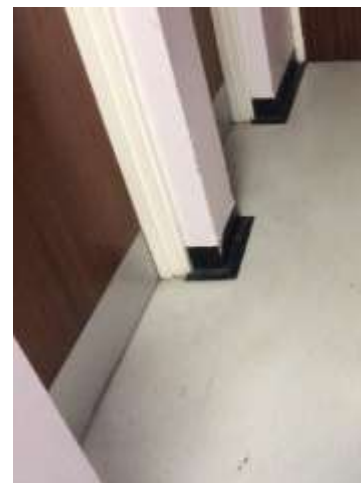
| Sample Reference | PS |

| Condition | |
|---|---|
| Good Condition | 0 |

Whilst the asbestos containing material continues to remain undisturbed, no immediate action is required. However a system of ongoing management should be implemented which includes routine condition inspections.

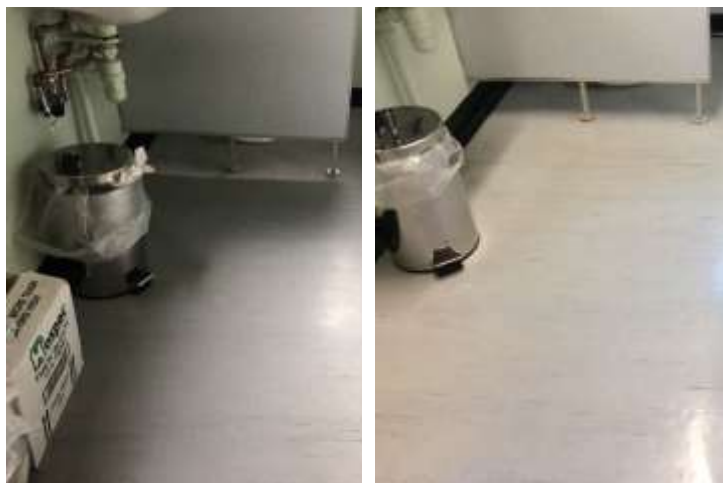
| Sample Reference | PS |

| Condition | |
|---|---|
| Good Condition | 0 |

Whilst the asbestos containing material continues to remain undisturbed, no immediate action is required. However a system of ongoing management should be implemented which includes routine condition inspections.

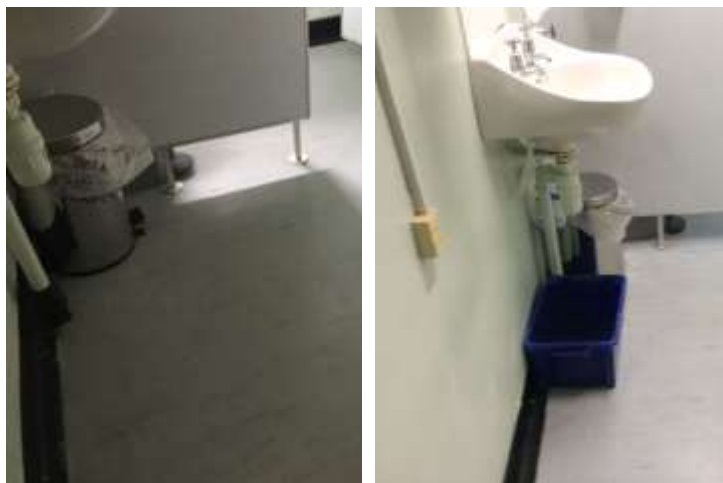
| Sample Reference | PS |

| Condition | |
|---|---|
| Good Condition | 0 |

Whilst the asbestos containing material continues to remain undisturbed, no immediate action is required. However a system of ongoing management should be implemented which includes routine condition inspections.

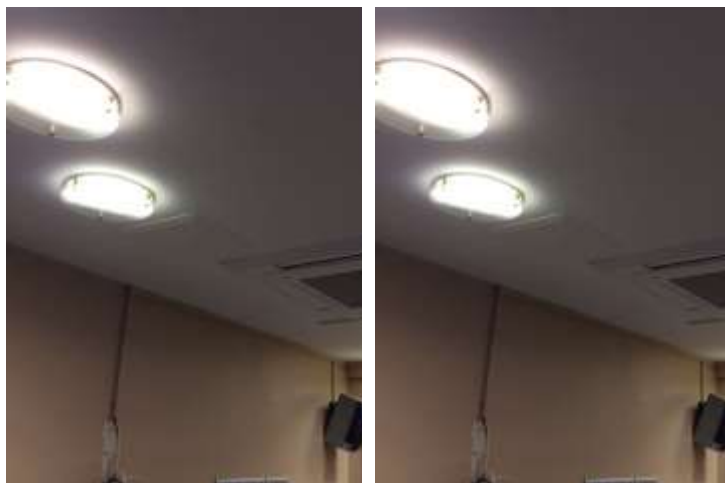
| Sample Reference | PS1/B-33011 |

| Description | Bitumen debris to ceiling void adjacent access hatch to air-conditioning unit |

| Condition | |
|---|---|
| High Damage | 3 |

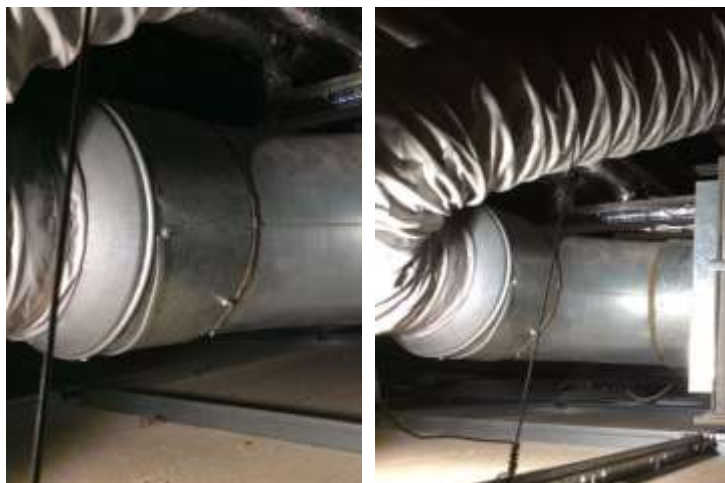
| Sample Reference | S001 |

| Condition | |
|---|---|
| Good Condition | 0 |

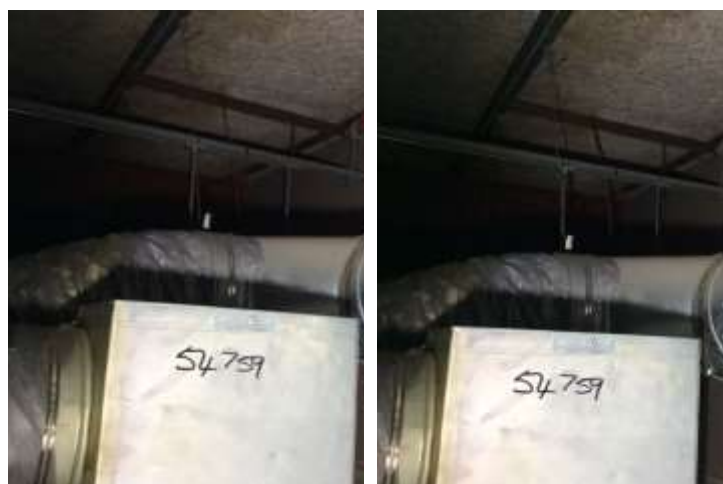
| Sample Reference | PX1/B-31201 |

| Condition | |
|---|---|
| Good Condition | 0 |

Whilst the asbestos containing material continues to remain undisturbed, no immediate action is required. However a system of ongoing management should be implemented which includes routine condition inspections.

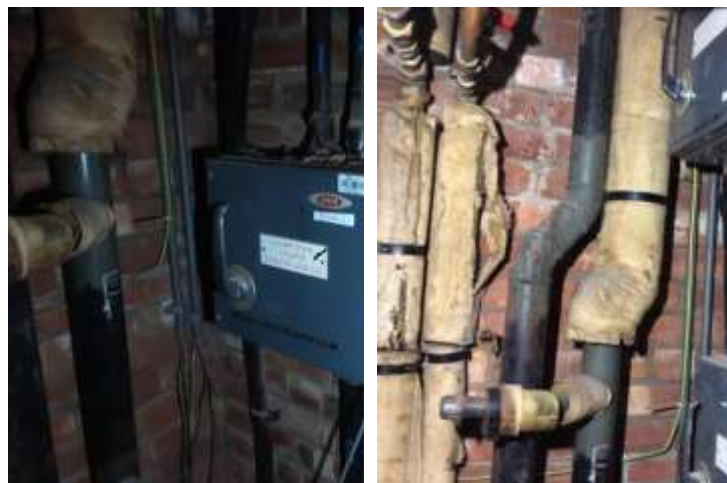
| Sample Reference | P |

| Condition | |
|---|---|
| Good Condition | 0 |

Whilst the asbestos containing material continues to remain undisturbed, no immediate action is required. However a system of ongoing management should be implemented which includes routine condition inspections.

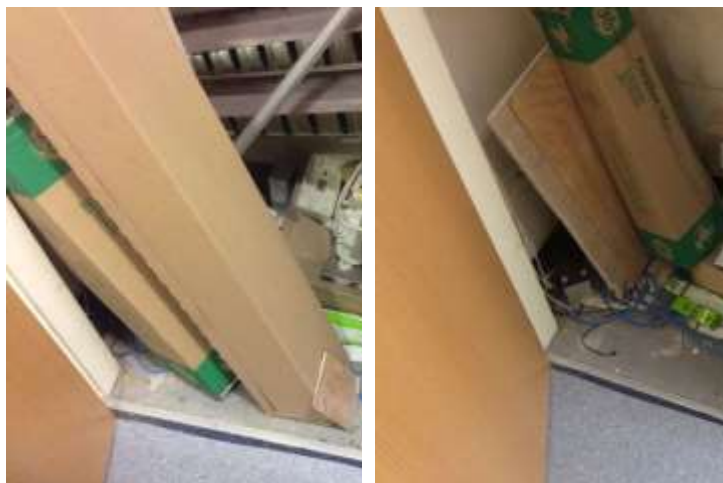
| Sample Reference | PS |

| Condition | |
|---|---|
| Good Condition | 0 |

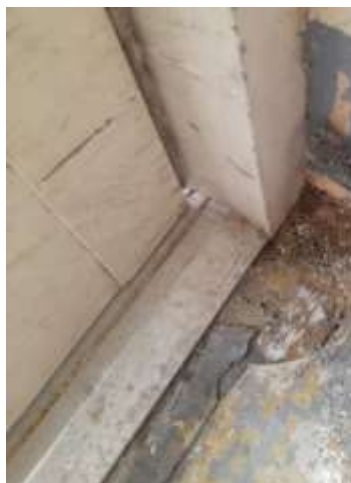
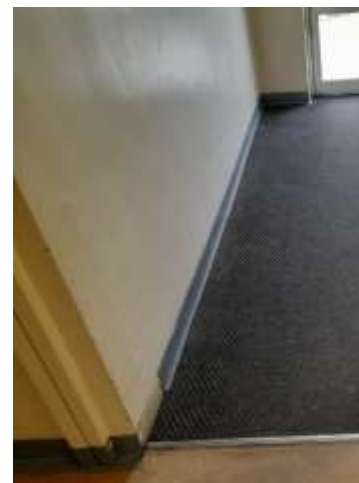
| Sample Reference | PS7/B-38691 |

| Condition | |
|---|---|
| Low Damage | 1 |

Whilst the asbestos containing material continues to remain undisturbed, no immediate action is required. However a system of ongoing management should be implemented which includes routine condition inspections. Although not a legal requirement, labelling the material as asbestos should be considered to reduce the risk of accidental disturbance. If however the asbestos containing material is likely to be disturbed during the refurbishment works then it should be removed and disposed of in full accordance with current and relevant legislation prior to the refurbishment works being undertaken.

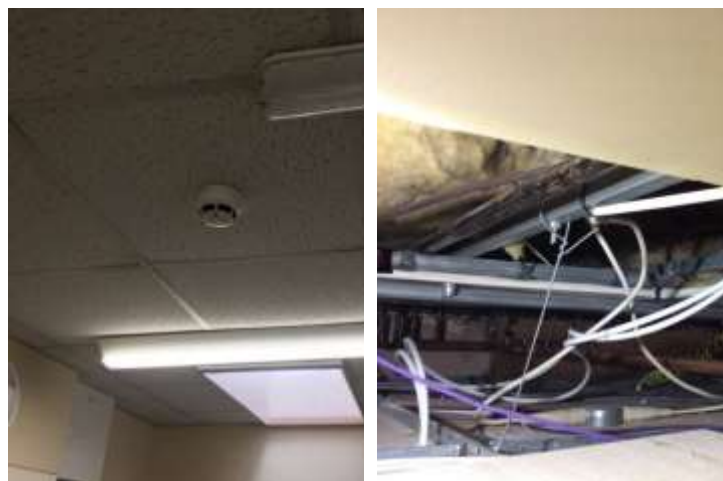
| Sample Reference | P |

| Condition | |
|---|---|
| High Damage | 3 |

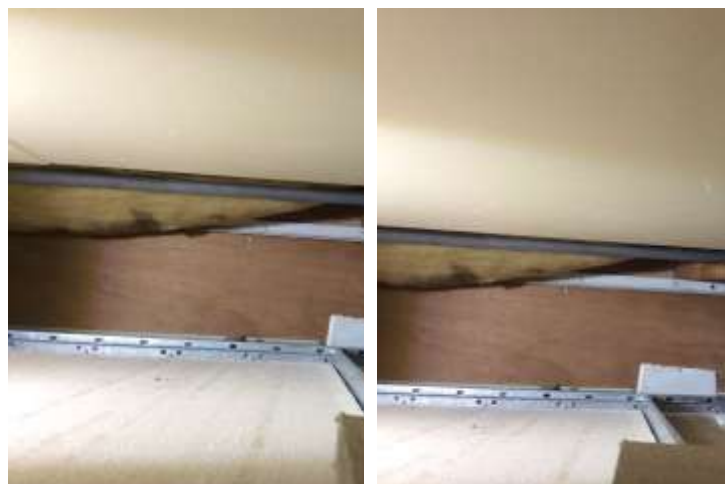
| Sample Reference | S003 |

| Condition | |
|---|---|
| High Damage | 3 |

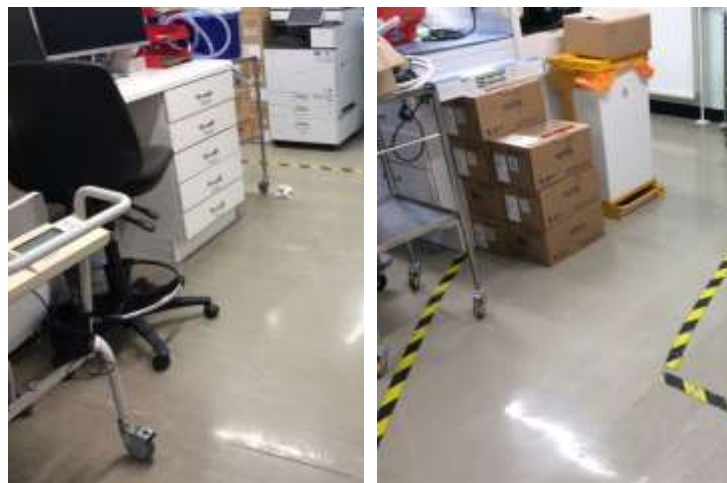
| Sample Reference | PX2/B-24309 |

| Condition | |
|---|---|
| Good Condition | 0 |

Whilst the asbestos containing material continues to remain undisturbed, no immediate action is required. However a system of ongoing management should be implemented which includes routine condition inspections.

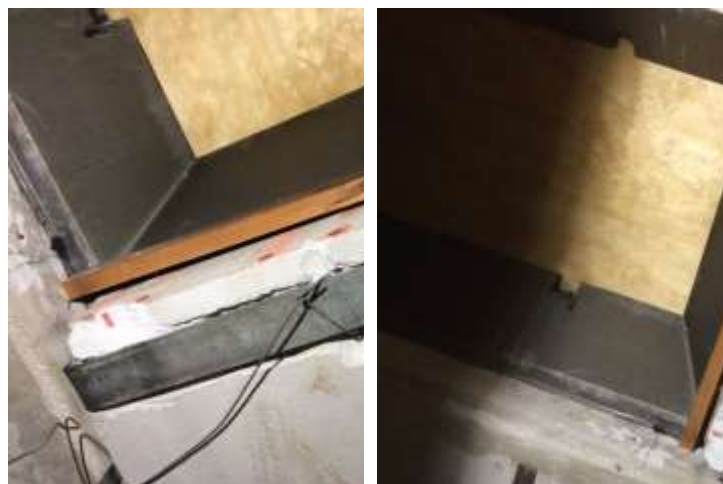
| Sample Reference | S004 |

| Condition | |
|---|---|
| High Damage | 3 |

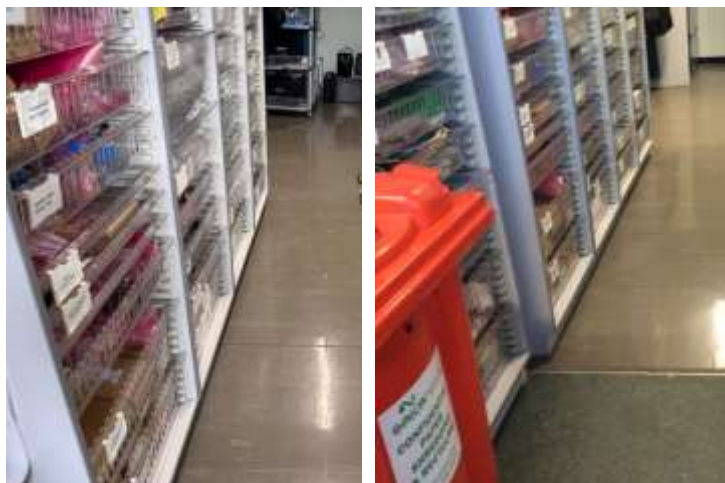
| Sample Reference | PS1/B-24309 |

| Condition | |
|---|---|
| Good Condition | 0 |

Whilst the asbestos containing material continues to remain undisturbed, no immediate action is required. However a system of ongoing management should be implemented which includes routine condition inspections.

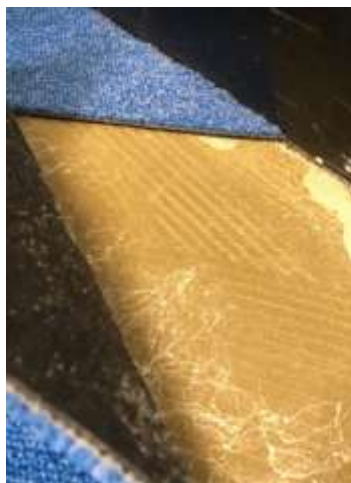
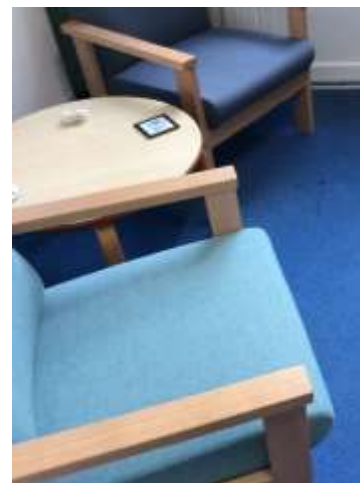
| Sample Reference | PS |

| Condition | |
|---|---|
| Good Condition | 0 |

Whilst the asbestos containing material continues to remain undisturbed, no immediate action is required. However a system of ongoing management should be implemented which includes routine condition inspections.

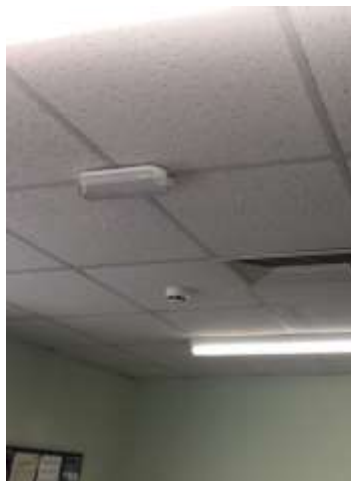
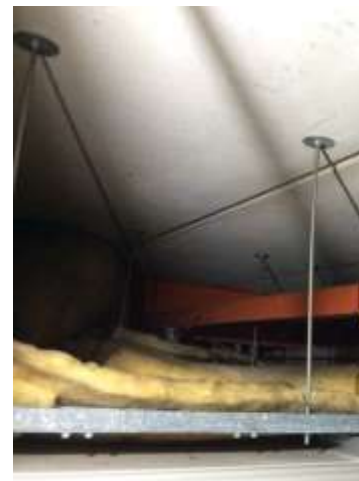
| Sample Reference | P |

| Condition | |
|---|---|
| High Damage | 3 |

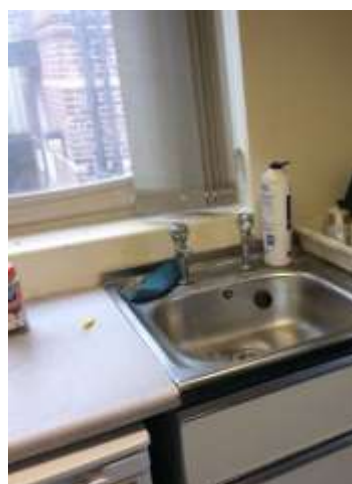
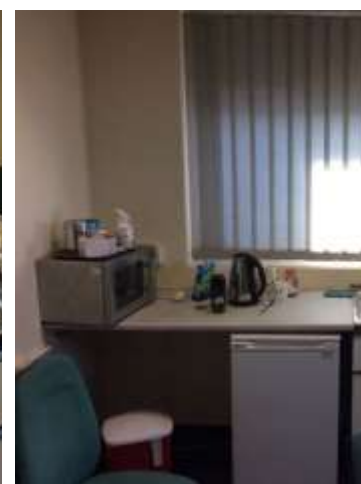
| Sample Reference | PS6/B-31201 |

| Condition | |
|---|---|
| Good Condition | 0 |

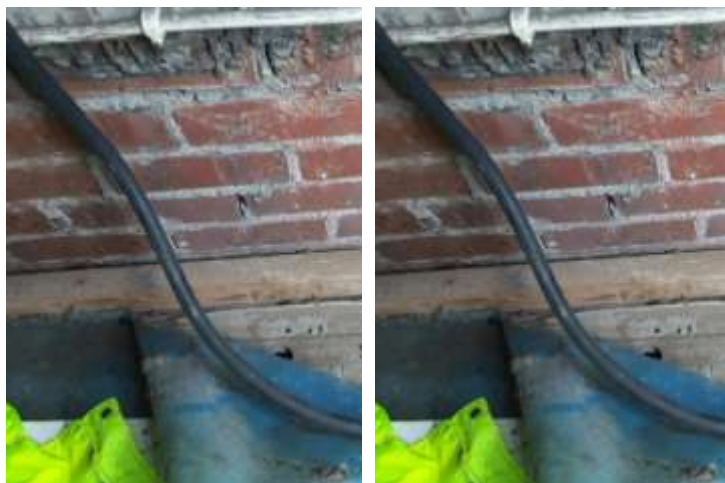
| Sample Reference | PS2/B-33011 |

| Condition | |
|---|---|
| High Damage | 3 |

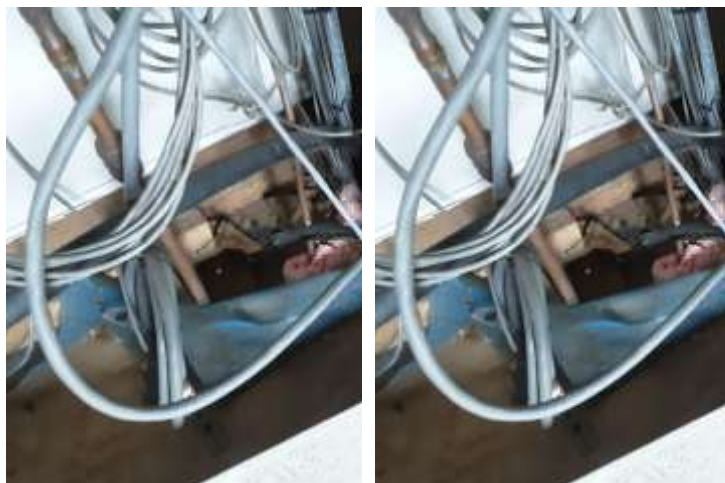
| Sample Reference | PS3/B-33011 |

| Condition | |
|---|---|
| High Damage | 3 |

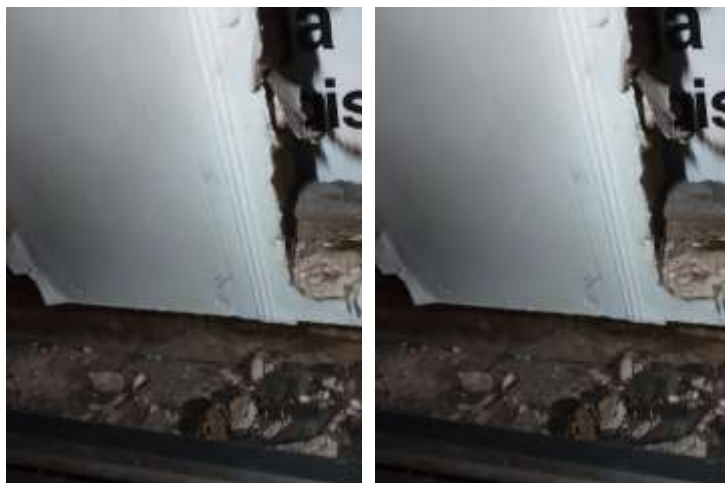
| Sample Reference | PS4/B-33011 |

| Condition | |
|---|---|
| High Damage | 3 |

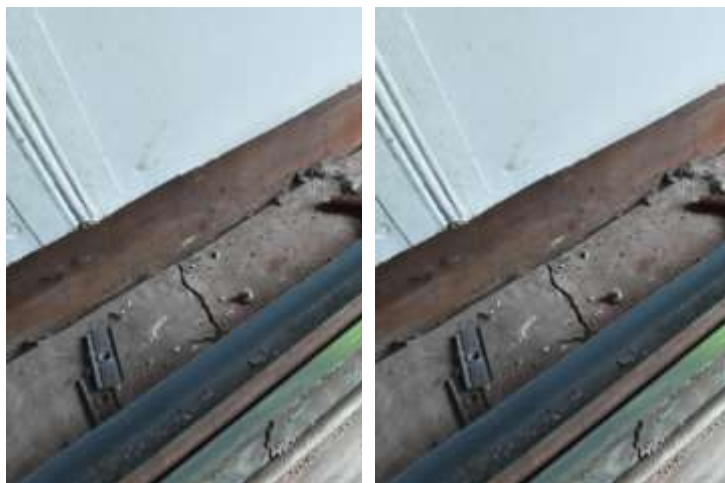
| Sample Reference | PS6/B-33011 |

| Condition | |
|---|---|
| High Damage | 3 |
