MURRAY  
TREE CONSULTANCY

## TREE CONDITION ASSESSMENT

PARRSWOOD LEISURE COMPLEX  
WILMSLOW ROAD  
MANCHESTER  
M20 5PG

March 2022

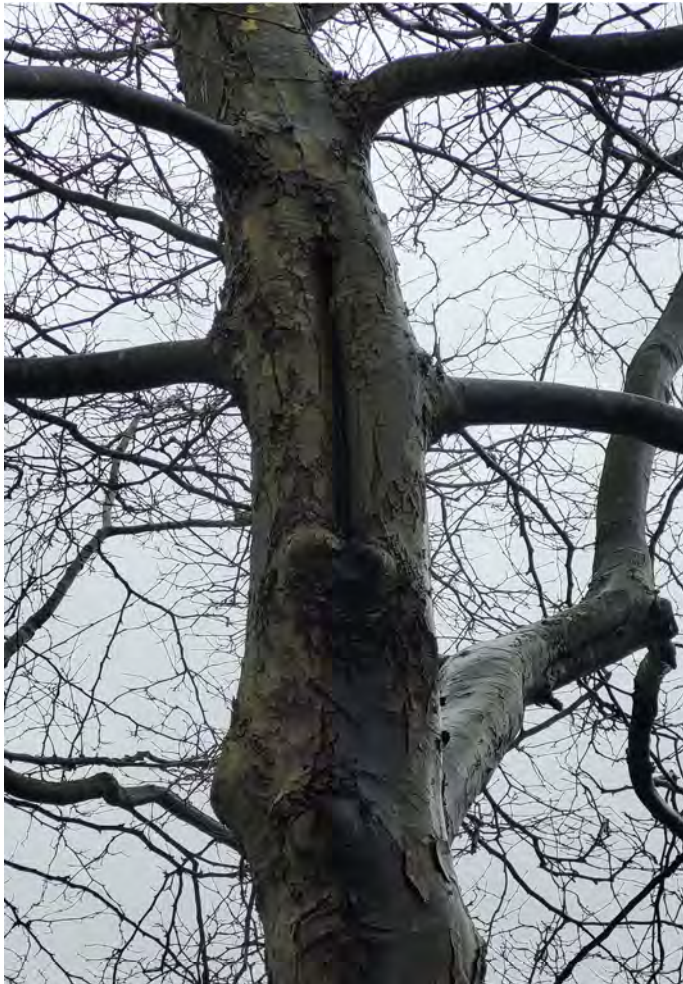
| Tree Condition Assessment: Parrswood Leisure Complex, Wilmslow Road, Manchester, M20 5PG    Date: 21/02/22    Weather: Inclement    Surveyor: PM | | | | | | | |
|---|---|---|---|---|---|---|---|
| G14 a – g | Group – London Plane | 6-10 | SM | C | Planted in shrub border adjacent to parking area and footpath. G14 c – g has been previously removed with several high stumps still present. G14a has a poor main fork and G14b has a stem cavity with decay present at approx. 4m. | <b>Fell both trees to ground level, grind out stumps and replace.</b> | <b>2</b> |

G14 - stem cavity

| Priority | Tree Number | Species | Description of Works |
|---|---|---|---|
| 2 | G14 a-g | London Plane | Fell both trees to ground level, grind out stumps and replace. |

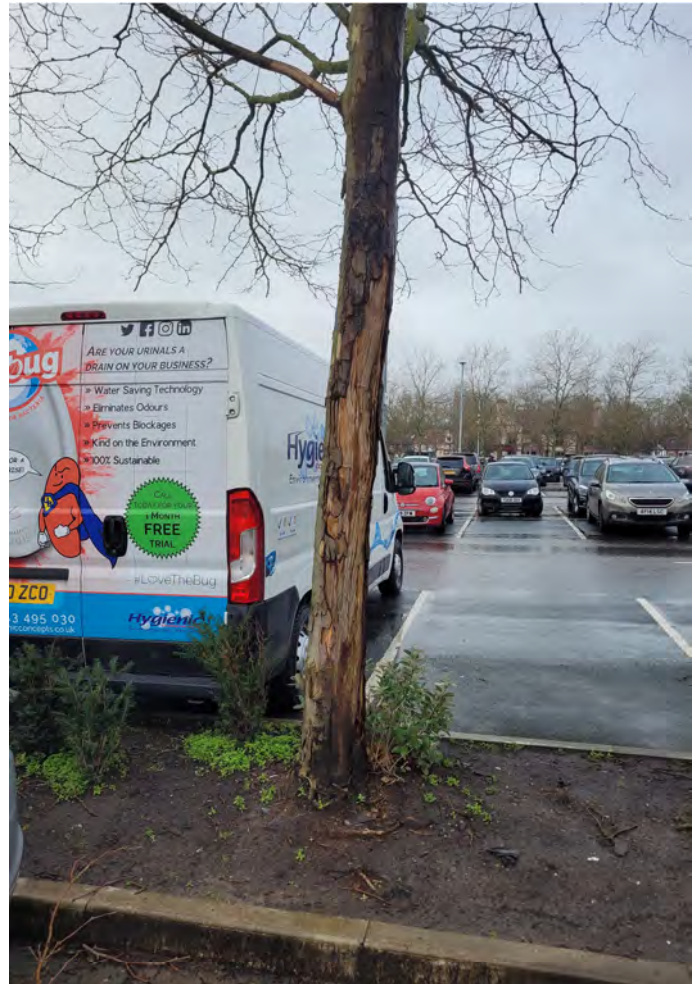
Tree d in G5 bark stripped

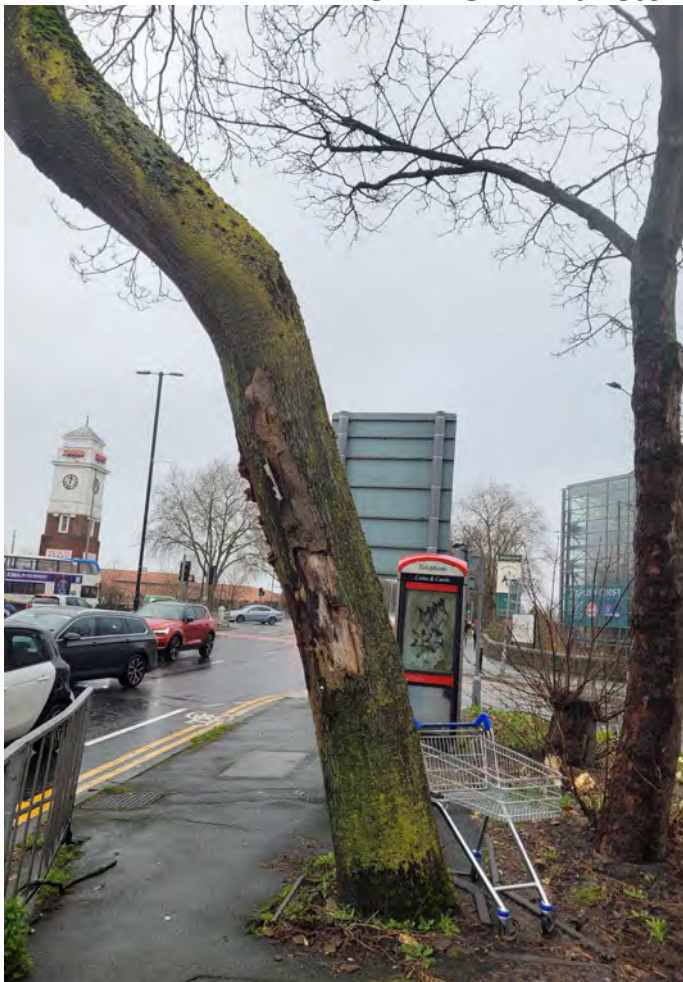
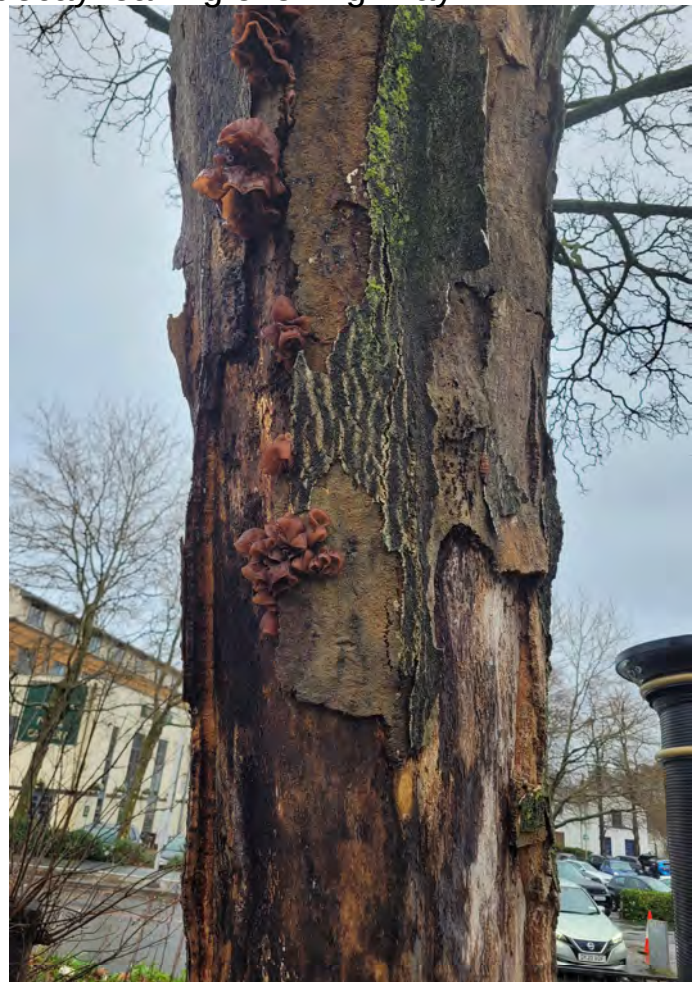
| Tree Condition Assessment: Parrswood Leisure Complex, Wilmslow Road, Manchester, M20 5PG    Date: 21/02/22    Weather: Inclement    Surveyor: PM | | | | | | | |
|---|---|---|---|---|---|---|---|
| G11 | Group – 2 Lime, 4 Norway Maple, 2 Sycamore & 1 Ash | 16-20 | M | B | A mature group of off-site trees planted in border adjacent to A34 Kingsway and bus stop. Significant deadwood in Lime trees. The Ash has a major lean over the highway with significant stem decay. | Remove Ash tree; advise tree owner of this recommendation. | 2 |

Ash in G11 with stem decay leaning over highway

| Priority | Tree Number | Species | Description of Works |
|---|---|---|---|
| 2 | G11 | Mixed | Remove Ash tree; advise tree owner of this recommendation. |

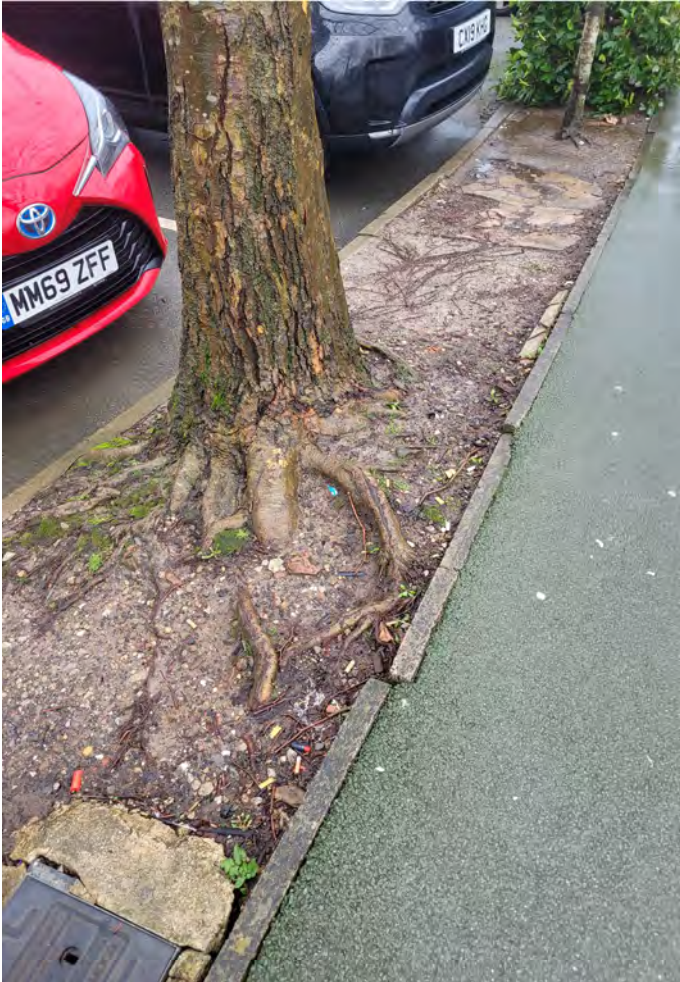
| Tree Condition Assessment: Parrswood Leisure Complex, Wilmslow Road, Manchester, M20 5PG    Date: 21/02/22    Weather: Inclement    Surveyor: PM | | | | | | | |
|---|---|---|---|---|---|---|---|
| G13 a – b | Group – London Plane | 11-15 | EM | B/C | Planted in shrub border adjacent to parking area. G13a exhibits reasonable form and vigour but slightly one sided. G13b has two large stem failures with decay present with low potential. Girdling roots present. | Fell both trees to ground level, grind out stumps and replace. | 2 |

G13 - girdling root

| Priority | Tree Number | Species | Description of Works |
|---|---|---|---|
| 2 | G13 a-b | London Plane | Fell both trees to ground level, grind out stumps and replace. |

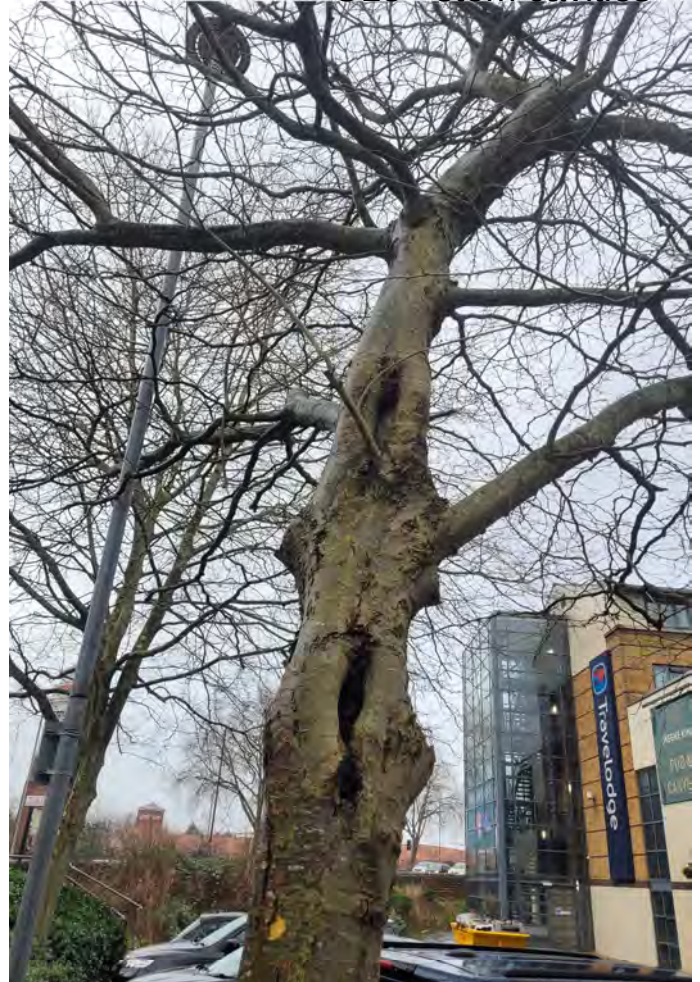
G13 - stem cavities
