## 2025 inspection report

Asset: 40m redundant brick boiler chimney  
Client: Zenith Management Ltd  
Site: Murrays Mill - Manchester  
Job No: 10872  
Inspector: John Breen  
Date: 27.01.2024

MURRAY'S MILL, 40m BRICK CHIMNEY – 2025 INSPECTION REPORT.

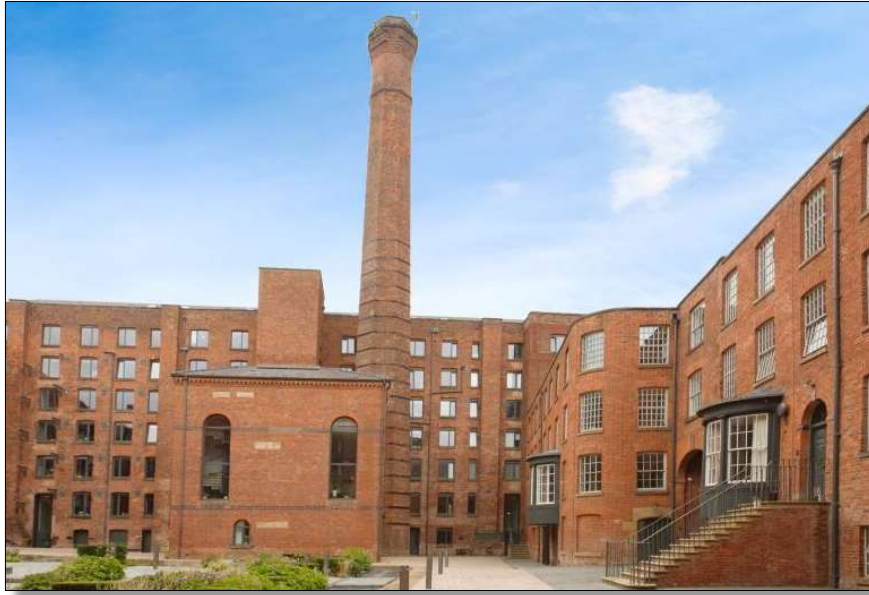
↑ Image 1.

General view of the chimney.  
North elevation.

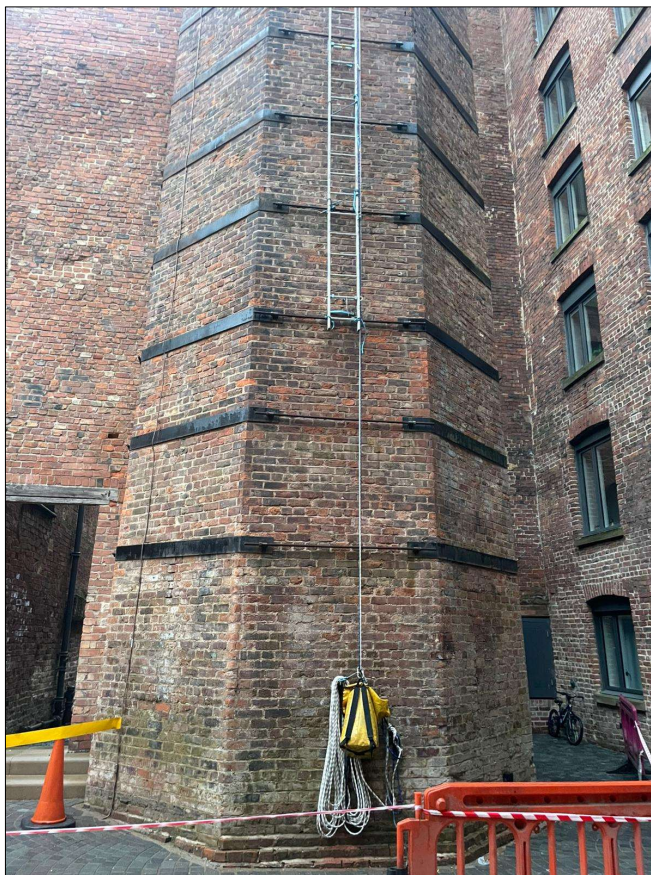
← Image 2.

General view of the chimney  
base showing the post  
tensioning band layout.  
+1.0m AGL.

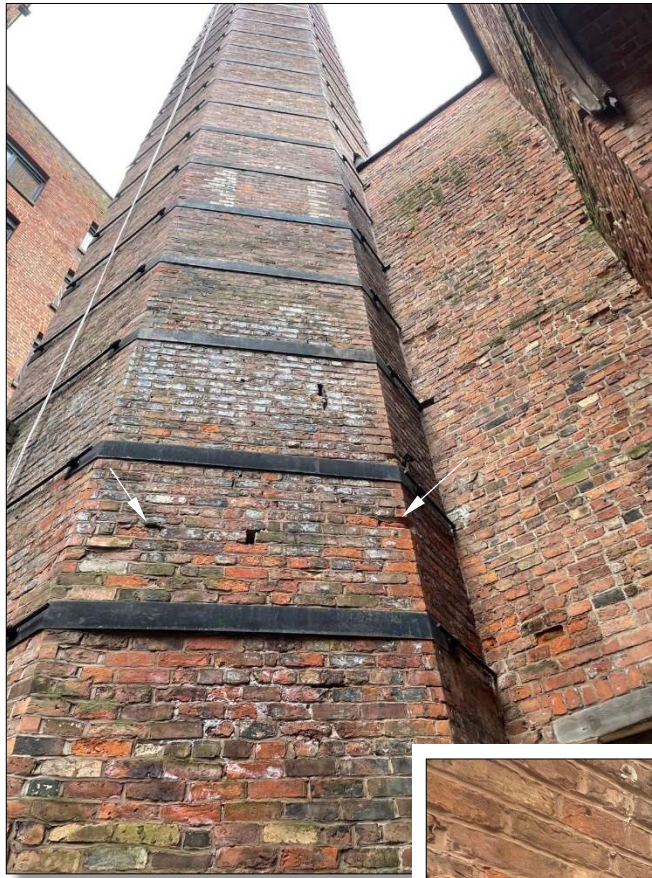
← Image 3.

The brick barrel received extensive internal and external repair during the 2016 refurbishment works. As a result, the material condition of the masonry typically remains in a good serviceable state. Localised spalling was found within several bricks located within the lower 3.6m of the chimney. Although this is of no immediate consequence to the durability of the masonry, this does pose a hazard to pedestrian traffic at the base of the chimney and therefore should be repaired at the earliest opportunity.

Fragmentation of isolated bricks within the chimney base.

+3.6m AGL.

3. ■ Remove all exfoliated brickwork from the lower 3.6m of the chimney. Approx 4x areas.
4. ■ Carry out patch repairs to the pointing using lime base mortar. Approx 2sq.m

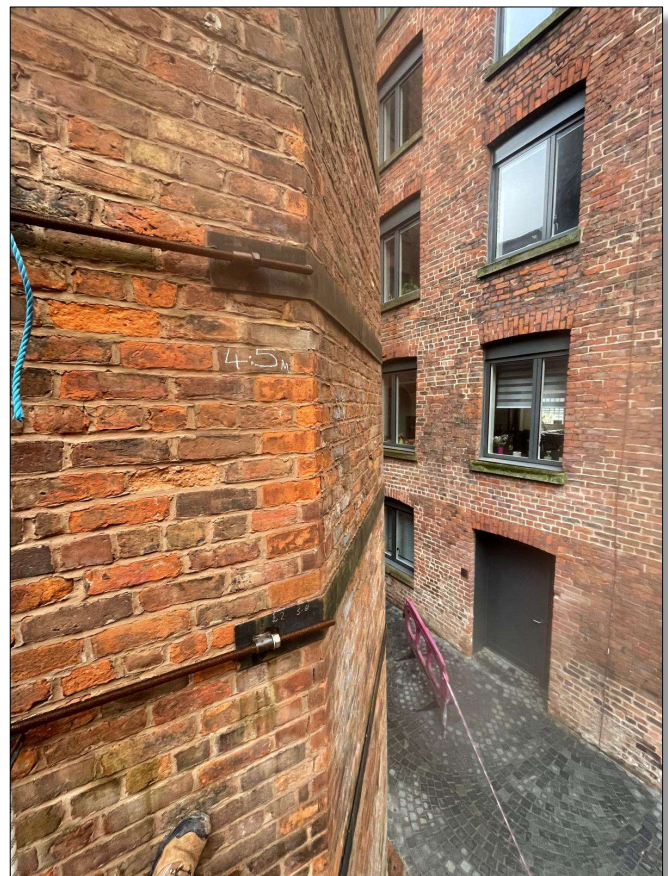
Image 4. →

General view of the masonry within the base region of the barrel. Pointing and brick fabric typically in good order.

+4.5m AGL.

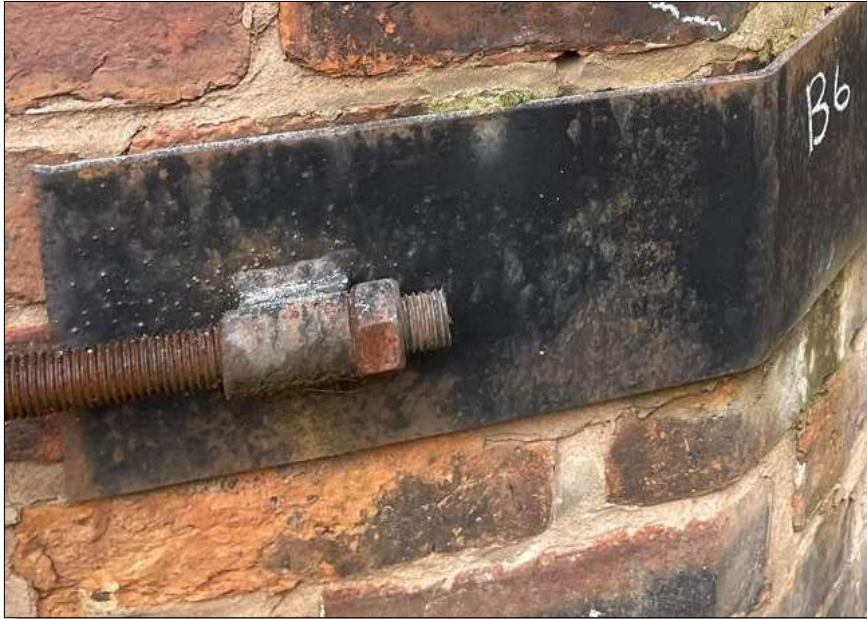
↑ Image 5.

Design of these bands is somewhat unconventional primarily due to their underspecified cross sectional area. CICIND model codes specifies a band cross section of 75mm deep x 10mm thick which gives a cross-sectional area of 750mm<sup>2</sup>. The current 150x4 bands adopt a cross-sectional area of 600mm<sup>2</sup>. However, due to bolt connection tubes located at the ends of each band segment, the 2016 bands have been notched to enable fitting of the nuts. This 50mm notch reducing the effective cross section area to 400mm<sup>2</sup>.

View of the structurally inadequate band bolt connection detail common throughout all barrel bands.

+8.6m AGL.

5. ■ Replace all bands located throughout the lower 25m of the chimney.  
All new bands to be fabricated from 75x10 (minimum) carbon steel plate with double reinforced lugs.  
New bands to be shop painted 1x coat of Interplus 256 and 1x coat of Interthane 990 (black)  
All bands to be sequentially bonded to the existing lightning conductor system in accordance with BSEN 62305.  
All fasteners to be galvanised coated.

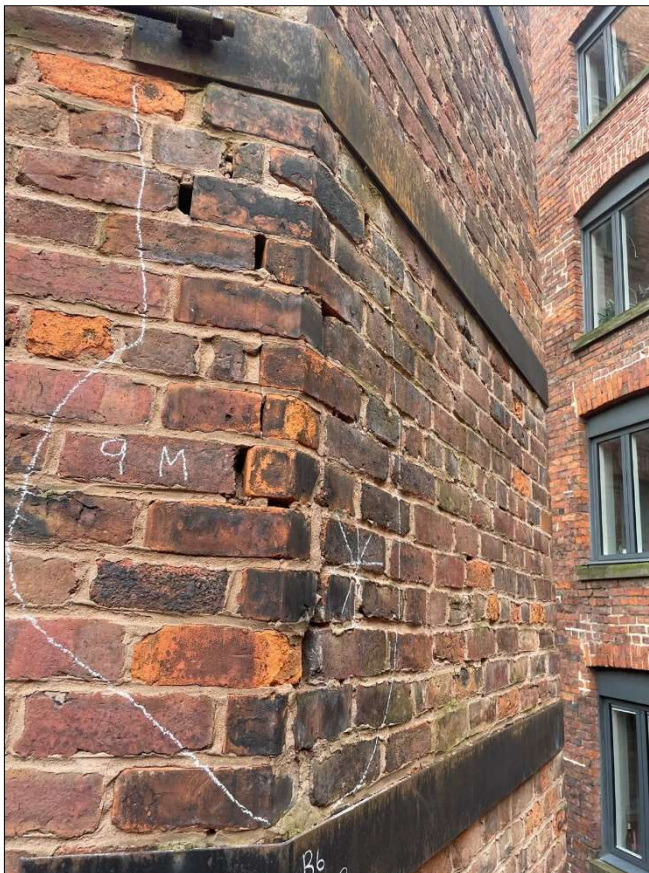
← Image 6.

As part of the above, the exterior of the chimney was totally repointed using lime-based mortar. The material condition of the pointing remains in a good serviceable condition. However, localised joints remain open where the original pointing was ground out and never reinstated. This is captured within images 6-12 which accompany this report.

Isolated areas of painting failure.

+9.0m AGL.

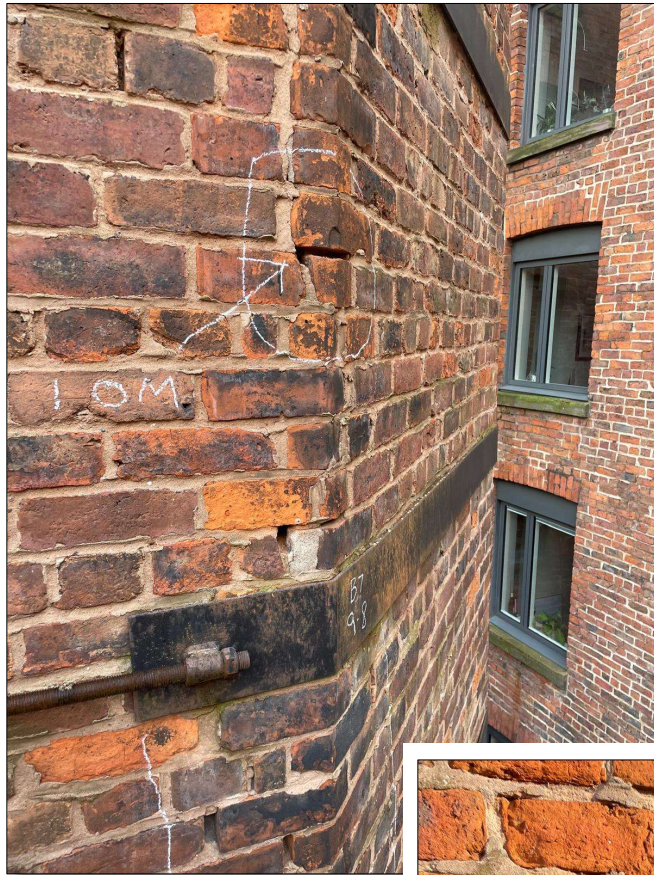
← Image 7.

Isolated areas of pointing failure.

+10.0m AGL.

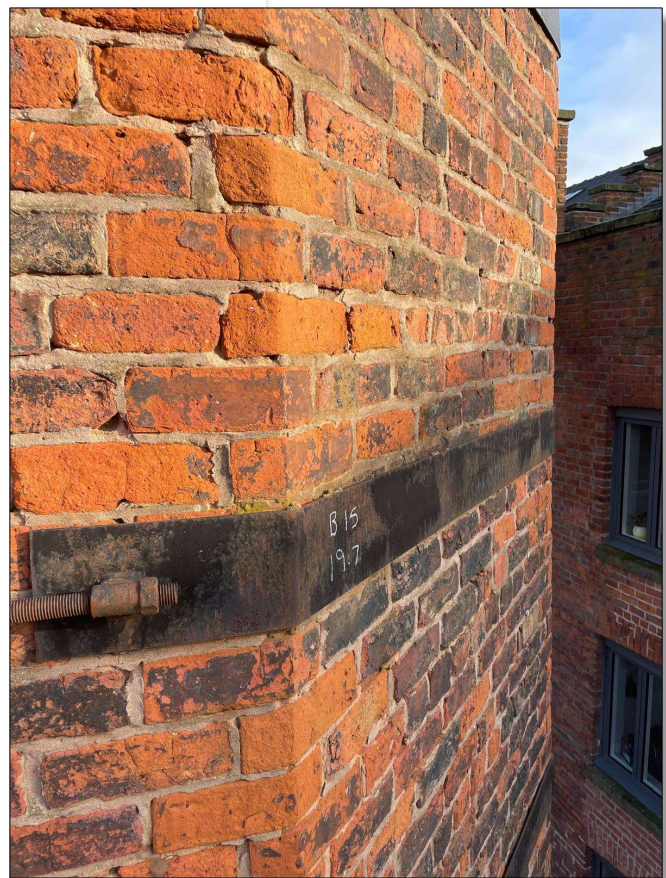
Image 8. →

View of the masonry around the central region of the barrel showing no areas of concern. Note the coating depletion of the band.

+19.7m AGL.

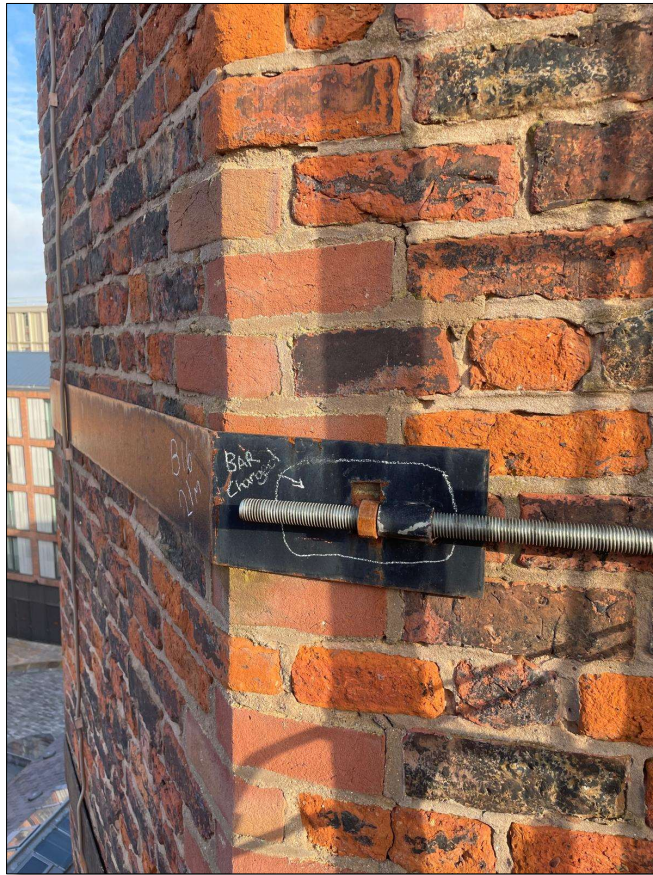
← Image 9.

View of the unconventional 150x5 carbon steel bands common throughout the brick barrel.

+21.0m AGL.

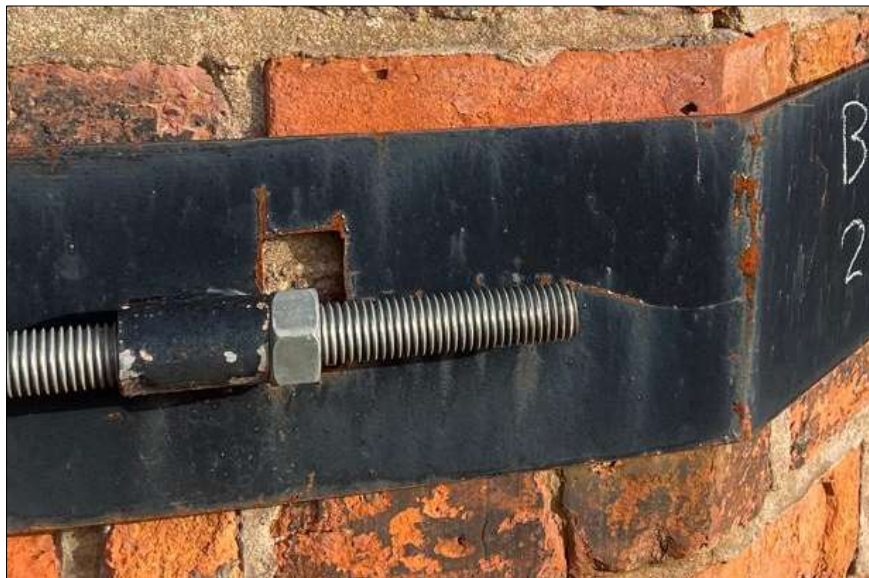
↓ Image 10.

Notching of the band to permit tightening of the M20 threaded bars.

+22.4m AGL.

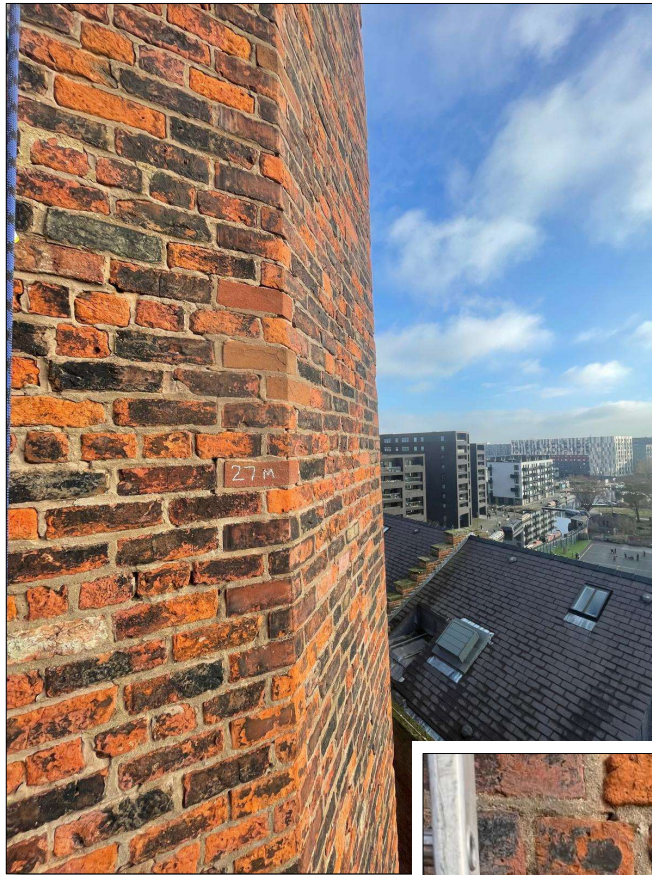
← Image 11.

Typical view of the masonry around the central region of the chimney showing no areas of immediate concern.  
+27.0m AGL.

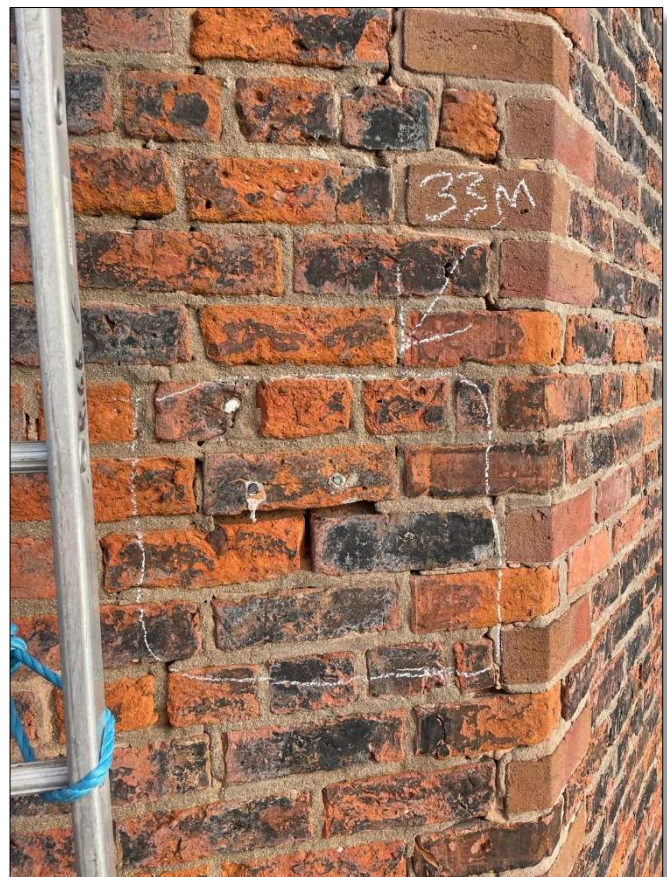
Image 12. →  
Isolated defective pointing.  
+33.0m AGL.

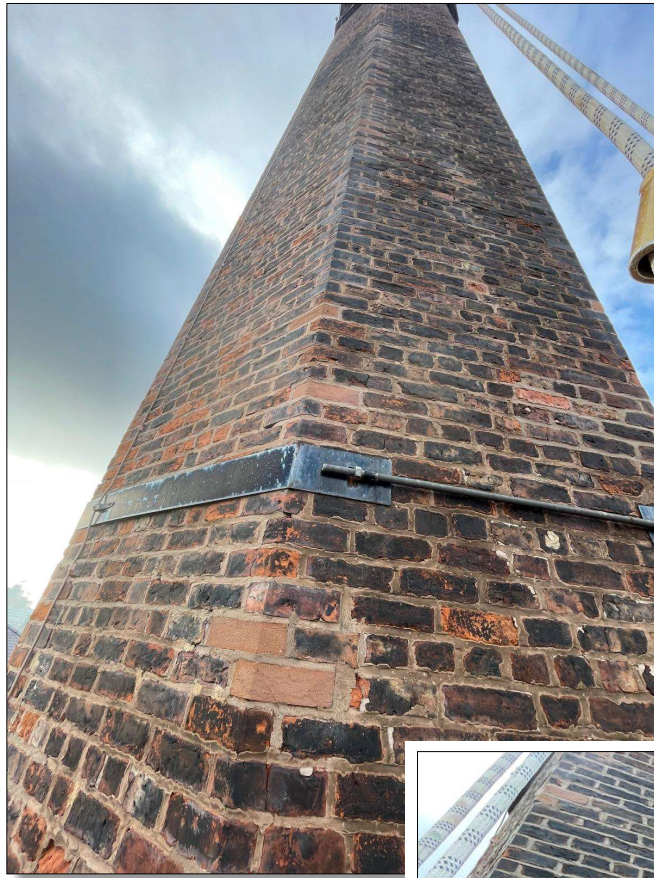
← Image 13.

Localised brick replacement  
to the corners of the barrel.  
Masonry in good order.

+25.0m AGL.

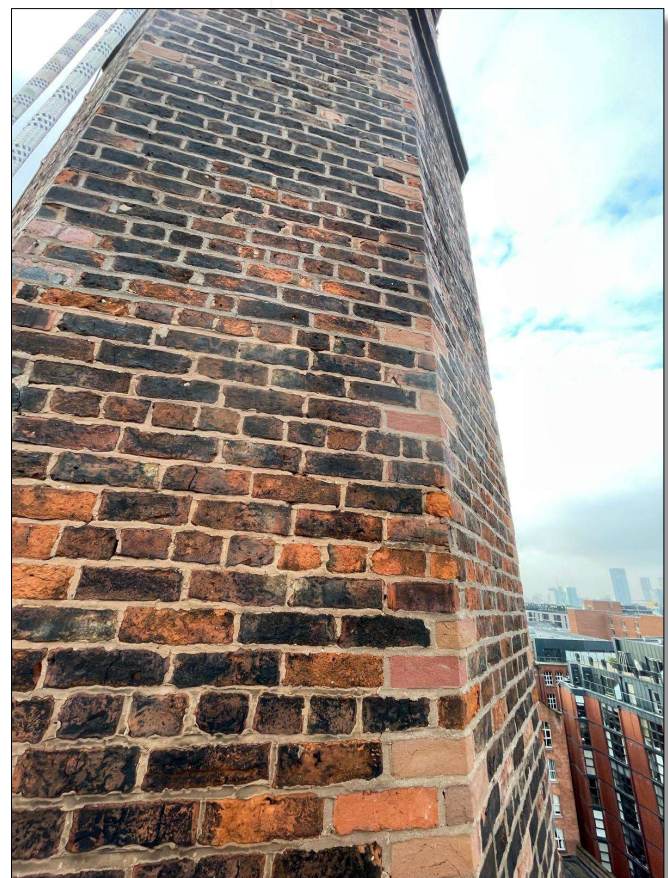
Image 14. →

General view of the masonry  
within the upper barrel section  
of the chimney showing no  
areas of concern.

+31.5m AGL.

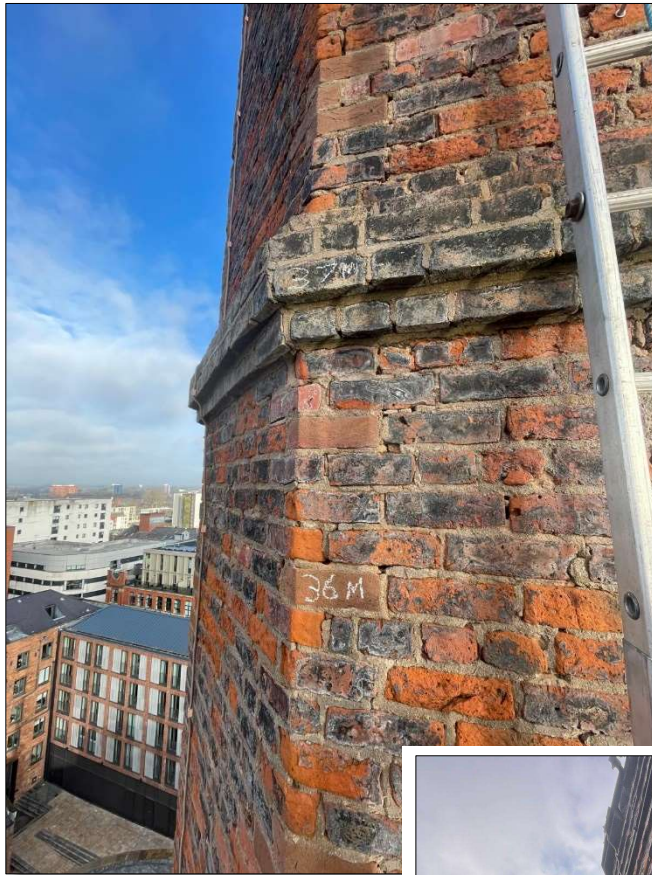
← Image 15.

General view of the masonry around the stringcourse level of the chimney. All in good order.

+34.6m AGL.

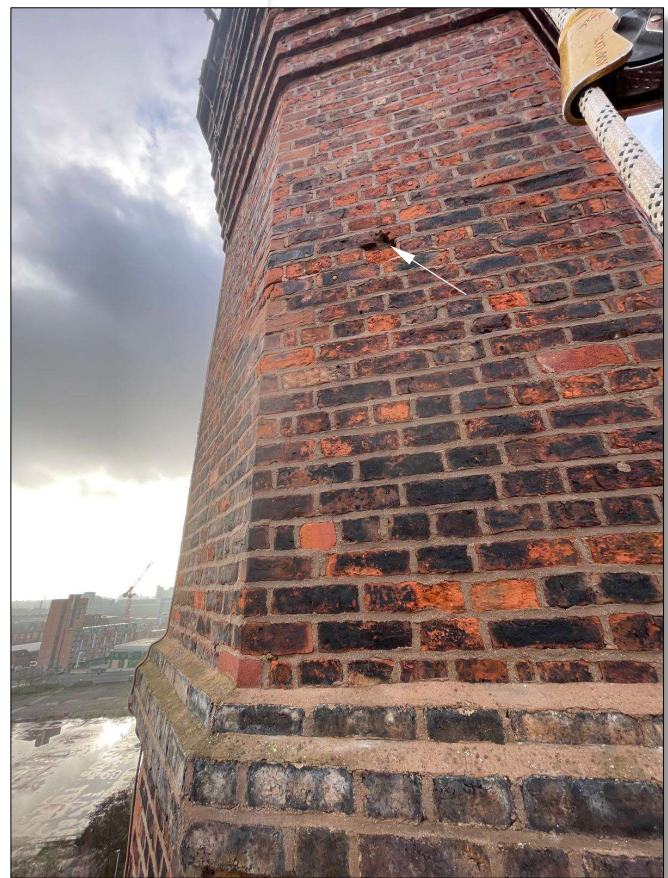
Image 16. →

Isolated fragmentation of a brick located within the neck section of the chimney.

+35.0m AGL.

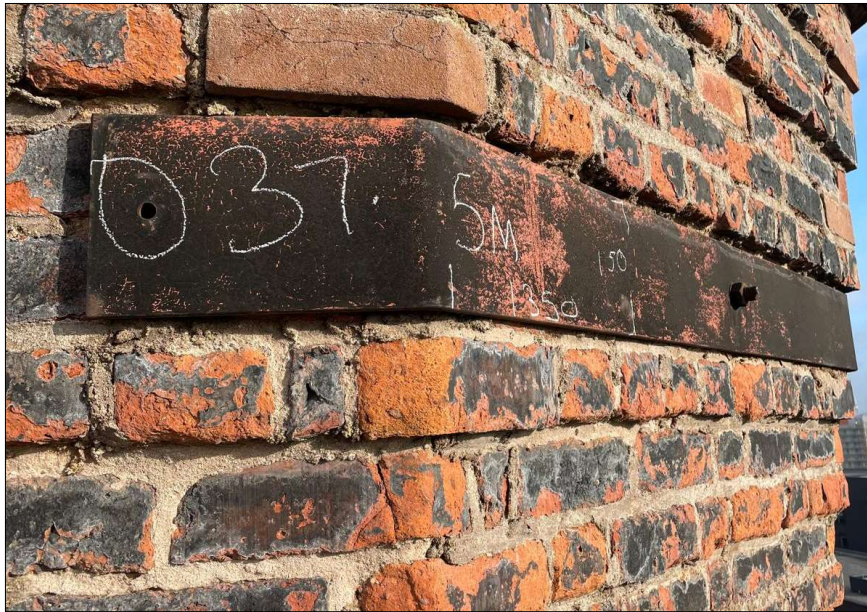
↑ Image 17.

Paint depletion to the carbon steel pattress plates which connect to the internal tie rods.

+37.9m GAL.

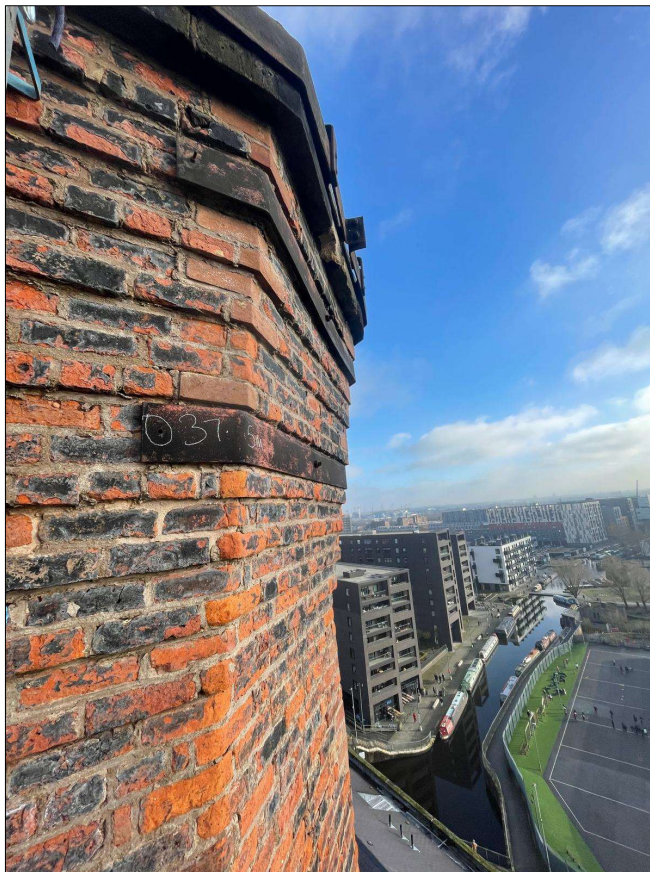
← Image 18.

View of the masonry common to the head section. All in good order.

+37.9m AGL.

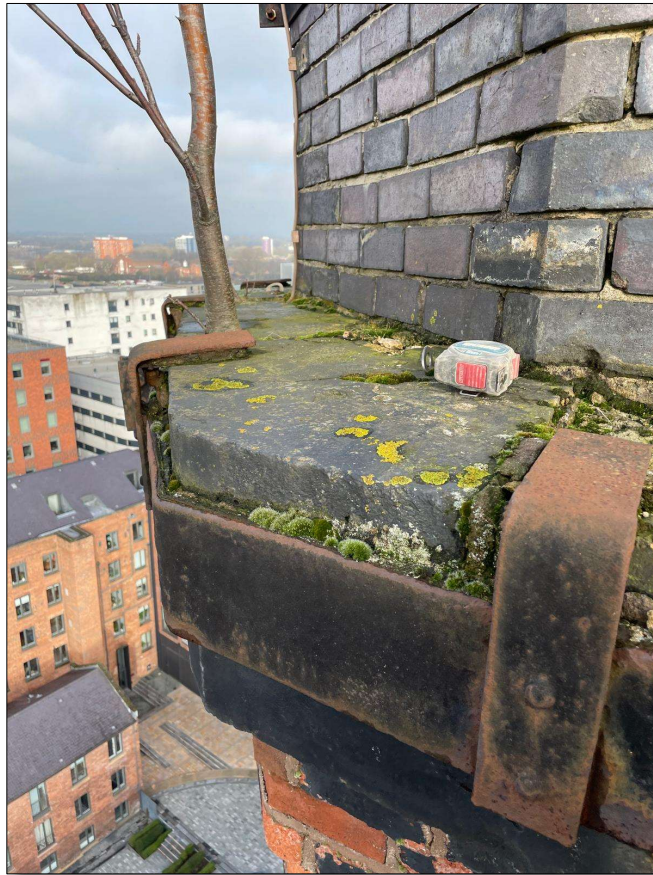
← Image 19.

Paint loss to the cornice  
hanger band.

+39.1m AGL.

1. ■ Replace the hanger band located around the exterior of the +3 9.15m sandstone cornice.  
New band to be fabricated in 8x equally sized segments.  
New band to be bonded to the existing lightning conductor.  
New band to be shop painted 1x coat of Interplus 256 and 1x coat of Interthane 990 (black)  
All fasteners to be galvanised coated.

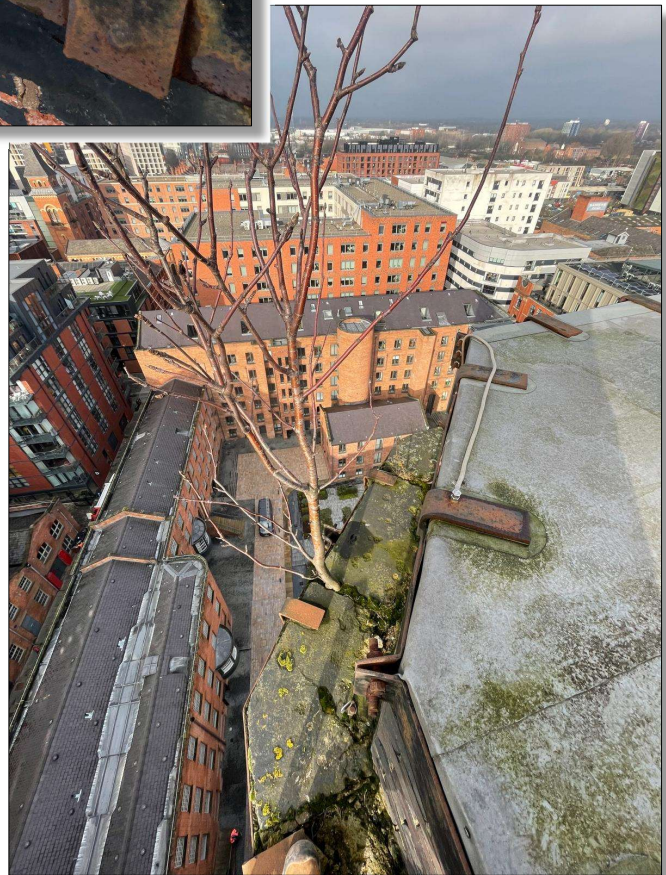
Image 20. →

Vegetation growth is present within mortar joints along with a bush growing within the N.W. elevation.

Bush growing within the open  
joint of the cornice.

+39.1m AGL.

2. ■ During the above hanger band replacement, remove all vegetation and friable material from the sandstone cornice.  
Repoint all joints within the cornice and reprofile the spalled stonework using a St Astier One Stone repair system or similar approved.

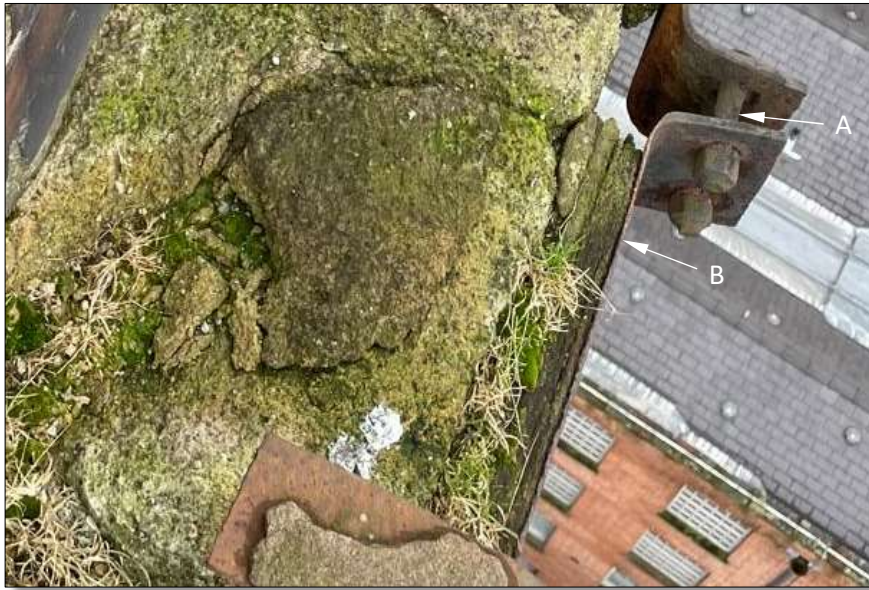
↑ Image 21.

The 150x12 carbon steel hanger band located around the sandstone cornice was found to be in a poor structural condition with severe section loss reducing its wall thickness from its original 12mm to 2mm (83% loss). Lateral pressure from expansive blistering corrosion to the rear of the band has caused outward displacement imposing additional tensile stress. This is evidenced by bending deformation of the lug connections and associated 2-M20 bolts. By inspection, this band appears to be quite old and it is assumed to have been installed circa 1950s. Due to the heavy material decay and deformation within the band, it is apparent that its serviceability is compromised to the extent that it is structurally unstable and needs urgent replacement.

Heavy deterioration to the cornice post tensioning band located +39.0m AGL renders it structurally unstable and, as a result, requires urgent replacement before its pending failure. Although replacement of these bands is straight forward, execution of the works is aggravated by heavy spalling within the cornice sandstone blocks. This needs to be considered when embarking on the remedial works. On completion of the band replacement, all loose and friable sandstone should be removed along with all vegetation growth and the affected sandstone reprofiled and pointed using a suitable hydraulic lime-based mortar.

Severe thinning (A) of the cornice hanger band. Note the tensile deformation of the bolts (B) and fragmentation of the sandstone cornice.

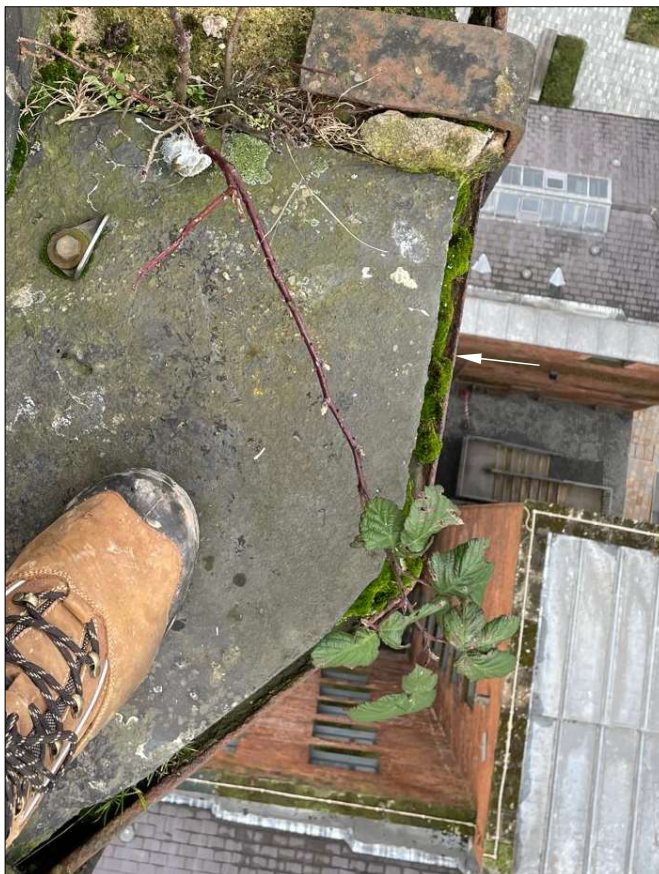
← Image 22.

85% section loss to the cornice hanger band.

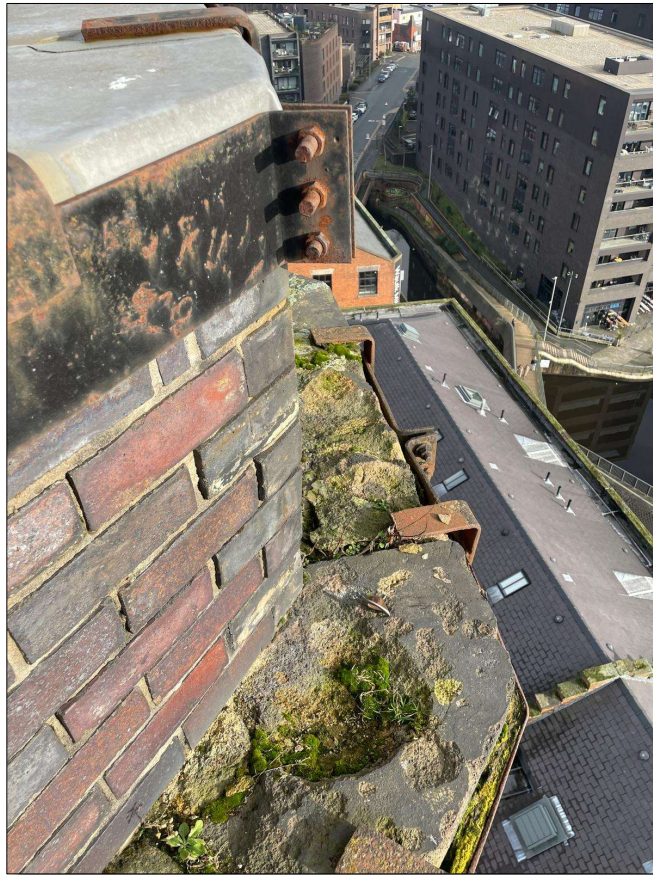
← Image 23.

The material condition of the top layer of blocks remains in a stable condition throughout the Northerly elevation of the chimney although conversely, the South side is heavily spalled and cracked.

Fragmentation of the  
sandstone cornice.

+39.1m AGL.

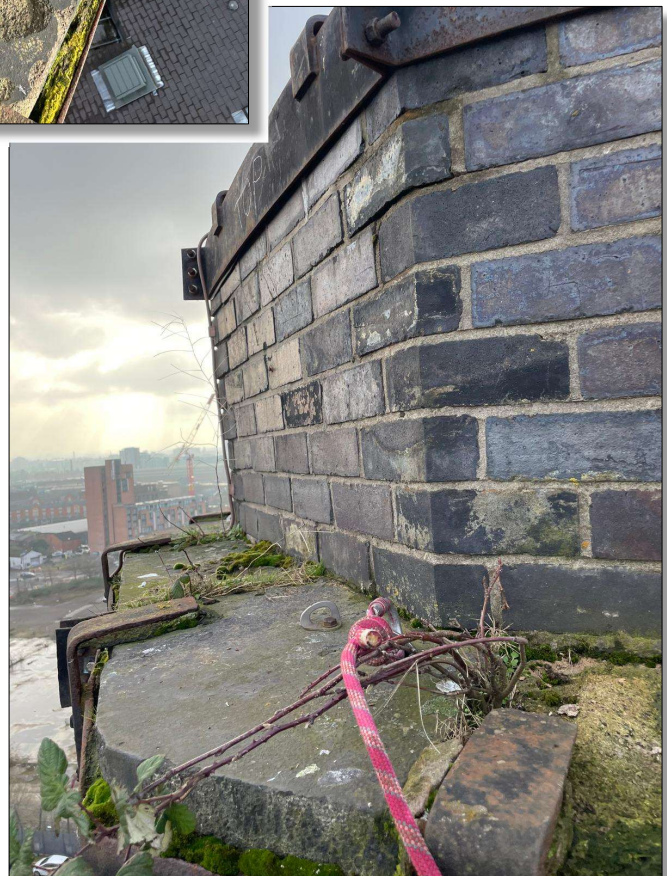
Image 24. →

View of the Staffordshire blue  
brickwork to the recently  
reconstructed head section.

All in good order.

+39.5m AGL.

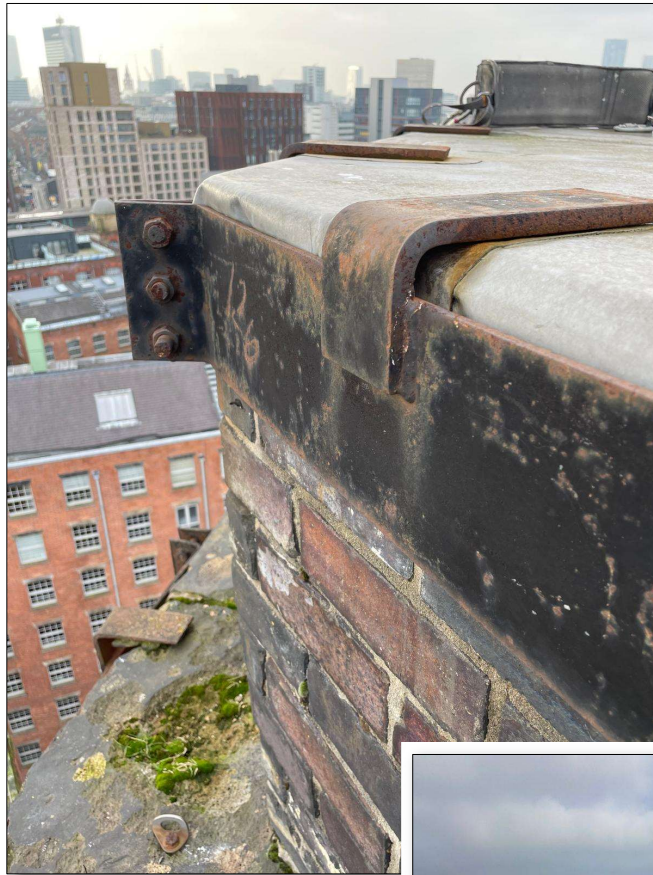
← Image 25.

By inspection, the uppermost band located around the perimeter of the head section is fabricated in 8x segments with each segment fabricated from 150x6 flat carbon steel plate. Each segment is connected to its neighbour using 3xM16 bolts. It would appear that the band was cleaned and painted during the 2016 works. The durability of the coating is starting to deplete enabling minor rust development on unprotected surfaces.

Coating depletion to the top hanger band.

+39.9m AGL.

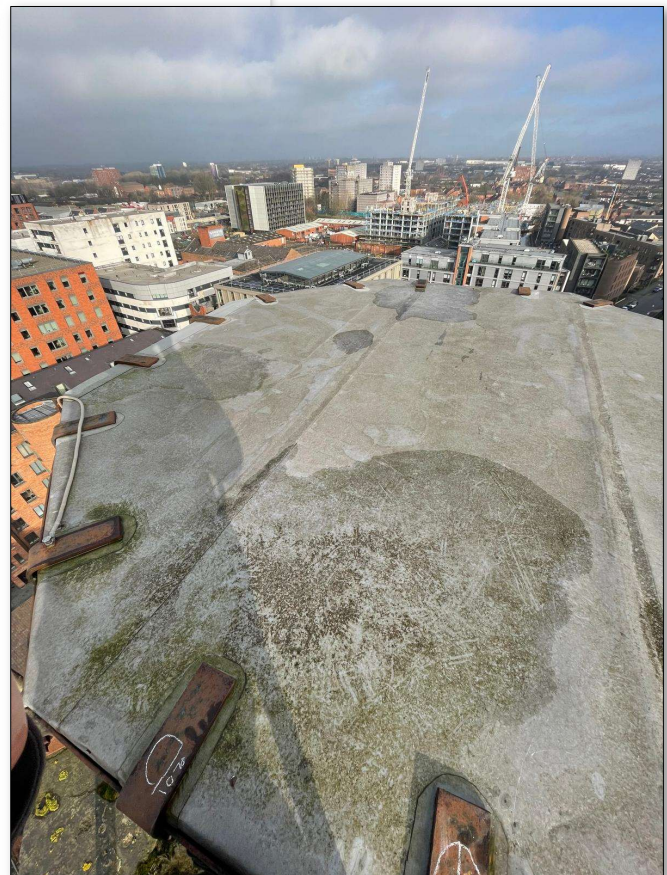
Image 26. →

It is usual in capping design to allow for natural ventilation, especially for a chimney which has been left open to the elements for a significant period of time. This capping has no provision for ventilation which could accelerate deterioration of the inaccessible substructure elements. In addition, ventilation also needs to be installed to the base of the chimney to enable air flow within the chimney interior.

General view of the polymeric roof covering. All in good order. Note the lack of natural ventilation to the chimney interior.

+40.0m AGL.

6. ■ Install 1x 150mm diameter ventilation hole and stainless steel weatherproof cover to the current capping arrangement.  
Change the current door at the chimney base with new. Door to incorporate a louvered opening to promote air flow within the chimney interior.

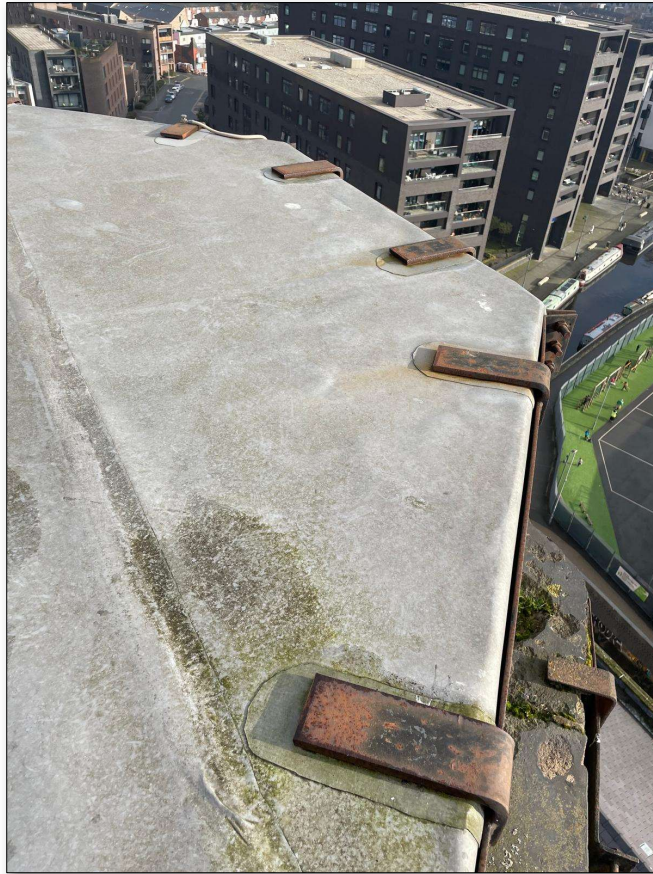
← Image 27.

General view of the  
terminating hanger band  
showing suitable retention  
of the roof covering.

+40.0m AGL.

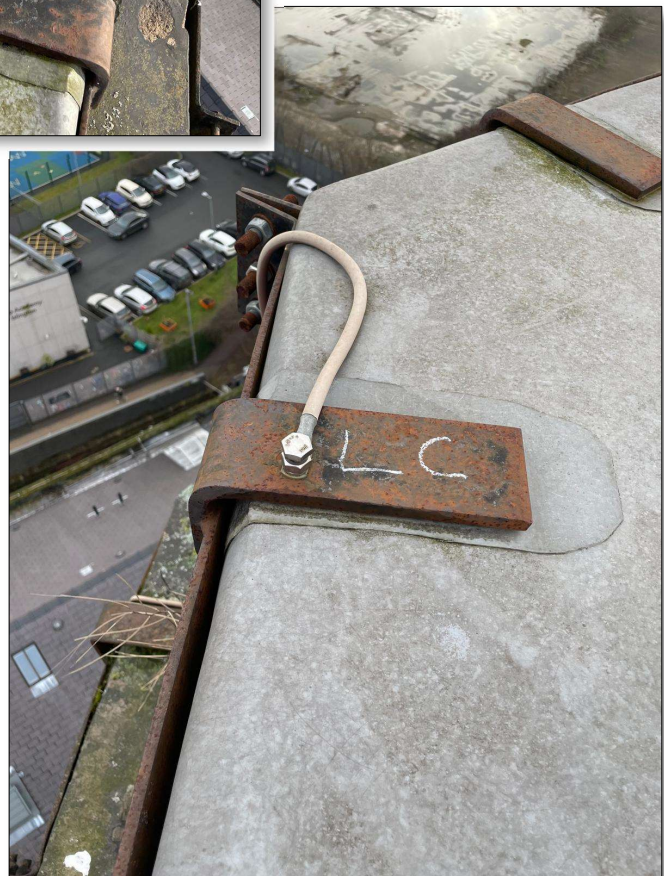
Image 28. →

Sequential bonding of the roof  
plate hanger band.

+40.0m AGL.
