## SURVEY & ENGINEERING PROJECTS

Job Number  
**S26205**

HAWTHORN LANE

# CCTV Inspection Report

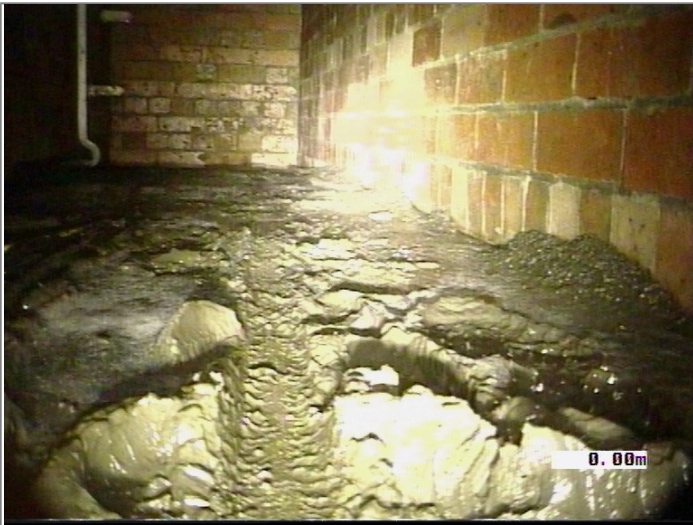
Start node type, manhole, reference UU2901

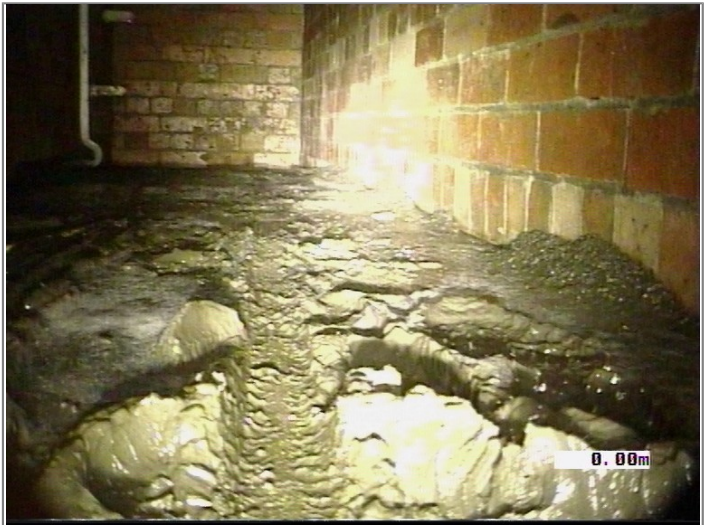
Water level 5% height/diameter

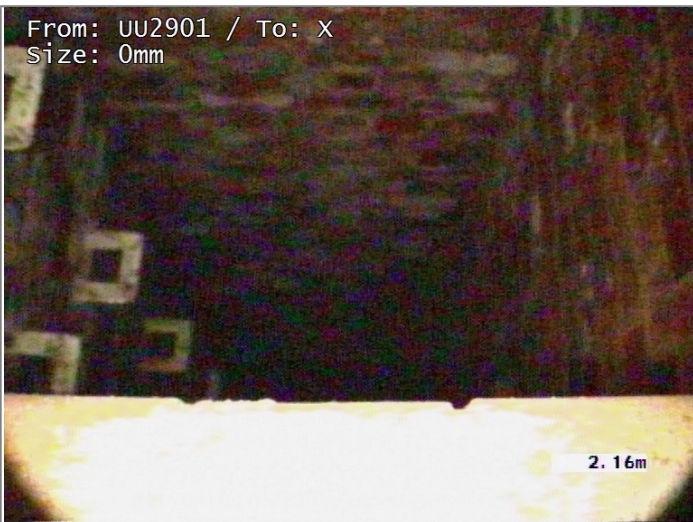
Survey abandoned - Remark: SEWER DEPTH ARROUND 12 TO 15M DEPTH

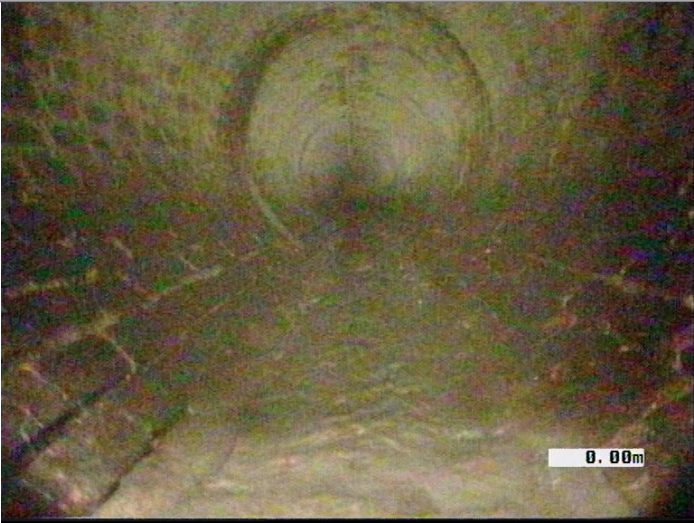
| Job Number<br><b>S26205</b> | Surveyed by (Operator)<br><b>JOE COLLINS</b> | Base Unit<br><b>LSDUKESDT</b> | Date<br><b>30/07/2025</b> |
|---|---|---|---|
| Start node type, manhole, reference MH2 | | | |

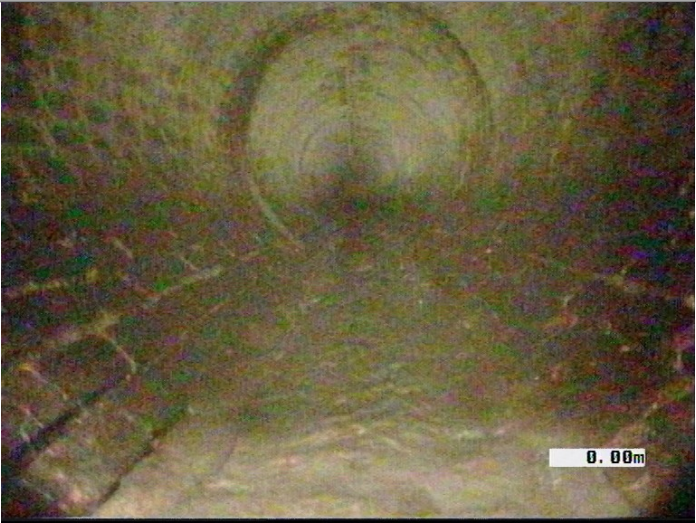
| Job Number<br><b>S26205</b> | Surveyed by (Operator)<br><b>JOE COLLINS</b> | Base Unit<br><b>LSDUKESDT</b> | Date<br><b>30/07/2025</b> |
|---|---|---|---|
| Water level 5% height/diameter | | | |

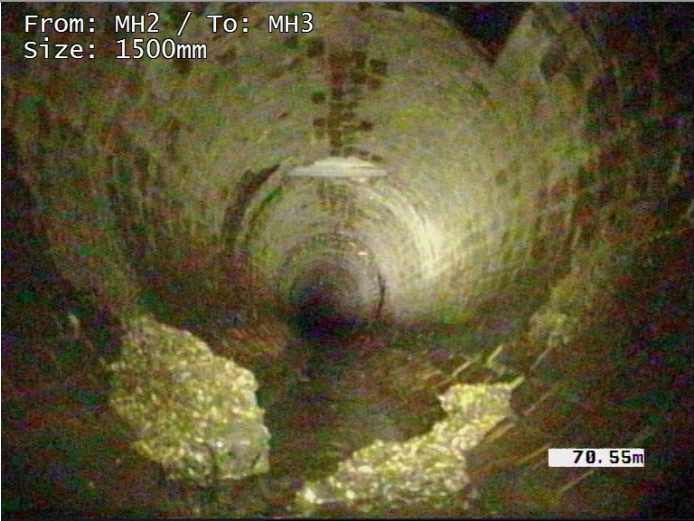
| Position | Code | Description | Photo | Type/Grade |
|---|---|---|---|---|
| | 70.55 | DEC | Settled deposits hard or compacted 10% cross-sectional area loss | 12734052 Service / 3 |

| Job Number<br><b>S26205</b> | Surveyed by (Operator)<br><b>JOE COLLINS</b> | Base Unit<br><b>LSDUKESDT</b> | Date<br><b>30/07/2025</b> |
|---|---|---|---|
| Settled deposits hard or compacted 10% cross-sectional area loss | | | |

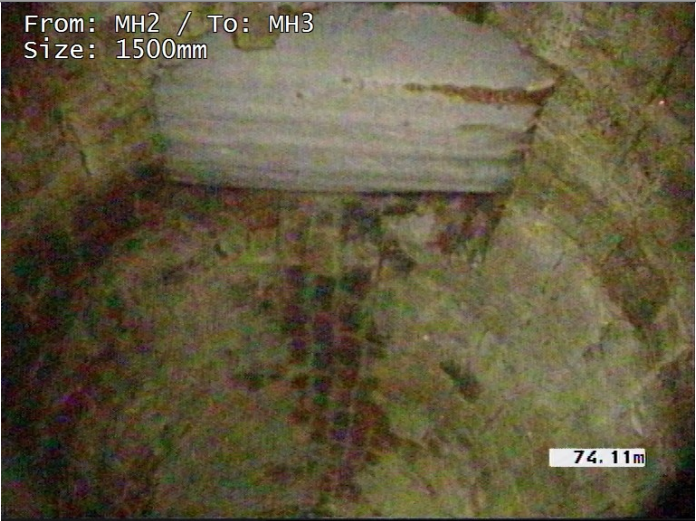
| Position | Code | Description | Photo | Type/Grade |
|---|---|---|---|---|
| | 74.11 | OBI | Other obstacles protruding through wall from 10 to 2 o'clock 10% cross-sectional area loss | 12734072 Service / 5 |

| Job Number<br><b>S26205</b> | Surveyed by (Operator)<br><b>JOE COLLINS</b> | Base Unit<br><b>LSDUKESDT</b> | Date<br><b>30/07/2025</b> |
|---|---|---|---|
| Other obstacles protruding through wall from 10 to 2 o'clock 10% cross-sectional area loss | | | |

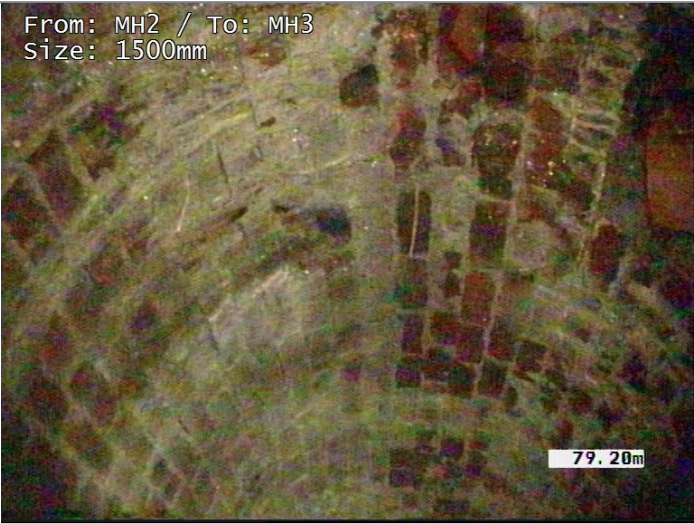
| Job Number<br><b>S26205</b> | Surveyed by (Operator)<br><b>JOE COLLINS</b> | Base Unit<br><b>LSDUKESDT</b> | Date<br><b>30/07/2025</b> |
|---|---|---|---|
| Connection other than junction at 2 o'clock, diameter 150mm | | | |

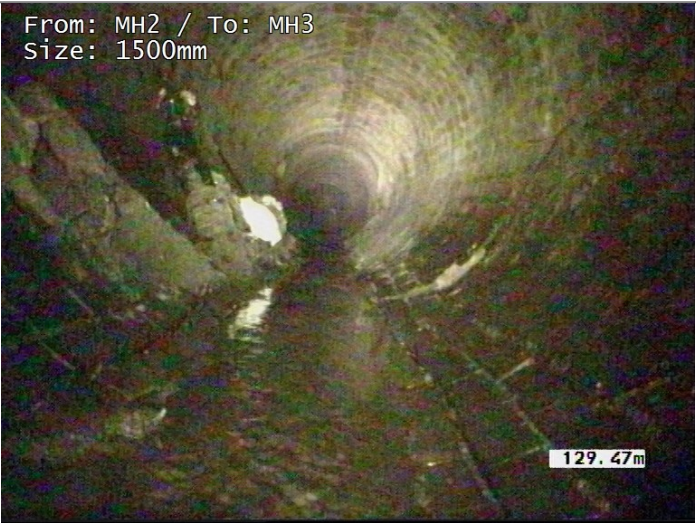
| Position | Code | Description | Photo | Type/Grade |
|---|---|---|---|---|
| | 129.47 | DEZ | Other attached deposits from 7 to 10 o'clock 10% cross-sectional area loss - Remark | 12734107 Service / 3 |

| Job Number<br><b>S26205</b> | Surveyed by (Operator)<br><b>JOE COLLINS</b> | Base Unit<br><b>LSDUKESDT</b> | Date<br><b>30/07/2025</b> |
|---|---|---|---|
| Other attached deposits from 7 to 10 o'clock 10% cross-sectional area loss - Remark | | | |

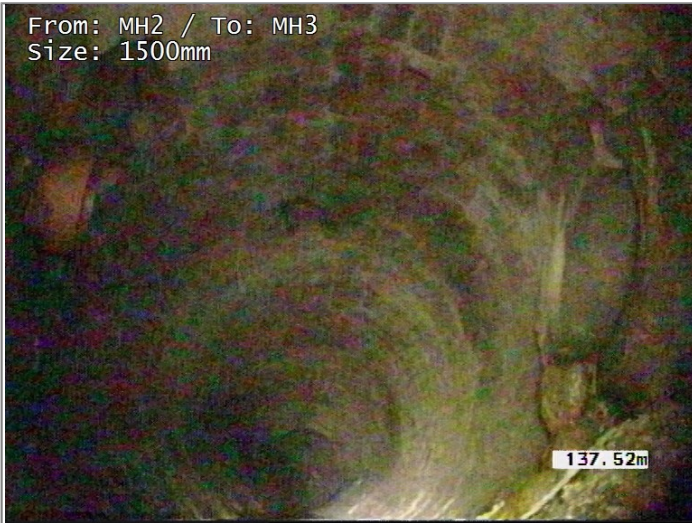
Connection other than junction at 3 o'clock, diameter 300mm

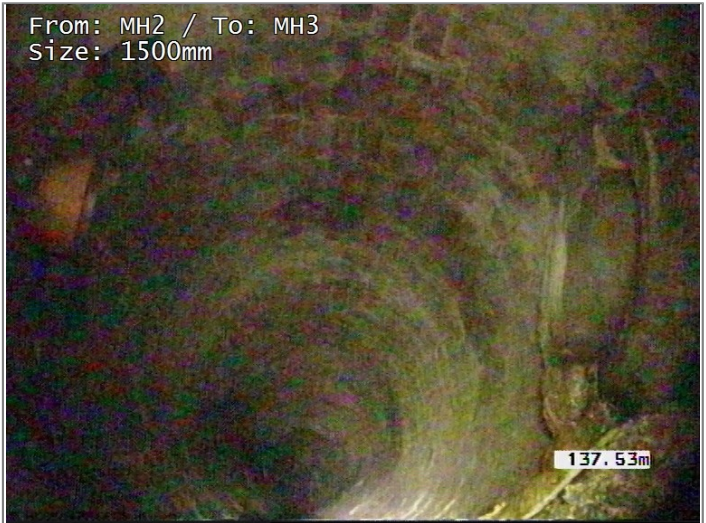
Connection other than junction at 10 o'clock, diameter 150mm

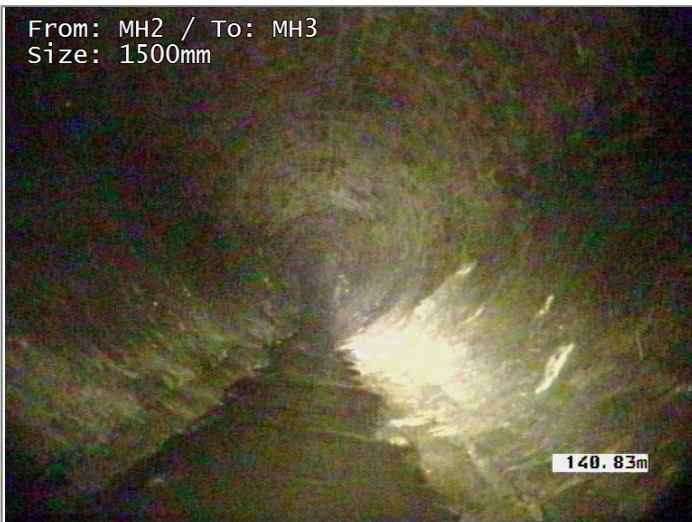
Survey abandoned - Remark: OUT OF CABLE OVERLAP REQUIRED

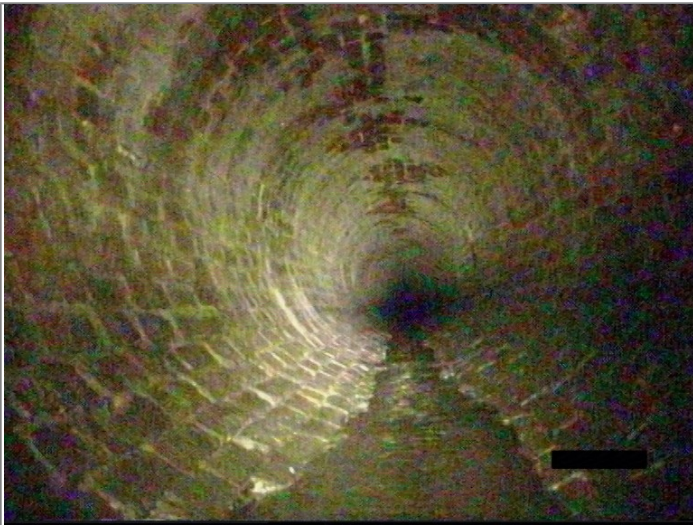
Start node type, manhole, reference MH2

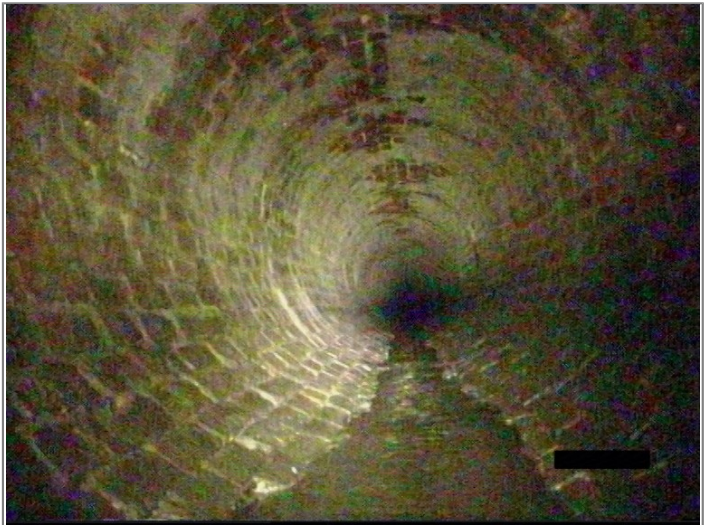
Water level 5% height/diameter

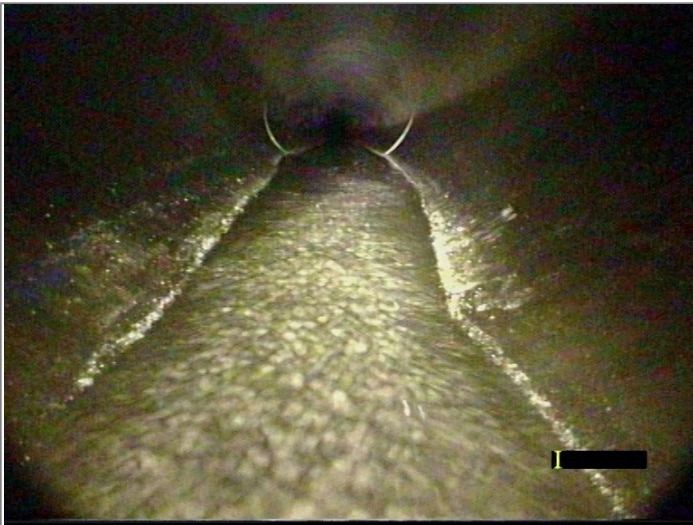
Start node type, manhole, reference MH1

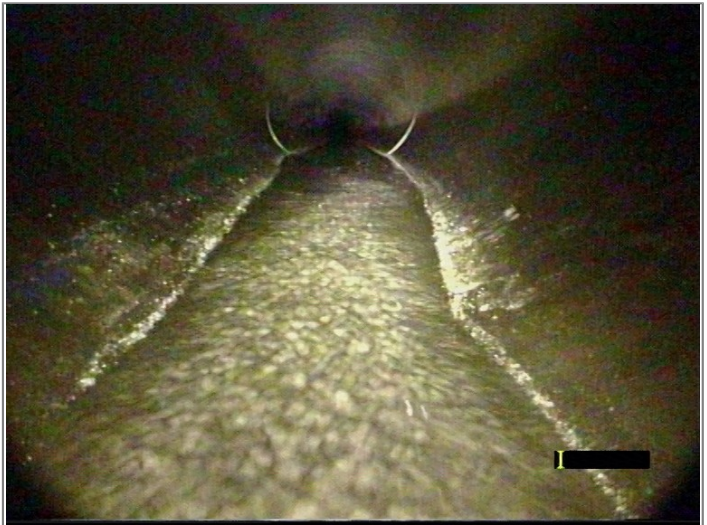
Water level 5% height/diameter

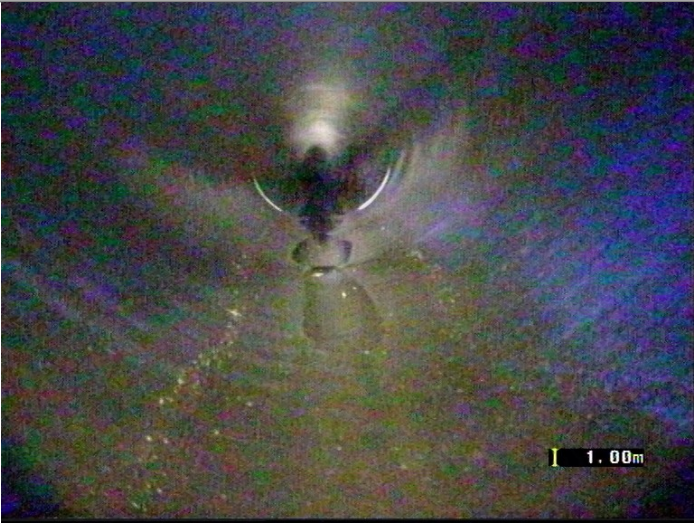
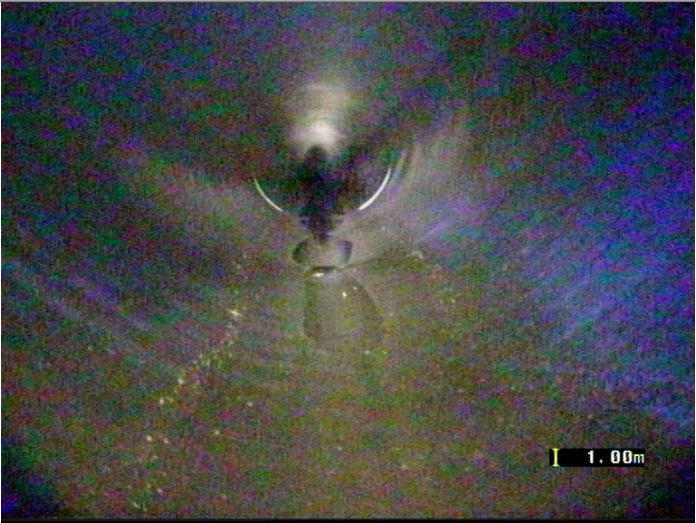
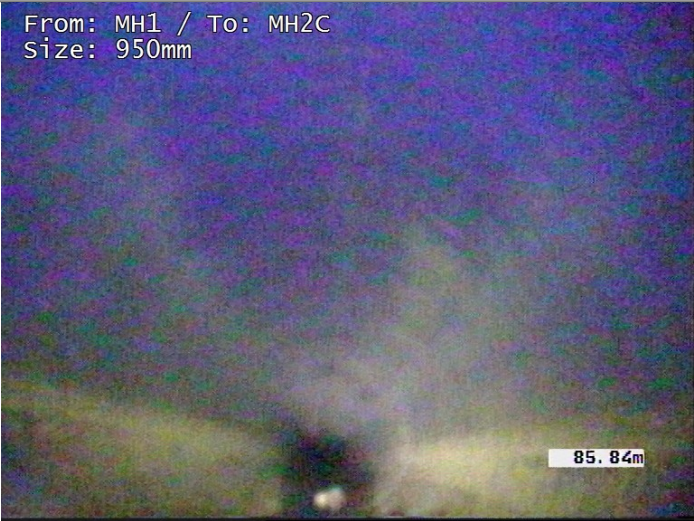
| Job Number<br><b>S26205</b> | Surveyed by (Operator)<br><b>JOE COLLINS</b> | Base Unit<br><b>LSDUKESDT</b> | Date<br><b>30/07/2025</b> |
|---|---|---|---|
| <p>Start node type, manhole, reference MH1</p> | | <p>Water level 5% height/diameter</p> | |
| <p>From: MH1 / To: MH2C<br/>Size: 950mm</p> <p>Finish node type, manhole, reference MH2C</p> | | | |

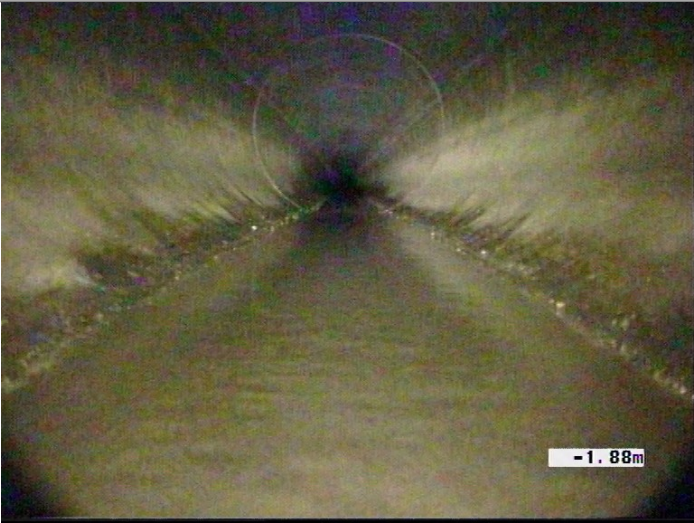
| Job Number<br><b>S26205</b> | Surveyed by (Operator)<br><b>JOE COLLINS</b> | Base Unit<br><b>LSDUKESDT</b> | Date<br><b>30/07/2025</b> |
|---|---|---|---|
| <p><b>-1.88m</b></p> <p>Start node type, manhole, reference MH2B</p> | | | |

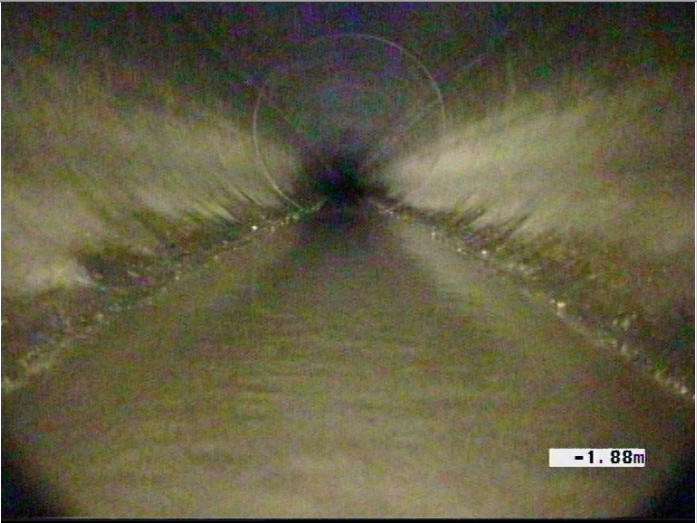
| Job Number<br><b>S26205</b> | Surveyed by (Operator)<br><b>JOE COLLINS</b> | Base Unit<br><b>LSDUKESDT</b> | Date<br><b>30/07/2025</b> |
|---|---|---|---|
| <p><b>-1.88m</b></p> <p>Water level 5% height/diameter</p> | | | |

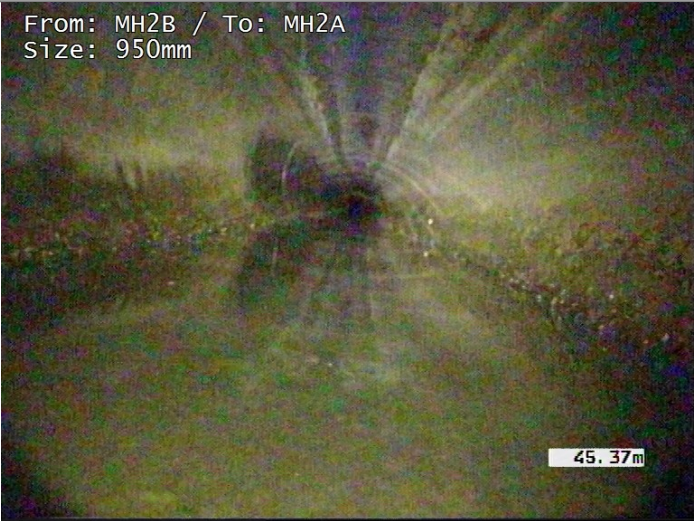
| Job Number<br><b>S26205</b> | Surveyed by (Operator)<br><b>JOE COLLINS</b> | Base Unit<br><b>LSDUKESDT</b> | Date<br><b>30/07/2025</b> |
|---|---|---|---|
| <p>From: MH2B / To: MH2A<br/>Size: 950mm</p> <p><b>45.37m</b></p> <p>Water level 15% height/diameter</p> | | | |

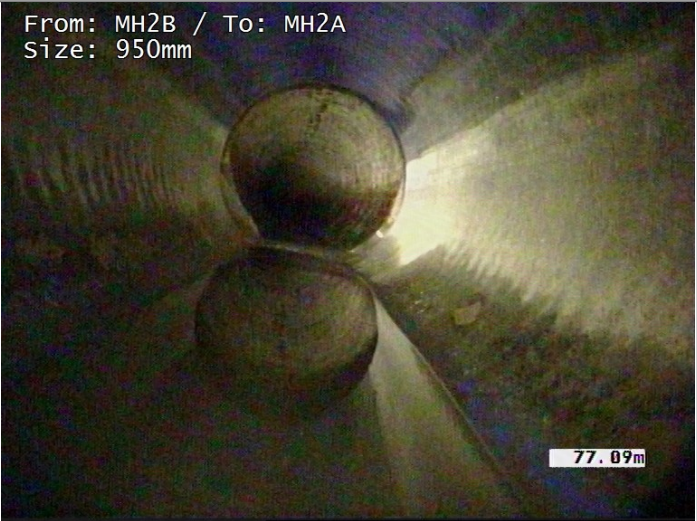
| Job Number<br><b>S26205</b> | Surveyed by (Operator)<br><b>JOE COLLINS</b> | Base Unit<br><b>LSDUKESDT</b> | Date<br><b>30/07/2025</b> |
|---|---|---|---|
| <p>From: MH2B / To: MH2A<br/>Size: 950mm</p> <p><b>77.09m</b></p> <p>Line of drain/sewer deviates left</p> | | | |

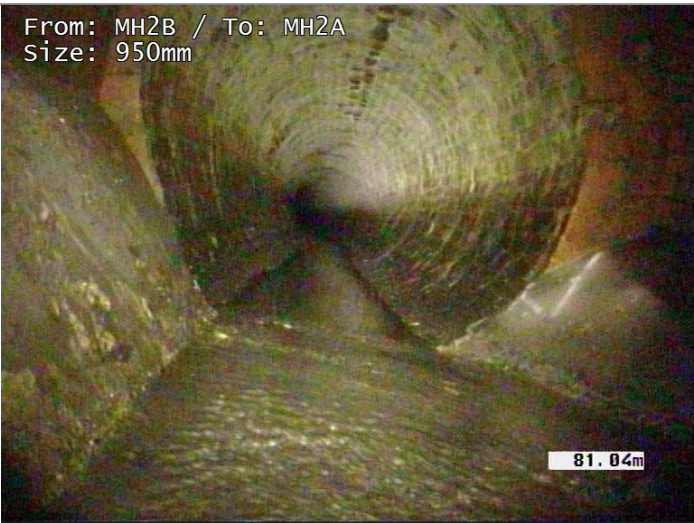
| Job Number<br><b>S26205</b> | Surveyed by (Operator)<br><b>JOE COLLINS</b> | Base Unit<br><b>LSDUKESDT</b> | Date<br><b>30/07/2025</b> |
|---|---|---|---|
| <p>From: MH2B / To: MH2A<br/>Size: 950mm</p> <p><b>81.04m</b></p> <p>Finish node type, manhole, reference MH2A</p> | | | |

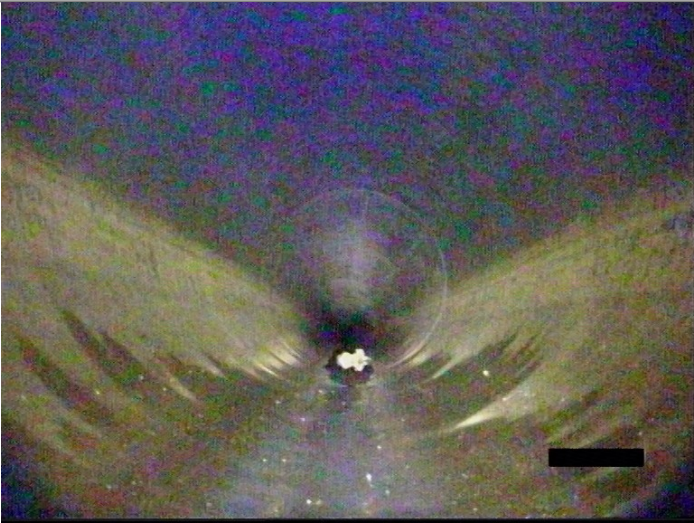
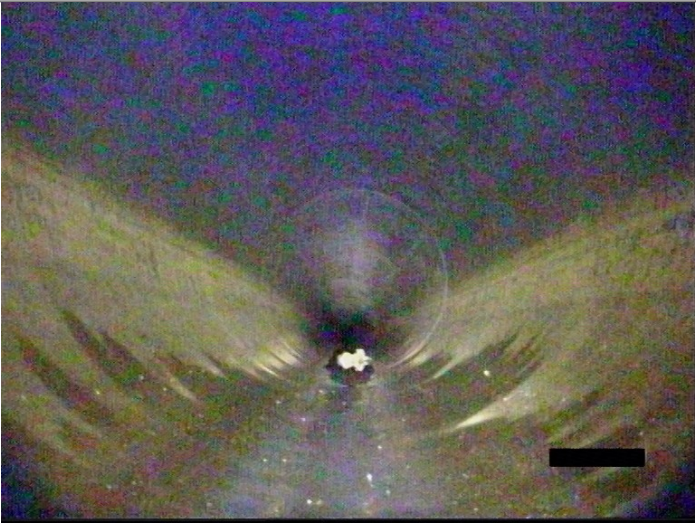
| Job Number<br><b>S26205</b> | Surveyed by (Operator)<br><b>JOE COLLINS</b> | Base Unit<br><b>LSDUKESDT</b> | Date<br><b>30/07/2025</b> |
|---|---|---|---|
| <p>Start node type, manhole, reference MH2C</p> | | <p>Water level 5% height/diameter</p> | |

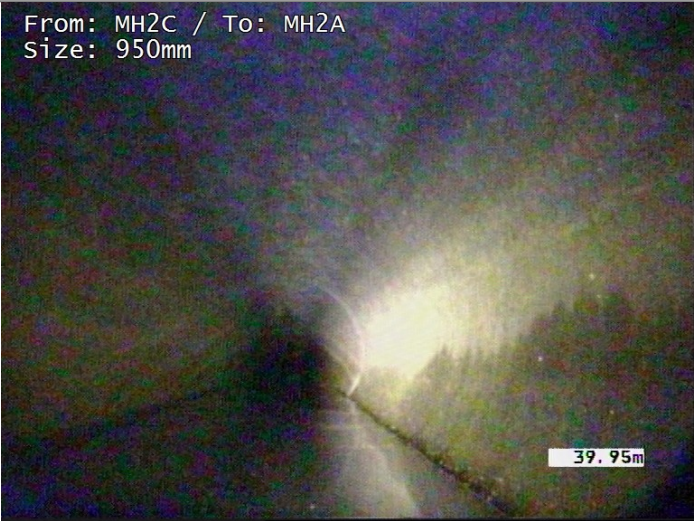
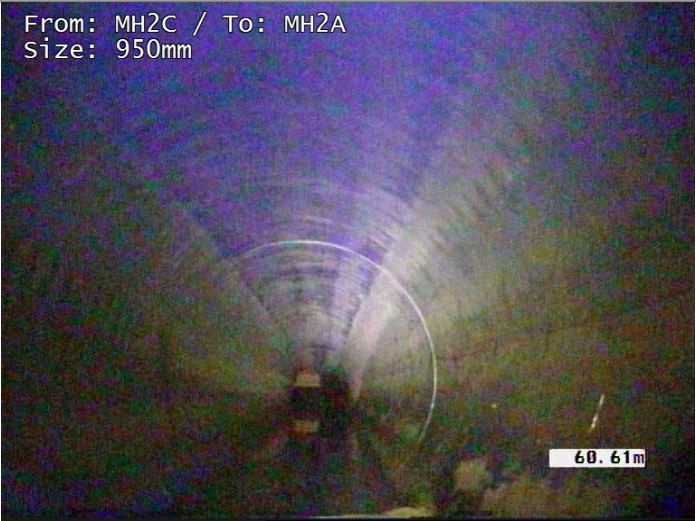
| Start Node Ref:MH2C I/L : metres Depth: 2.08 metres | | | | | Photo | Type/Grade |
|---|---|---|--|--|---|---|
| 60.61 | DER | Settled deposits coarse 10% cross-sectional area loss | | | 12737103 | Service / 3 |

| Job Number<br><b>S26205</b> | Surveyed by (Operator)<br><b>JOE COLLINS</b> | Base Unit<br><b>LSDUKESDT</b> | Date<br><b>30/07/2025</b> |
|---|---|---|---|
| <p>From: MH2C / To: MH2A<br/>Size: 950mm</p> <p>39.95m</p> <p>Water level 15% height/diameter</p> | | <p>From: MH2C / To: MH2A<br/>Size: 950mm</p> <p>60.61m</p> <p>Settled deposits coarse 10% cross-sectional area loss</p> | |

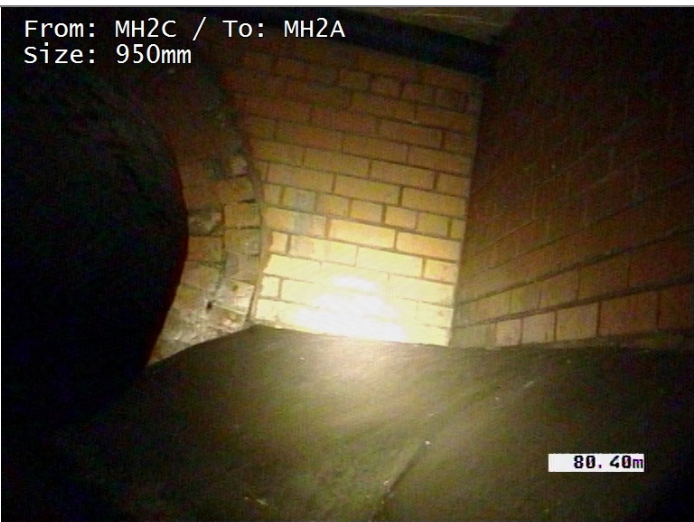
| Job Number<br><b>S26205</b> | Surveyed by (Operator)<br><b>JOE COLLINS</b> | Base Unit<br><b>LSDUKESDT</b> | Date<br><b>30/07/2025</b> |
|---|---|---|---|
| <p>From: MH2C / To: MH2A<br/>Size: 950mm</p> <p>80.40m</p> <p>Finish node type, manhole, reference MH2A</p> | | | |
