# Asbestos Demolition Survey Report

Job Ref No: **696151**, Account Ref No: **27292**, Contract Ref No: **134661**

## EDF Wythenshawe Laboratories, Timpson Road, Wythenshawe, M23 9LL

**Title:** Asbestos R&D Survey - EDF Demolition Project

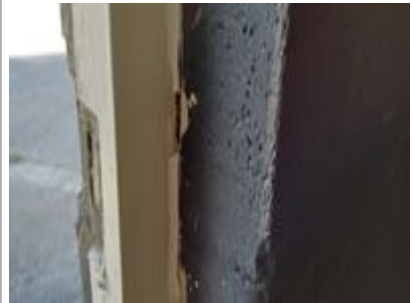
| Building | Level | Location | Item / Product Examined | Sample No. | Material Description | Fibre Type | Material Score | Extent | Risk Level Assessment | Initial Control Recommendation | Photograph |
|---|---|---|---|---|---|---|---|---|---|---|---|
| EDF Wythenshawe Laboratories - Hazardous waste | 0 | 001/ store OD40 | Sealant to door frame | 696151-6 | Asbestos-containing mastic | Chrysotile | 3 | 5 Lm. | R3 | Remove | |

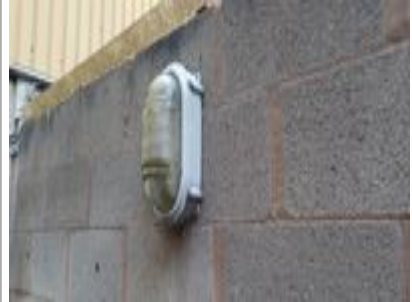
| Building | Level | Location | Item / Product Examined | Sample No. | Material Description | Fibre Type | Material Score | Extent | Risk Level Assessment | Initial Control Recommendation | Photograph |
|---|---|---|---|---|---|---|---|---|---|---|---|
| EDF Wythenshawe Laboratories - Hazardous waste | 0 | 999/ store OD40 and gas bottle store OD40A externals | Bulk head light to gas store OD40A | 696151-8 | Asbestos-containing mastic | Chrysotile | 3 | 2 No. | R3 | Remove | |

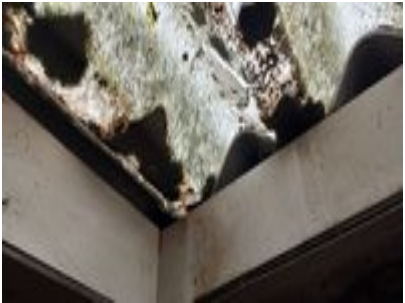
| Building | Level | Location | Item / Product Examined | Sample No. | Material Description | Fibre Type | Material Score | Extent | Risk Level Assessment | Initial Control Recommendation | Photograph |
|---|---|---|---|---|---|---|---|---|---|---|---|
| EDF Wythenshawe Laboratories - Stores Annexe | 0 | 001/G56A Store | Underside of roof | 696151-1 | Asbestos-containing cement | Chrysotile | 4 | 200 Sqm. | R3 | Remove | |

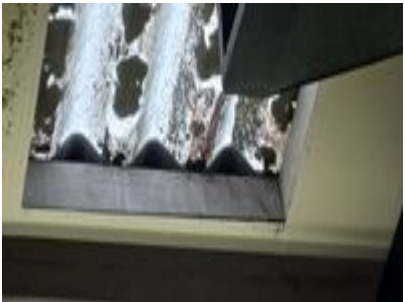
| Building | Level | Location | Item / Product Examined | Sample No. | Material Description | Fibre Type | Material Score | Extent | Risk Level Assessment | Initial Control Recommendation | Photograph |
|---|---|---|---|---|---|---|---|---|---|---|---|
| EDF Wythenshawe Laboratories - Stores Annexe | 0 | 002/G56 store | Underside of roof | 696151-1 | Asbestos-containing cement | Chrysotile | 4 | 150 Sqm. | R3 | Remove | |

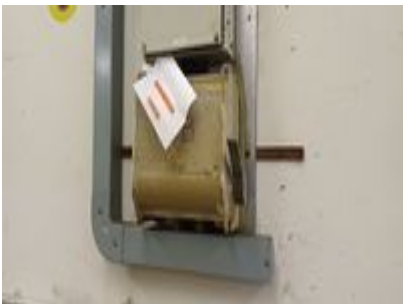
| Building | Level | Location | Item / Product Examined | Sample No. | Material Description | Fibre Type | Material Score | Extent | Risk Level Assessment | Initial Control Recommendation | Photograph |
|---|---|---|---|---|---|---|---|---|---|---|---|
| EDF Wythenshawe Laboratories - Stores Annexe | 0 | 002/G56 store | Bill Royal electrical box | | Asbestos-containing woven product | Presume Chrysotile | 5 | 1 No. | R3 | Remove | |

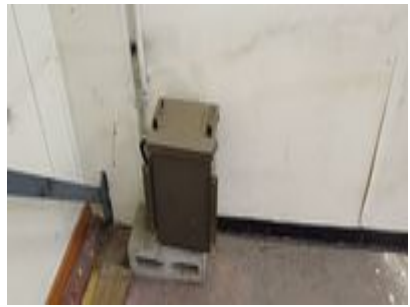
| Building | Level | Location | Item / Product Examined | Sample No. | Material Description | Fibre Type | Material Score | Extent | Risk Level Assessment | Initial Control Recommendation | Photograph |
|---|---|---|---|---|---|---|---|---|---|---|---|
| EDF Wythenshawe Laboratories - Stores Annexe | 0 | 002/G56 store | Transformer unit | | Asbestos-containing woven | Presume Chrysotile | 5 | 1 No. | R3 | Remove | |

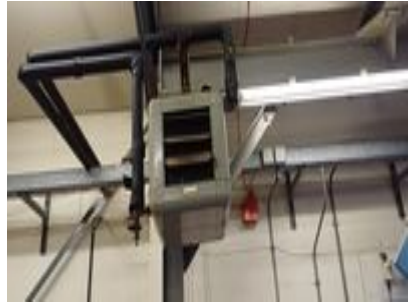
| Building | Level | Location | Item / Product Examined | Sample No. | Material Description | Fibre Type | Material Score | Extent | Risk Level Assessment | Initial Control Recommendation | Photograph |
|---|---|---|---|---|---|---|---|---|---|---|---|
| EDF Wythenshawe Laboratories - Stores Annexe | 0 | 002/G56 store | Heater | | Asbestos-containing woven product | Presume Chrysotile | 5 | 1 No. | R3 | Reinspect Periodically | |

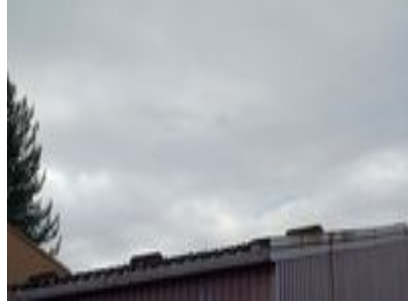
| Building | Level | Location | Item / Product Examined | Sample No. | Material Description | Fibre Type | Material Score | Extent | Risk Level Assessment | Initial Control Recommendation | Photograph |
|---|---|---|---|---|---|---|---|---|---|---|---|
| EDF Wythenshawe Laboratories - Stores annexe | 0 | 999/stores annexe externals | Roof covering | 654823-2 | Asbestos-containing cement | Chrysotile | 4 | 250 Sqm. | R3 | Reinspect Periodically | |

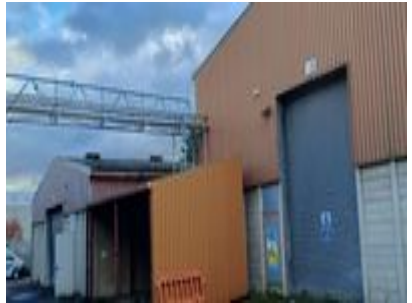
| Building | Level | Location | Item / Product Examined | Accessibility | Surveyor Additional Comments At Time Of Survey | Photograph |
|---|---|---|---|---|---|---|
| EDF Wythenshawe Laboratories - Stores | 0 | 001/whole Building | <b>Entire Location</b> | No Access | reasons of health and safety | |
| | | | | | 💬 excessive bird guano throughout building | |

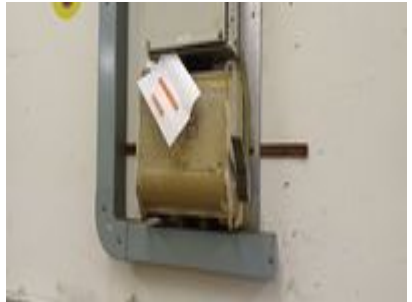
| Building | Level | Location | Item / Product Examined | Accessibility | Surveyor Additional Comments At Time Of Survey | Photograph |
|---|---|---|---|---|---|---|
| EDF Wythenshawe Laboratories - Stores Annexe | 0 | 002/G56 store | Bill Royal electrical box | No Access | Live service supply | |
| | | | | | 💬 Unable to inspect / sample, an assessment should be made once isolated by trained personnel | |

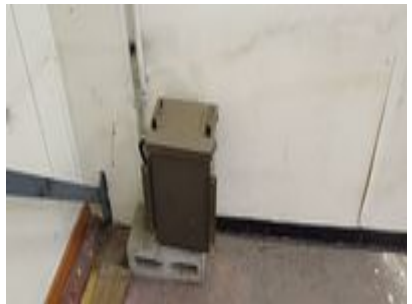
| Building | Level | Location | Item / Product Examined | Accessibility | Surveyor Additional Comments At Time Of Survey | Photograph |
|---|---|---|---|---|---|---|
| EDF Wythenshawe Laboratories - Stores Annexe | 0 | 002/G56 store | Transformer unit | No Access | Live service supply | |
| | | | | | 💬 Unable to inspect / sample due to live services, an assessment should be made once isolated by trained personnel | |

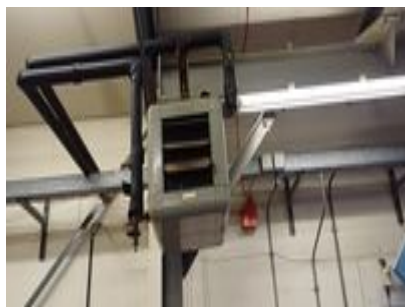
| Building | Level | Location | Item / Product Examined | Accessibility | Surveyor Additional Comments At Time Of Survey | Photograph |
|---|---|---|---|---|---|---|
| EDF Wythenshawe Laboratories - Stores Annexe | 0 | 002/G56 store | Heater | No Access | Live service supply | |
| | | | | 🗨️ Unable to inspect / sample due to live services, an assessment should be made once isolated by trained personnel | | |
