# RYEBANK, CHORLTON

## LONGFORD BROOK TECHNICAL NOTE

RBM-REN-XX-XX-RP-C-90001

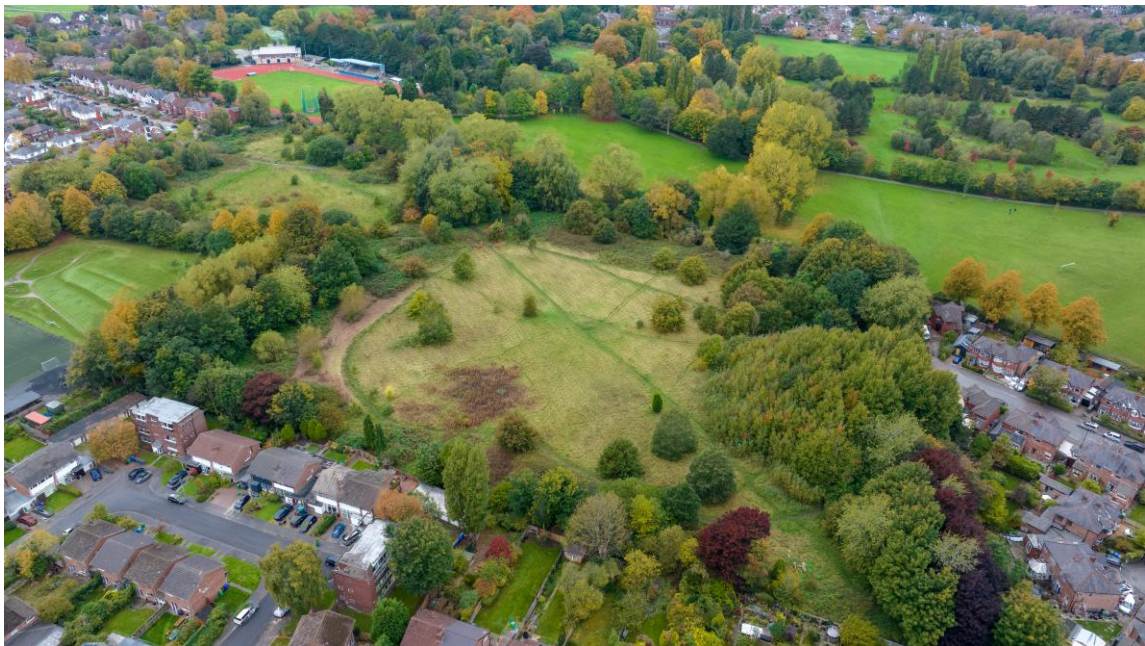
**Figure 4.1 – Aerial site photo showing dense vegetation.**

Due to the presence of the outfall pipe the LLFA requested for the eastern boundary to be investigated to look for a potential incoming pipe. In order to complete this survey work, the vegetation along the eastern boundary needed to be removed prior to the surveyors attending site. Unfortunately attempts to remove the vegetation where unsuccessful due to resistance from protestors and therefore the survey works could not be completed.

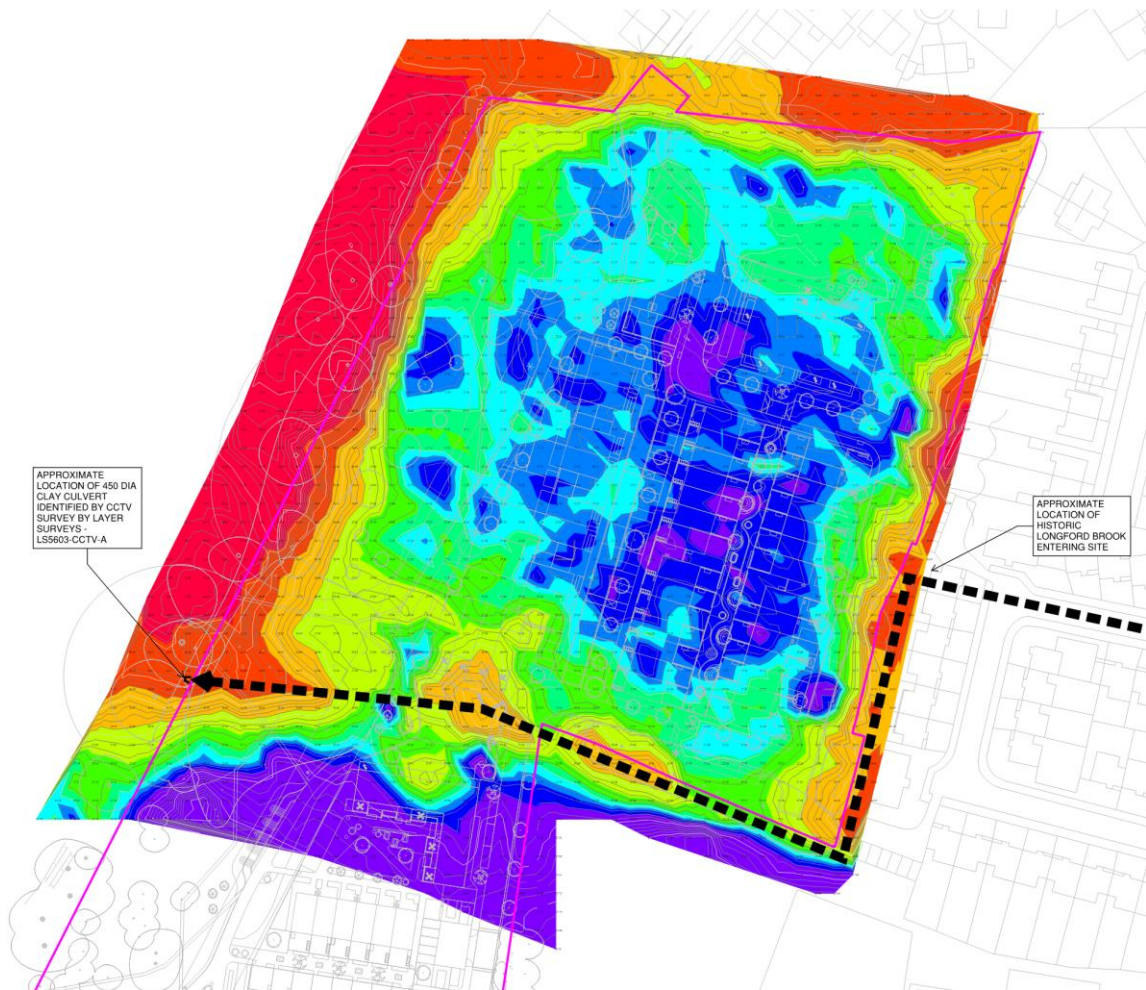
**Figure 4.2 –Topographical Drone Survey Extract**

The survey indicates there is not a consistent above ground drainage channel along the eastern boundary that would convey flow through the site.

The survey also shows that it would not be possible for the brook to be culverted through the site due to insufficient cover. The western outfall is calculated to have an invert level of 25.920 and the route to the eastern boundary is circa 250m. Assuming a very shallow gradient of 1:500 and a 450mm diameter pipe, based on the survey findings at the western boundary, the soffit level at the eastern boundary would be 26.870mAOD, which is above the ground level in this area. Therefore, it is not possible for the brook to exist as a culvert through the site.

Therefore, it is not considered feasible for the brook to be culverted on site, due to the level of the outfall relative to the topographical surveys measured upstream across the site to the Eastern boundary.

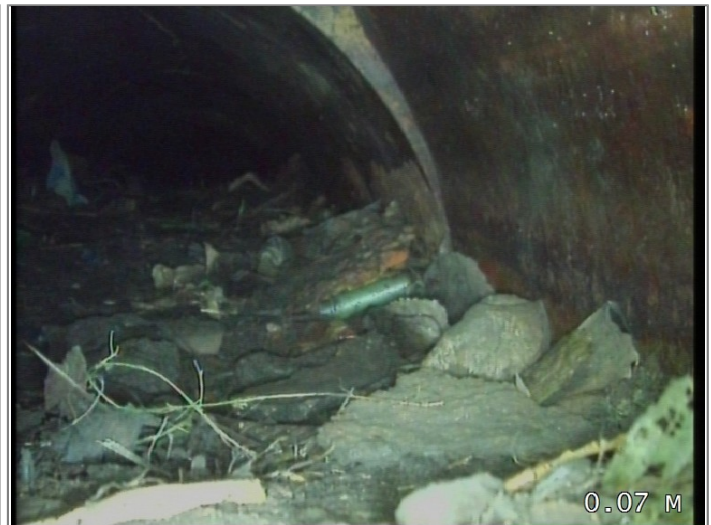
Water level 5% height/diameter

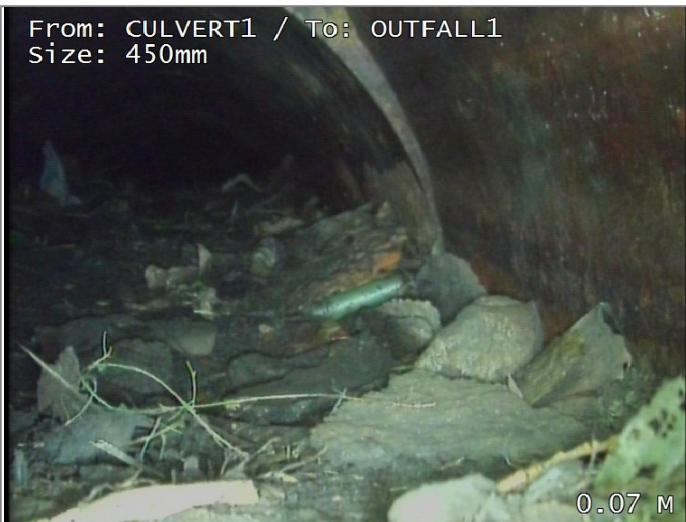
Settled deposits coarse 60% cross-sectional area loss, Start

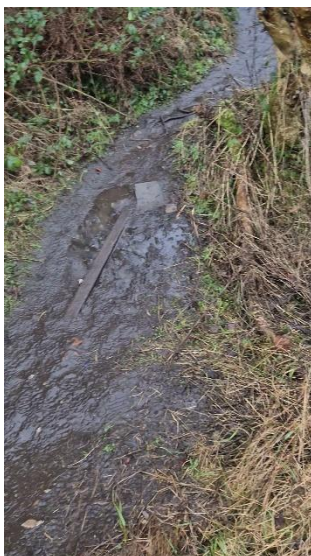
Photo 17

Photographs 17, 18 & 19 show the ditch through the middle of the development that is indicated on the topographical survey. There is a small volume of ponding in the bottom of the ditch which is to be expected given the recent rainfall. Sections of the ditch are heavily vegetated and there was no evidence of running water at the time of the survey. No large volumes of water were found which would suggest there are no inflows from a watercourse in the east.

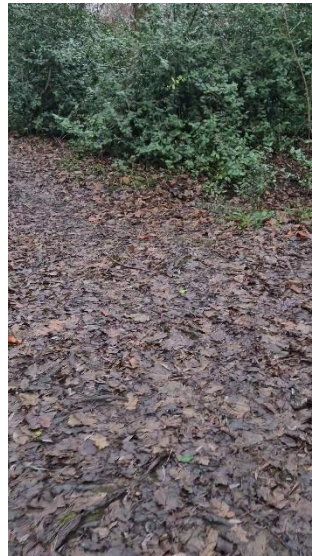
Photo 20

Towards the western boundary the ditch is visible again (Photograph 20) and this coincides with the locations of the fords indicated on OS mapping. Again, there was no evidence of running water within the ditch.

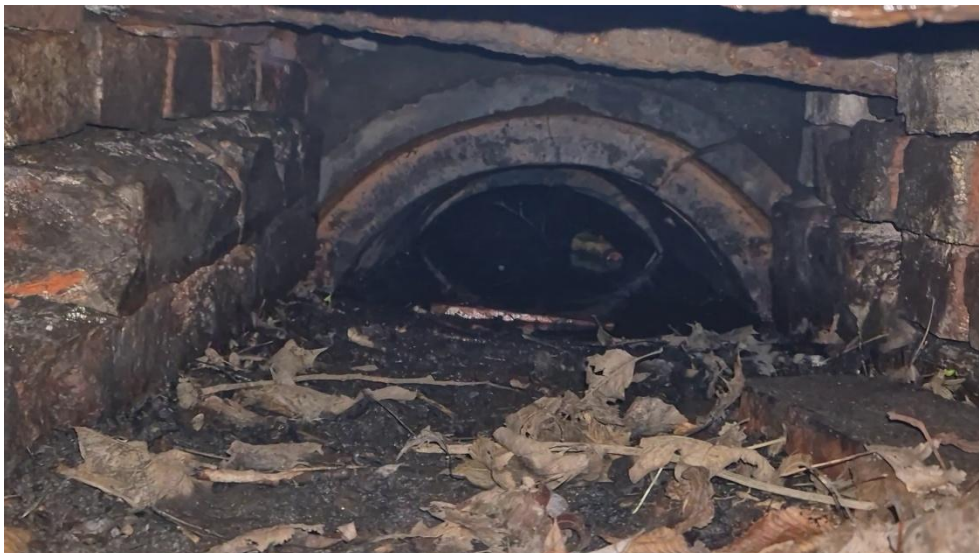
Photo 21

Photograph 21 shows an outfall head wall previously identified by the 2024 drainage survey undertaken by Layer Surveys. The pipe is heavily silted and does not convey any flow downstream.
