**Tree Survey**  
**at**  
**1 Old Hall Lane,**  
**Middleton,**  
**Manchester City M24 4GZ**  
**Greater Manchester**  
**with reference to bats and nesting birds**

**2<sup>nd</sup> April 2026 V2**

**Dave Bentley Ecology Services (since 1984)**

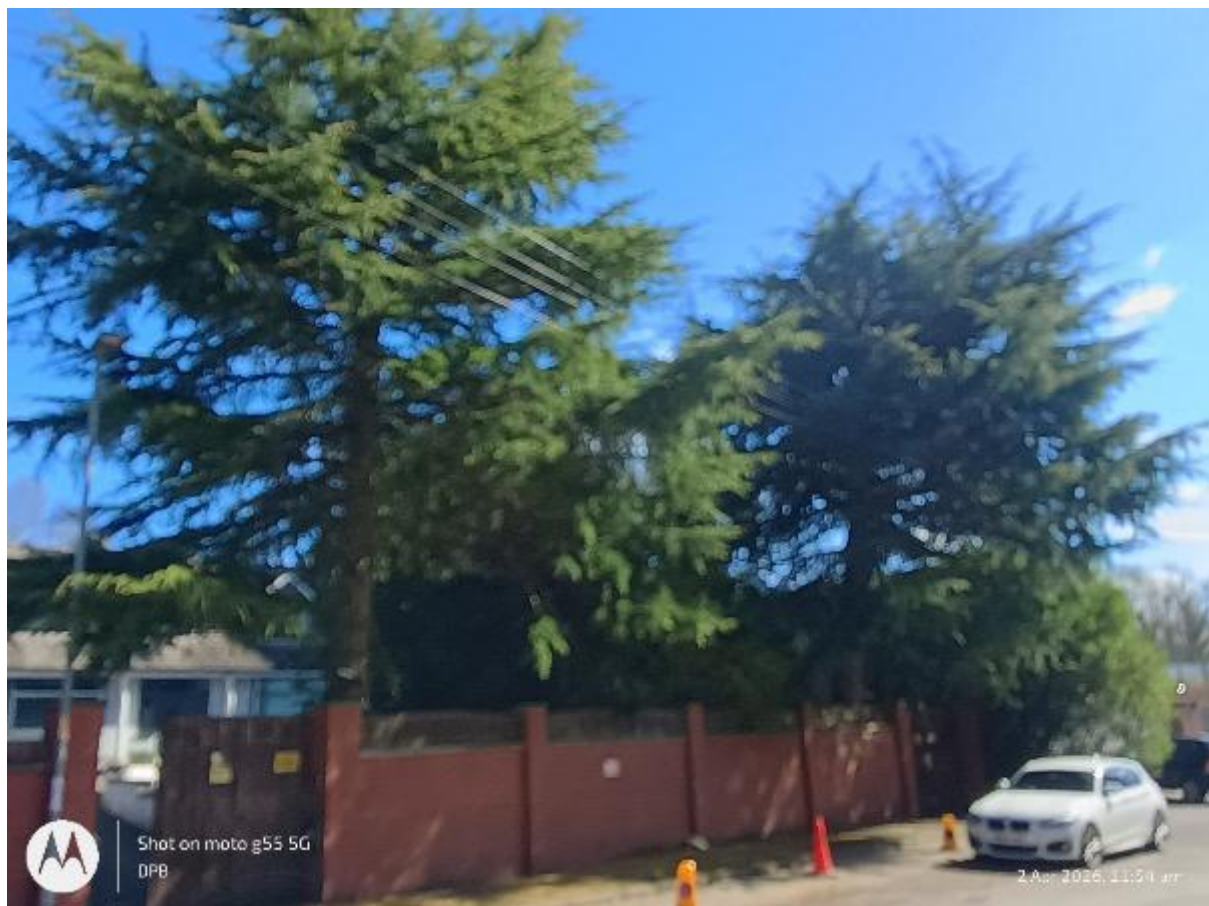
The northern Cedar is c40cm DBH and height of 12m, and the southern Cedar is c53cm DBH with a height of 13m. The needles are around 5cm long and in whorls of many, making Deodar Cedar the only candidate. Both trees are mature, healthy, and with the crown spreading equally all around.

Two Deodar Cedar in front garden (above)

8.2 British Standards requires that, to protect the Cedar trees in the front garden from working area activities such as compression from cars, vans, wagons, temporary buildings or the storage of building materials or bonfires requires, we calculate the Root Protection Area (RPA). The RPA should be calculated as an area equivalent to a circle with a radius 12 times the stem diameter. Thus we have two Cedar trees with stems diameters of 40cm and 53cm. This gives a RPA of 4.8m for the northern tree and 6.36m for the southern tree. The simplest way is to erect a single fence through the front garden using these measurements from the base of the trees. The protected area should be secured with Heras fencing and rubber feet. The British Standards document is available here and shows how this metal fence should be erected:

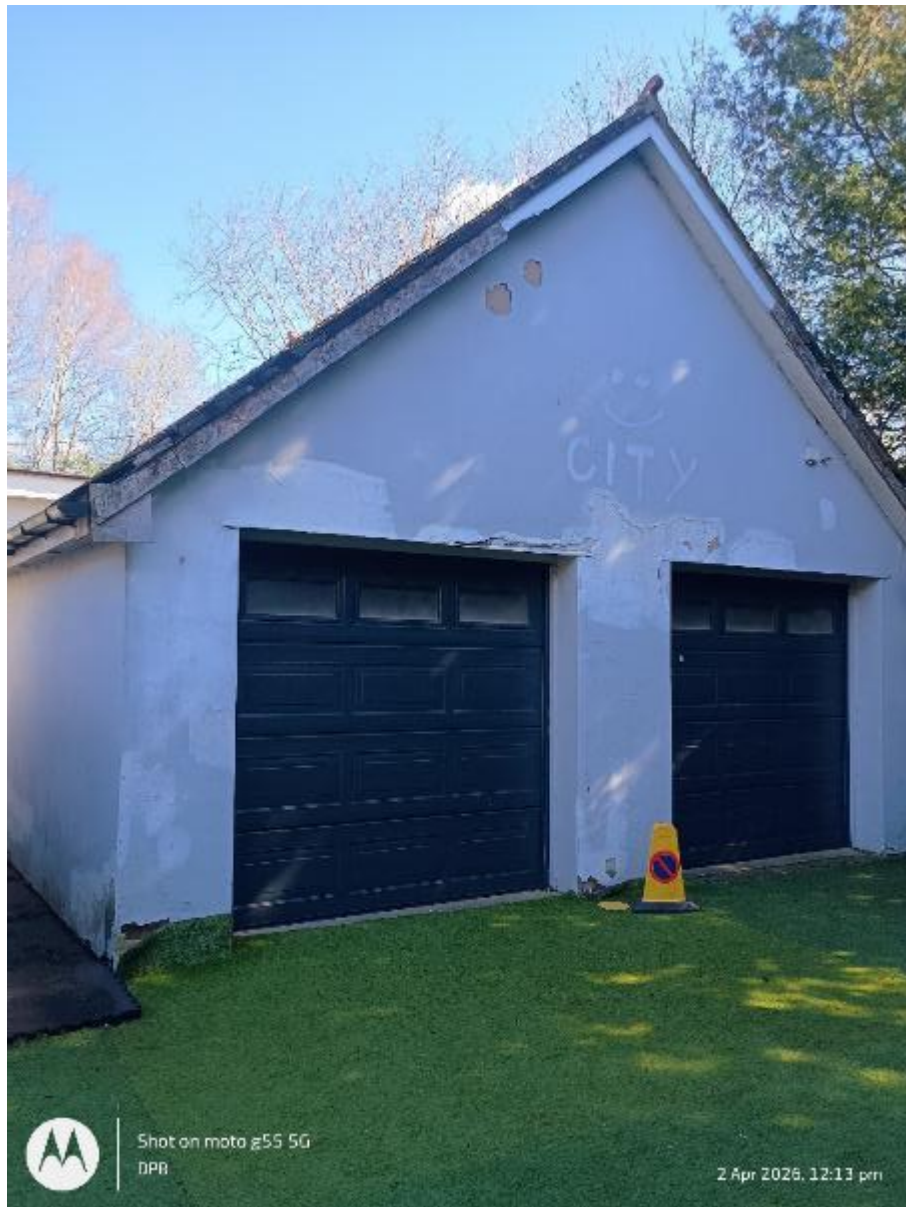
The garage, or basically a large store, is a modern building. It sits right adjacent the main house and the pair of roll up doors face the rear living room windows across a small patio. The garage was dug into the rising land of the rear garden so that the east and south sides are well below the landform level. There is a vertical wall of soil about a half a metre or so from the garage walls. This gap contains a water tank for a shower and plumbing, and old wheels/tyres.

The tiles and ridge tiles are in good condition providing no potential entry for bats.

Existing garage (above)

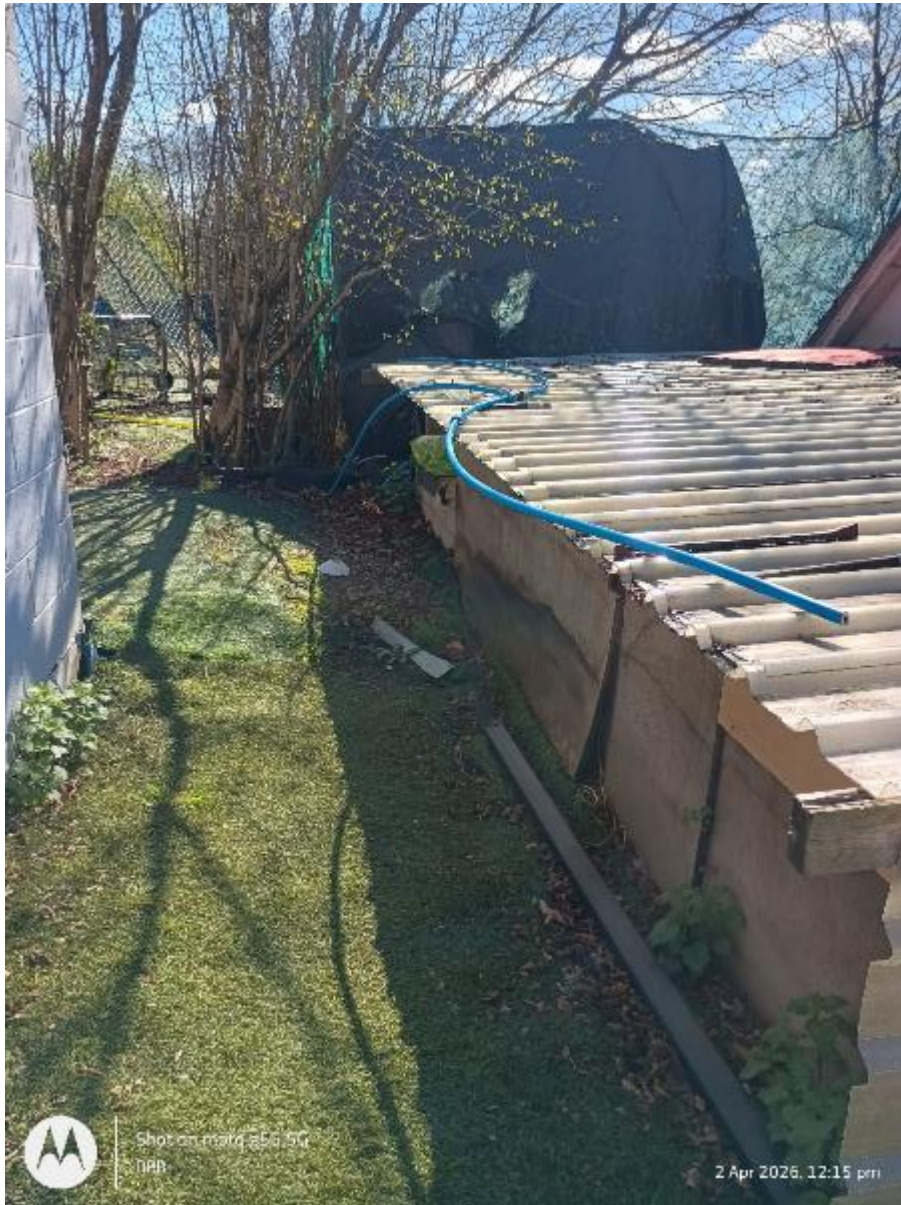
Comments: The corner of the existing/proposed building lies 126cm from the base of the bush. One thin branch overtops the roof of the existing outhouse by 190cm. One branch has been cut on this side in the past. The removal of a single thin branch spreading over the redevelopment will have negligible impact on the tree or the function of the tree belt as a shield. It will not grow much larger.

Comments: Tree spreading to west mainly given competition from others in group of Hazel with the corner of the existing/proposed building 165cm from the base of the bush. One thin branch overtops the roof of the existing outhouse by 220cm. The removal of a single thin branch spreading over the redevelopment will have negligible impact on the tree or the function of the tree belt as a shield. The group of Hazel is at the end of the tree line, and this bush lies between the outhouse and the corner of the retail car park. It will not grow much larger.

Roof of existing outhouse with T1 group Hazels (above)

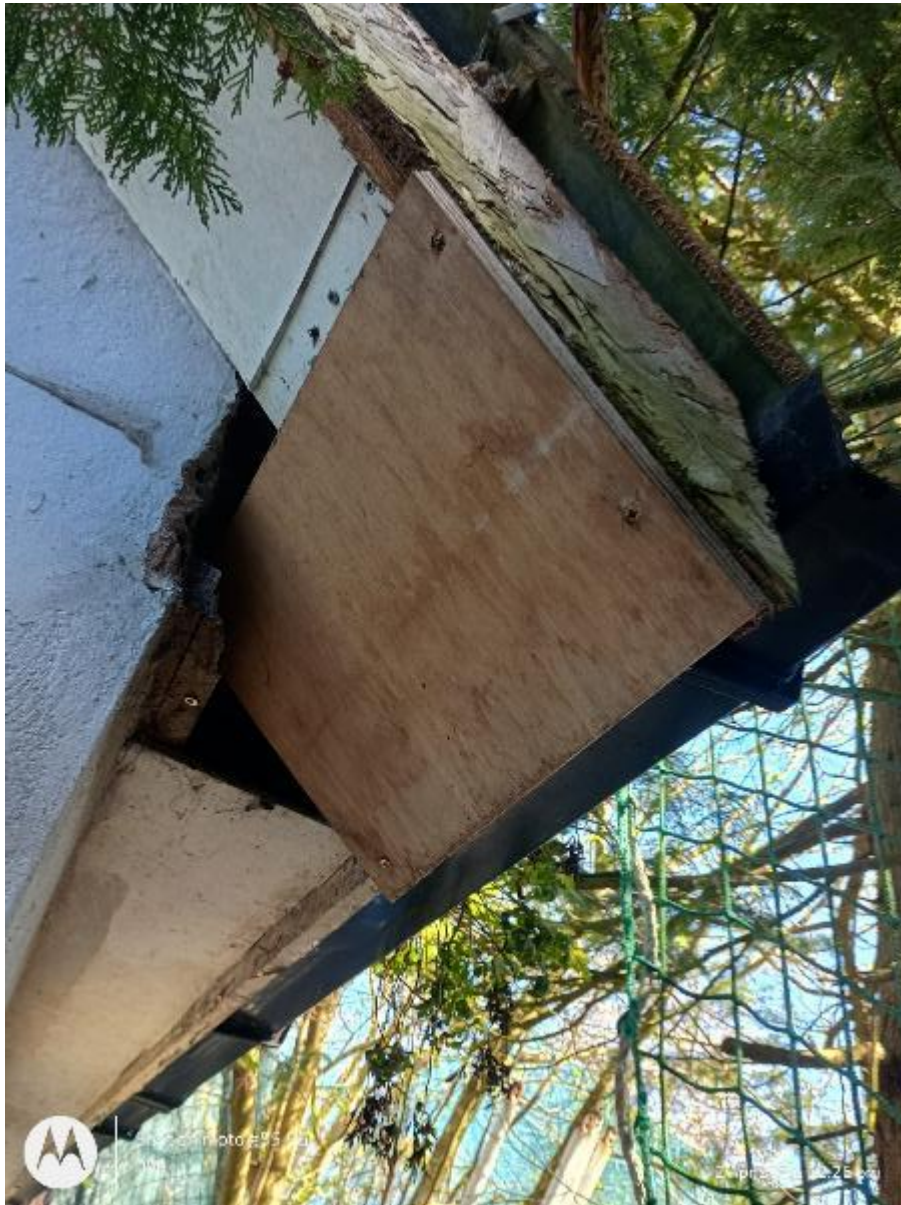
The barge boards and soffit boards are generally flush with the building providing no means of entry to bats or small birds, with the exception of the lower most parts were rotting and warping have open up small gaps. No evidence of bat usage was seen here (no droppings, no urine streaks, and presence of some spider webs) but there is potential enough to require a planning condition that should bats be found work should stop and a bat specialists advice be sought. Should work not proceed in 2026 a re-examination in subsequent years will be needed.

Example of area of potential bat and breeding bird access to garage (no evidence 2/4/2026)(above)

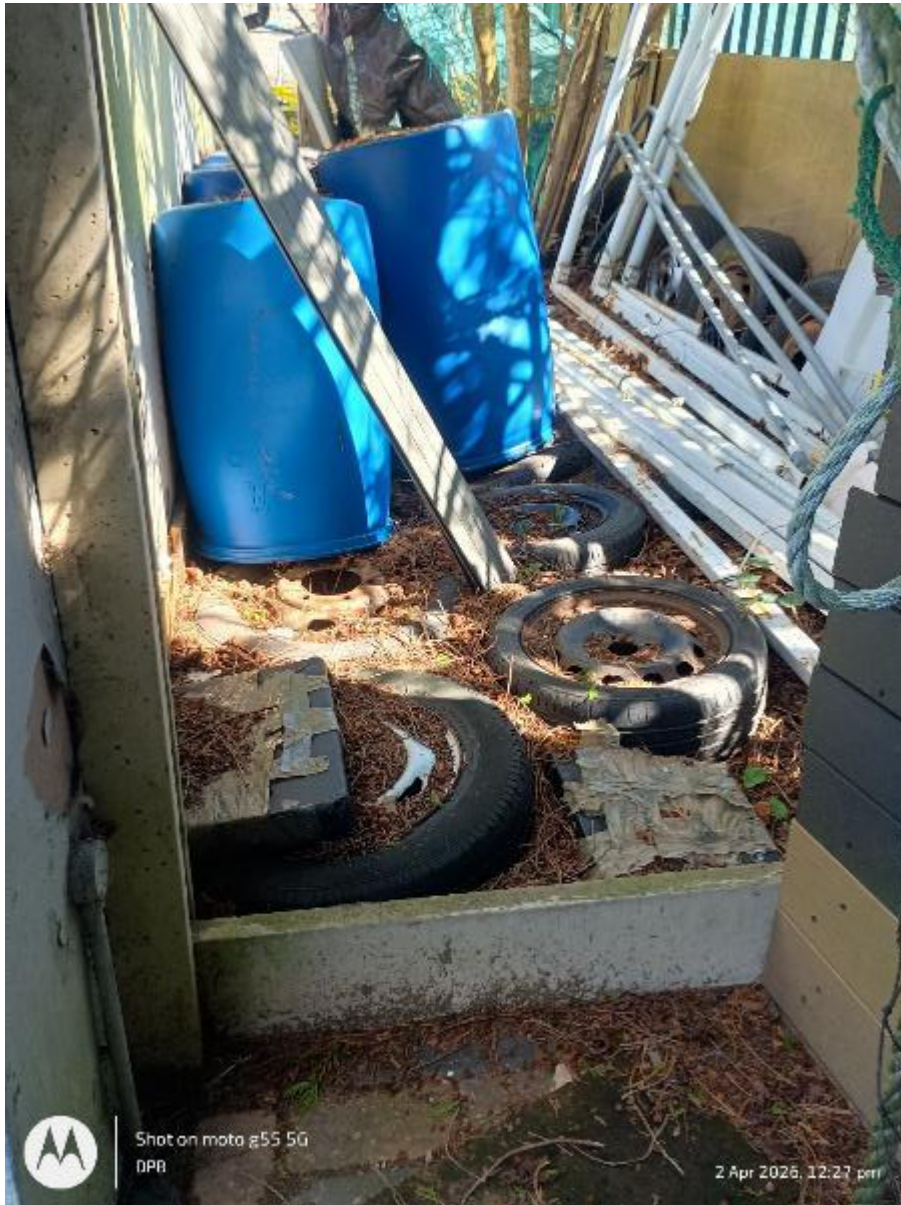
The south side adjacent the tree line includes a line of tyres and wheels, upon which sit blue barrels and which also contain a below ground level water tank and plumbing. Although it can't be confirmed without lifting all these wheels it appears as though the land that was excavated away to build the garage, where it was not occupied by the garage, was backfilled with these wheels to provide a barrier between the walls and the soil of the tree line. This suggests that there will be little or no root damage to adjacent trees should a new building be constructed on this footprint. None of this area can be considered soft ground with flora;

Space between garage and treeline (above)
