**JUNCTION HOTEL  
ROLLS CRESCENT  
MANCHESTER  
M15 5FT**

**HIGHWAY DILAPIDATION  
SURVEY**

**23<sup>RD</sup> JUNE 2026**

DOCUMENT No:  
26013-DOC-002-A

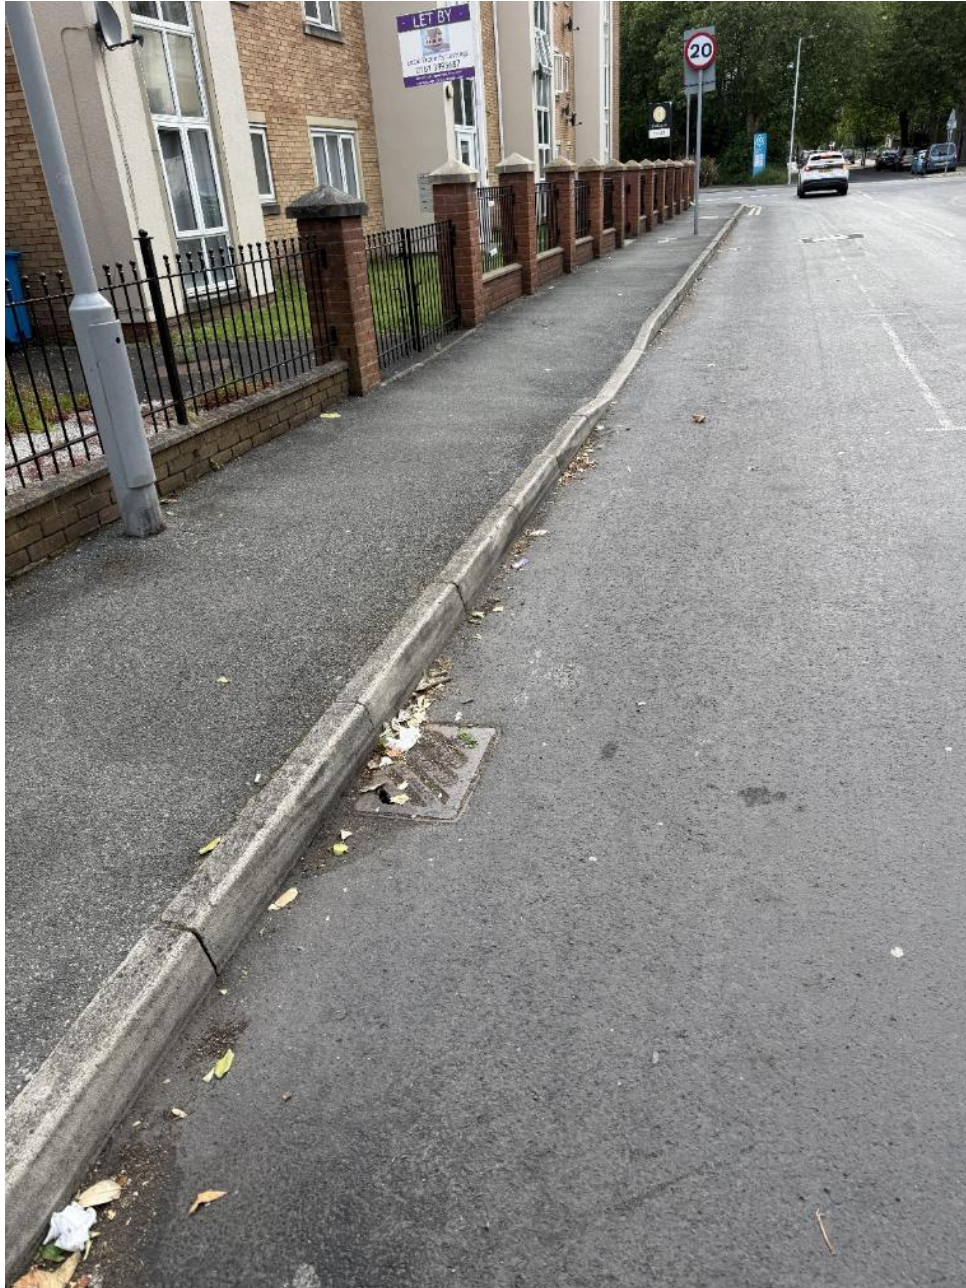
**Location 1**

**Fairly new kerbs and footpath in good condition.**

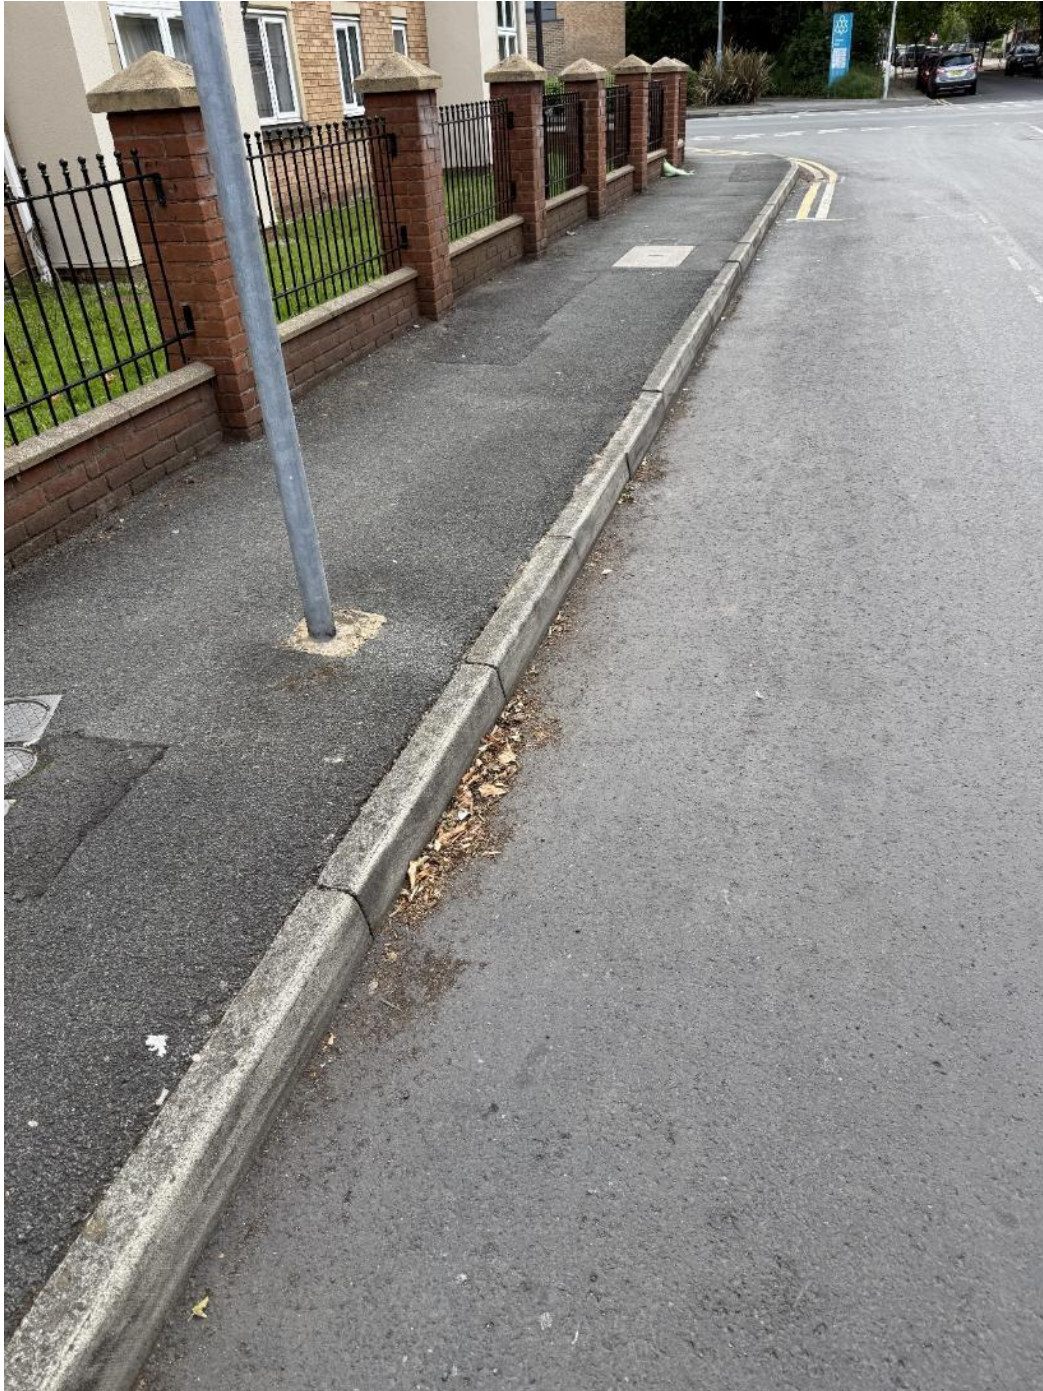
**Location 2**

**Some kerb displacement, not severe at the moment.**

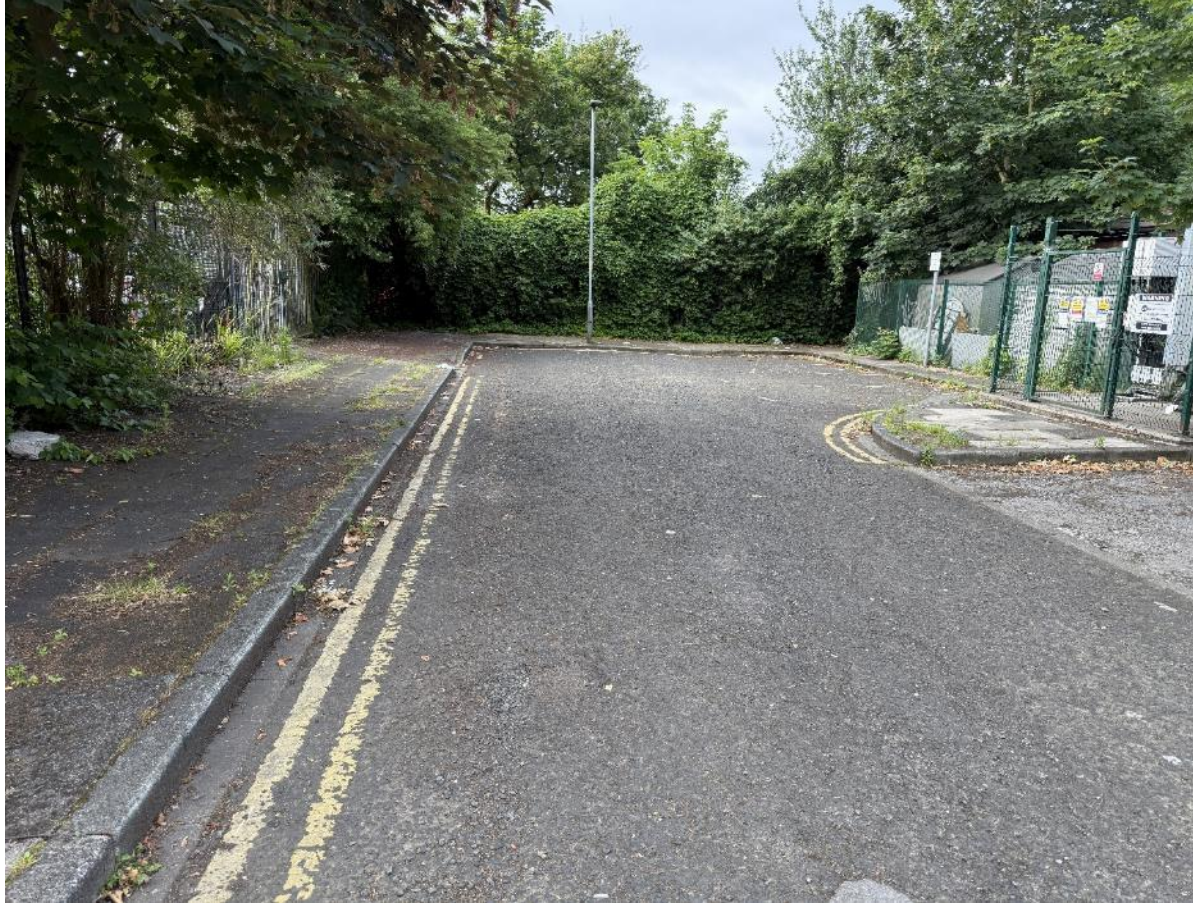
**Location 3**

**View into turning beyond the boundary of the site.**

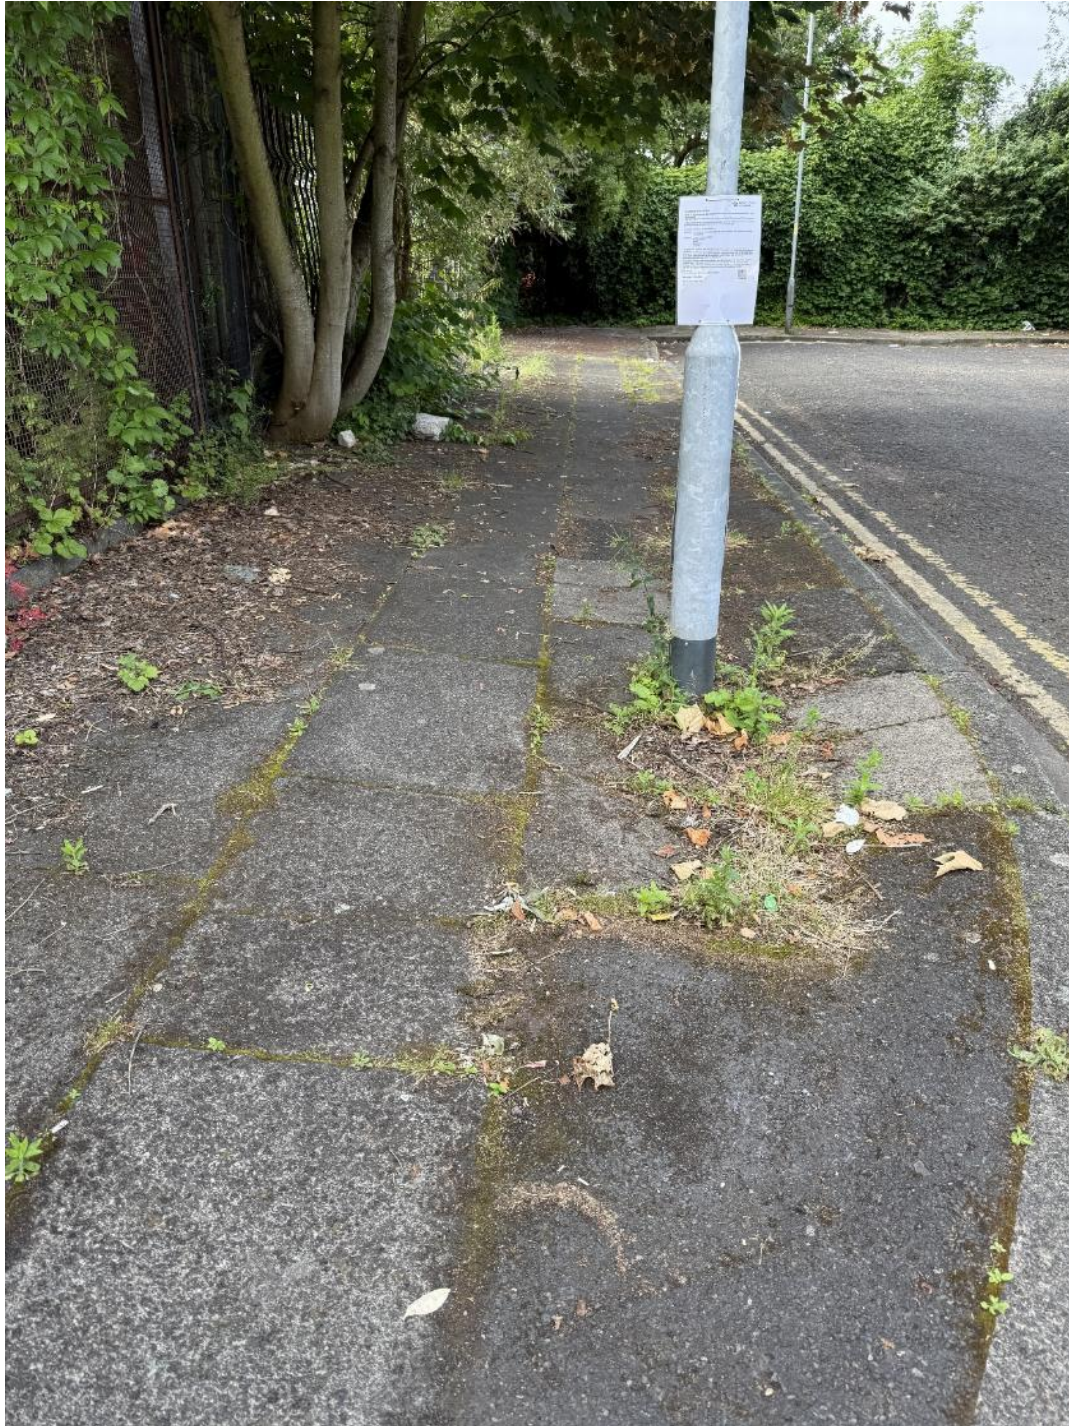
**Location 4**

**Concrete slabs broken and severely sunken.**

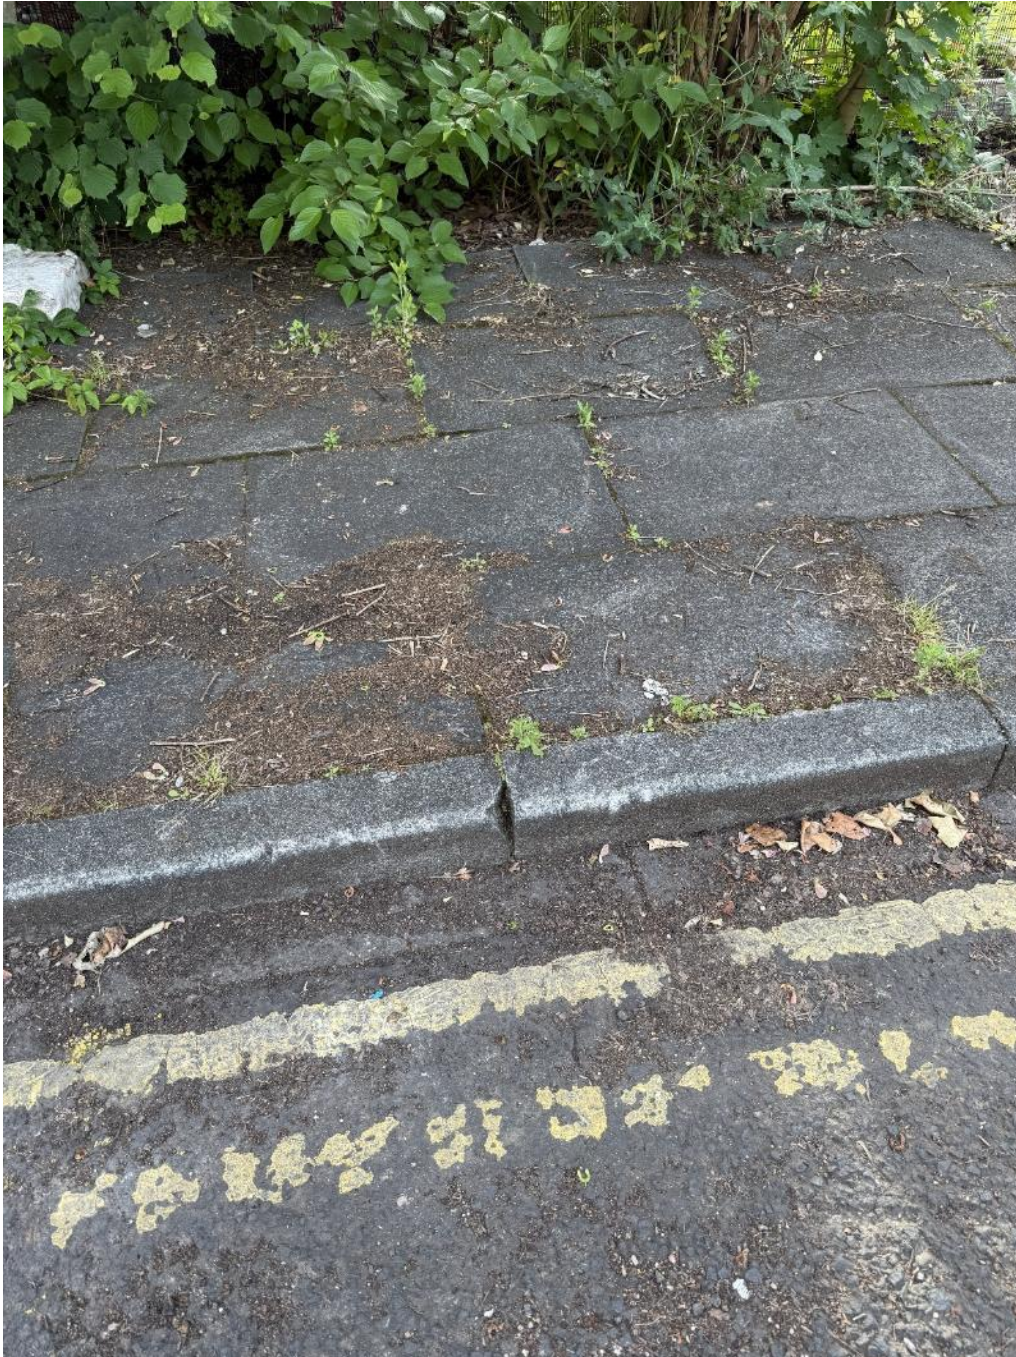
**Location 5**

**Damage to kerb.**

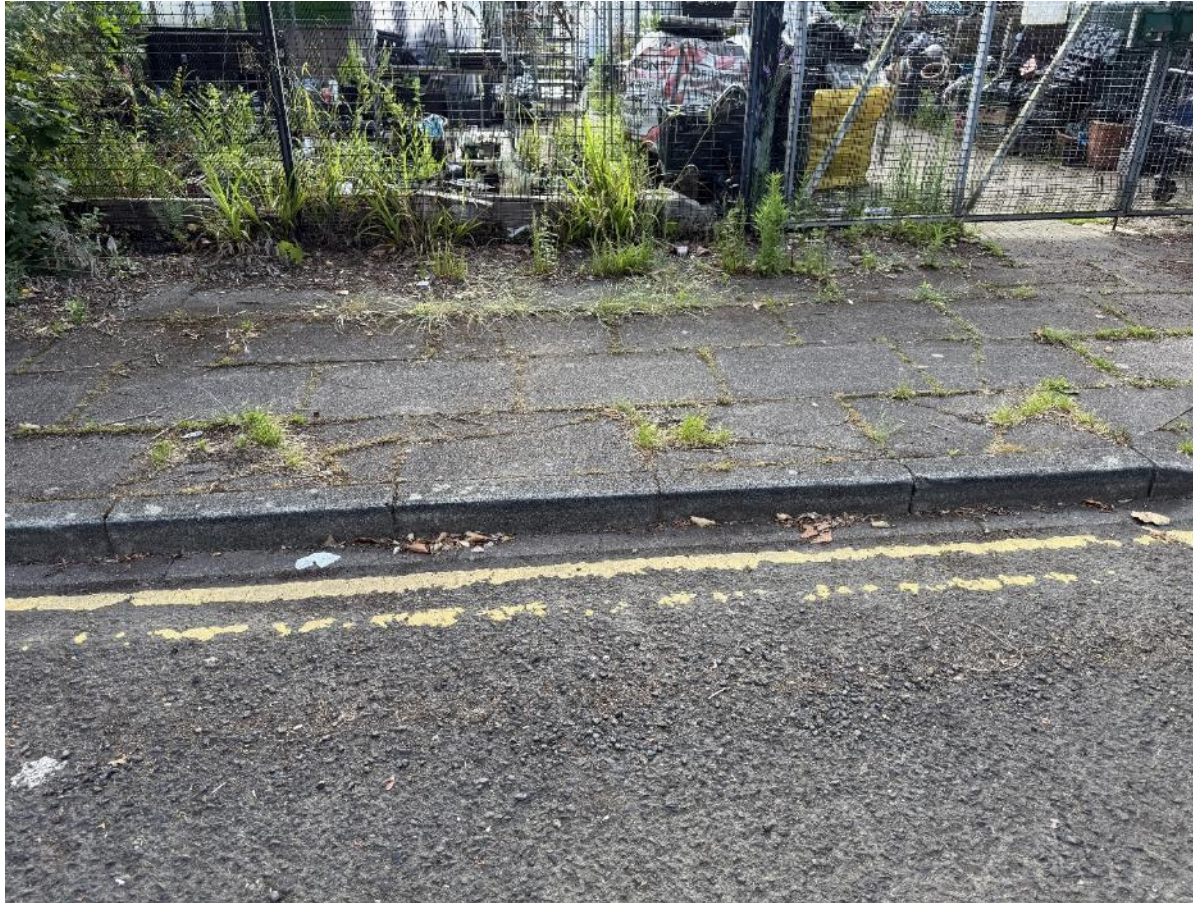
**Location 6**

**Concrete slabs cracked.**

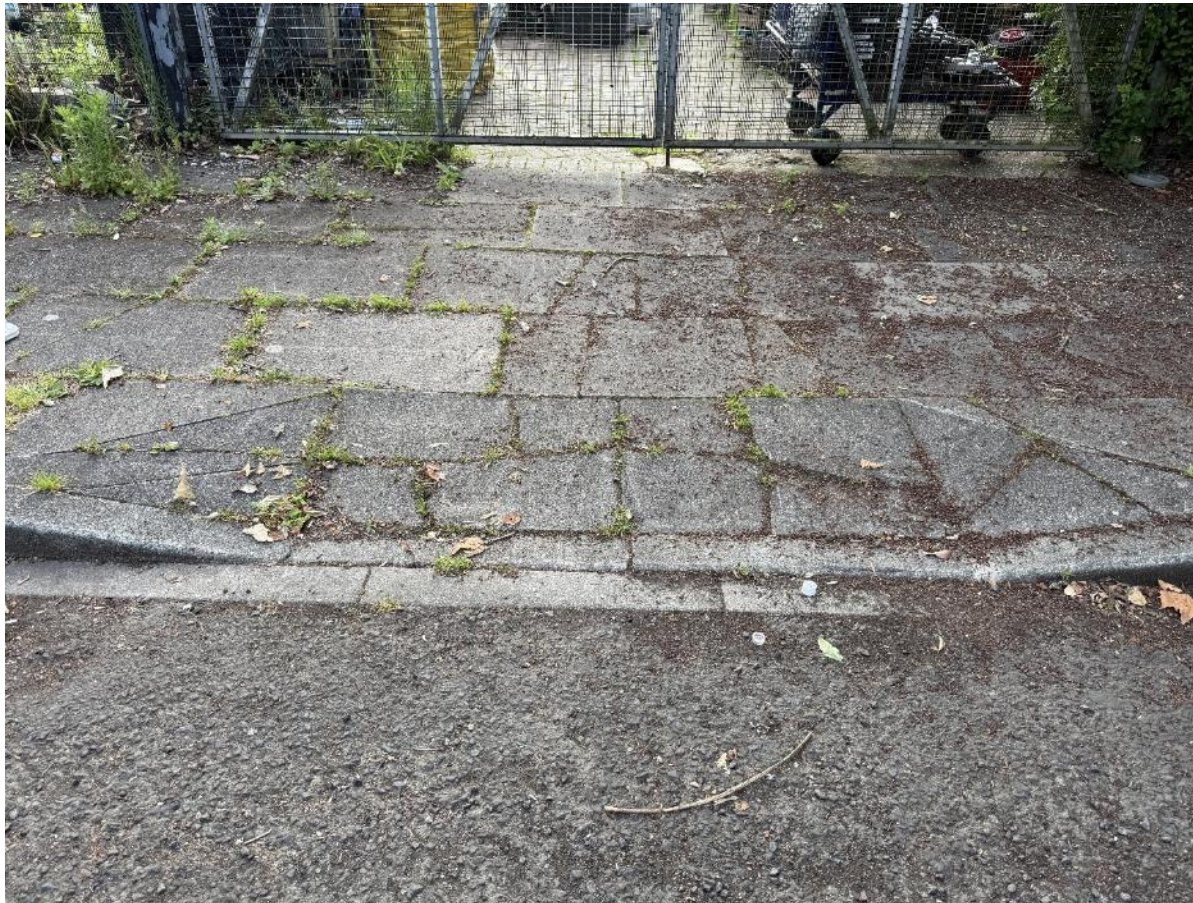
**Location 7**

**Concrete slabs cracked.**

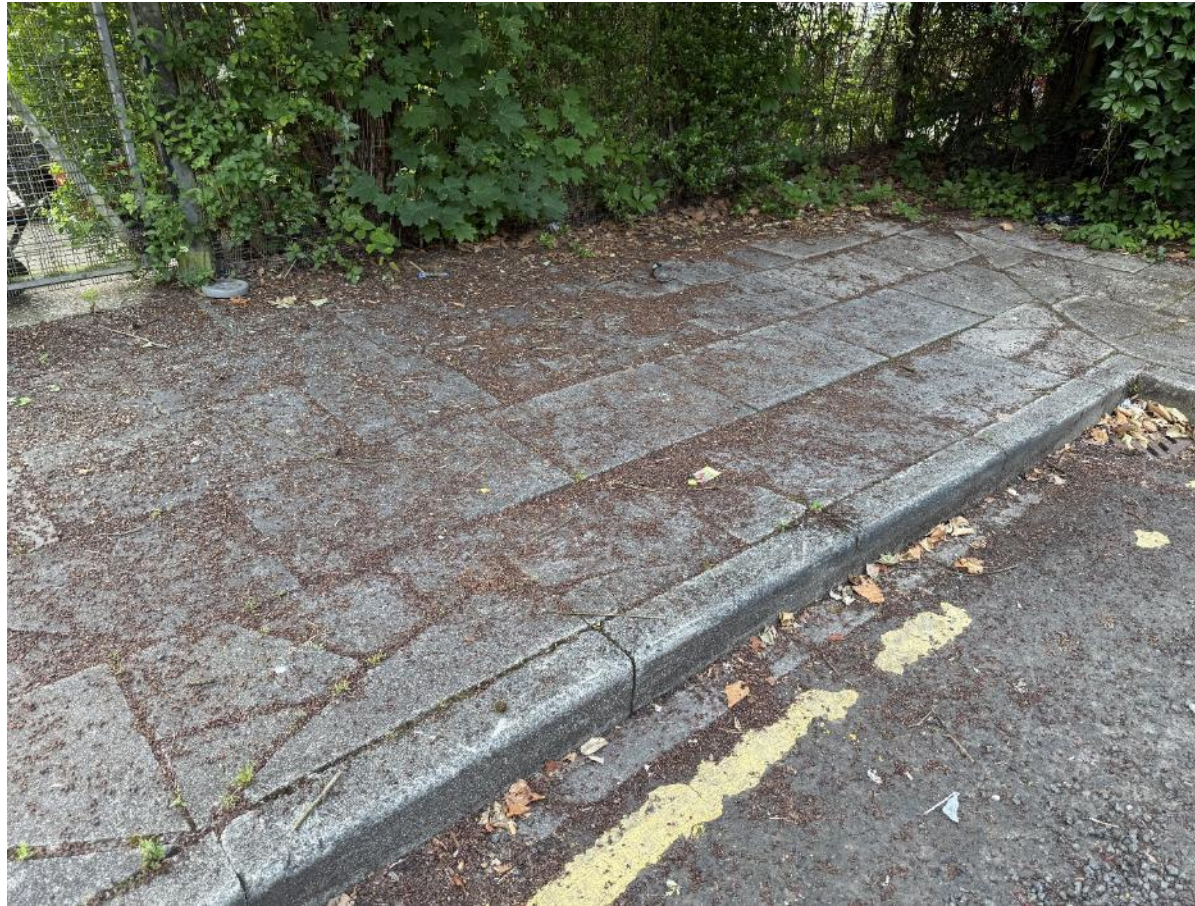
**Location 8**

**Concrete slabs cracked.**

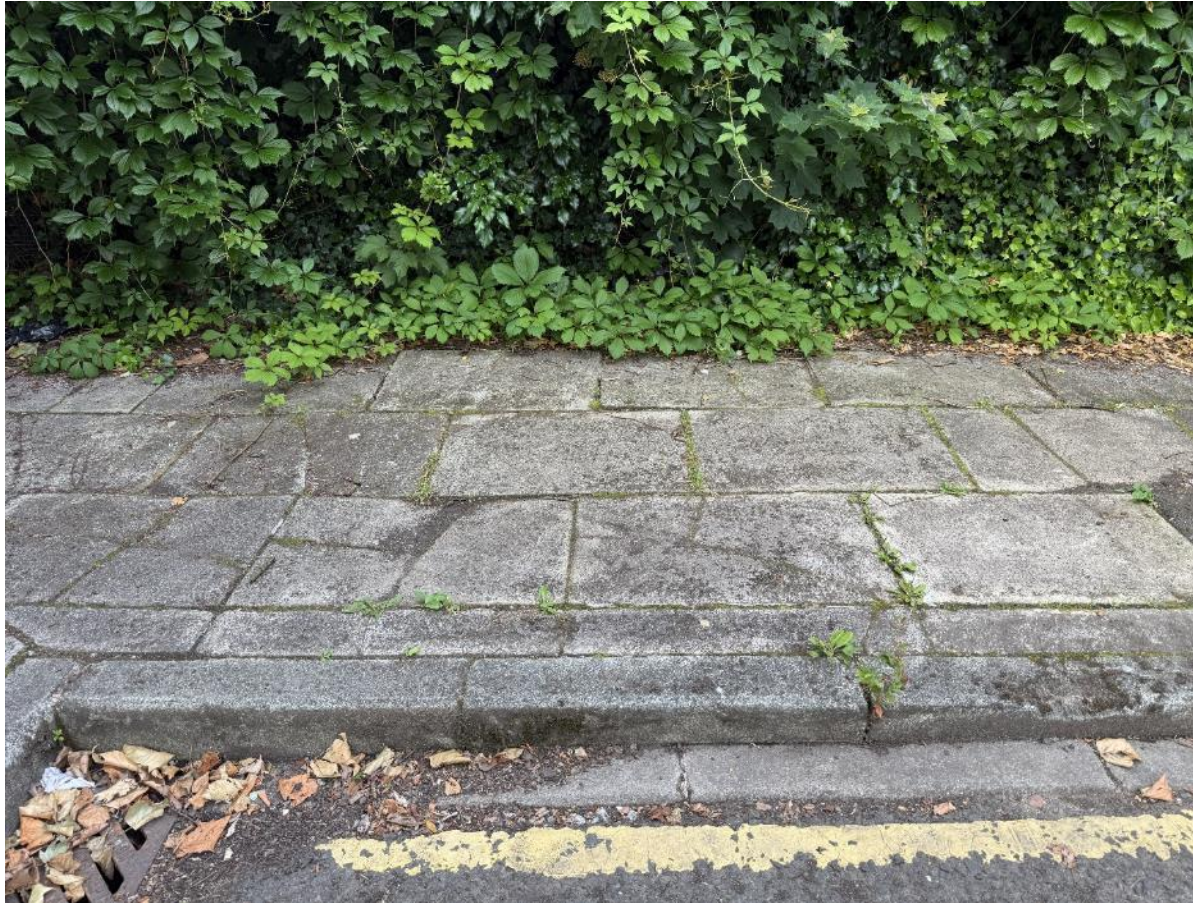
**Location 9**

**Concrete slabs cracked.**

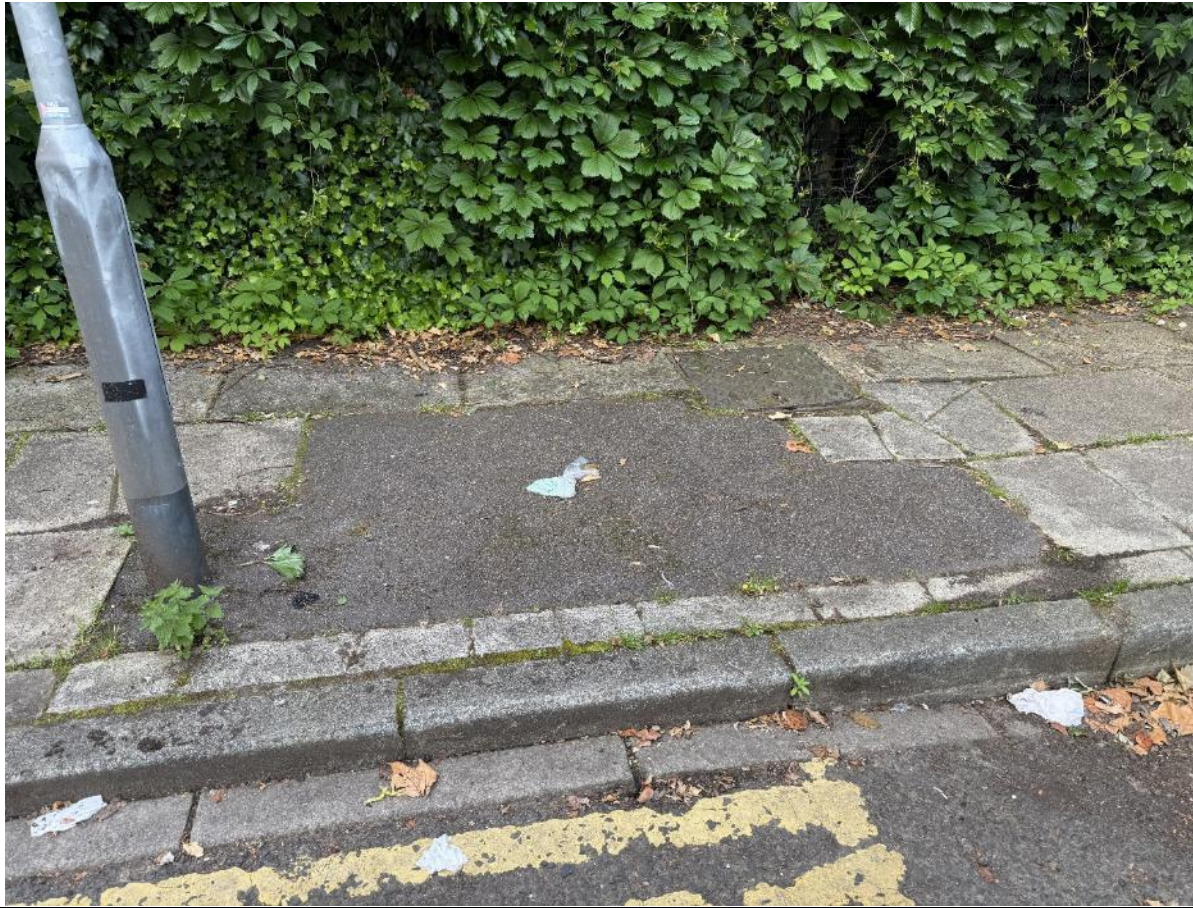
**Location 10**

**Tarmac patch repair in concrete slabbed footpath.**

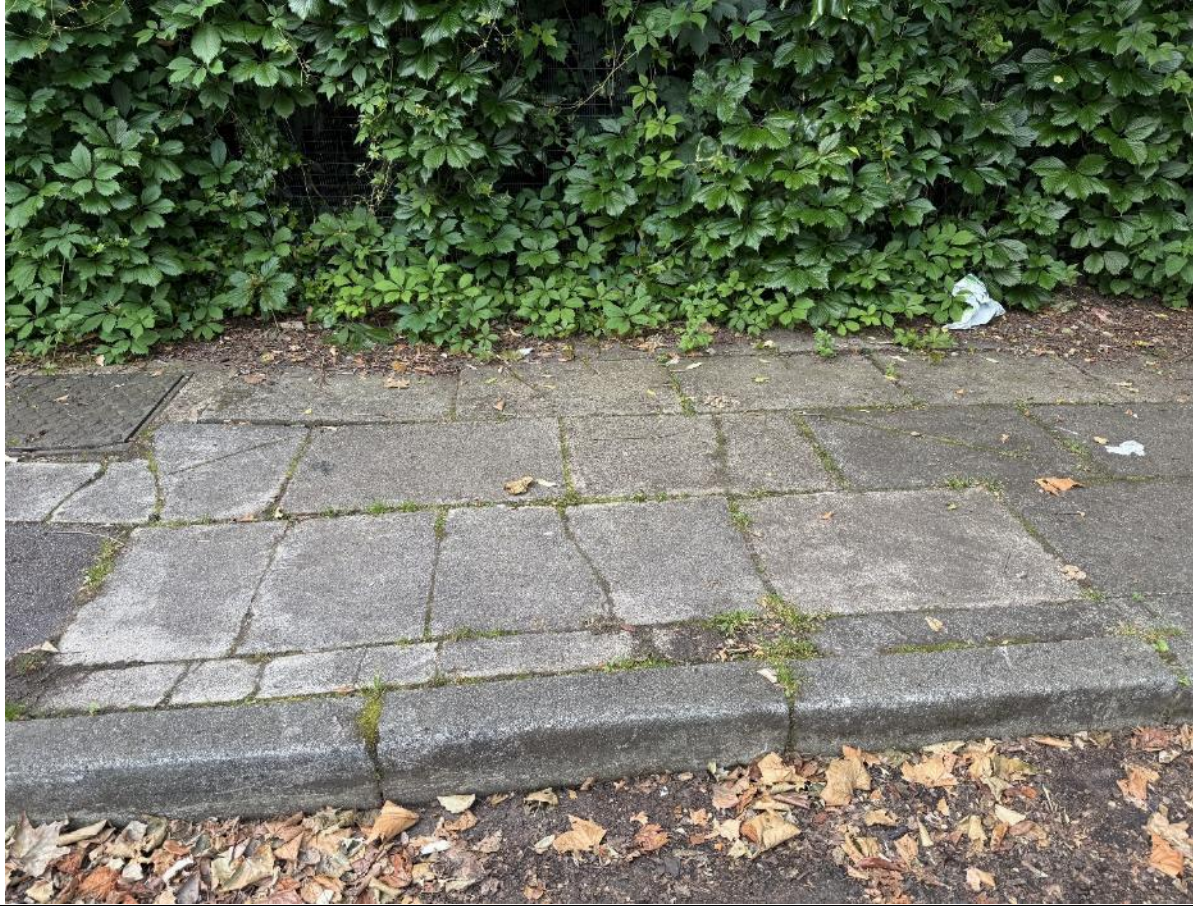
**Location 11**

**Flags cracked and displaced.**

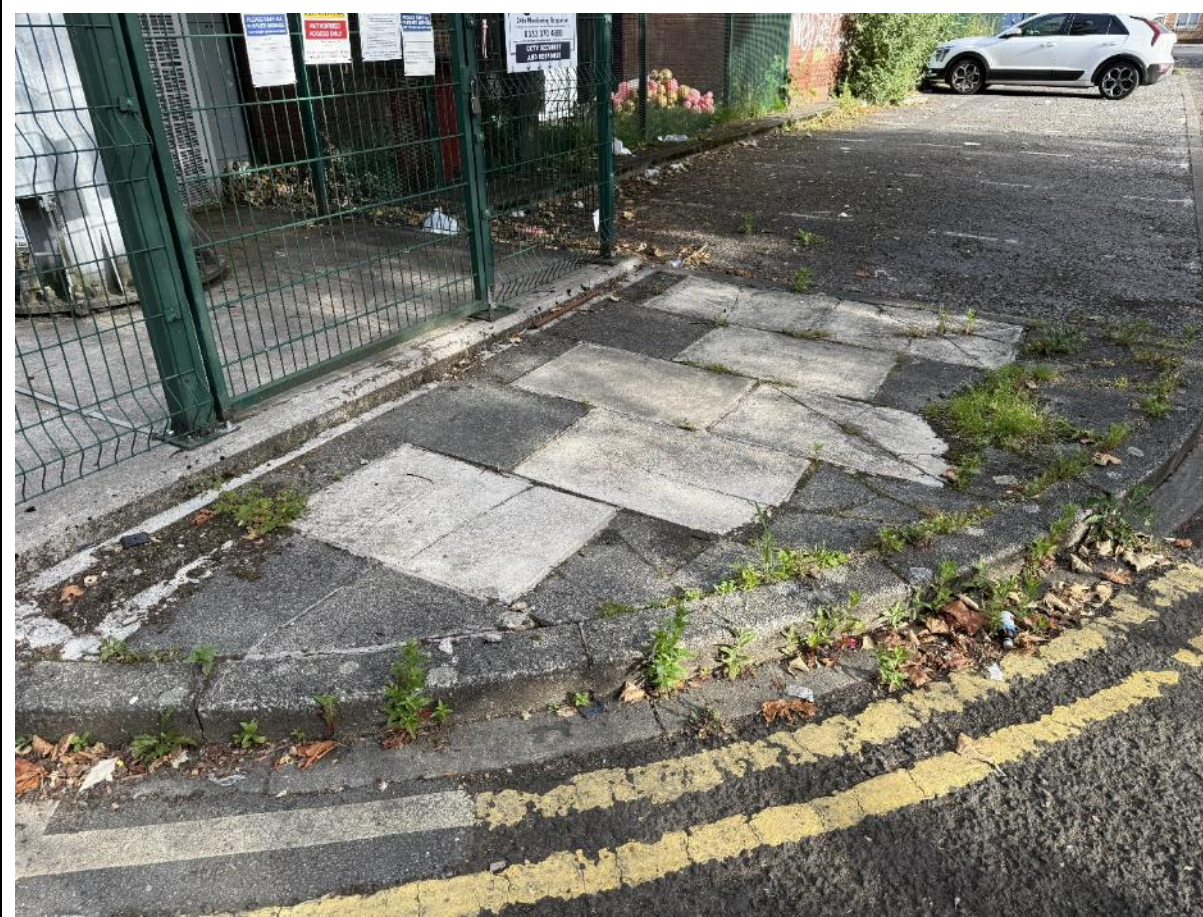
**Location 12**

**Flags cracked.**

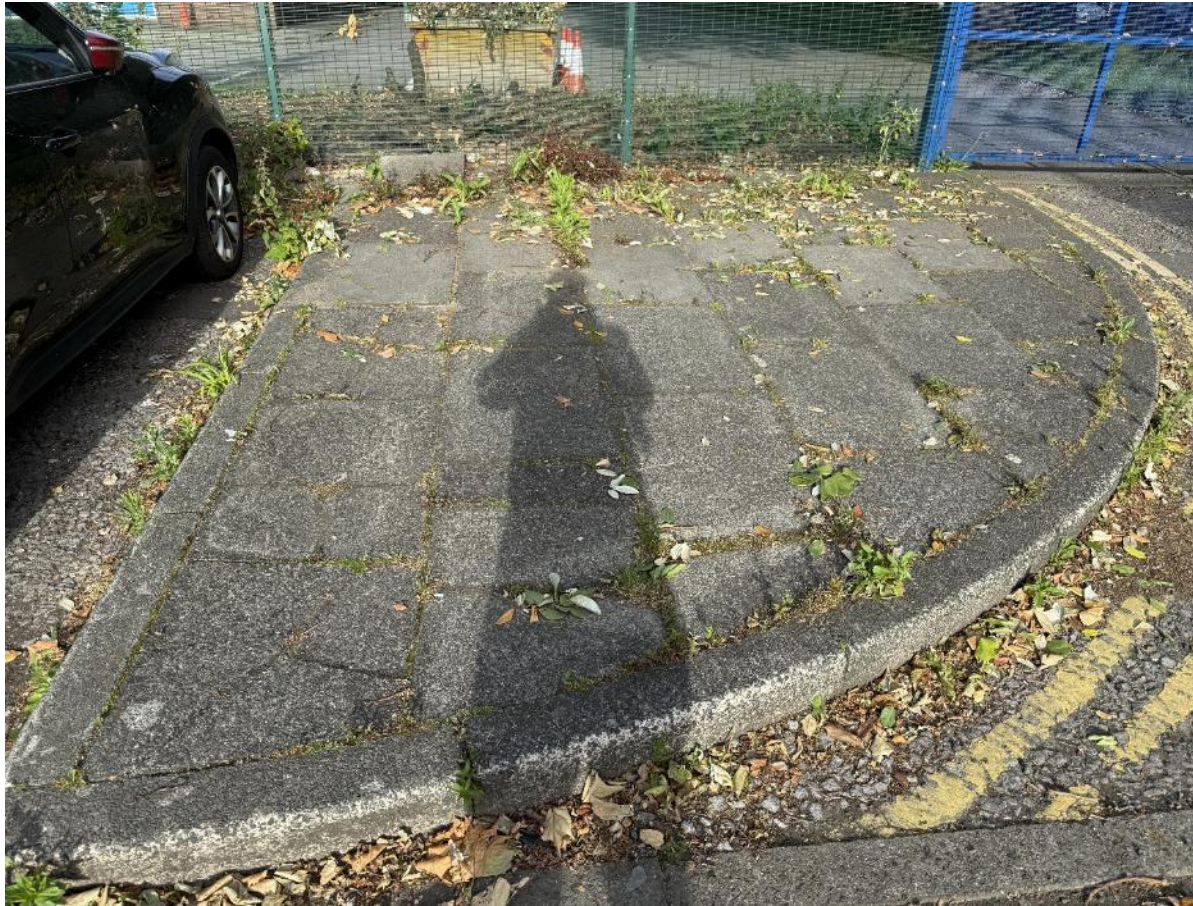
**Location 13**

**Flags cracked.**

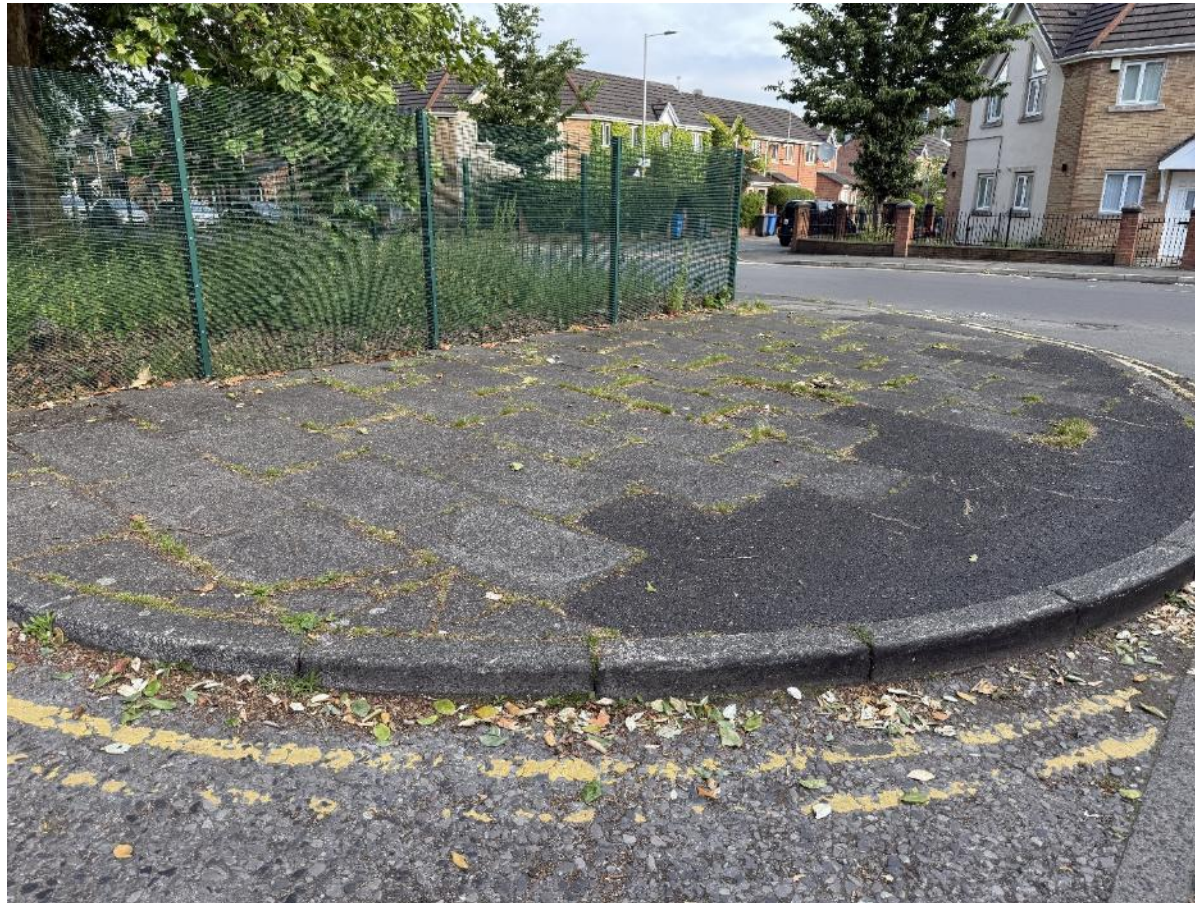
**Location 14**

**Flags cracked, and a tarmac patch repair in footpath.**

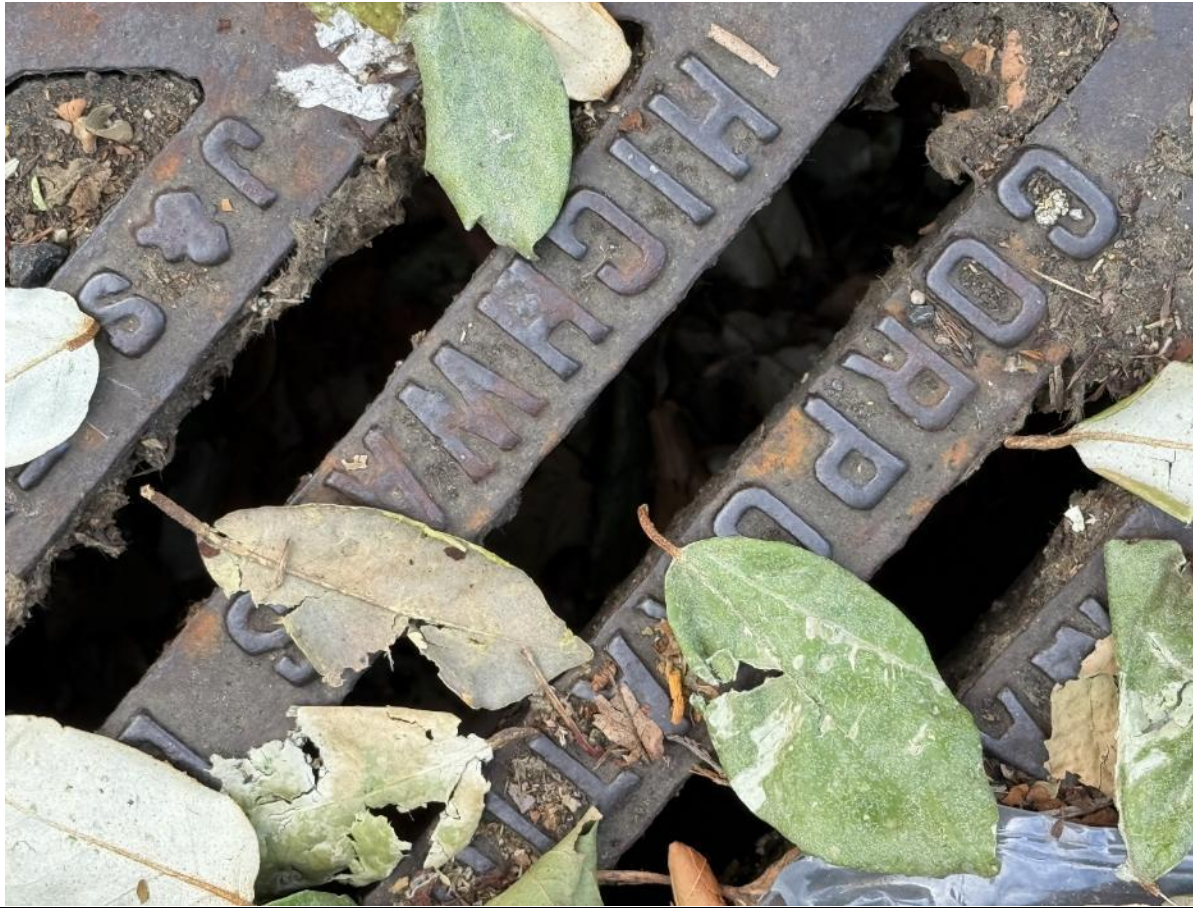
**Location 15**

**Gully blocked.**

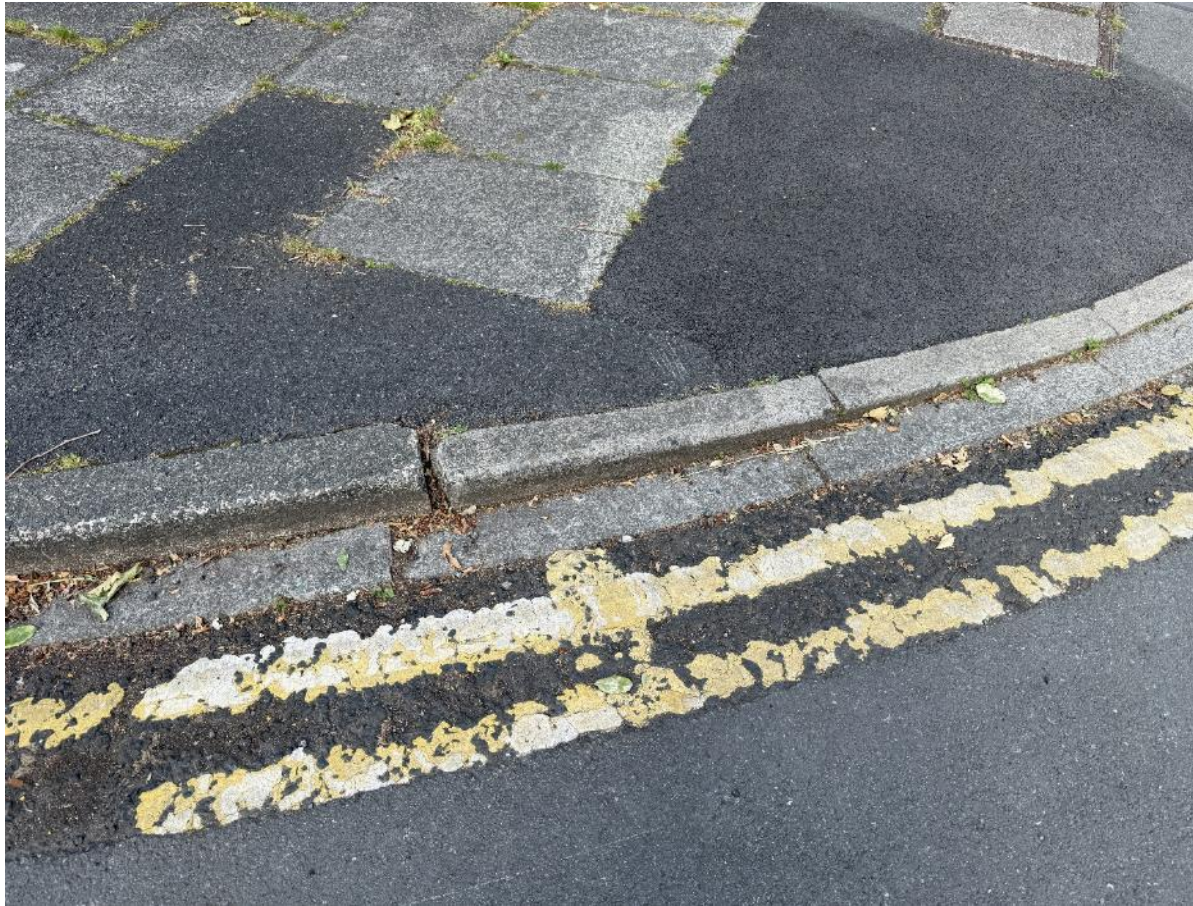
**Location 16**

**Kerb damaged and sunken.**

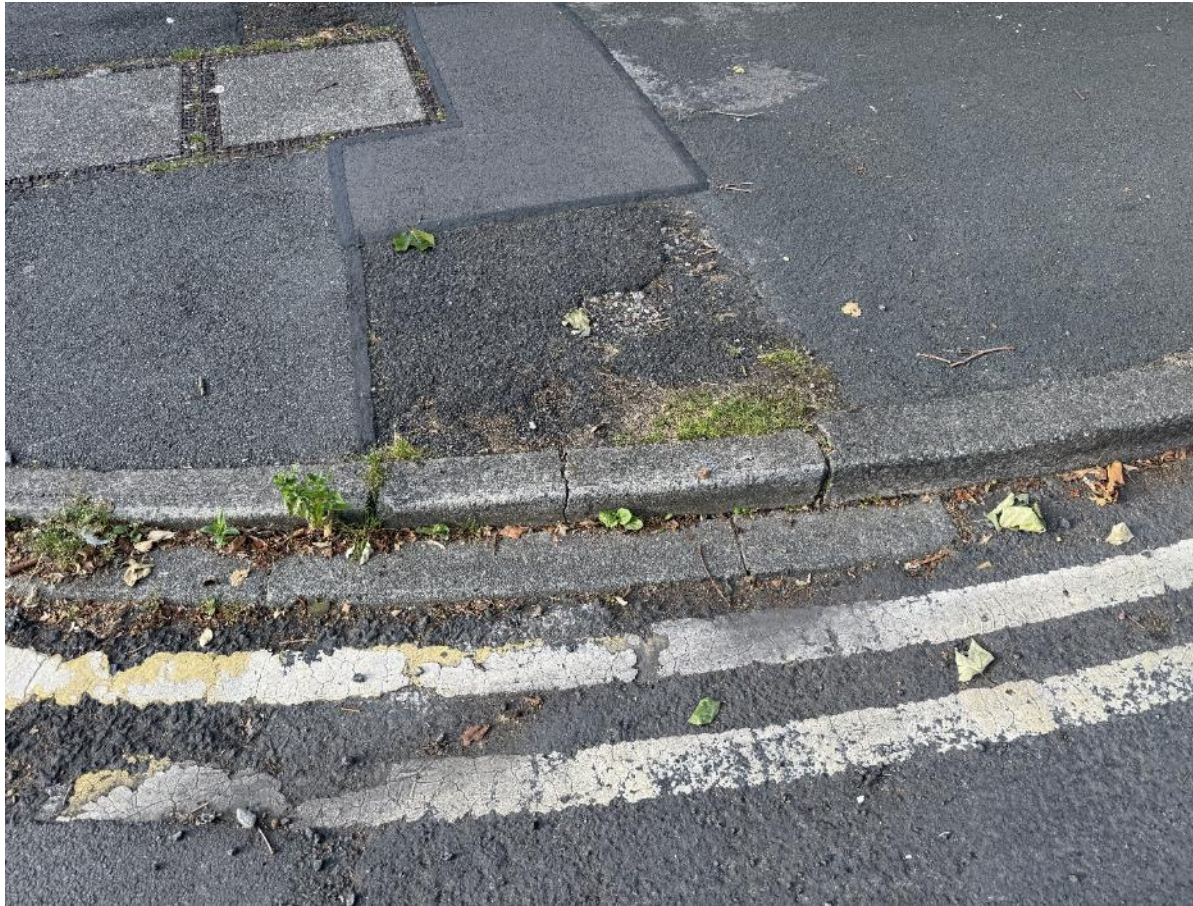
**Location 17**

**Crack in kerb and tarmac patch repair.**

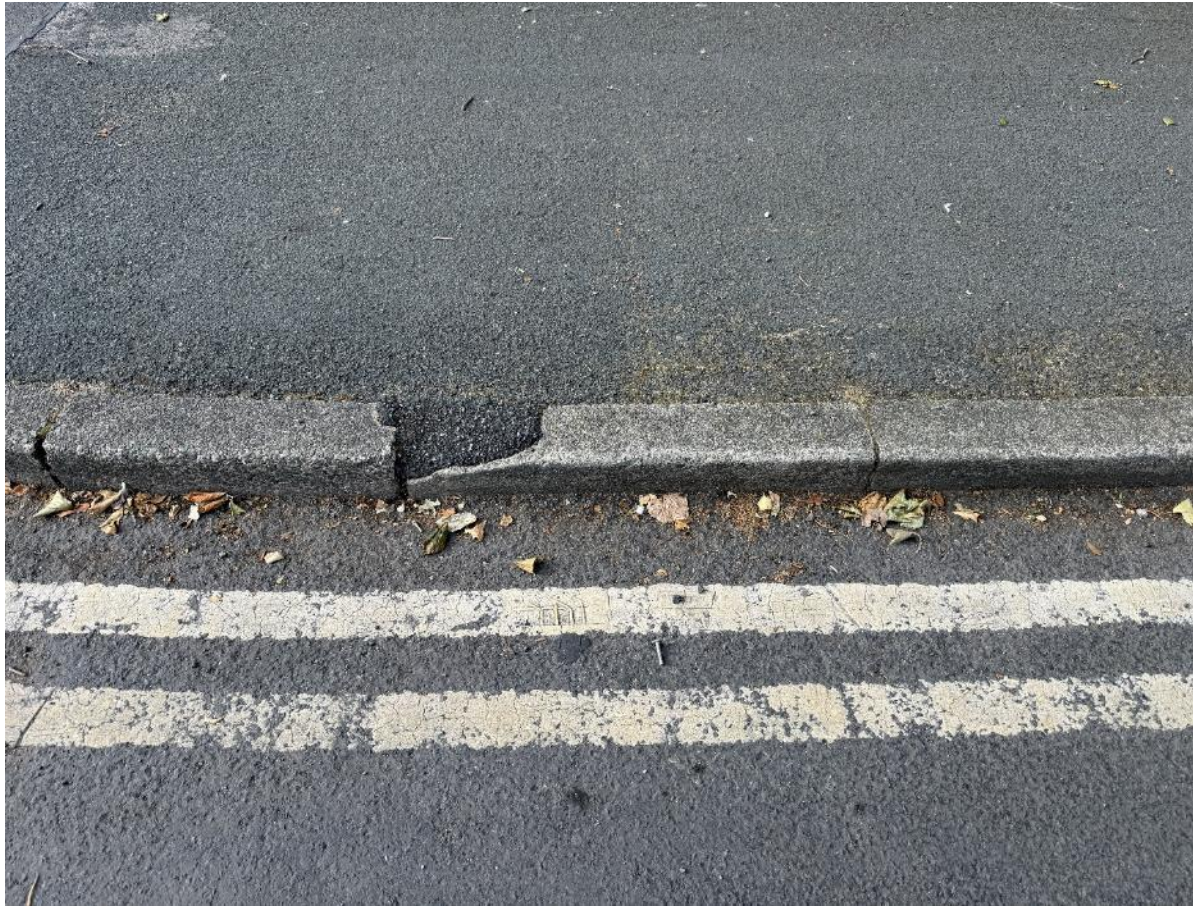
**Location 18**

**Kerb damaged with an attempt to repair it with tarmac.**

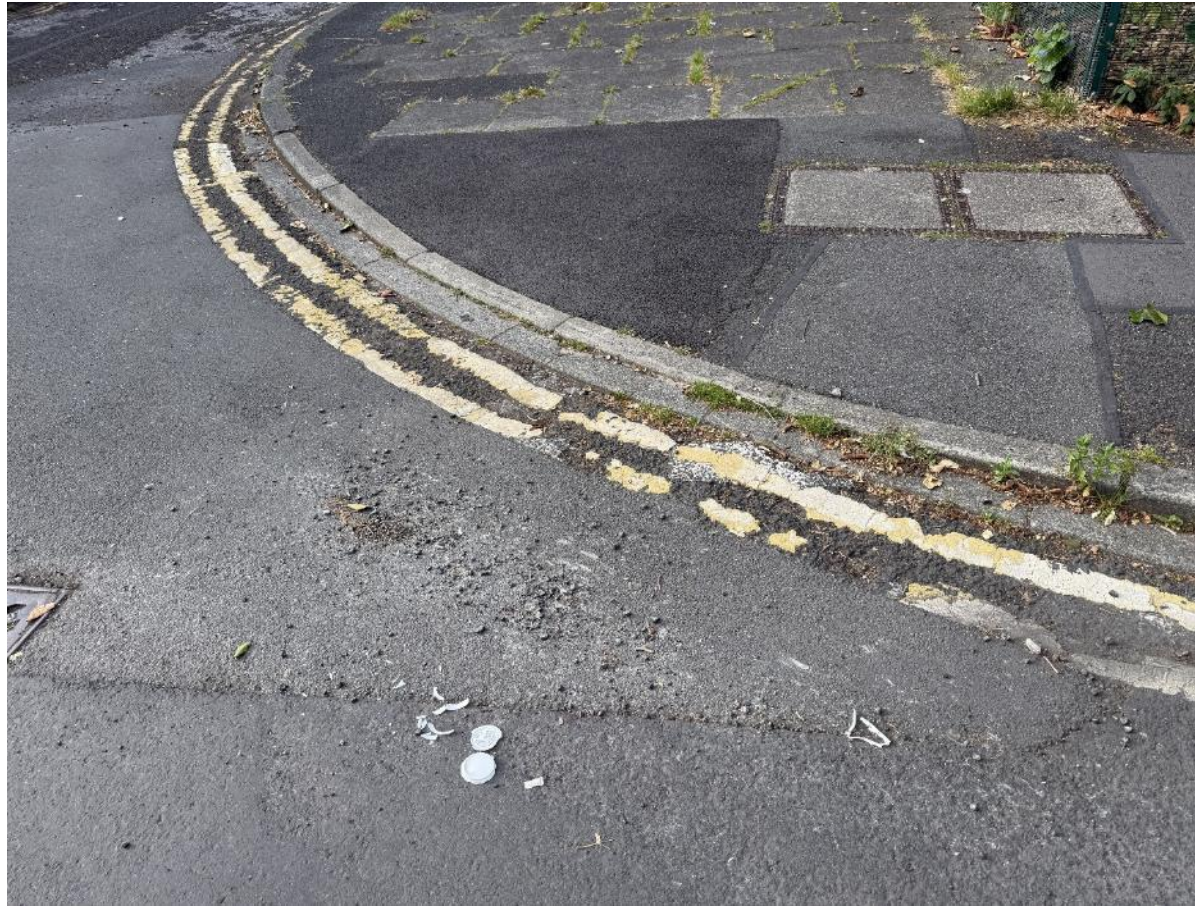
**Location 19**

**Junction appears to be newer tarmac however the edges are eroding.**

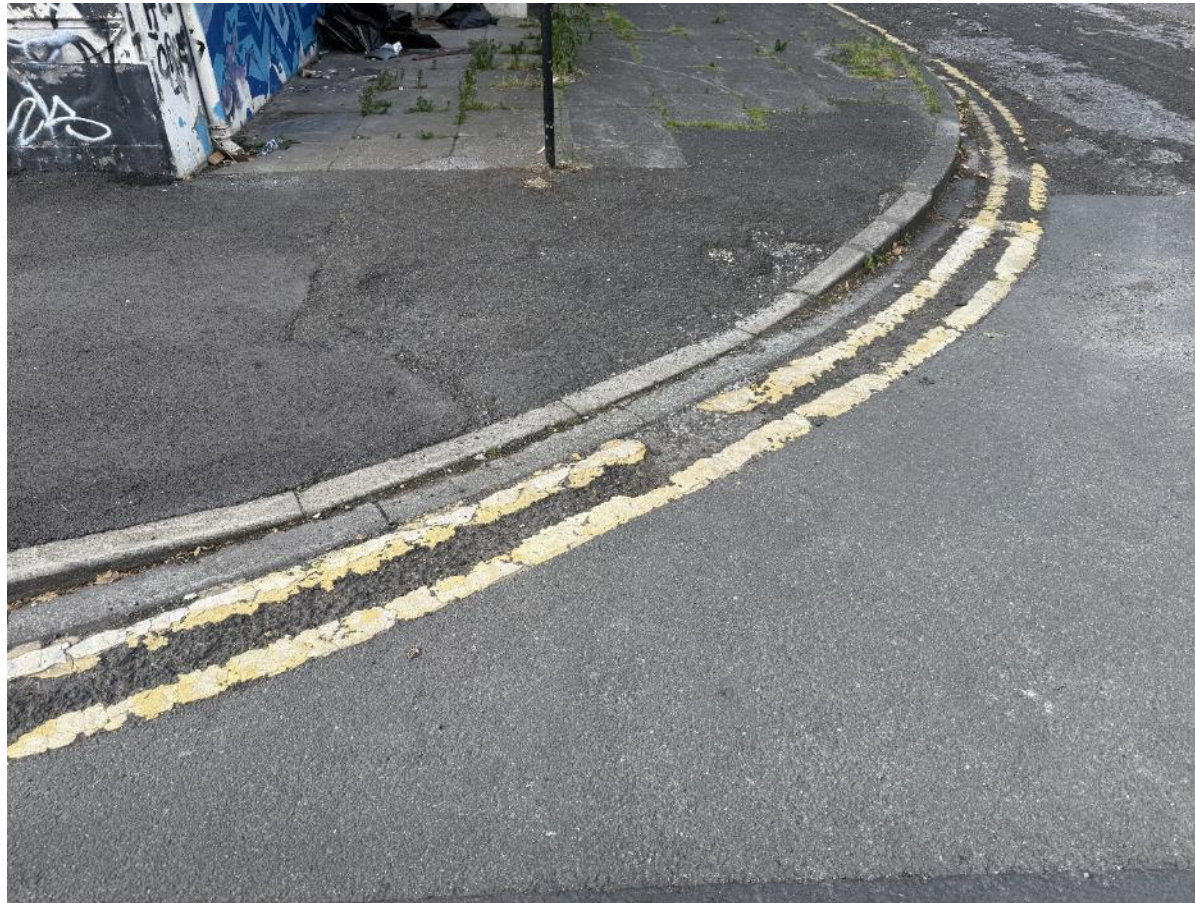
**Location 20**

**Junction appears to be newer tarmac however the edges are eroding.**
