**JUNCTION HOTEL  
ROLLS CRESCENT  
MANCHESTER  
M15 5FT**

**HIGHWAY DILAPIDATION  
SURVEY**

**23<sup>RD</sup> JUNE 2026**

DOCUMENT No:  
26013-DOC-002-A

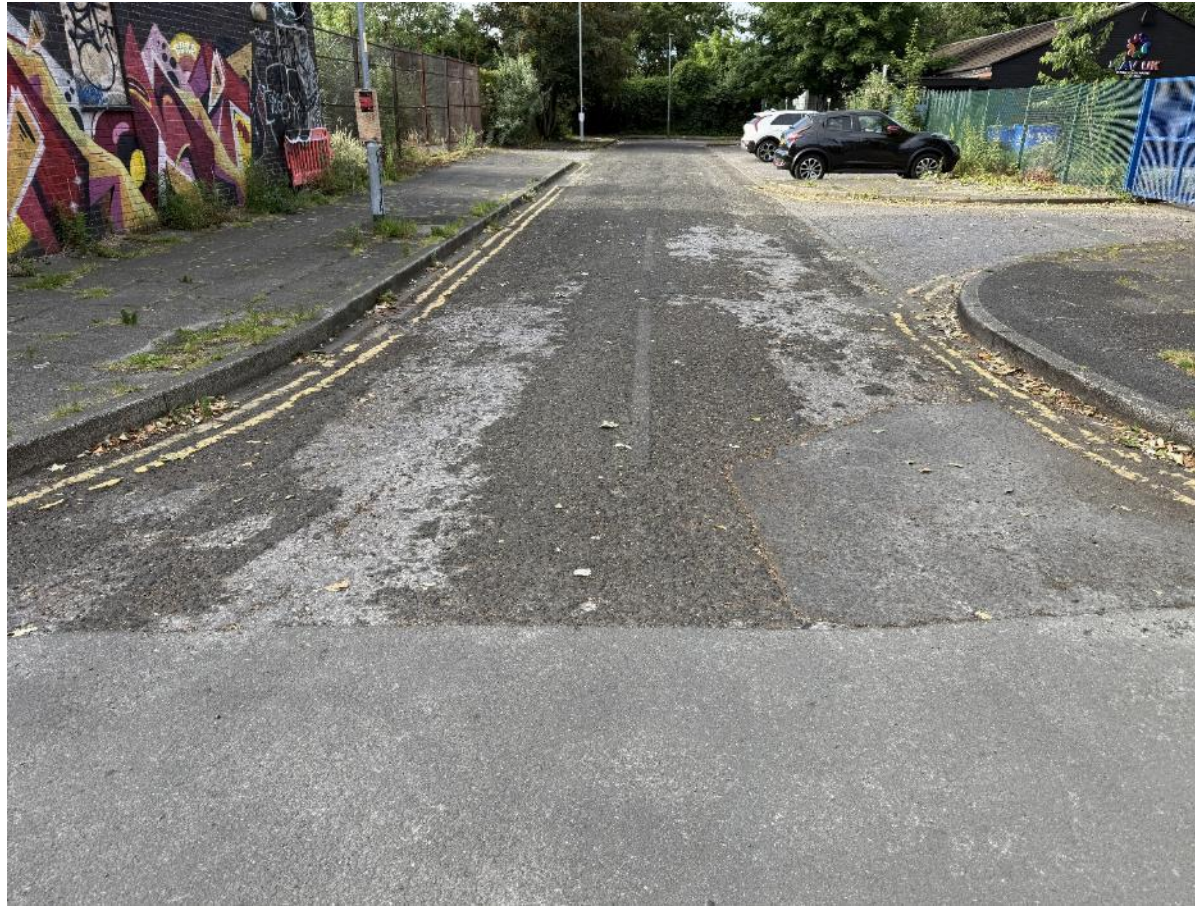
**Location 21**

**Main carriageway surface heavily eroded away.**

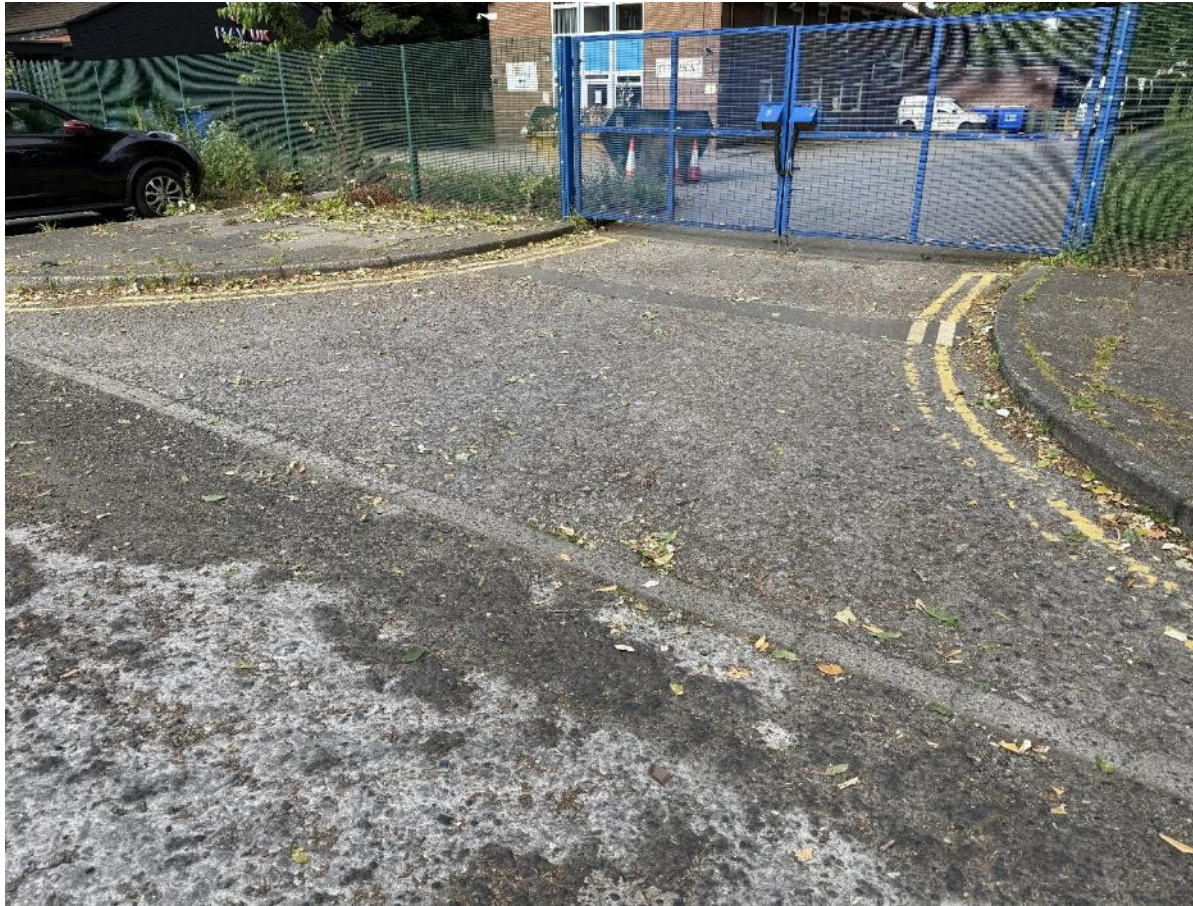
**Location 22**

**Main carriageway surface heavily eroded away.**

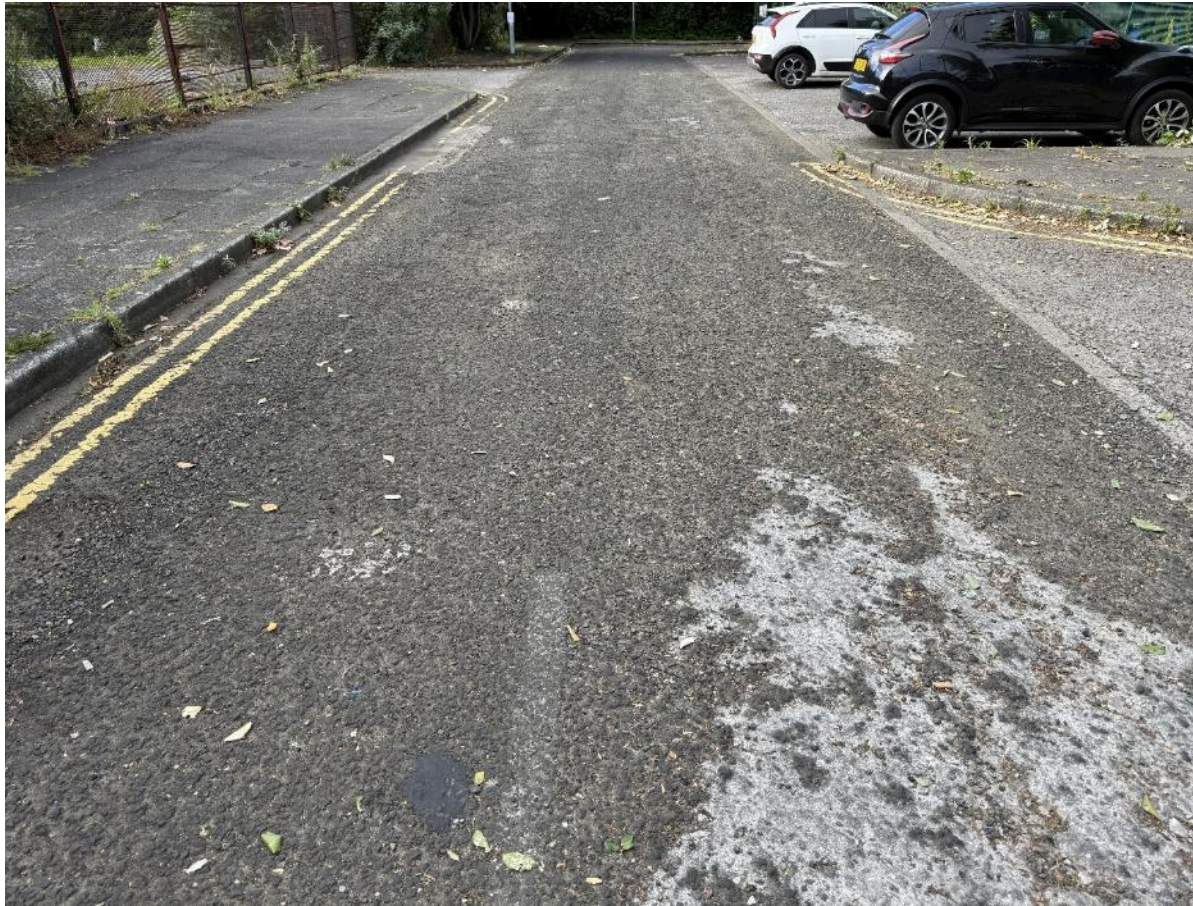
**Location 23**

**Main carriageway surface heavily eroded away.**

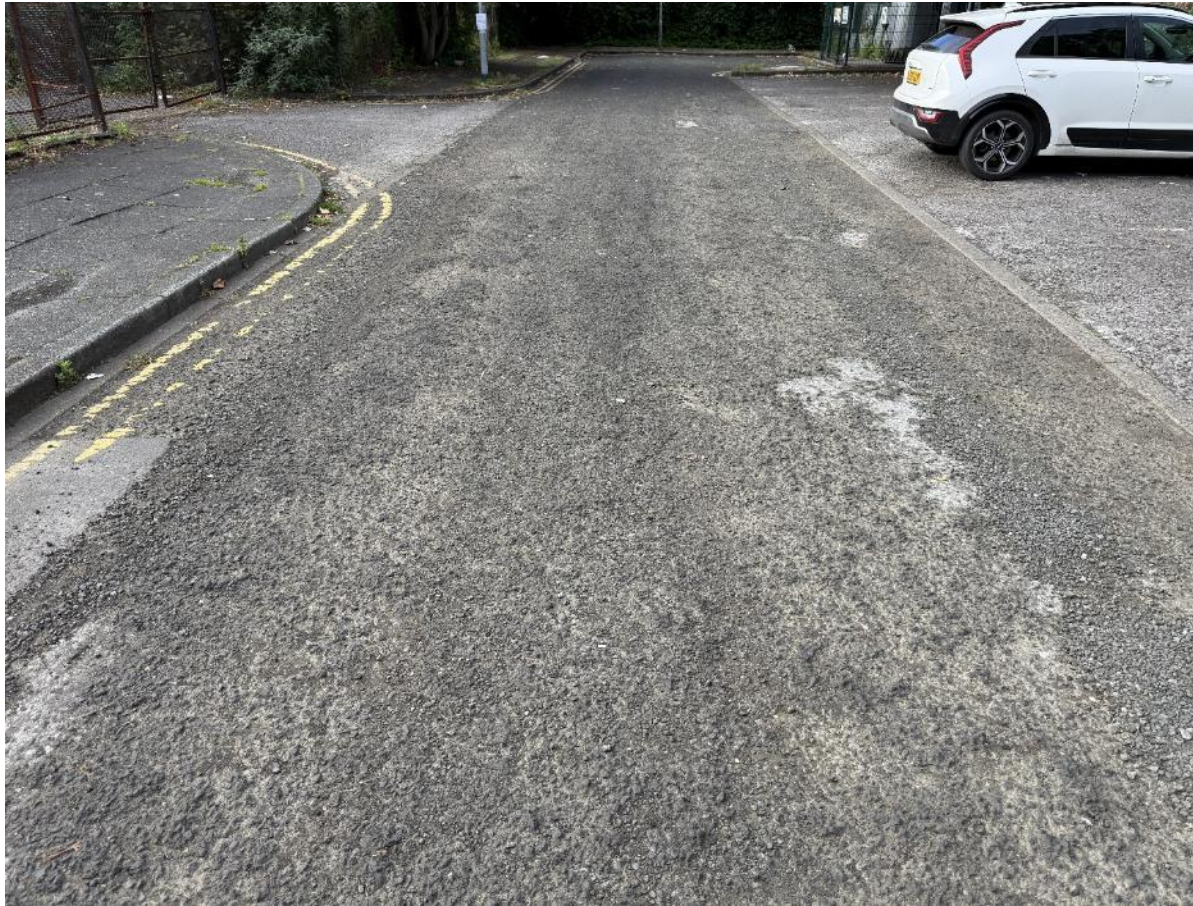
**Location 24**

**Main carriageway surface heavily eroded away.**

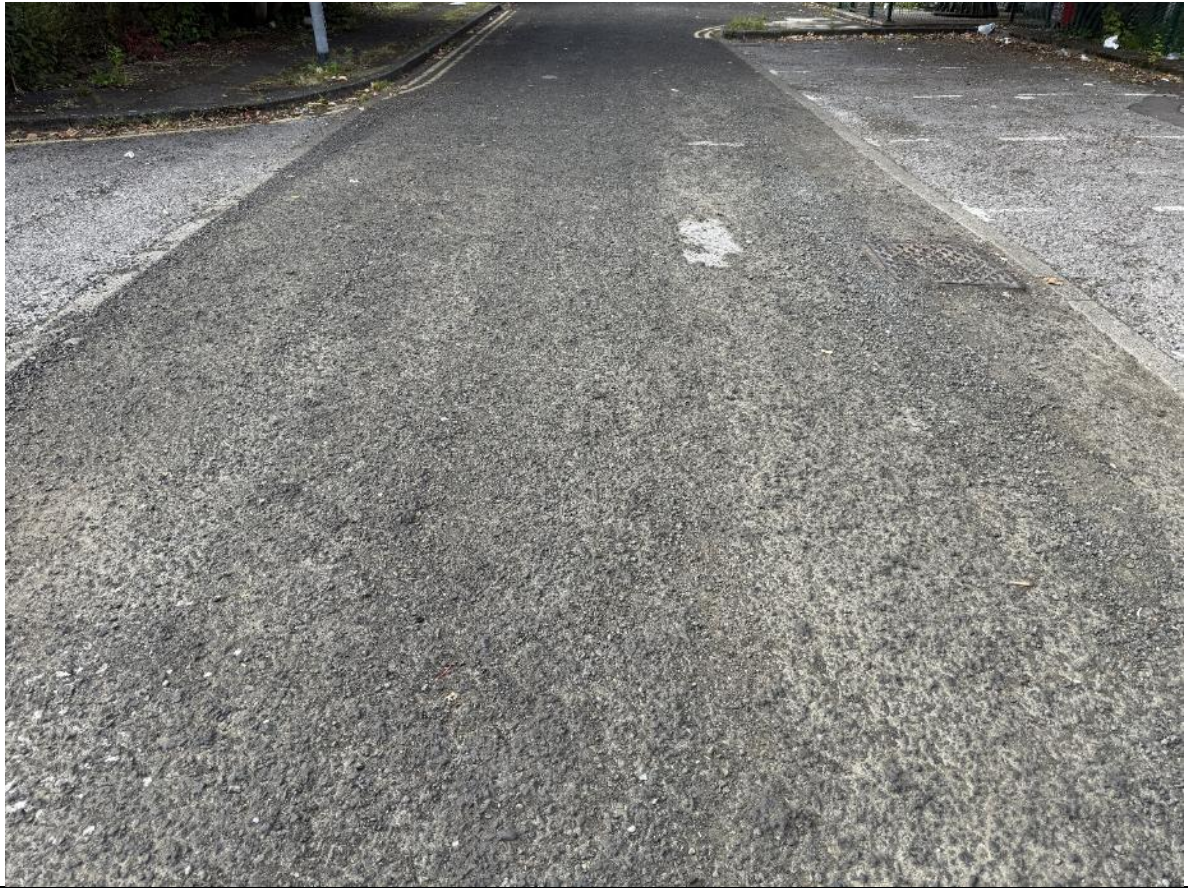
**Location 25**

**Main carriageway surface heavily eroded away.**

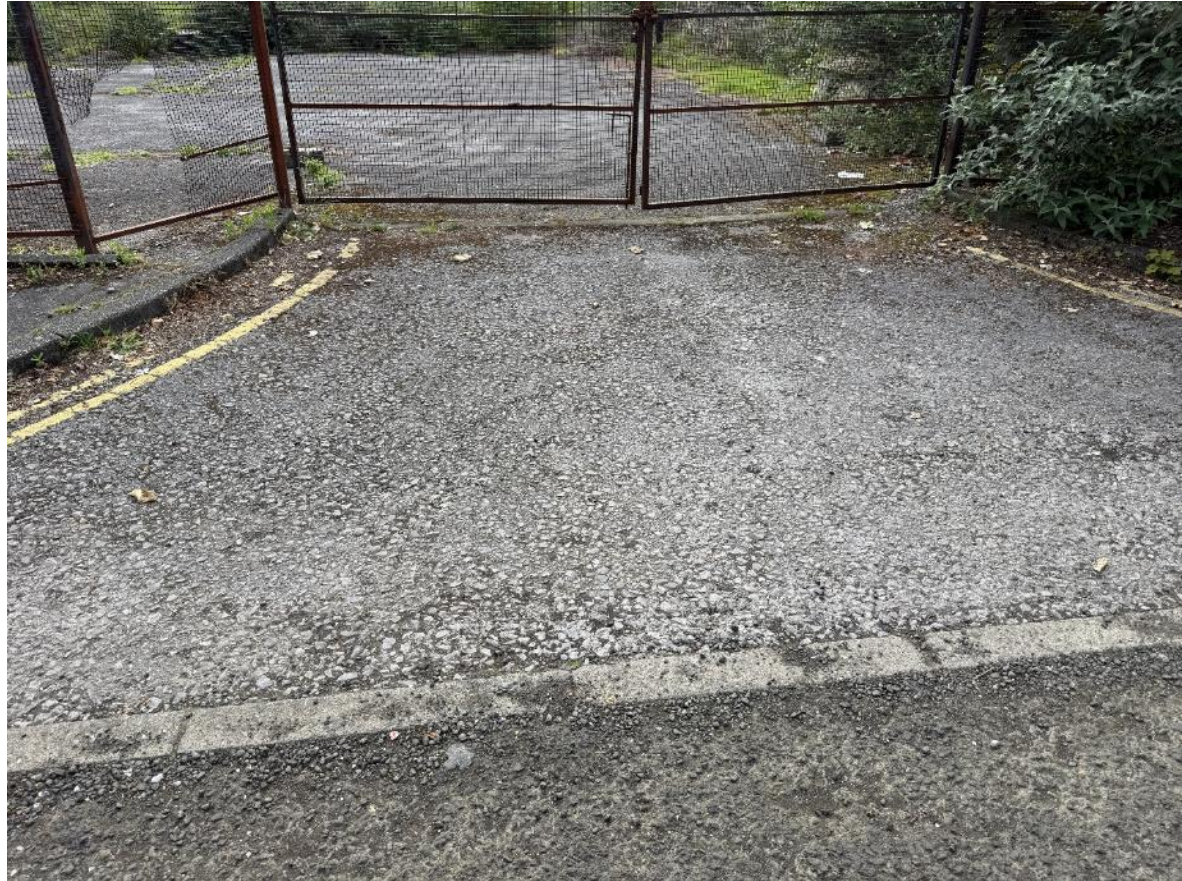
**Location 26**

**Main carriageway surface heavily eroded away.**

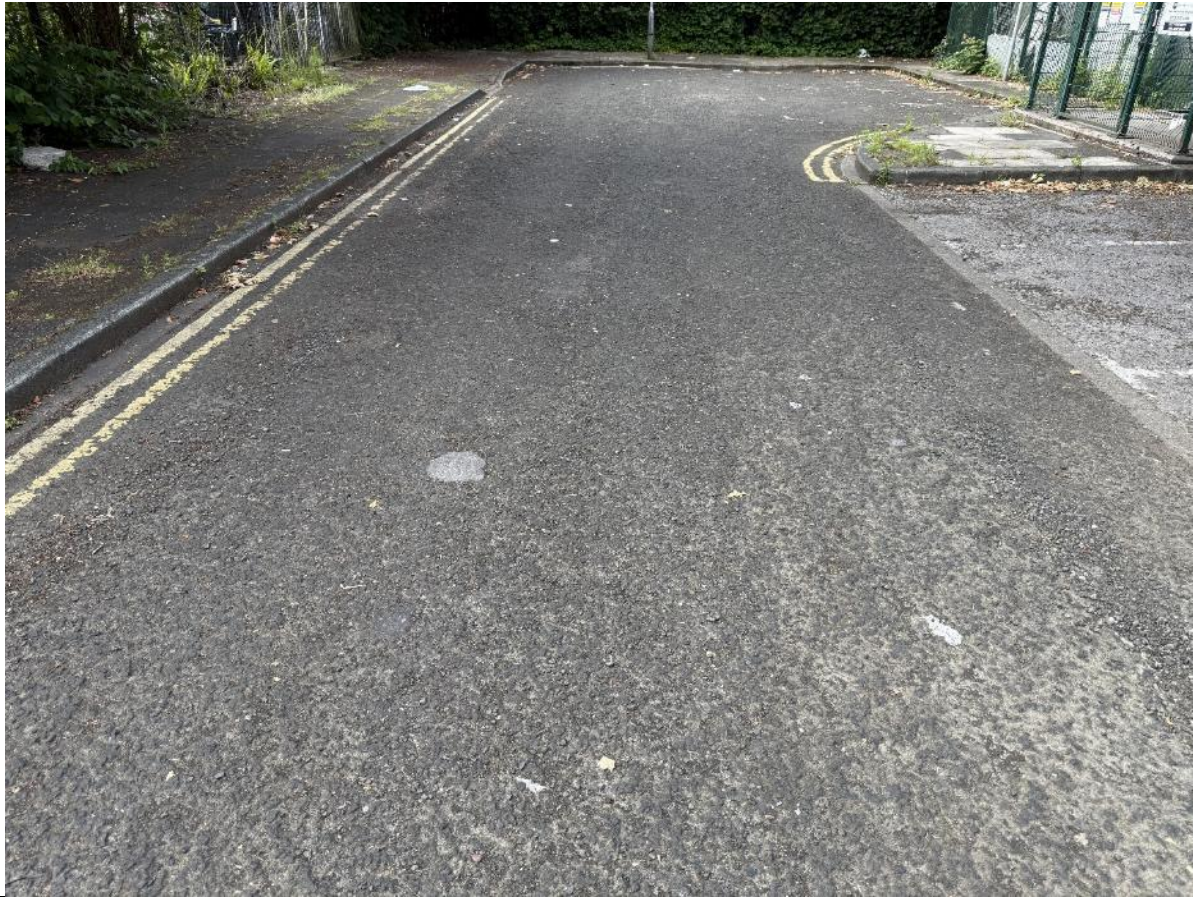
**Location 27**

**Main carriageway surface heavily eroded away.**

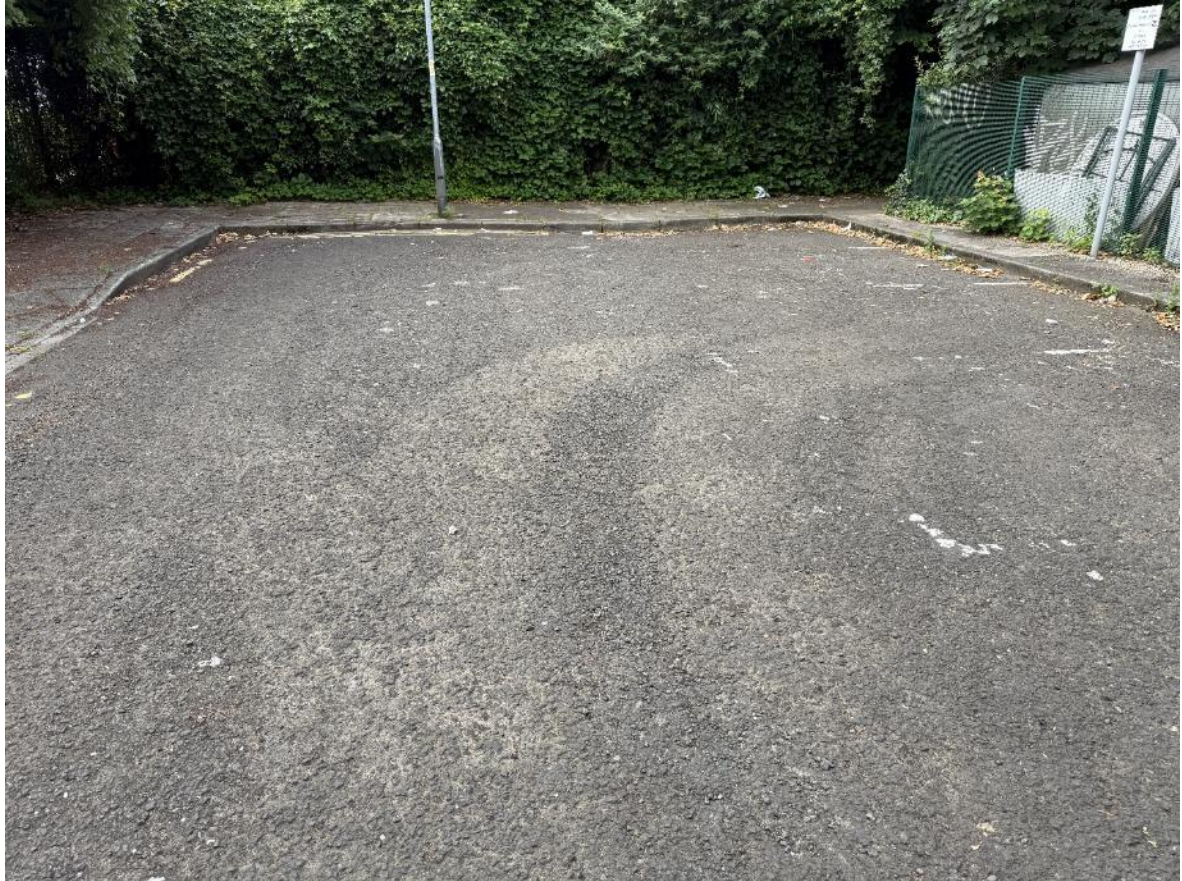
**Location 28**

**Main carriageway surface heavily eroded away.**

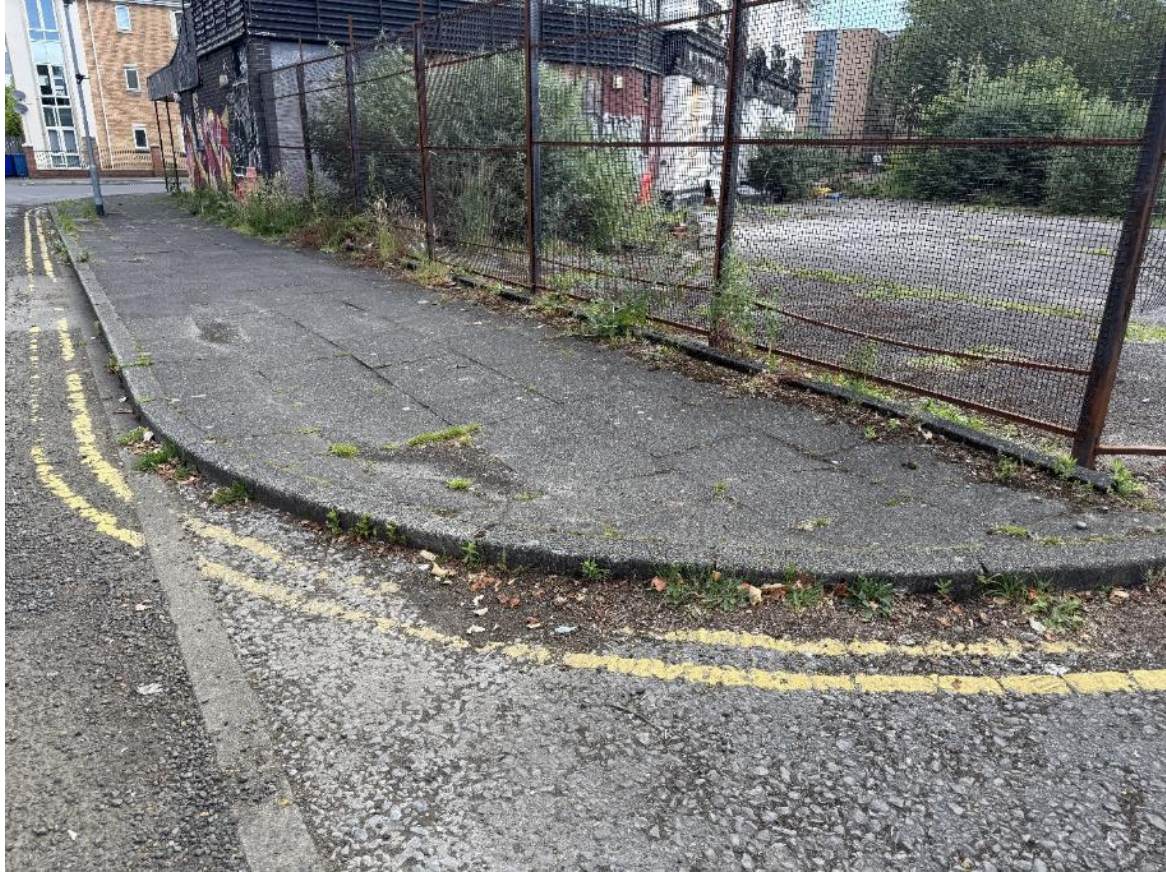
**Location 29**

**Flags broken and sunken.**

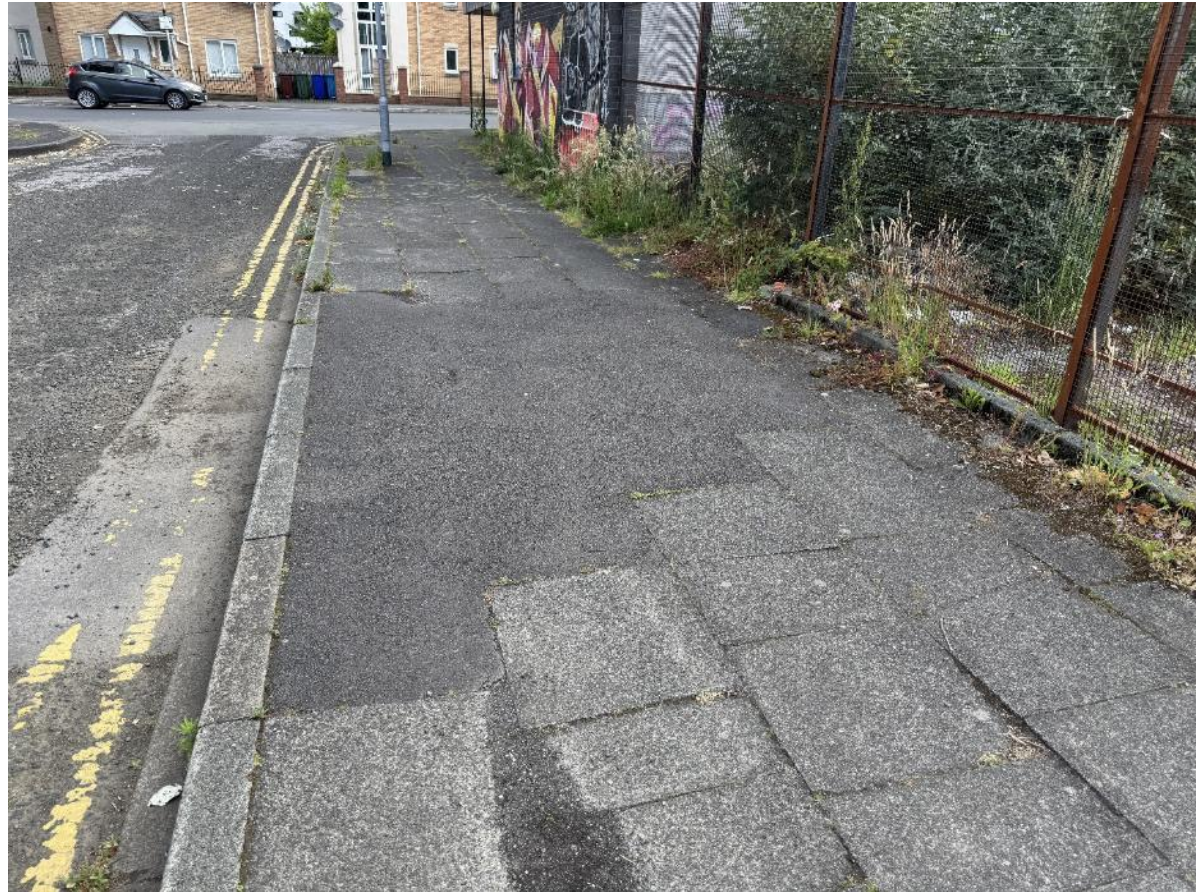
**Location 30**

**Tarmac patch repair in concrete flagged footpath.**

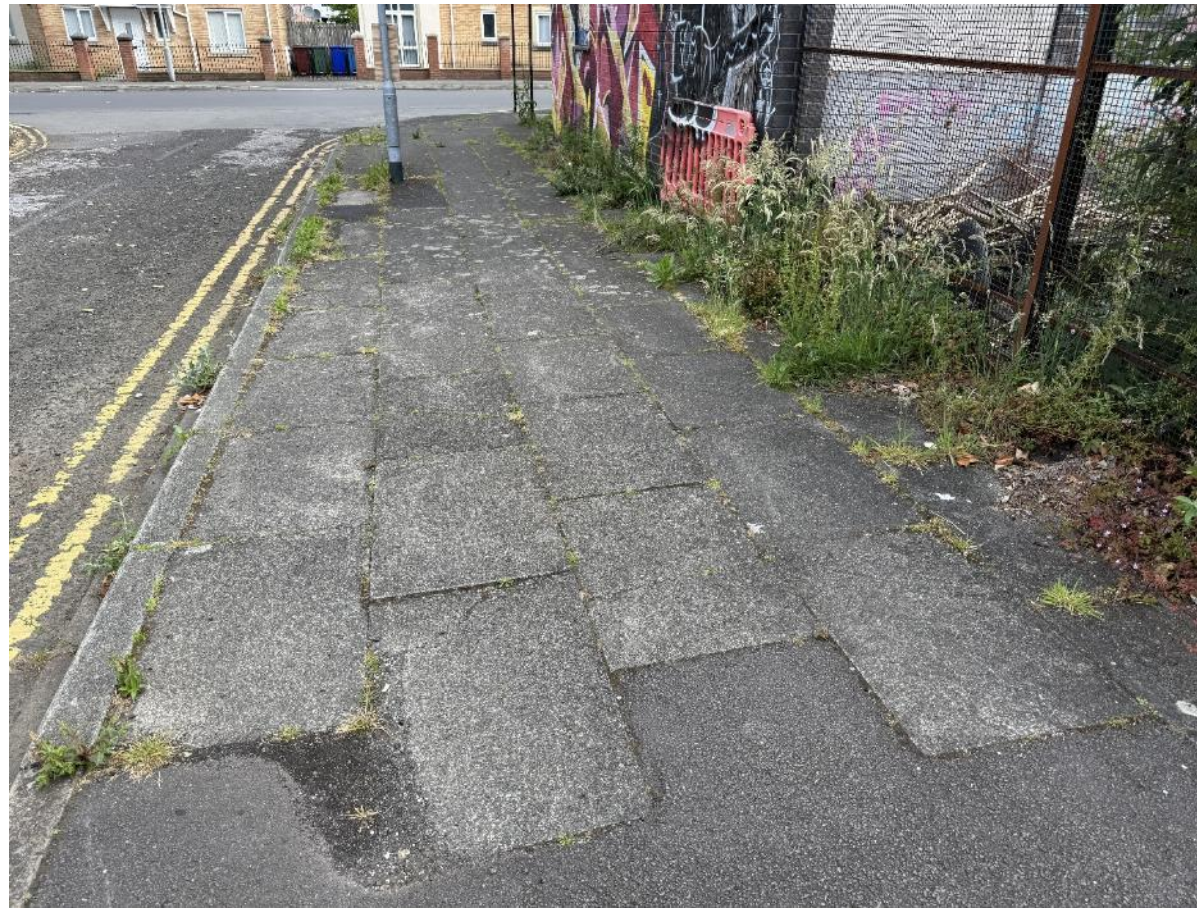
**Location 31**

**Broken and sunken flags.**

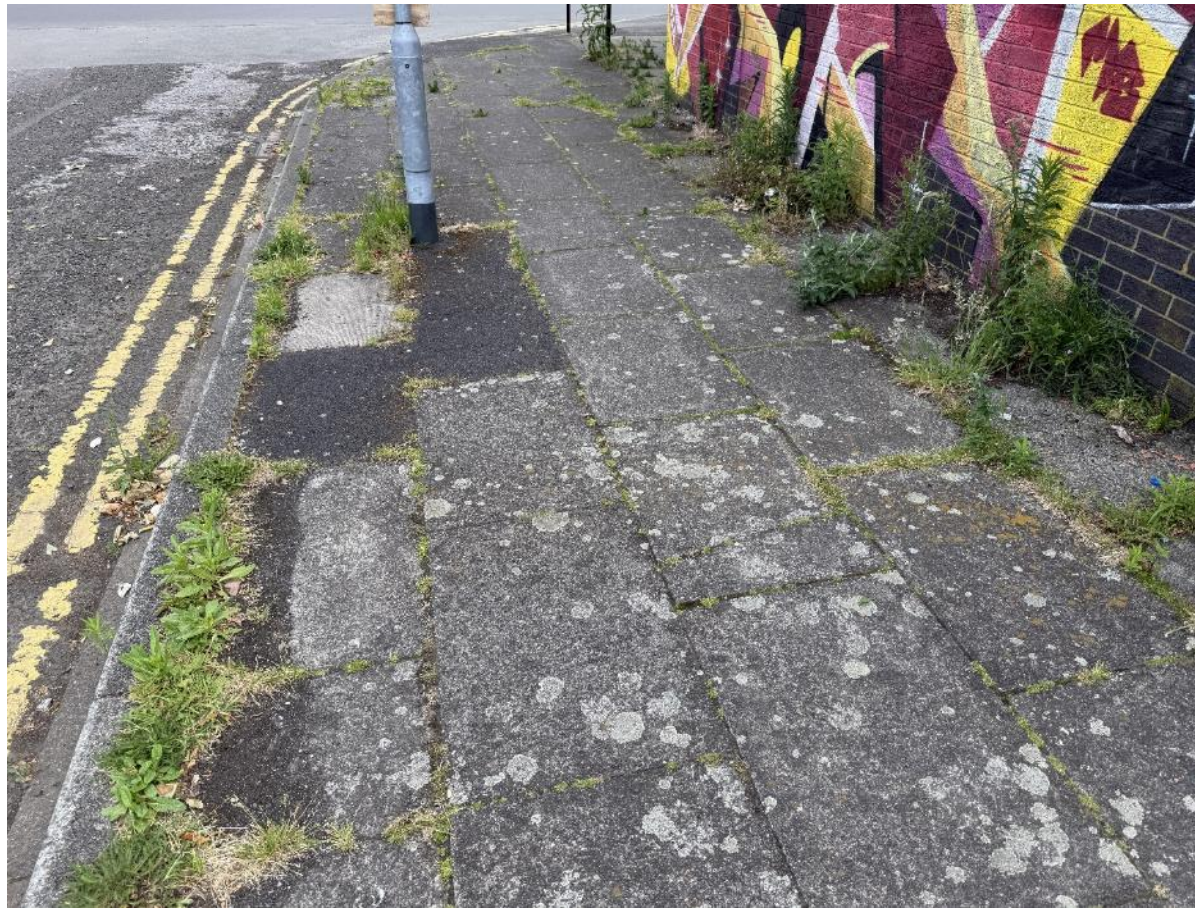
**Location 32**

**Broken and sunken flags, as well as a tarmac patch repair.**

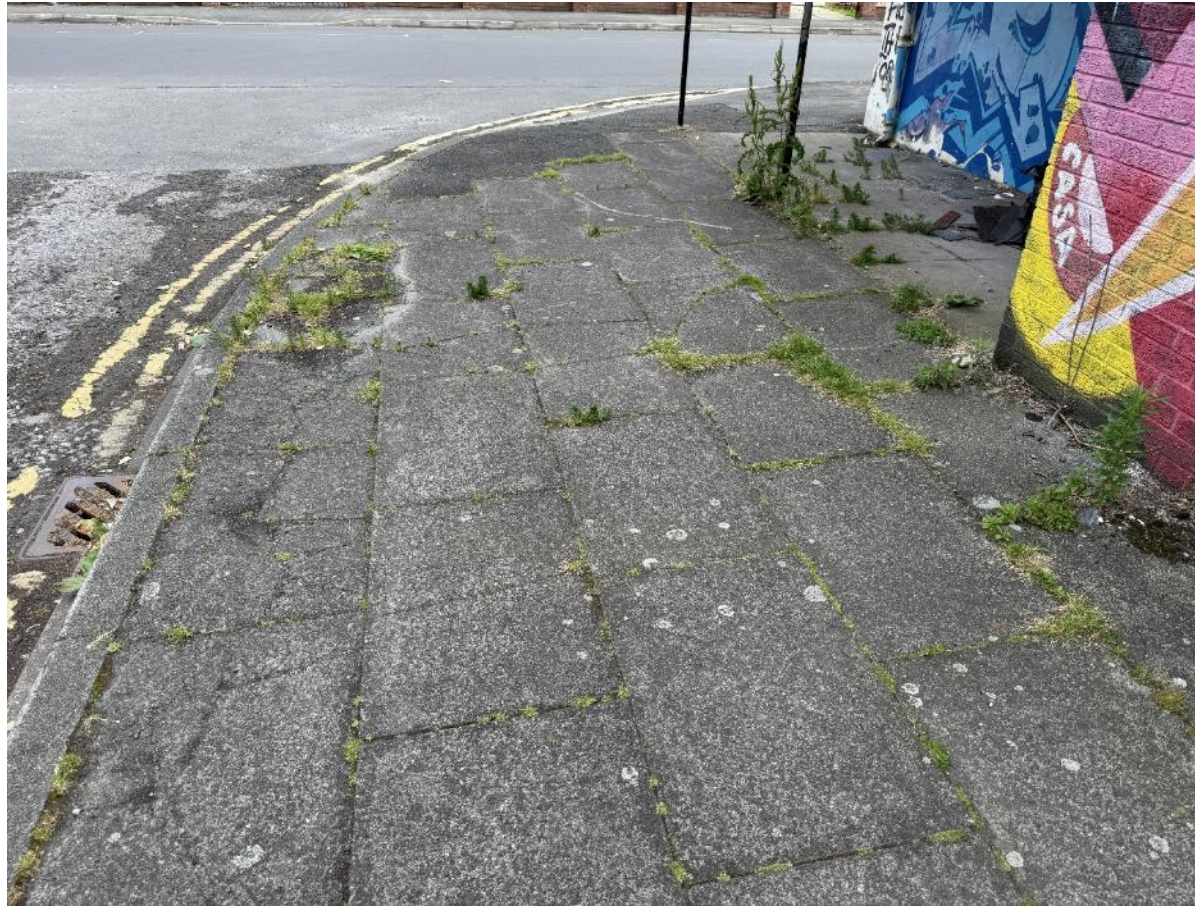
**Location 33**

**Broken and sunken flags as well as vegetative growth in footpath.**

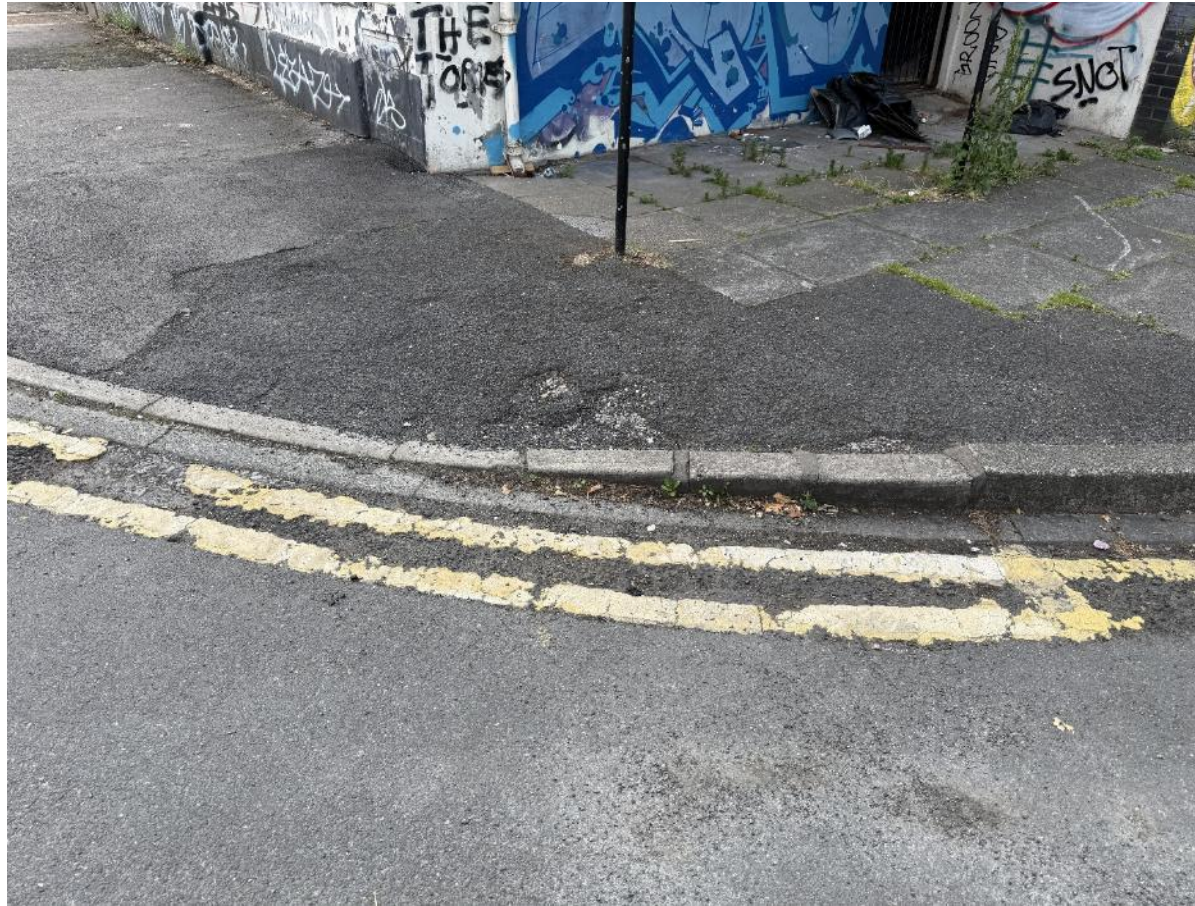
**Location 34**

**Damage to kerbs on dropped crossing as well as a tarmac patch repair.**

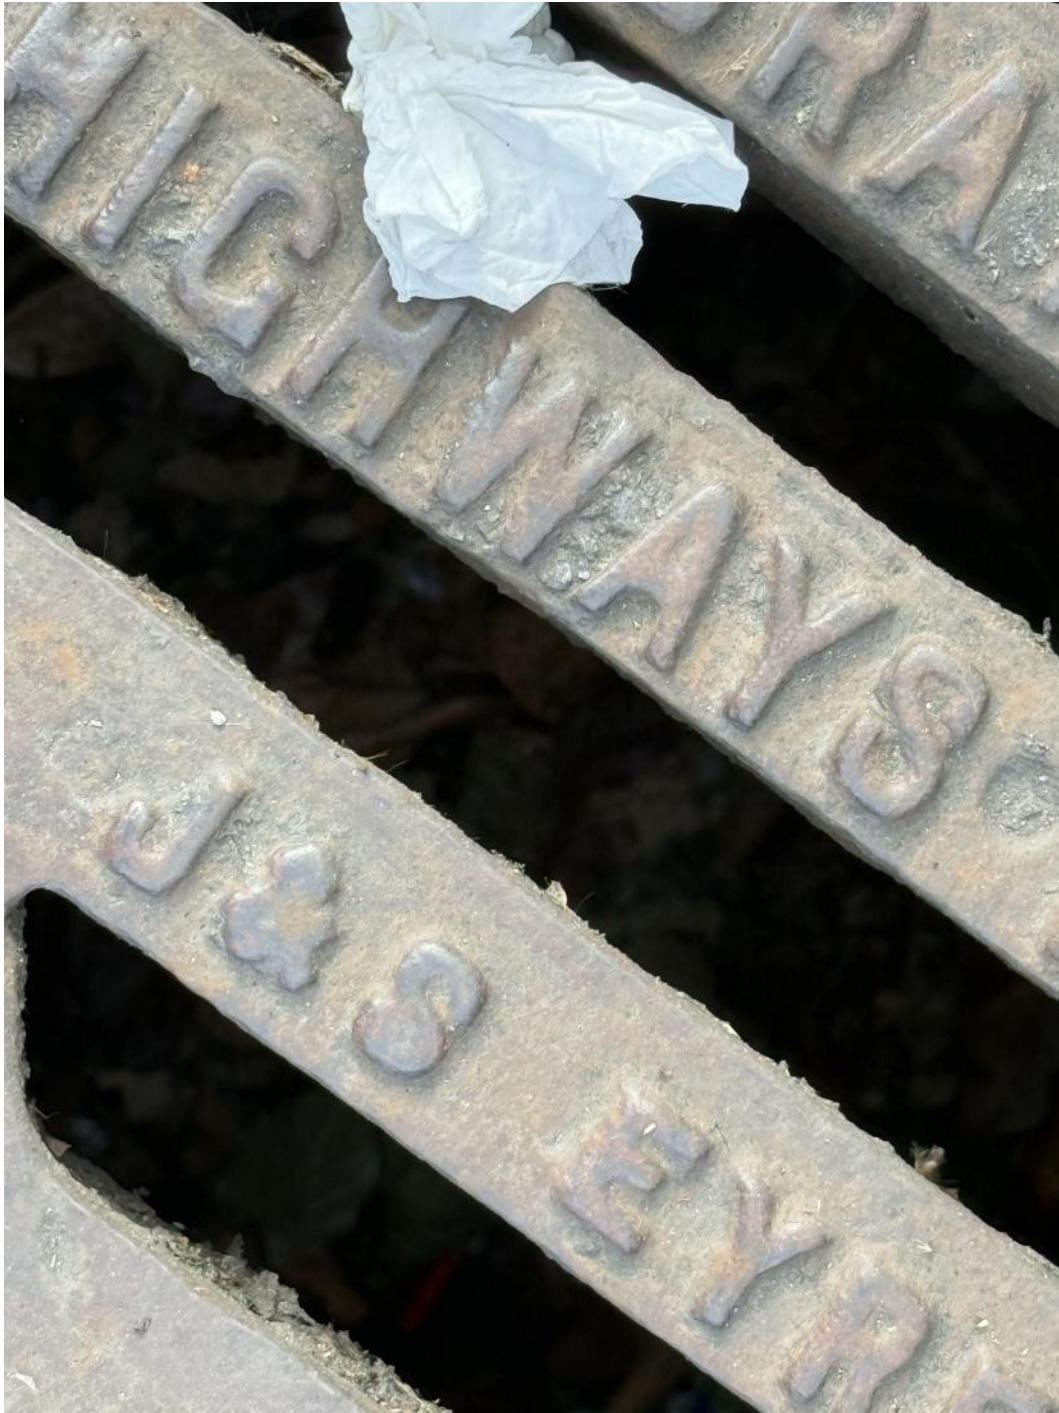
**Location 35**

**Gully blocked.**

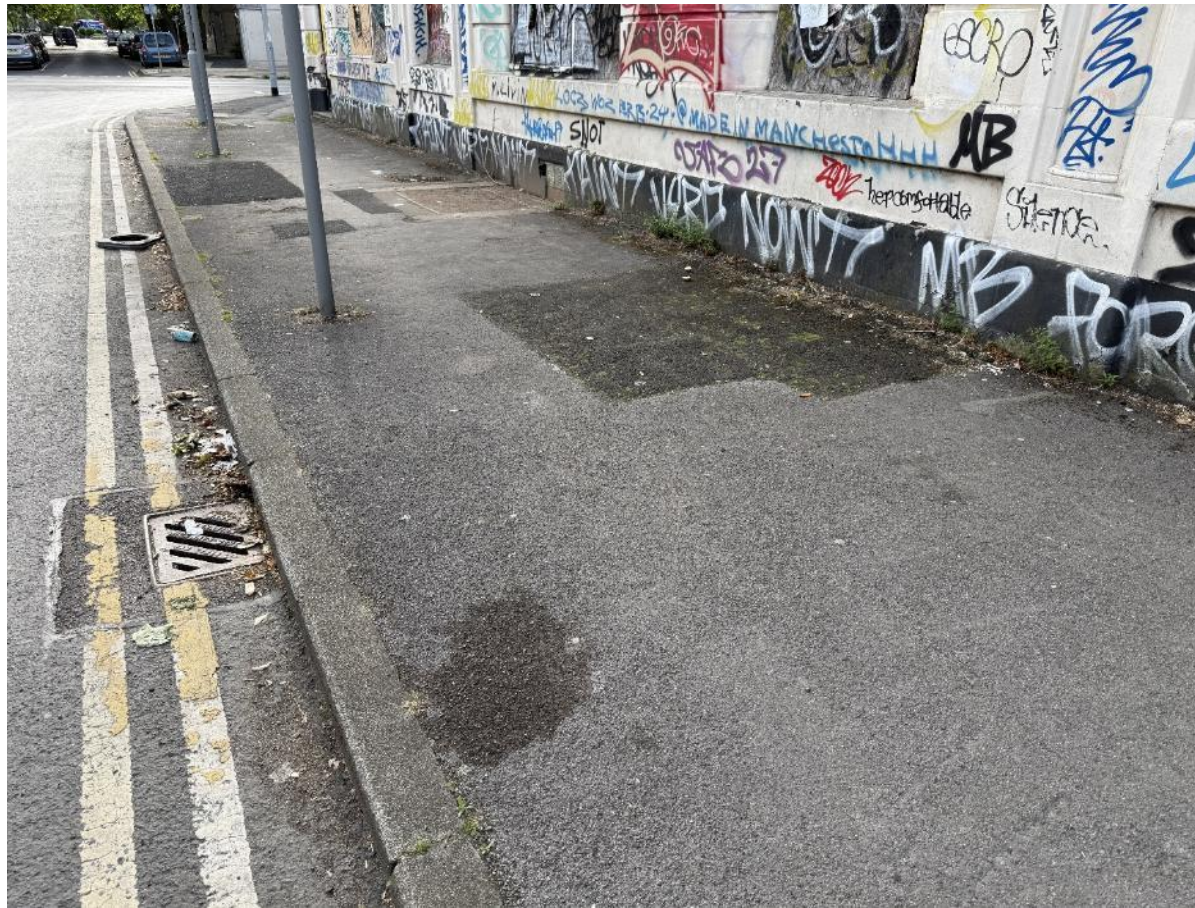
**Location 36**

**Patch repairs in tarmac.**

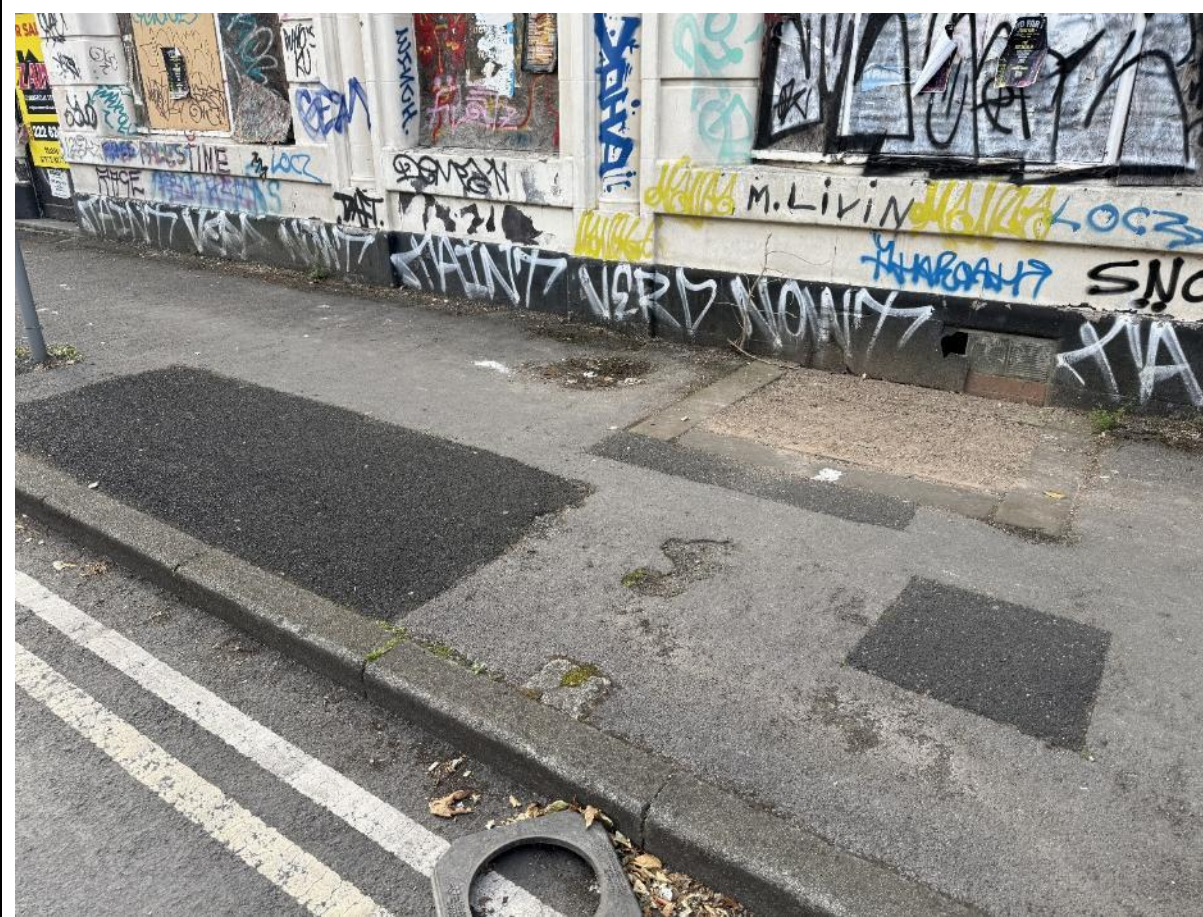
**Location 37**

**Tarmac patch repairs, areas of erosion as well as an area sunken close to the building.**

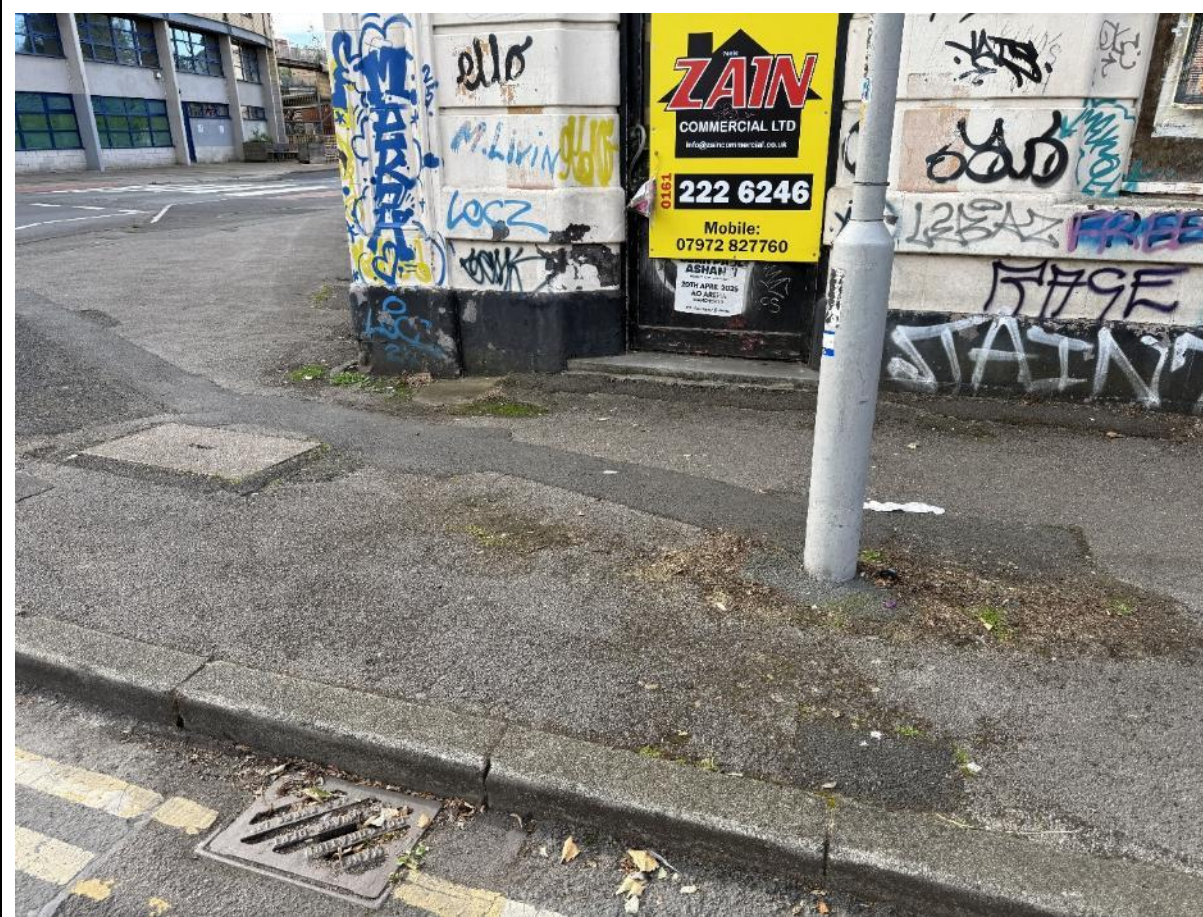
Location 38

Tarmac patch repairs, areas of erosion as well as an area sunken.

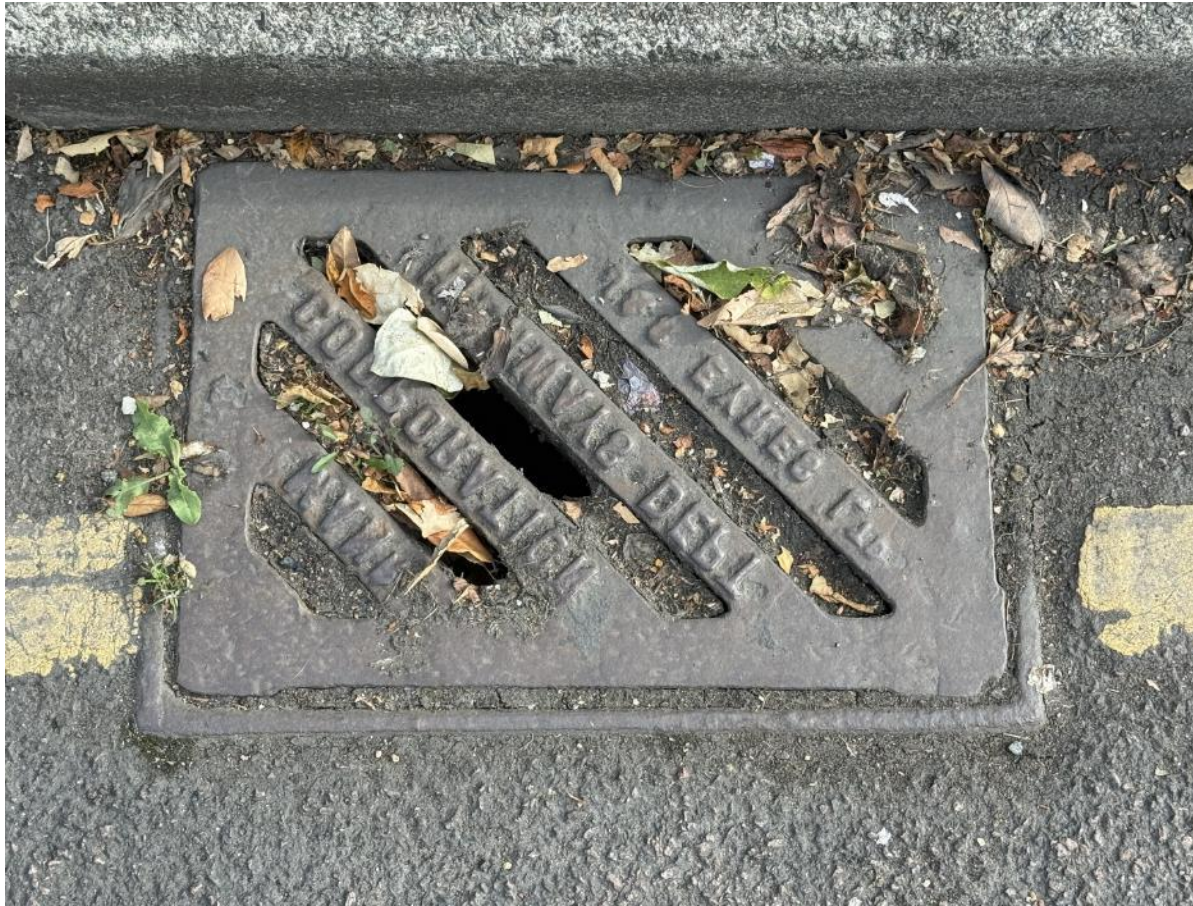
**Location 39**

**Gully blocked.**

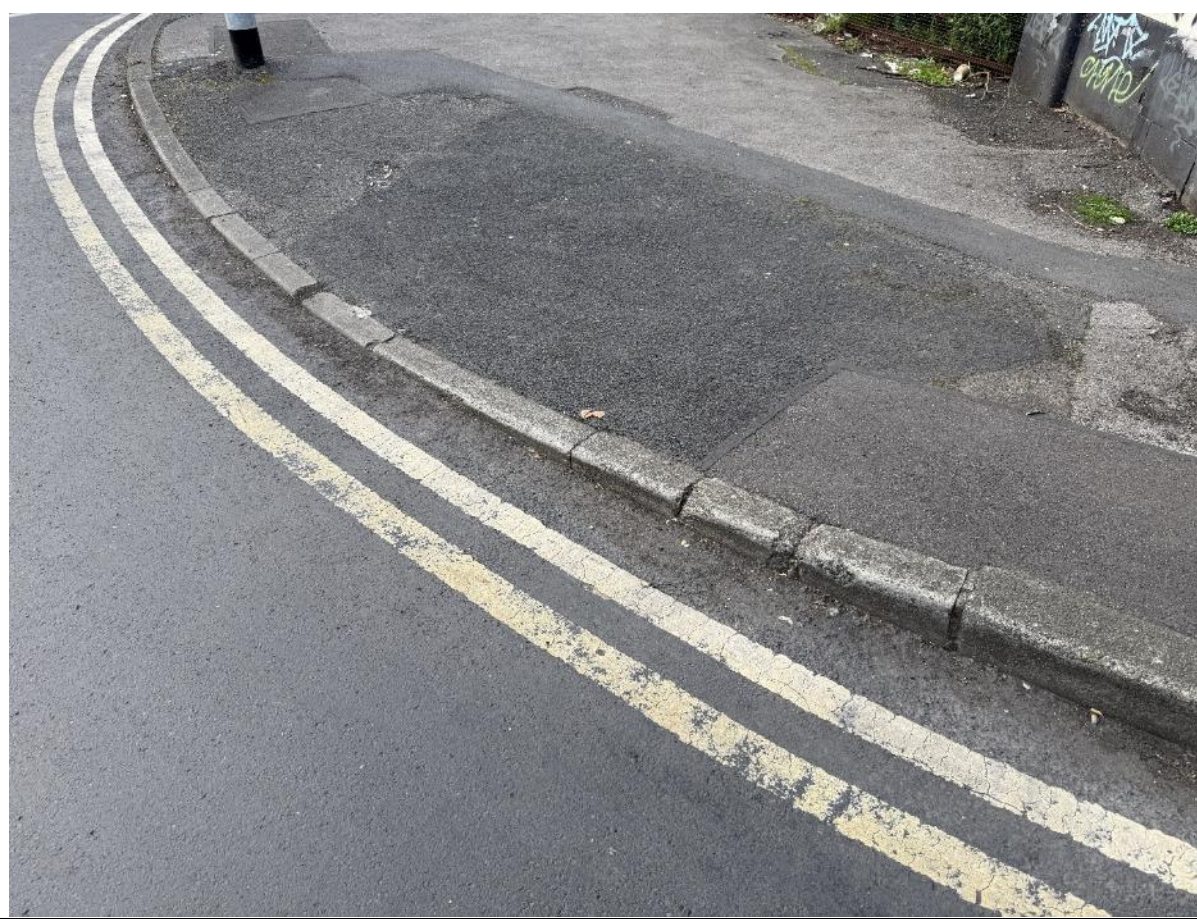
**Location 40**

**Damage to kerbs.**

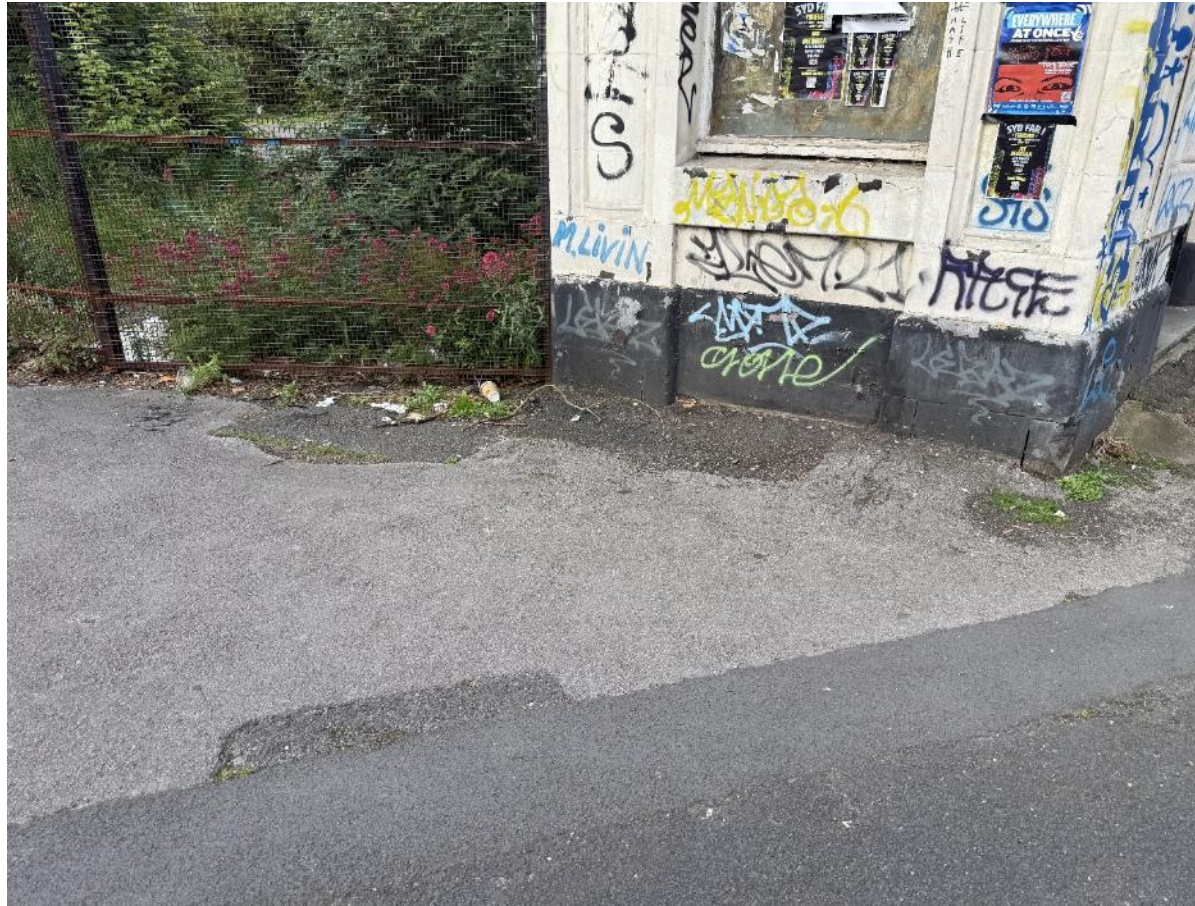
**Location 41**

**Tarmac patch repair but is eroding away and sinking along the back of footpath.**
