**JUNCTION HOTEL  
ROLLS CRESCENT  
MANCHESTER  
M15 5FT**

**HIGHWAY DILAPIDATION  
SURVEY**

**23<sup>RD</sup> JUNE 2026**

DOCUMENT No:  
26013-DOC-002-A

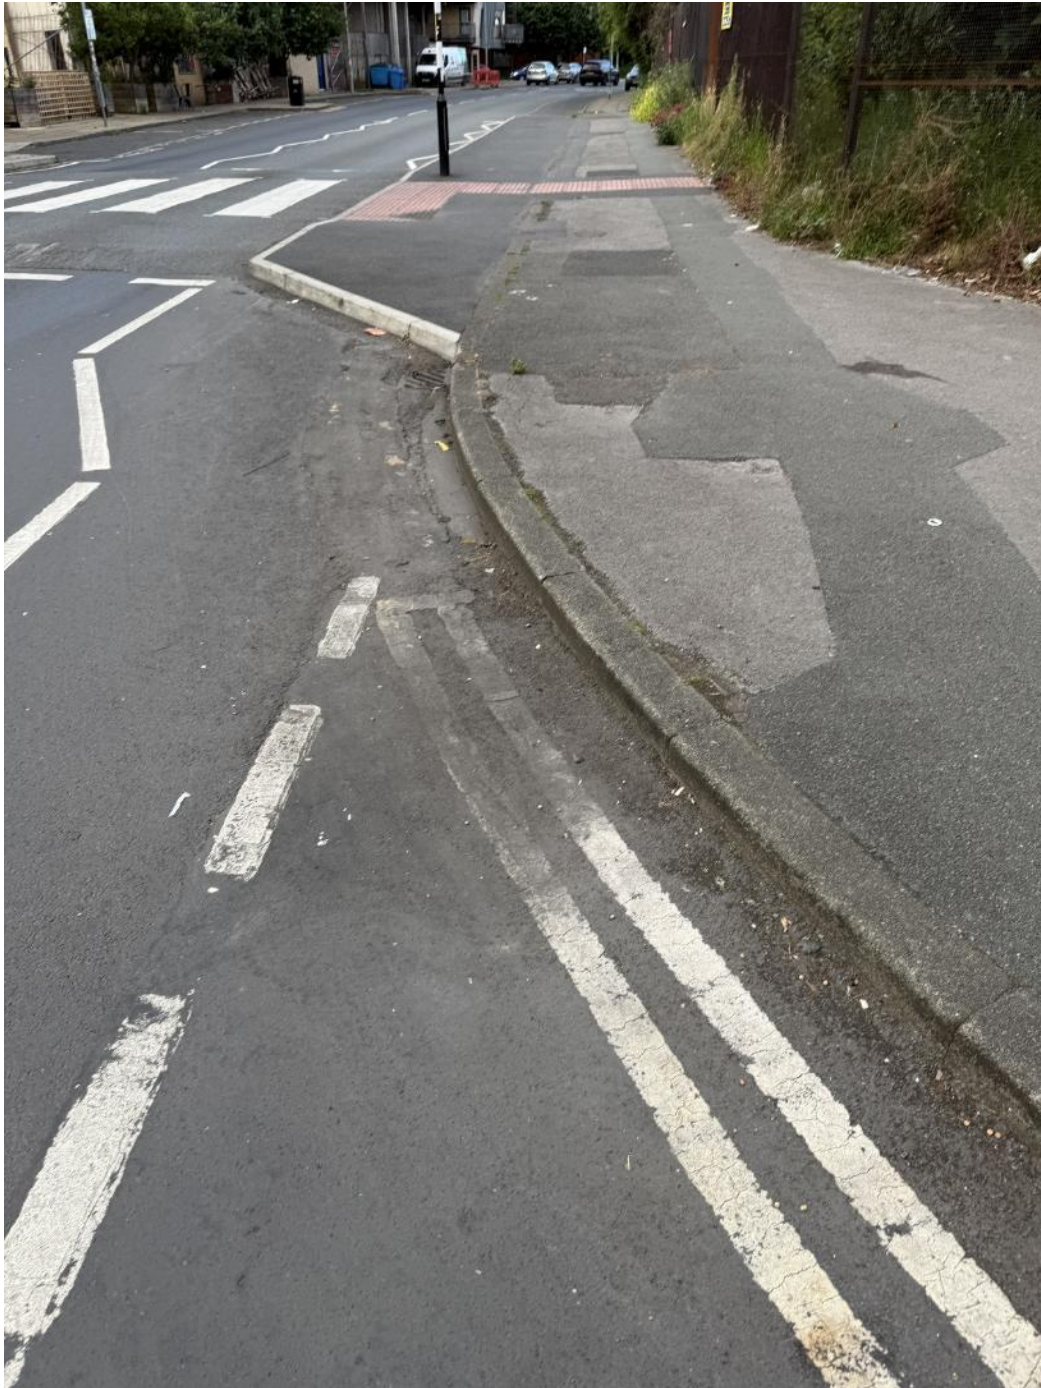
**Location 42**

**Tarmac Patch repairs.**

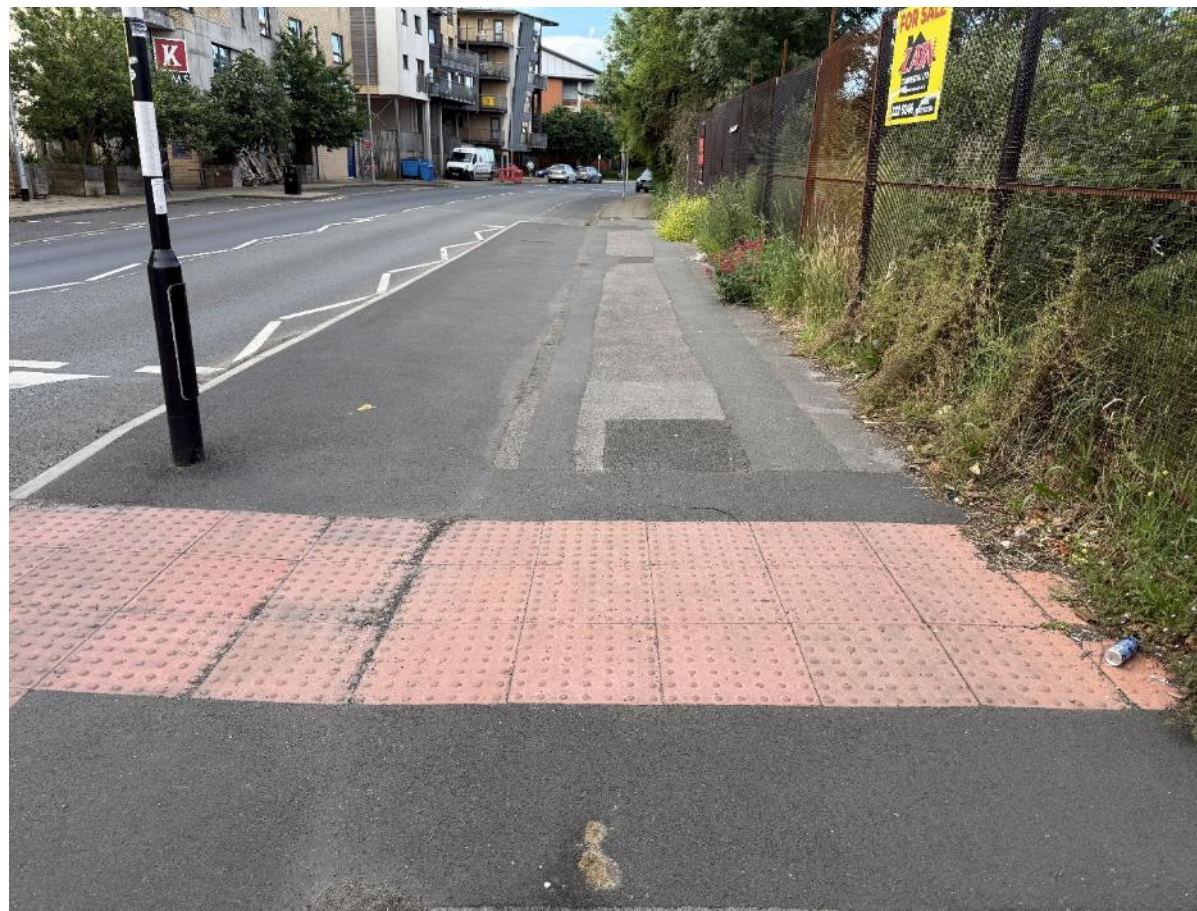
**Location 43**

**Section of new footpath and pedestrian crossing with tactile paving, new section is in good condition.**

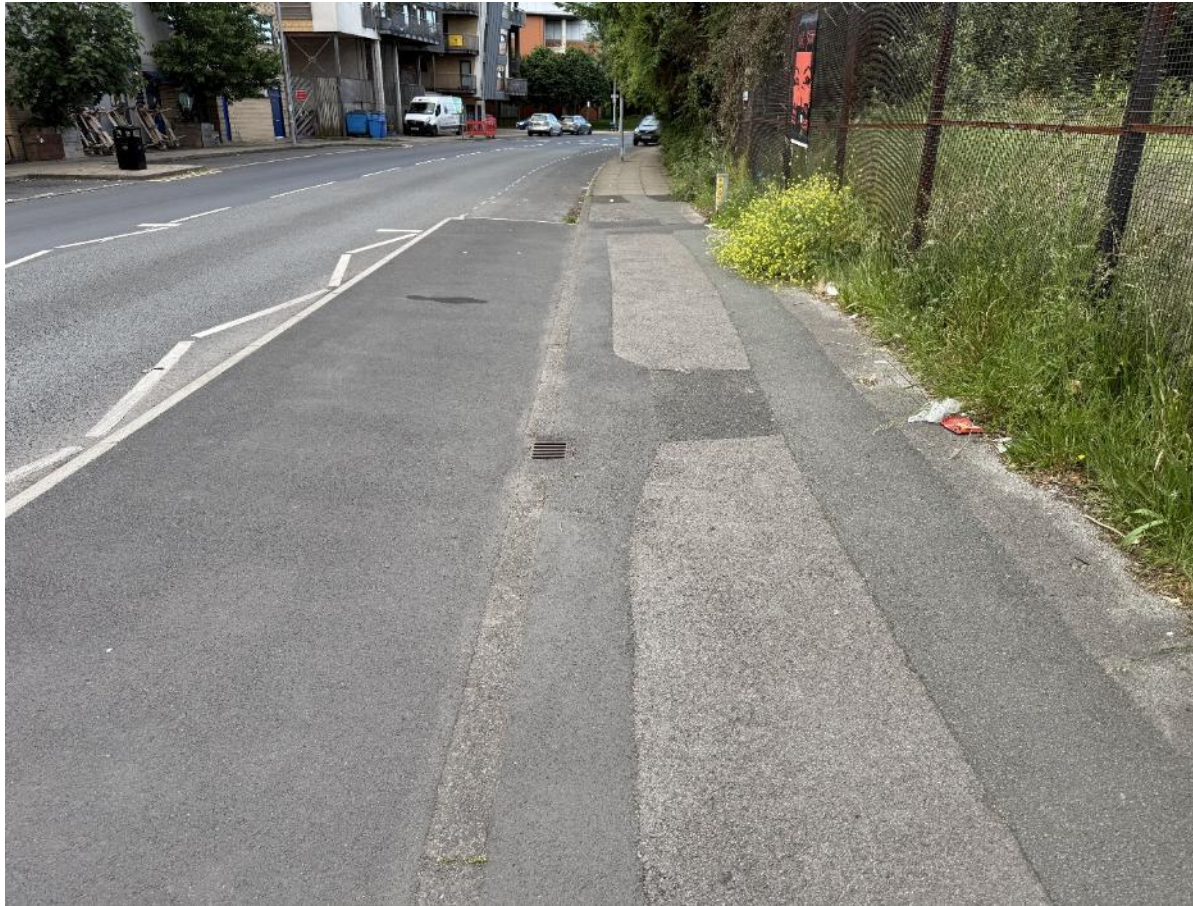
**Location 44**

**Tarmac patch repairs and gully in footpath.**

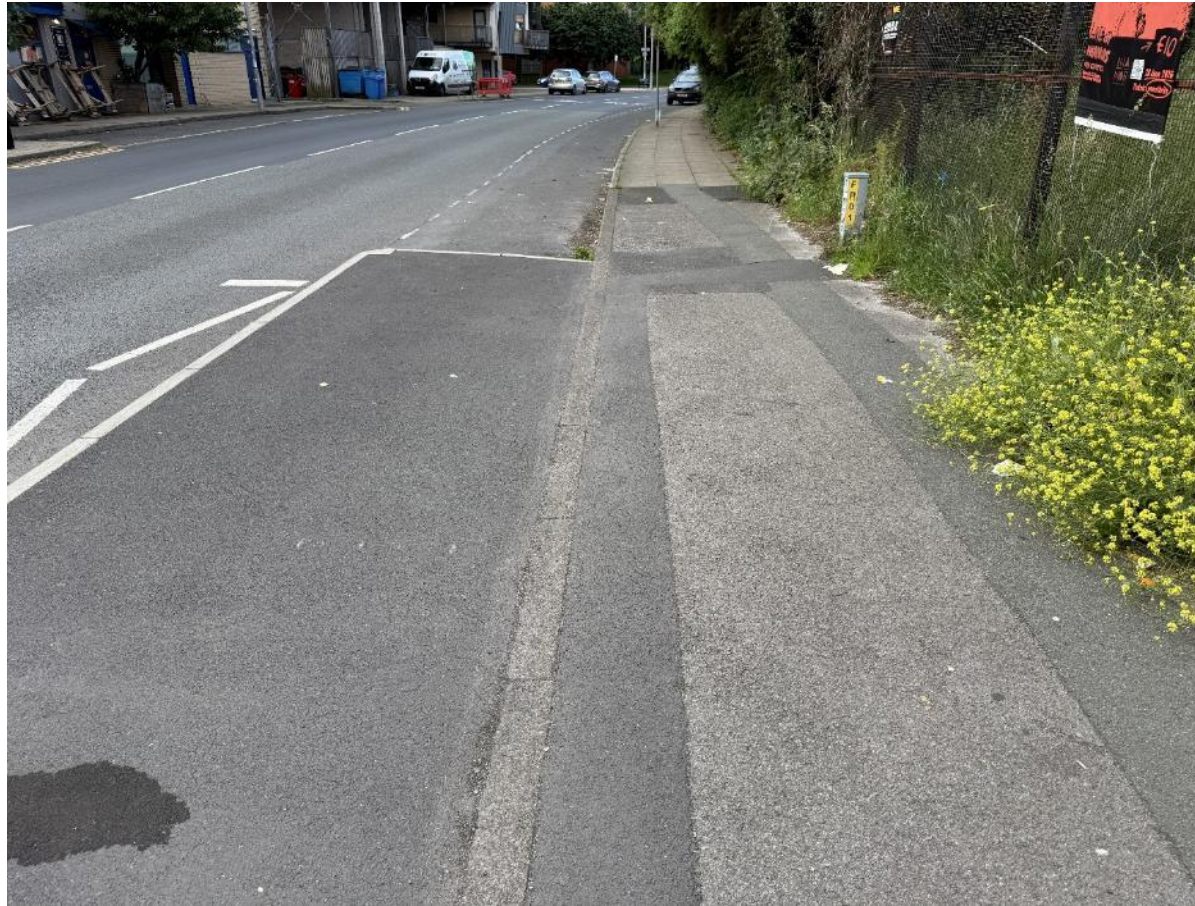
**Location 45**

**Overview of footpath.**

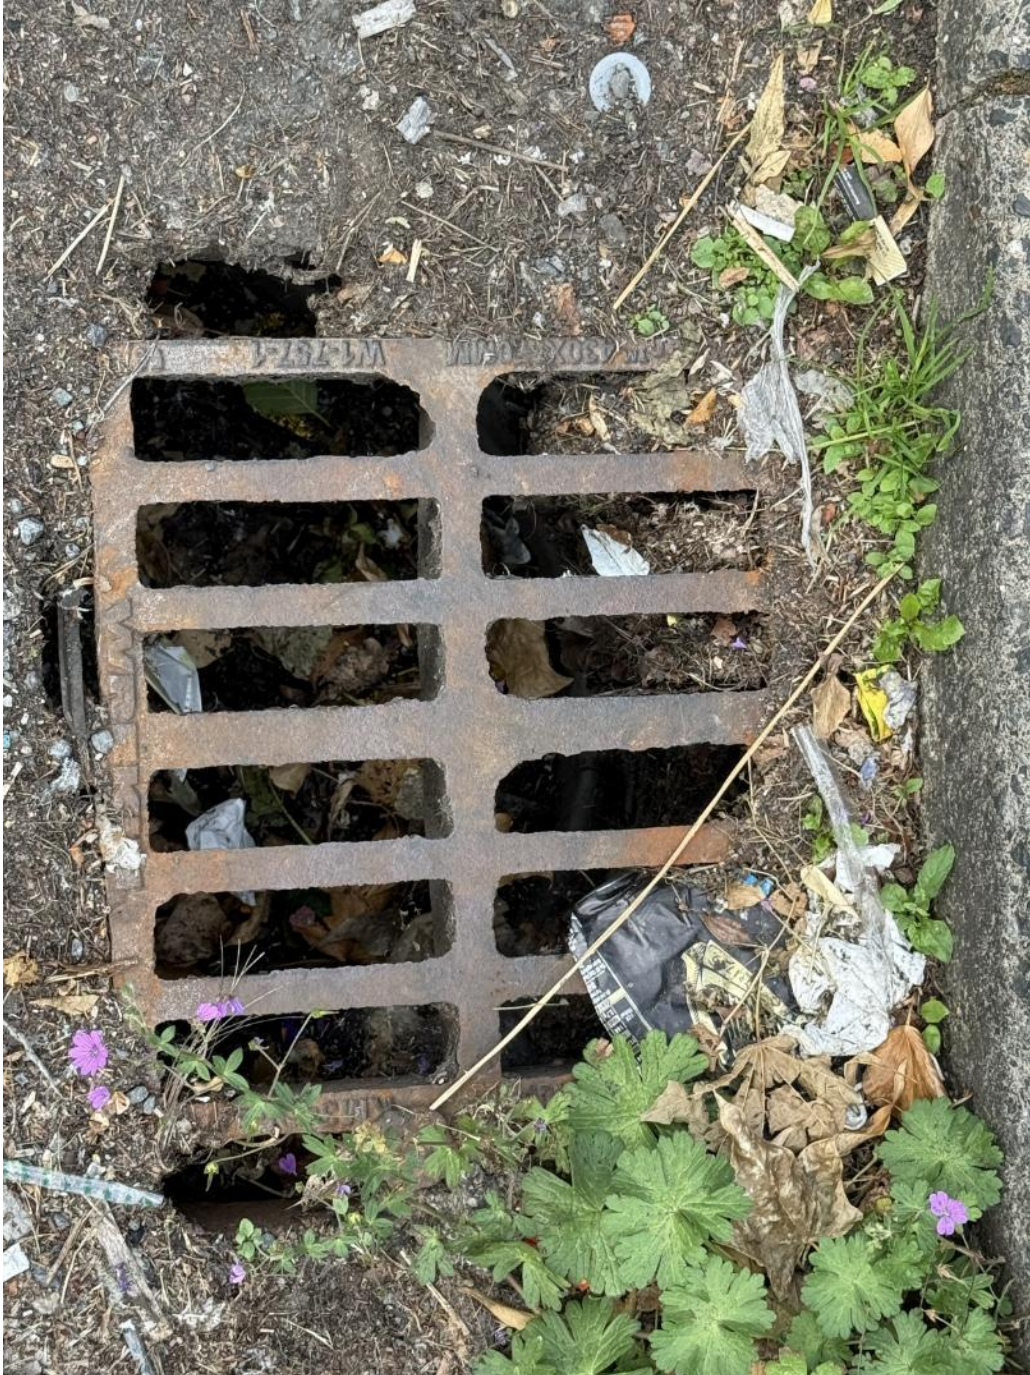
**Location 46**

**Gully blocked.**

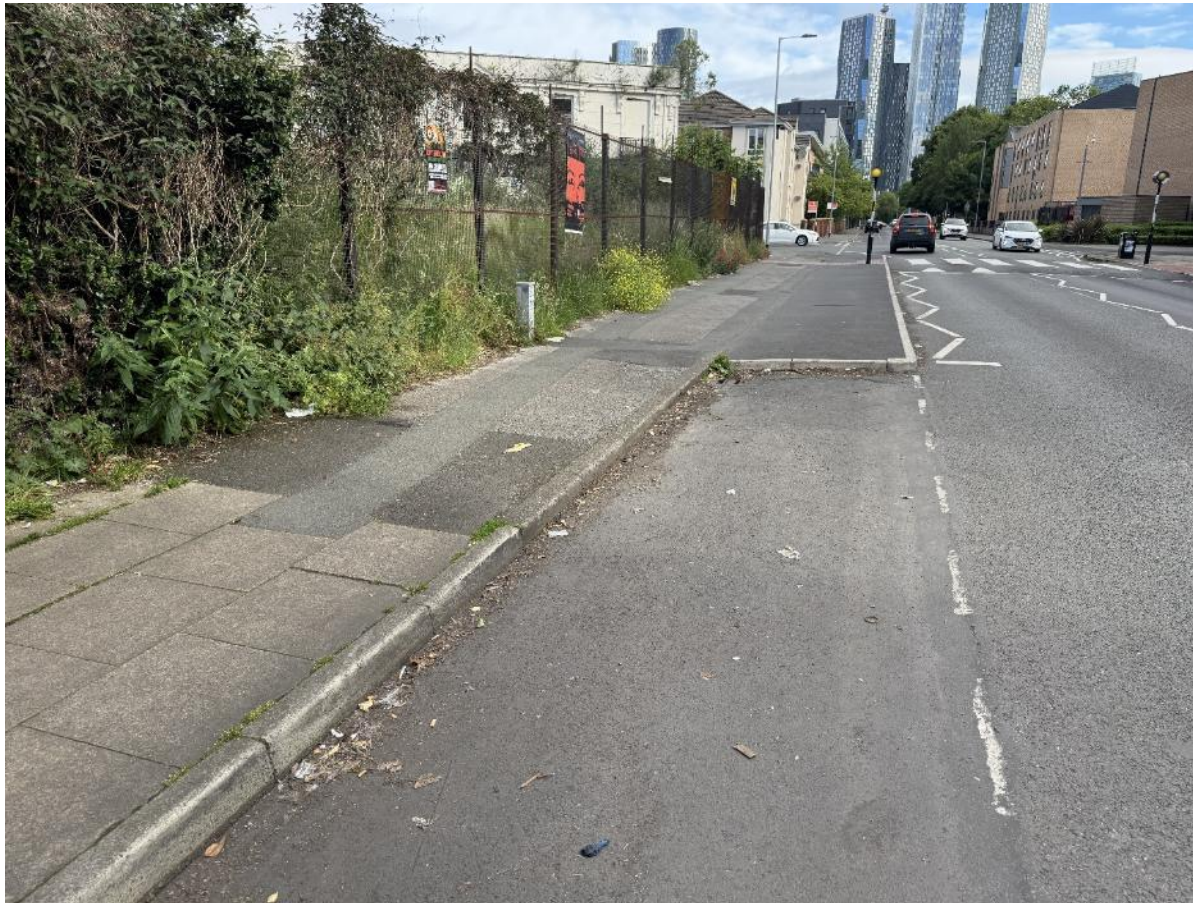
**Location 47**

**Overview of footpath.**
