## CONDITION SURVEY

Premier Inn Manchester Airport (Heald Green)  
Hotel, Finney Lane, Heald Green, Cheadle  
SK8 3QH

31 March 2026

BSC03722

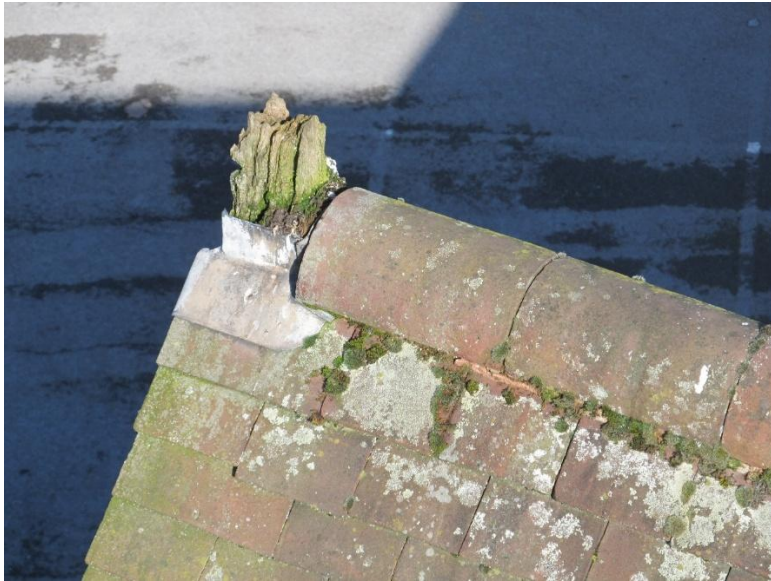
4. Main Pitched Roofs – significant deterioration of oak finials to all gable ends.

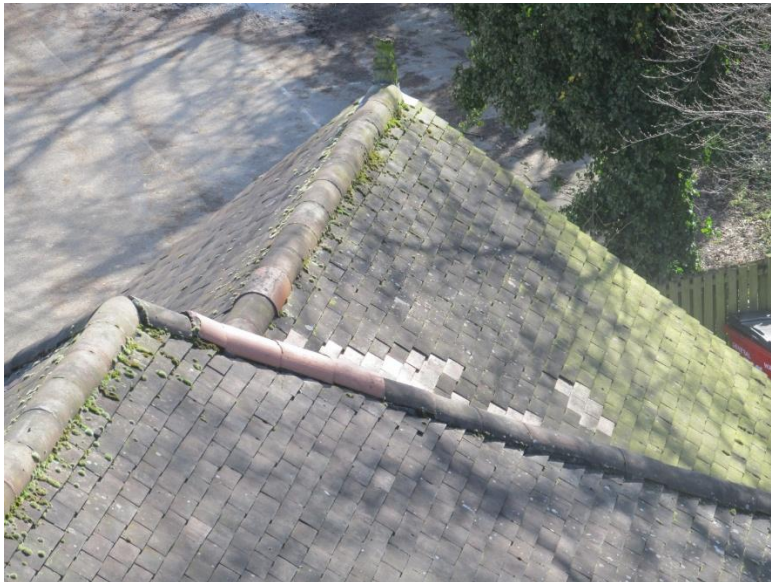
5. Main Pitched Roofs – example of individual tile replacements to both the roof slopes and hips.

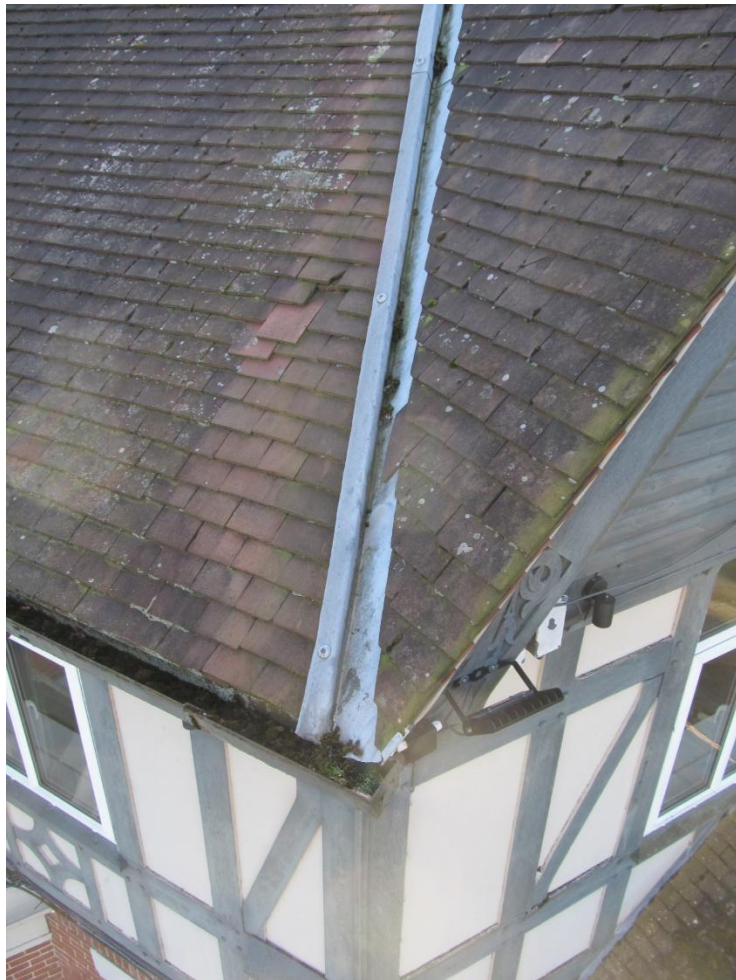
| 7. | Main Pitched Roofs – sheet lead soaker /valley flashing mechanically fixed and subject to patch repair where the lead has split. Further example of slipped tiles. | |

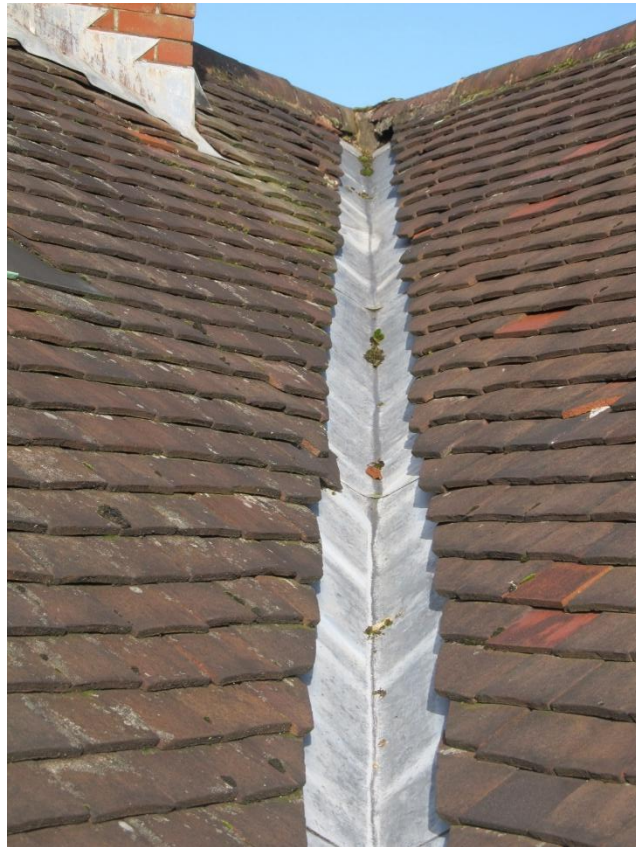
13. Main Pitched Roofs – leadwork to internal valley gutter with evidence of deterioration beneath the ridge line.

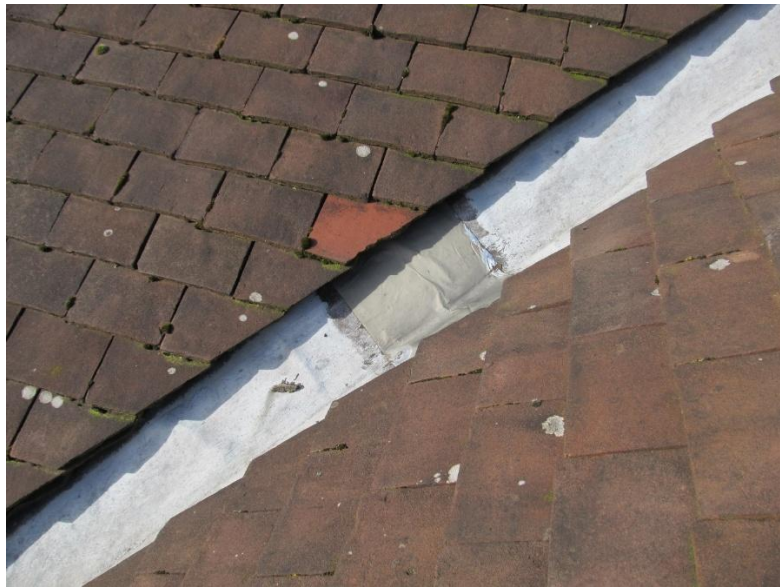
14. Main Pitched Roofs – temporary patch repairs undertaken to the sheet lead where this has split.

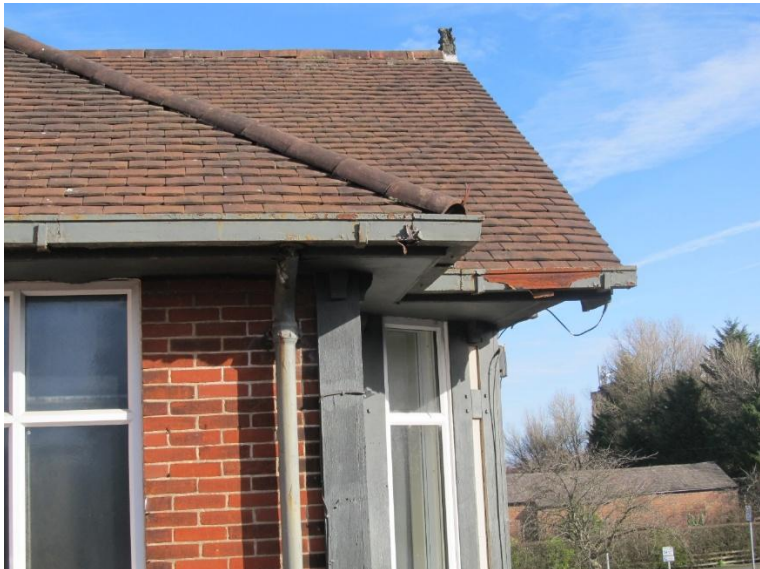
18. Main Pitched Roofs – perimeter cast iron guttering in various states of disrepair.

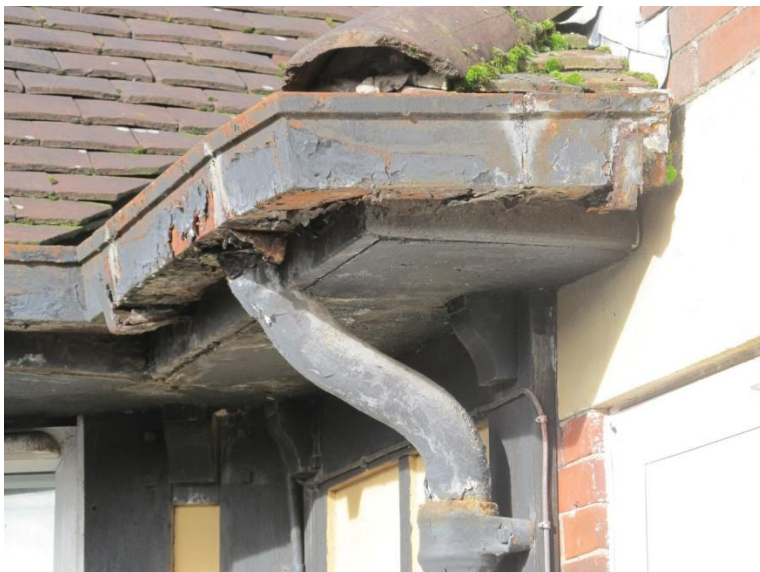
19. Main Pitched Roofs – corrosion to gutter brackets and splits to downpipes noted.

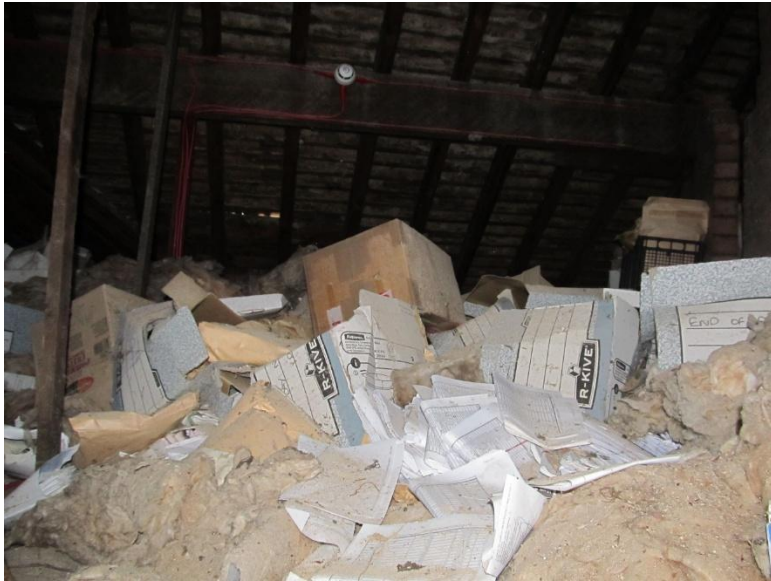
23. Main Pitched Roofs – rubbish and stored paperwork within attic space presenting a potential fire and vermin risk.

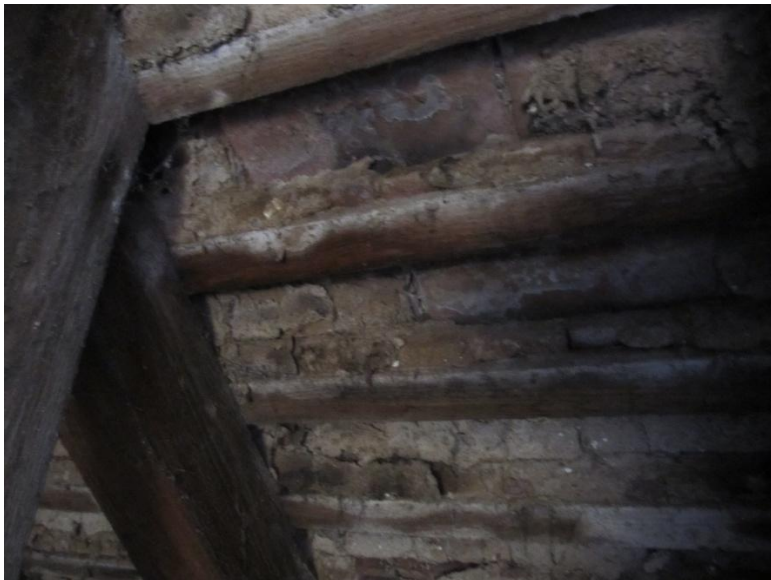
24. Main Pitched Roofs – further close up photograph of backpointing – the risk of decay to the battens and corrosion to the nails is increased by the mortar holding moisture.

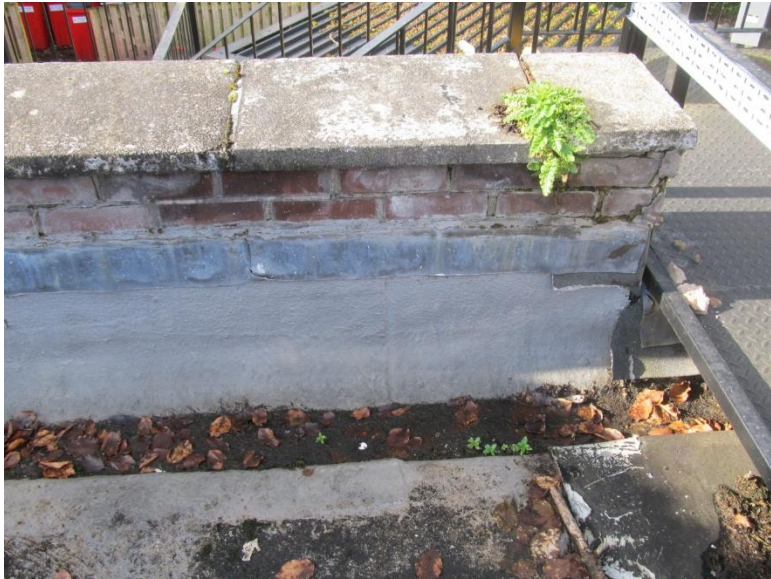
32. Flat Roof to Link – coping and parapet to be repointed / rebbed and encapsulated with new membrane.

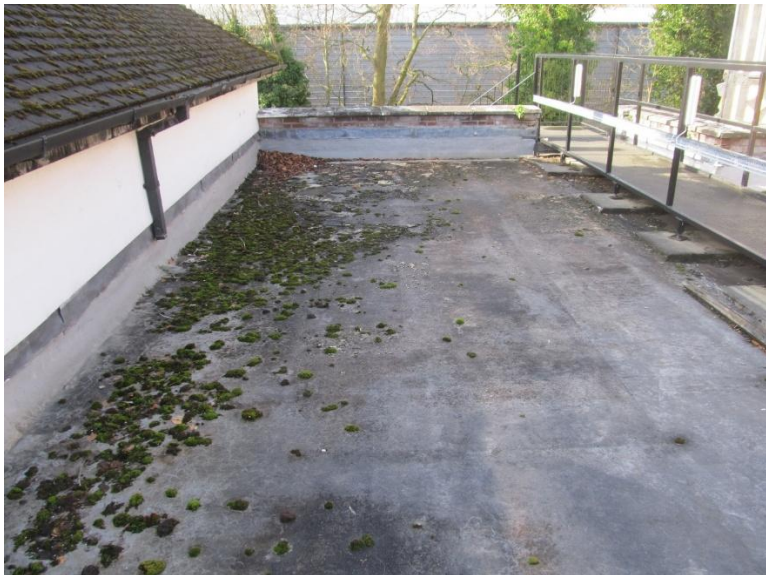
33. Flat Roof to Link – membrane debonded in places; renewal recommended in the short to medium term.

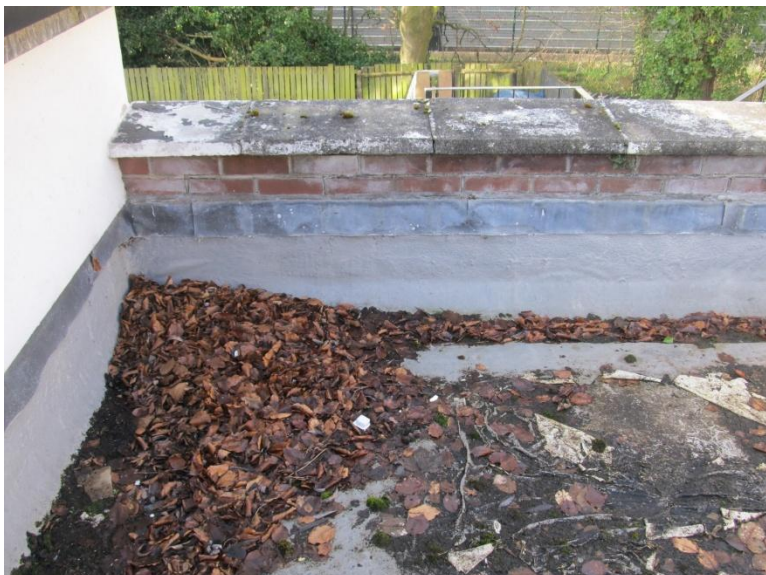
34. Flat Roof to Link – tree litter and evidence of past liquid plastic polymer repairs to the skirting upstand.

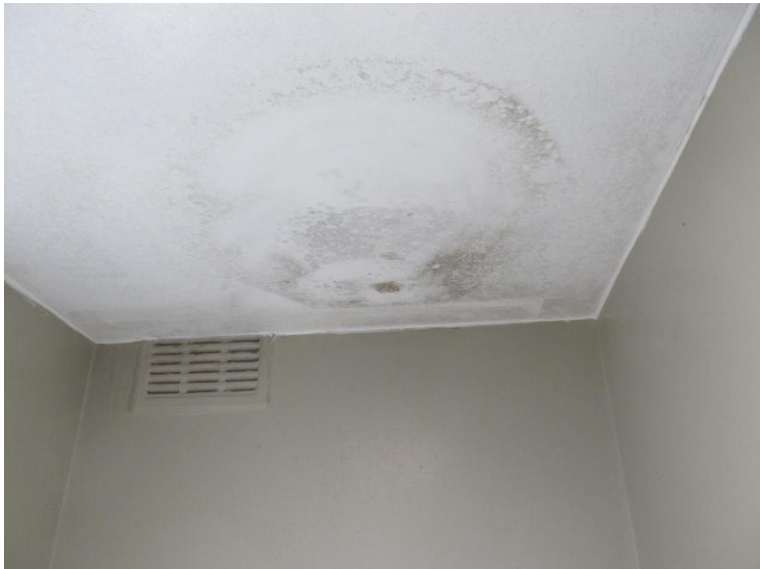
42. Corresponding soffit beneath flat roofs – extensive condensation mould where false ceilings damp due to r/w penetration.

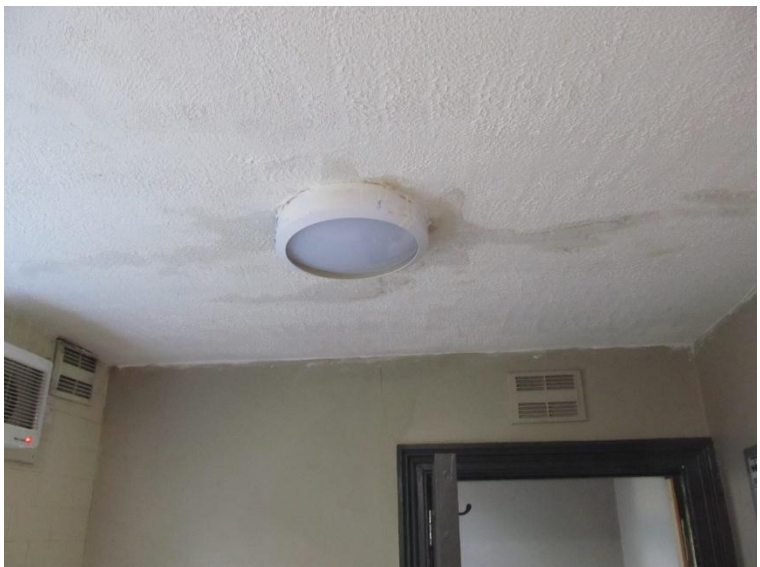
43. Water damage to ceilings beneath the lower level flat roofs.

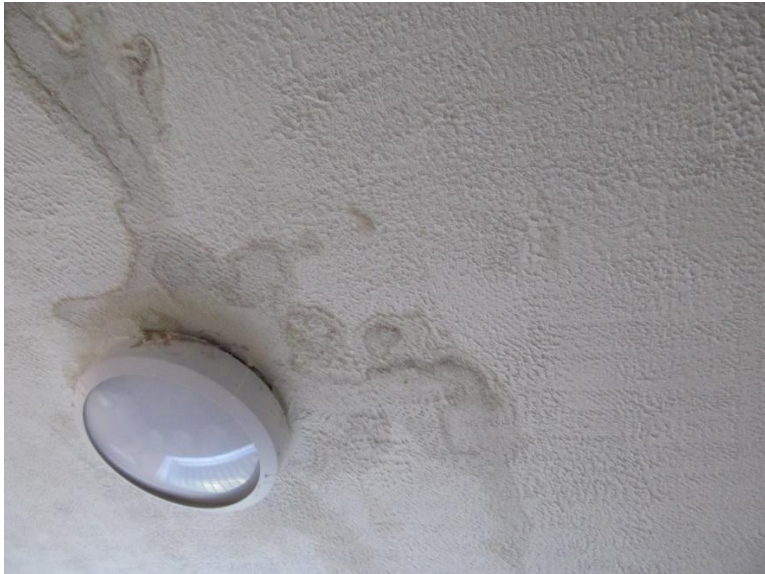
44. As above – evidence of longtsanding rainwater ingress through the flat roof coverings.

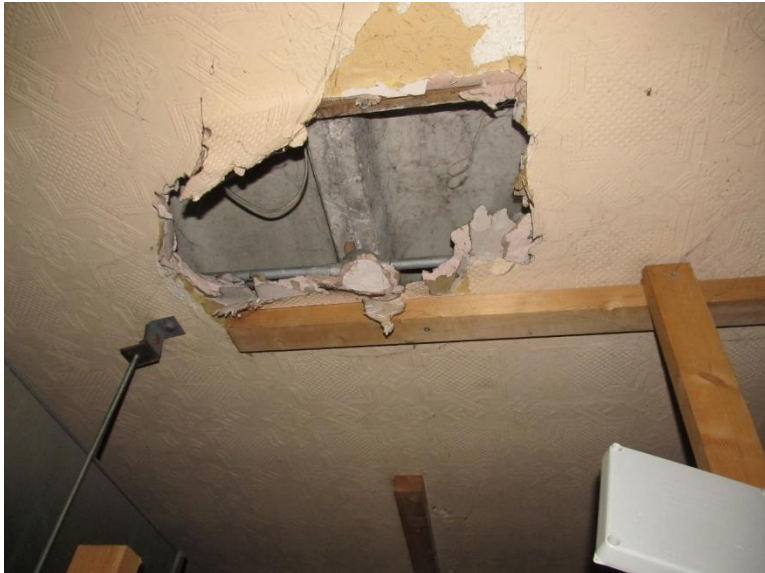
| Item | Element | Location | Description | Comments | Remedial Works |
|---|---|---|---|---|---|
| | | | We've noted internally where exposed above the false ceiling, the deck comprises a precast concrete plank. | <p>The concrete will need to be tested for high alumina cement ("HACC"), and it might be necessary to consider strengthening the deck.</p> <p>As a footnote whilst we do not believe the deck concrete comprises planks of reinforced autoclaved aerated concrete ("RAAC") we advise the engineer's brief extends to confirming this is indeed the case.</p> <p>As reported above for other areas of flat roof the membranes are approaching the end of their life expectancy and should be renewed in the short to medium term.</p> | Include for redressing lead work to the parapet chutes and hopper heads and for encapsulating/ capping the coping stones. |

45. Structural soffit to flat roof deck exposed above the false ceilings. The deck comprises pre-cast concrete planks, which need to be tested for HACCC and their structural integrity ascertained by undertaking further intrusive investigations; given the dipping noted to the roof deck externally and the evidence of longtsanding rainwater incursion, we are concerned that the planks might have lost strength

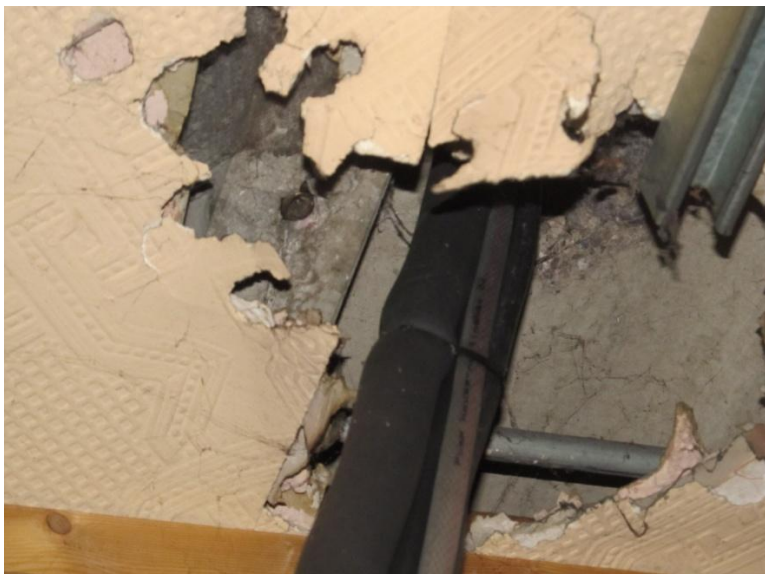
46. Precast concrete deck planks visible above the original false ceiling.

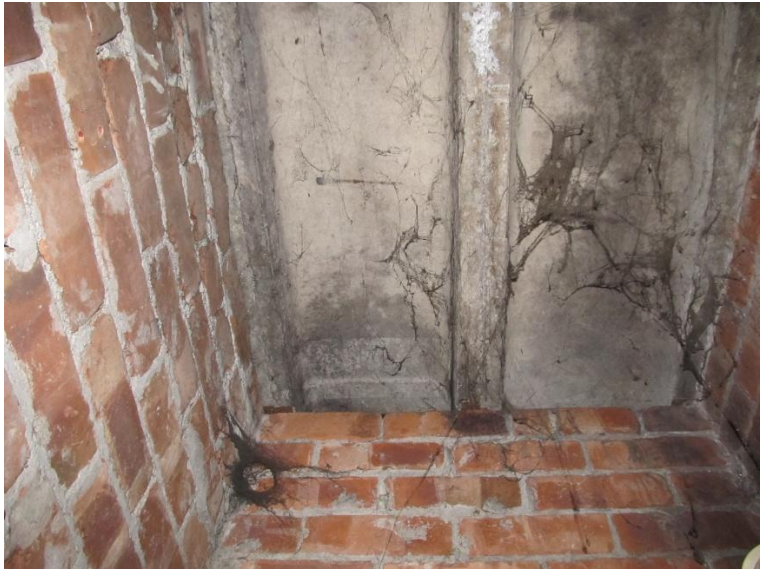
47. Precast concrete plank flat roof decks – further tests are required to determine whether they contain High Alumina Cement and to establish the quality of the concrete. Whilst these deck planks do not appear to be RACC there is still a risk that they have deteriorated and lost strength.

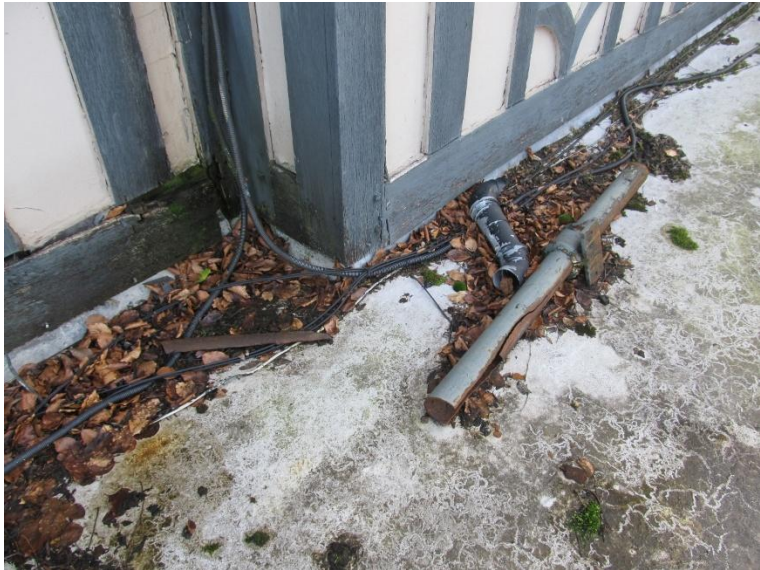
50. Rear (Western) Large Flat roof over Dining Room and Elevation to First Floor Bedrooms – damaged rainwater goods.

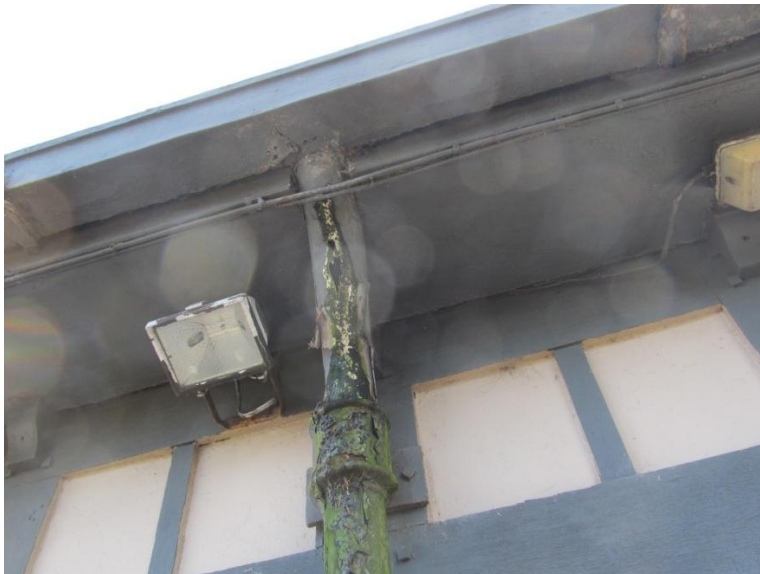
52. Rear (Western) Large Flat roof over Dining Room and Elevation to First Floor Bedrooms – as above.

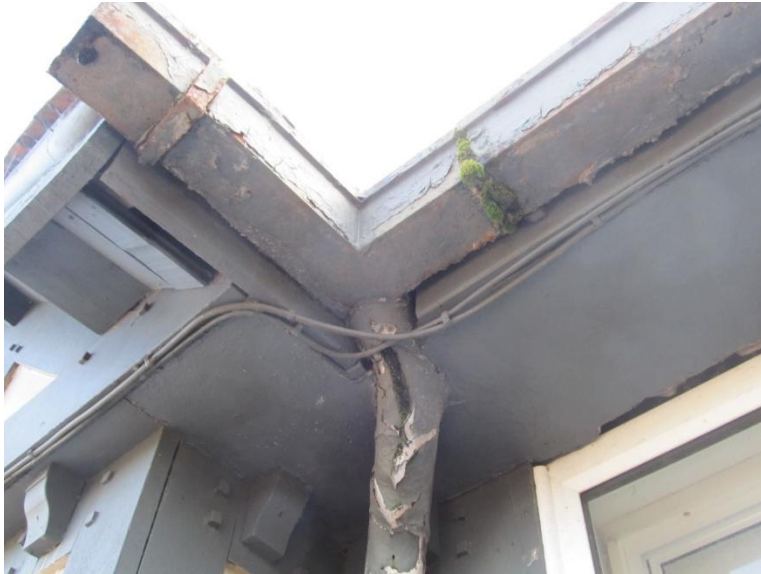
53. Rear (Western) Large Flat roof over Dining Room and Elevation to First Floor Bedrooms – guttering stop end missing and further defects to rainwater goods.

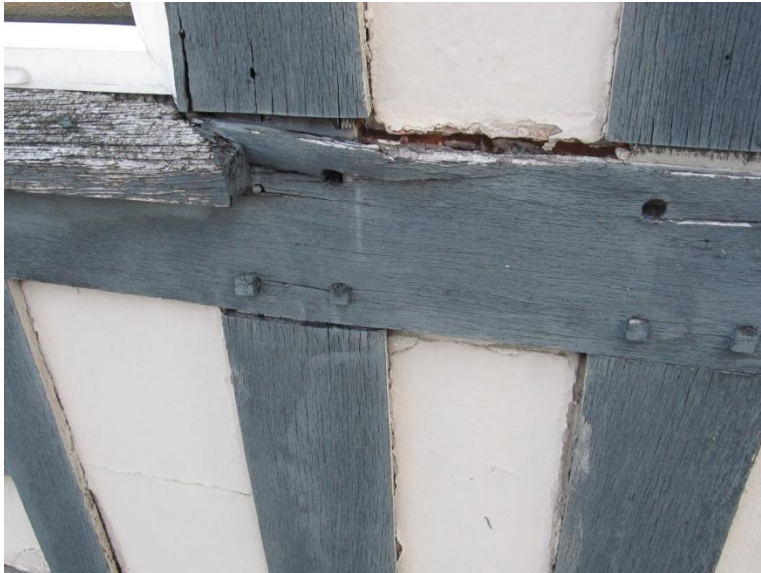
54. Rear (Western) Large Flat roof over Dining Room and Elevation to First Floor Bedrooms – example of movement to timber boarding and weathering to sub-cills.

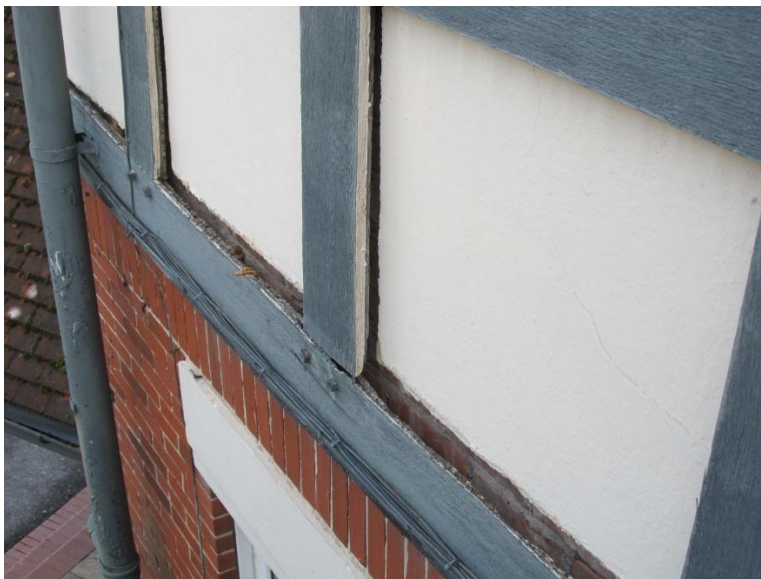
55. Rear (Western) Large Flat roof over Dining Room and Elevation to First Floor Bedrooms – as above. The planks/boards have pulled away from the underlying masonry and are now loose.

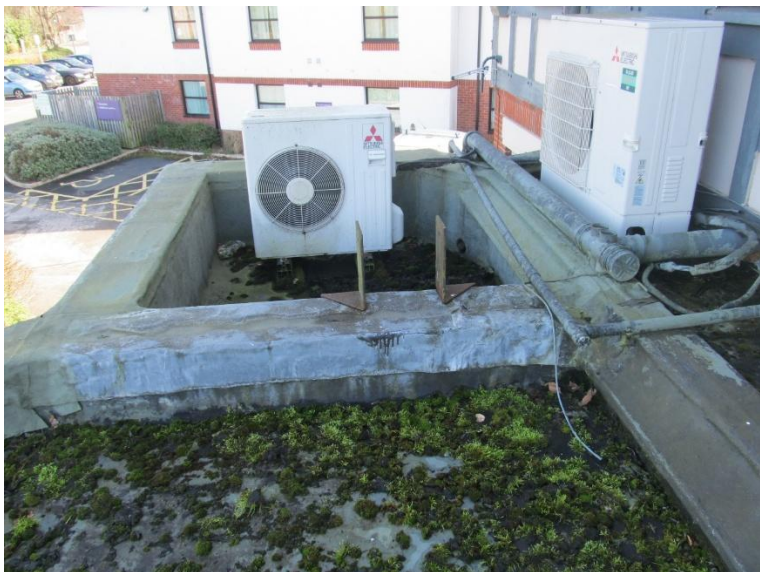
64. Front Flat Roof – further example of poor drainage with moss and silt build up.

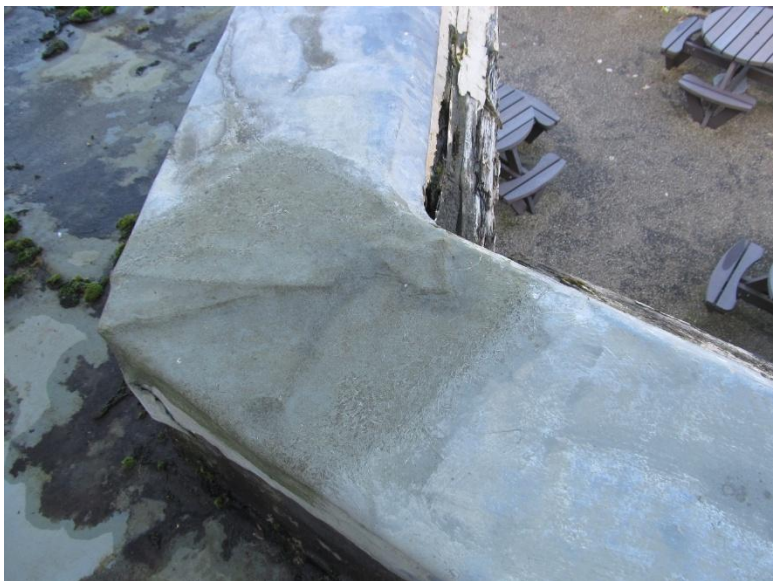
67. Front Flat Roof – further example of temporary repairs to the leadwork.

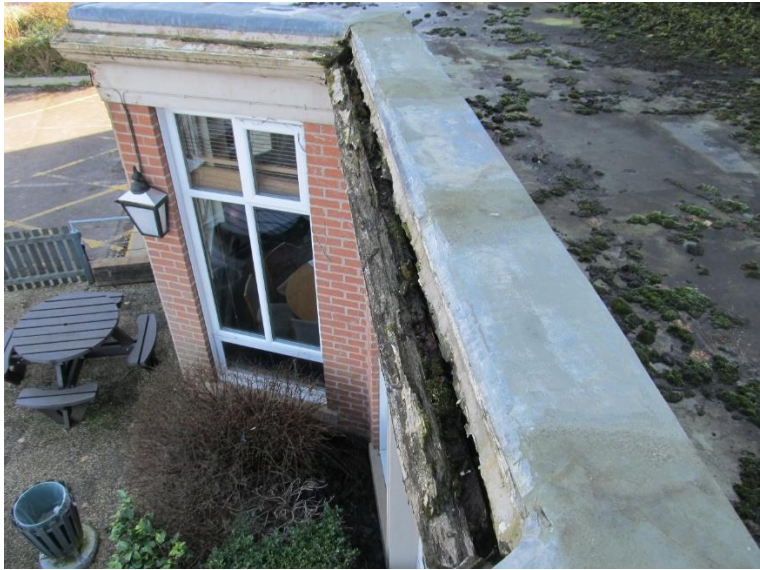
| 68. | Front Flat Roof – significant deterioration to the underlying timber fascia and support to the parapet capping. | |

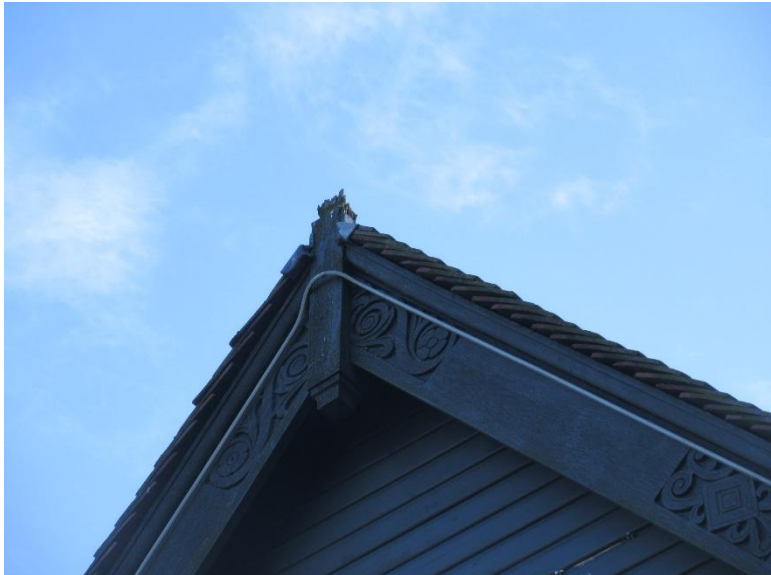
72. Typical example of a decayed finial.

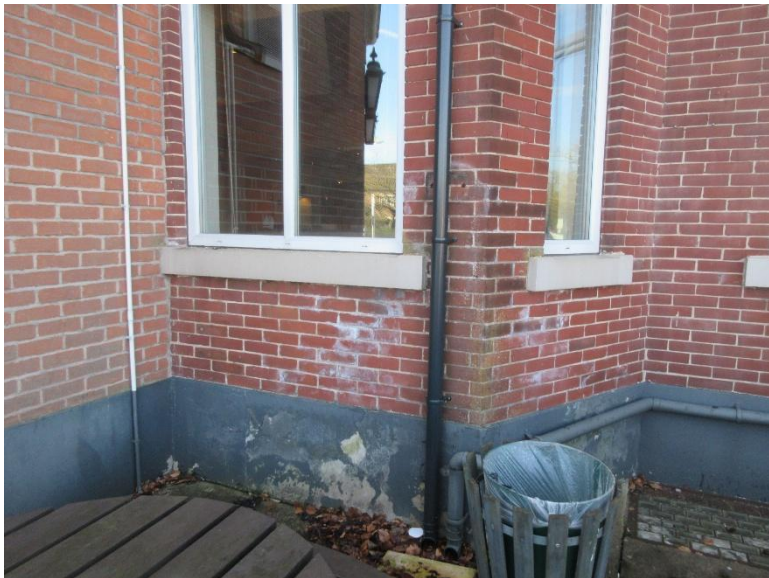
77. North Elevation – water staining and efflorescence adjacent to a downpipe position and peeling paint finishes to the low-level masonry.

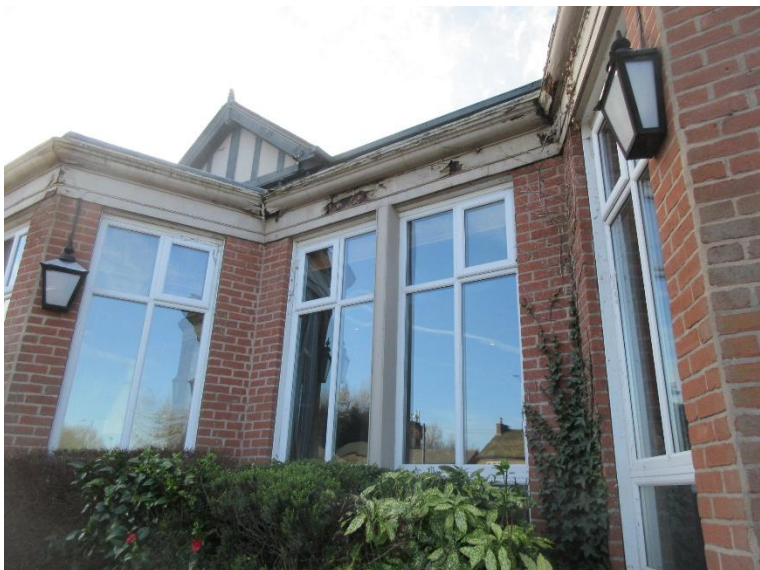
78. North Elevation – typical example of decay to the timber cornice and fascia.

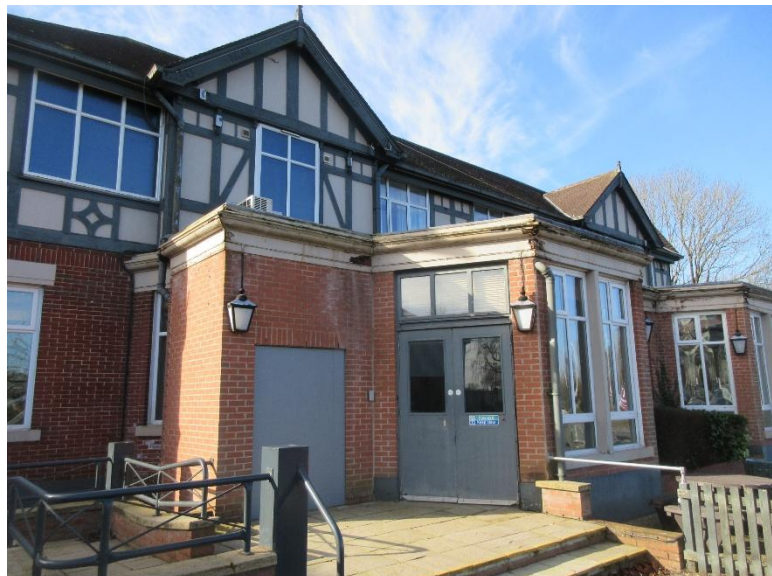
79. North Elevation – store entrance boarded over and double doors with initial stages of decay and interstitial condensation to the double-glazed fanlight.

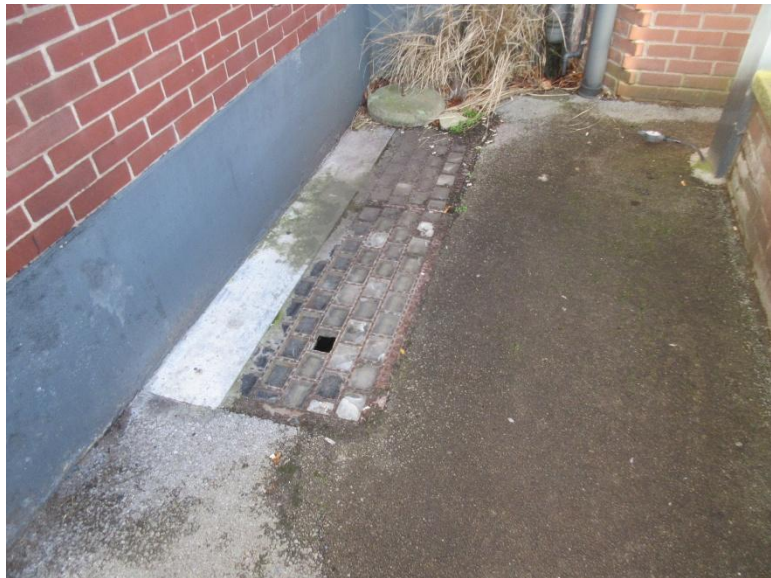
| 80. | North Elevation – holed and cracked glazing to the pavement lights. | |

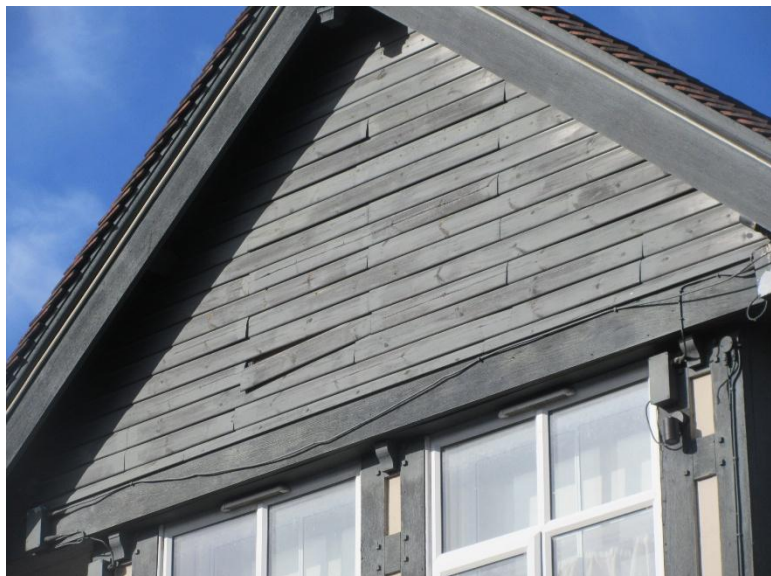
| Item | Element | Location | Description | Comments | Remedial Works |
|---|---|---|---|---|---|
| | | | | <p>To the East Elevation, the timber cladding to the gable end is misaligned and loose.</p> <p>Decorative finishes are peeling to the fascias and soffits in some instances; cyclical redecoration is now due to the previously painted timber elements and rendering.</p> | |

| 82. | East Elevation – loose timber cladding to the gable. | |

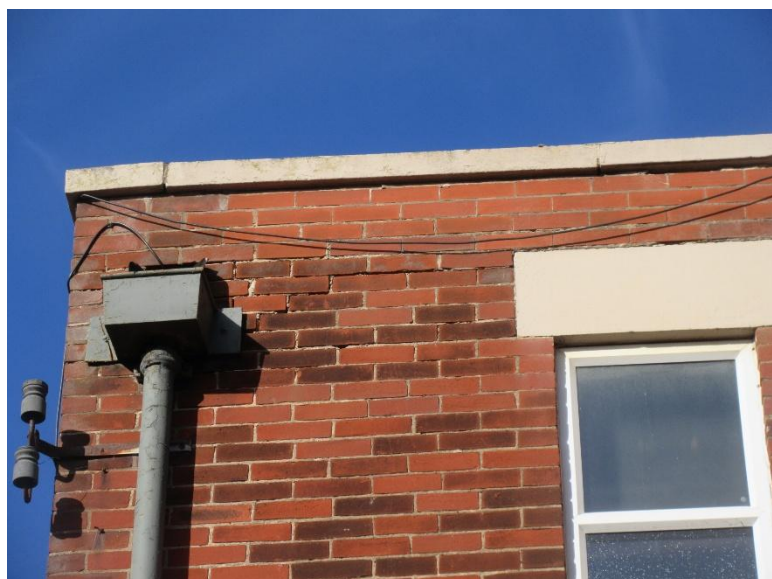
85. East Elevation – deteriorated mortar joints adjacent to the hopper.

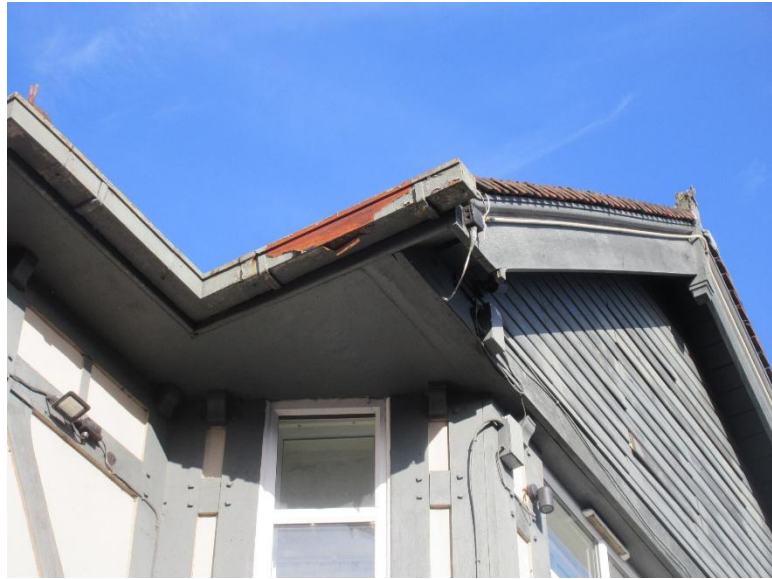
86. East Elevation – example of flaking paint finishes and corrosion to gutters.

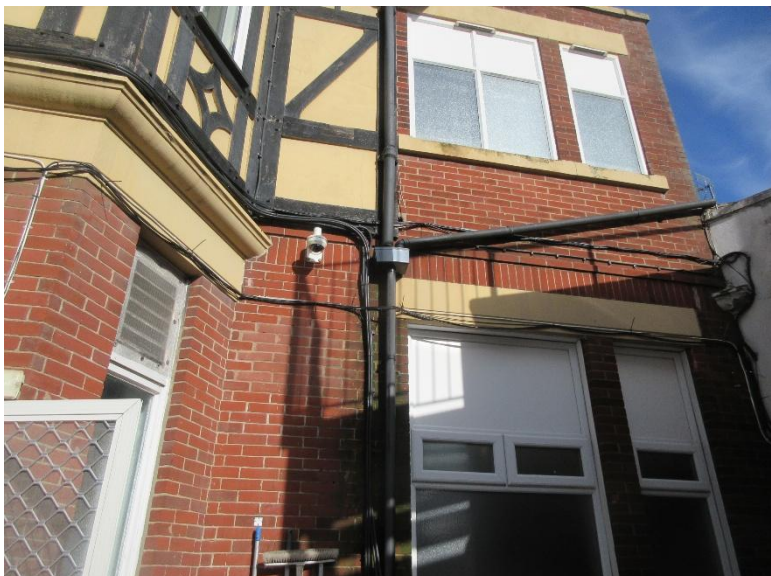
91. South Elevation – water staining adjacent to a downpipe position.

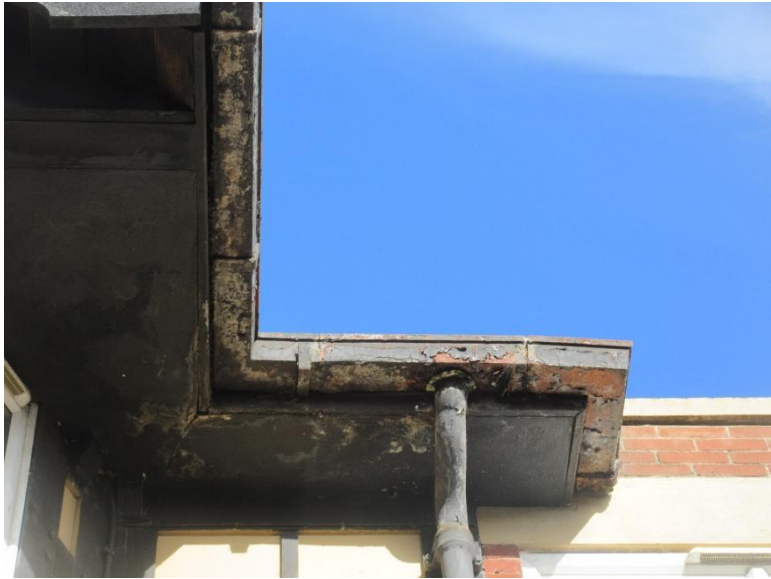
92. South Elevation – further example of corrosion to gutters.

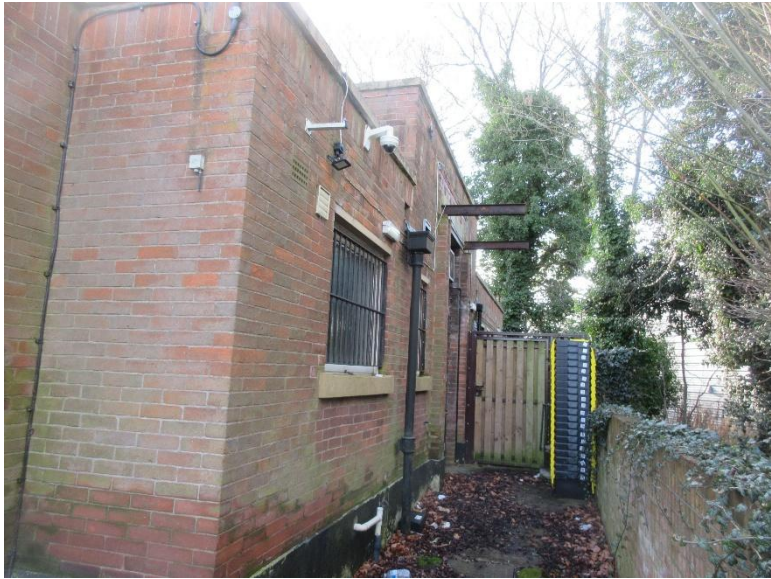
98. West Elevation – projecting steel to a presumed former canopy position.

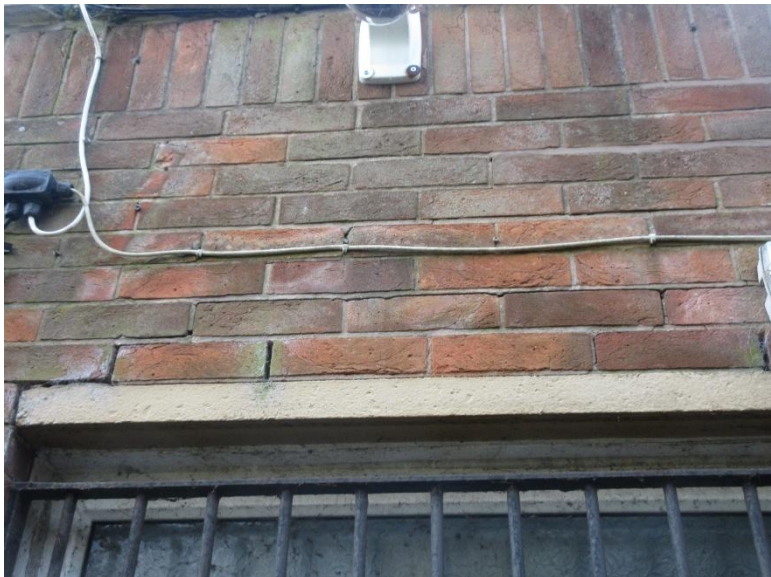
99. West Elevation – minor cracking above a boot lintel position.

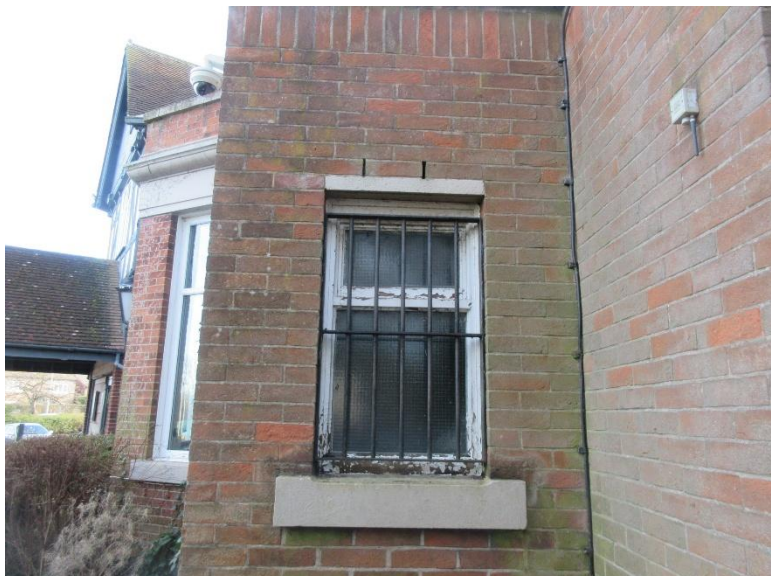
| Item | Element | Location | Description | Comments | Remedial Works |
|---|---|---|---|---|---|
| 3.07 | | West Elevation | Georgian wired single glazed timber framed window at Ground Floor level. | Paint finishes have flaked and there is decay to the timber window frame. | Replace the window with a modern equivalent. Include for removing the reinstating the window bars on completion. |

100. West Elevation – single glazed timber window with decay.

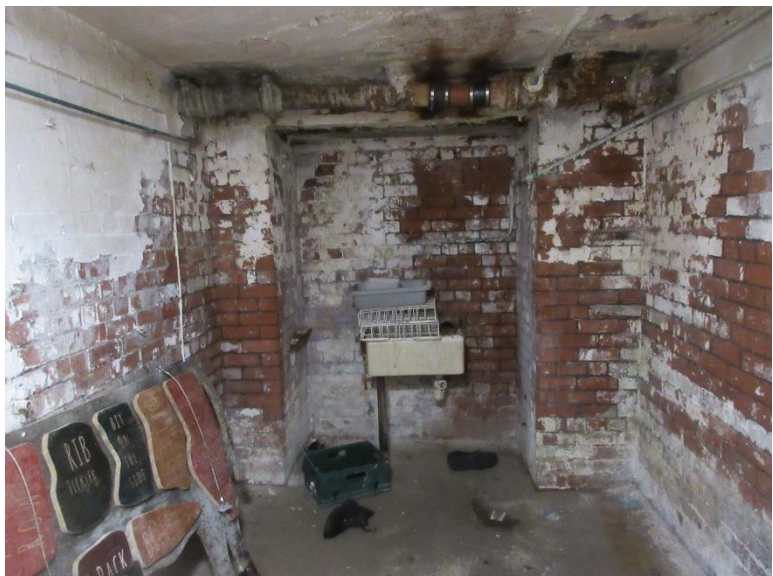
106. Cellar – flaking paint finishes and standing water to the floor slab.

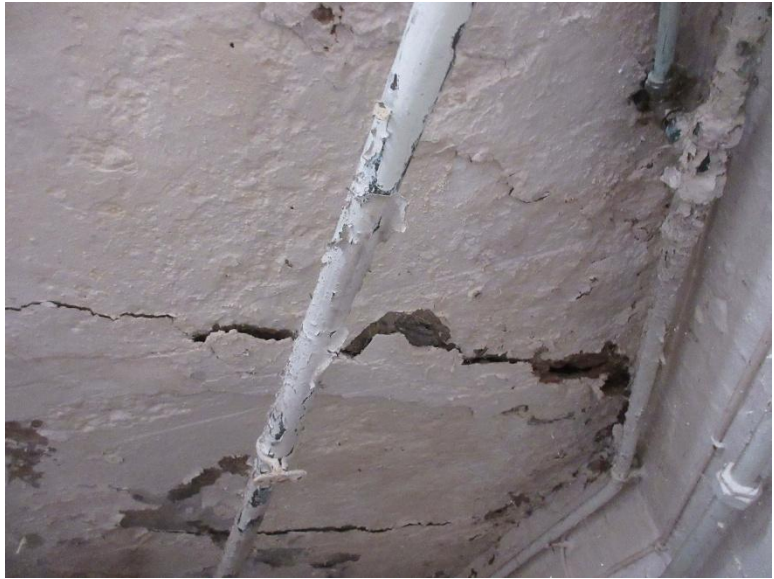
107. Cellar – cracking to the Ground Floor slab soffit.

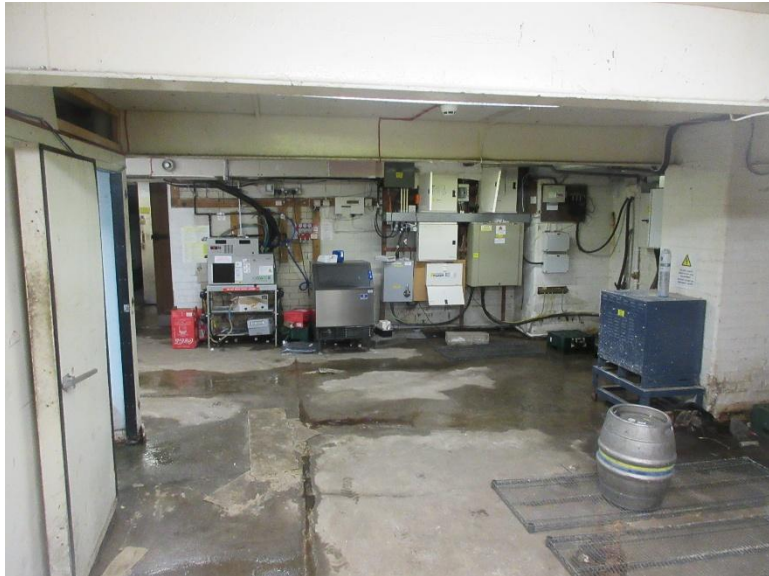
110. Cellar – further standing water to the floor slab. Incoming 3 phase electrical supply to the rear wall.

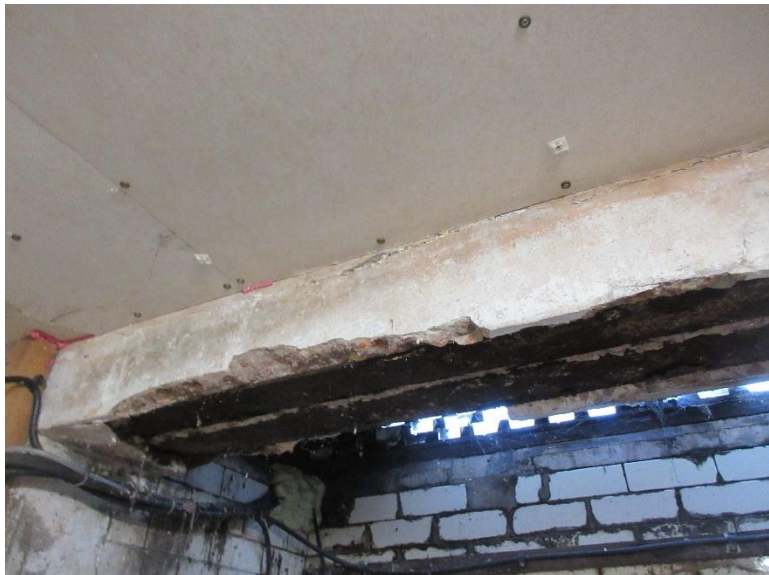
111. Cellar – spalled concrete and corroded steel beams adjacent to the pavement light position.

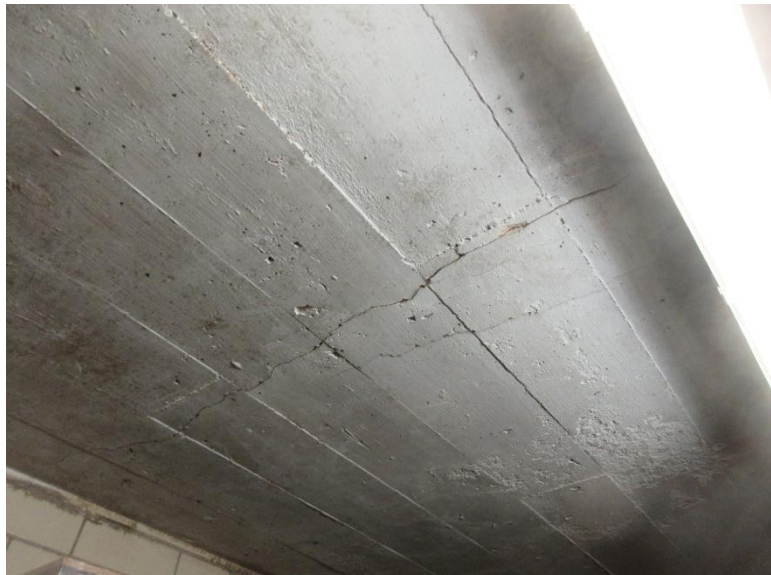
114. Cellar – further cracking to the Ground Floor slab.

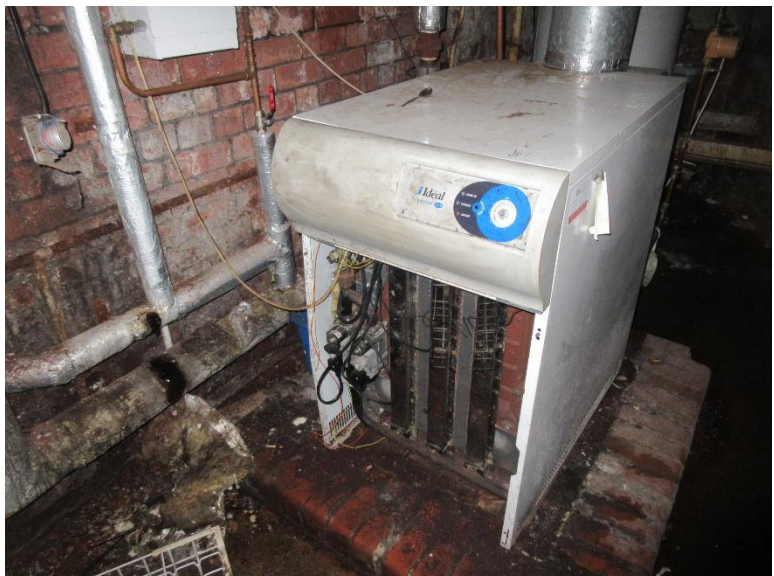
| Item | Element | Location | Description | Comments | Remedial Works |
|---|---|---|---|---|---|
| 5.02 | Gas supply | Cellar and kitchen | Incoming gas supply to the cellar which in turns supplies the kitchen. The gas boiler located in the cellar was noted to have been mothballed. | The gas boiler and wet radiator heating system is believed to have been mothballed and heating is predominantly provided by split DX units and electric panel radiators. | Consider removal of the redundant boiler and wet radiator heating system. |

118. Cellar – mothballed boiler.

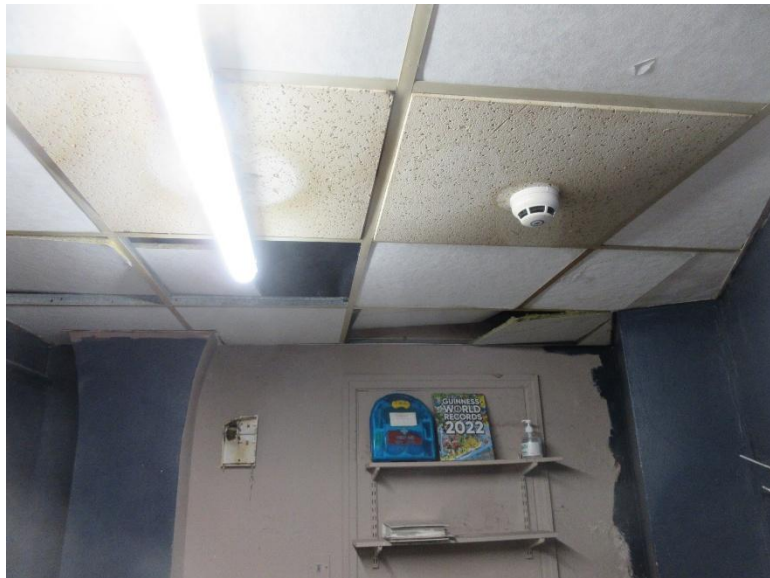
119. Ground Floor Store Room adjacent to the cellar entrance – stained and misaligned ceiling tiles.

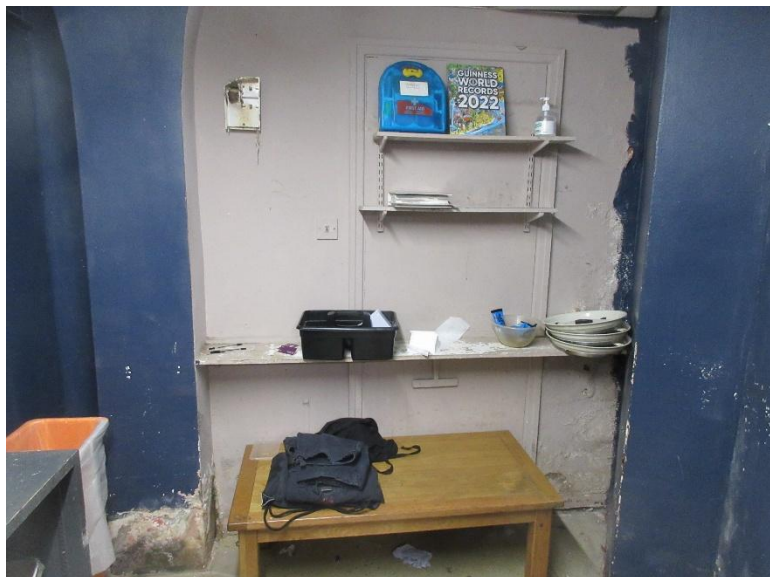
120. Ground Floor Store Room adjacent to the cellar entrance – signs of water damage to the low level plaster finishes.
