## CONDITION SURVEY

Premier Inn Manchester Airport (Heald Green)  
Hotel, Finney Lane, Heald Green, Cheadle  
SK8 3QH

31 March 2026

BSC03722

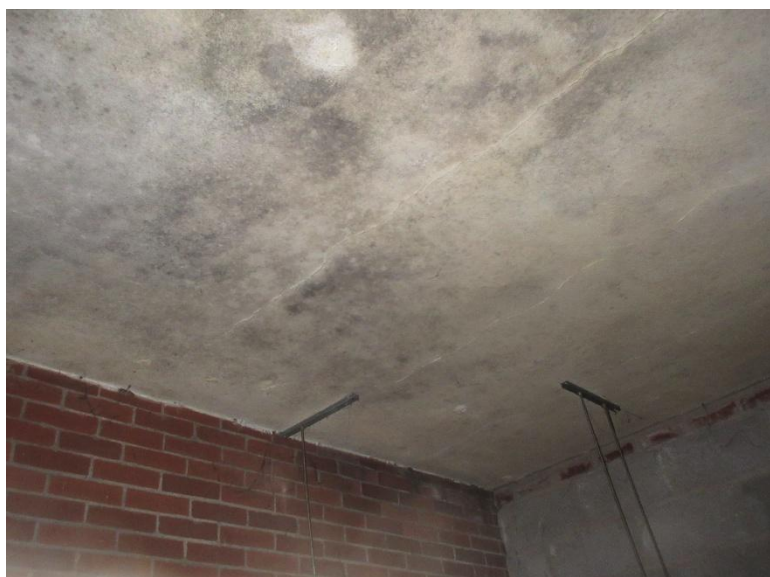
121. Ground Floor Store Room adjacent to the cellar entrance – mouldy and cracked plaster finishes above the suspended ceiling.

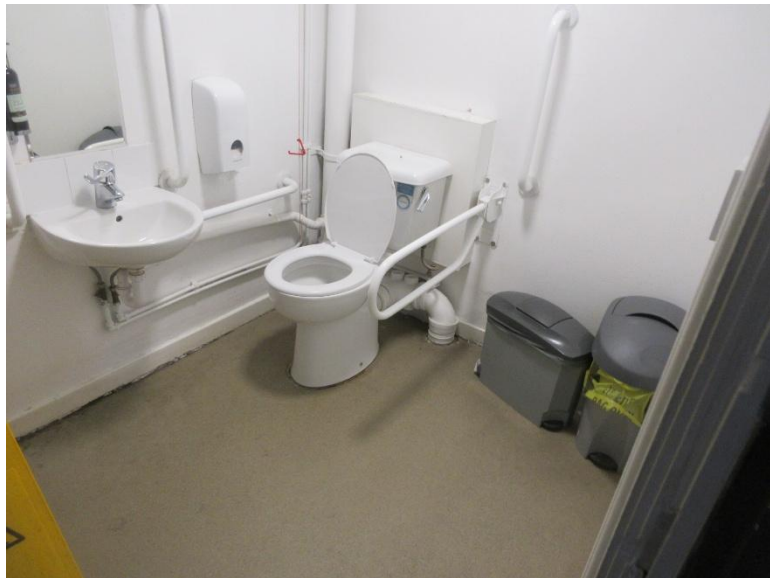
122. Ground Floor Wheelchair Accessible WC – the WC flush has dropped and handrails are non-contrasting with the adjacent finishes.

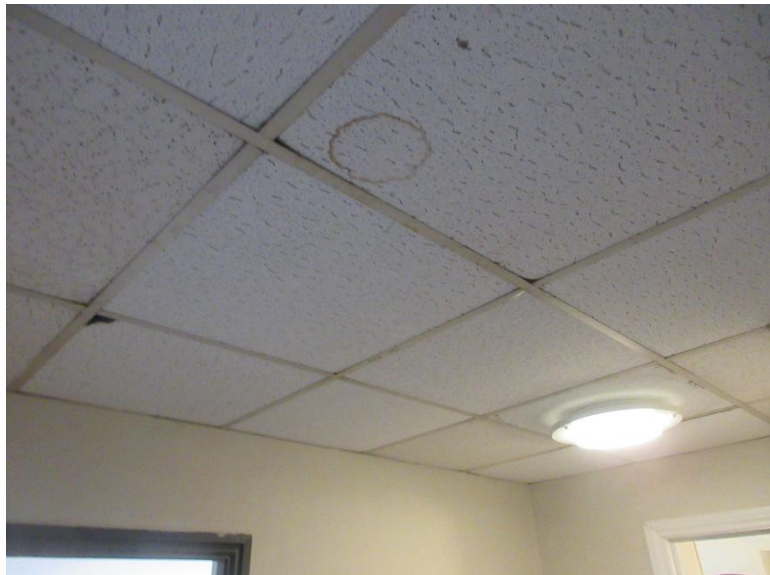
123. Ground Floor Corridor adjacent Wheelchair Accessible WC – stained and chipped ceiling tiles.

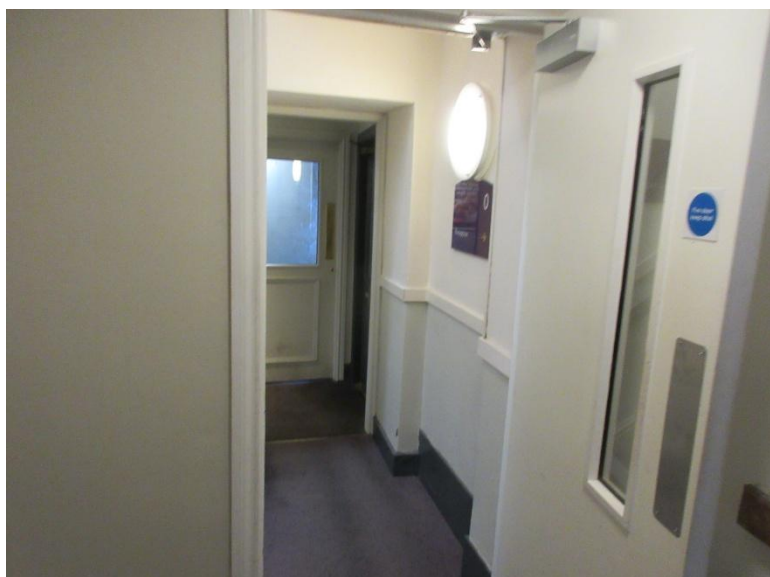
124. Ground Floor Store Room adjacent to the cellar entrance – door keep open device missing in part.

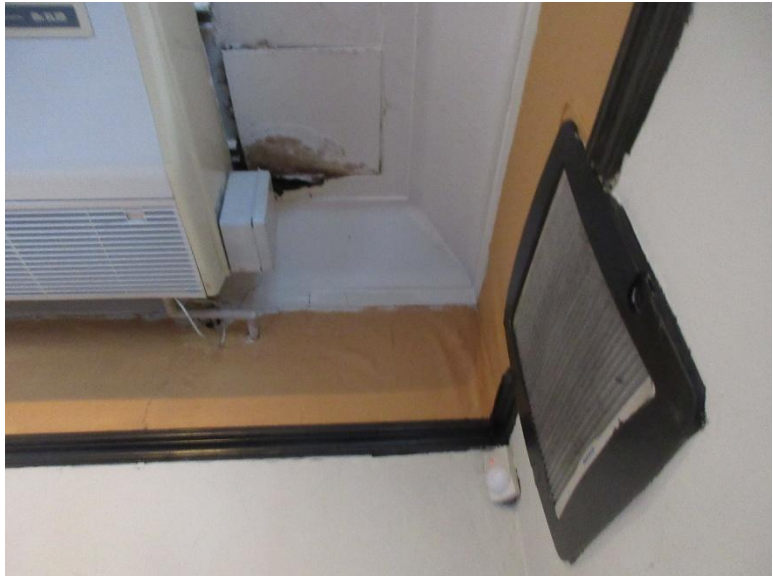
131. Ground Floor Restaurant and Bar Area – water staining to the ceiling adjacent to the North Elevation.

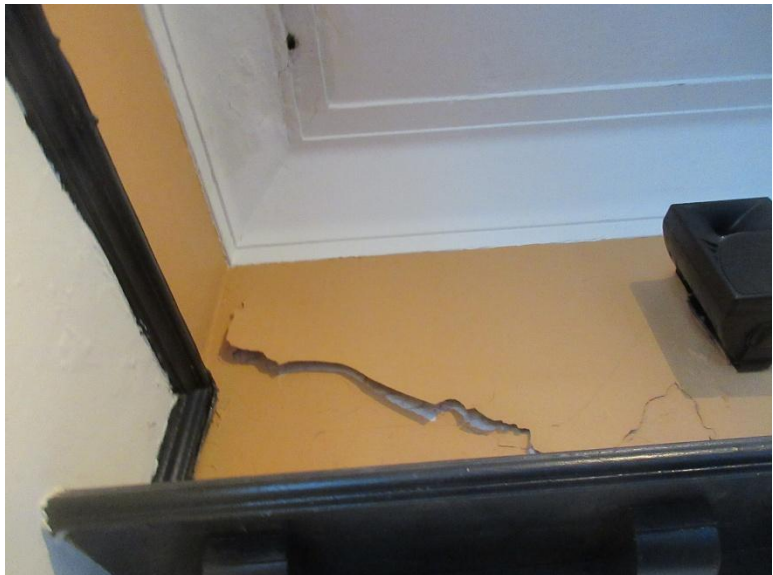
132. Ground Floor Restaurant and Bar Area – further signs of water ingress to the ceiling and peeling paint finishes to walls.

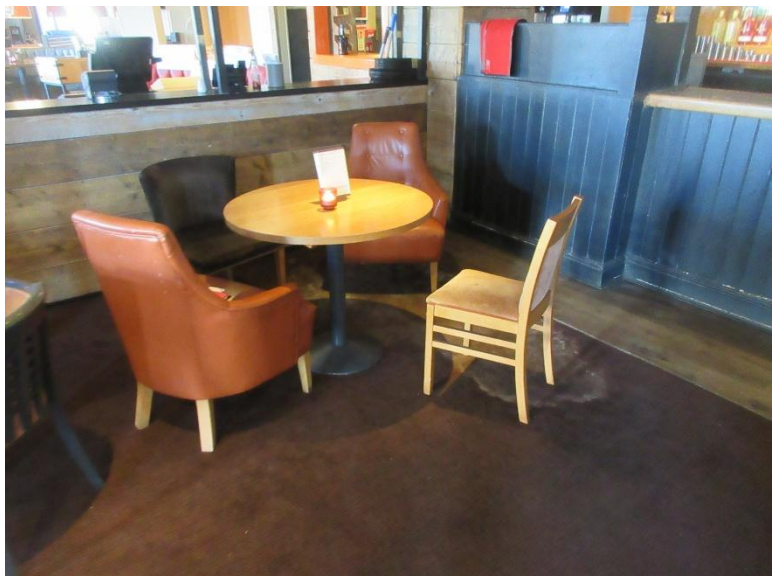
133. Ground Floor Restaurant and Bar Area – staining to the carpet adjacent to the bar.

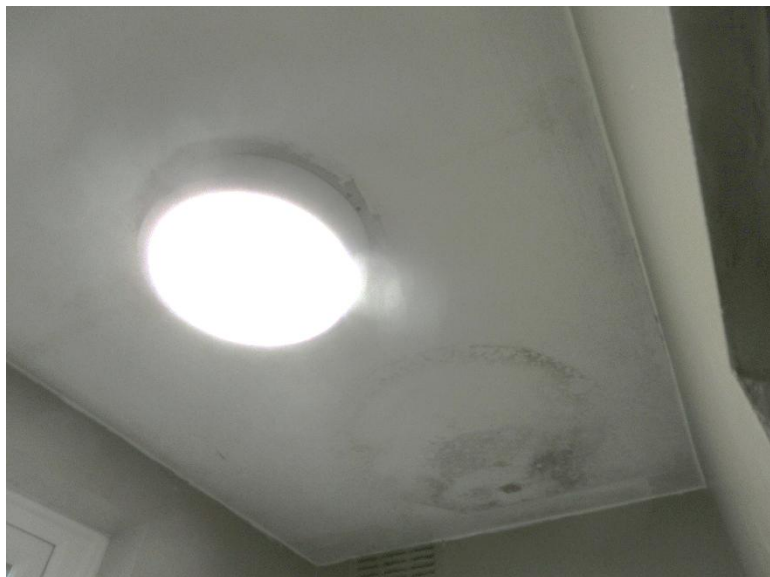
138. Female WC adjacent to the bar area – water staining to the ceiling.

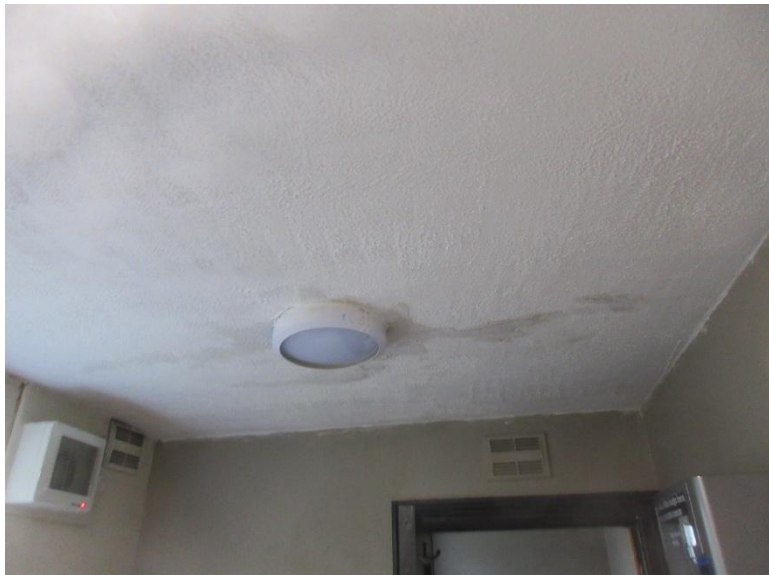
141. Male WC adjacent to the bar area – water staining to the ceiling adjacent to a light fitting.

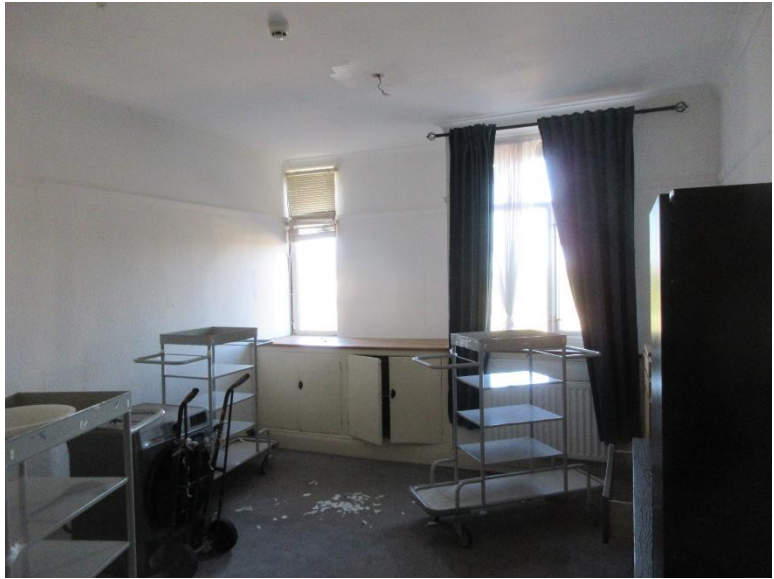
143. First Floor Apartment – missing light fitting.
