**Mitchells and Butlers**

**Browns Manchester**

**Condition Survey 2026**

**Engineers Report**

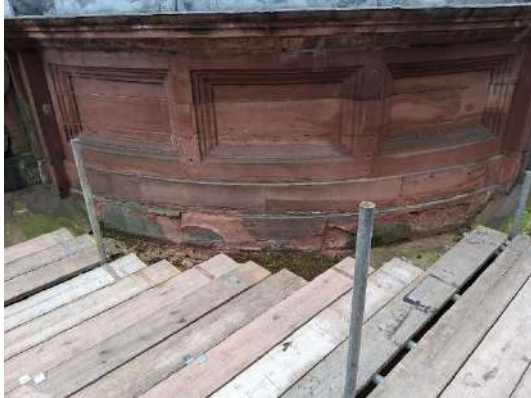
| | Photograph | Description |
|---|---|---|
| 001 | | <p>Friable and delaminated masonry was identified at this location. The affected masonry may continue to deteriorate, with loose material potentially becoming dislodged and falling, presenting a potential hazard if left untreated.</p> <p>We would recommend that the affected masonry is carefully de-frassed back to sound material, removing all loose and unstable material. Following removal, consideration should be given to carrying out localised repairs using a suitable colour-matched repair mortar, finished to blend with the surrounding masonry as closely as practicable.</p> |

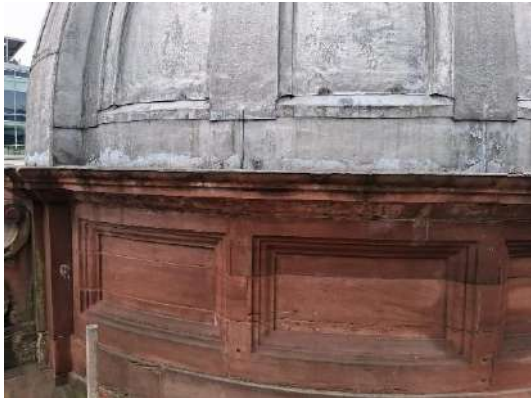
| | Photograph | Description |
|---|---|---|
| 002 | | <p>Friable masonry was identified to the underside of the cornice detail at this location. The affected masonry may continue to deteriorate, with loose material potentially becoming dislodged and falling, presenting a potential hazard if left untreated.</p> <p>We would recommend that the affected masonry is carefully de-frassed back to sound material, removing all loose and unstable material only.</p> |

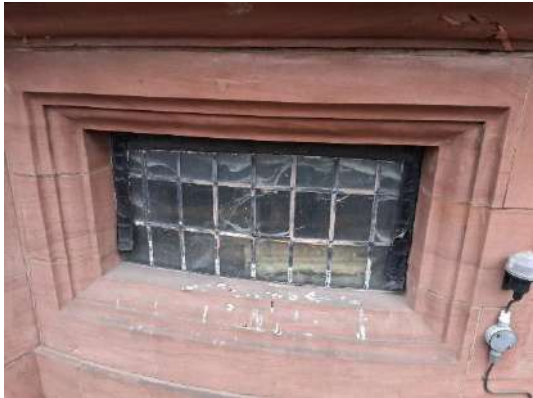
| 007 | | <p>The leaded window has historically been taped around the perimeter due to defective sealant at this location. The existing tape is no longer considered a suitable long-term weatherproofing measure and may allow water ingress if the perimeter seal remains defective.</p> <p>We would recommend that the existing tape is carefully removed and the perimeter of the window is thoroughly cleaned and prepared before carrying out resealing works using a suitable flexible sealant compatible with the existing window and surrounding masonry.</p> |

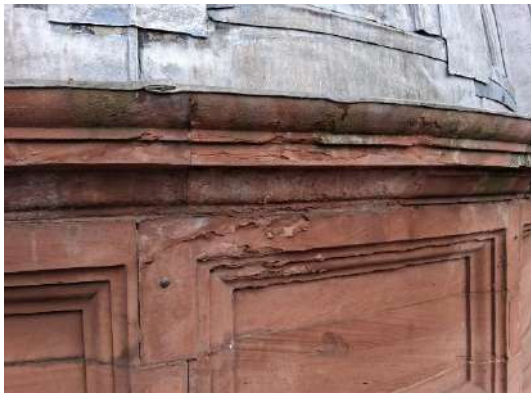
| 008 | | <p>Friable masonry was identified around the high-level cornice detail below the dome at this location. The affected masonry may continue to deteriorate, with loose material potentially becoming dislodged and falling, presenting a potential hazard if left untreated.</p> |

| | | We would recommend that a full de-frass of the high-level masonry is undertaken to carefully remove all loose and unstable material, exposing sound masonry. |

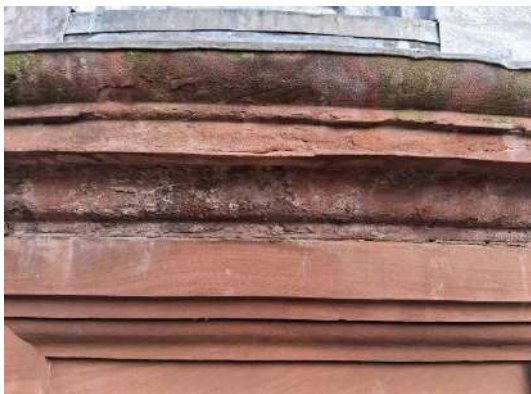
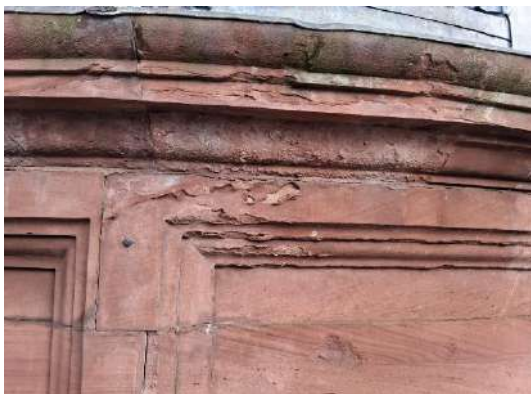
| 010 | | <p>Failed pointing and friable masonry were identified to the high-level stonework at this location. The friable masonry may become loose and potentially dislodged and fall, presenting a potential hazard, while the failed pointing may allow water ingress and lead to further deterioration of the surrounding stonework if left untreated.</p> <p>We would recommend that the affected masonry is carefully de-frassed back to sound material, removing all loose and unstable material. The failed pointing should then be carefully removed and localised patch repointing carried out using an approved lime mortar mix compatible with the existing stonework.</p> |

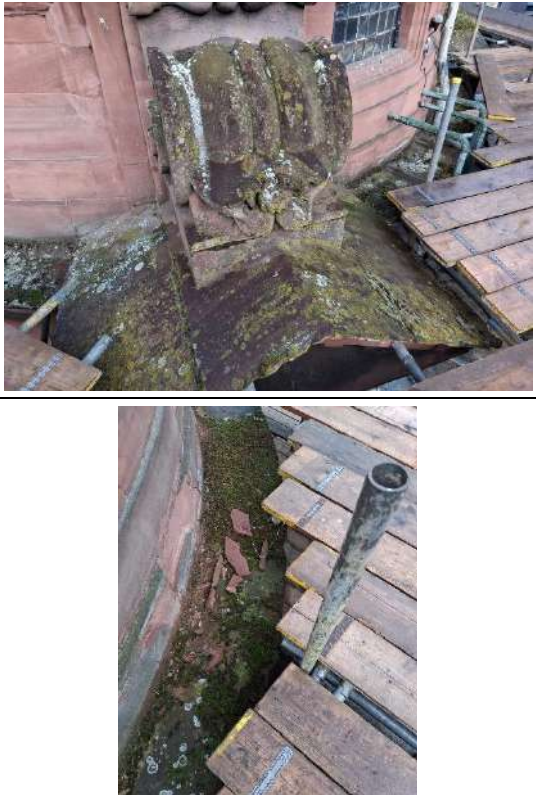
| 011 | | <p>Heavy algae growth was identified to the full upper string course detail at this location. The biological growth can retain moisture against the masonry and may contribute to staining and gradual surface deterioration if left untreated.</p> <p>We would recommend that the affected masonry is carefully cleaned using a DOFF steam cleaning system to remove all algae growth, using a controlled method appropriate to the existing stonework to minimise the risk of damage and preserve the masonry.</p> |

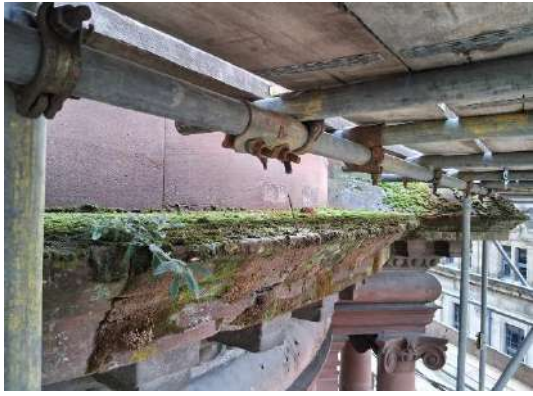
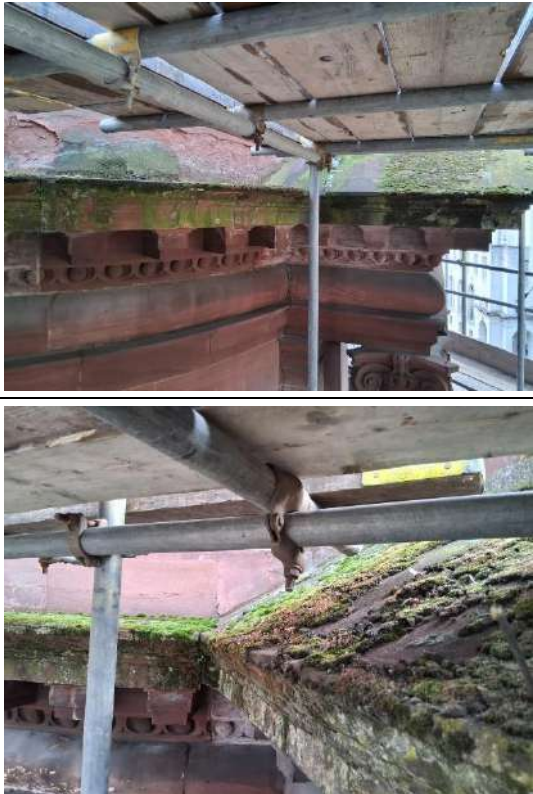
| 015 | | <p>Heavy algae growth was identified to the string course detail extending around the full circumference of the tower. The biological growth can retain moisture against the masonry and may contribute to staining and gradual surface deterioration if left untreated.</p> |

| 015 | | <p>We would recommend that the affected masonry is carefully cleaned using a DOFF steam cleaning system to remove all algae growth, using a controlled method appropriate to the existing stonework to minimise the risk of damage and preserve the masonry.</p> |

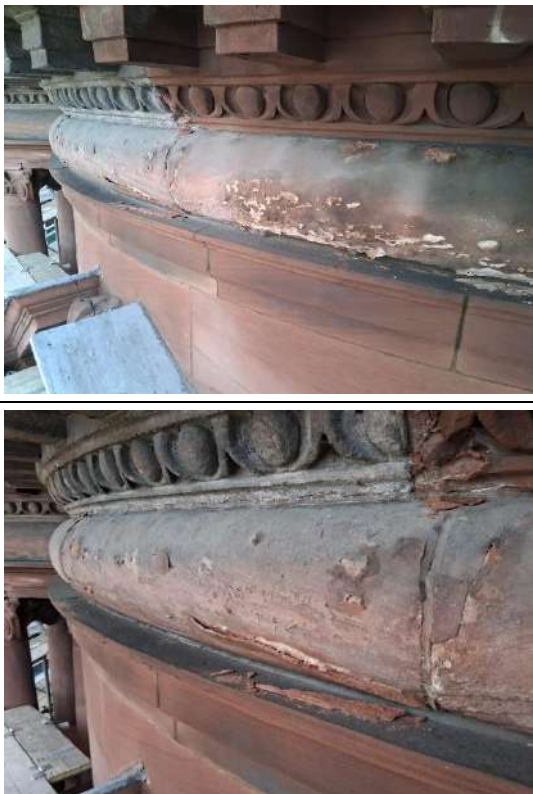
| 016 | | <p>Friable masonry was identified at this location. The affected masonry may continue to deteriorate, with loose material potentially becoming dislodged and falling, presenting a potential hazard if left untreated.</p> <p>We would recommend that the affected masonry is carefully de-frassed back to sound material, removing all loose and unstable material only.</p> |

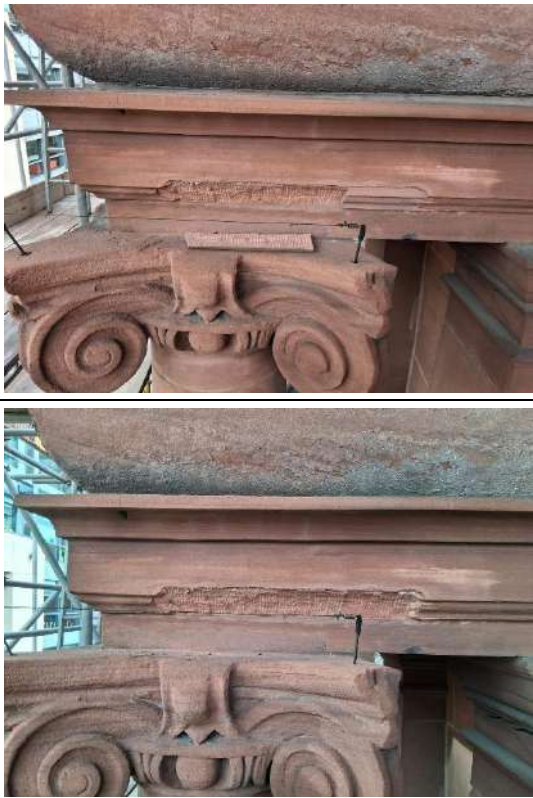
| 017 | | <p>The historic repair had become loose at this location. Our engineers carefully removed the failed repair while on site to make the area safe and eliminate the immediate risk of the repair becoming dislodged and falling.</p> <p>We would recommend that the affected masonry is repaired using a suitable colour-matched repair mortar, incorporating suitable stainless-steel reinforcement to provide additional stability and reduce the risk of further failure.</p> |

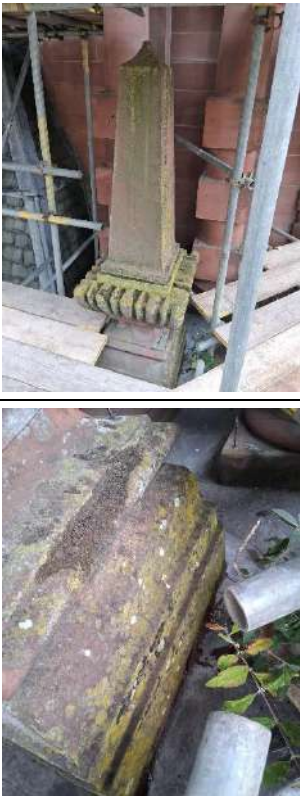
| 018 | | <p>Vegetation growth was identified emerging from behind the lead capping at this location. The vegetation may compromise the integrity of the capping and surrounding masonry and could allow water ingress if left untreated.</p> <p>We would recommend that the vegetation is carefully removed, taking care not to damage the existing lead capping. Any void or hole left following removal should be suitably made good using either a compatible flexible sealant or an approved lime mortar mix, as appropriate to the location.</p> |

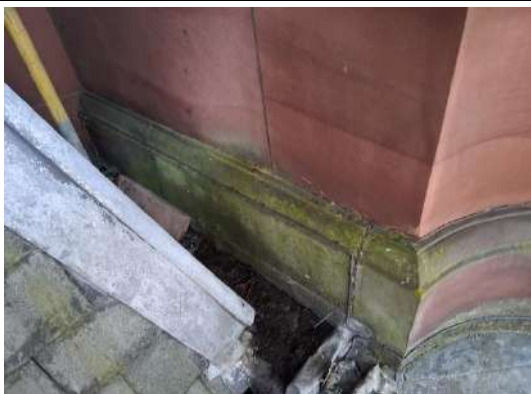
| 020 | | <p>Debris was identified within the lead box gutter, together with algae growth to the adjoining masonry, indicating a potential issue with rainwater drainage and possible water ingress at this location. If left untreated, restricted drainage may result in overflowing rainwater and further deterioration to the surrounding masonry.</p> |

| | | <p>We would recommend that all debris is carefully removed from the lead box gutter and associated outlets to allow rainwater to disperse correctly. The affected masonry should then be carefully cleaned using a DOFF steam cleaning system to remove the algae growth. Further investigation should subsequently be undertaken to determine the potential source of the water ingress and identify any additional remedial works required.</p> |

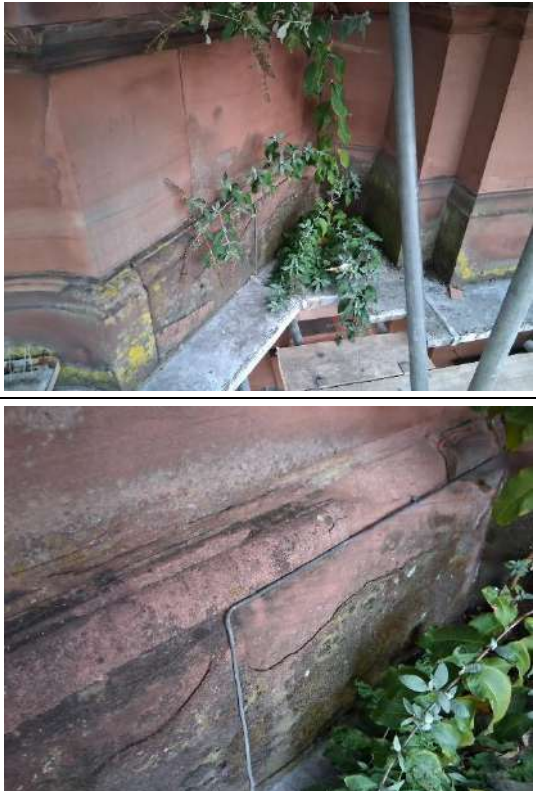
| 021 | | <p>Vegetation growth was identified emerging from behind the lead capping, together with delaminated masonry at this location. The vegetation may allow water ingress and contribute to further deterioration, while the delaminated masonry may contain loose material that could become dislodged and fall if left untreated.</p> <p>We would recommend that the vegetation growth is carefully removed, taking care not to damage the existing lead capping. Any open joints should then be sealed using a suitable compatible material, and the affected masonry carefully de-frassed back to sound material to remove all loose and unstable material.</p> |

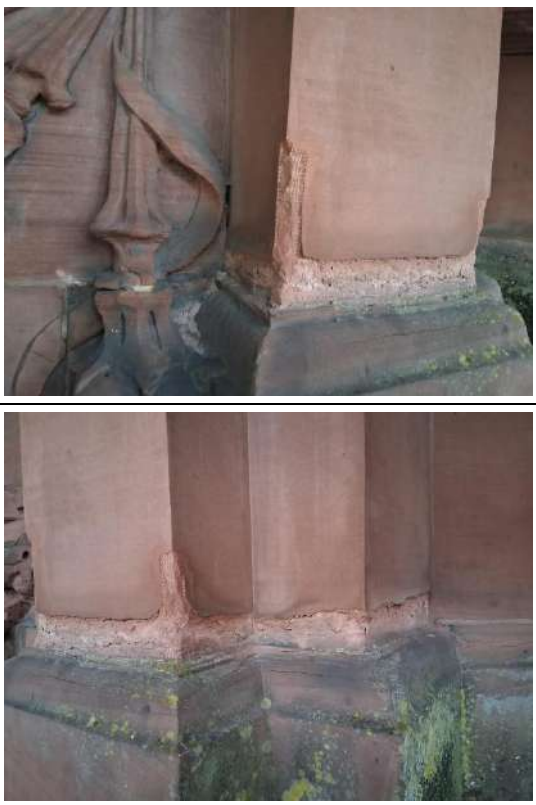
| 022 | | <p>Friable masonry was identified at this location. The affected masonry may continue to deteriorate, with loose material potentially becoming dislodged and falling, presenting a potential hazard if left untreated.</p> <p>We would recommend that the affected masonry is carefully de-frassed back to sound material, removing all loose and unstable material. Following removal, consideration should be given to carrying out localised repairs using a suitable colour-matched stone repair mortar, finished to blend with the surrounding masonry as closely as practicable.</p> |

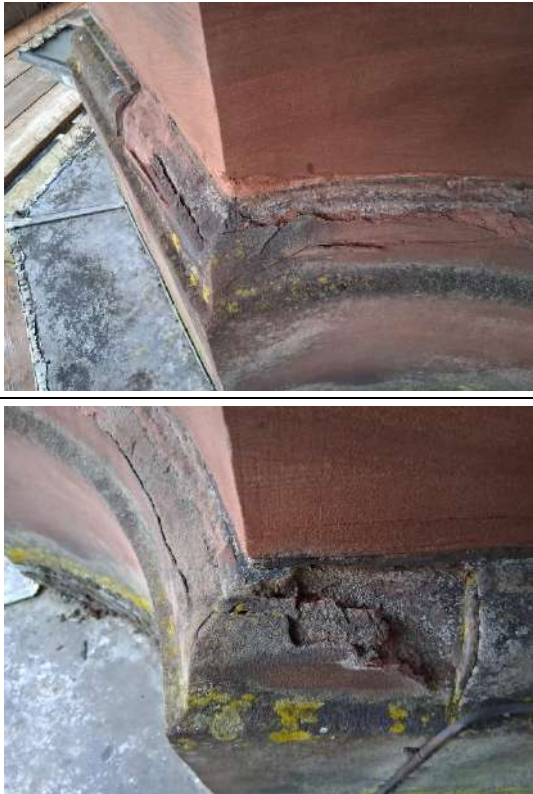
| 023 | | <p>Friable masonry was identified at this location. The affected masonry may continue to deteriorate, with loose material potentially becoming dislodged and falling, presenting a potential hazard if left untreated.</p> <p>We would recommend that the affected masonry is carefully de-frassed back to sound material, removing all loose and unstable material. Following removal, the area should be assessed to determine whether any further repairs are required using a suitable colour-matched stone repair mortar.</p> |

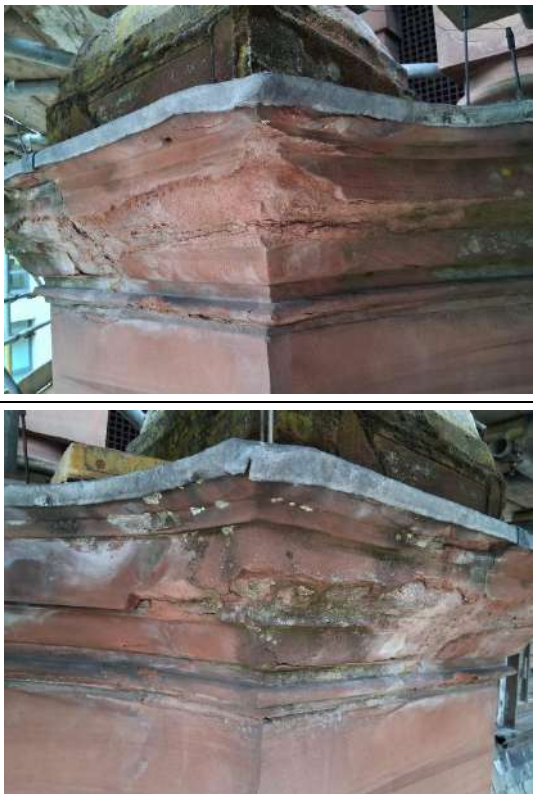
| 024 | | <p>Friable masonry was identified to the underside of the string course detail at this location. The affected masonry may continue to deteriorate, with loose material potentially becoming dislodged and falling, presenting a potential hazard if left untreated.</p> <p>We would recommend that the affected masonry is carefully de-frassed back to sound material, removing all loose and unstable material only.</p> |

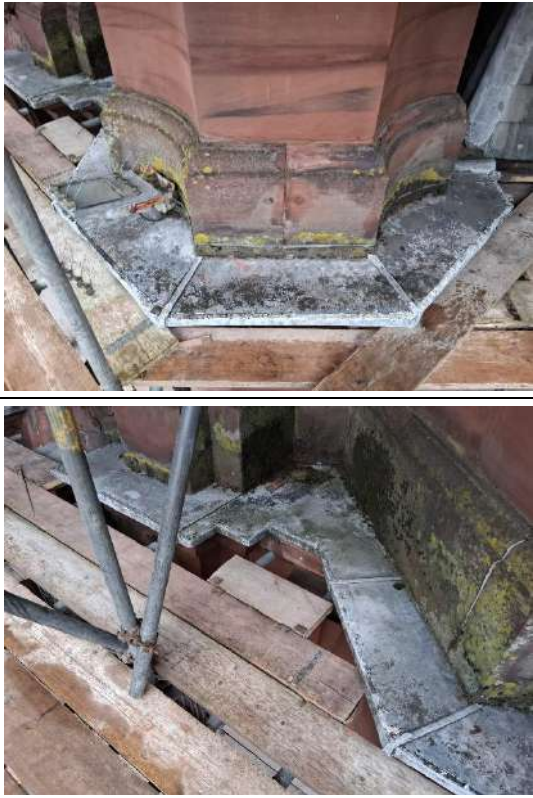
| 025 | | <p>The lead capping detail was found to be in good overall condition; however, the joint between the masonry and leadwork was found to be failing. Algae growth was also identified to the surrounding masonry. The defective joint may allow water ingress and could lead to further deterioration if left untreated.</p> <p>We would recommend that the affected masonry is carefully cleaned using a DOFF steam cleaning system to remove the algae growth. The defective sealant should then be carefully removed and the joint between the leadwork and masonry resealed using a suitable flexible sealant compatible with both materials.</p> |

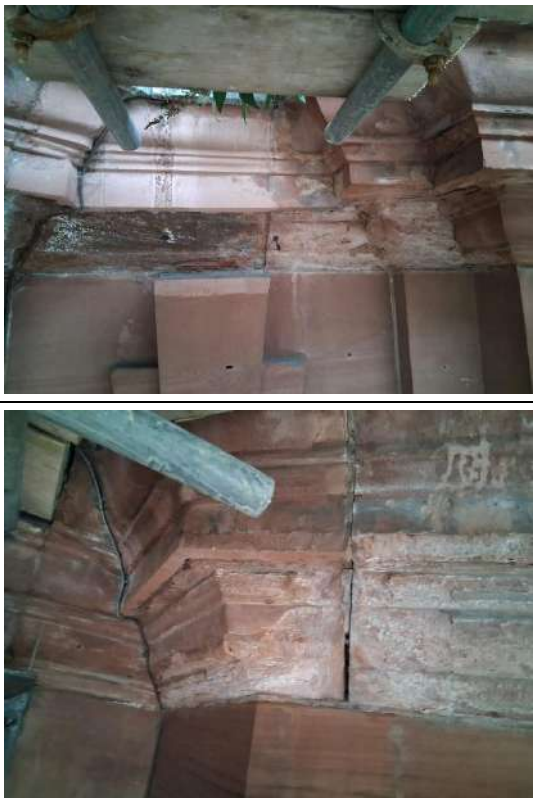
| 026 | | <p>Friable masonry and open joints were identified to the underside of the string course detail at this location. The friable masonry may become loose and potentially dislodged and fall, presenting a potential hazard, while the open joints may allow water ingress and lead to further deterioration of the surrounding masonry if left untreated.</p> <p>We would recommend that the affected masonry is carefully de-frassed back to sound material, removing all loose and unstable material. The open joints should then be carefully cleaned out and localised patch repointing carried out using an approved mortar mix compatible with the existing masonry.</p> |

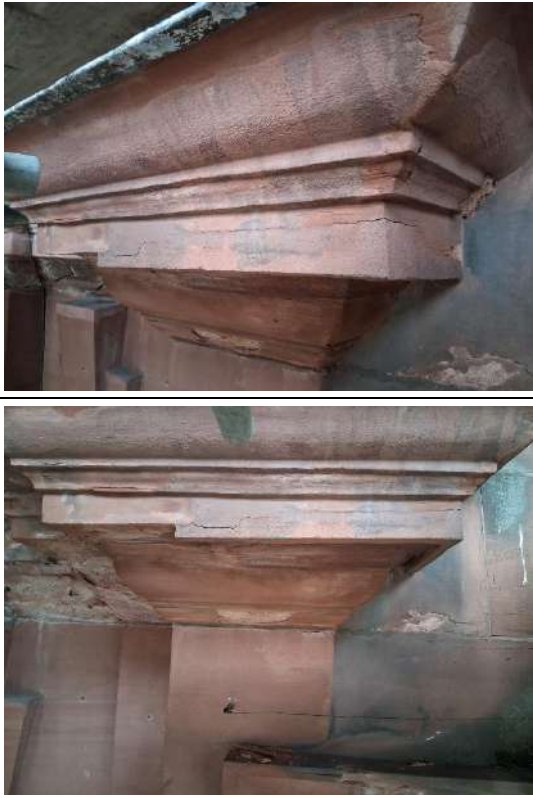
| 027 | | <p>Friable masonry and a failed historic repair were identified at this location. The friable masonry may become loose and potentially dislodged and fall, presenting a potential hazard, while the failed historic repair may also become detached if left untreated.</p> <p>We would recommend that the affected masonry is carefully de-frassed back to sound material, removing all loose and unstable material. The defective historic repair should then be carefully removed and replaced using a suitable colour-matched stone repair mortar, finished to blend with the surrounding masonry as closely as practicable.</p> |

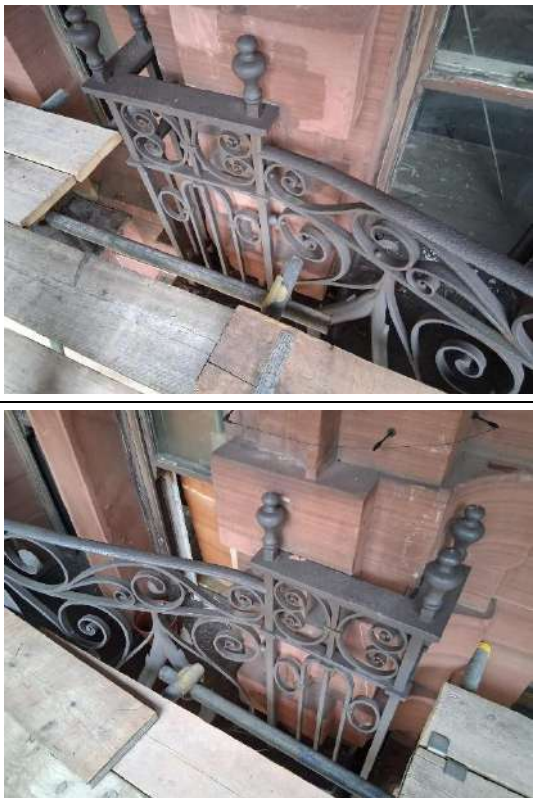
| 028 | | <p>The iron railings to the Juliet balcony were found to be in good overall condition; however, the existing paint coating system is deteriorating. If left untreated, the exposed ironwork may be susceptible to corrosion and further deterioration.</p> <p>We would recommend that the iron railings are suitably prepared and redecorated using an appropriate protective paint coating system to provide ongoing protection to the ironwork and reduce the risk of corrosion.</p> |

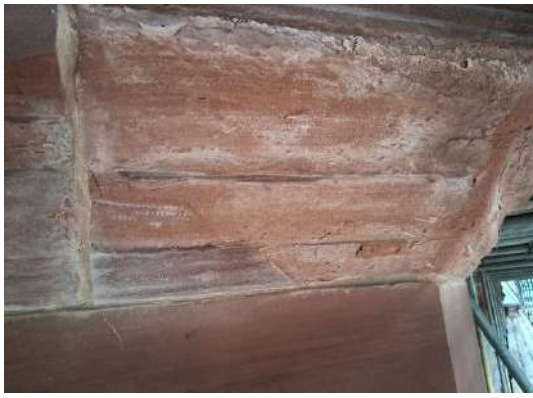
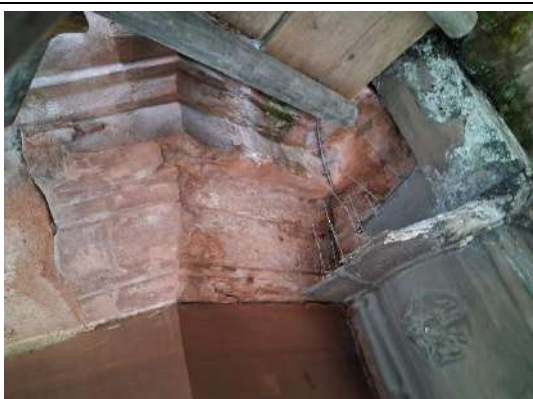
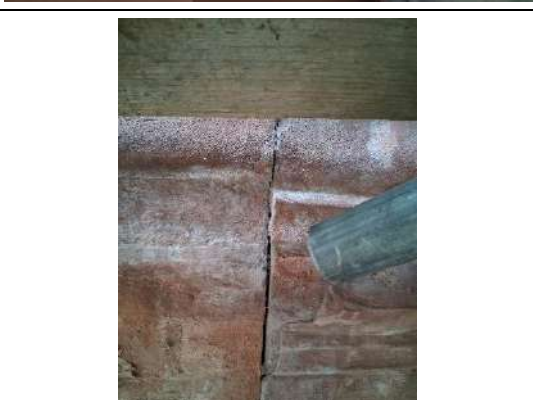
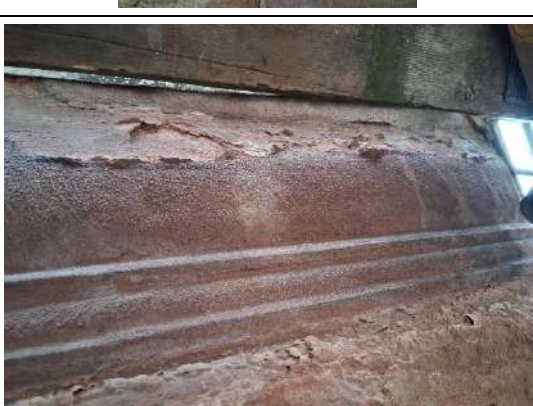
| 031 | | <p>Friable masonry and failed pointing were identified to the string course detail at this location. The friable masonry may become loose and potentially dislodged and fall, presenting a potential hazard, while the failed pointing may allow water ingress and lead to further deterioration of the surrounding masonry if left untreated.</p> <p>We would recommend that the affected masonry is carefully de-frassed back to sound material, removing all loose and unstable material. The failed pointing should then be carefully removed and localised patch repointing works carried out using an approved lime mortar mix compatible with the existing masonry.</p> |

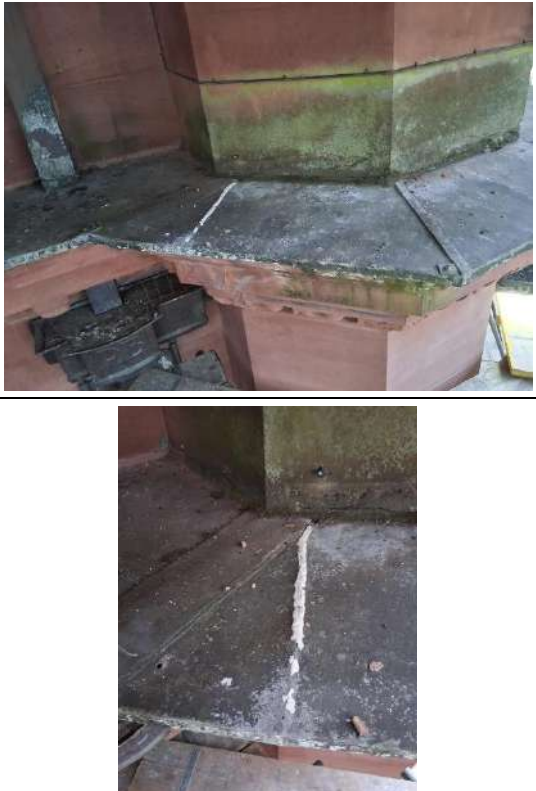
| 032 | | <p>A split was identified to the lead capping at this location, which has previously been repaired using a flexible sealant. The existing repair has failed and may allow water ingress if left untreated.</p> <p>We would recommend that the failed sealant is carefully removed and a suitable lead weld repair is carried out to the affected area, providing a durable and weatherproof repair.</p> |

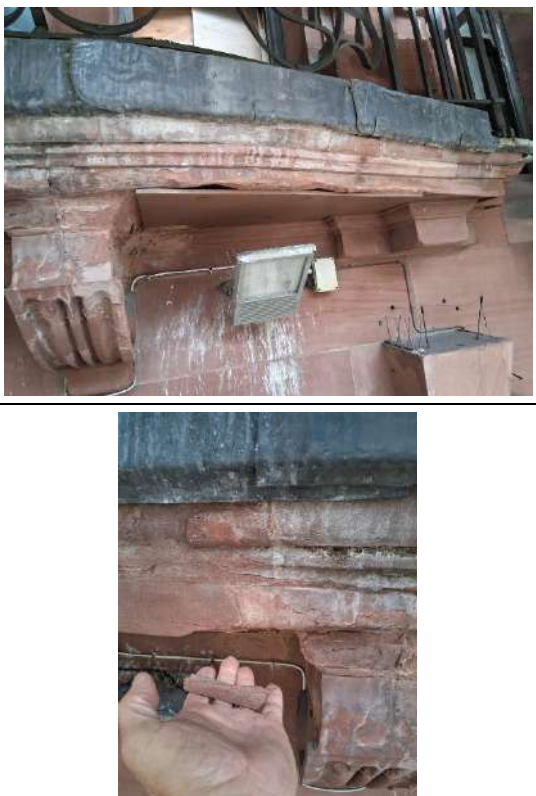
| 033 | | <p>Friable masonry was identified to the underside of the Juliet balcony at this location. The affected masonry may continue to deteriorate, with loose material potentially becoming dislodged and falling, presenting a potential hazard if left untreated.</p> <p>We would recommend that the affected masonry is carefully de-frassed back to sound material, removing all loose and unstable material only.</p> |

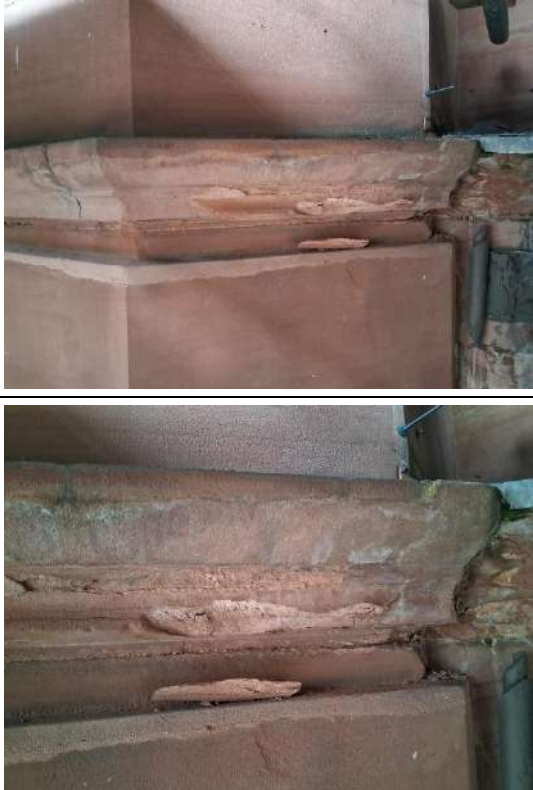
| 035 | | <p>Friable masonry was identified to the low-level string course at this location. The affected masonry may continue to deteriorate, with loose material potentially becoming dislodged and falling, presenting a potential hazard if left untreated.</p> <p>We would recommend that the affected masonry is carefully de-frassed back to sound material, removing all loose and unstable material only.</p> |

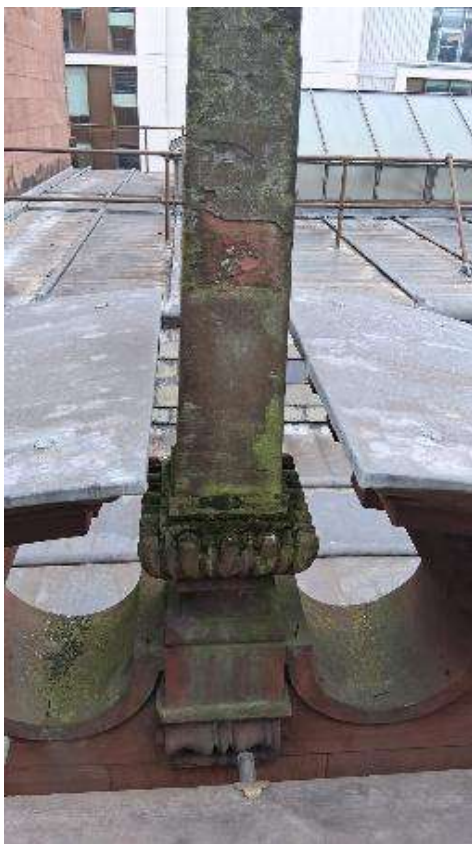
| | Photograph | Description |
|---|---|---|
| 001 | | <p>Algae growth and friable masonry were identified to the high-level stone finial at this location. The biological growth can retain moisture against the masonry and may contribute to staining and gradual surface deterioration, while the friable masonry may continue to deteriorate, with loose material potentially becoming dislodged and falling, presenting a potential hazard if left untreated.</p> <p>We would recommend that the affected masonry is carefully cleaned using a DOFF steam cleaning system to remove the algae growth, using a controlled method appropriate to the existing stonework. The friable masonry should then be carefully de-frassed back to sound material, removing all loose and unstable material only.</p> |

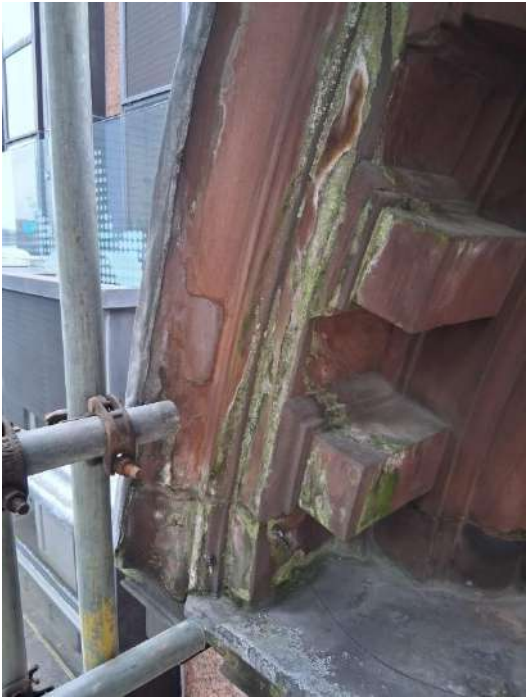
| 002 | | <p>Friable masonry and algae growth were identified to the underside of the arched stone detail at this location. The biological growth can retain moisture against the masonry and may contribute to staining and gradual surface deterioration, while the friable masonry may continue to deteriorate, with loose material potentially becoming dislodged and falling, presenting a potential hazard if left untreated.</p> <p>We would recommend that the affected masonry is carefully cleaned using a DOFF steam cleaning system to remove the algae growth, using a controlled method appropriate to the existing stonework. The friable masonry should then be carefully de-frassed back to sound material, removing all loose and unstable material only.</p> |

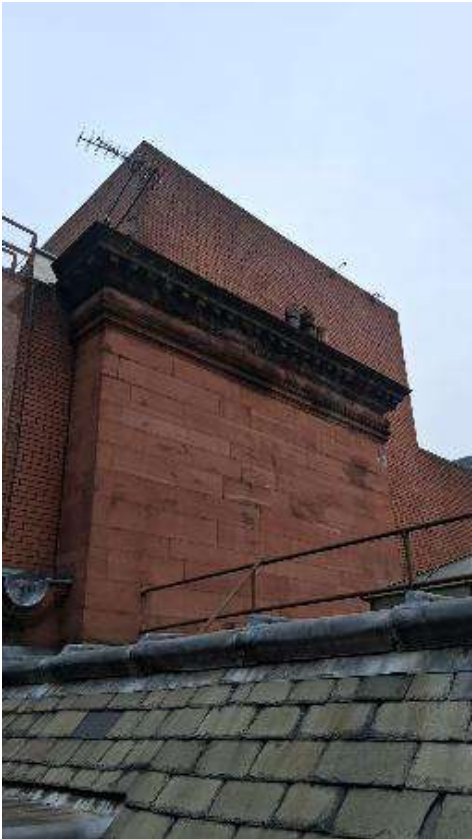
| 003 | | <p>Algae growth and friable masonry were identified to the high-level cornice detail at this location. The biological growth can retain moisture against the masonry and may contribute to staining and gradual surface deterioration, while the friable masonry may continue to deteriorate, with loose material potentially becoming dislodged and falling, presenting a potential hazard if left untreated.</p> <p>We would recommend that the affected masonry is carefully cleaned using a DOFF steam cleaning system to remove the algae growth, using a controlled method appropriate to the existing stonework. The friable masonry should then be carefully de-frassed back to sound material, removing all loose and unstable material only.</p> |

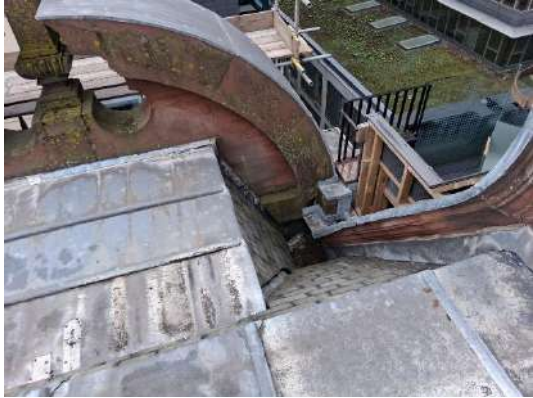
| 005 | | <p>A report of a leak in the vicinity of the lead box gutter was noted, and the gutter was found to be full of debris at the time of inspection. The accumulation of debris may restrict the effective drainage of rainwater and could contribute to water ingress if left untreated.</p> <p>We would recommend that all debris and waste are carefully removed from the lead box gutter and associated outlets to allow rainwater to drain correctly. Further investigation should then be undertaken to identify and confirm the source of the reported leak and determine any additional remedial works required.</p> |

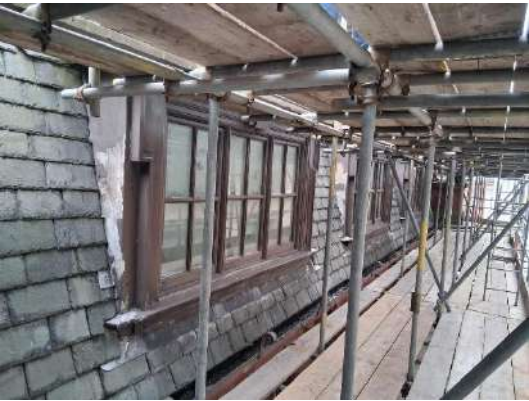
| 009 | | <p>The paint coating system to the dormer windows was found to be deteriorating and failing in areas. If left untreated, the exposed timber may become susceptible to moisture ingress and further deterioration.</p> <p>We would recommend that the dormer windows are suitably prepared and redecorated using an appropriate external timber paint coating system to protect and preserve the existing timber windows.</p> |

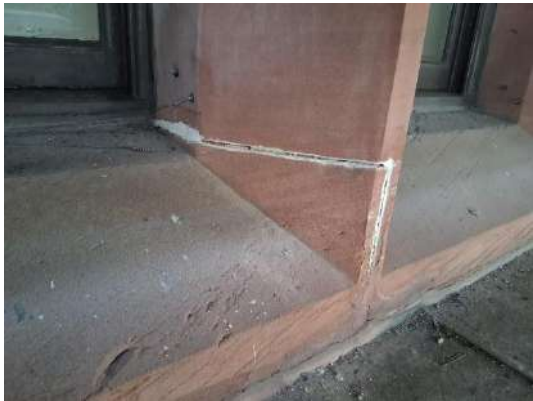
| 013 | | <p>Failed pointing was identified to the stone window mullion at this location. The defective pointing may allow water ingress and could lead to further deterioration of the surrounding stonework if left untreated.</p> <p>We would recommend that the failed pointing is carefully removed and localised repointing works are carried out using an approved lime mortar mix compatible with the existing stonework, finished to match the surrounding pointing as closely as practicable.</p> |

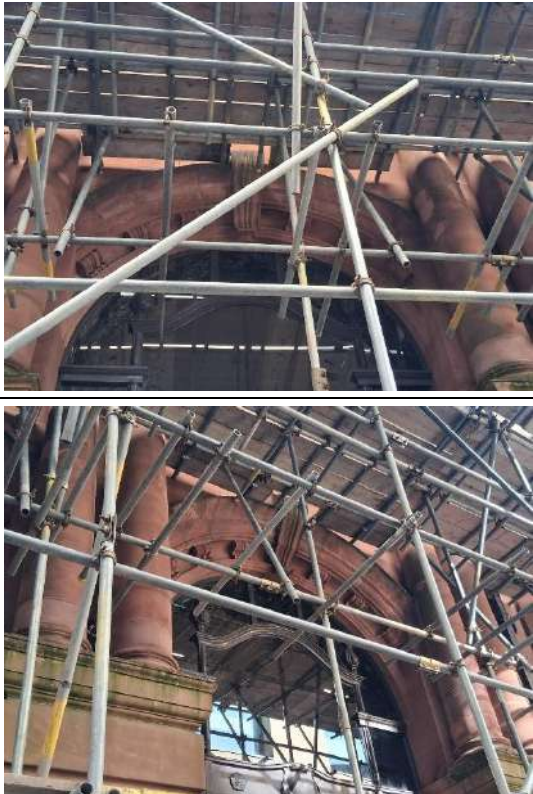
| | | <p>removing all loose and unstable material only.</p> <p><b><i>Please note that the scaffold will require modification at this location to provide suitable access, as the existing scaffold lifts are currently not boarded out.</i></b></p> |

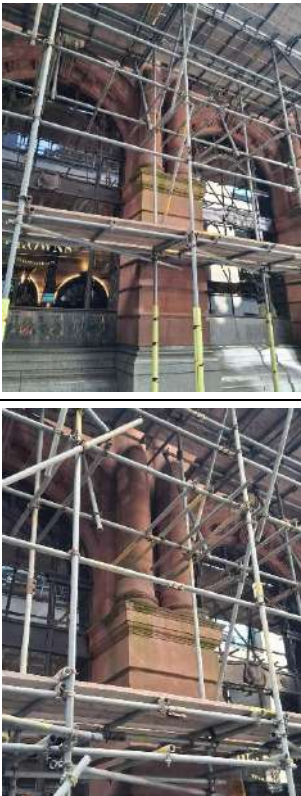
| 017 | | <p>The four masonry columns and associated plinth details between the windows were found to have algae growth. The biological growth can retain moisture against the masonry and may contribute to staining and gradual surface deterioration if left untreated.</p> <p>We would recommend that the affected masonry is carefully cleaned using a DOFF steam cleaning system to remove the algae growth, using a controlled method appropriate to the existing masonry.</p> <p><b><i>Please note that the scaffold will require modification at this location to provide suitable access, as the existing scaffold lifts are currently not boarded out.</i></b></p> |

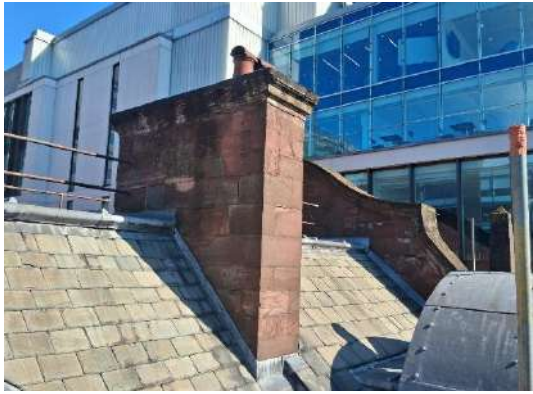
| 002 | | <p>The three chimneys at roof level on this elevation were found to have algae growth and friable masonry. The biological growth can retain moisture against the masonry and may contribute to staining and gradual surface deterioration, while the friable masonry may continue to deteriorate, with loose material potentially becoming dislodged and falling, presenting a potential hazard if left untreated.</p> <p>We would recommend that the affected chimney masonry is carefully cleaned using a DOFF steam cleaning system to remove the algae growth, using a controlled method appropriate to the existing masonry. The friable masonry should then be carefully de-frassed back to sound material, removing all loose and unstable material only.</p> |

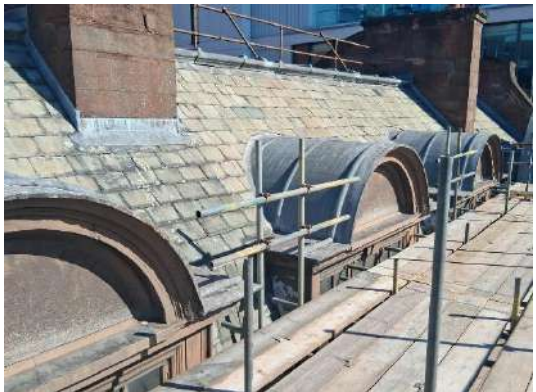
| 005 | <br> | <p>One area of defective timberwork was identified to the lead dormers, with the remaining lead dormers found to be in good overall condition. The defective timber may continue to deteriorate if left untreated.</p> <p>We would recommend that a suitably qualified joiner is employed to assess and carry out the necessary timber repairs to the affected area, using materials compatible with the existing dormer construction.</p> |

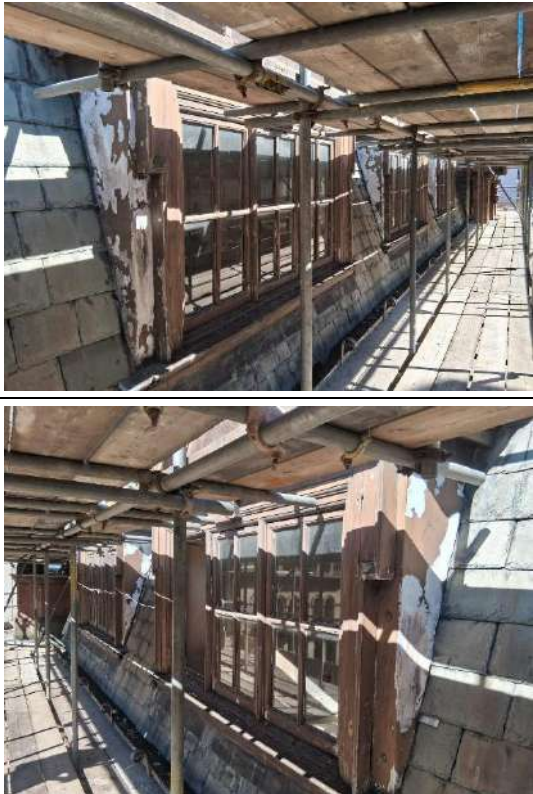
| 006 | | <p>The paint coating system to the five dormer windows was found to be deteriorating. If left untreated, the exposed timber may become susceptible to moisture ingress and further deterioration.</p> <p>We would recommend that the dormer windows are suitably prepared and redecorated using an appropriate external timber paint coating system to protect and preserve the existing timber.</p> |

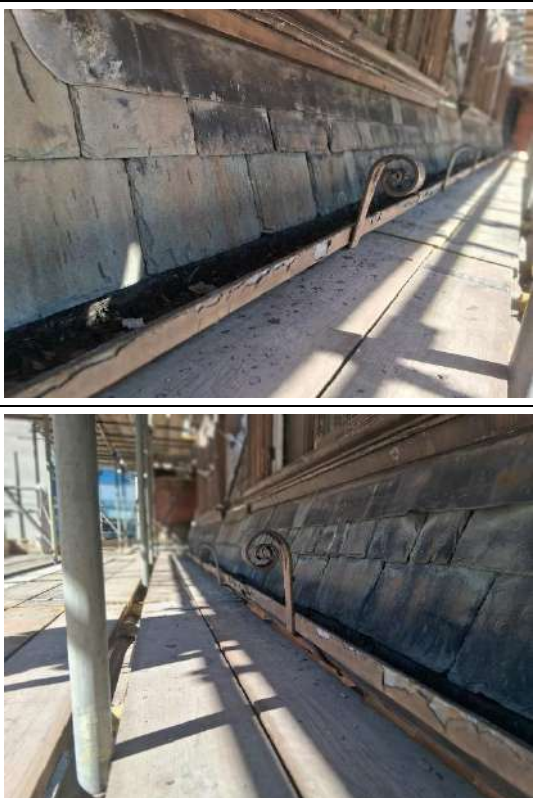
| 007 | | <p>The paint coating system to the rainwater guttering was found to be deteriorating. If left untreated, the exposed metalwork may become susceptible to corrosion and further deterioration.</p> <p>We would recommend that the rainwater guttering is suitably prepared and redecorated using an appropriate protective paint coating system to protect the metalwork and reduce the risk of corrosion.</p> |

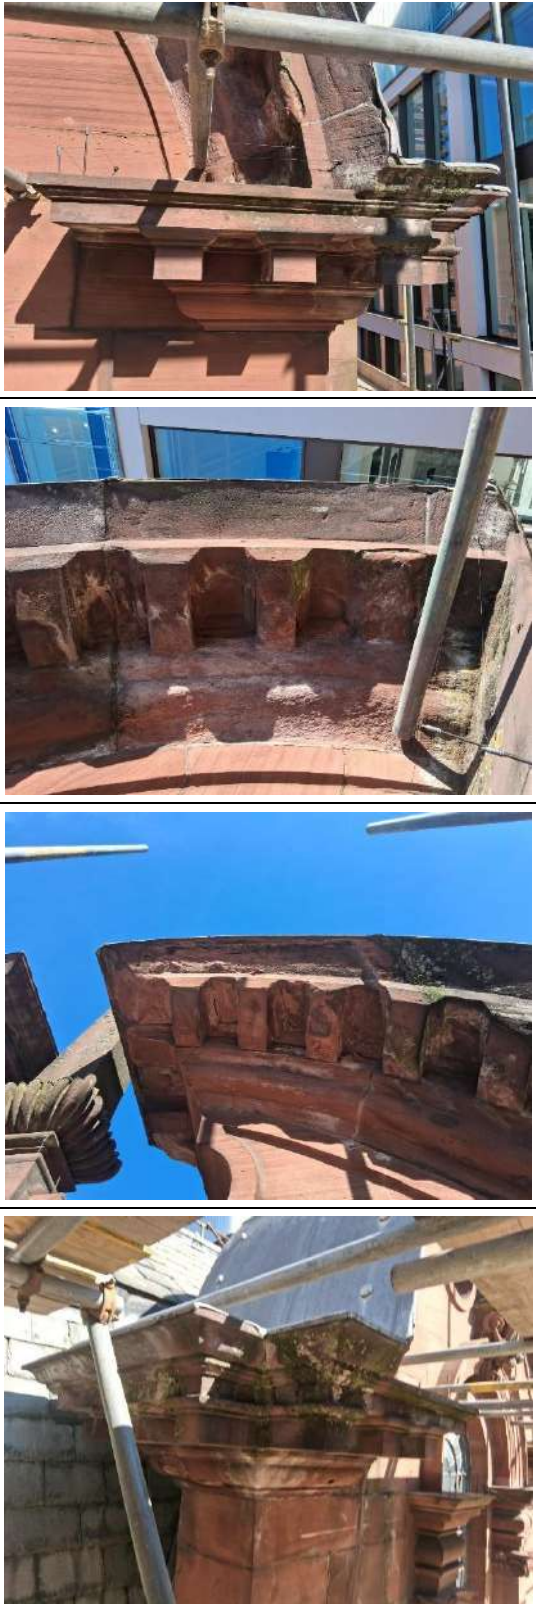
| 008 | | <p>Algae growth and friable masonry were identified to the arched stonework at this location. The biological growth can retain moisture against the stonework and may contribute to staining and gradual surface deterioration, while the friable masonry may continue to deteriorate, with loose material potentially becoming dislodged and falling, presenting a potential hazard if left untreated.</p> <p>We would recommend that the affected stonework is carefully cleaned using a DOFF steam cleaning system to remove the algae growth, using a controlled method appropriate to the existing stonework. The friable masonry should then be carefully de-frassed back to sound material, removing all loose and unstable material only.</p> |

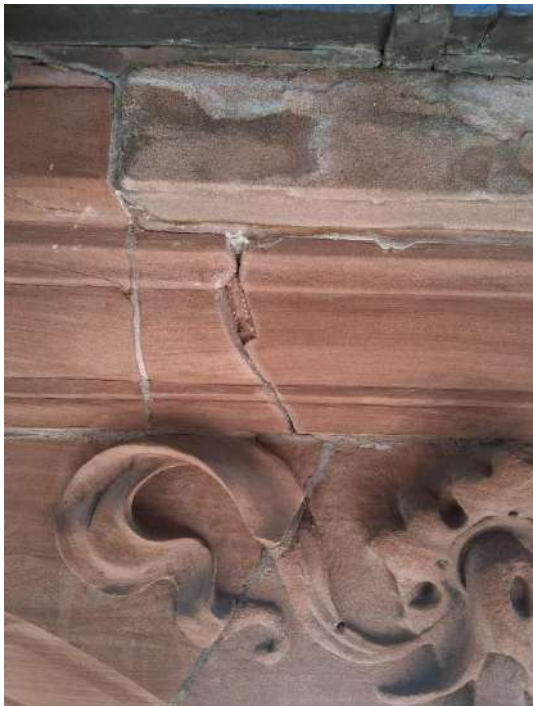
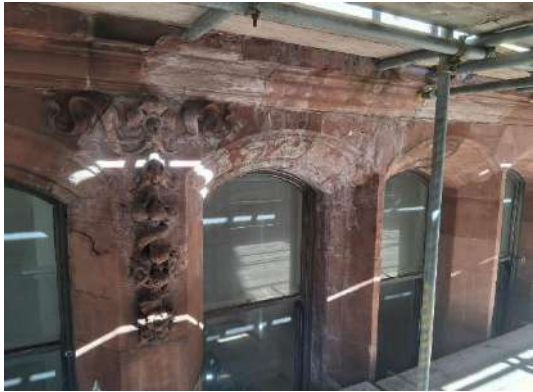
| 012 | | <p>Failed pointing and a crack were identified to the masonry at this location. The defective pointing may allow water ingress and could lead to further deterioration of the surrounding masonry, while the crack may also allow water ingress if left untreated.</p> <p>We would recommend that the failed pointing is carefully removed and localised repointing works are carried out using a suitable mortar compatible with the existing masonry. The crack should be carefully cleaned out and made good using a suitable colour-matched stone repair mortar, finished to blend with the surrounding masonry as closely as practicable.</p> |

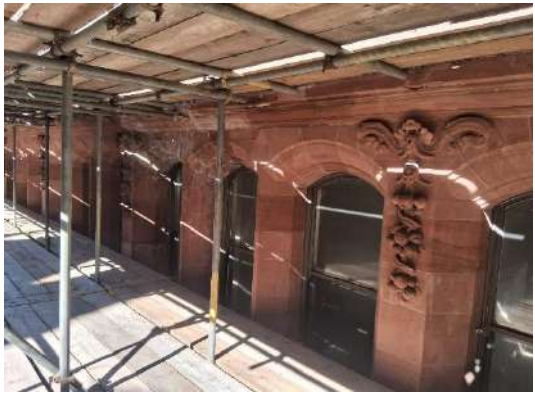
| 015 | | <p>The 15 timber sash windows were found to be in good overall condition; however, the existing paint coating system has deteriorated. If left untreated, the exposed timber may become susceptible to moisture ingress and further deterioration.</p> <p>We would recommend that the sash windows are suitably prepared and redecorated using an appropriate external timber paint coating system to protect and preserve the existing timber.</p> |

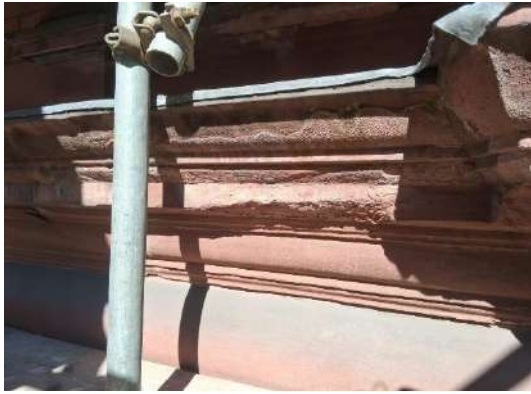
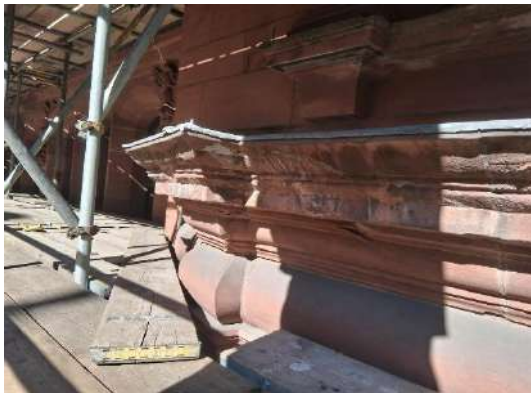
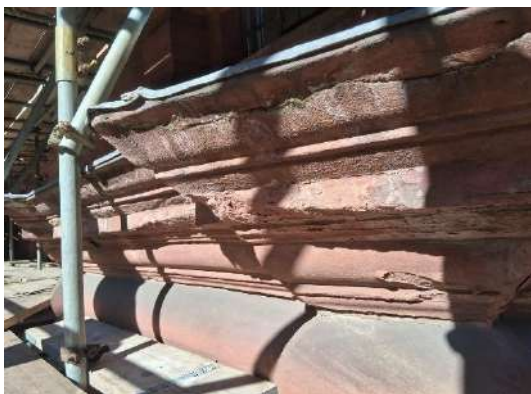
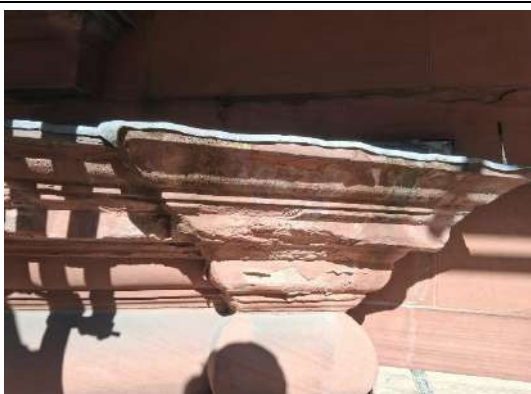
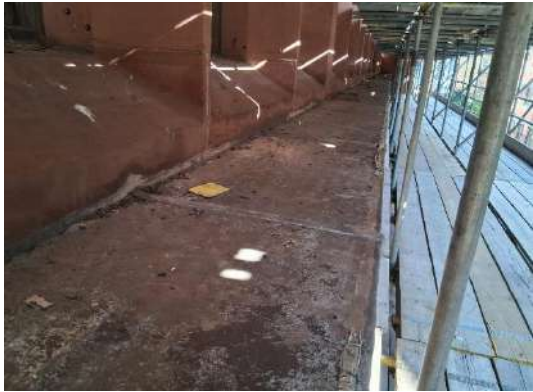
| 016 | | <p>The lead covering to the cornice detail at this location was found to be in good overall condition; however, friable masonry was identified to the underside of the cornice detail. The friable masonry may continue to deteriorate, with loose material potentially becoming dislodged and falling, presenting a potential hazard if left untreated.</p> <p>We would recommend that the affected masonry is carefully de-frassed back to sound material, removing all loose and unstable material. Following completion of the de-frassing works, the cornice should be reassessed to determine whether further repairs are required, with consideration given to localised repairs using a suitable colour-matched stone repair mortar where necessary.</p> |

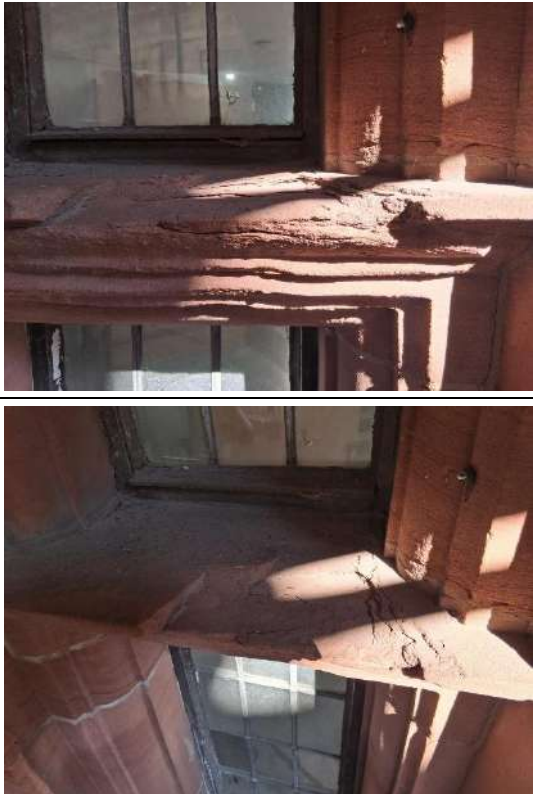
| 018 | | <p>Friable masonry was identified to the window transom at this location. The affected masonry may continue to deteriorate, with loose material potentially becoming dislodged and falling, presenting a potential hazard if left untreated.</p> <p>We would recommend that the affected masonry is carefully de-frassed back to sound material, removing all loose and unstable material. Following removal, localised stone repairs should be carried out using a suitable colour-matched stone repair mortar, finished to blend with the surrounding stonework as closely as practicable.</p> |

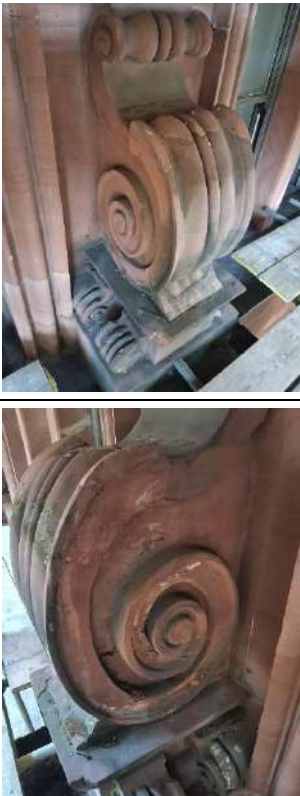
| 019 | | <p>Six ornamental stone corbels, comprising decorative scroll (volute) mouldings and curved, fluted stone detailing, were identified to have algae growth and friable masonry. The biological growth can retain moisture against the stonework and may contribute to staining and gradual surface deterioration, while the friable masonry may continue to deteriorate, with loose material potentially becoming dislodged and falling, presenting a potential hazard if left untreated.</p> |
