**Mitchells and Butlers**

**Browns Manchester**

**Condition Survey 2026**

**Engineers Report**

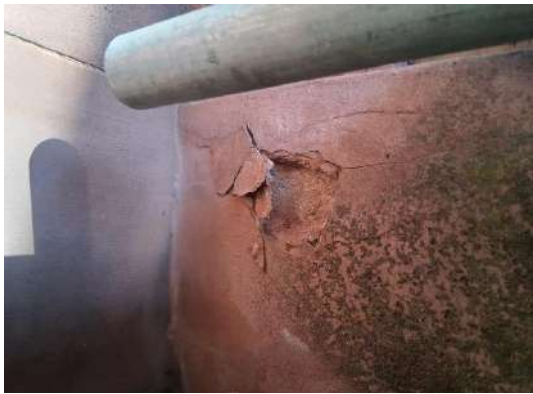
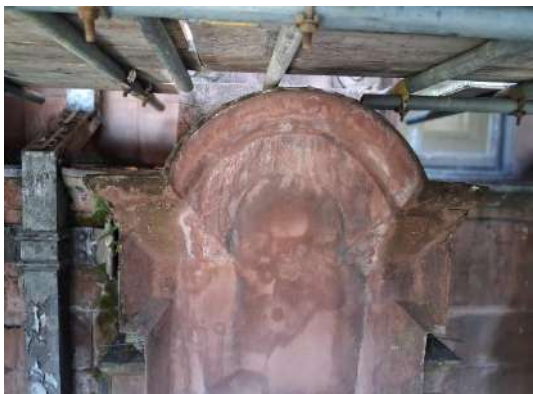
| 022 | | <p>Algae growth and friable masonry were identified at this location. The biological growth can retain moisture against the masonry and may contribute to staining and gradual surface deterioration, while the friable masonry may continue to deteriorate, with loose material potentially becoming dislodged and falling, presenting a potential hazard if left untreated.</p> |

| | | <p>We would recommend that the affected masonry is carefully cleaned using a DOFF steam cleaning system to remove the algae growth, using a controlled method appropriate to the existing masonry. The friable masonry should then be carefully de-frassed back to sound material, removing all loose and unstable material only.</p> |

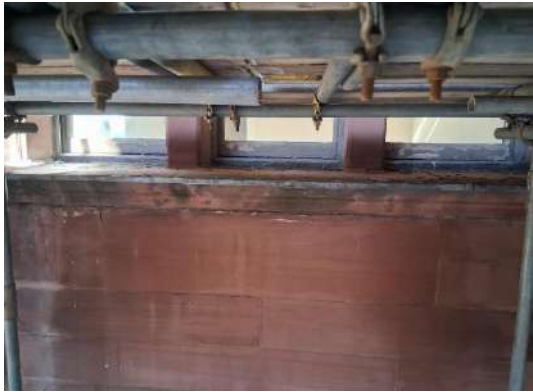
| 028 | | <p>Water ingress was reported at this location. The lead covering to the cornice detail was inspected and no splits or tears were identified; however, the pointing where the lead terminates into the masonry had failed. In addition, there was no sealant to the upstand at the window cill, which may be allowing water to track behind the leadwork. Friable masonry was also identified within this area.</p> <p>We would recommend that all failed pointing is carefully removed and the affected areas are repointed using a suitable mortar compatible with the existing masonry. The upstand at the window cill should then be sealed using a suitable flexible sealant to prevent further water tracking behind the leadwork. The friable masonry should also be carefully de-frassed back to sound material, removing all loose and unstable material only.</p> |

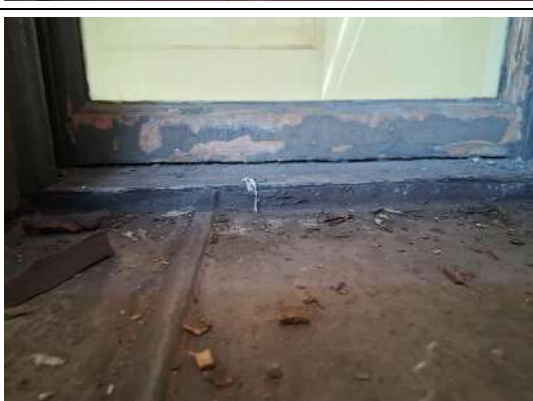
| 029 | | <p>Water ingress was reported at this location. The lead covering to the cornice detail was inspected and no splits or tears were identified; however, the pointing where the lead terminates into the masonry had failed. In addition, there was no sealant to the upstand at the window cill, which may be allowing water to track behind the leadwork. Friable masonry was also identified within this area.</p> <p>We would recommend that all failed pointing is carefully removed and the affected areas are repointed using a suitable mortar compatible with the existing masonry. The upstand at the window cill should then be sealed using a suitable flexible sealant to prevent further water tracking behind the leadwork. The friable masonry should also be carefully de-frassed back to sound material, removing all loose and unstable material only.</p> |

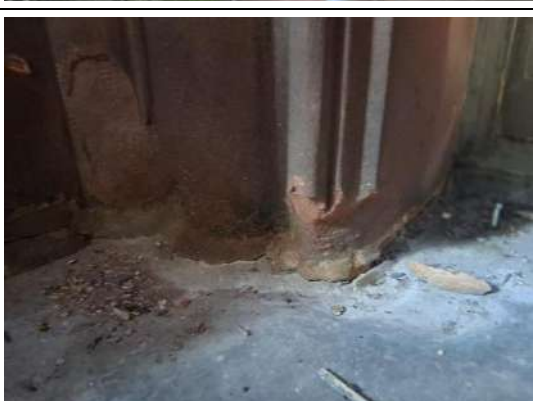
| 030 | | <p>Water ingress was reported at this location. The lead covering to the cornice detail was inspected and no splits or tears were identified; however, the pointing where the lead terminates into the masonry had failed. In addition, there was no sealant to the upstand at the window cill, which may be allowing water to track behind the leadwork. Friable masonry and open jointing were also identified within this area.</p> <p>We would recommend that all failed pointing and open jointing are carefully removed and localised repointing works are carried out using an approved mortar mix compatible with the existing masonry. The upstand at the window cill should then be sealed using a suitable flexible sealant to prevent further water tracking behind the leadwork. The friable masonry should also be carefully de-frassed back to sound material, removing all loose and unstable material only.</p> |

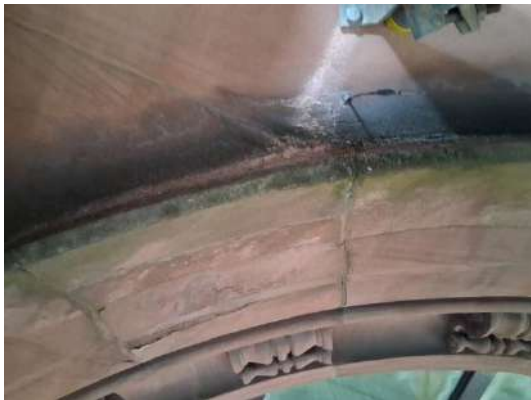
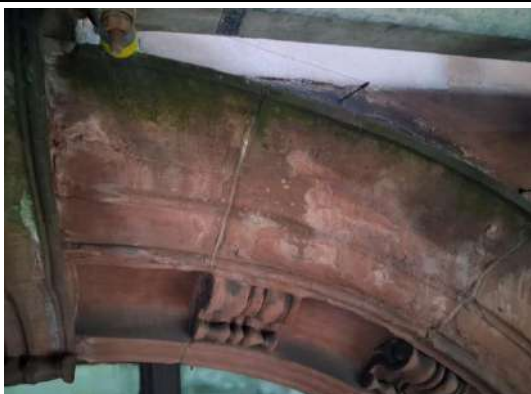
| 036 | | <p>Algae growth and friable masonry were identified to the arched stone window head at this location. The biological growth can retain moisture against the stonework and may contribute to staining and gradual surface deterioration, while the friable masonry may continue to deteriorate, with loose material potentially becoming dislodged and falling, presenting a potential hazard if left untreated.</p> <p>We would recommend that the affected stonework is carefully cleaned using a DOFF steam cleaning system to remove the algae growth, using a controlled method appropriate to the existing stonework. The friable masonry should then be carefully de-frassed back to sound material, removing all loose and unstable material only.</p> |

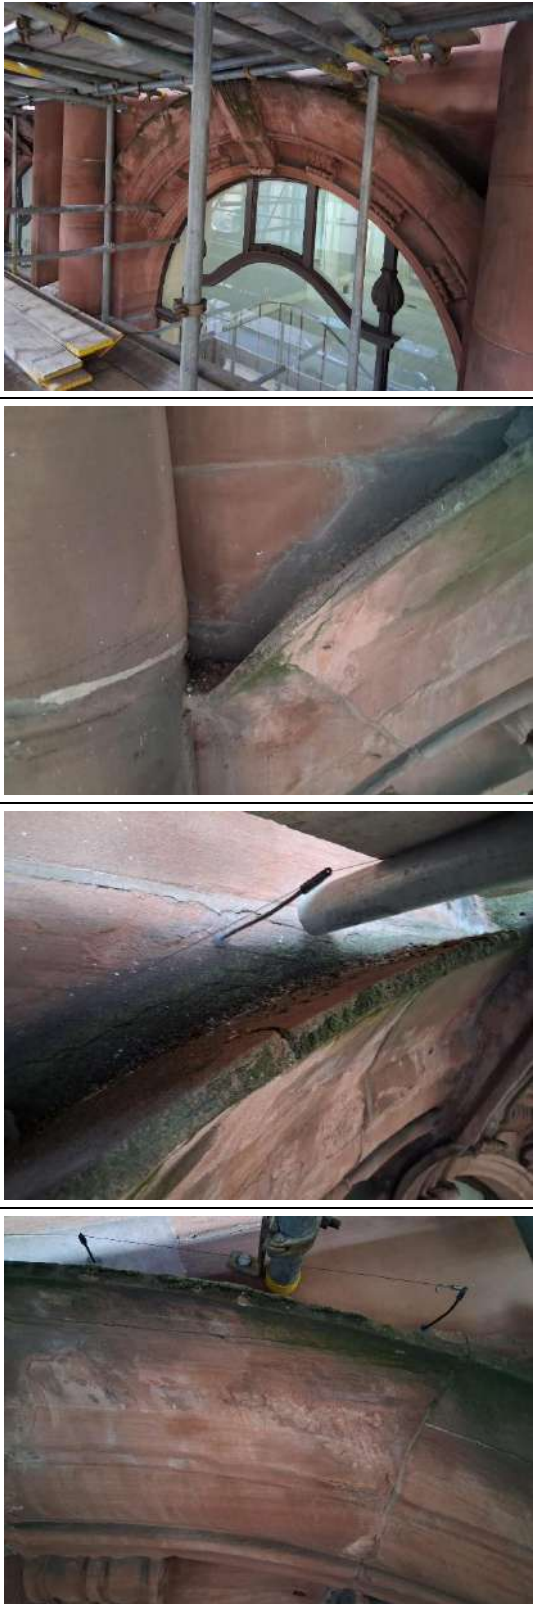
| 037 | | <p>Algae growth and friable masonry were identified to the arched stone window head at this location. The biological growth can retain moisture against the stonework and may contribute to staining and gradual surface deterioration, while the friable masonry may continue to deteriorate, with loose material potentially becoming dislodged and falling, presenting a potential hazard if left untreated.</p> <p>We would recommend that DOFF steam cleaning is undertaken to remove the algae growth, using a controlled method appropriate to the existing stonework. The friable masonry should then be carefully de-frassed back to sound material, removing all loose and unstable material only.</p> |

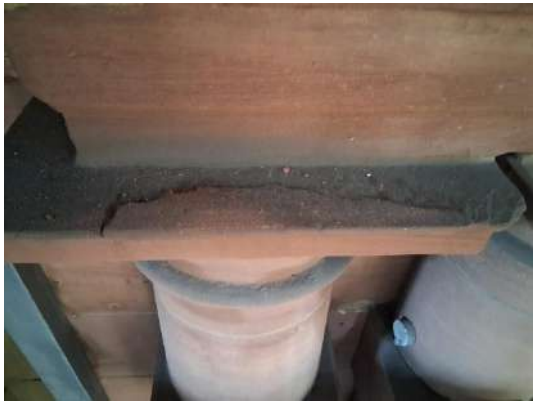
| 038 | | <p>A crack was identified to the top of the stone column at this location. The crack may allow water ingress and could lead to further deterioration of the surrounding stonework if left untreated.</p> <p>We would recommend that the cracked area is carefully assessed and repaired either by carrying out a suitable stone indent repair or by making good with a suitable colour-matched stone repair mortar, depending on the extent and condition of the affected stonework.</p> |

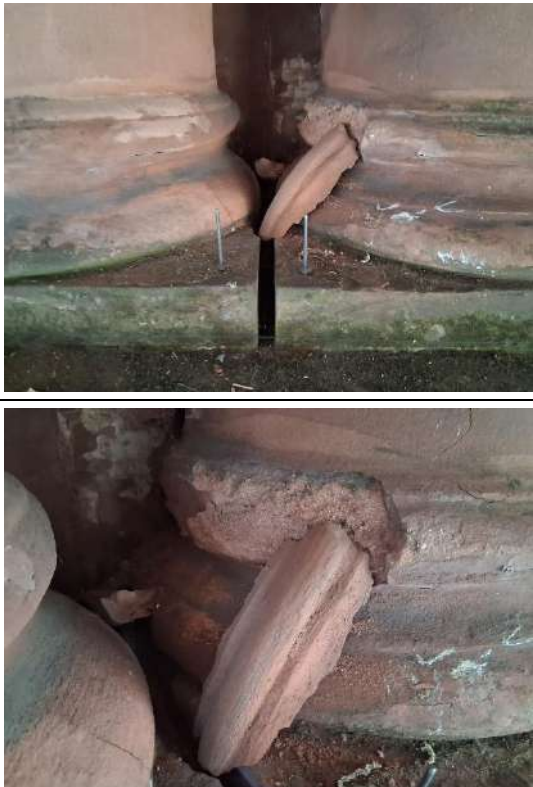
| 039 | | <p>Damaged and friable masonry was identified to the base of the columns at this location. The affected masonry may continue to deteriorate, with loose material potentially becoming dislodged and falling, presenting a potential hazard if left untreated.</p> <p>We would recommend that the affected masonry is carefully de-frassed back to sound material, removing all loose and unstable material. Localised stone repairs should then be carried out using a suitable colour-matched stone repair mortar, finished to blend with the surrounding stonework as closely as practicable.</p> |

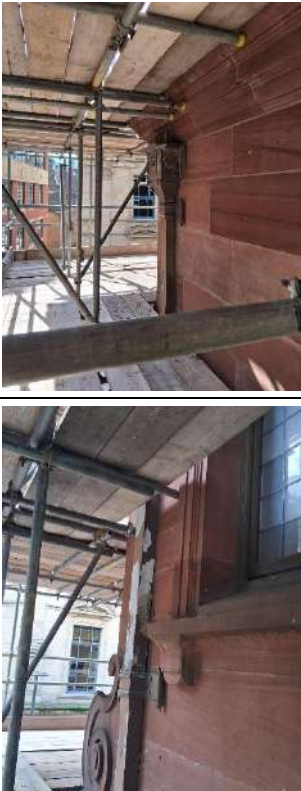
| 003 | | <p>The lead rainwater pipe appeared to be in good overall condition at the time of inspection; however, the existing paint coating system had deteriorated. If left untreated, further deterioration of the coating may leave the leadwork exposed to the elements and result in further surface deterioration.</p> <p>We would recommend that the lead rainwater pipe is suitably prepared and redecorated using an appropriate protective coating system suitable for application to lead.</p> |

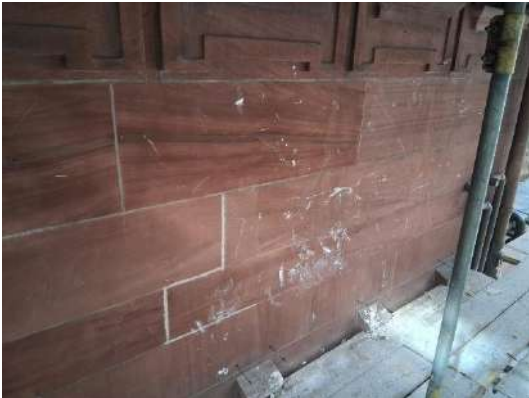
| 004 | | <p>Marks and staining were identified to the stonework at this location, which appeared to be potentially associated with the loading and handling of materials during the ongoing refurbishment works.</p> <p>We would recommend that the affected stonework is carefully cleaned using a DOFF steam cleaning system to remove the marks and staining, using a controlled method appropriate to the existing stonework.</p> |

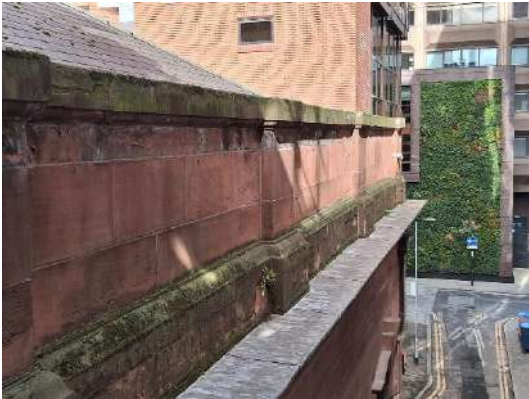
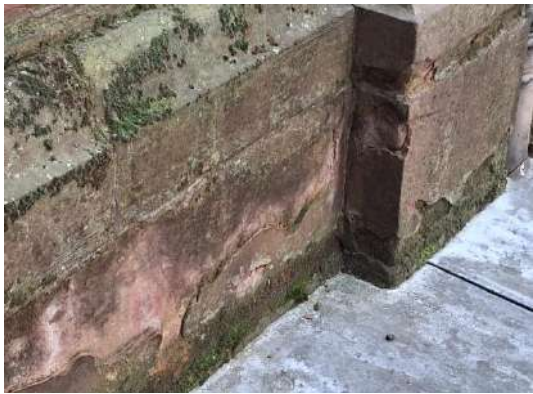
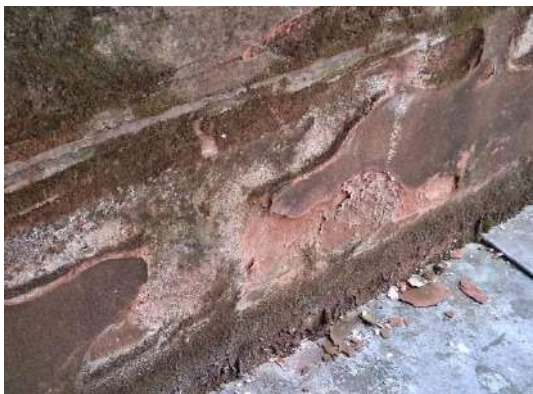
| 005 | | <p>Algae growth and delaminating masonry were identified to the parapet wall at this location. The biological growth can retain moisture against the masonry and may contribute to staining and gradual surface deterioration, while the delaminating masonry may continue to deteriorate, with loose material potentially becoming dislodged and falling, presenting a potential hazard if left untreated.</p> |

| 005 | | <p>Algae growth and delaminating masonry were identified to the parapet wall at this location. The biological growth can retain moisture against the masonry and may contribute to staining and gradual surface deterioration, while the delaminating masonry may continue to deteriorate, with loose material potentially becoming dislodged and falling, presenting a potential hazard if left untreated.</p> |

| | | <p>We would recommend that the affected parapet wall is carefully cleaned using a DOFF steam cleaning system to remove the algae growth, using a controlled method appropriate to the existing masonry. The delaminating masonry should then be carefully de-frassed back to sound material, removing all loose and unstable material only.</p> |

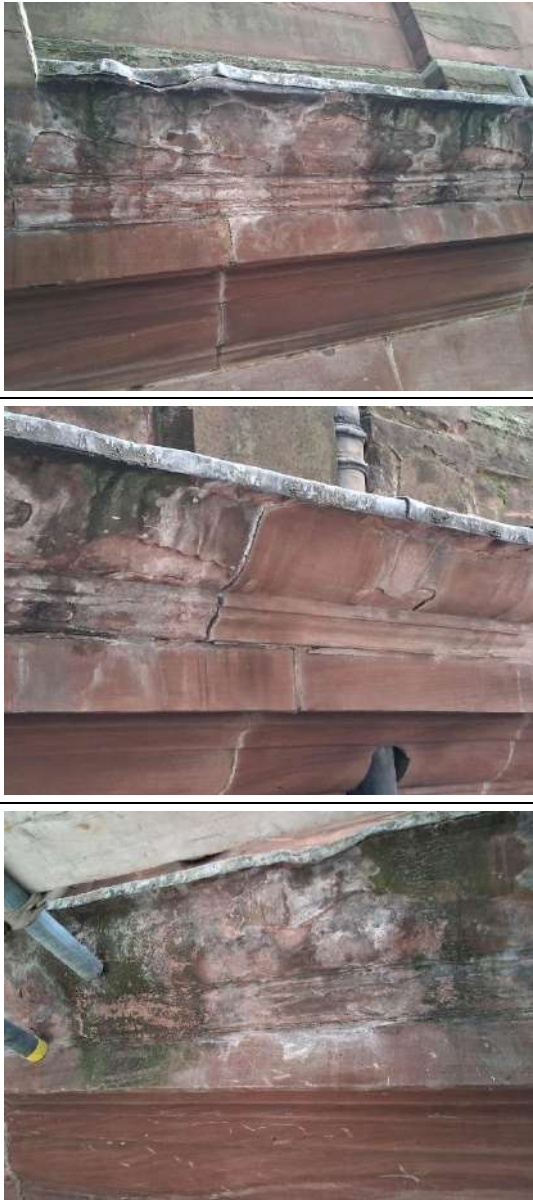
| 006 | | <p>Algae growth, salt staining and friable masonry were identified to the underside of the stone string course at this location. The algae growth can retain moisture against the stonework, while the salt staining may indicate moisture movement through the masonry and contribute to further surface deterioration. The friable masonry may also continue to deteriorate, with loose material potentially becoming dislodged and falling, presenting a potential hazard if left untreated.</p> <p>We would recommend that the affected stonework is carefully cleaned using a DOFF steam cleaning system to remove the algae growth and salt staining, using a controlled method appropriate to the existing stonework. The friable masonry should then be carefully de-frassed back to sound material, removing all loose and unstable material only.</p> |

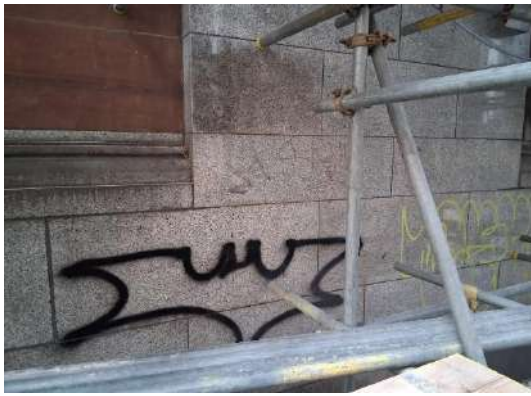
| | | Graffiti was identified to the low-level masonry on the Milk Street elevation. If left untreated, the graffiti may cause staining and detract from the appearance of the masonry. |

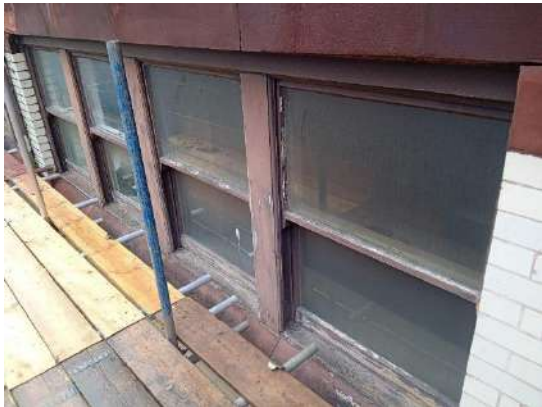
| 7 | | <p>Timber window frames would benefit from being overhauled by sanding, filling and new paint coating application. It is believed M&amp;B already have a contractor onsite carrying out these works.</p> |
