# DESIGN STATEMENT

## BARRACKS HOUSE MANCHESTER

Revision A

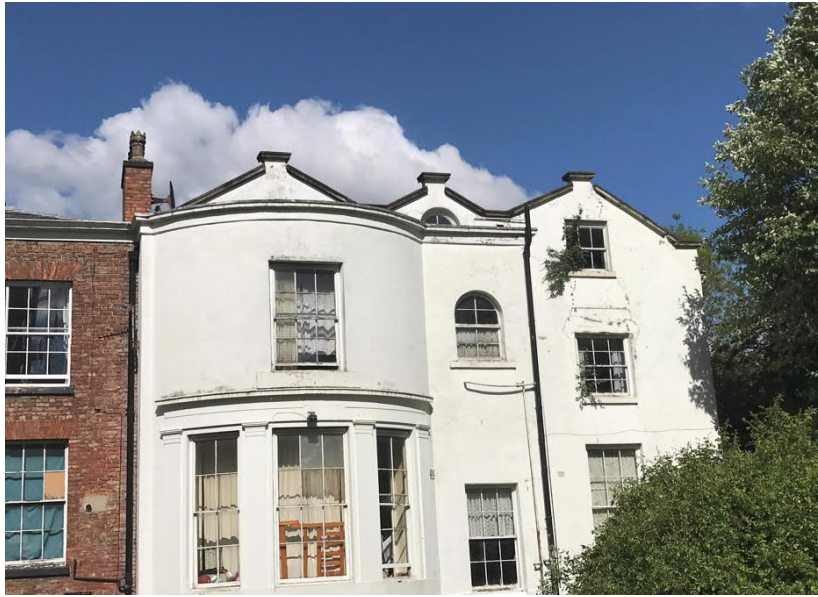
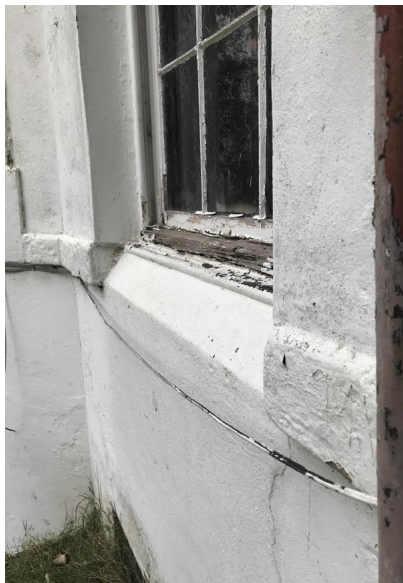
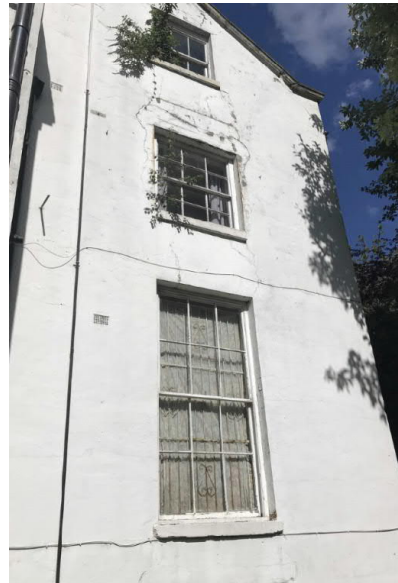
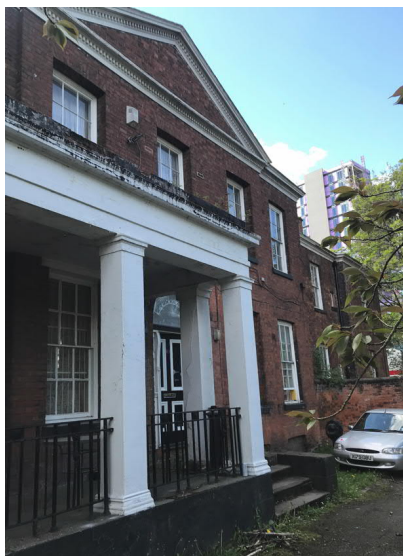
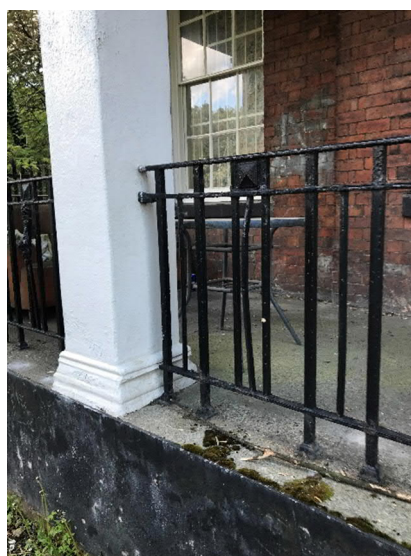
- 4.1 The south facing gable and a large part of the west facing elevation to the rear are currently rendered.
- 4.2 Existing render is generally cracked and spalling to the facades it is applied to
- 4.3 Given that the existing render is unsound it is considered more appropriate to remove the existing render and reapply a new render to the face of the building following all the same detailing as currently exists to window surrounds and cornices
- 4.4 Black render applied to the plinth and to the base of the portico will also be replaced.
- 4.5 Damaged cornice around the top of the portico will be repaired and replaced where necessary with identical mouldings and then redecorated

*Areas of render to the existing elevation*

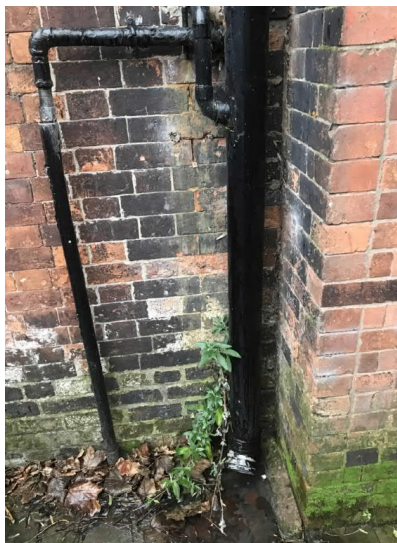
- 5.3 Some low-level areas also show damage to the brick and will be replaced
- 5.4 Brick will be carefully selected to match the existing and sample panels will be provided on site for approval by the Conservation Officer

*Damage to low level brick*

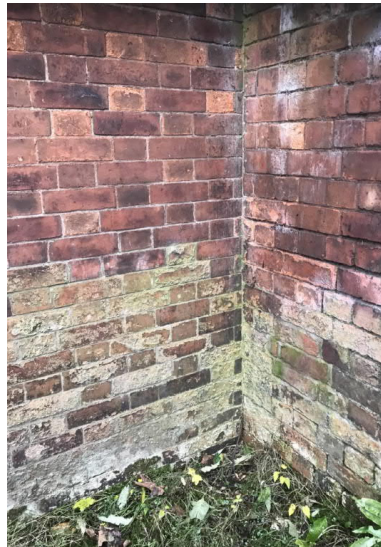
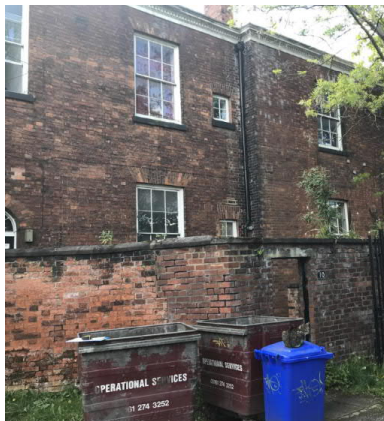
- 5.6 The existing curved garden wall to the right of the drive is in a state of disrepair with numerous spalled brick and some previously poor attempts at repointing. It is proposed that sections of this wall will be removed and rebuilt using a matching reclaimed brick with the same stone features

*Existing curved wall to side of drive*

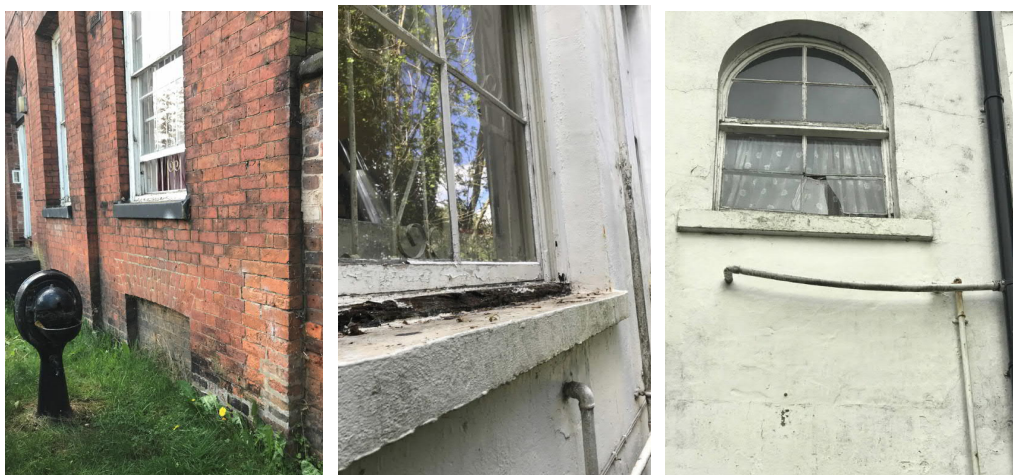
- 6.1 The existing windows are painted timber sash windows and are generally in a state of disrepair with signs of rot to cills in particular, damaged and missing glazing bars and slipped or broken glass.

- 6.2 The building is suffering from condensation issues typical of single glazing. Security bars are present to the more vulnerable ground floor windows

*windows in various states of disrepair with security bars to vulnerable ground floor*

- 6.8 All windows will therefore be fully repaired and redecorated, new secondary glazing will be installed throughout and the existing security bars will be retained to vulnerable windows
- 6.9 A schedule of repairs is included with the application.
- 6.10 Sample window repairs can be provided for the approval of the Conservation Officer.

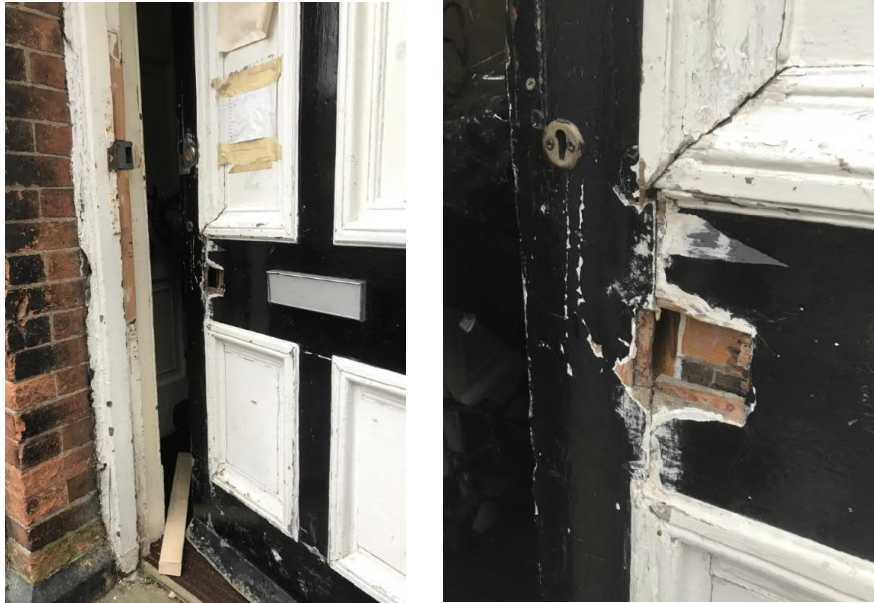
- 7.1 Existing painted window cills will be repainted rather than stripped back
- 7.2 External doors have suffered a series of repairs over the years and are not in good condition. However, these too will be repaired and redecorated throughout including decorative mouldings and the damaged fanlight over the main entrance door

*Damage to timber panelled doors and frames*

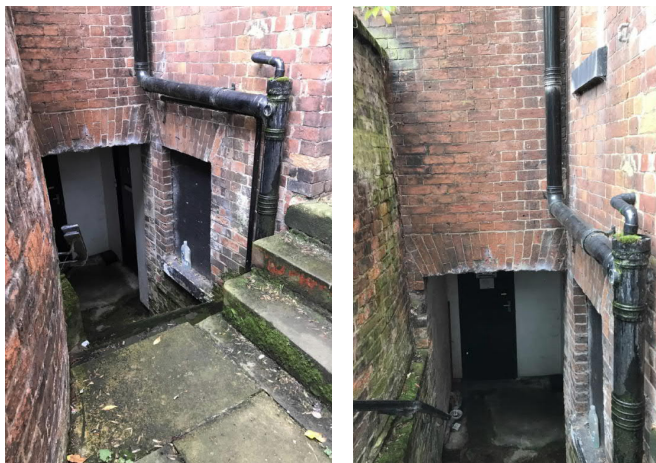
- 8.1 A number of soil stacks are showing signs of leaking at collar junction. These will be repaired where practical and where not they will be replaced with new heritage style stacks.
- 8.2 Rainwater downpipes are also causing damage to the brickwork in some locations by virtue of the fact that the junctions are loose or, at low level, the gullies appear to be blocked and this has resulted in running water to the basement stair for instance
- 8.3 All gullies on site and all manholes will be inspected and cleared. Any damaged downpipes will be replaced with new heritage style pipes

*Leaking downpipes and stacks*
