10 Minshull Street and 11 Bloom Street

**TANKING DETAILS PROPOSALS**

PLANNING CONDITIONS RELEASE 11(e)

Planning Permission 119374/FO/2018 – BOTH BUILDINGS

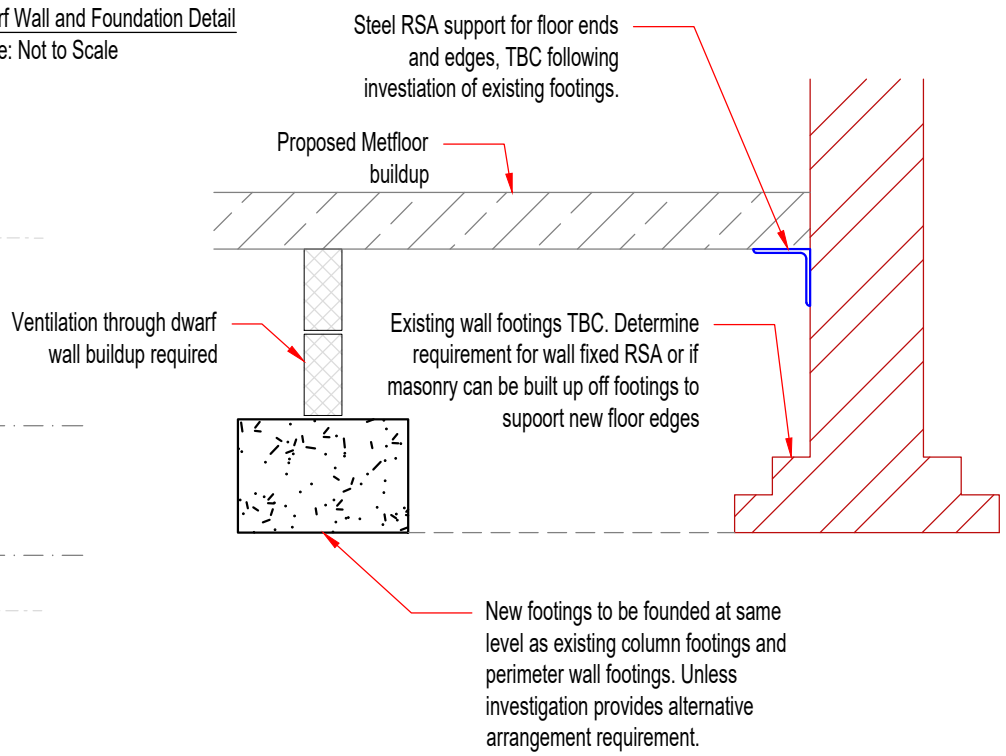
Dwarf Wall and Foundation Detail  
Scale: Not to Scale

Existing dwarf walls exposed to date appear to be of poor quality and founded at varying levels. Demolition of all dwarf walls and rebuilding on new strip footings recommended

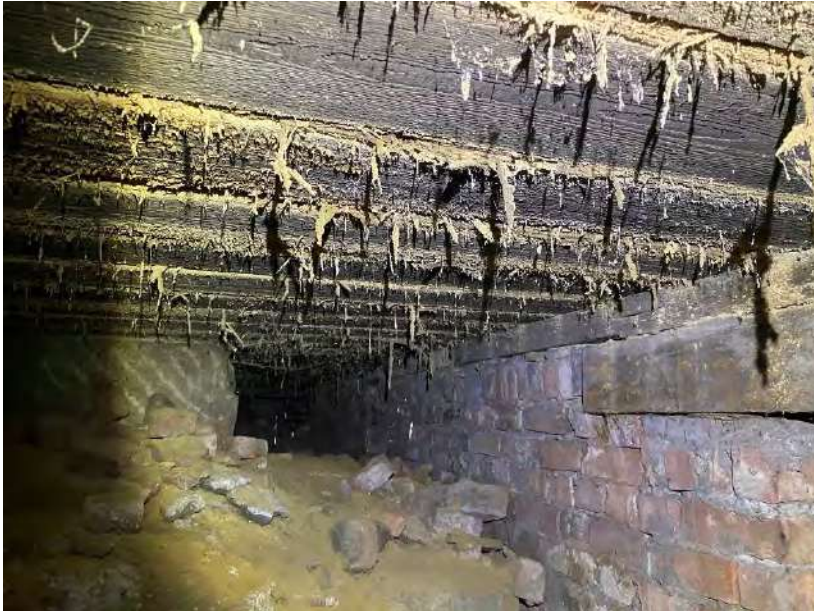
**Fig 3:**

Lower ground floor; showing widespread tunnelling to the underside of the floorboards caused by wood-boring weevil infestation

Note the frass which has collected within cobwebs and on the earth below

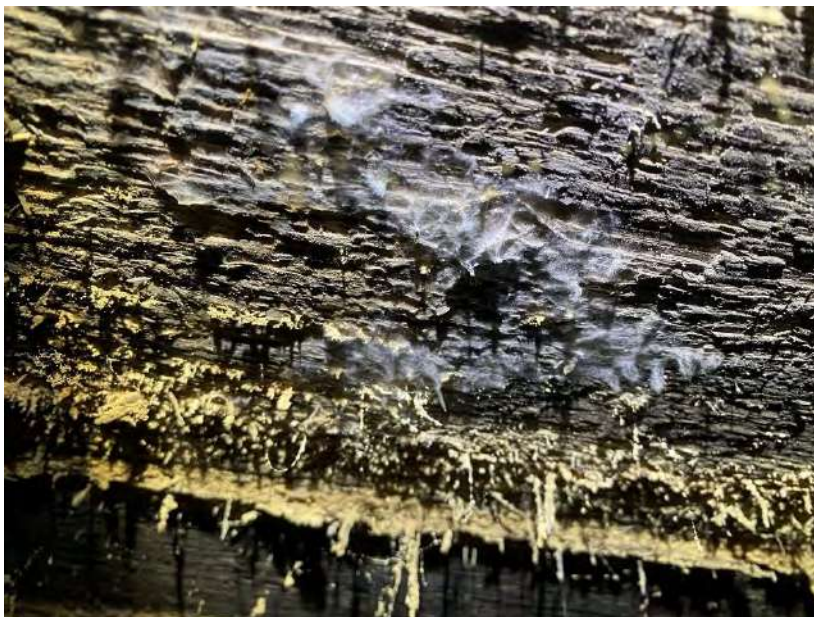
**Fig 4:**

Lower ground floor; showing a close-up of the wood-boring weevil tunnelling and fungus to the underside of a floorboard

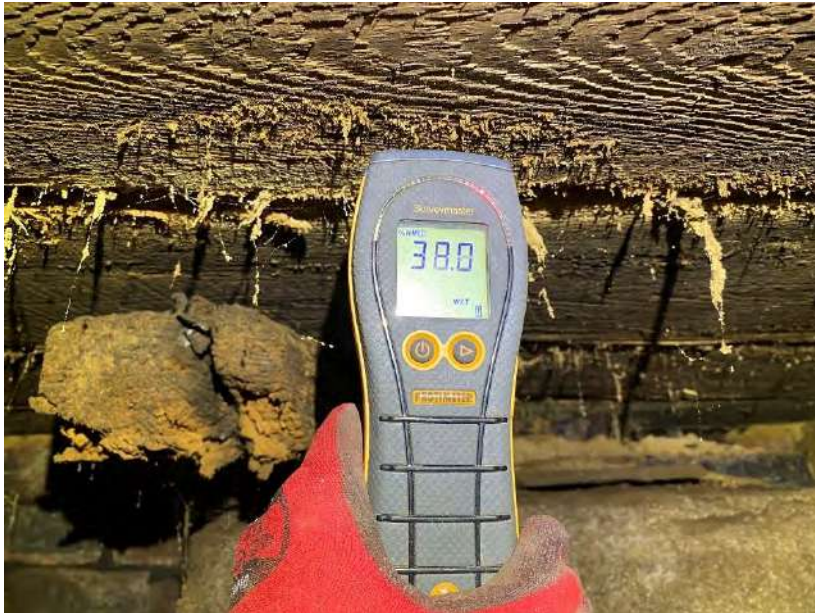
**Fig 5:**

Lower ground floor; showing a surface moisture content reading of 38 per cent in a floorboard. This can be attributed to inadequate natural ventilation and is high enough to sustain fungal growth and wood-boring weevil infestation

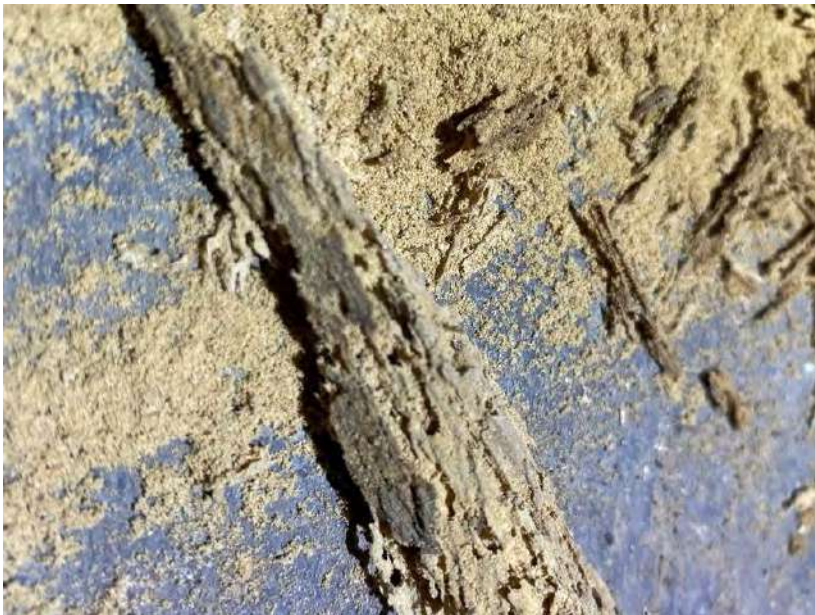
**Fig 6:**

Lower ground floor; showing a close-up of wood-boring weevil tunnelling and flight holes in a heavily decayed section of removed floorboard

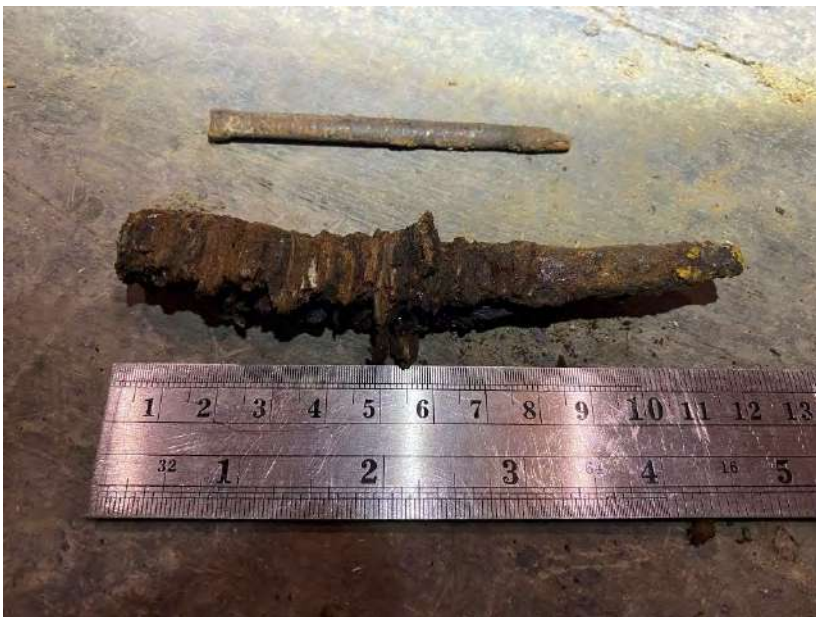
**Fig 8:**

Lower Ground Floor; showing a close up of a oval wire nail (above). The end of the nail was corroded and snapped off during extraction from the wall plate

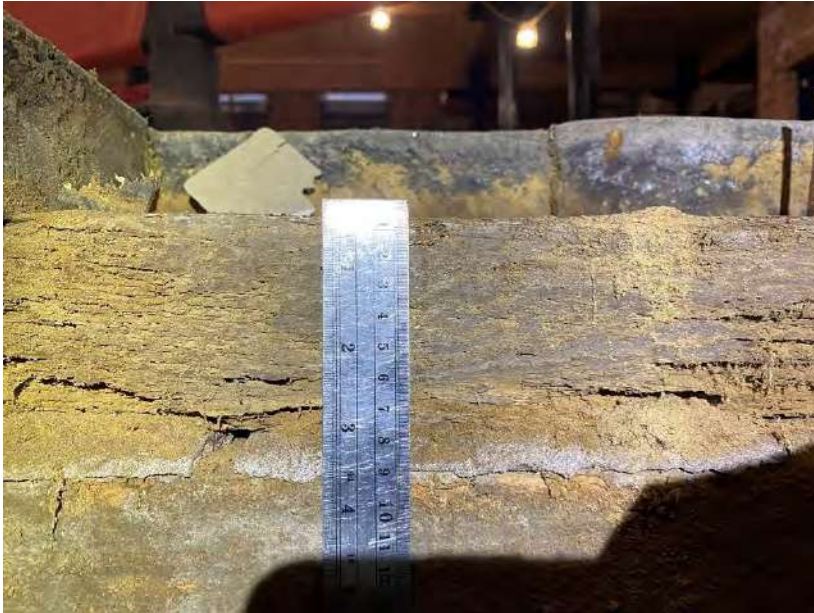
**Fig 9:**

Lower ground floor; showing a view of a heavily decayed wall plate from within the floor void. The wall plate was supported on a lime mortar bed above a brick sleeper wall

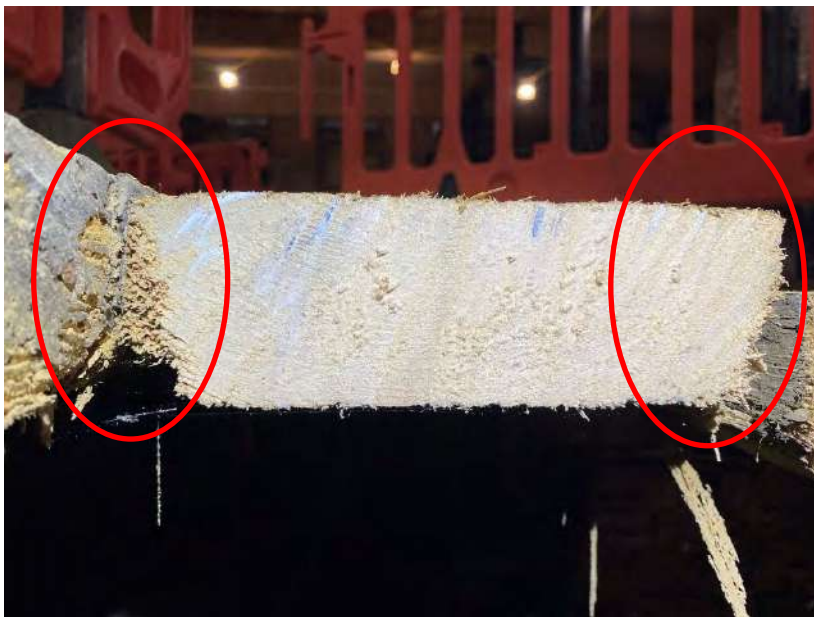
**Fig 10:**

Lower ground floor; showing a typical example of wood-boring weevil tunnelling concentrated in the sides of a floorboard

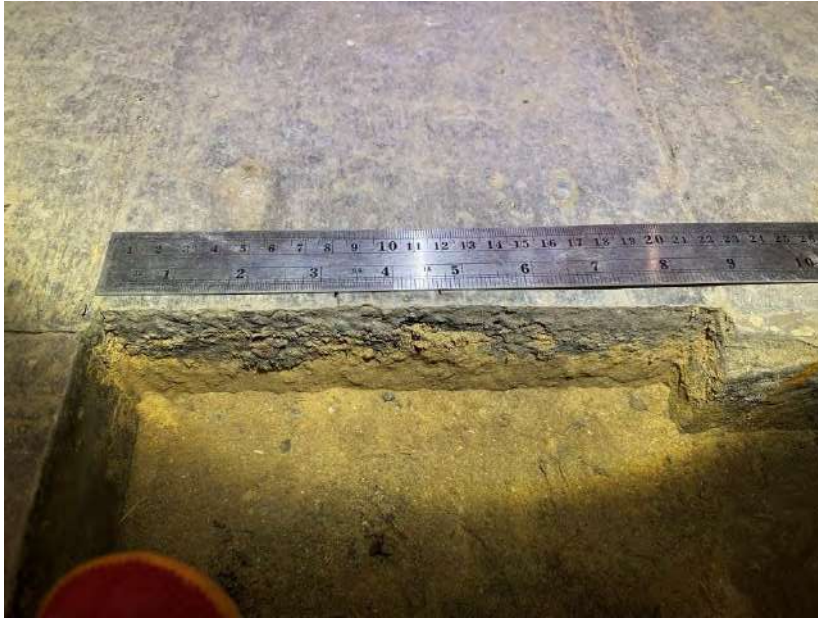
**Fig 11:**

Lower ground floor; showing the tight fitting square-edge floorboards that measured 220mm in width. The floorboards are tight due to their increased moisture content and swelling

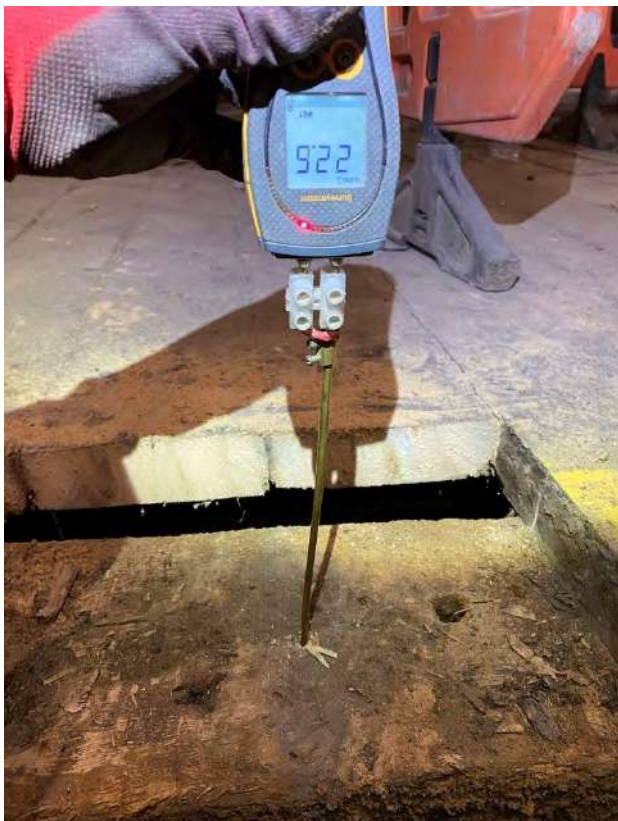
**Fig 14:**

Lower ground floor; showing a deep moisture content of 22.6 per cent w/w taken from the supporting wall plate. This is sufficient to support fungal growth and wood-boring weevil infestation

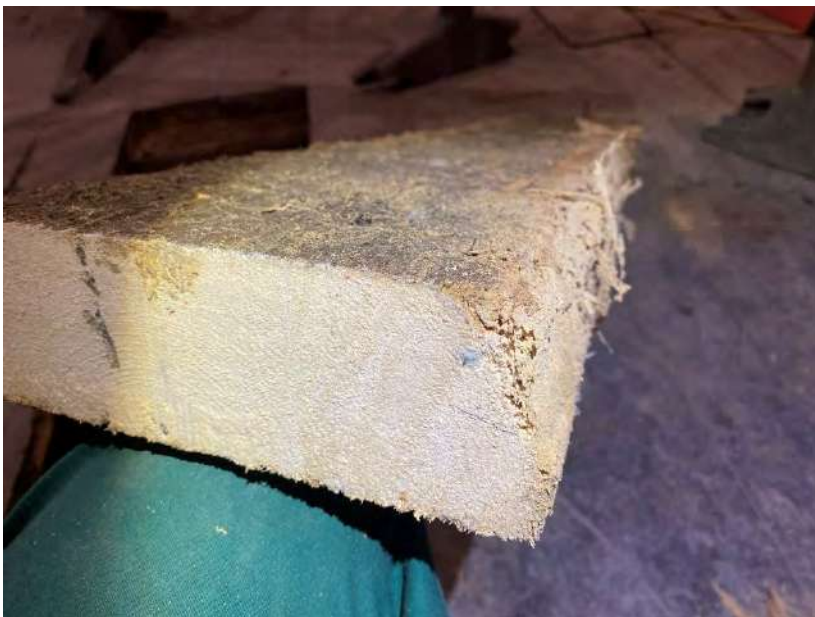
**Fig 16:**

Lower ground floor; showing a typical example of wood-boring weevil tunnelling concentrated in the sides and underside of a floorboard

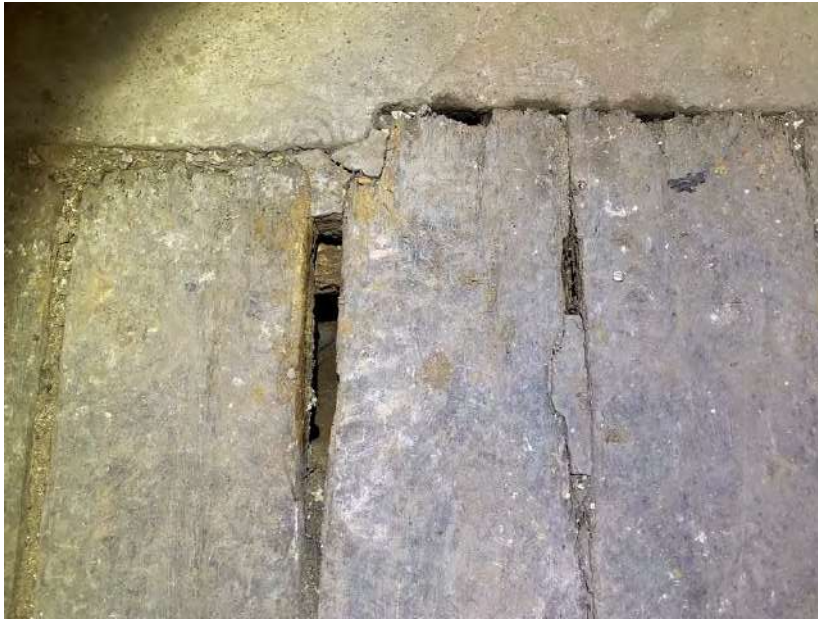
**Fig 19:**

Lower ground floor; showing the end of the floorboards where they abut an area of solid concrete floor. The decay was considerably worse in this location

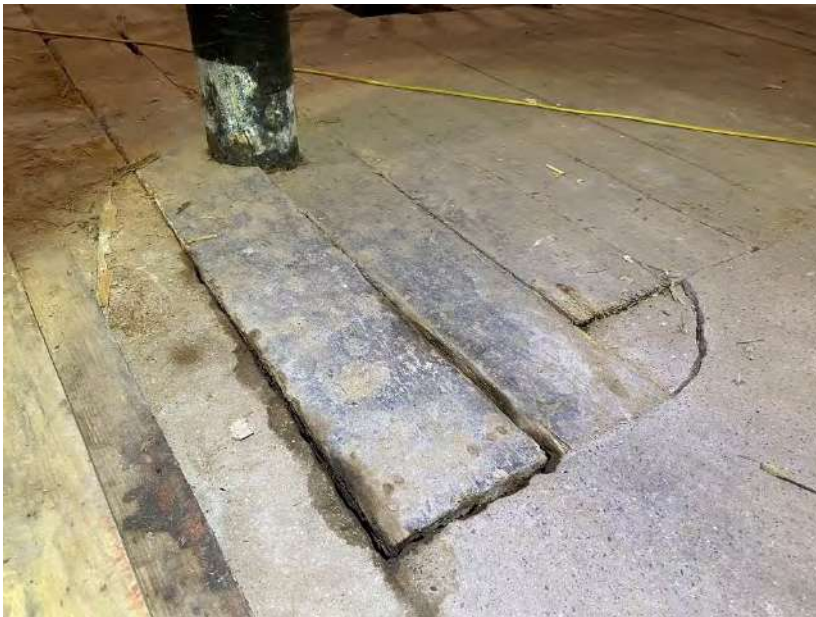
**Fig 20:**

Lower ground floor; showing the end of the floorboards where they abut an area of solid concrete floor. The decay was considerably worse in this location

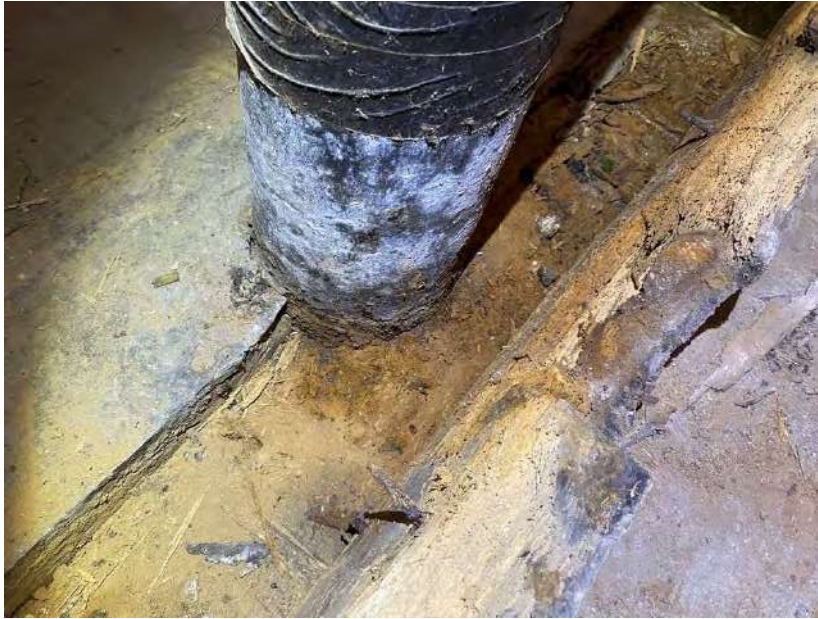
**Fig 21:**

Lower ground floor; showing the exposed floorboard. The underside of the floorboard was heavily decayed in this location

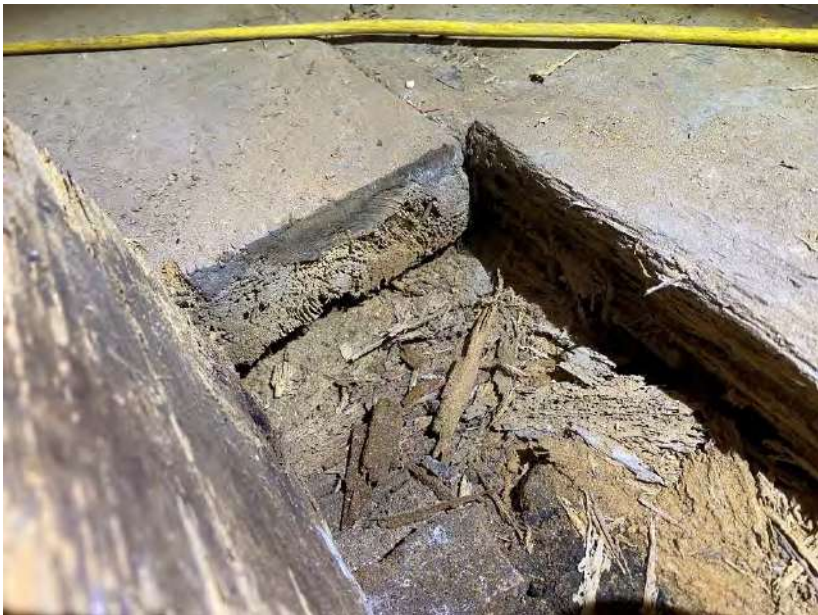
**Fig 22:**

Lower ground floor; showing extensive decay in the floorboards

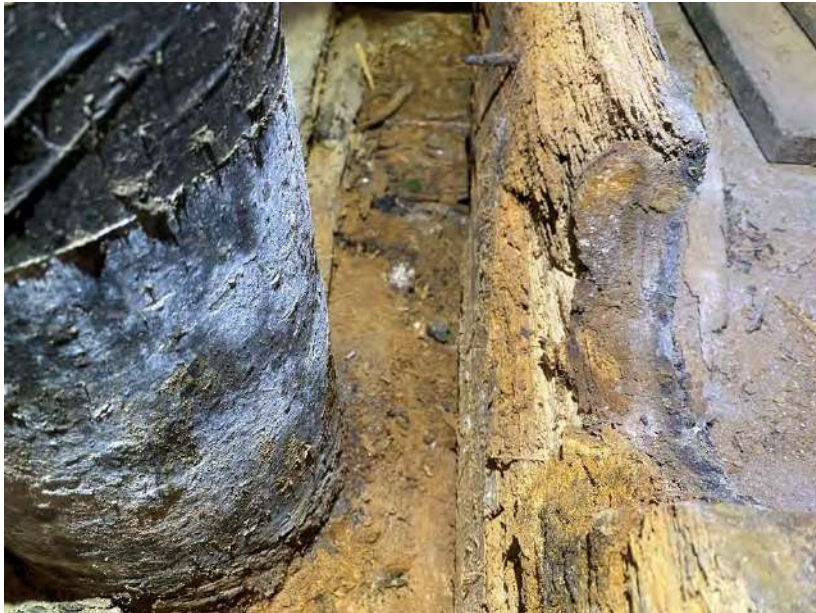
**Fig 23:**

Lower ground floor; showing extensive decay in the floorboards

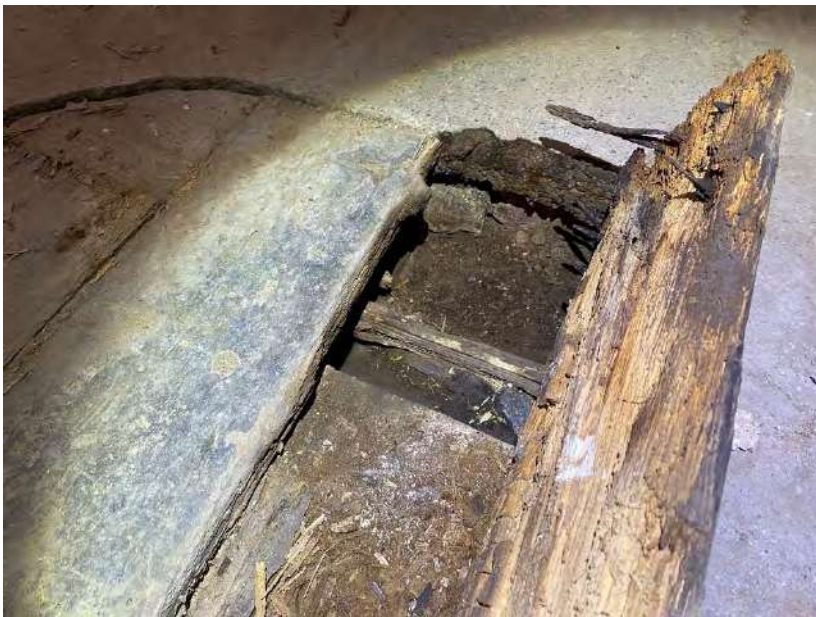
**Fig 24:**

Lower ground floor; showing heavy decay in the floorboards and significant corrosion in the nail fixings

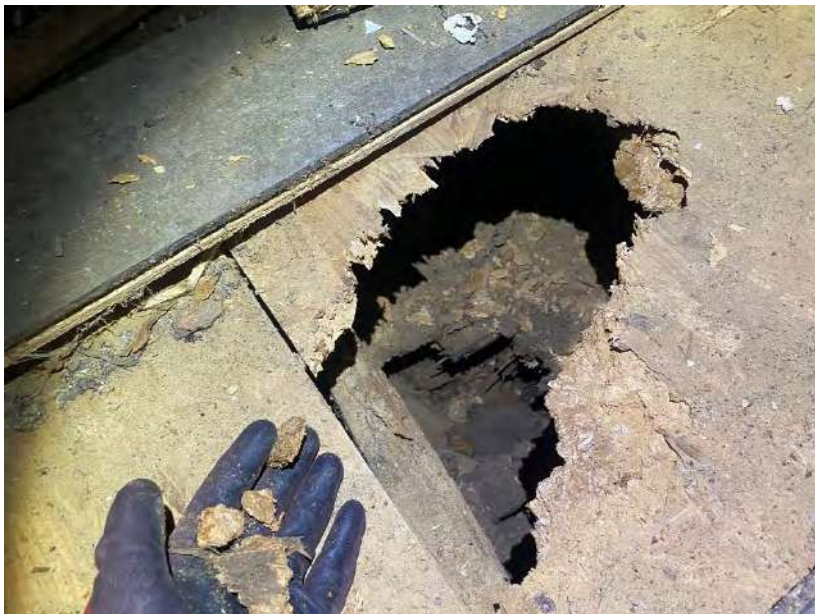
**Fig 44:**

Lower ground floor; showing a view through the OSB. There was evidence of an earlier timber floor beneath but timbers were heavily decayed

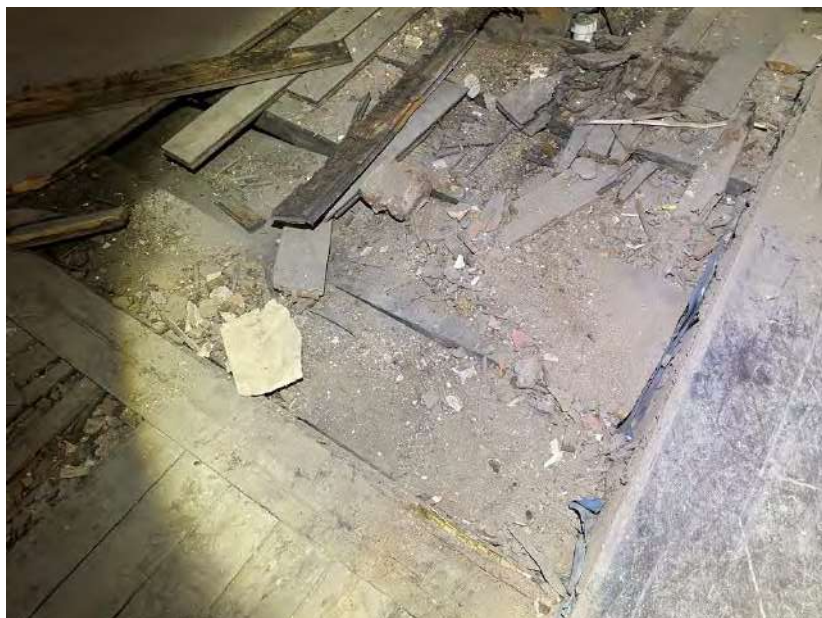
**Fig 3:**

Lower ground floor, Floor 1; showing an area of decay in the grooved softwood millboards and hardwood t&g floor covering. Decay was historical and appeared to be related to a former plumbing leak

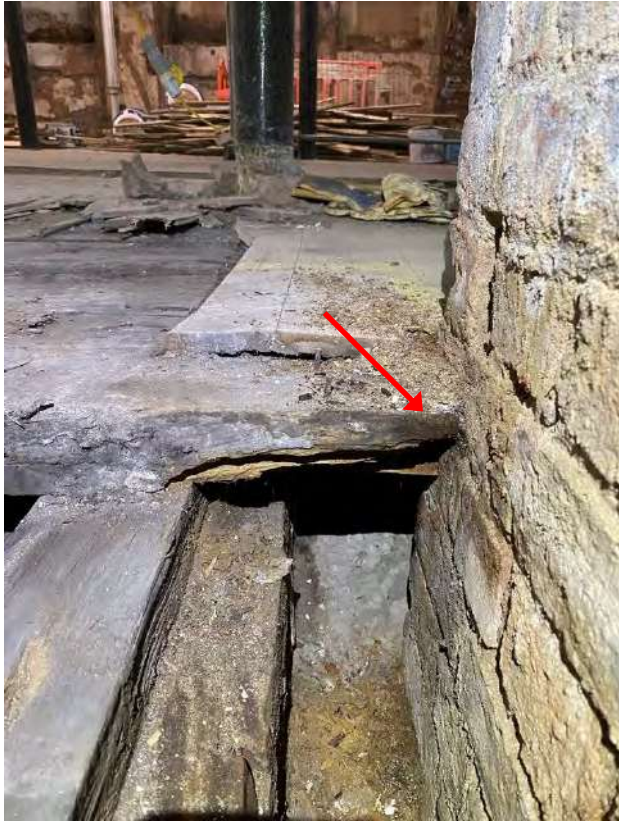
**Fig 9:**

Lower ground floor, Floor 2; showing decay in the ends of the millboards where they were abutting the central goods lift masonry wall

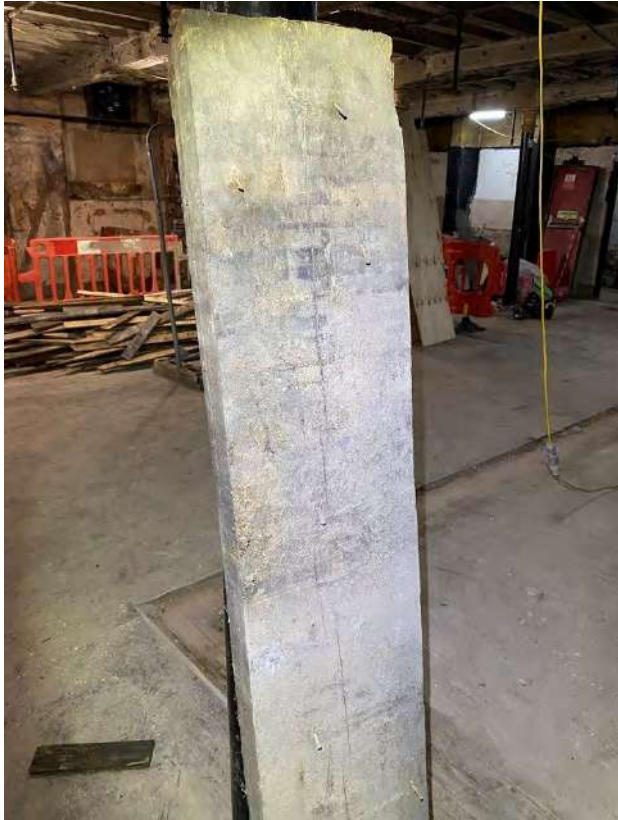
**Fig 13:**

Lower ground floor, Floor 2; showing a view of the underside of a millboard. There was no significant decay in this millboard

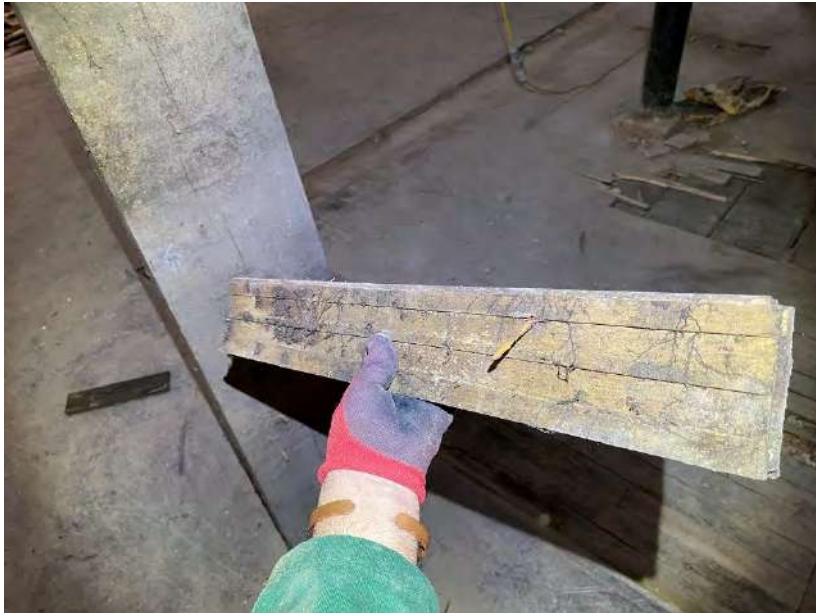
**Fig 15:**

Lower ground floor, Floor 2; showing the underside of a section of removed hardwood t&g flooring. There was wet rot mycelium growth over the timber but no decay was identified

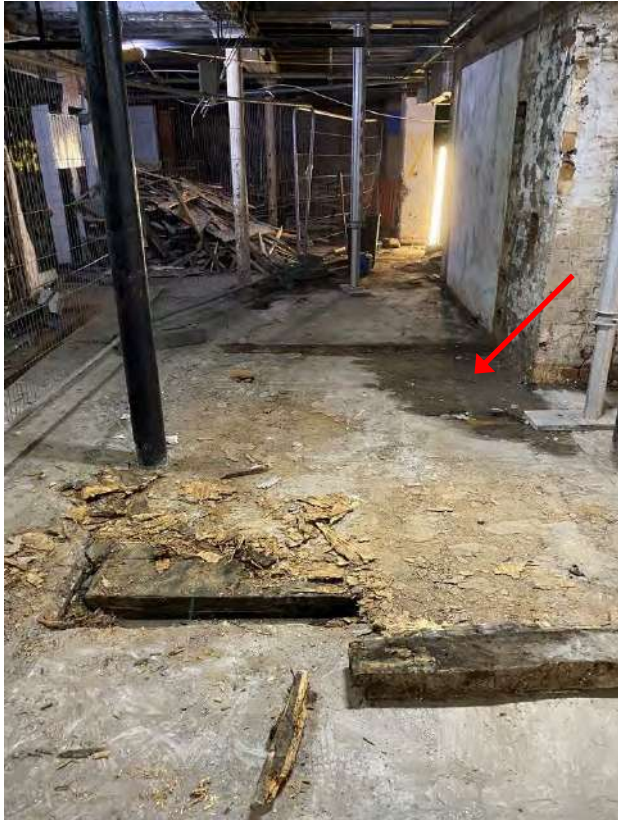
**Fig 17:**

Lower ground floor, Floor 3; showing area of ongoing water penetration via the central roof. Timbers were wet and decayed by wet rot fungus and active wood-boring weevil infestation

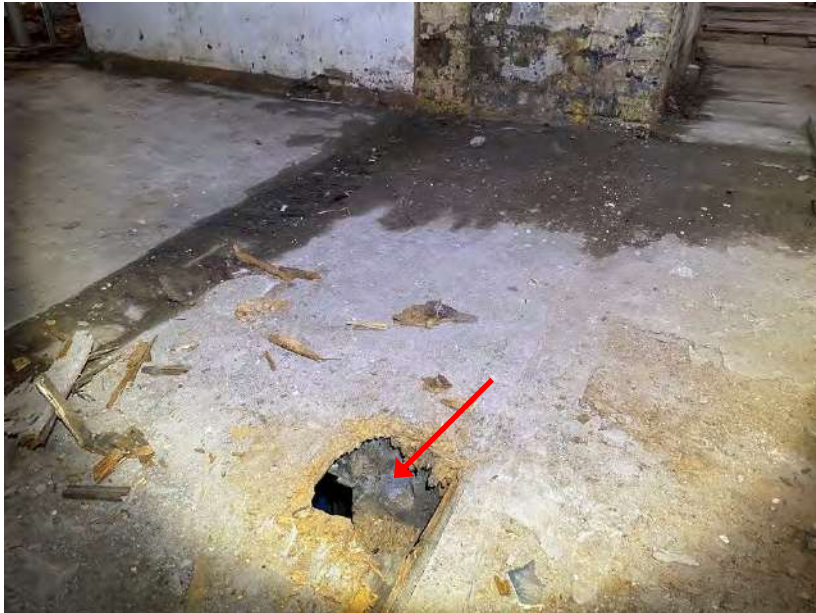
**Fig 23:**

Lower ground floor, Floor 4; showing a small opening made through the decayed OSB floor covering

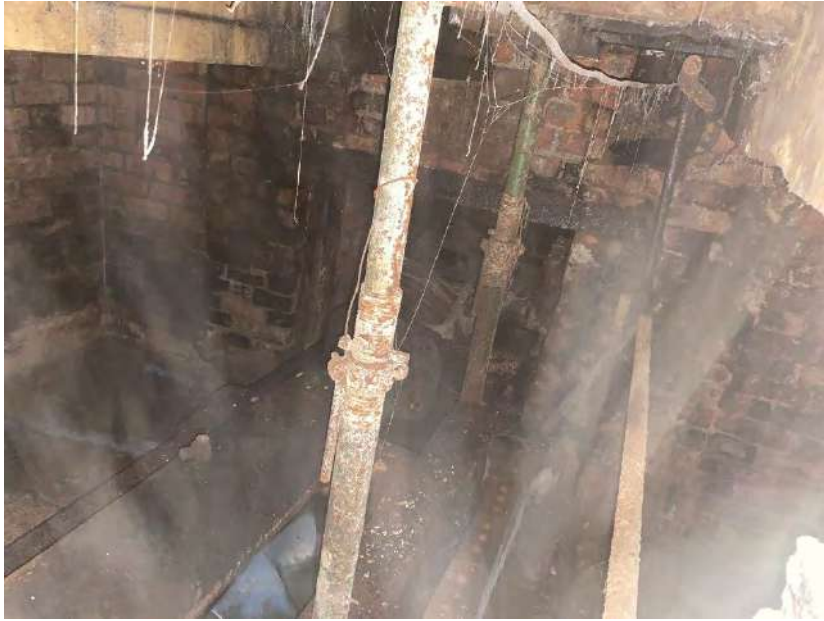
**Fig 25:**

Lower ground floor; showing a view inside the basement beneath Floor 4. Note the surface corrosion to the Acrow props

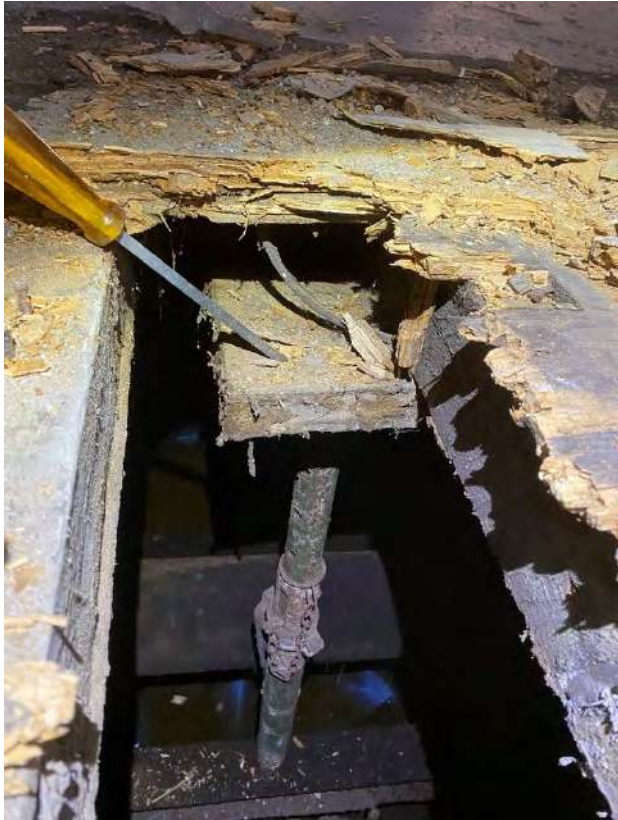
**Fig 27:**

Lower ground floor, Floor 4; showing significant decay in the timber wedging placed beneath the floor joists
