Arboricultural  
Impact Assessment  
with  
Tree Protection Measures

**The Greenfinch  
140 Palatine Road  
Didsbury**

Project No. AIA.13448.01

28<sup>th</sup> March 2022

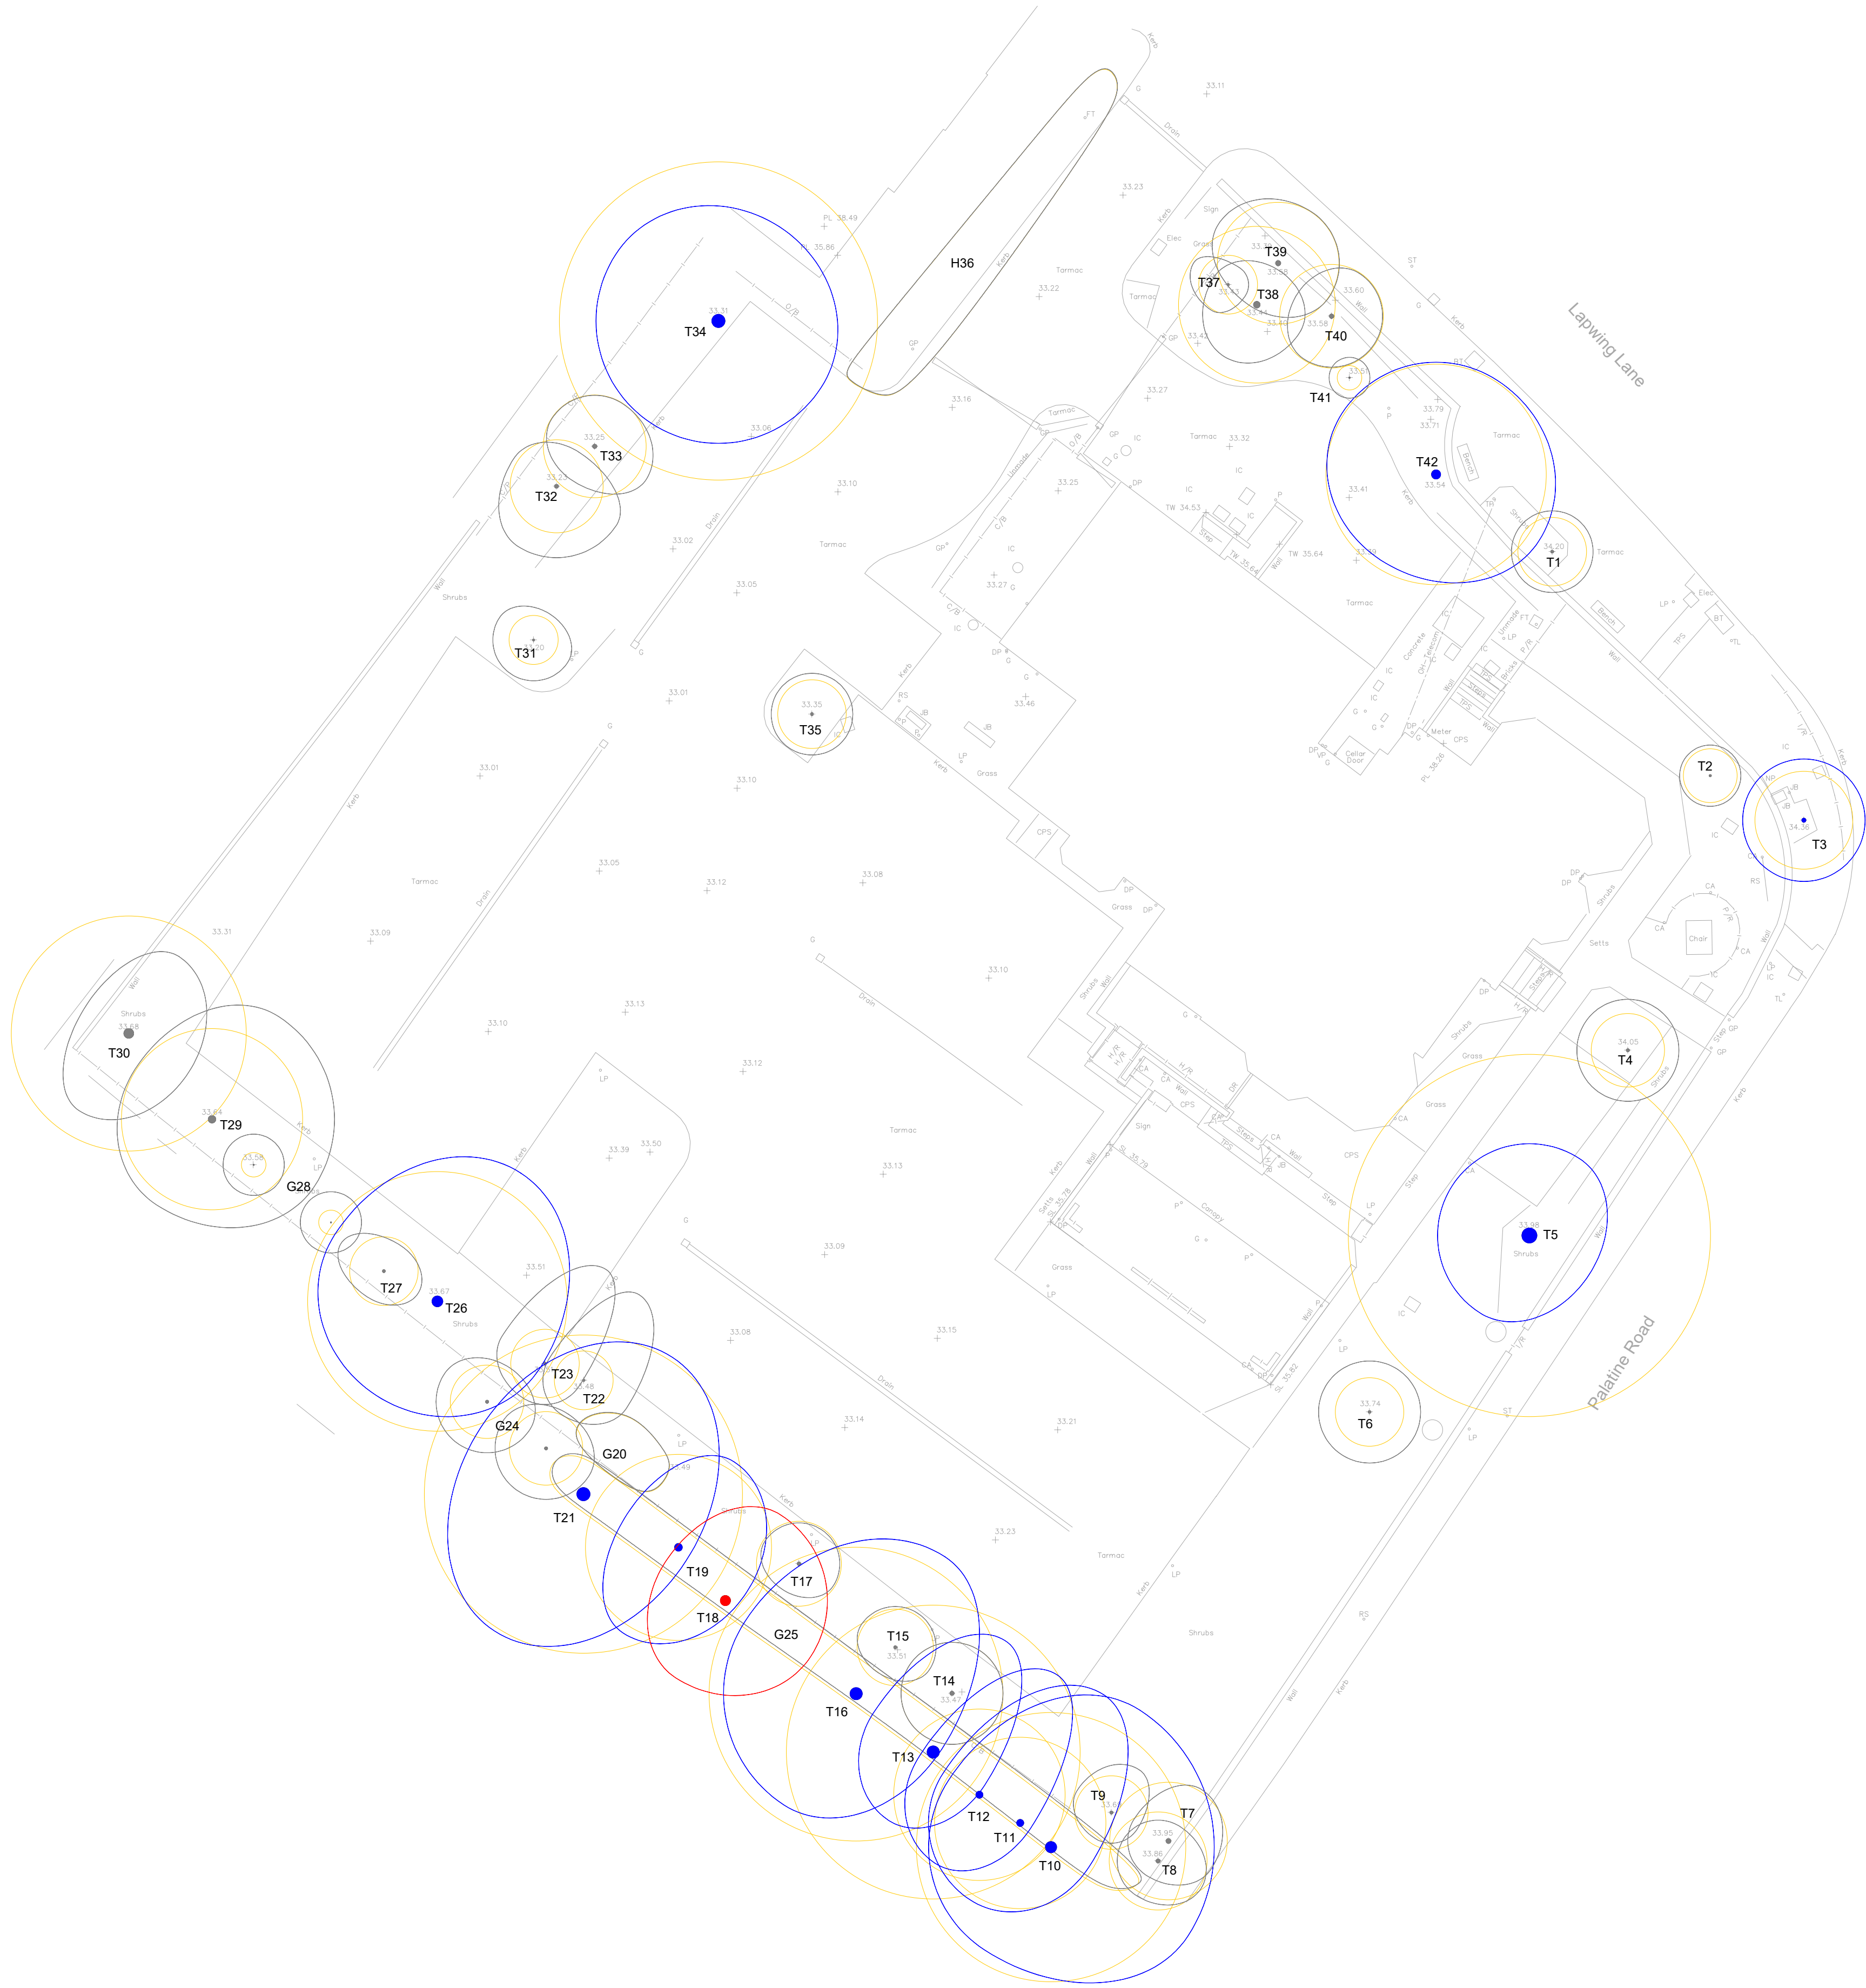
## Drawing 1. Tree Constraints Plan

The trees were generally found to be in a good to fair condition, however, one individual tree (**T18**) was classified as retention category 'U' (unsuitable for retention). This tree is located on adjacent land.

The proposed development directly impacts upon one individual tree and one section of hedge, both are considered to be low quality ('C' category) specimens. The tree and hedge shall require removal due to their close proximity to construction activity.

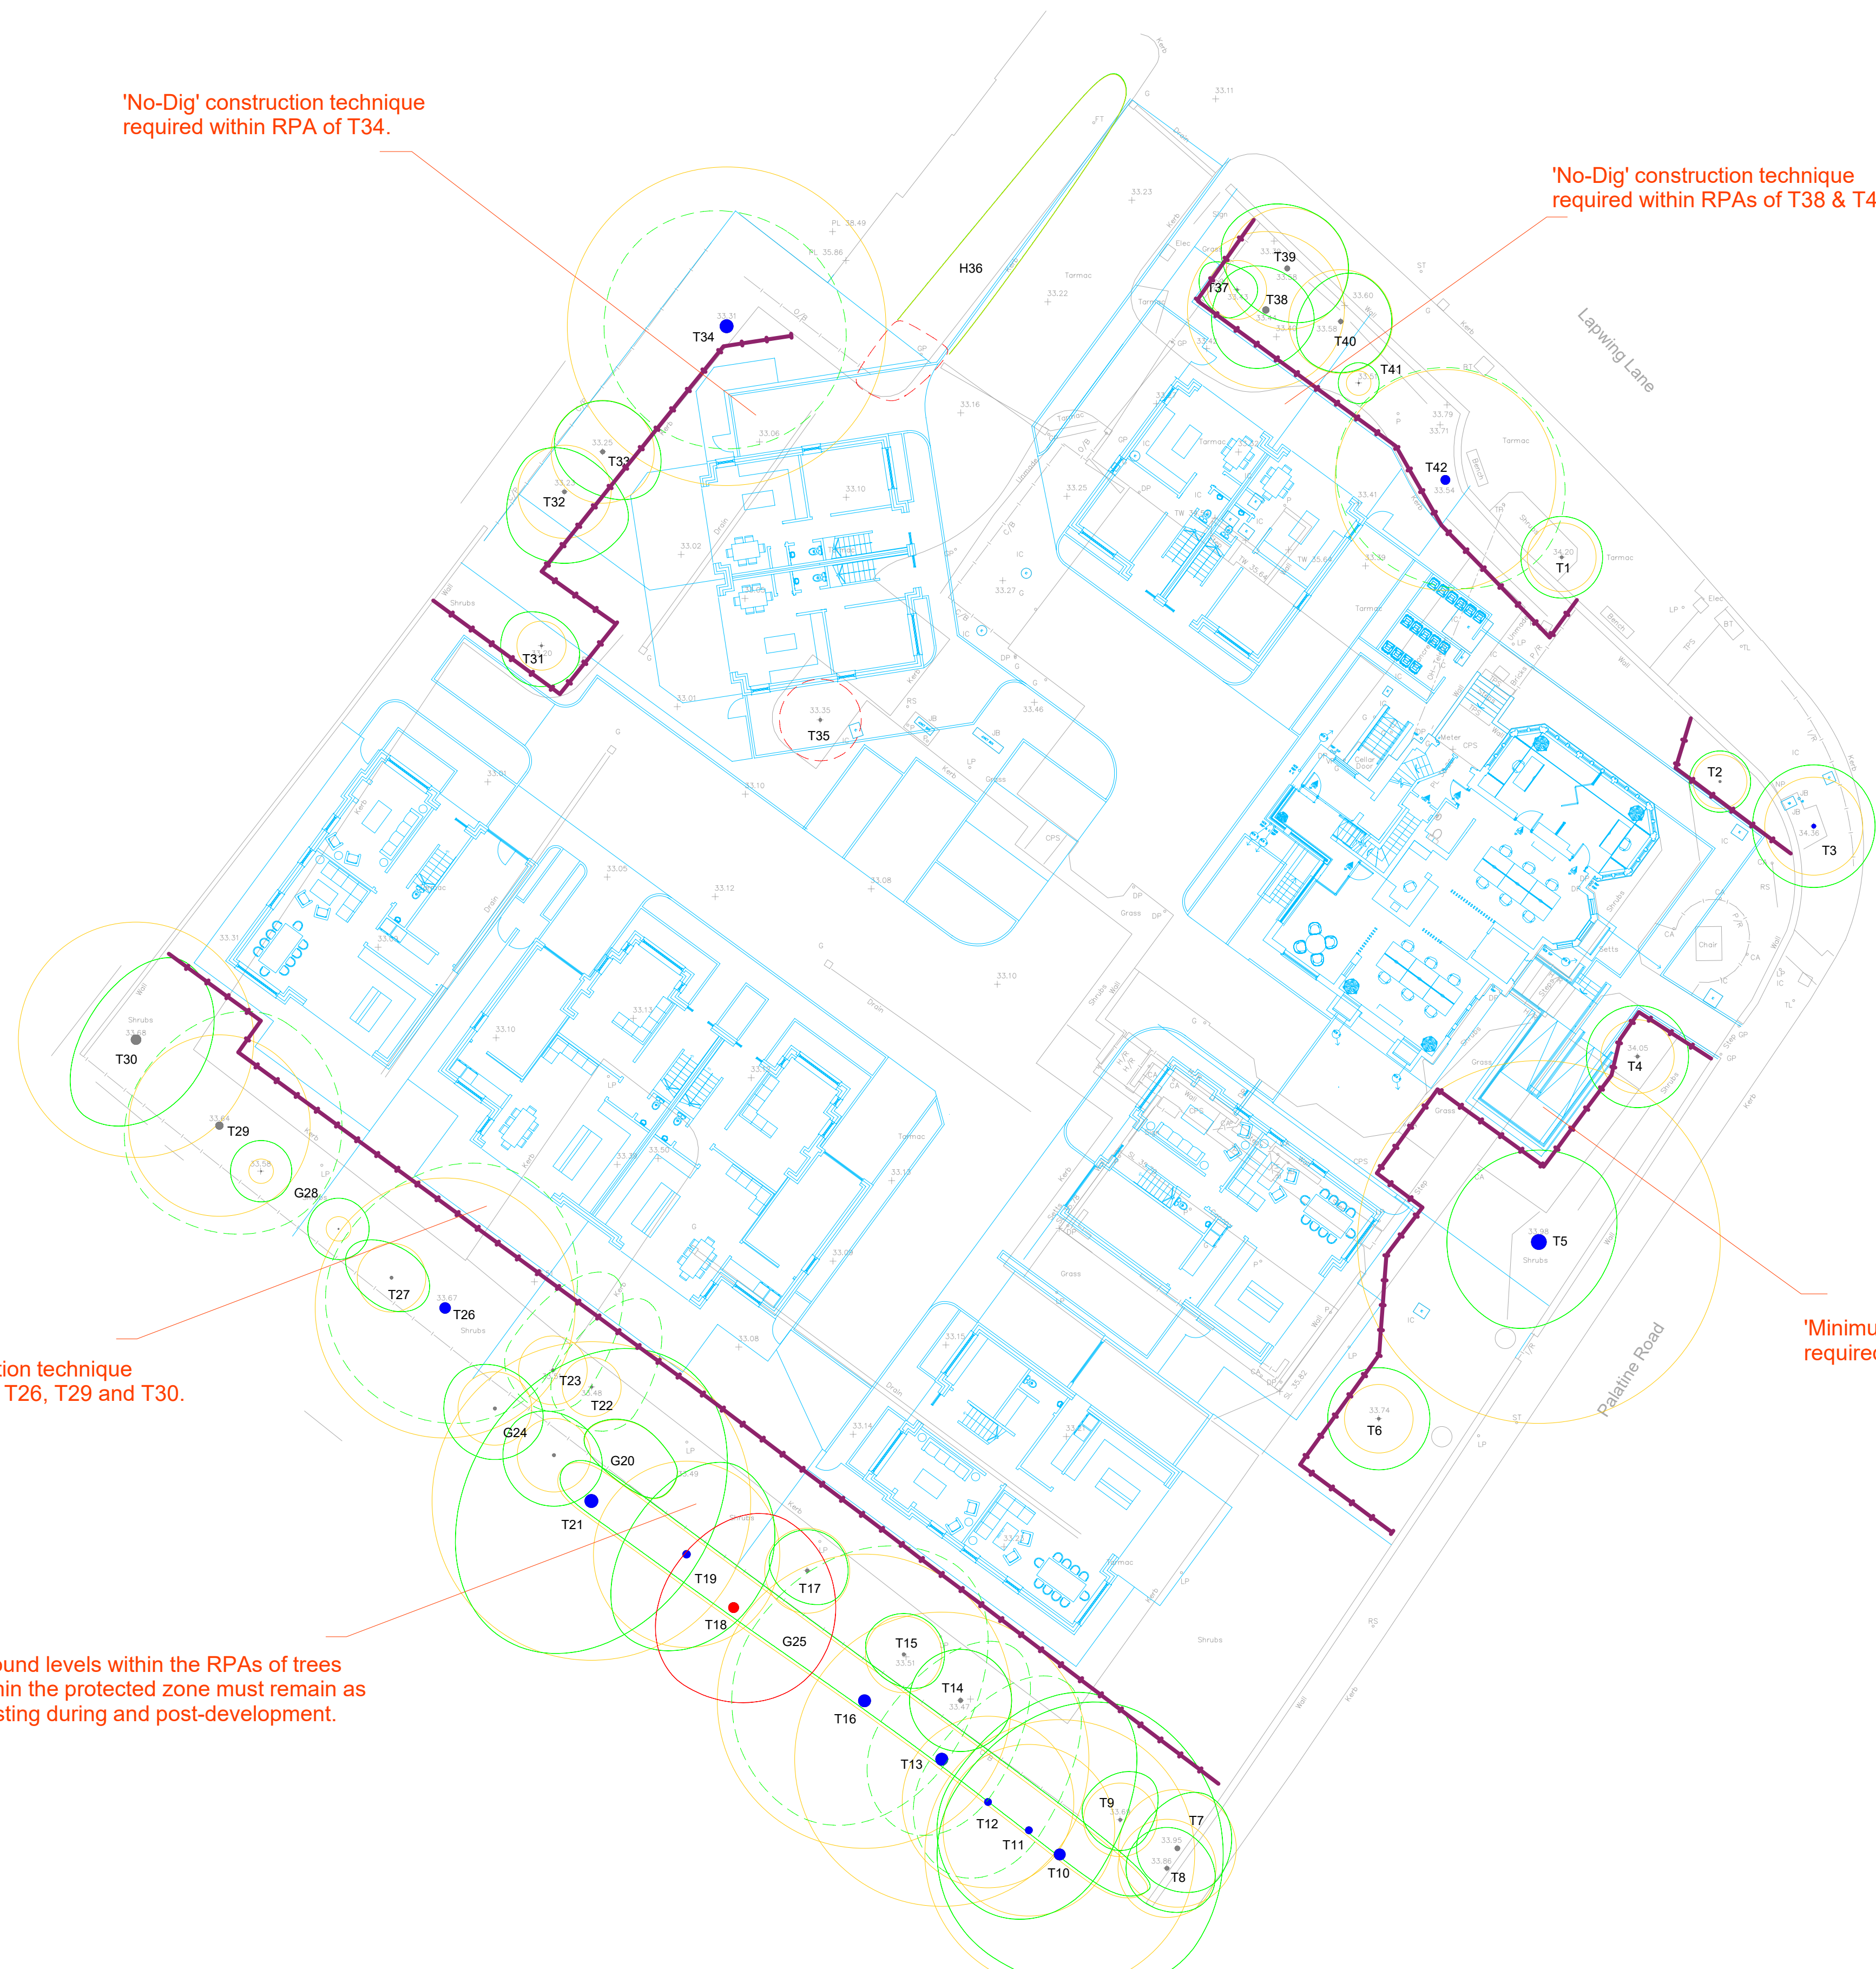
## Drawing 2. Tree Protection Plan

- 3.5.1. Sections of RPA from several trees (**T5**, **T26**, **T29** and **T30**) extend beyond the temporary barrier and into areas proposed for hard surface paving/patio areas (or an access ramp for **T5**). Given the minor potential area of RPA disturbance (less than 9% of total RPA for each tree), the proposed hard surfaces are not expected to cause any long-term harm to adjacent trees. Also, it should be noted that tarmac hard surfaces are currently in place above these RPAs. However, as a precautionary measure, it is recommended that the proposed hard surfaces are constructed using a *Minimum-Dig* technique that is sympathetic to tree roots.

- 3.5.2. In addition, sections of RPA from trees **T34**, **T38** and **T42** also extend beyond the temporary barrier and into areas proposed for hard surface parking/paving areas. Given the potential area of RPA disturbance (10% to 18% of total RPAs), it is recommended that these hard surfaces are constructed using techniques sympathetic to tree roots (a *No-Dig* Cellular Confinement System). It should be noted that these sections of RPA are also currently located beneath existing tarmac hard surfaces, and that the removal of this base and its replacement with a porous surfaced Cellular Confinement System would not cause any harm to the adjacent trees.

- 4.2.3. Please see *Appendix 4* for suggested barrier construction detail. It is recommended that in this instance the protective barrier shown in *Figure 1* would be appropriate. The suggested location for protective fencing is shown on the *Tree Protection Plan (Drawing 2)*.

- 4.6.1. It is recommended that the proposed paving/patio areas within the RPAs of **T5**, **T26**, **T29** and **T30** are constructed in a manner that would not cause the adjacent trees any long-term harm. In this instance, it is recommended that a 'Minimum-Dig' method is used.
- 4.6.2. Excavations within the RPA *must only* be undertaken by hand to establish the presence of roots. Any tree roots exposed within the RPA must be left as intact as careful digging with hand tools will allow, avoiding the use of heavy machinery within the RPA.
- 4.6.3. No more than 100mm of soil should be removed before the ground is inspected for roots. Depending on the presence of roots it may then be acceptable to remove a further 50mm of soil down to the required depth.

- 4.7.1. It is recommended that the proposed parking/paving areas within the RPAs of trees **T34**, **T38** and **T42** are constructed in a manner that would not cause the trees any long-term harm. In this instance, it is recommended that a 'No-Dig' technique incorporating a Cellular Confinement System is used to prevent damage to the underlying RPA.
- 4.7.2. Please see *Appendix 6* for examples of ways to install the access track on top of existing ground levels. The three examples show different methods for installing non-intrusive kerb edgings to retain the Cellular Confinement System. The product shown is Cellweb, which is designed by Geosynthetics.
