Arboricultural Impact Assessment and Method Statement

Tesco Parrs Wood, Didsbury

Reference: 80-541-R2-4

Date: January 2022

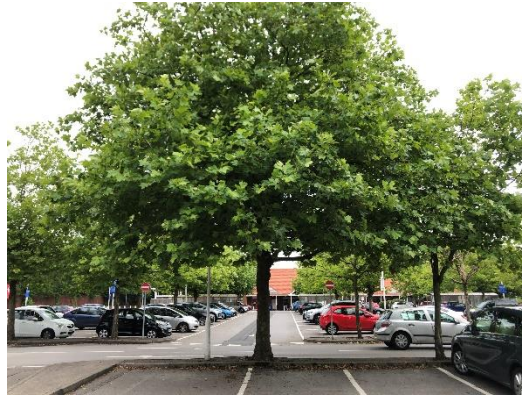
PLATE 1      T1

| TREE NO. | SPECIES | HEIGHT (M) | DBH (MM) | CROWN SPREAD | | | | HEIGHT OF C.C | AGE | COMMENTS | ERC | CATEGORY | RPA (M²) | RPA RADIUS (M) |
|---|---|---|---|---|---|---|---|---|---|---|---|---|---|---|
| T1 | London plane<br>( <i>Platanus x hispanica</i> ) | 7 | 350 | 4 | 4 | 4 | 4 | 2 | SM | Roots lifting paving blocks and tarmac on car park.<br>Crown obscuring street light. | 20+ | B1 | 55 | 4.2 |

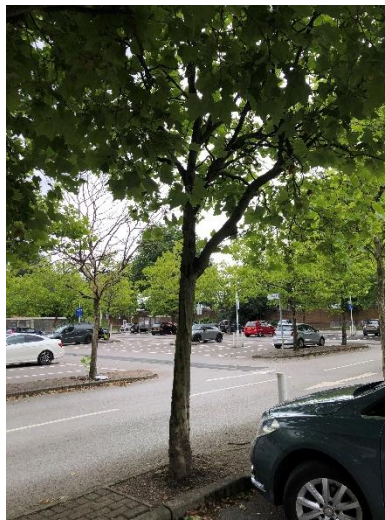
PLATE 2      T2

| TREE NO. | SPECIES | HEIGHT (M) | DBH (MM) | CROWN SPREAD | | | | HEIGHT OF C.C | AGE | COMMENTS | ERC | CATEGORY | RPA (M²) | RPA RADIUS (M) |
|---|---|---|---|---|---|---|---|---|---|---|---|---|---|---|
| T2 | London plane<br>( <i>Platanus x hispanica</i> ) | 5 | 160 | 3 | 3 | 3 | 1 | 2 | Y | Crown suppressed on west side by adjacent tree. | 10+ | C1 | 12 | 1.92 |

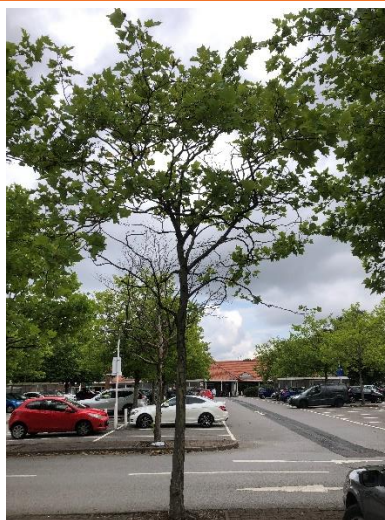
PLATE 3      T3

| TREE NO. | SPECIES | HEIGHT (M) | DBH (MM) | CROWN SPREAD | | | | HEIGHT OF C.C | AGE | COMMENTS | ERC | CATEGORY | RPA (M²) | RPA RADIUS (M) |
|---|---|---|---|---|---|---|---|---|---|---|---|---|---|---|
| T3 | London plane<br>( <i>Platanus x hispanica</i> ) | 5 | 130 | 3 | 2 | 3 | 2 | 2 | Y | Sparse crown with dead twigs. | 10+ | C1 | 8 | 1.56 |

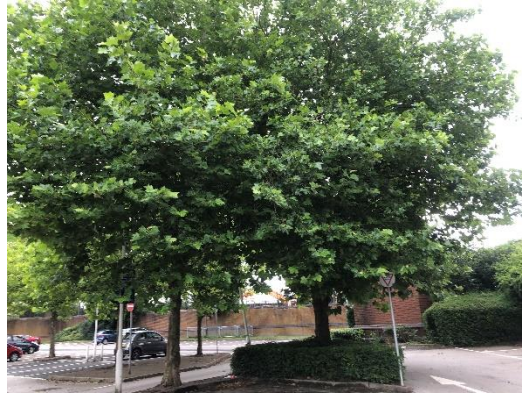
PLATE 4      T7 & T8

| TREE NO. | SPECIES | HEIGHT (M) | DBH (MM) | CROWN SPREAD | | | | HEIGHT OF C.C | AGE | COMMENTS | ERC | CATEGORY | RPA (M²) | RPA RADIUS (M) |
|---|---|---|---|---|---|---|---|---|---|---|---|---|---|---|
| T7 | London plane<br>( <i>Platanus x hispanica</i> ) | 8 | 310 | 4 | 3 | 4 | 4 | 2 | SM | No signs of ill health or significant structural defects. | 20+ | B1 | 43 | 3.72 |
| T8 | London plane<br>( <i>Platanus x hispanica</i> ) | 8 | 450 | 4 | 4 | 4 | 4 | 2 | EM | Located in shrub bed. dense undergrowth preventing full visual inspection. lapsed pollard at approximately 3m. | 20+ | B1 | 92 | 5.4 |

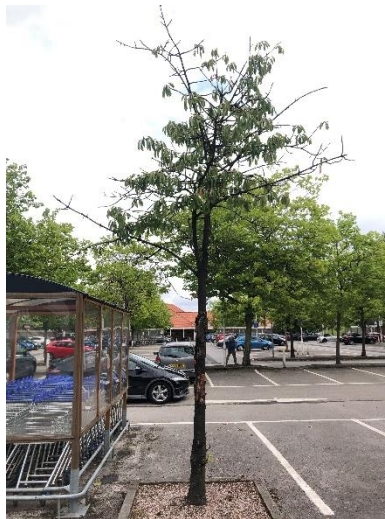
PLATE 5      T10

| TREE NO. | SPECIES | HEIGHT (M) | DBH (MM) | CROWN SPREAD | | | | HEIGHT OF C.C | AGE | COMMENTS | ERC | CATEGORY | RPA (M²) | RPA RADIUS (M) |
|---|---|---|---|---|---|---|---|---|---|---|---|---|---|---|
| T10 | Cherry sp.( <i>Prunus</i> sp.) | 4 | 110 | 2 | 2 | 2 | 2 | 2 | Y | Approximately 40% crown dieback. | <10 | U | 5 | 1.32 |
