| CEILING PLAN-STRIP OUT | | | |
| DRAWING NO. | | | 2101-25 |

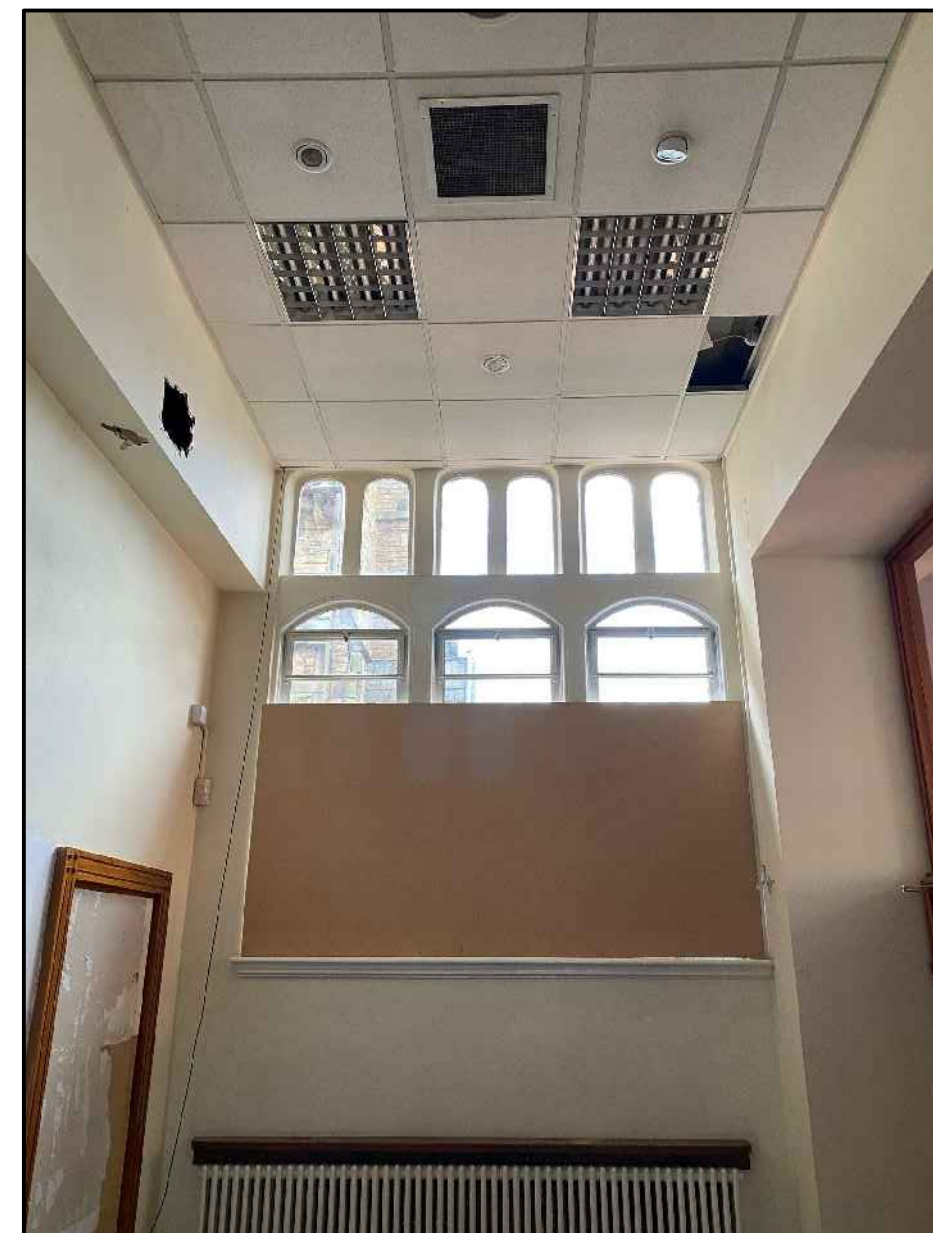
MAIN ENTRANCE

EXISTING PLASTERBOARD CEILING  
REPAIRED MAJOR GYOOD INCLUDING  
ALL MOULDINGS

EXISTING BEAM  
ENCASED IN PLASTERBOARD  
AND SKIM WITH NEW CHUNCE  
EITHER SIDE

VOID OVER EXISTING CEILING  
HOUSING EXISTING VENTILATION

EXISTING WALL LINE CUT BACK FROM STEEL BEAM

NEW PLASTERBOARD  
AND SKIM INFL TO FORM  
SECULAR ROOM
