Arboricultural  
Impact Assessment  
with  
Tree Protection Measures

**The Greenfinch  
140 Palatine Road  
Didsbury**

Project No. AIA.13398.01

25<sup>th</sup> November 2021

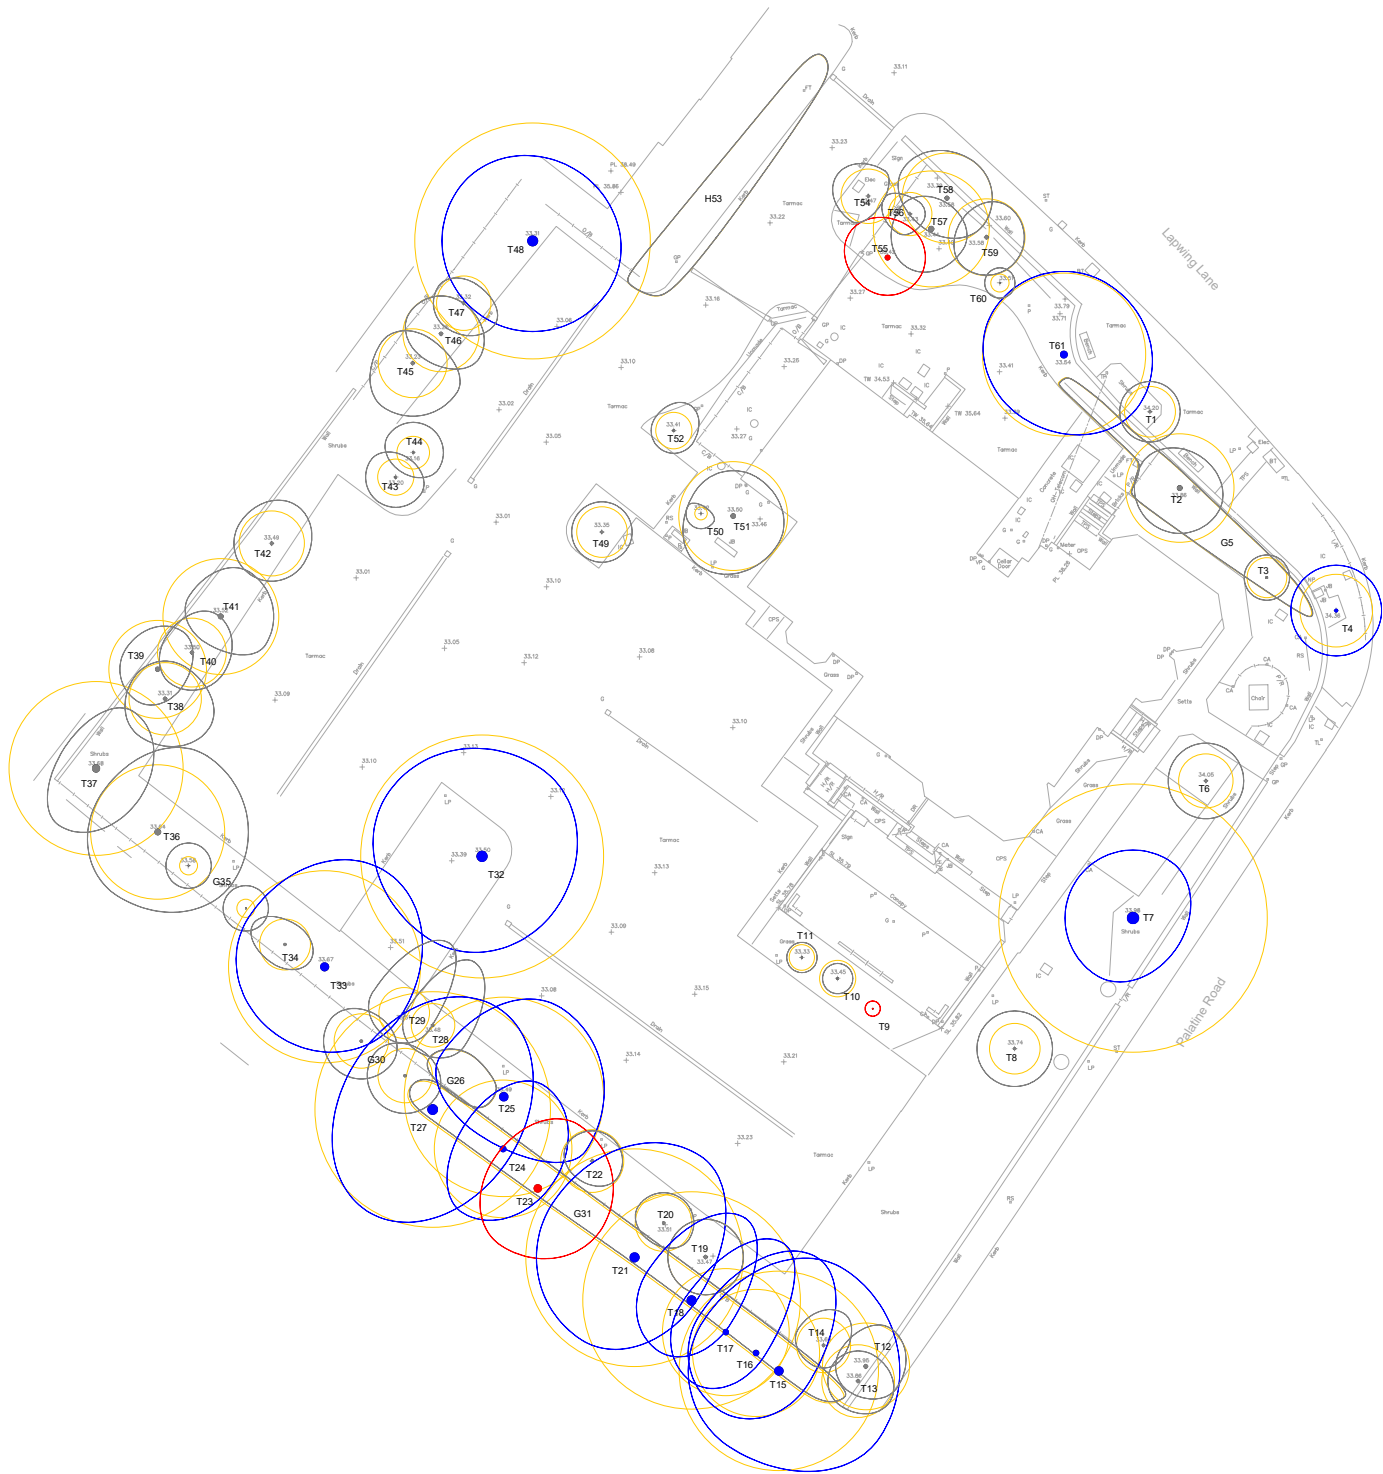
## Drawing 1. Tree Constraints Plan

The trees were generally found to be in a good to fair condition, however, three individual trees (**T9**, **T23** and **T55**) were classified as retention category 'U' (unsuitable for retention).

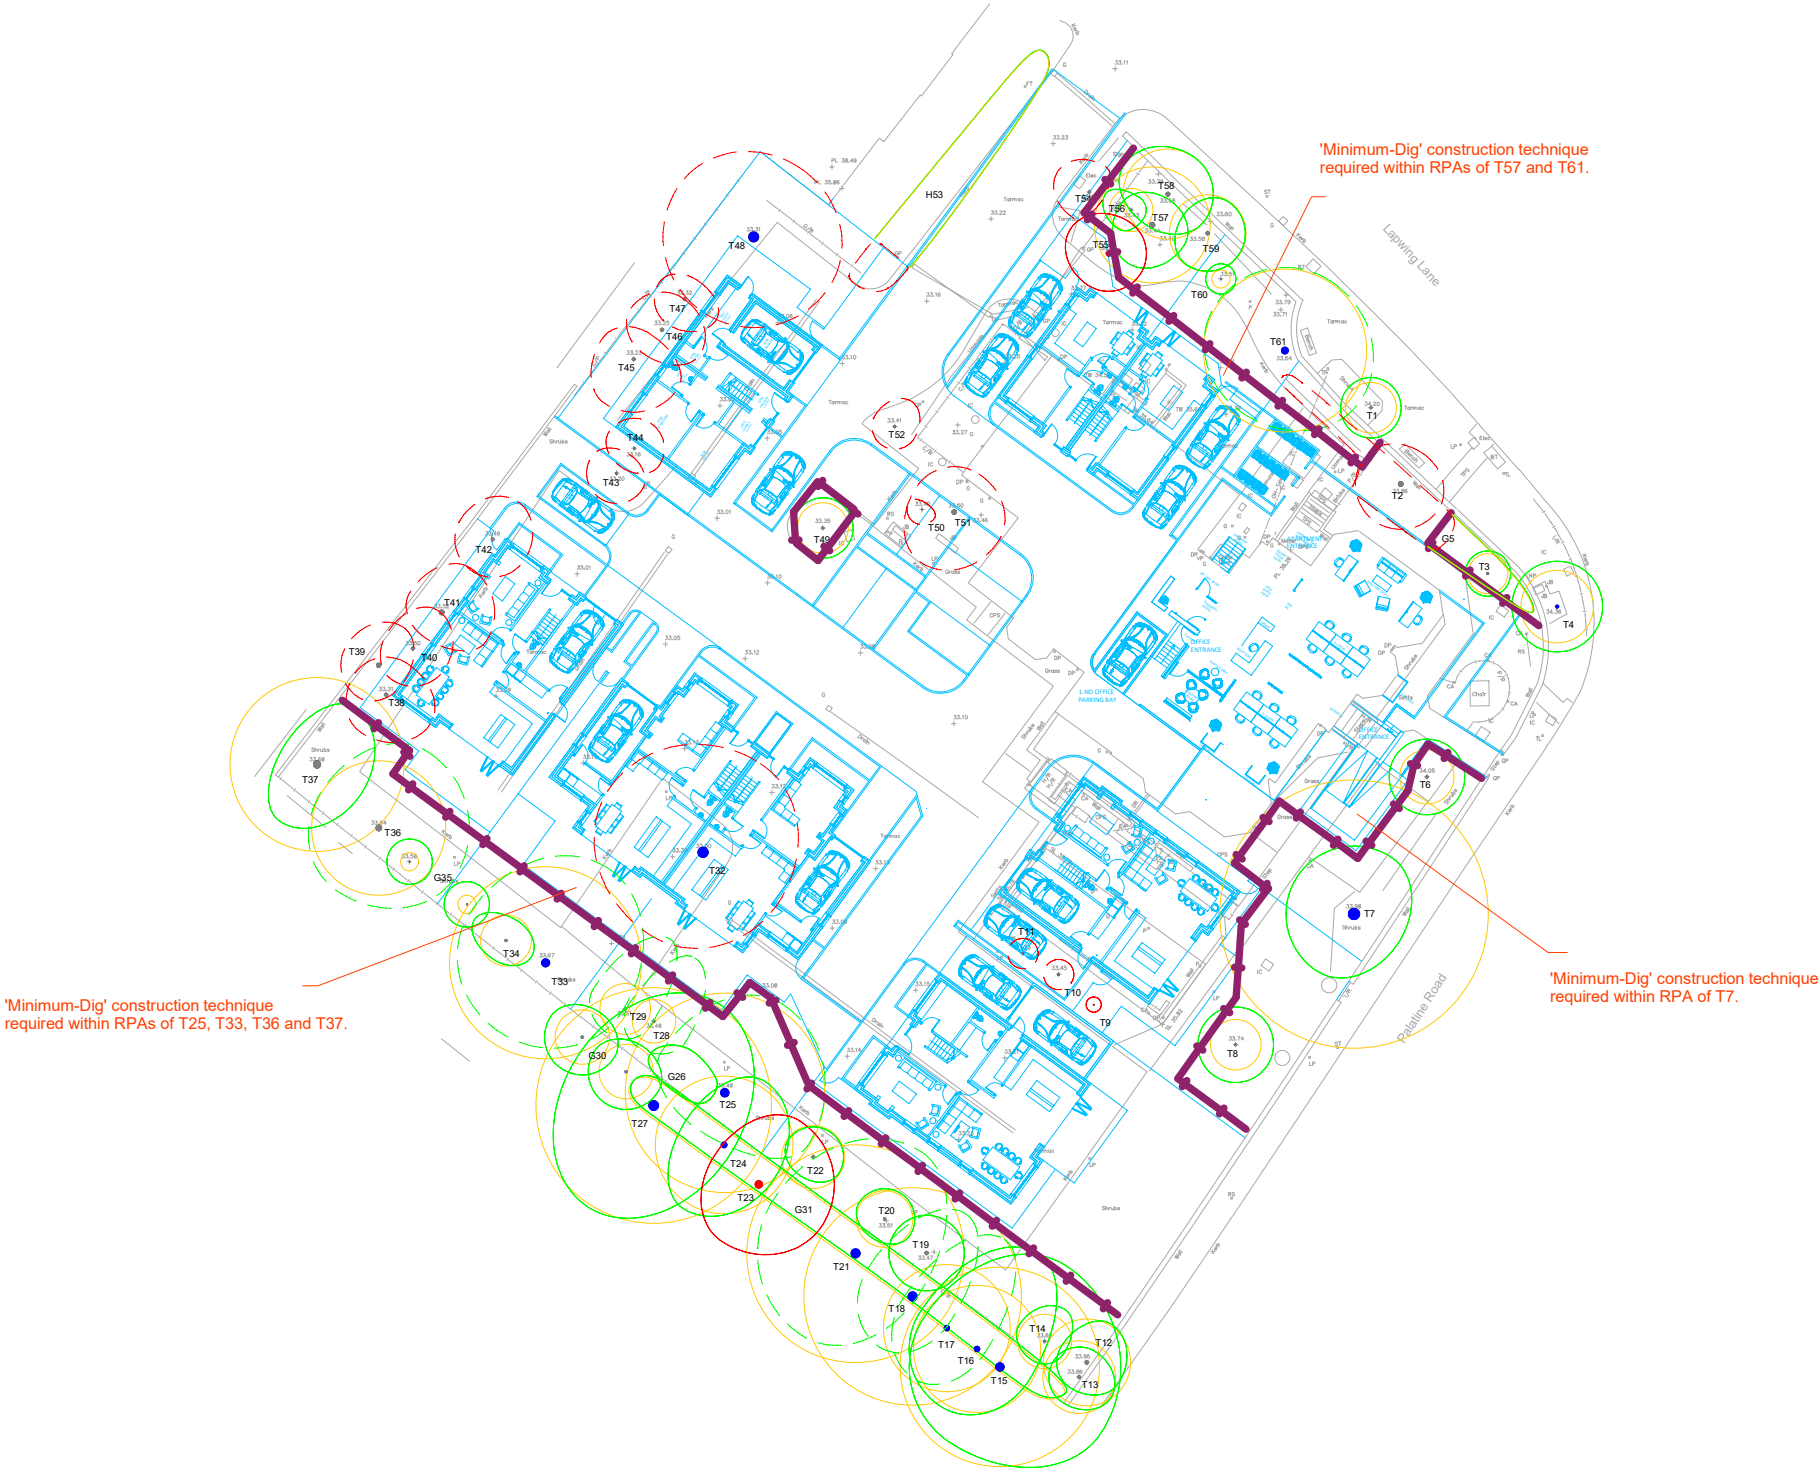
## Drawing 2. Tree Protection Plan

| | T17, T18, T21, T25, T28, T29, T33, T36 & T61 |

- 3.2.4. The formative pruning of several trees **T17**, **T18**, **T21**, **T25**, **T28**, **T29**, **T33**, **T36** and **T61** is recommended to ensure sufficient clearance between the proposed dwellings and adjacent branches.

- 4.2.3. Please see *Appendix 4* for suggested barrier construction detail. It is recommended that in this instance the protective barrier shown in *Figure 1* would be appropriate. The suggested location for protective fencing is shown on the *Tree Protection Plan (Drawing 2)*.
