Manchester Metropolitan University School of Art

# Grosvenor Lifecycle Refurbishment Project

Design & Access Statement - Grosvenor

September 2021

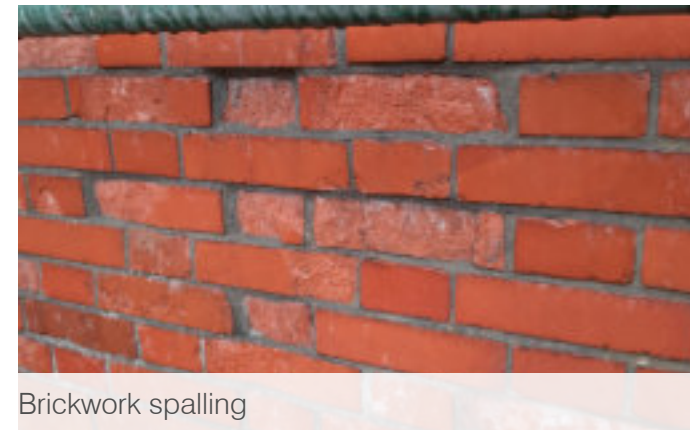
Brickwork spalling

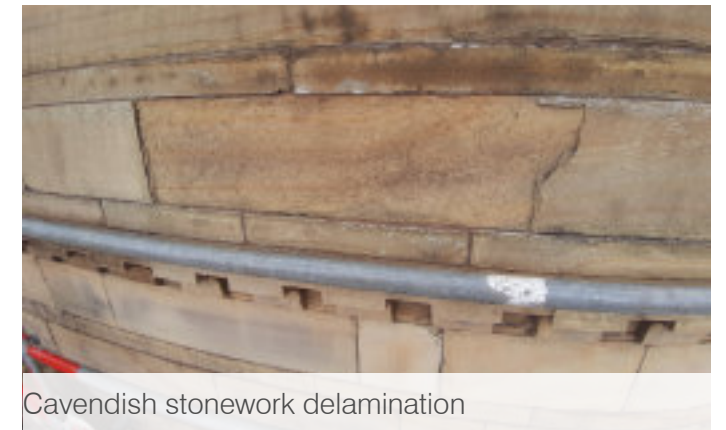
The Stone façade to Cavendish St and return to Higher Ormond St shows extensive lamination of the natural beds within the stone. This lamination can result in moisture retention, frost attack and further decay to the stone face.

Cavendish stonework delamination

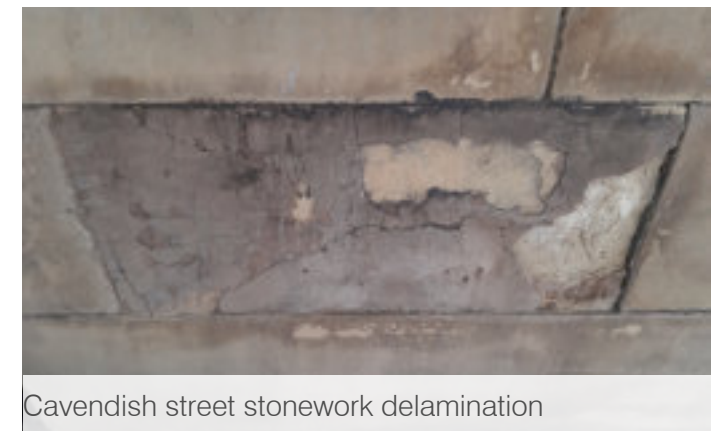
Cavendish street stonework delamination

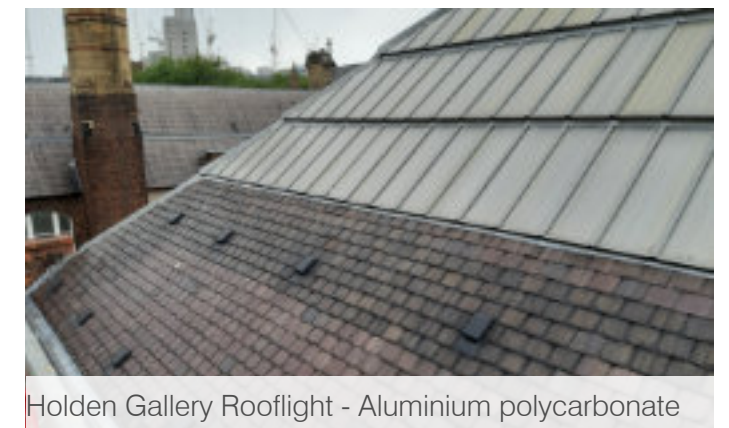
Holden Gallery Rooflight - Aluminium polycarbonate

From the survey, the observation notes that it is likely the gaskets are neoprene or asbestos rope which will have degraded over time. The glazing system is made up of non-ferrous aluminium which should have retained its integrity.

There are instances of failure, leading to internal water ingress. As with the roof fabric, safe access for maintenance and protection of the heritage asset is limited, leading to ongoing and detrimental issues.

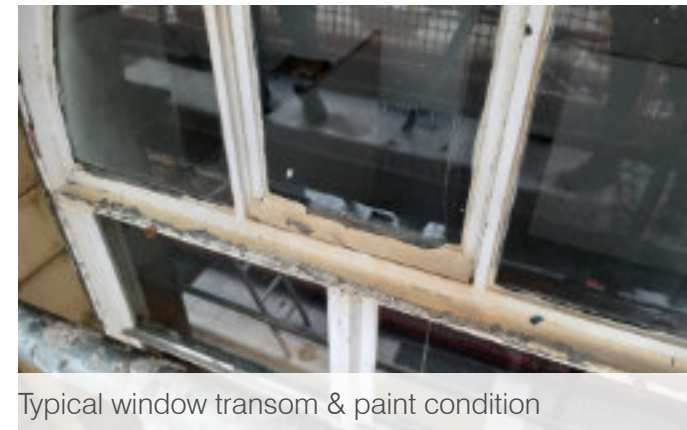
The paintwork to the window is in a variable condition around the façade. Many windows have crazing, flaking and de-bonding in large pieces/flakes to their external face. Internally the paintwork is generally sound. The paint is very thick in places reflecting many years of over coating. This failure of the paint has exacerbated moisture ingress into the timber and the remaining paint may be masking areas of decay.

Typical window transom & paint condition

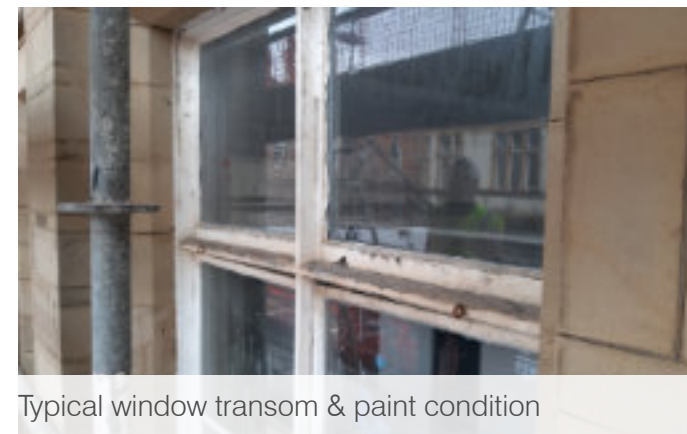
Typical window transom & paint condition

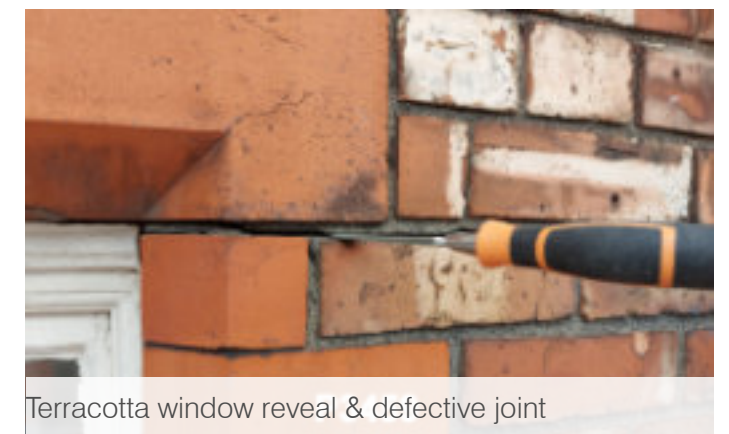
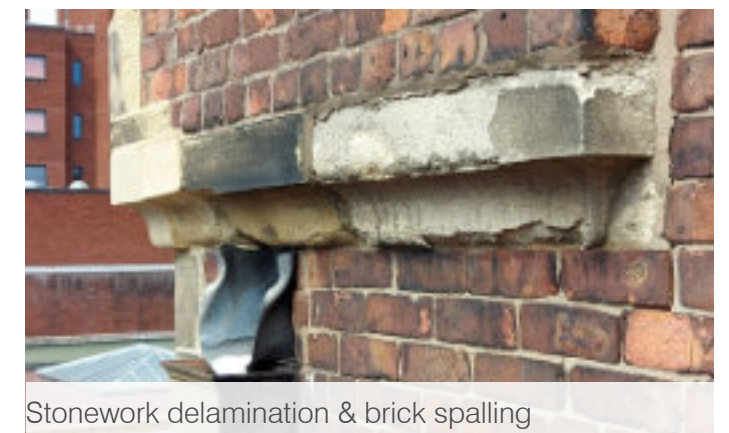
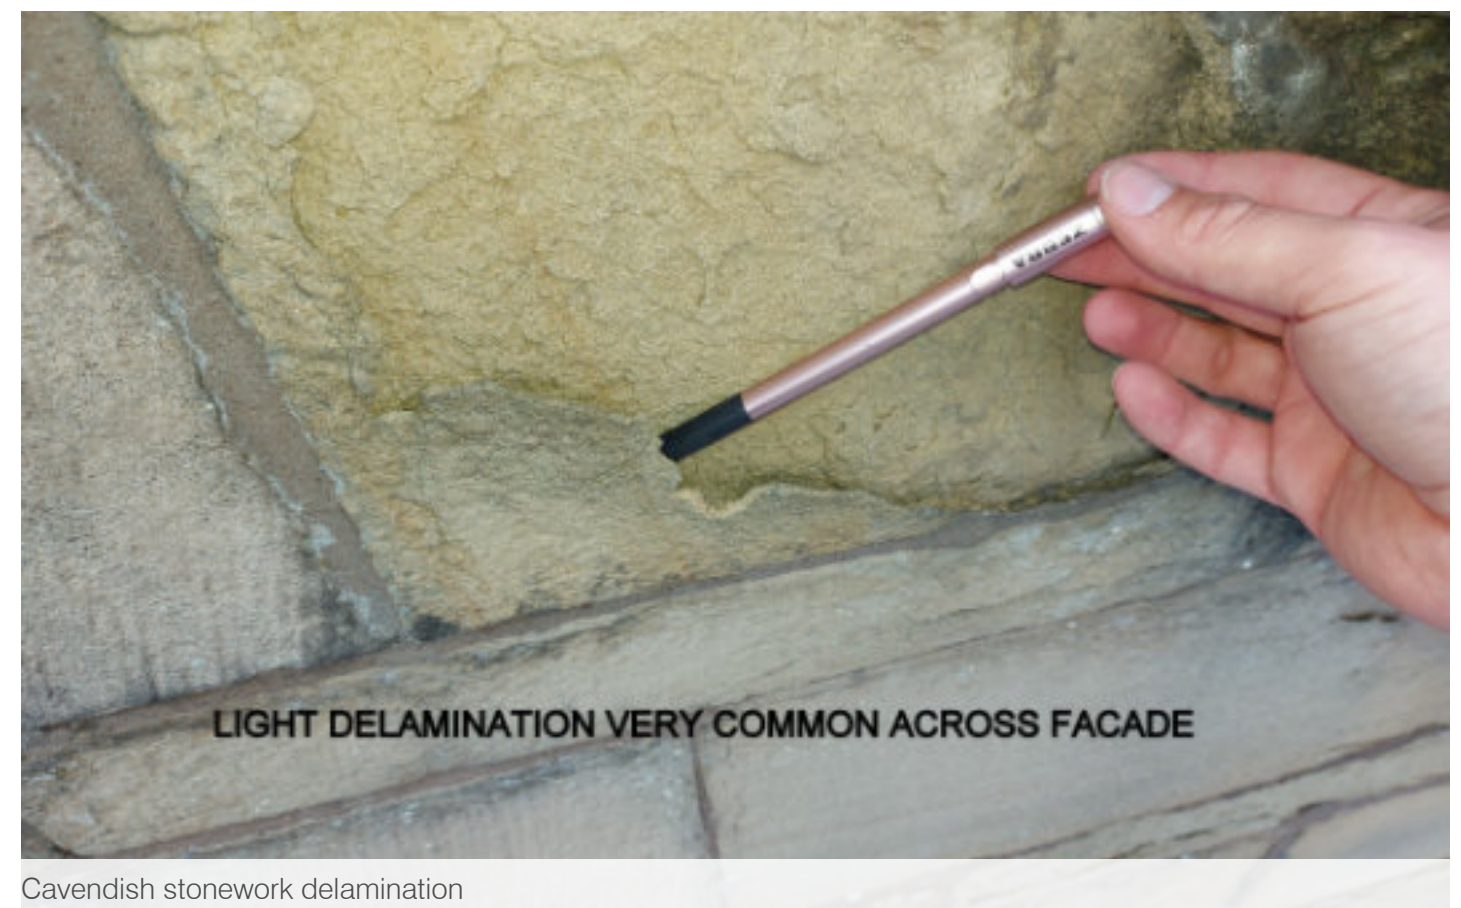
Cavendish stonework delamination

- Introduce any preformed supports according to need and the extent of repair.
- Restore forward in layers in specialist lime-based Stone Restoration Mortar compressing well on to a pre-dampened surface and around any reinforcement. For continuity and mix control pre bagged restoration mortar from companies are available and to be utilised.
- A separate colour will be required for the restoration of brick surfaces.
- The finish is to be worked with wooden profiles to match the original profile.
- Should it be found that upon cutting away that the depth of decay precludes achieving a sound mechanical base on which to apply the repair mortar it may be necessary to affect a new stone replacement.

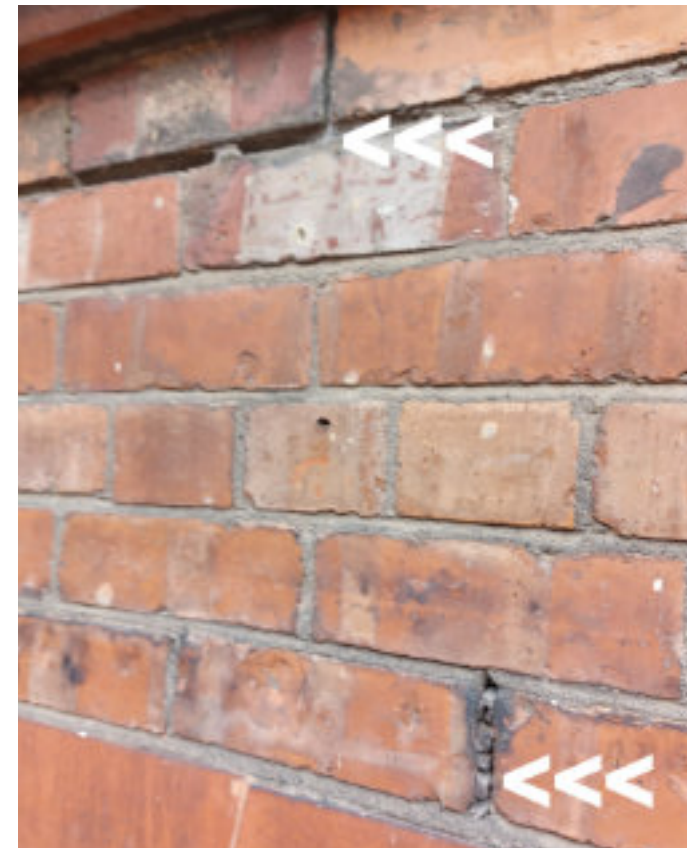
Defective mortar joints and detrimental timber noggins

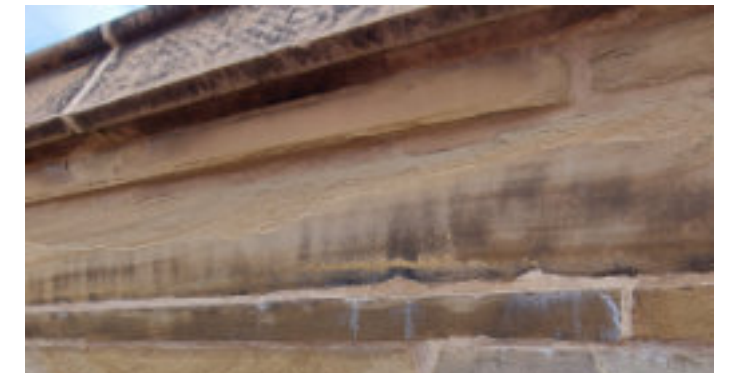
Salting or calcium deposits on parapet pointing

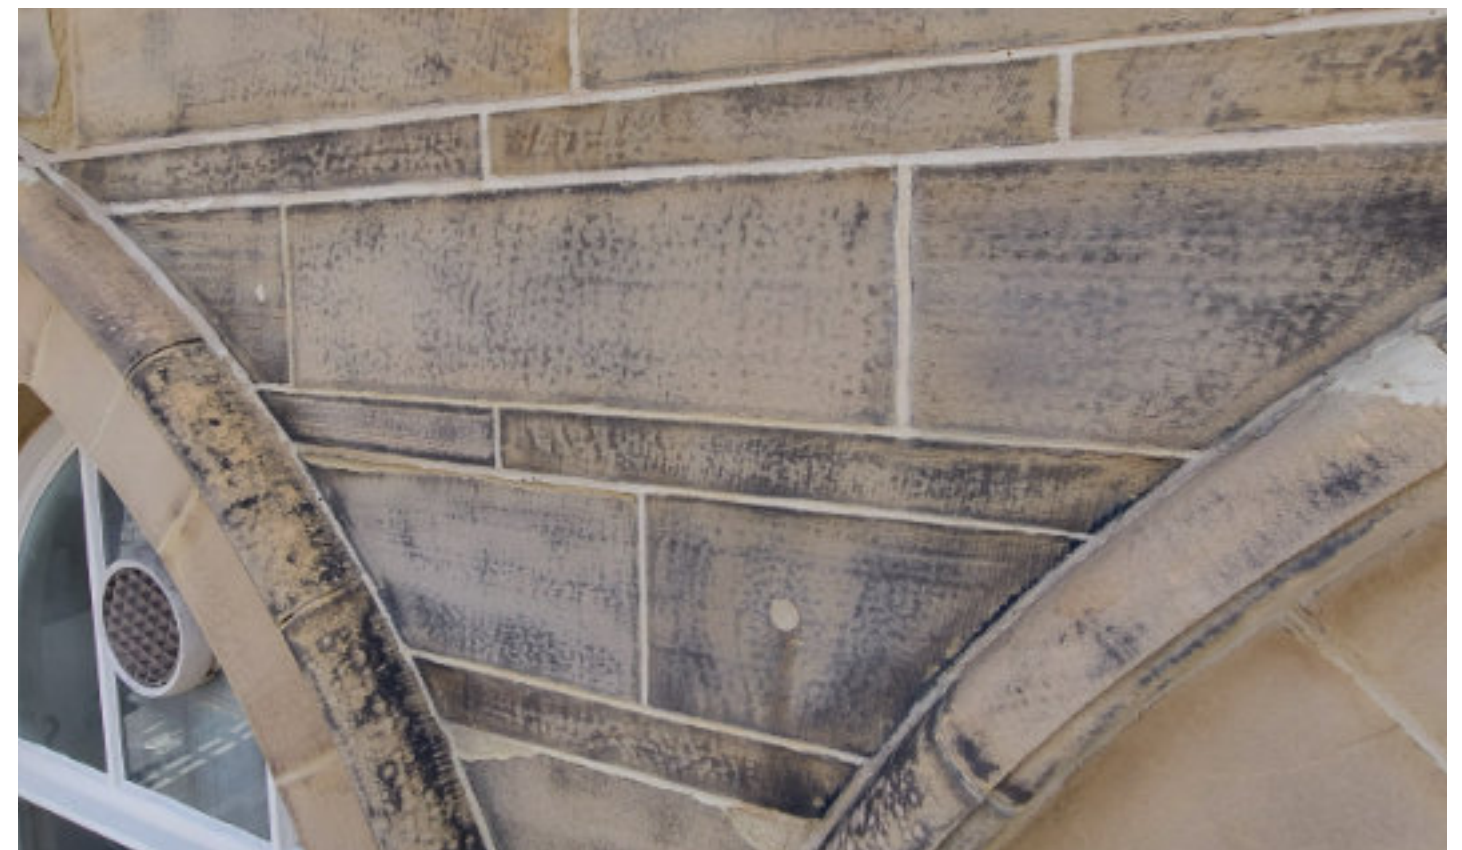
Higher Ormond Street Elevation - Failing mortar to be restored

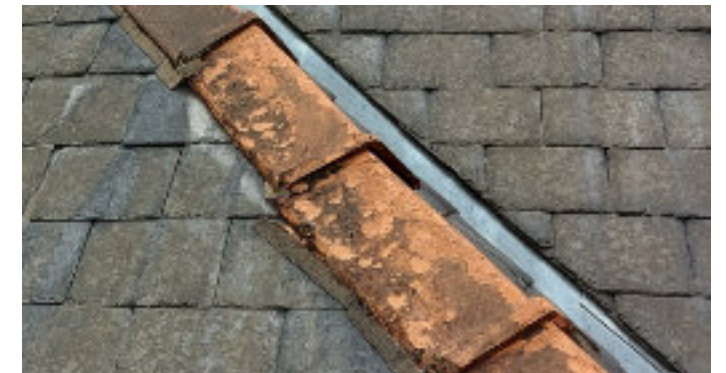
Clay Hip tiles are showing signs of surface degradation and break down / shaling.

Ridge tile surface degrading

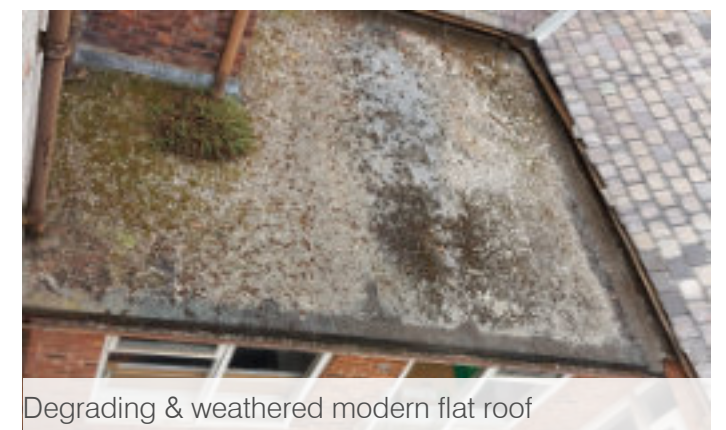
Degrading & weathered modern flat roof

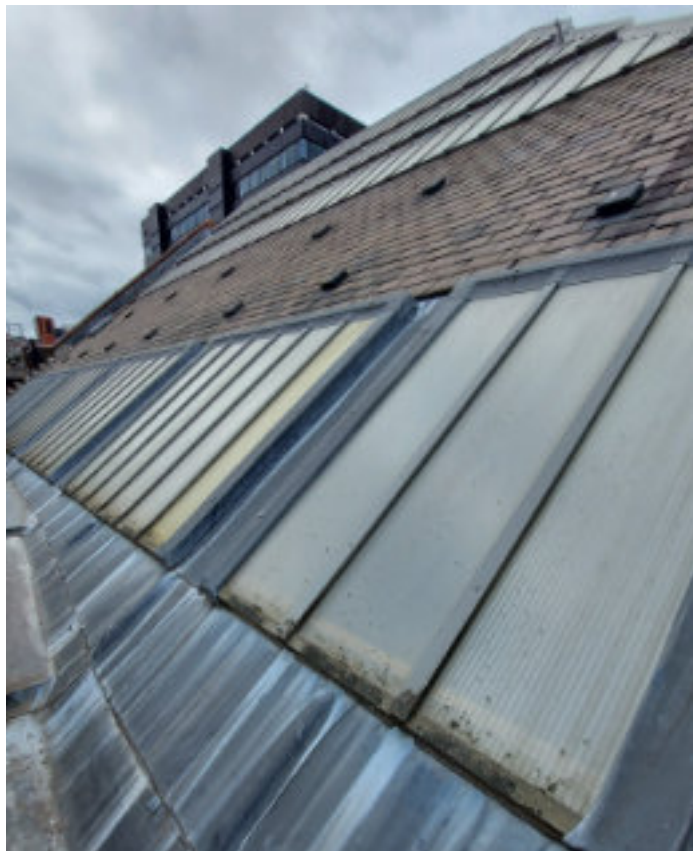
These are an Aluminium 'T' system without thermal break and is infilled with walled type polycarbonate sheet. Polycarbonate sheet that is circa 30 years old will have degraded due to UV attack.

Degrading aluminium rooflight & polycarbonate light

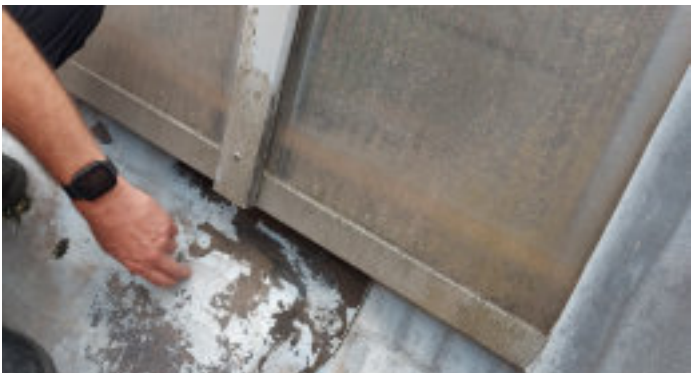
Mastic split repairs to lead

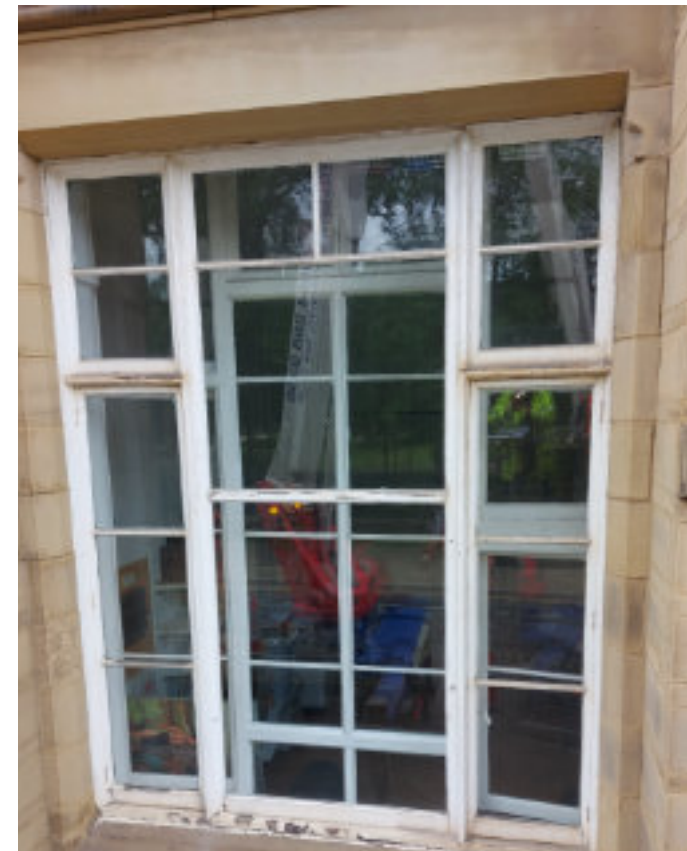
Outer frame altered from original - to be restored

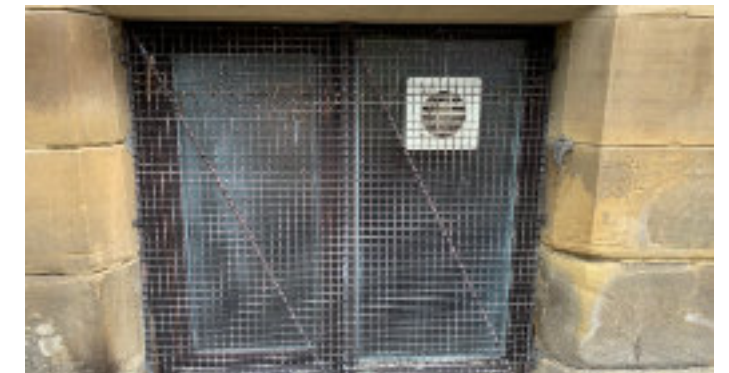
Modern frame with services + security mesh - replace

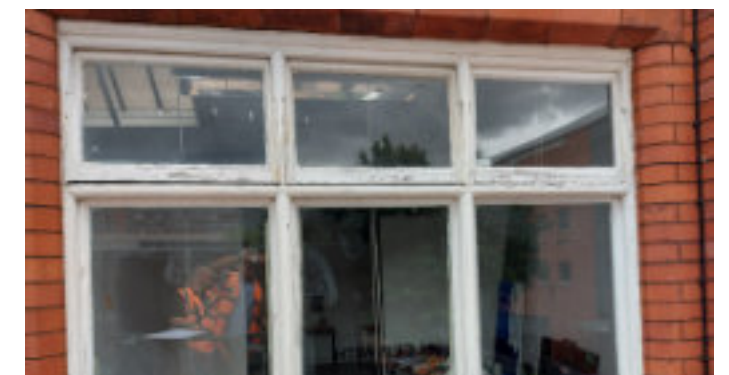
Flaking paint and missing beading

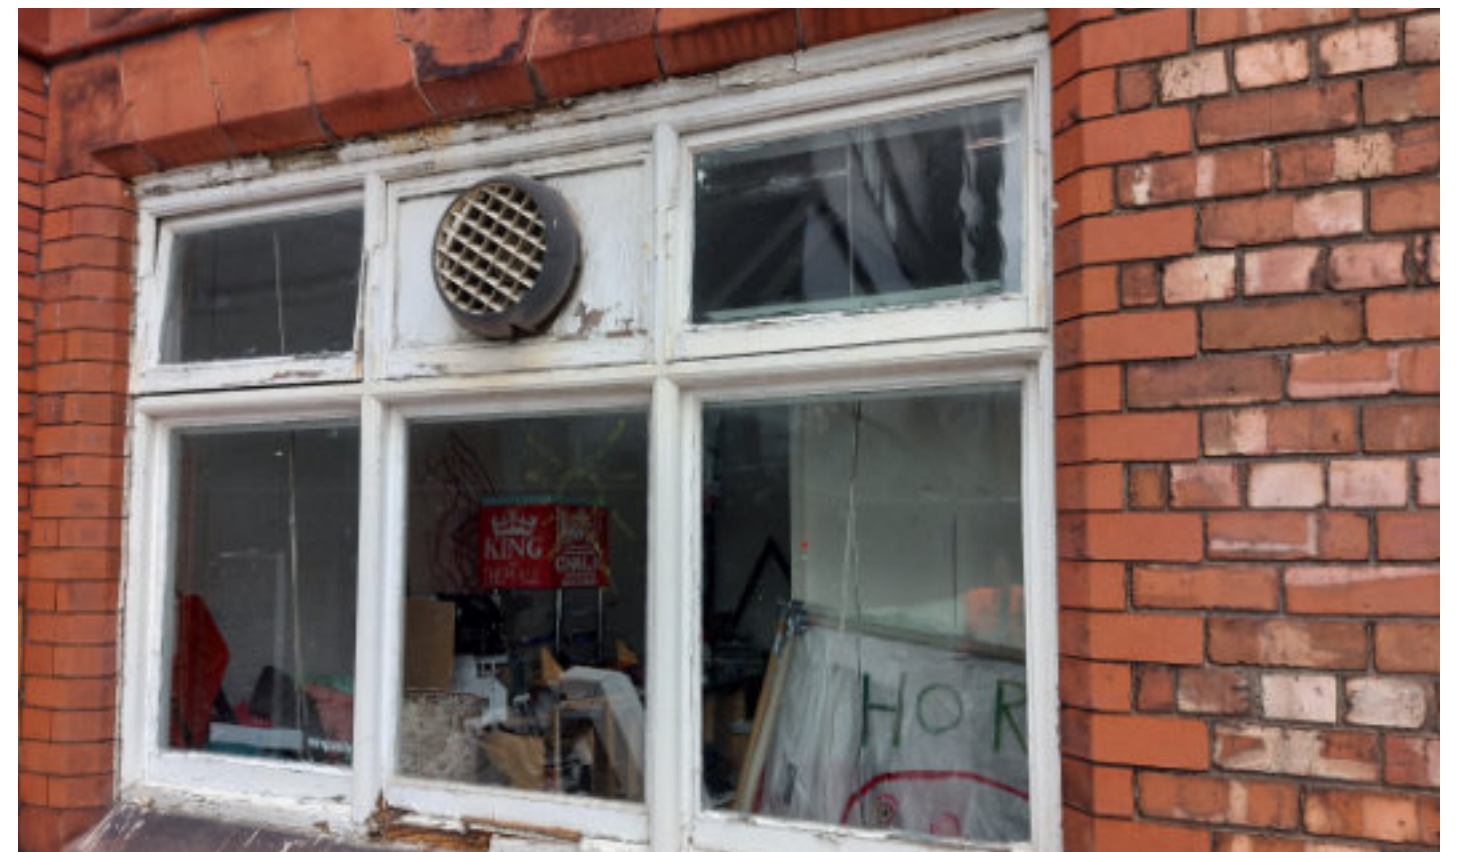
Example of timber rot & decay to window frames for resin repair of rail replacement (cill) - modern services infill

- Area to be lightly sanded in preparation for redecoration.

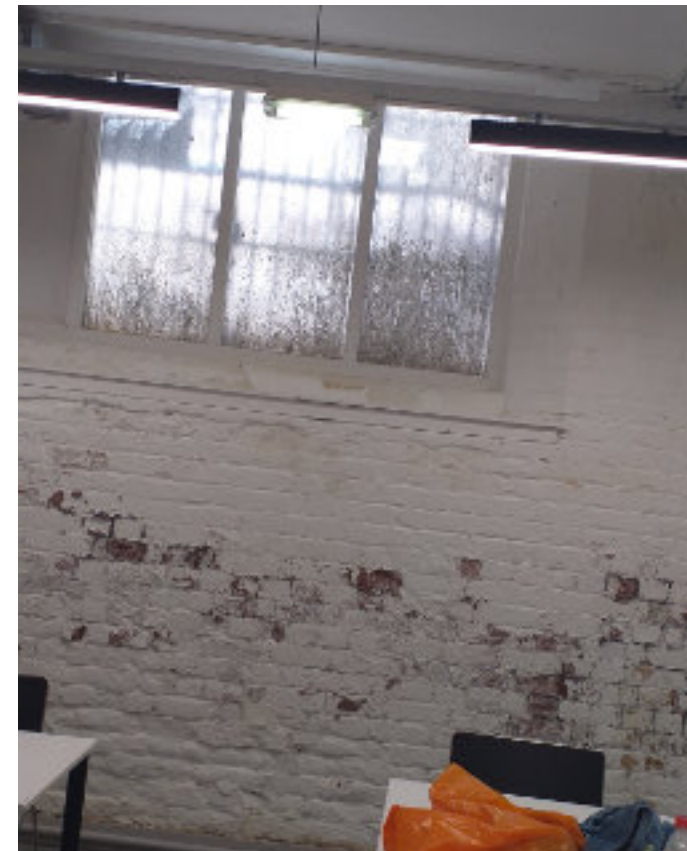
There was damp staining at the base of sandstone faced walls to the north and west elevations, while there were instances of recessed and open mortar joints on all elevations surveyed. No damp-proof course was visible on sandstone facades, but there was an asphalt damp-proof course at the base of external brick walls to the south. At the south elevation this dpc has been bridged by modern paving, providing a route for moisture penetration. External brick walls to the service yard were damp where affected by defective rainwater and soil pipes. The tops of sills to basement windows on the north and south elevations were generally flush, or near flush, with adjacent ground levels, making them vulnerable to water penetration, while cracks in the main front entrance steps in the north elevation were probably admitting water to room B08 below.

Existing damp issues within the basement
