# MAG Building 401

Arboricultural Impact Assessment

MAG Property

October 2021

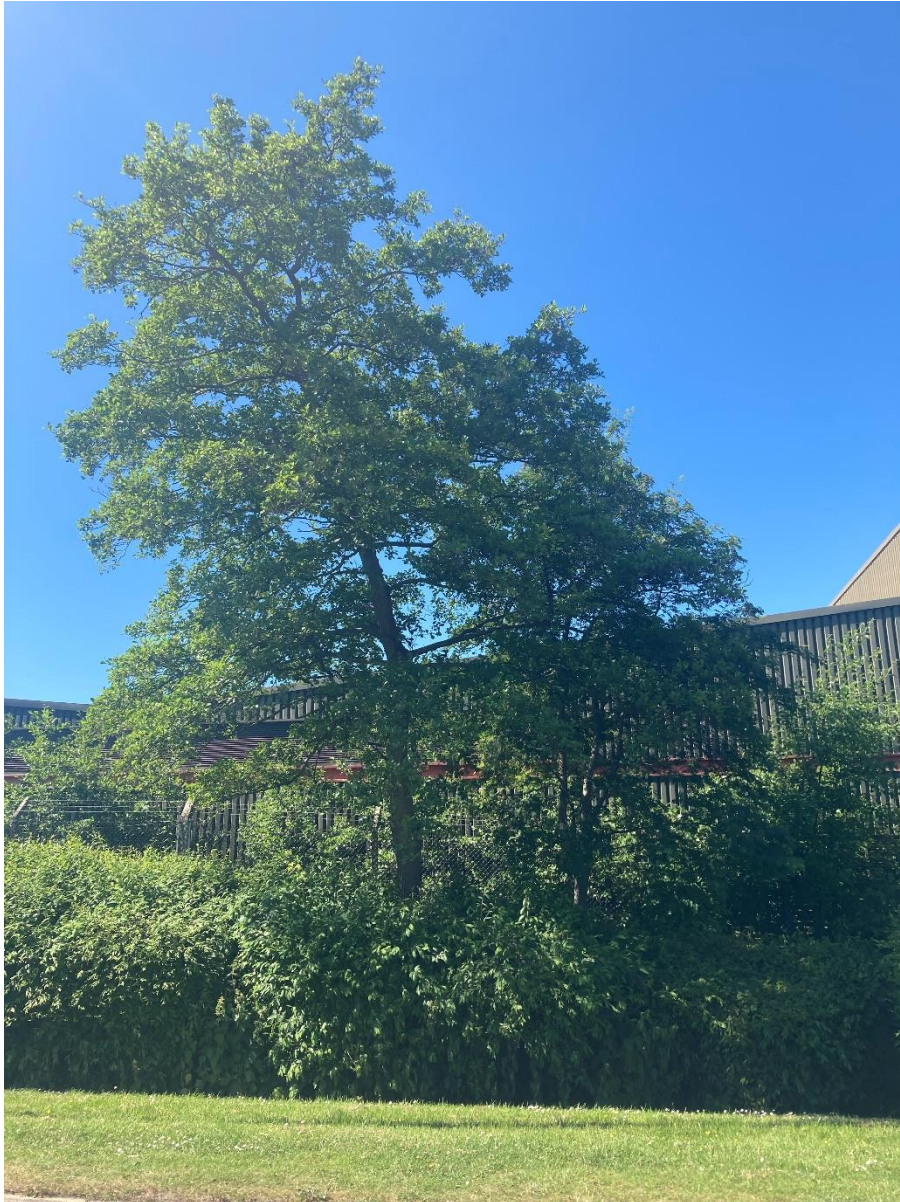
Photo 1 Planted trees (T2 & T3) within G8

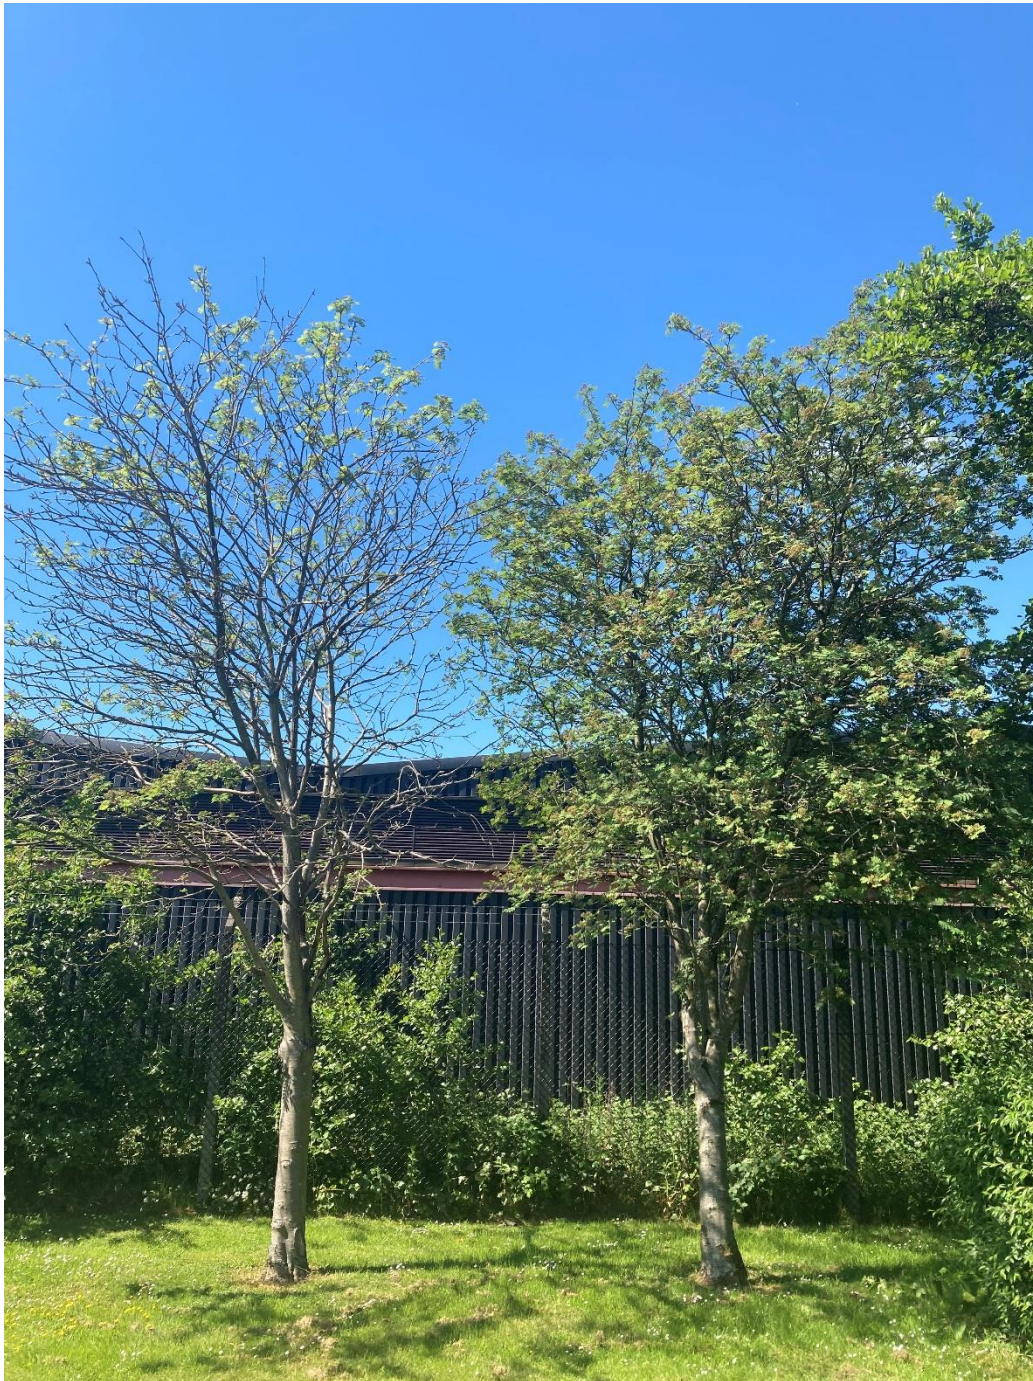
| Ref. No | Species Common Name<br>(Scientific name) | Estimated Height (m) | Stem Diameter (mm) | Canopy Spread (m) | | | | First Significant Branch & direction (m) | Canopy Clearance height (m) | Physiological Condition | Life Stage | Structural Condition | Observations | Preliminary Management Recommendations | Work Required to Facilitate the Proposed Development | Estimated Remaining Contribution (yrs) | Category | RPA (m²) | RPA Radius (m) |
|---|---|---|---|---|---|---|---|---|---|---|---|---|---|---|---|---|---|---|---|
| T6 | Rowan ( <i>Sorbus aucuparia</i> ) | 5 | 240 | 3 | 3 | 0.5 | 3 | 3.0/W | 2 | Poor | SM | Poor | Failure to come into full leaf with very small and sporadic foliage. Likely dead buds throughout. Decay throughout the main stem, major wounds from base upwards into the crown. | Fell to ground level and replant. <3 months | | <10 | U1 | 2.9 | 0.96 |

Photo 2 Planted rowan trees with T6 being in poor condition (T5 & T6)

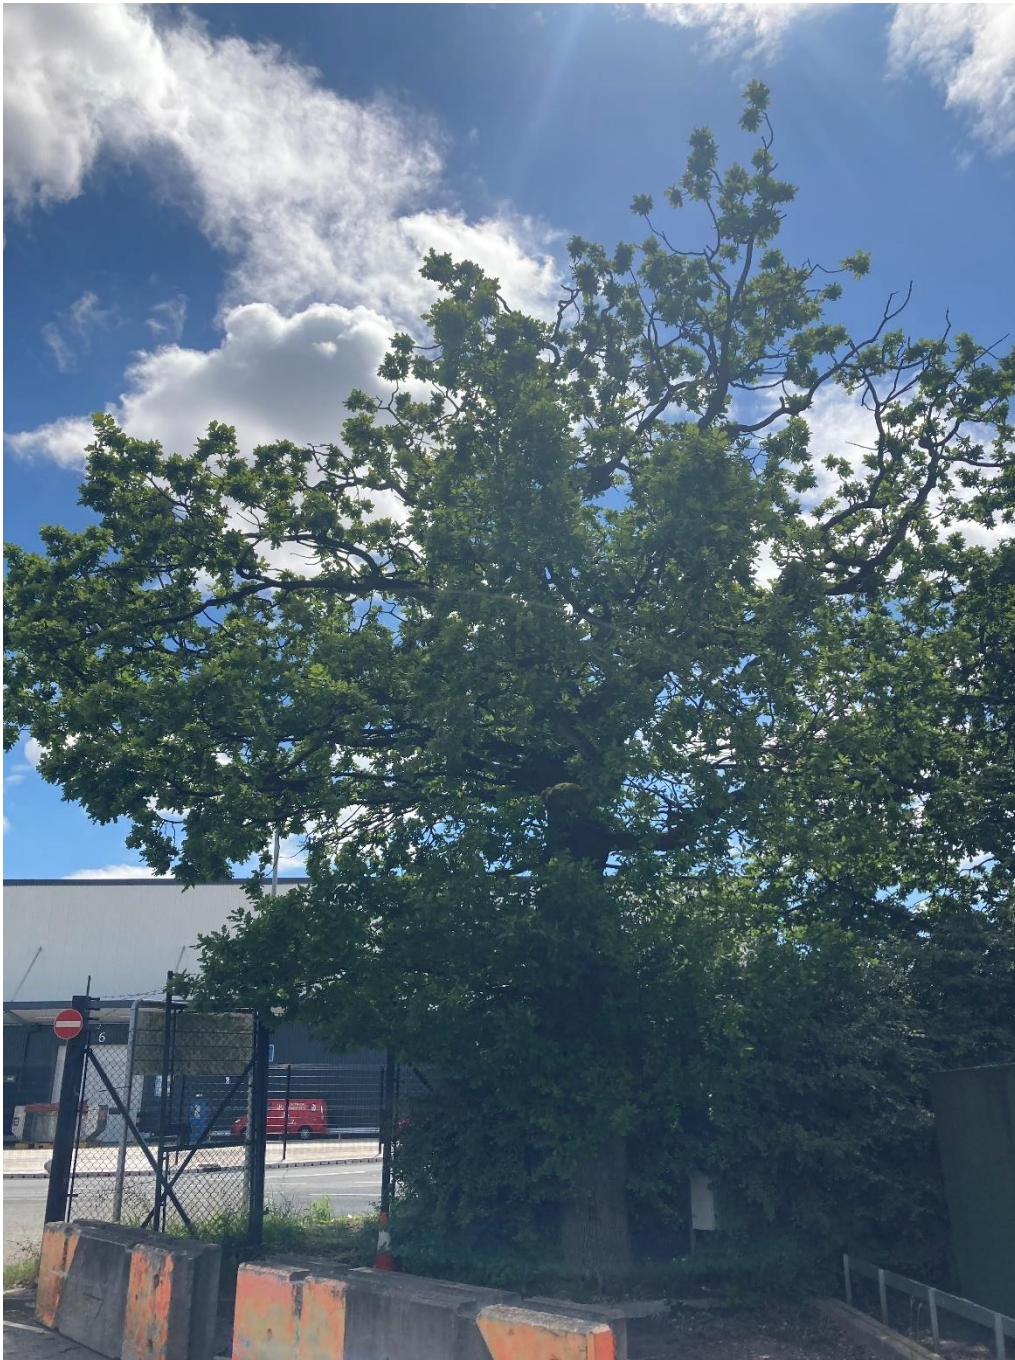
Photo 3 A mature oak (T14) at the entrance to the Site.

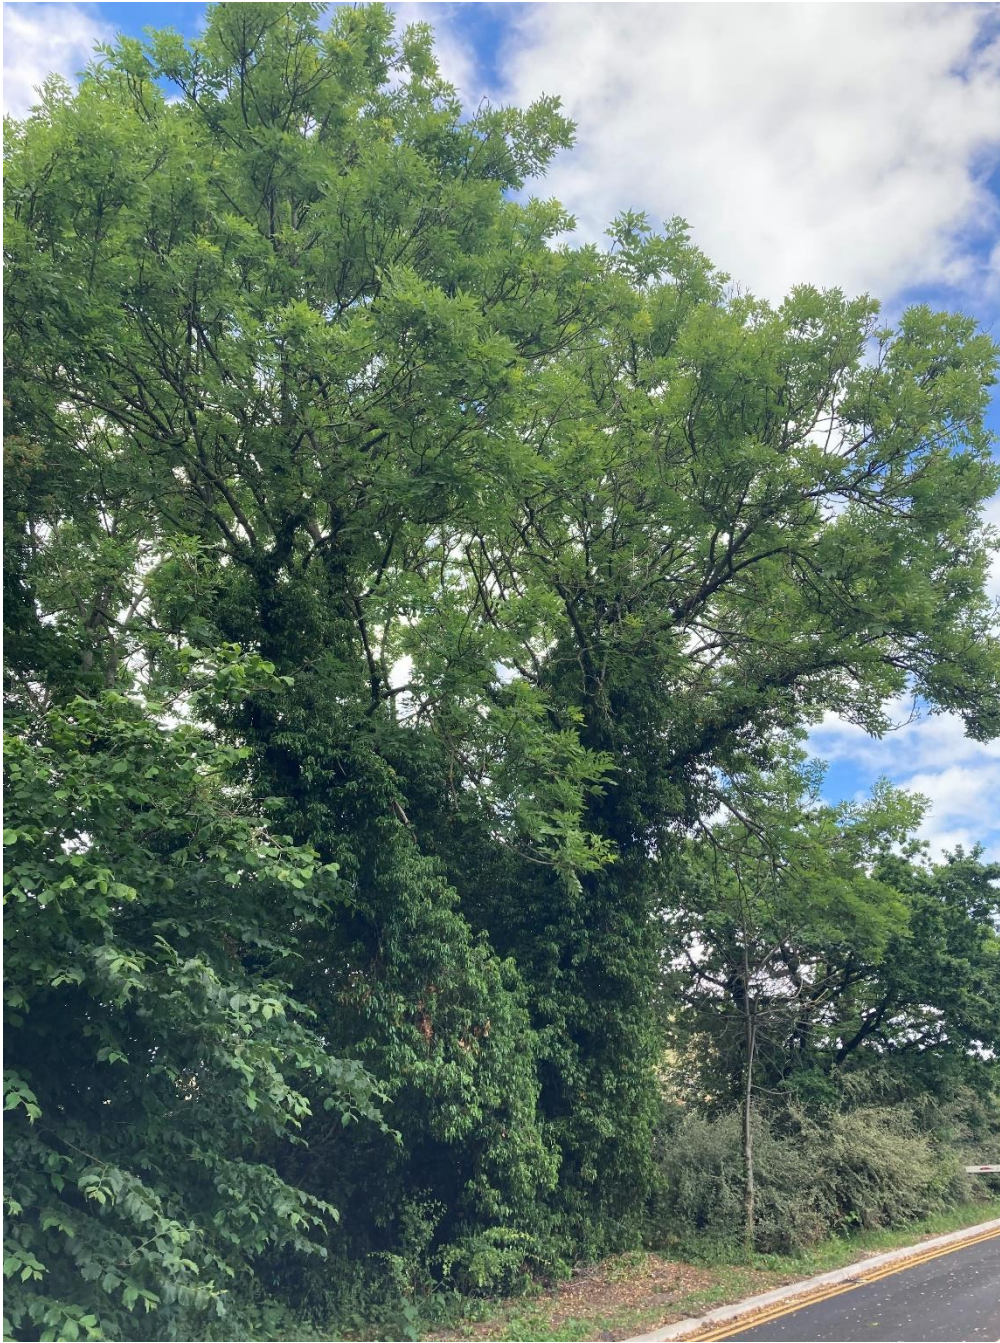
Photo 4 T17, a mature ash with dense ivy growth obscuring visibility

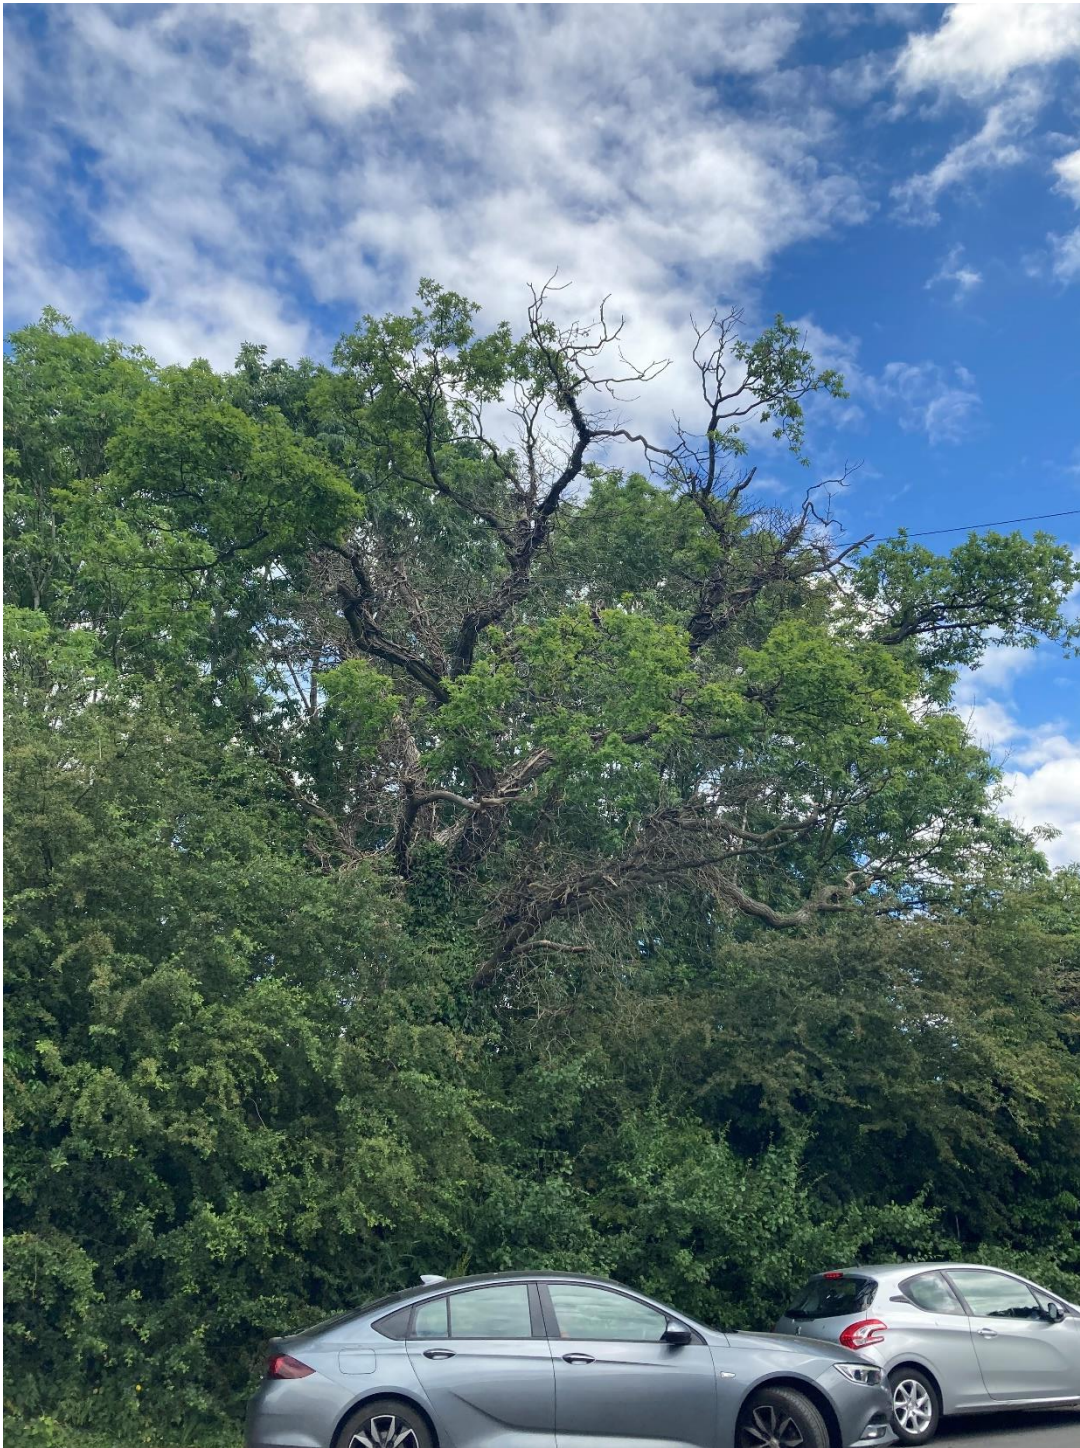
| Ref. No | Species<br>Common Name<br>( <i>Scientific name</i> ) | Estimated Height (m) | Stem Diameter<br>(mm) | Canopy Spread (m) | | | | First Significant<br>Branch & direction<br>(m) | Canopy Clearance<br>height (m) | Physiological<br>Condition | Life Stage | Structural Condition | Observations | Preliminary<br>Management<br>Recommendations | Work Required to<br>Facilitate the<br>Proposed<br>Development | Estimated Remaining<br>Contribution (yrs) | Category | RPA<br>(m²) | RPA<br>Radius<br>(m) |
|---|---|---|---|---|---|---|---|---|---|---|---|---|---|---|---|---|---|---|---|
| T18 | Common Oak<br>( <i>Quercus robur</i> ) | 13 | 600 | 6 | 4 | 6 | 7 | 5.0/E | 6 | Poor | M | Fair - Poor | Low vitality with sparse foliage and significant sections of deadwood throughout its crown. Potentially in terminal decline. Lower stem swamped in ivy from the base. Overhead wires running through tree's crown. Sounding hammer test didn't suggest any extensive decay but ivy preventing full visual assessment. | Sever ivy, remove dead wood over hard surfacing < 3 months | | 10+ | C1 | 7.2 | 1.51 |

Photo 5 A large declining oak (T18) at the edge of the woodland group, large dead limbs but still some life, although sparse growth in the crown

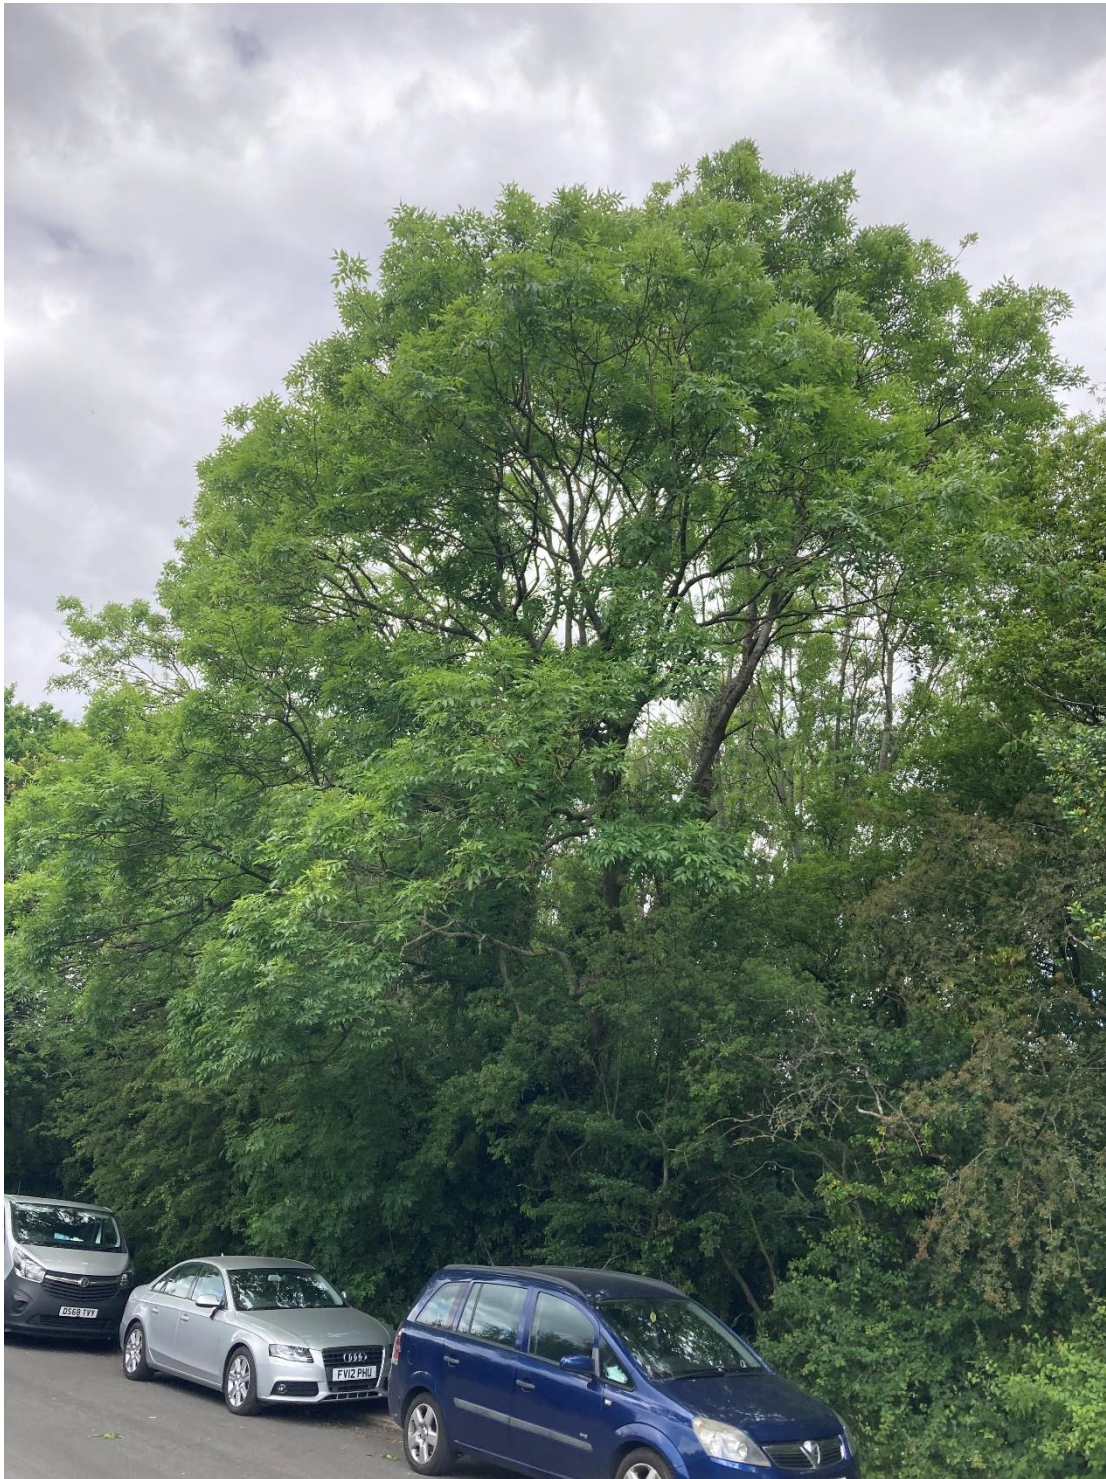
Photo 6 One of many mature ash trees lining the woodland edge

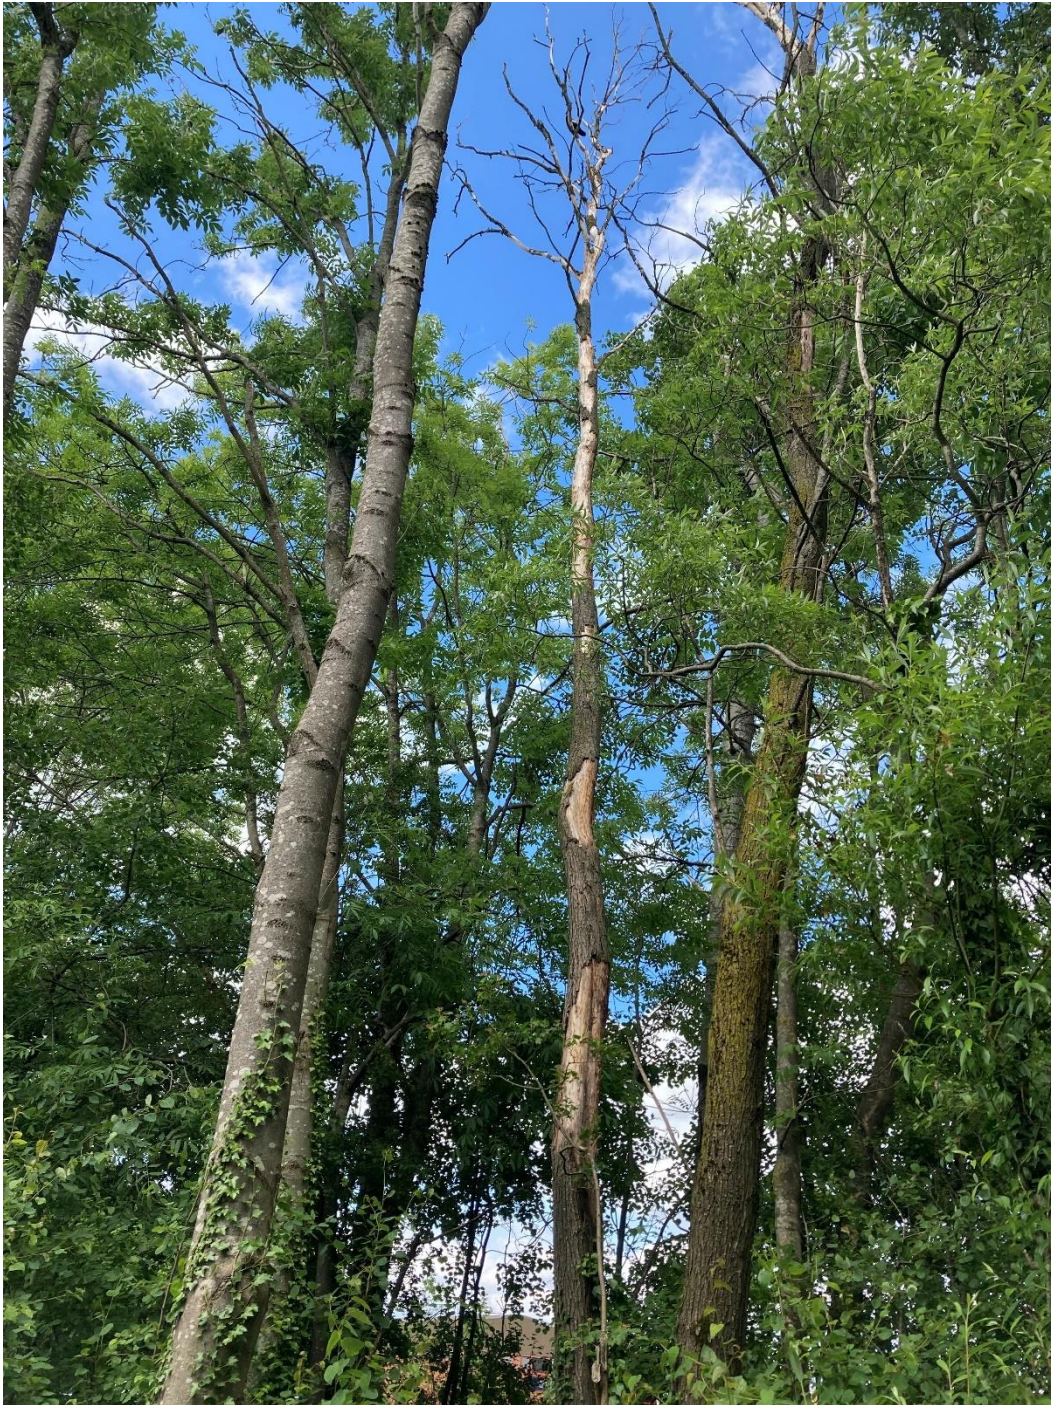
Photo 7 Standing dead tree within the woodland group

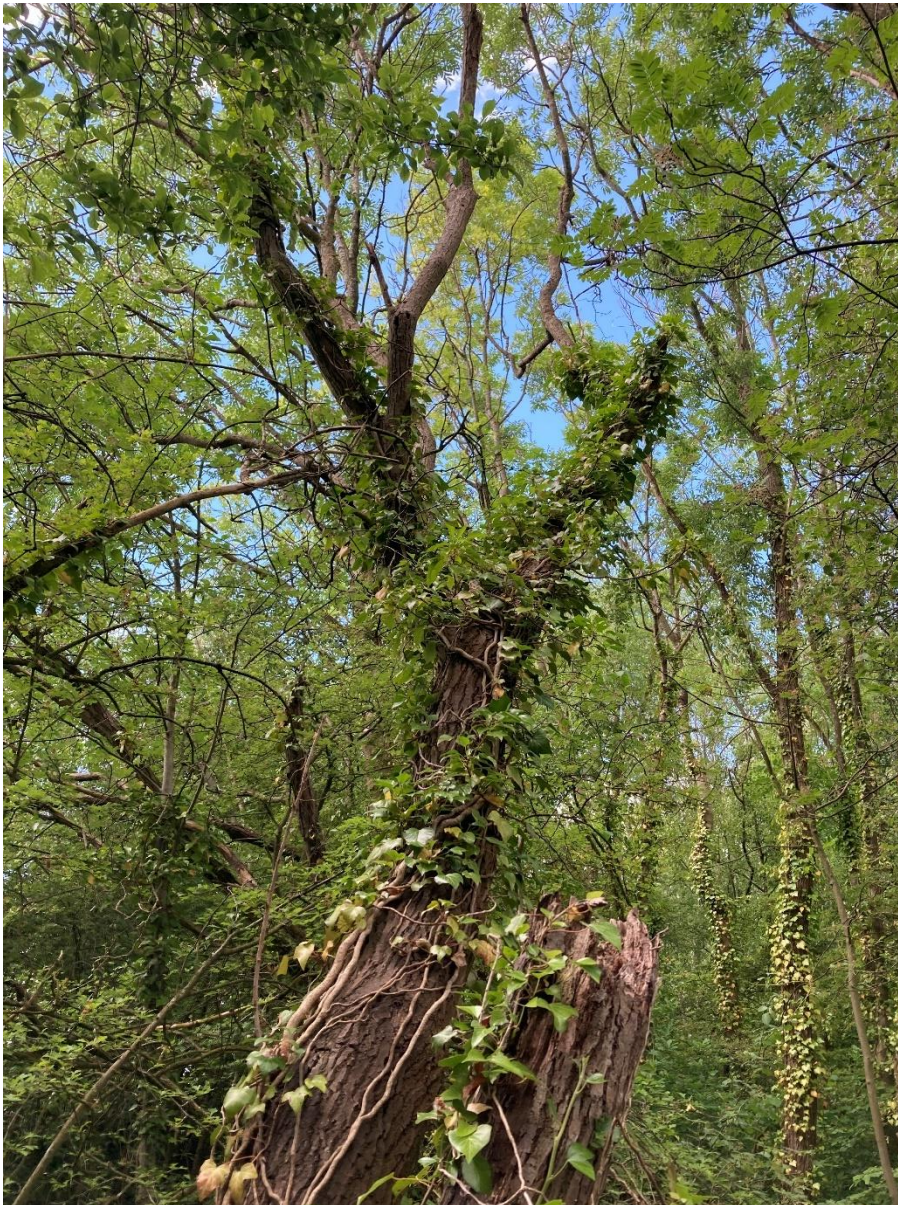
Photo 8 Another section of standing deadwood within the woodland group providing habitat value
