# Preliminary Roost Assessment

2-32 Bridgenorth Road  
Blackley  
Manchester  
M9 8HN

For  
Northwards Housing

# Gritstone Ecology

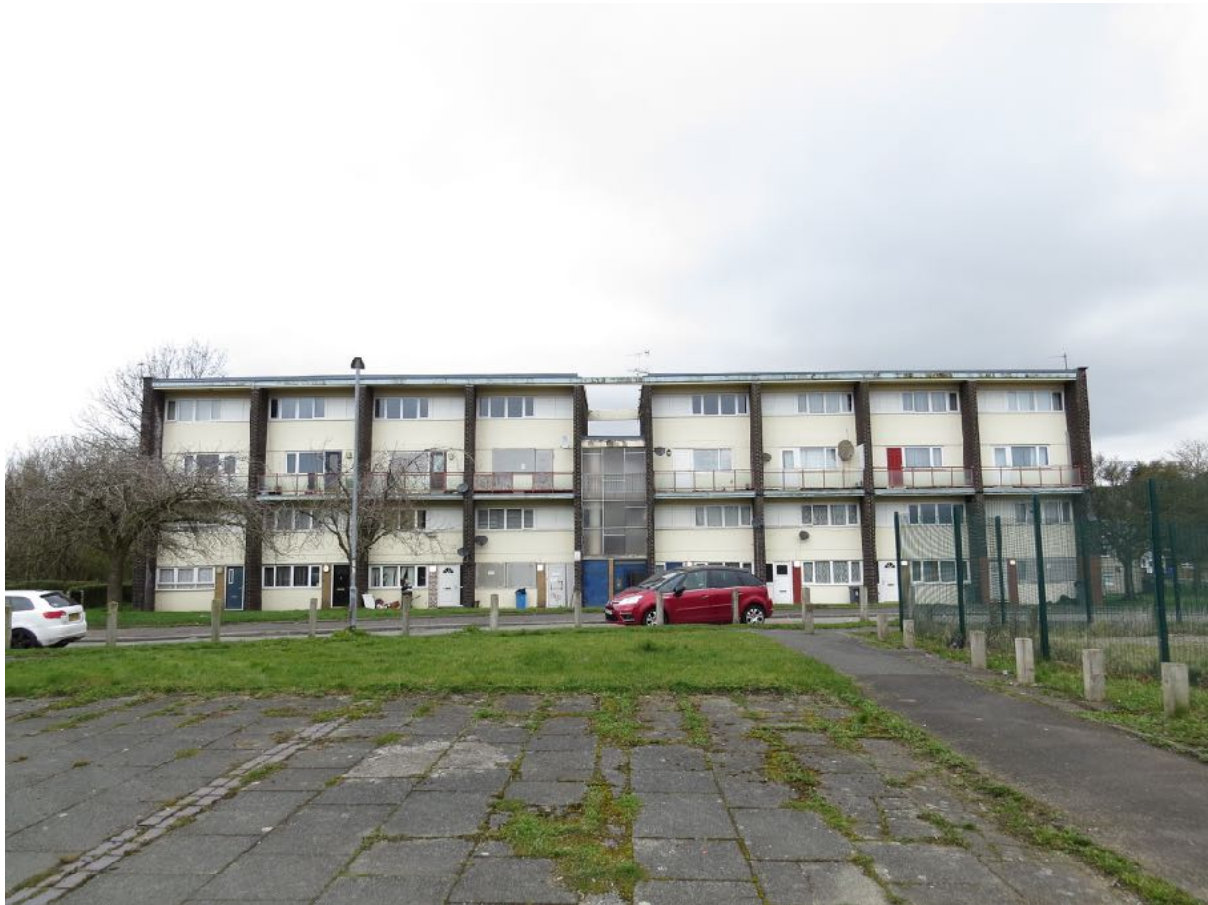
3.1a – The front of the building.

2-32 Bridgenorth Road Blackley is a block of 16 maisonette apartments, the majority of which are occupied. The building has a reinforced concrete frame, with a flat felt-covered concrete roof, and cavity insulated brick walls between apartments. Front and rear walls of individual apartments are constructed from brick with a white painted cement render, and UPVC window and door frames.

End walls are fitted with concrete capping stones, no fascia boards or boxed soffits are fitted, and there are no chimneys or leadwork. The majority of apartments are occupied. Vacant apartments have been secured with ventilated steel panels, which are securely fitted with no gaps suitable for use by roosting bats.

The building is in reasonable condition. There are no gaps between capping stones and brickwork at the end walls. There are no gaps or cracks in brickwork which could be used by roosting bats. Cement has perished in some areas, but only leaves a superficial crevice with no access to the wall cavity. There are no gaps between concrete and brickwork, and no gaps between indoor and door frames and walls.

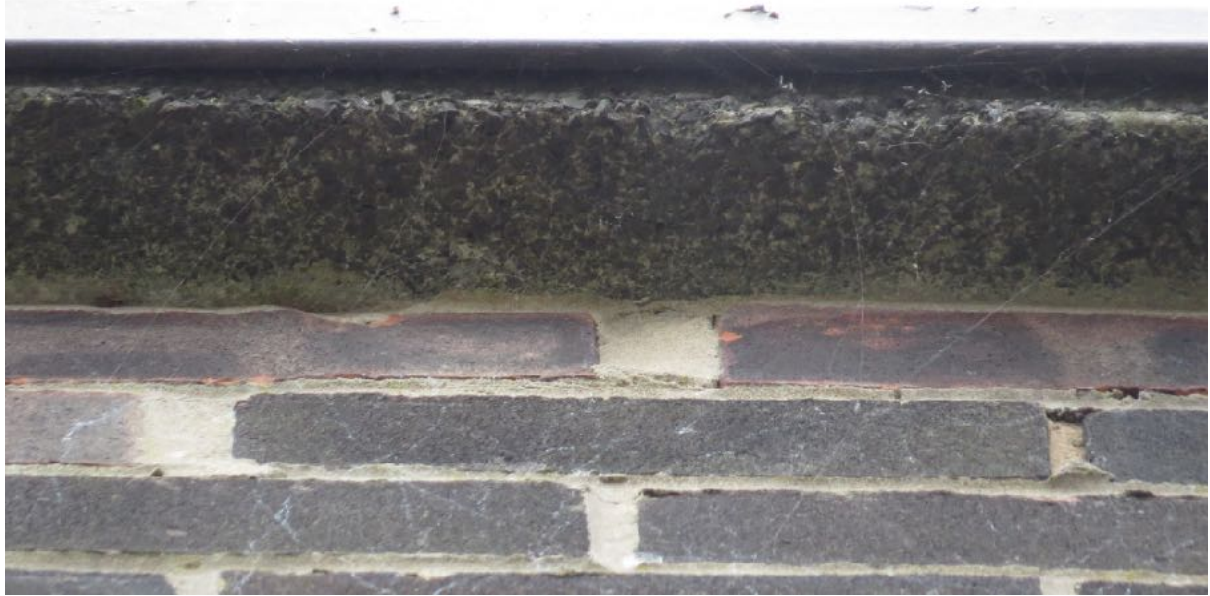
3 – Concrete capping stones on the end walls are tightly fixed with no suitable gaps.

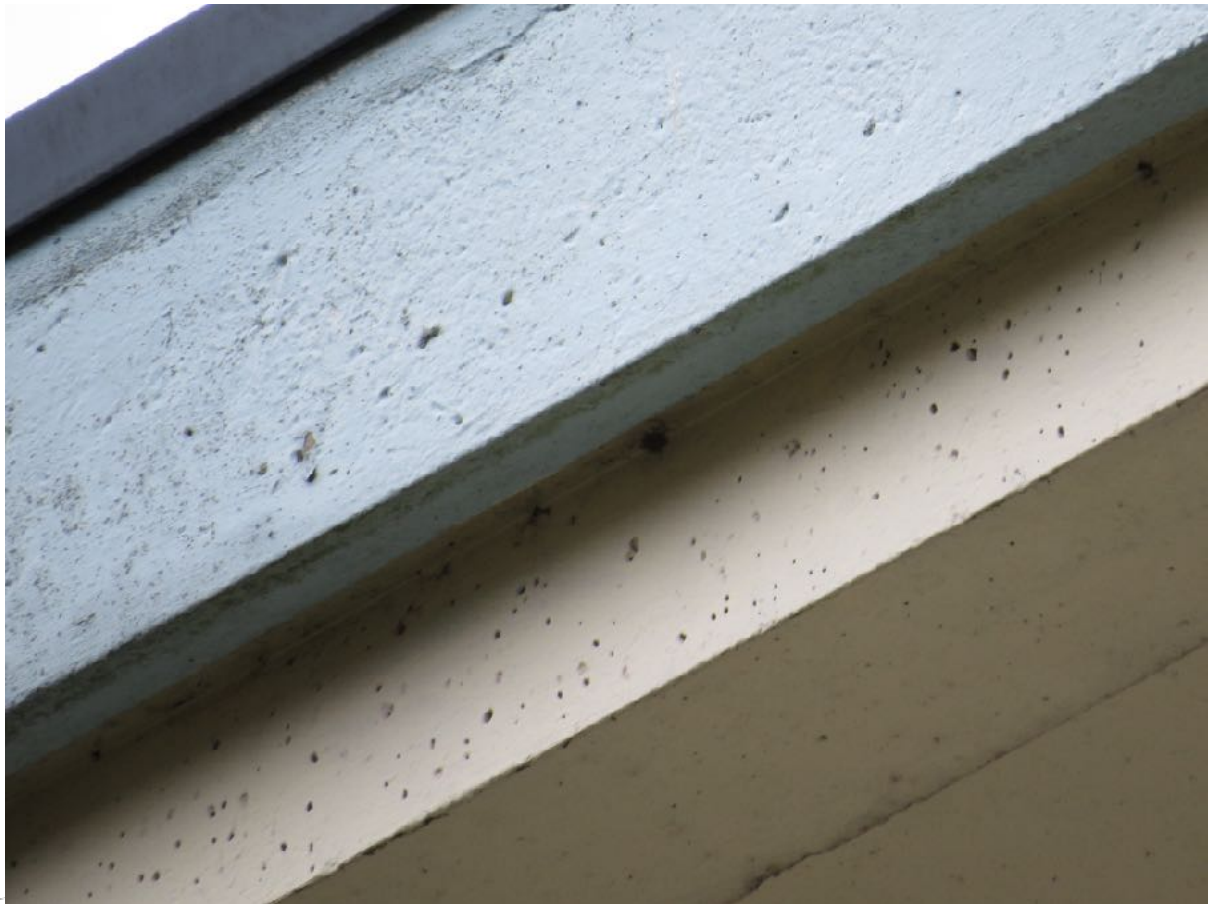
The building has a felt covered flat concrete roof. There are no gaps between roofing materials which could be used by roosting bats.

There are no fascia boards or boxed soffits, and no other materials externally which are likely to be used by roosting bats.

4 – There are no fascia boards, and no gaps between roofing materials and walls.

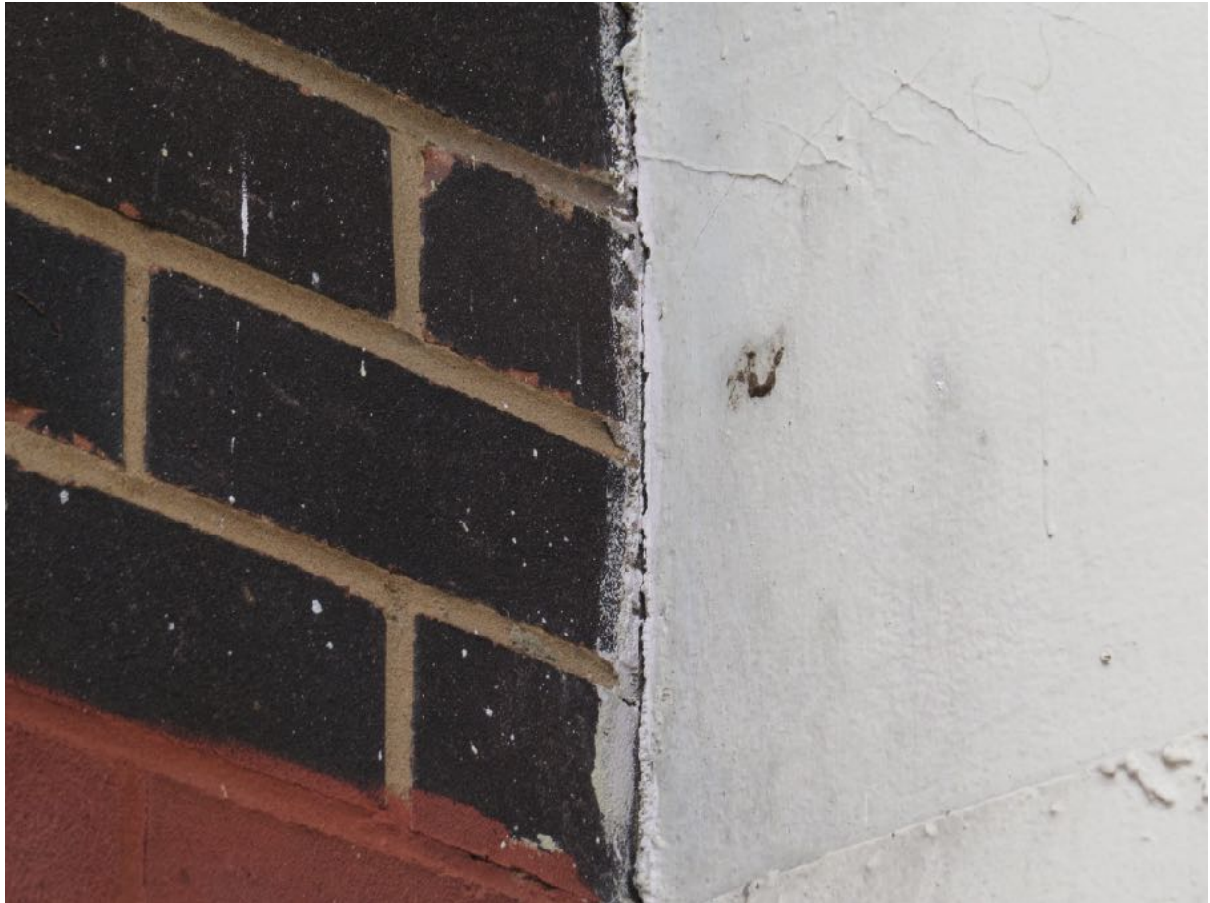
5 – There are no gaps between rendered walls and brickwork.

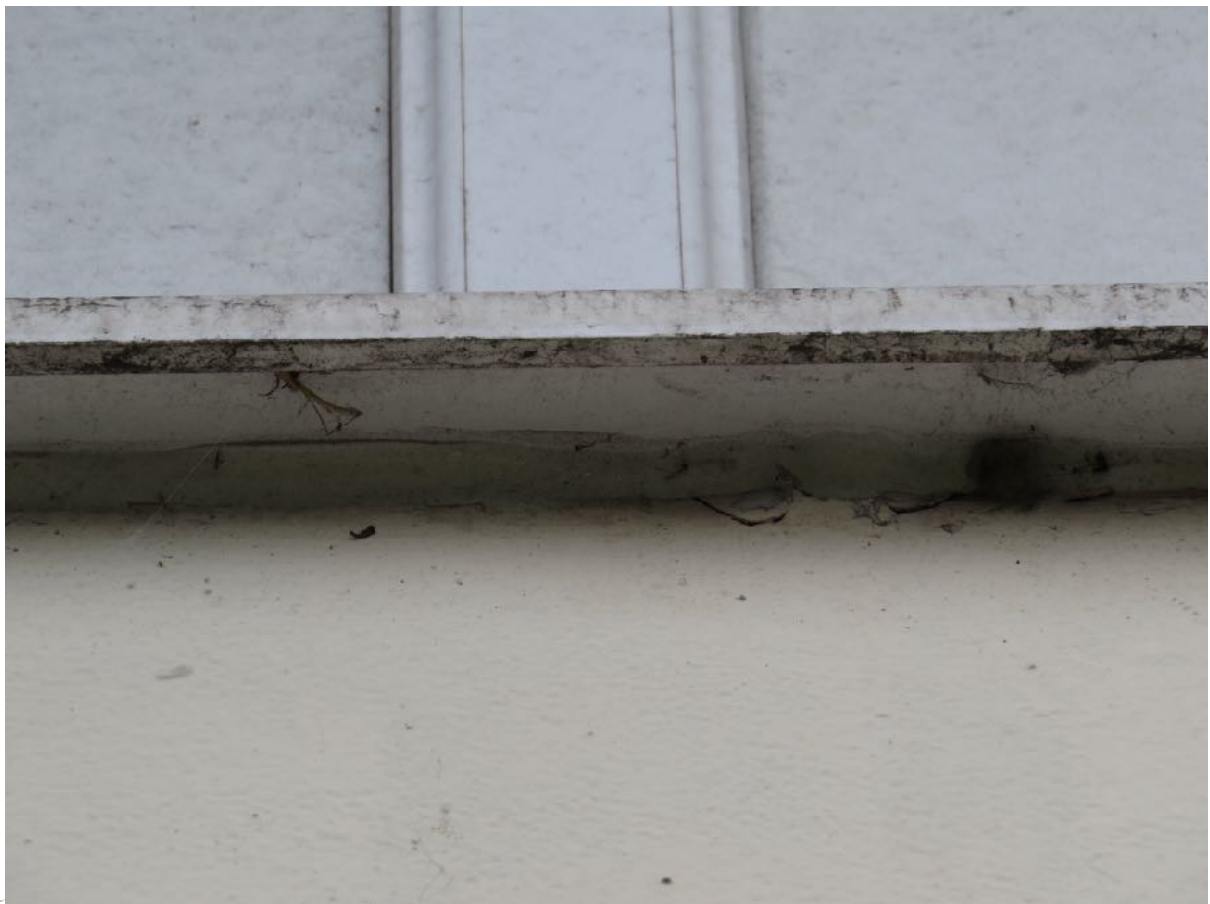
Window and door frames are fixed into the walls, gaps are filled with sealant, and offer no suitable roosting opportunities.

6 – There are no gaps between window and door frames and brickwork.

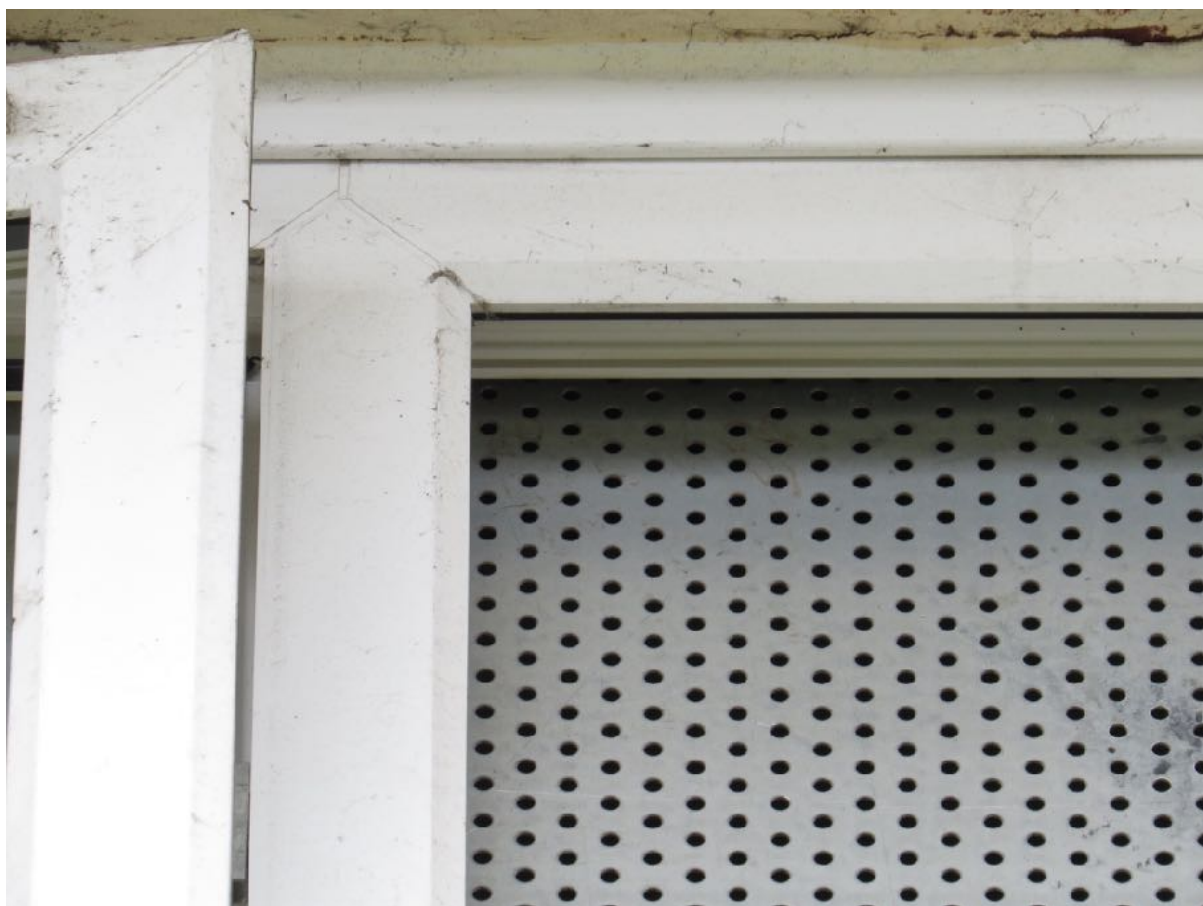
All glass is intact in occupied apartments; vacant apartments are secured with ventilated steel security panels, with no gaps which could be used by roosting bats.

7 – Vacant apartments are secured with steel security panels with no suitable gaps.

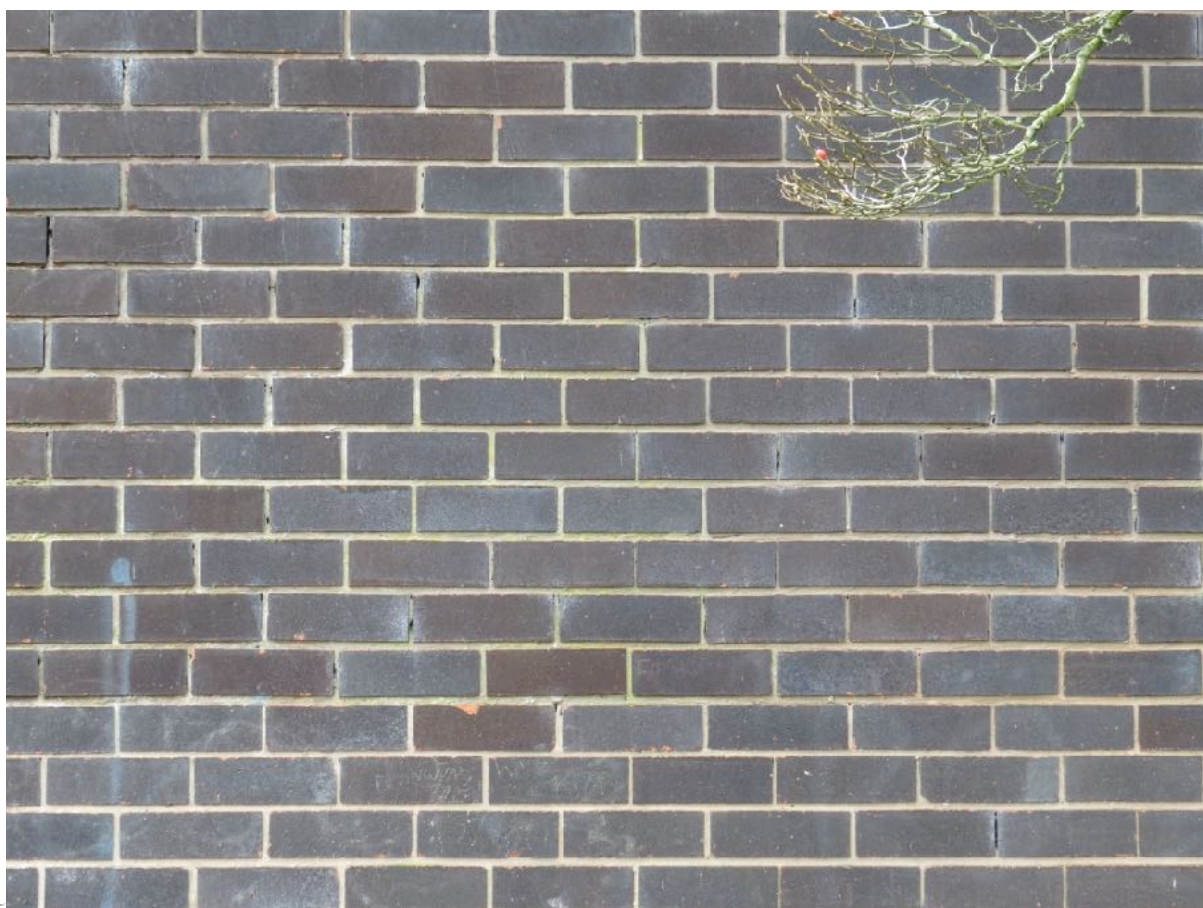
End walls, and walls between apartments are brick with an insulating cavity. Walls are in good condition, with no cracks, or missing mortar which could be used by crevice dwelling bats.

8 – Brickwork at the end walls is in good condition with no suitable gaps in mortar.
