**Tree Appraisal Report**  
***44 Kingston Road, Manchester, M20 2SB:***

**“BS 5837 2012: Trees in Relation to Design, Demolition and Construction – Recommendations”**

Date: 4<sup>th</sup> February 2021  
Ref: RTS/04022021  
Revision: 001

***44 Kingston Road, Manchester M20 2SB:***

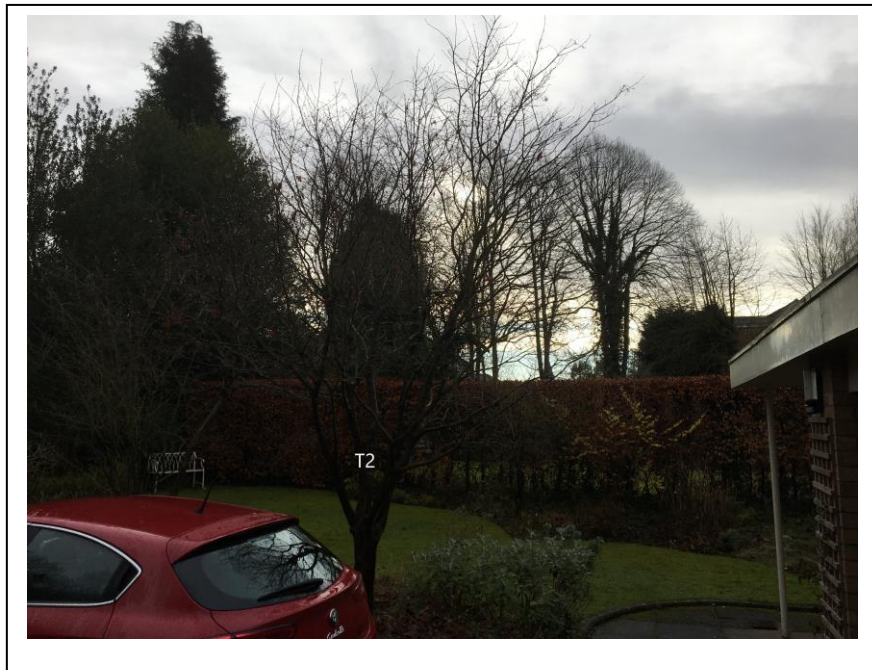
**Photo 01:**

**3.3.1** Tree T2 is a small tree at 5 metres high and T7 another small tree at 3.5 metres high. Both do not significantly contribute to the visual amenity of the street scene, (photo 01 and 02) and their removal would most likely be unnoticed.

| Tree | Tree Work | Priority |
|---|---|---|
| T2, T3 and T7 | Fell to ground level and grind out the remaining stumps | Prior to any other site works |

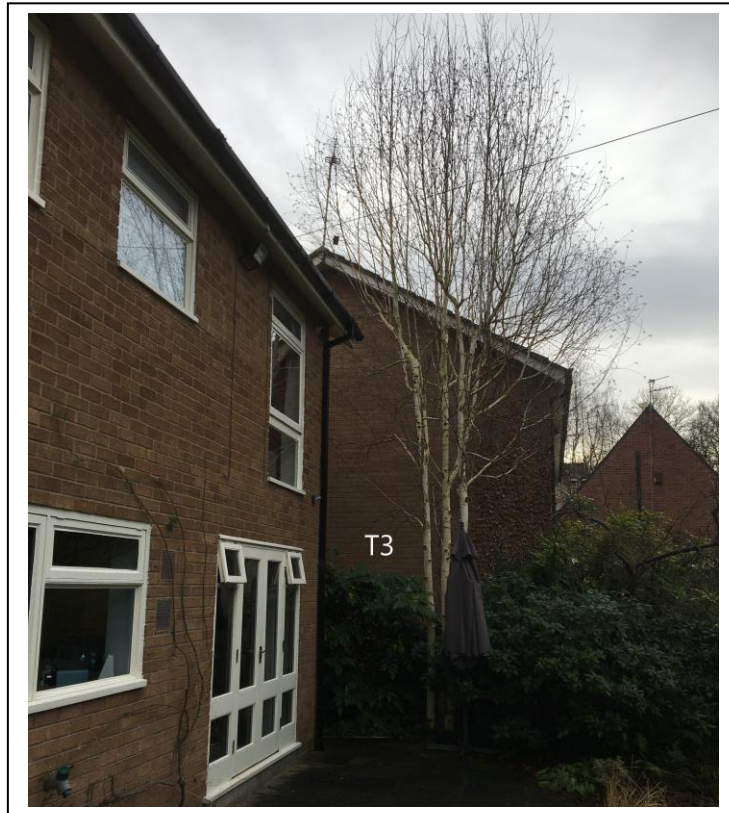
**Photo 03:**

**3.3.2** Tree T3 is a multi-stemmed Himalayan Birch which has been inappropriately planted adjacent to the rear corner of the building and the gable elevation of the neighbouring property (photo 03). The tree has recently been crown reduced, presumably to abate the nuisance of branch contact with the adjacent buildings. Also of note is that root growth from T3 is beginning to displace the surrounding patio paving, which may result in trip hazards (photo 04). Due to its future high growth potential, the long term practicality of T3 in this location is limited and its removal is recommended irrespective of the proposed building development. Similar to T2 and T7, T3 does not significantly contribute to the visual amenity of the street scene, (photo 05) and its removal would also most likely be unnoticed.
