**MANCHESTER OPERA HOUSE.**

**DESIGN, ACCESS AND HERITAGE STATEMENT**

**FOR THE REPAIR OF FAÇADE RENDER AND DECORATION**

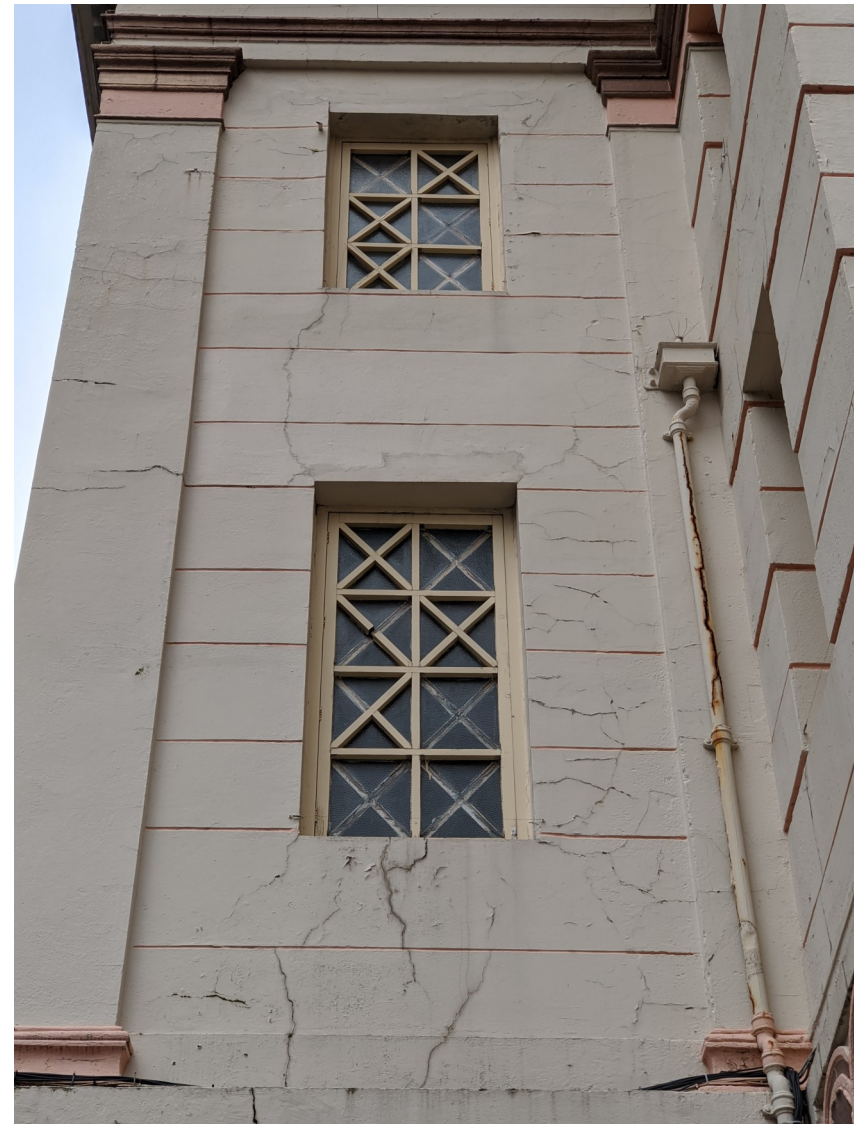
The front façade is currently looking tired and has areas of significant cracking. Paint decoration is dirty and there are areas that are peeling and flaking. To some of the decorative moulded sections render has cracked and fallen revealing some sections of exposed rebar.

Example of current render condition

The majority of the proposed works is localised repair of the façade render. This will involve cutting back render where cracked or hollow and applying new render and decoration.

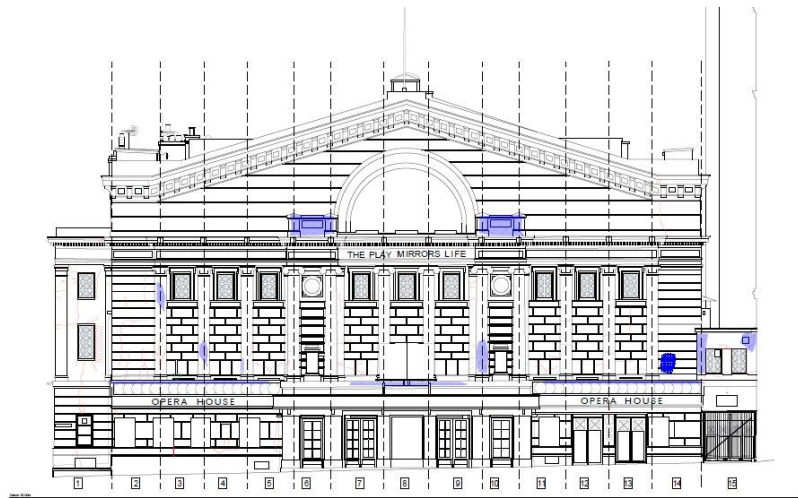
EXISTING QUAY STREET ELEVATION  
1:100

Defects survey taken from street level. Visual inspection only.

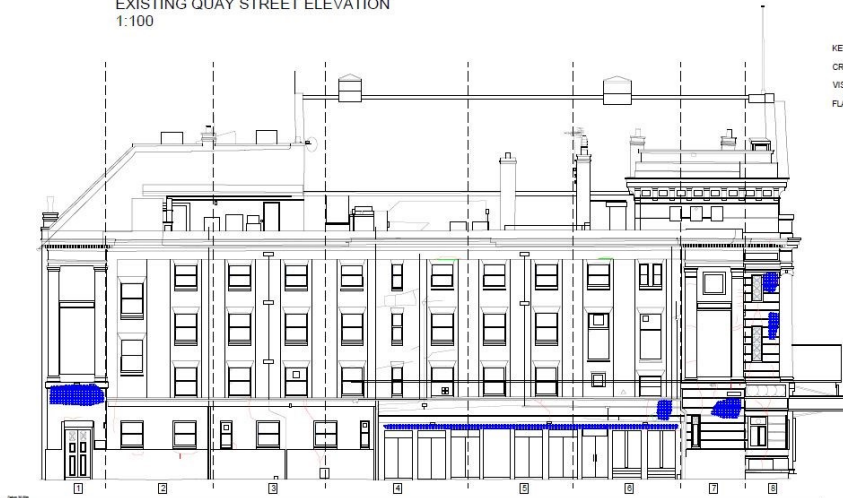
EXISTING BYROM STREET ELEVATION  
1:100

Whilst the majority of repairs are focused on the principal façade there are other areas that require additional attention including areas above door soffits on Byrom Street where render to lintels has failed and fallen in some instances.

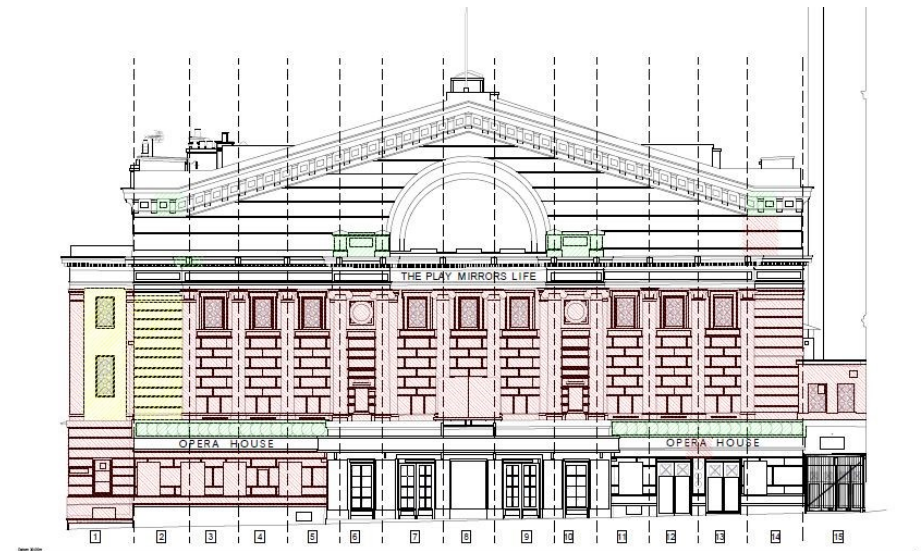
EXISTING QUAY STREET ELEVATION  
1:100

The drawings highlight that the front West corner of the building has the most issues with the render with a greater amount of cracking and delamination. In these areas it is proposed that the render is removed in its entirety and a new Keim Universal render is applied. The keim render should offer greater flexibility and uses mesh reinforcement within the render.

As with other areas of the façade it is proposed that the render is painted to match the existing colour scheme. It is proposed to use a Keim mineral paint to achieve better bonding with the substrate and also increased breathability to aid drying out of damp sections of the façade.
