## 2.3 Site Photographs - Existing Building

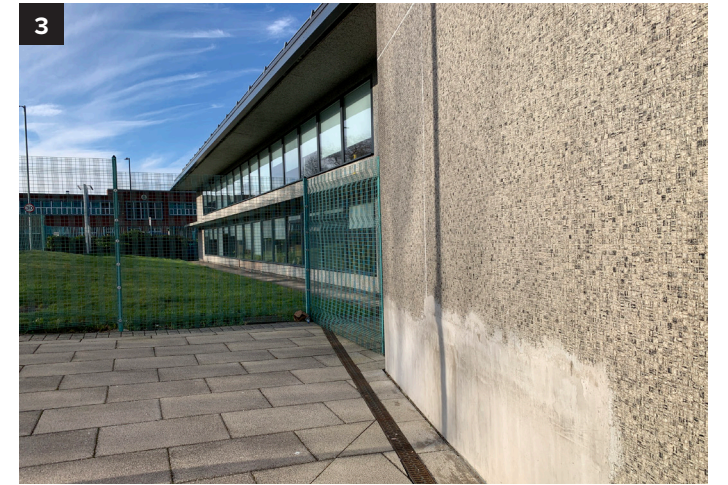
Existing condition of mini-mosaic tiles to south elevation at ground level

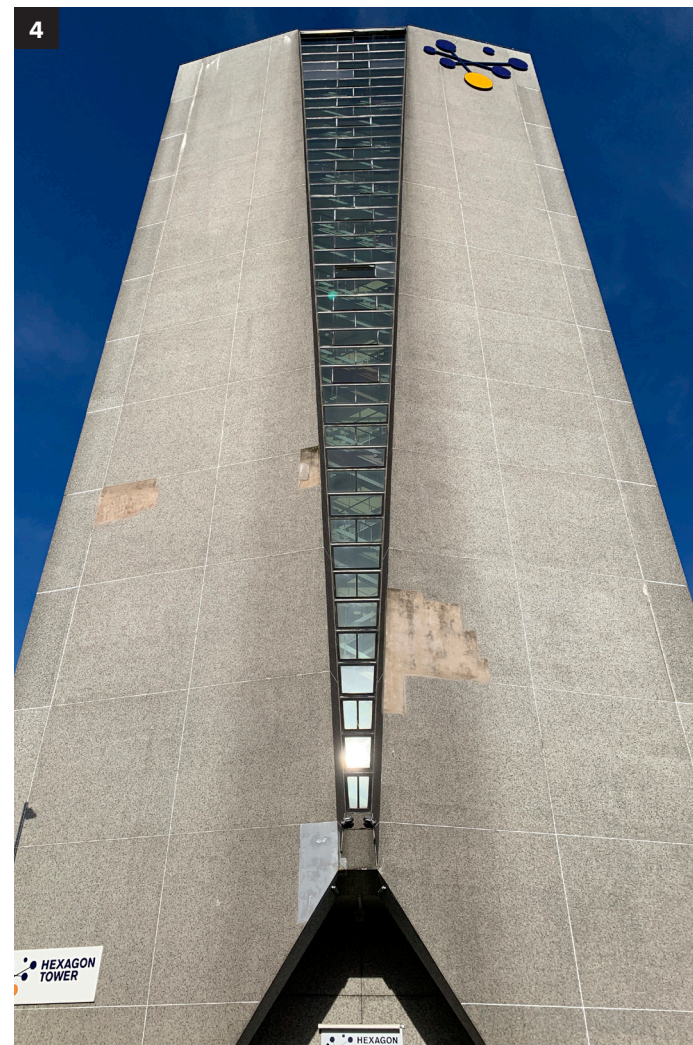
View looking up to tower; original joint lines visible; areas of mosaic delamination and remediation apparent.

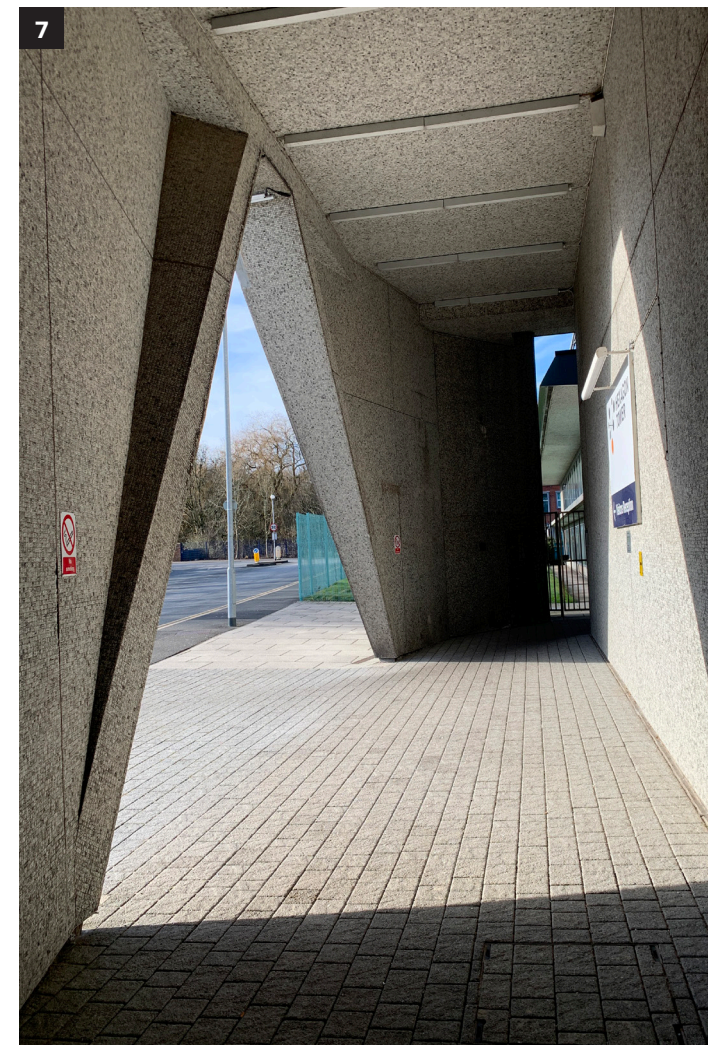
View within recessed entrance area to south elevation, showing mosaics to soffit and walls.
