## ARBORICULTURAL REPORT (BS 5837:2012)

FORMER DUCIE ARMS  
424 STOCKPORT RD  
MANCHESTER  
M12 4EX

April 2021

PM/BS/07/04/21

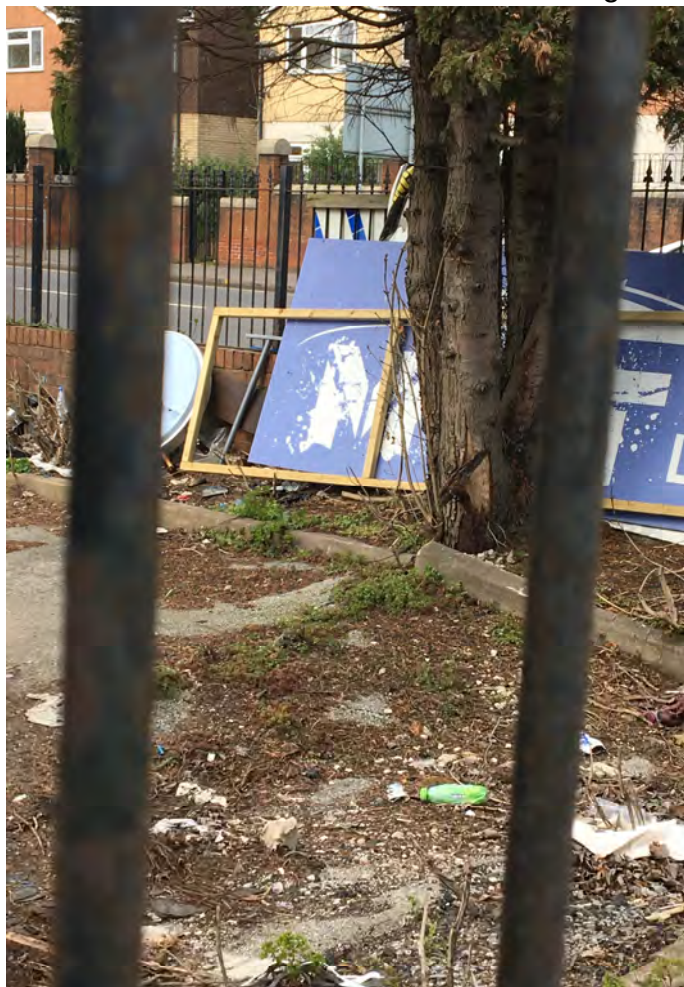
| Arboricultural Data Sheet: Former Ducie Arms, 424 Stockport Rd, Manchester, M12 4EX | | | | | | | | | | Date of Survey: 07/04/21 | | Weather: Dry | | Surveyor: PM | | |
|---|---|---|---|---|---|---|---|---|---|---|---|---|---|---|---|---|
| T3 | Lawson Cypress | 550 | 8 | EM | 2 | 2 | 2 | 2 | 2 | B/C | A multi-stemmed specimen with some damage at base and several broken branches. High crown from previous pruning. Major root disturbance to tarmac surfacing. Low potential. | n/a | 5-10 | U | 136.85 | 6.60 |

T3 - Buttress damage and major root disturbance

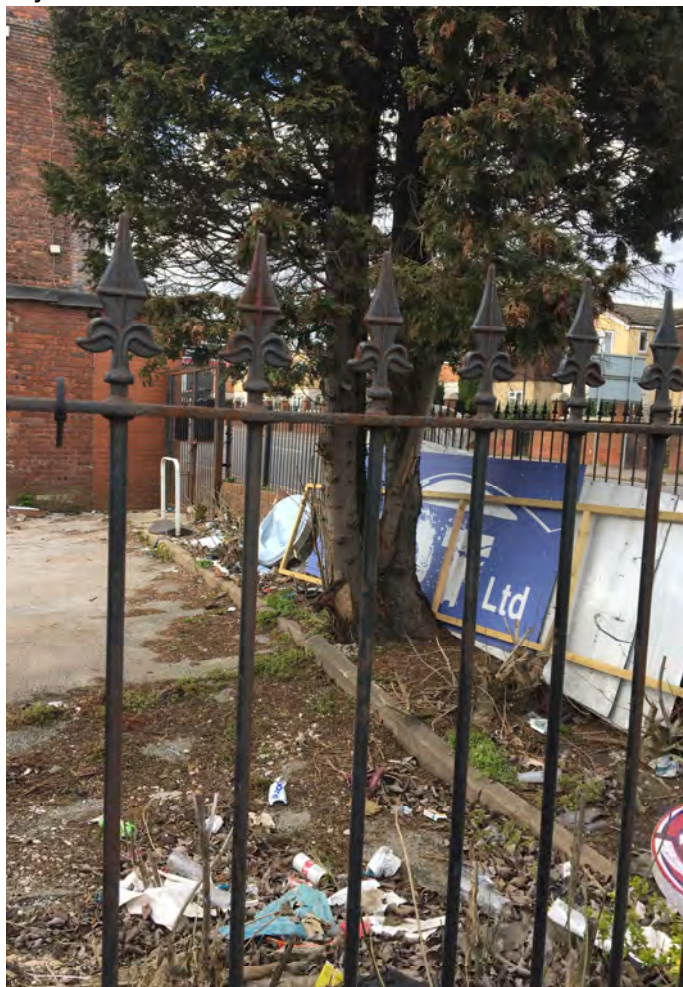
| Arboricultural Data Sheet: Former Ducie Arms, 424 Stockport Rd, Manchester, M12 4EX | | | | | | | | | | Date of Survey: 07/04/21 | | Weather: Dry | | Surveyor: PM | | |
|---|---|---|---|---|---|---|---|---|---|---|---|---|---|---|---|---|
| Scrub | Ash & Buddleia | - | <2 | Y | 1 | 1 | 1 | 1 | 0 | C | Adventitious self-sown minor scrub due to site neglect. | Remove. | 0-5 | U | - | - |

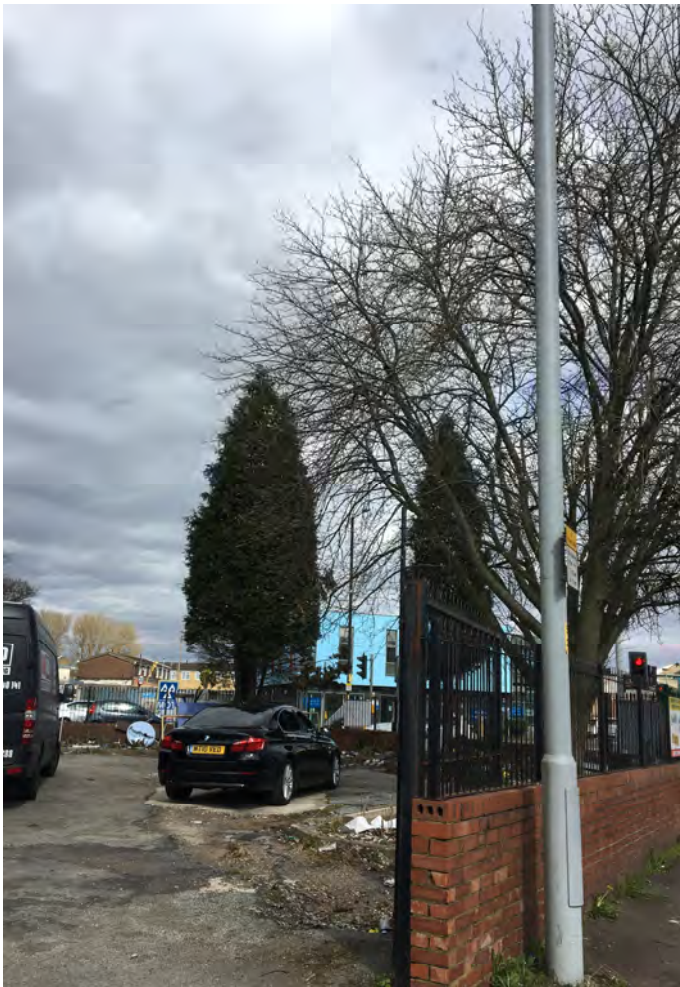
| Arboricultural Data Sheet: Former Ducie Arms, 424 Stockport Rd, Manchester, M12 4EX | | | | | | | | | | Date of Survey: 07/04/21 | | Weather: Dry | | Surveyor: PM | | |
|---|---|---|---|---|---|---|---|---|---|---|---|---|---|---|---|---|
| T2 | Lawson Cypress | 180 | 6 | EM | 1 | 1 | 1 | 1 | 2 | B | A minor specimen located adjacent to boundary wall. High crown due to previous pruning. Minor root disturbance to tarmac surfacing. Low potential. | n/a | 10+ | C2 | 14.66 | 2.16 |
