# ARBORICULTURAL IMPLICATIONS ASSESSMENT

PROPOSED DEVELOPMENT

POTATO WHARF  
CASTLEFIELD

Author: C. Salisbury  
Date: 16 January 2021  
Ref: TRE/PW/Rev A

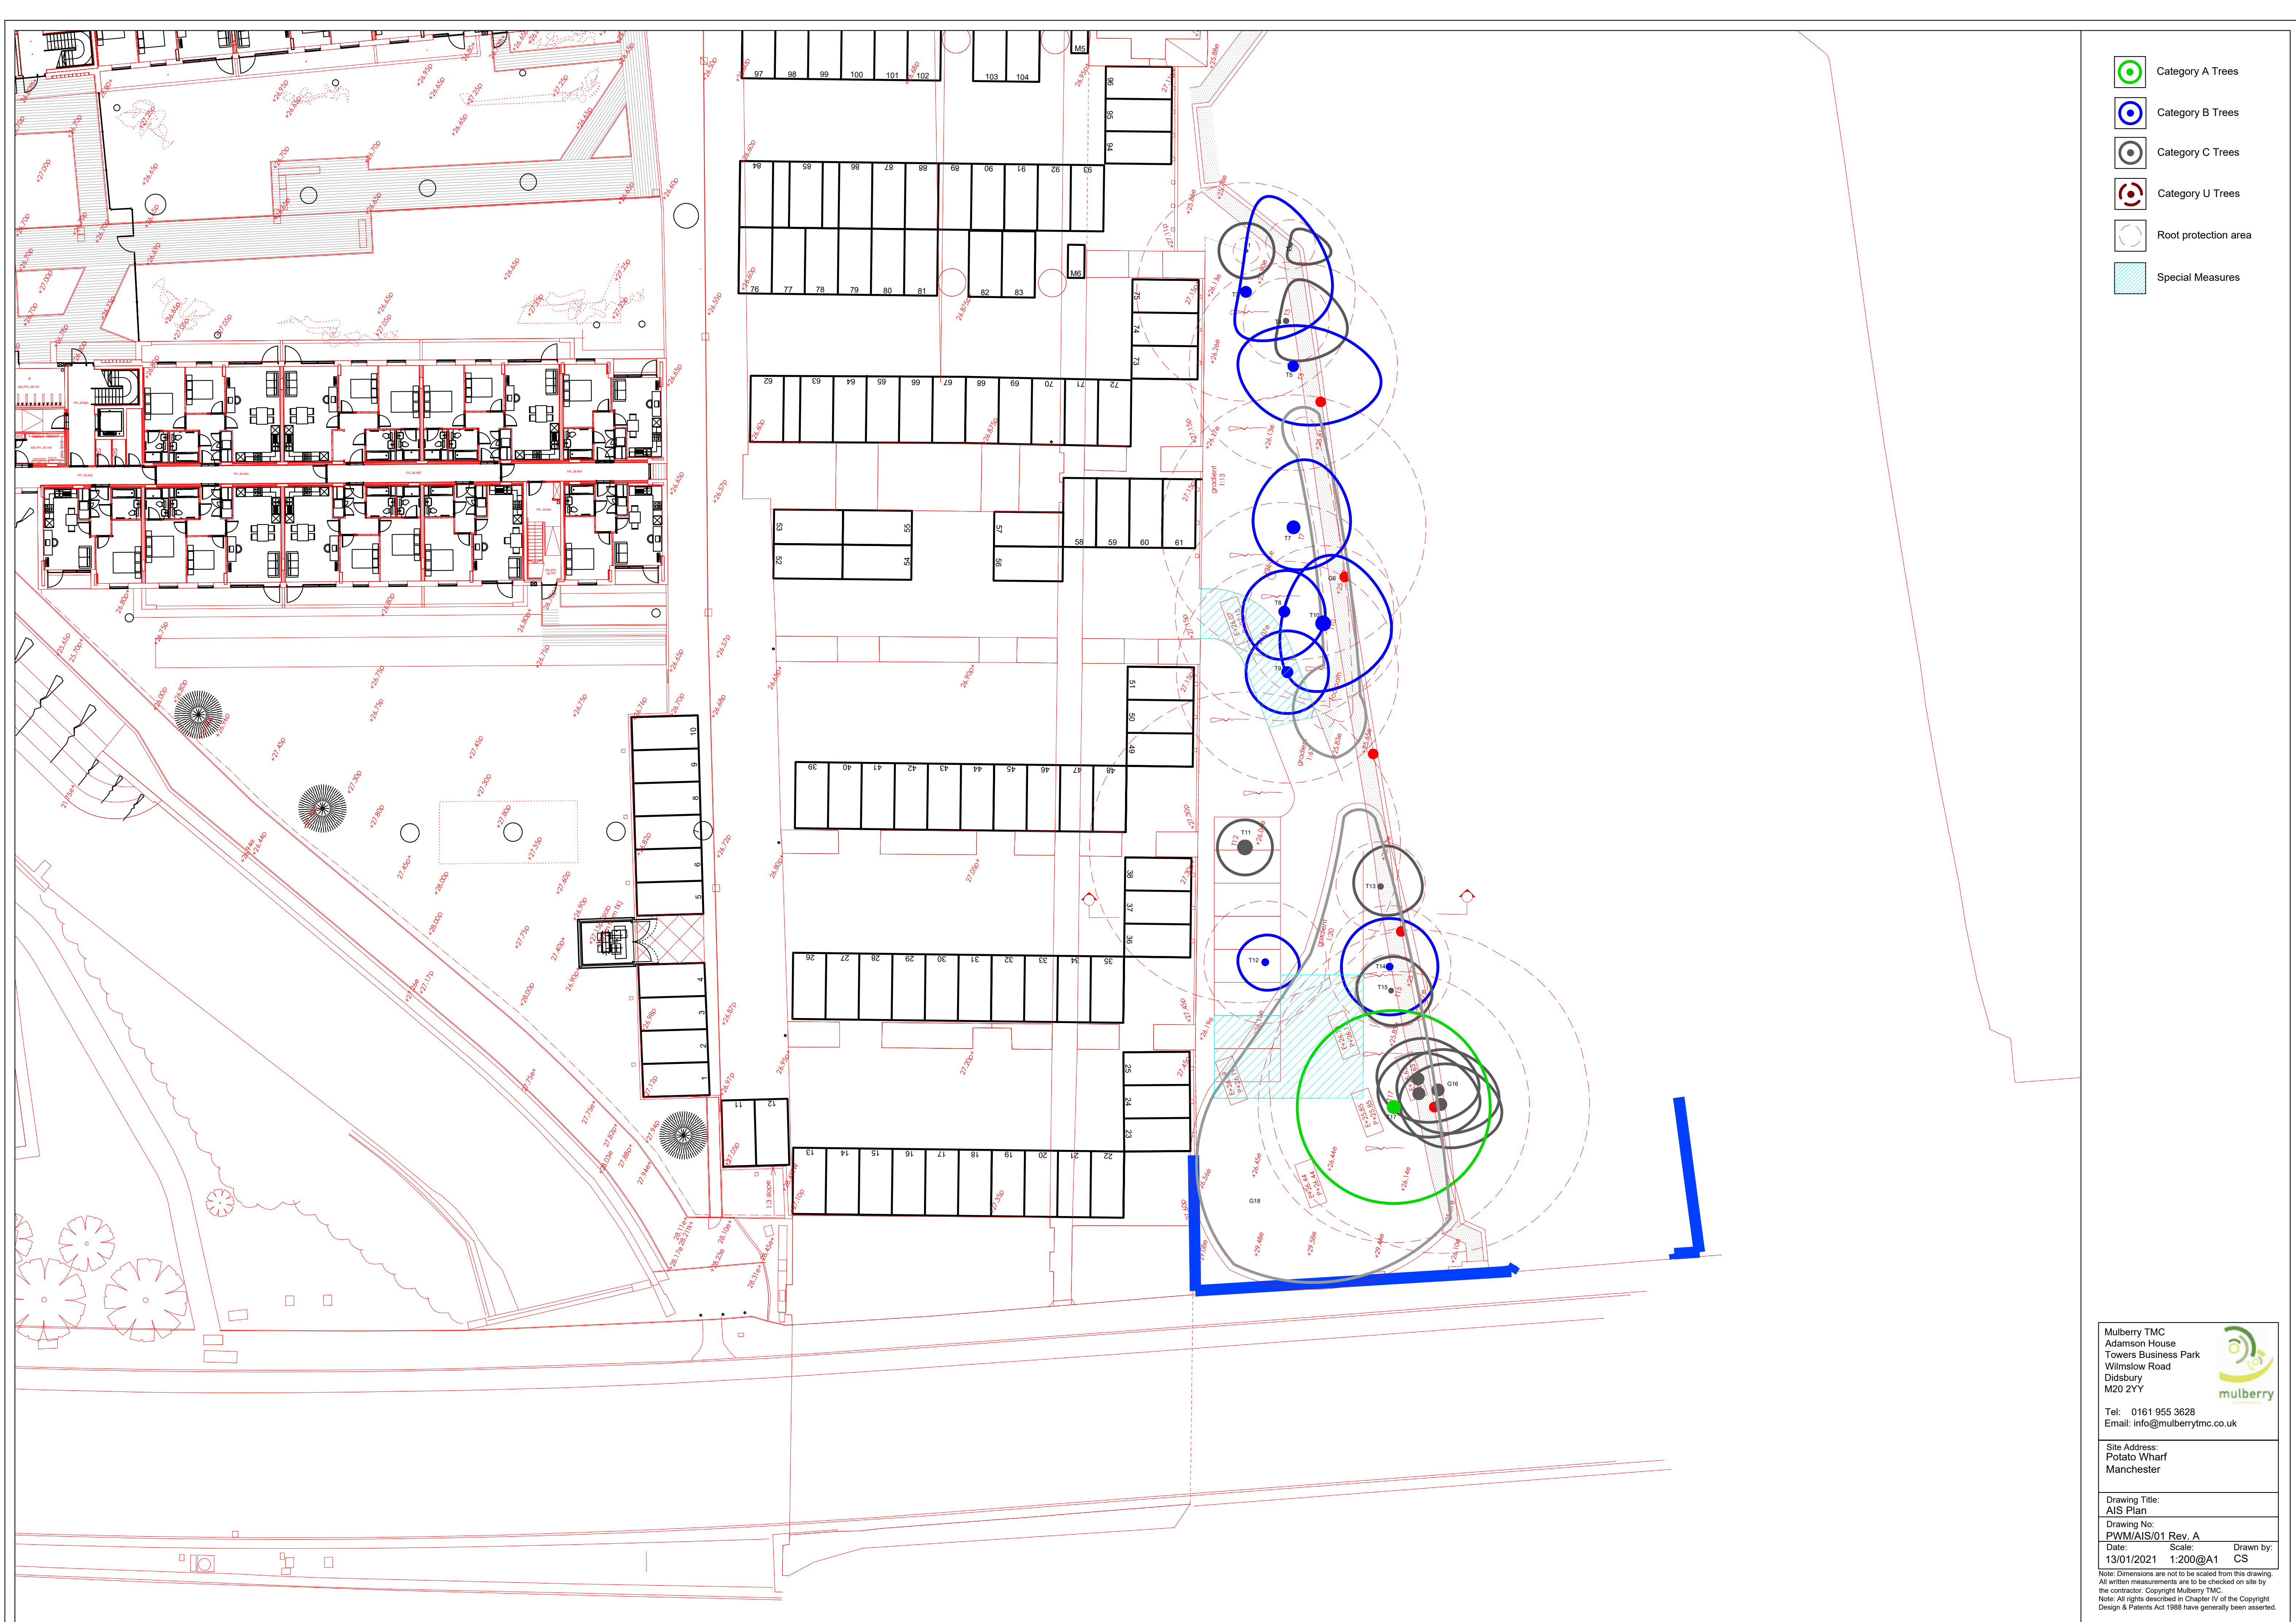
## **Plans**

- 2.1 Due to the proposed development and its associated infrastructure there are a number of locations where the proposals are in close proximity to the trees surveyed. The Site Layout Plan within appendix three identifies the trees in relation to the proposed development.
- 2.2 In order to fully assess the impact of the proposals an Impact Table has been created detailing each tree, which shows the proximity of the associated works to the tree.
